## BAD PRACTICE 不良作业方式

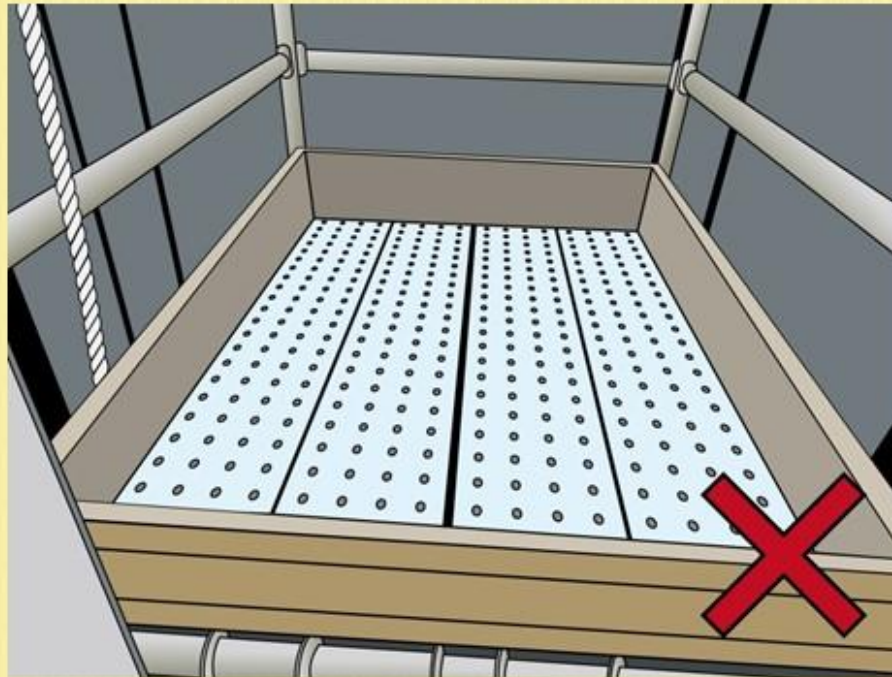
**No stairs / ladders were observed as the safe means of access and egress to the lift pit.**

没有提供安全的楼梯/梯子进出升降机槽底。

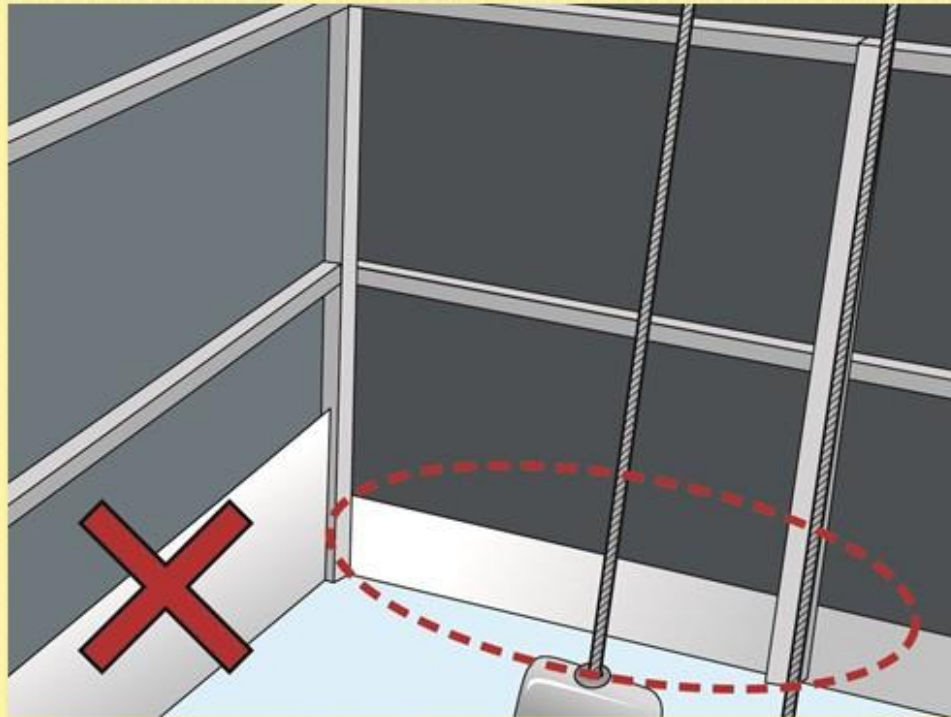
A portion of toe-board was found not up to the required 200MM height

部分踢脚板发现不够所需的200MM高度。

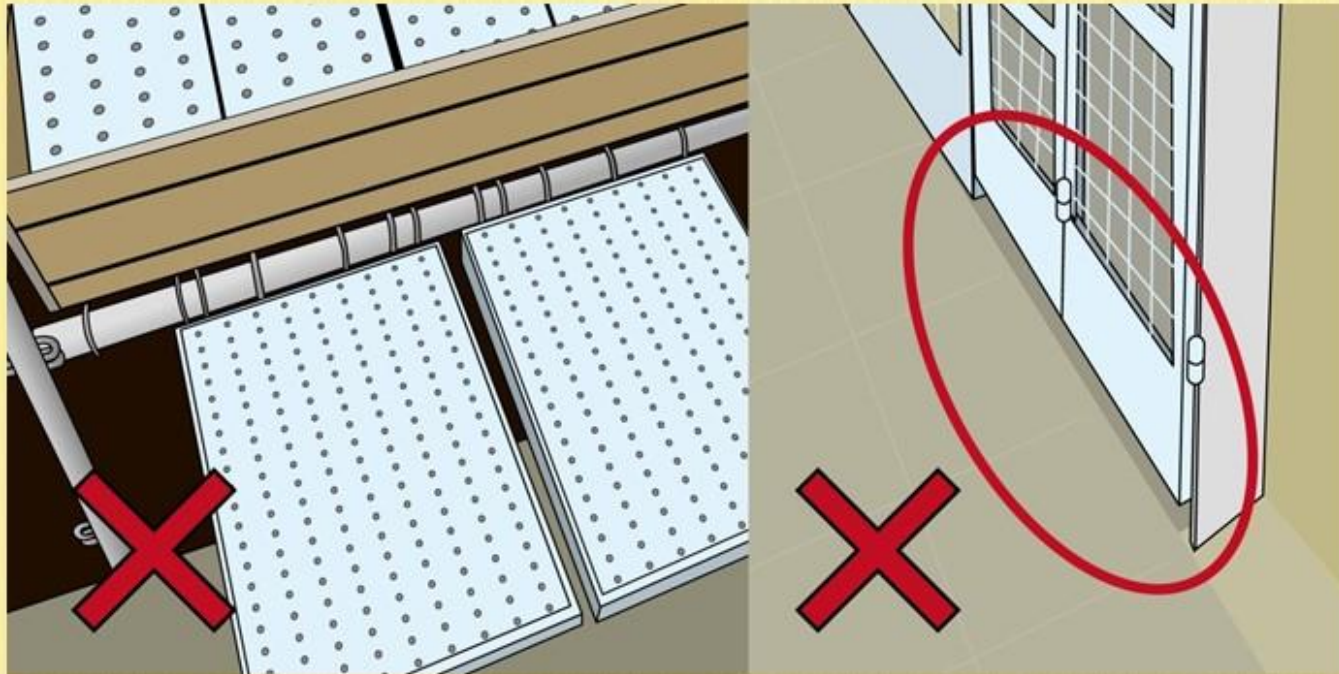
**Gaps were found at the access and the toeboard of the gate - room to improvement**

通道及踢脚板上发现空隙

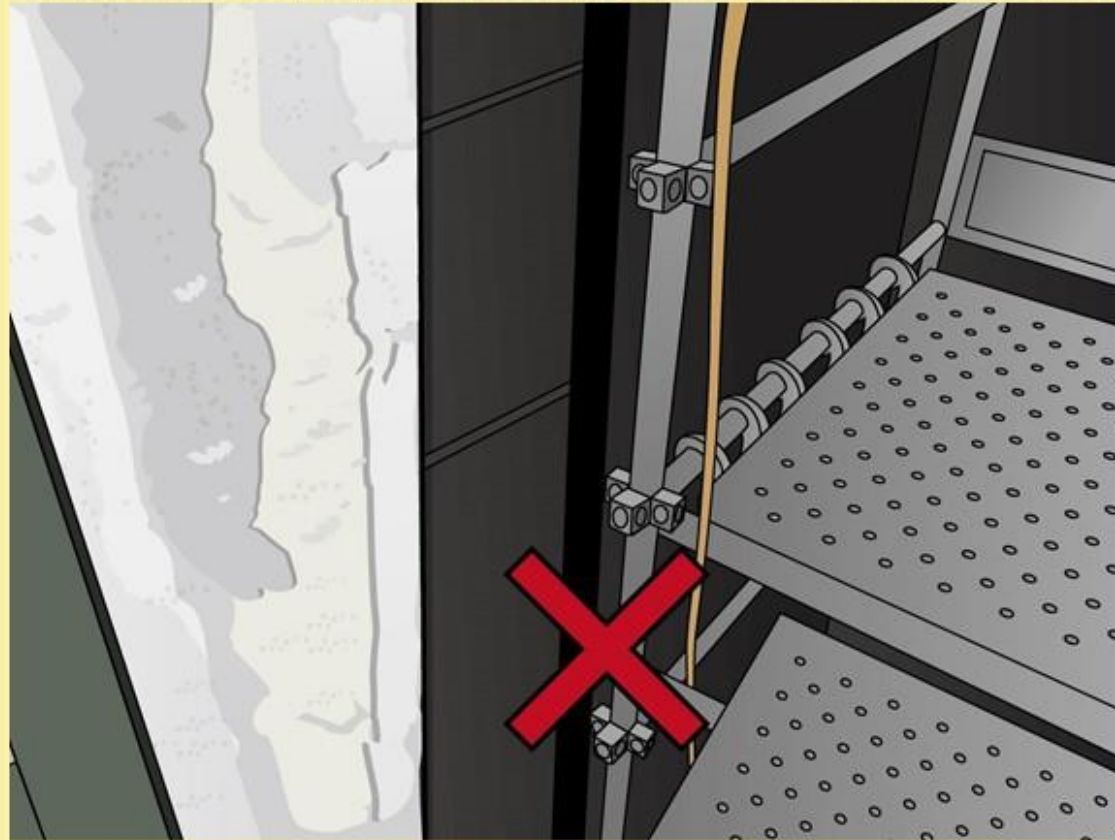
Dangerous edge was not guarded and toeboard was found missing 危险的边缘未有保护好及没有踢脚板

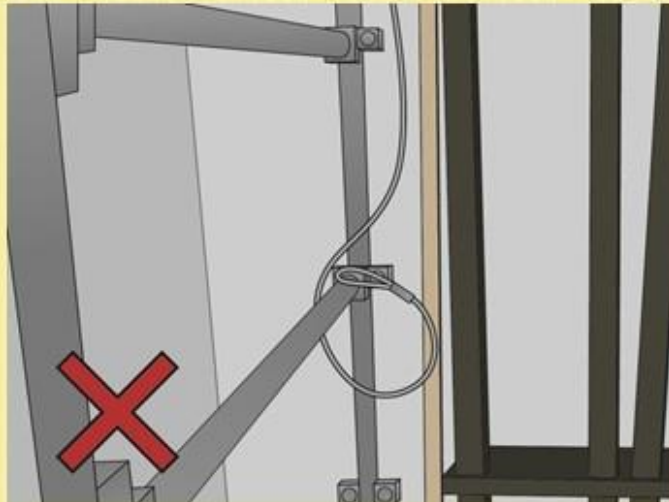
Wire sling was found without colour code 吊索被发现没有喷上颜色代码。

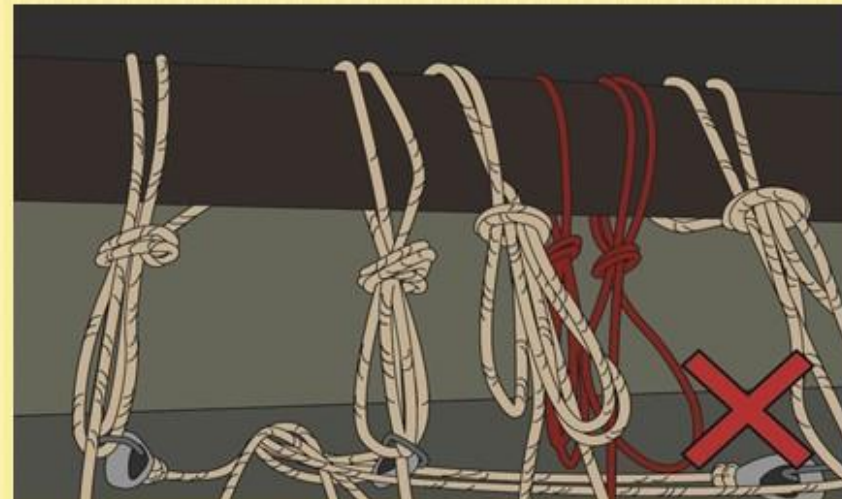
Independent life line provided at lift shaft. However, the loading capacity should be further checked and confirmed to meet the COP requirement 虽然升降机槽已提供独立救生绳，但承载能力应进一步检查和确认。

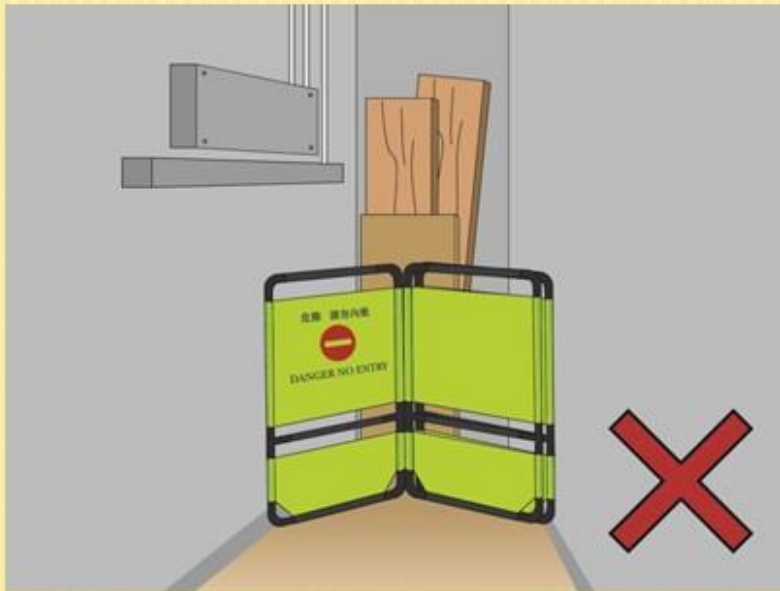
Materials should be cleared off  
in the public area 物料不应该  
堆放在公共区域

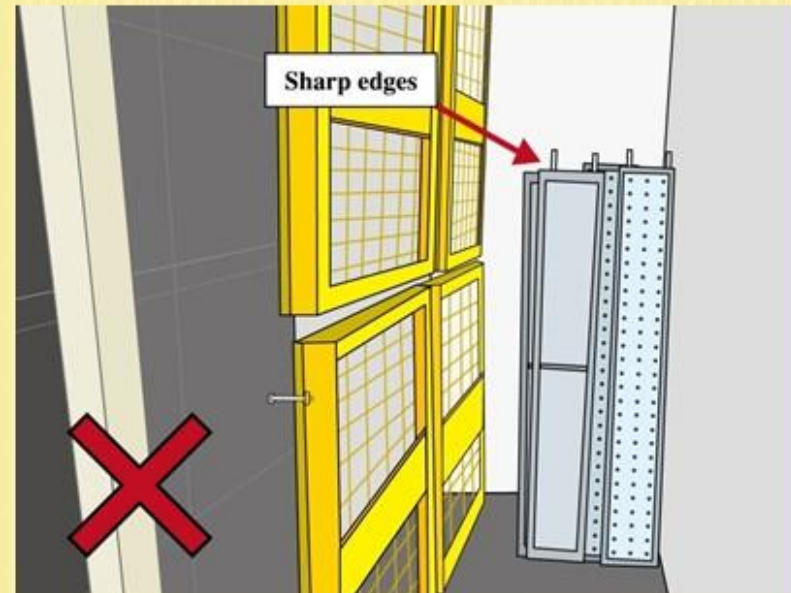
Stored materials were not fixed  
properly.  
不安全的物料堆放

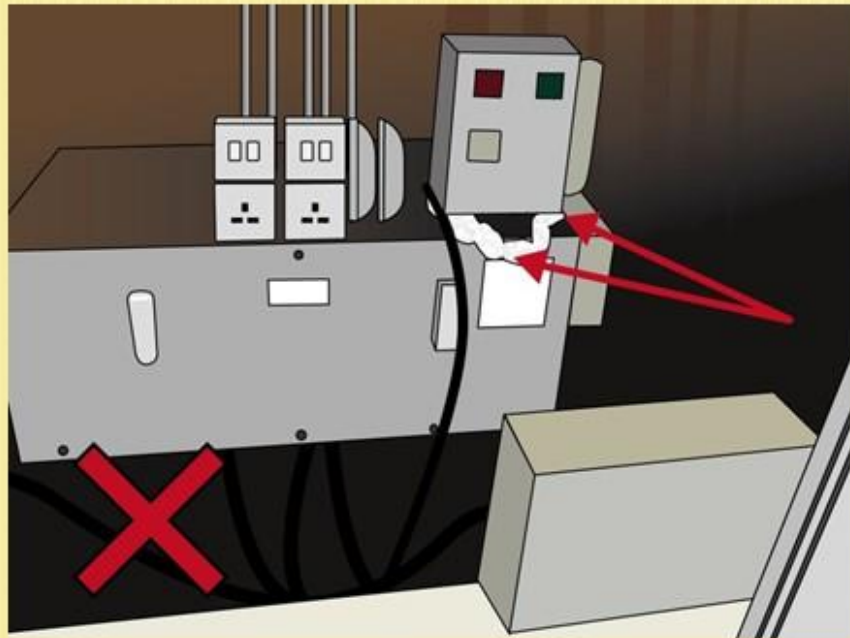
Improper waste disposal on top of the lift car was observed 电梯轿厢的顶部有废物堆放。

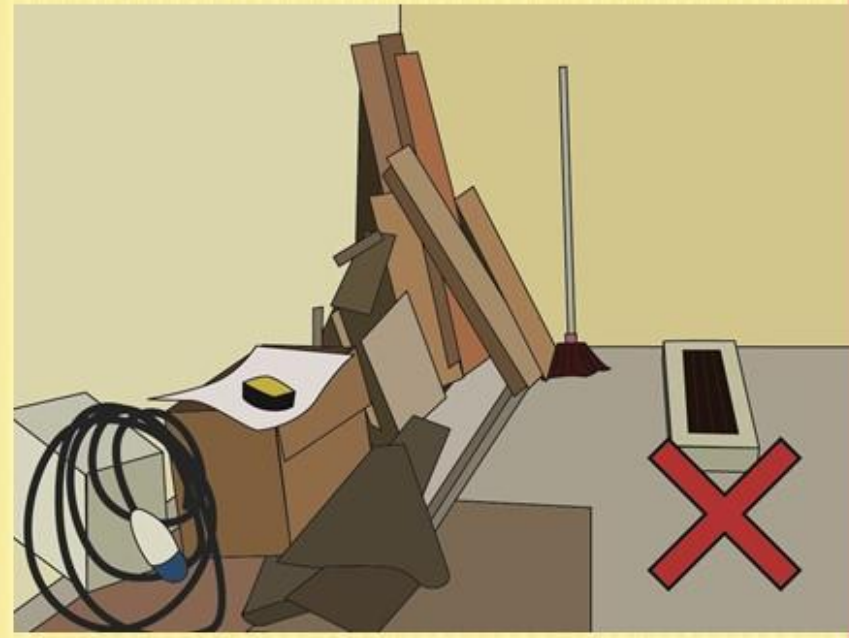
Construction materials should be stored properly in the machine room 在机房施工材料应妥善保存。

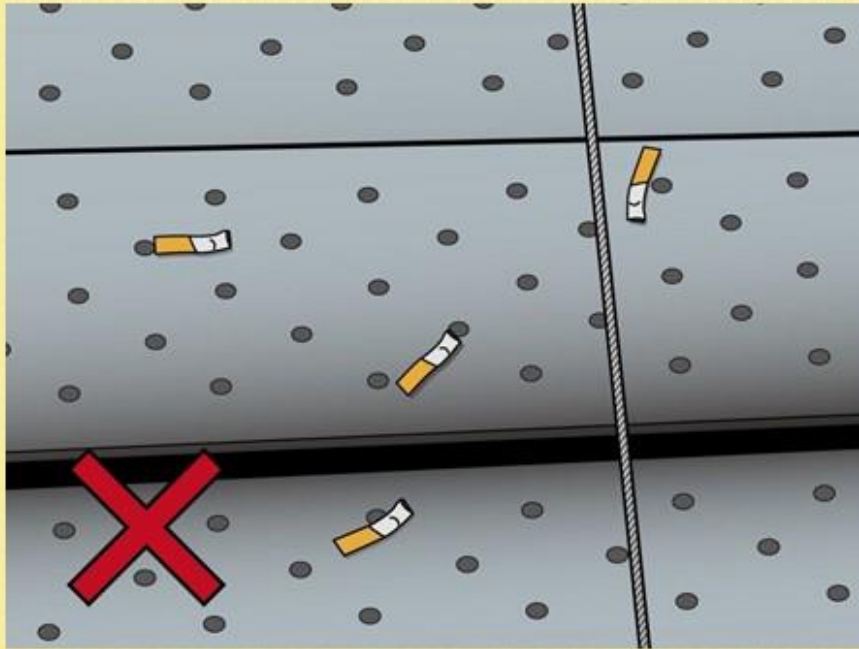
Cigarette ends in workplace  
在工作场所弃置烟蒂

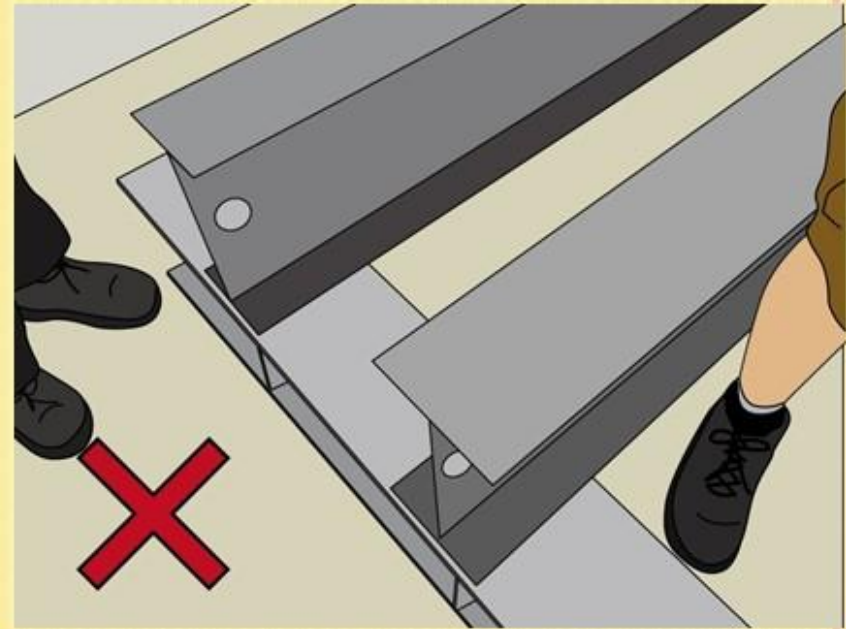
Sharp edges of H-beams in lift machine  
room should be adequately protected.  
在电梯机房的锋利的边缘应得到充分保护。

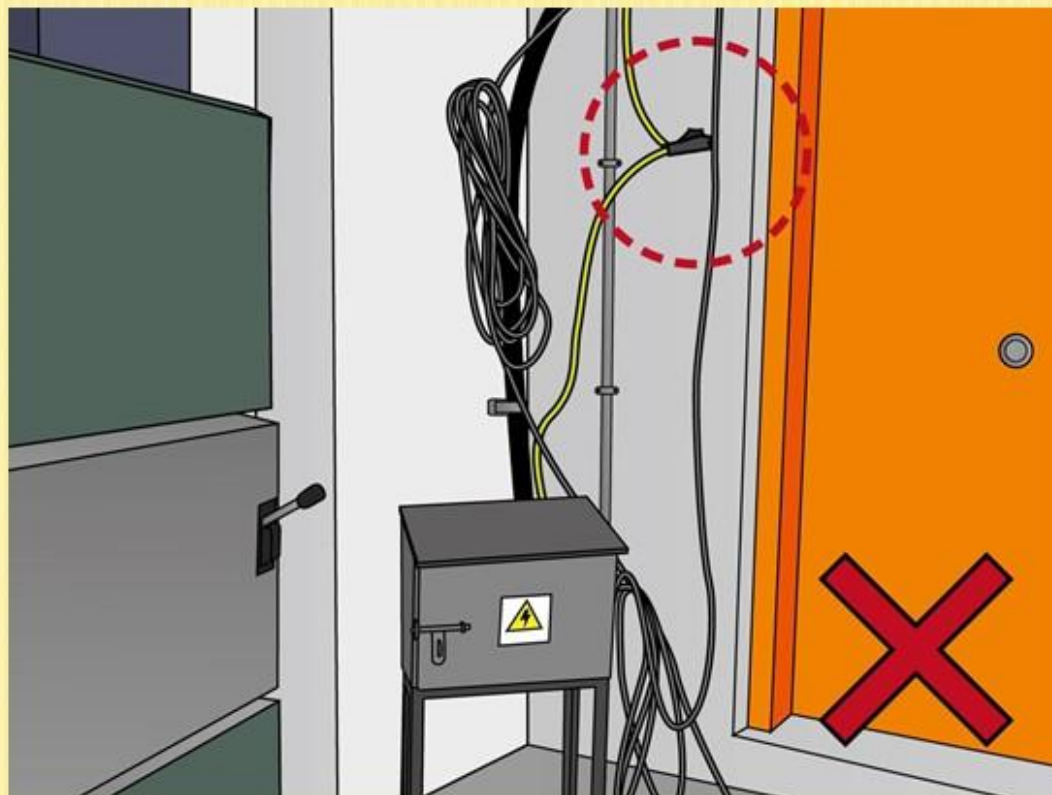
**The bonding line should be maintained in a good condition** 接合线应保持在良好状态

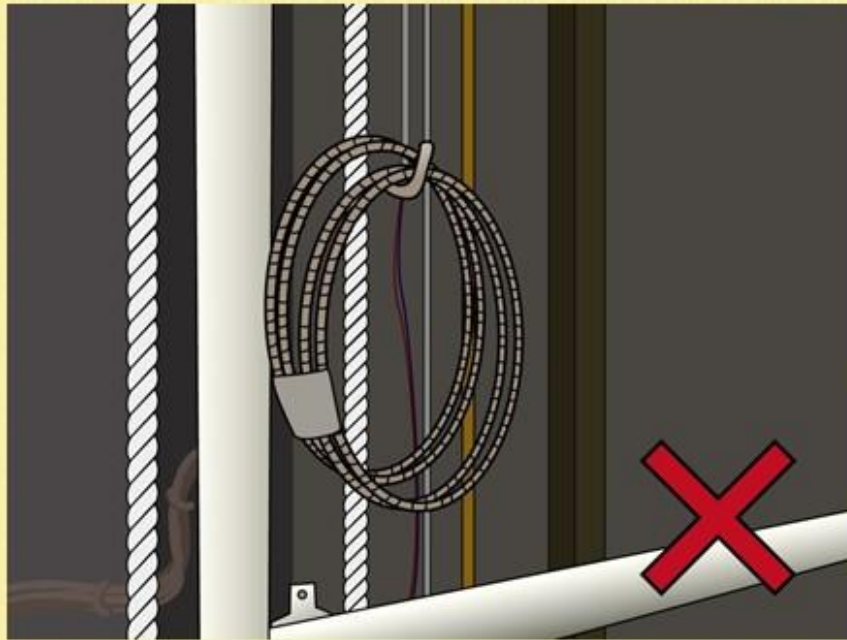
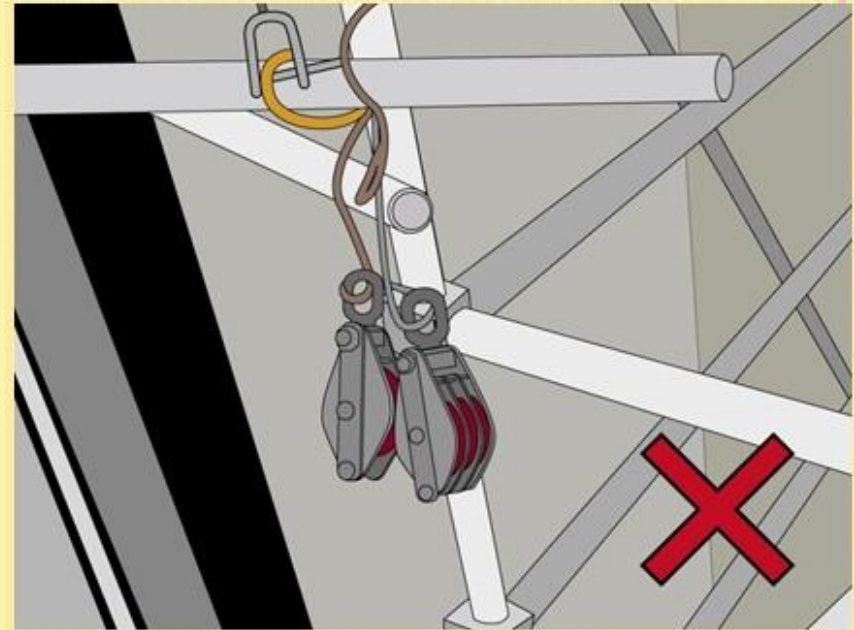
Lifting gear inside the lift shaft did not have proper colour code

升降机槽内的起重装置欠缺颜色代码

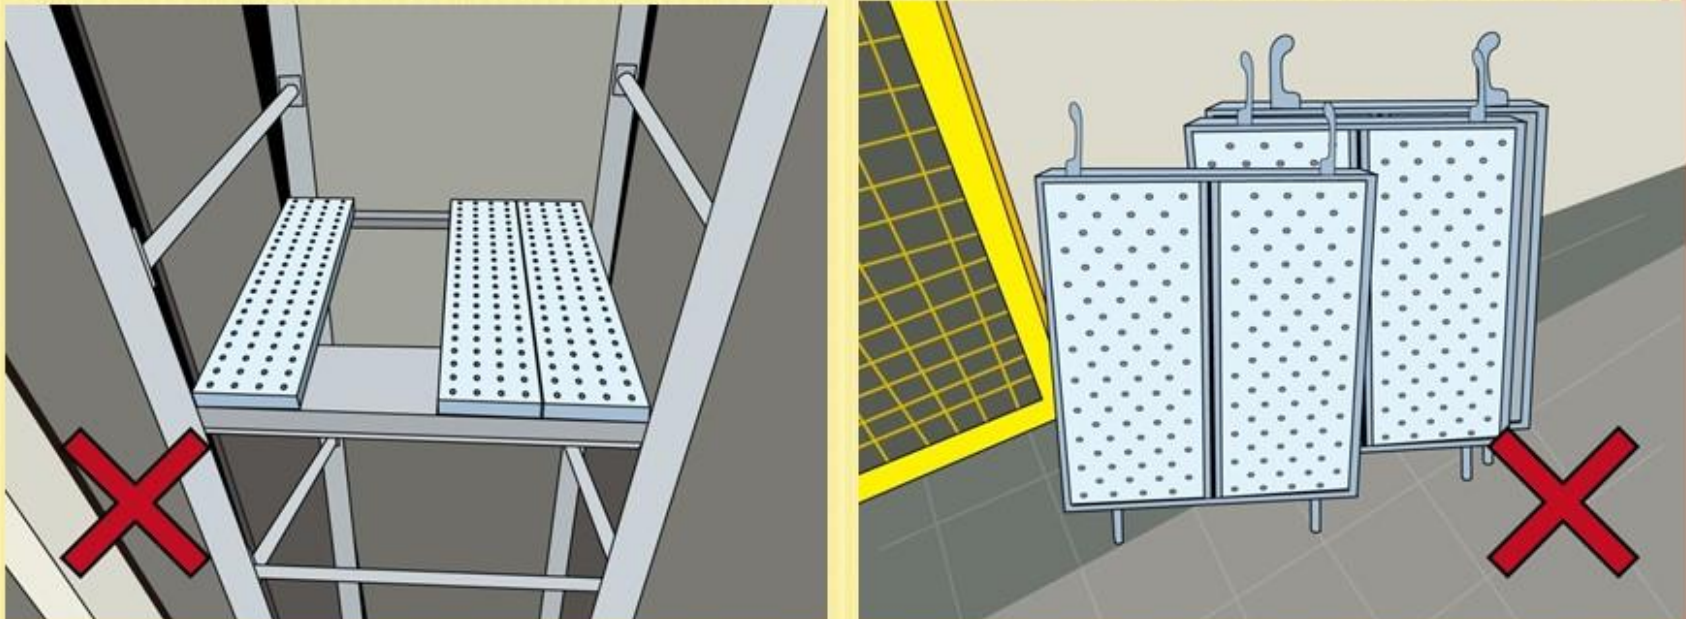
Working platform of the metal scaffold inside the lift shaft was not provided with full set of planking / toe-boards / guard-rails 未有装好地台板/ 踢脚板/ 安全围栏的工作平台

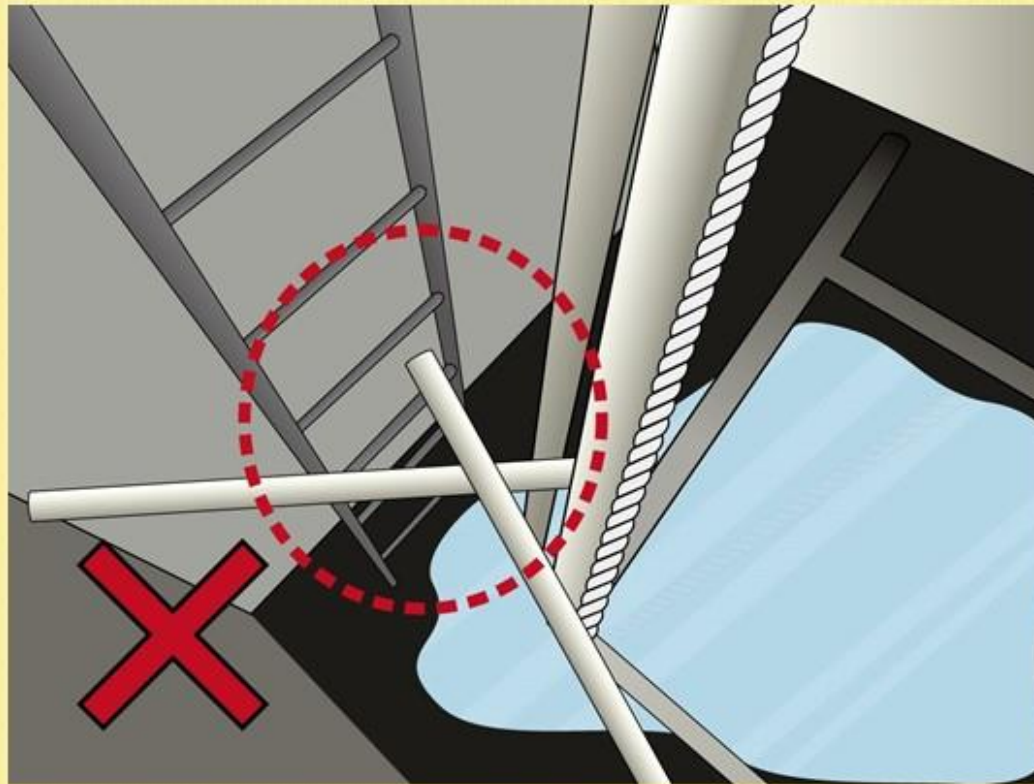
Cat-ladder was obstructed by the tieback. Stagnant water was observed in the lift pit

爬梯(猫梯)被系杆阻塞, 升降机槽底部有积水

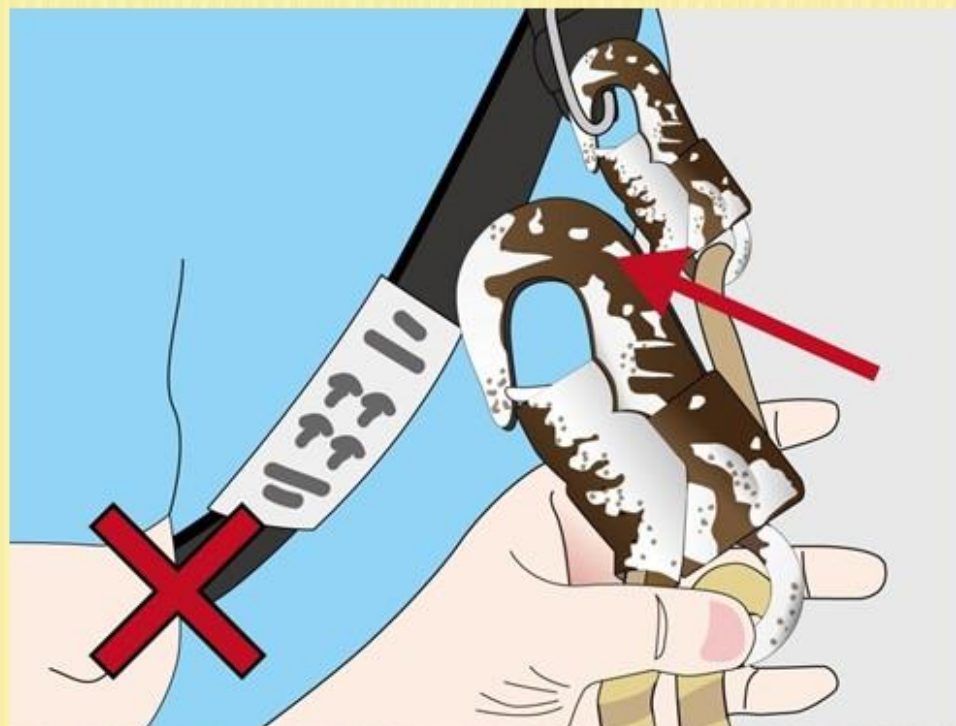
Substandard Lanyard of Safety Harness  
防墮裝置(安全帶防墮扣)未有保養好

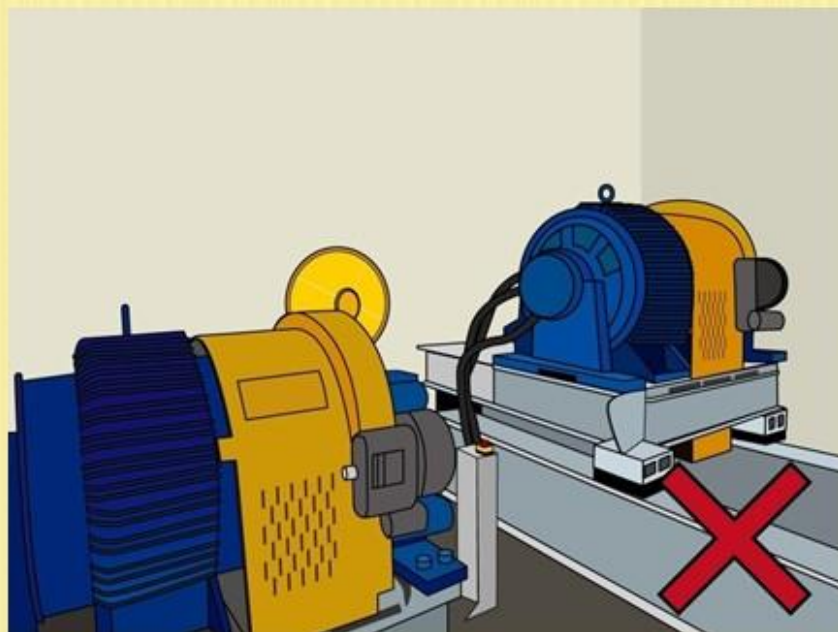
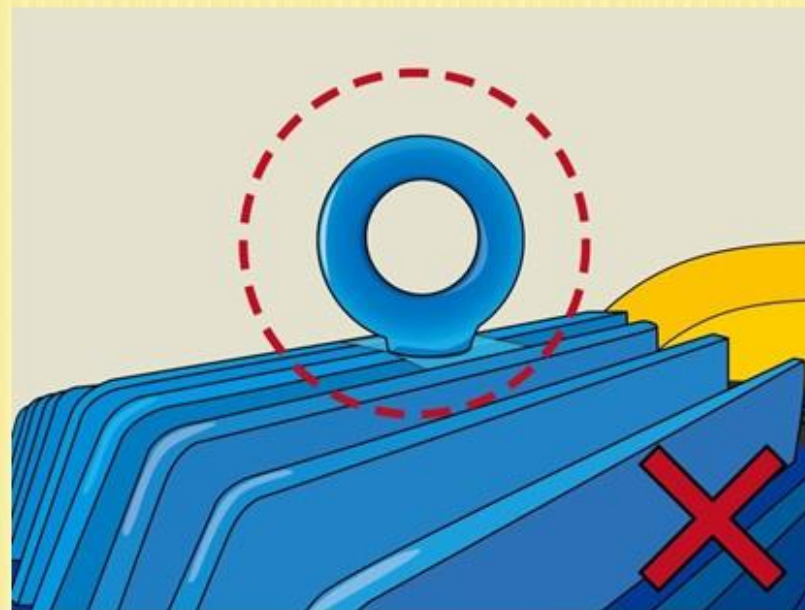
Unable to present the test certificate of the lifting eye during the audit verification on site 未能出示防坠装置锚固点的检验证书

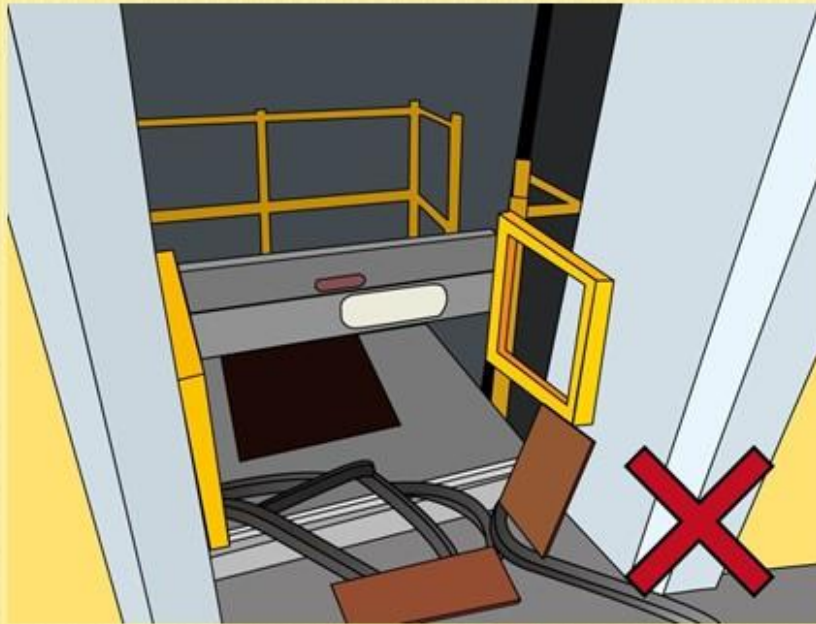
Poor Housekeeping at the access  
升降机槽出入口欠妥善整理

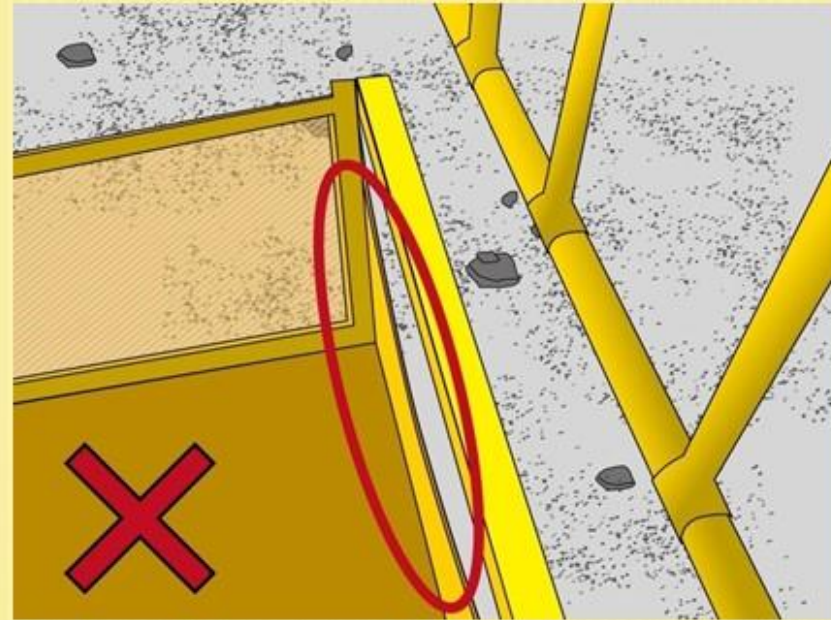
Improper Protection of Sharp Material  
锋利物料保护不当

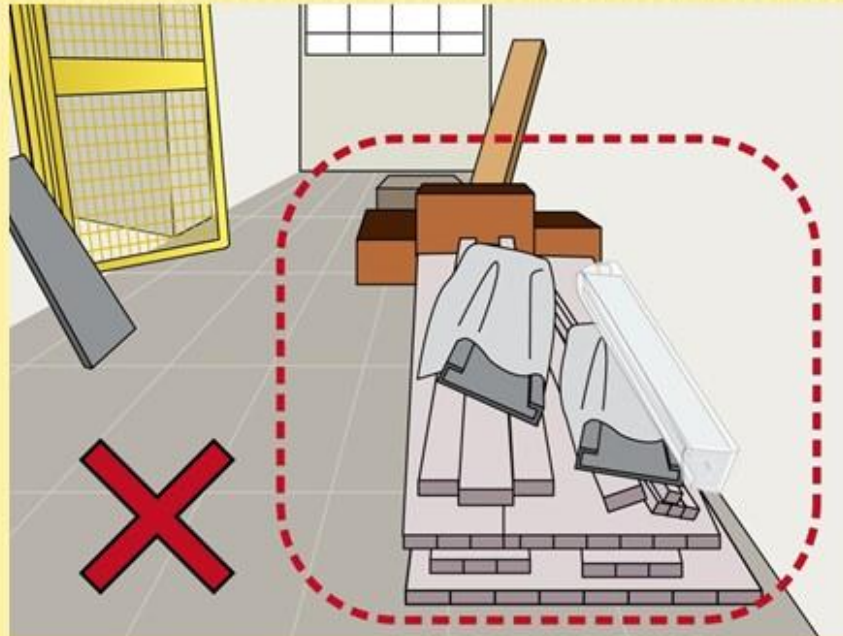
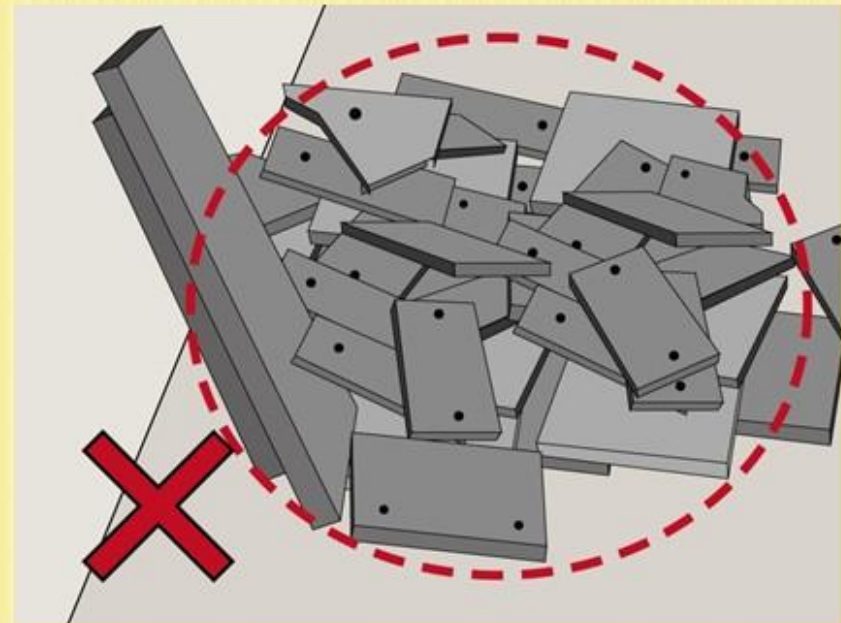
Workplace was not Maintained in Good Condition

工地设施欠妥善整理

- 1) add barrier to separate the storage area
- 2) container should be provided to store small objects

- 1)使用围栏分隔物料储存区域
- 2)提供存箱子储较小的物料

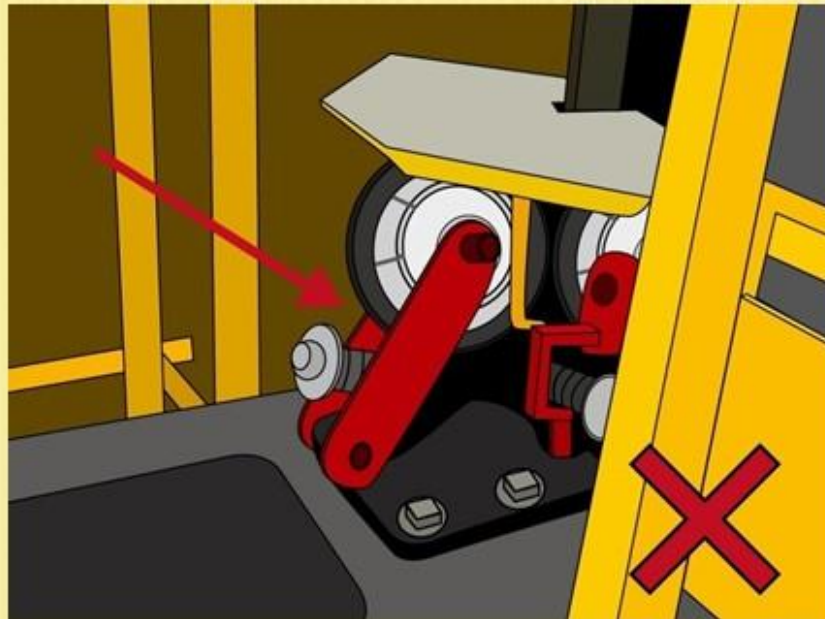
In-running roller have gap with proper protection 运行中滚轴有缝隙，保护不当

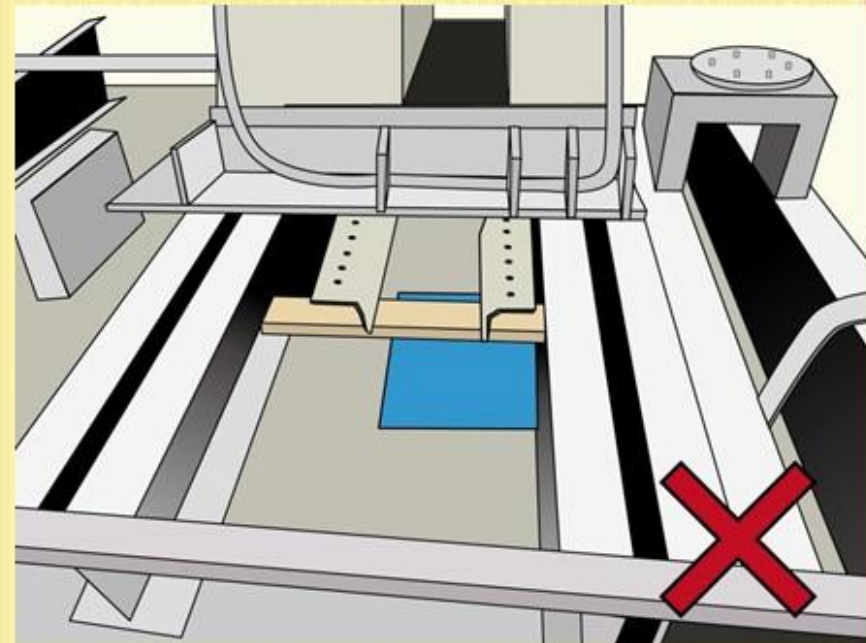
The small openings should be protected by the timber plates instead of the polyfoam

开口保护不当，应用较坚固料盖好

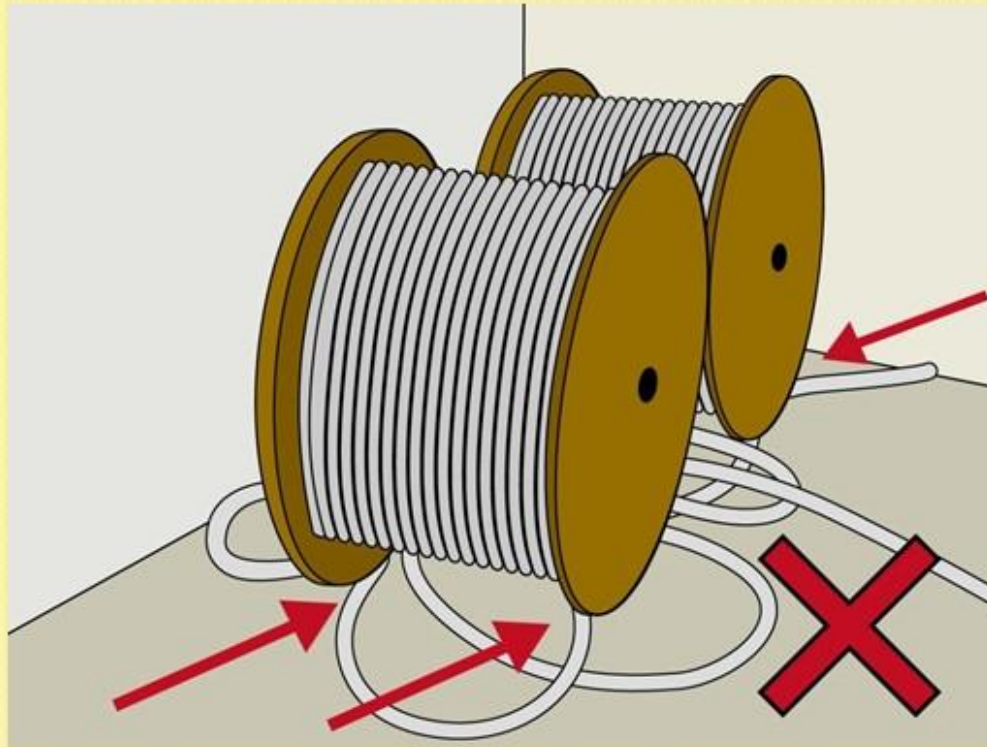
Improper Wedge of Cable Drums  
电缆滚筒欠妥善整理

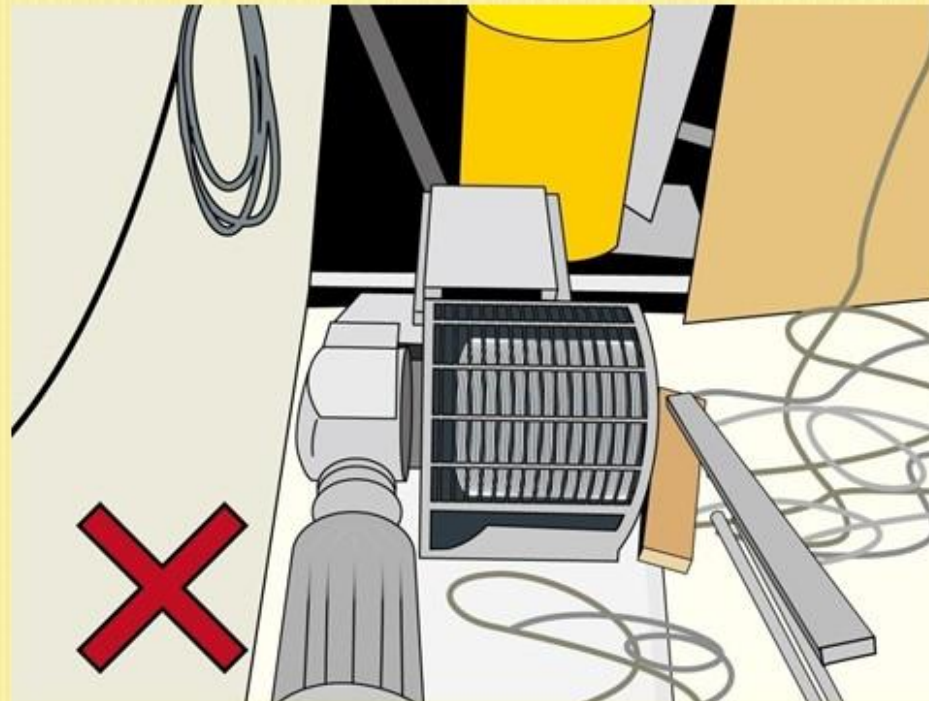
Improper Guarding on Electrical Winch  
电器绞盘保护不当

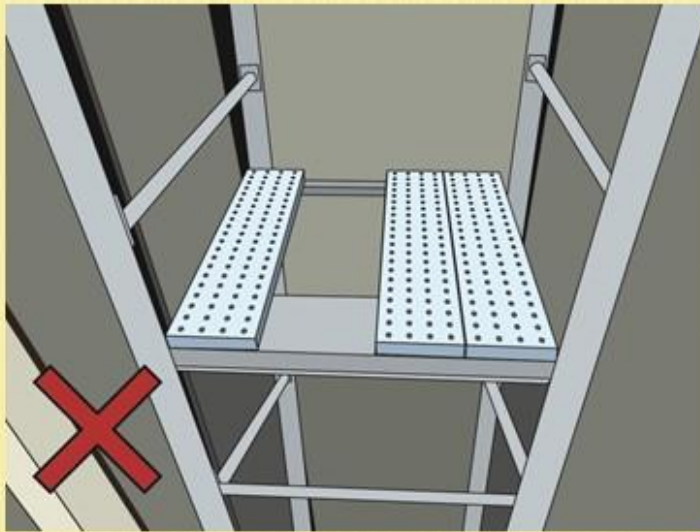
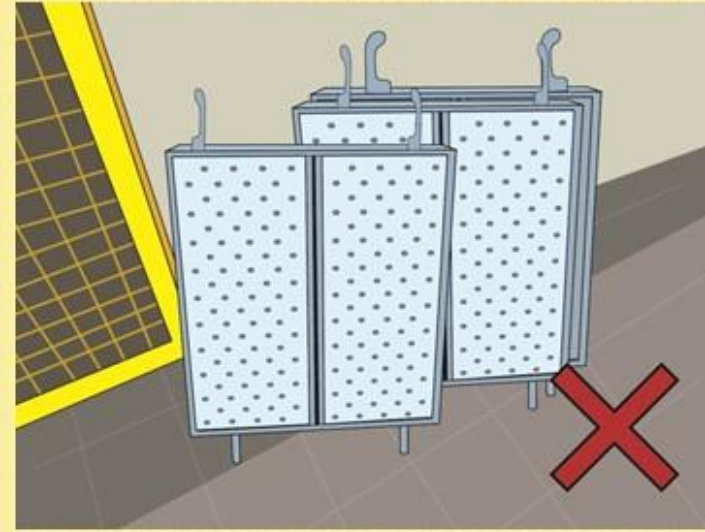
- Working platform was not provided together with full set of planking / toe-boards / guard-rails in the metal scaffold inside the lift shaft
- 未有装好工作平台的地台板/ 踢脚板/ 安全围栏

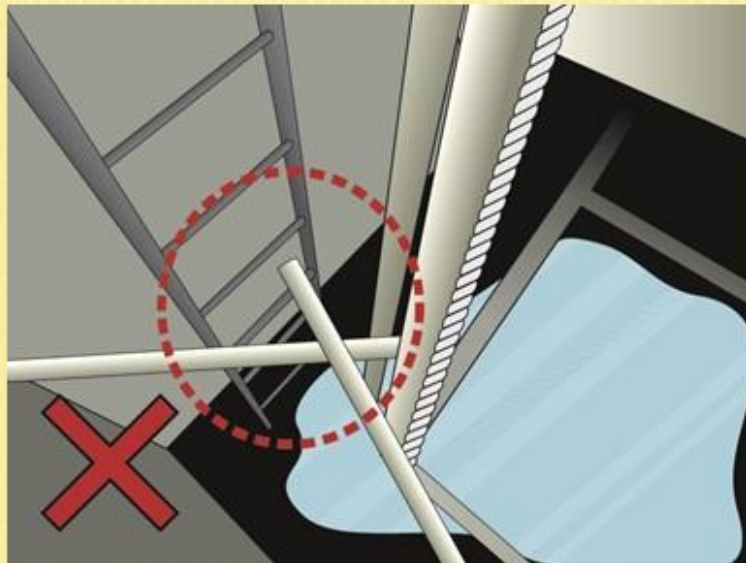
- Cat-ladder was obstructed by the tieback, stagnant water was observed in the lift pit
- 爬梯(猫梯)被回接管阻塞, 电梯槽底部有积水

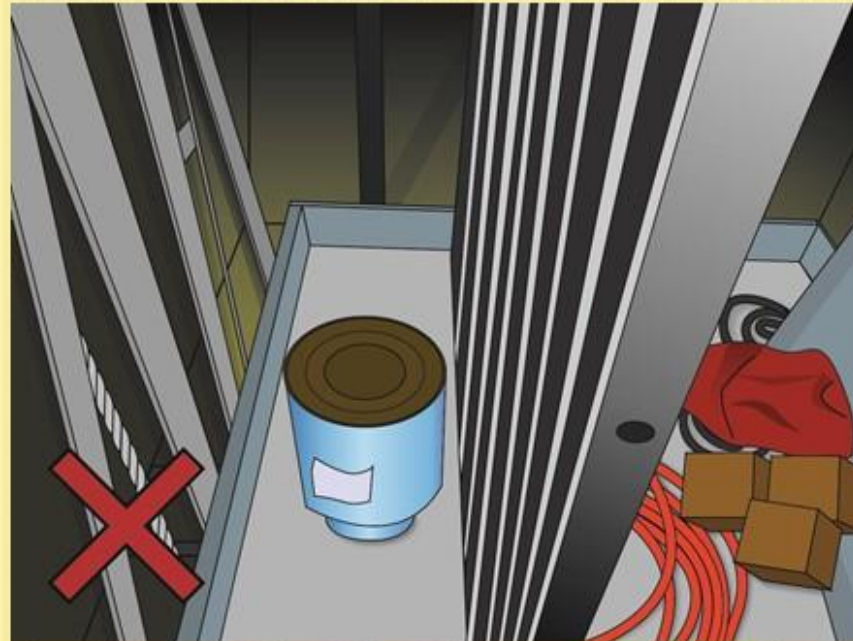
- Improper working platform
- 不当工作台

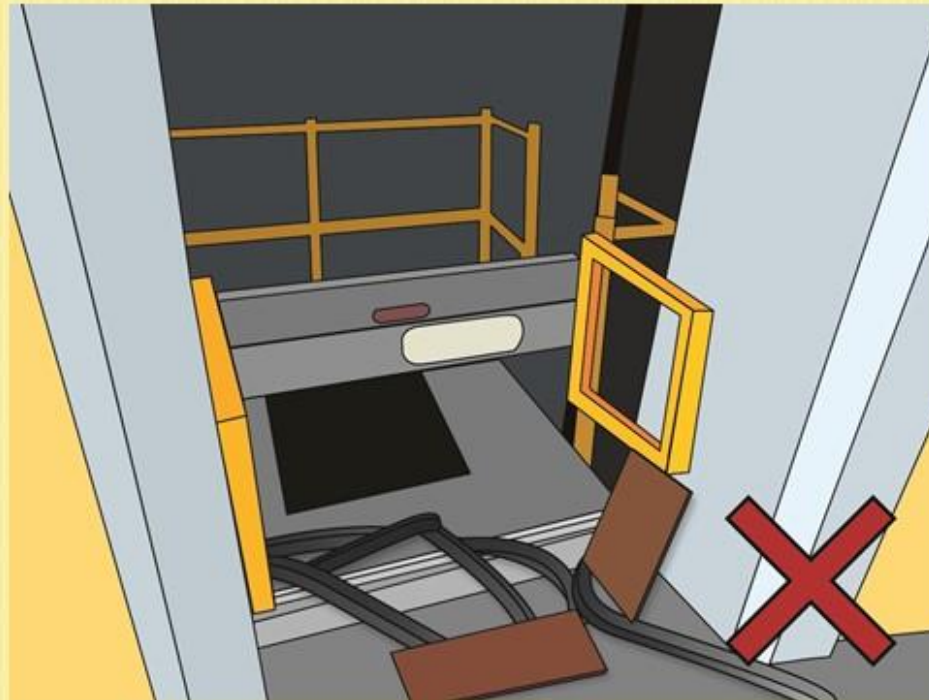
- Poor housekeeping at the access
- 升降机槽出入口欠妥善整理

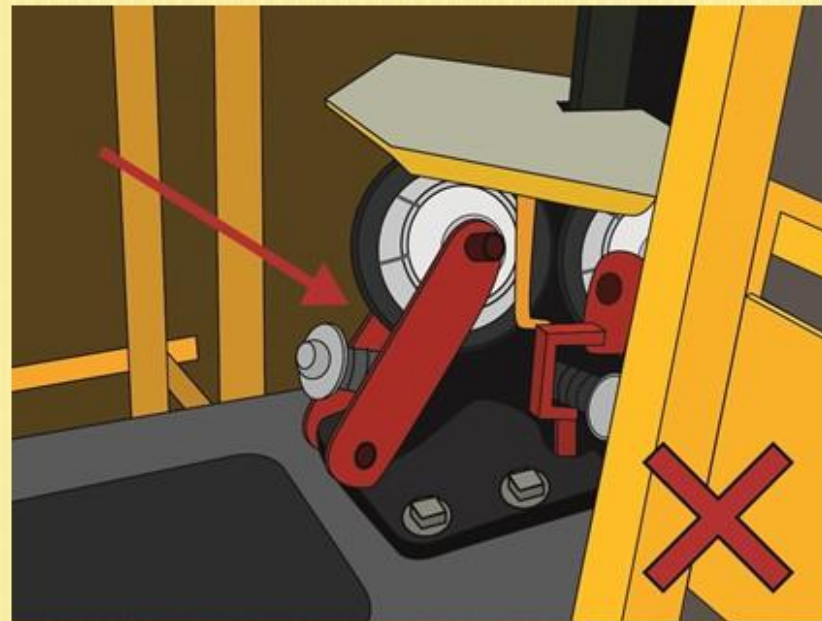
- Inadequate protective guard to the in-running roller
- 运行中滚轴有缝隙，保护不当

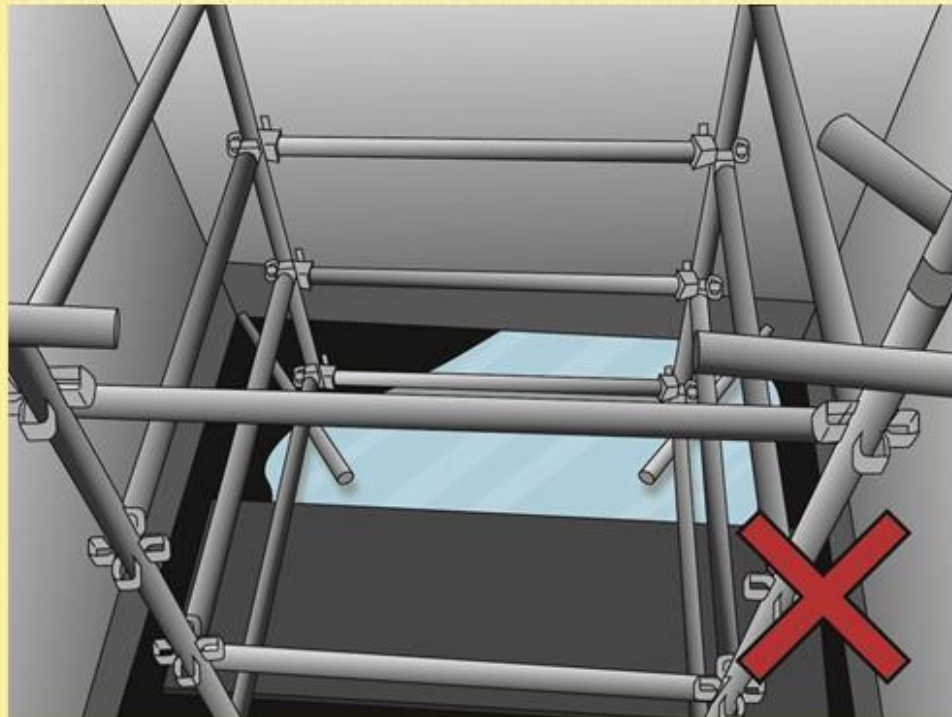
- Water contained in lift shaft
- 升降机槽内有积水

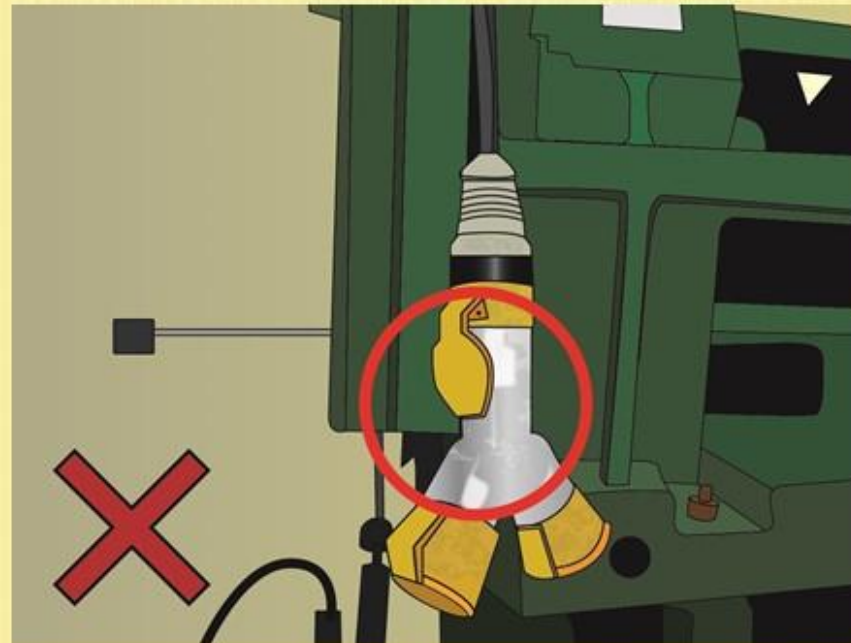
- Damaged electrical connector
- 损坏的接头

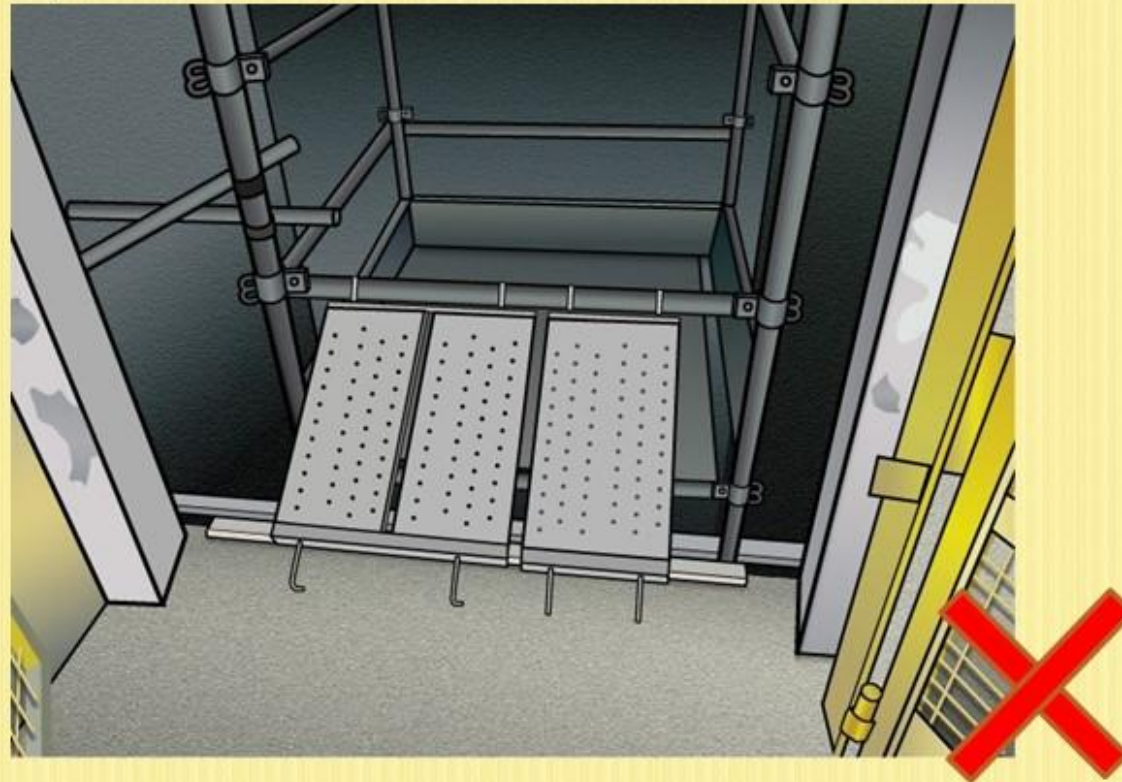
- Unsafe access to working platform
- 不安全进出口
