## BAD PRACTICE 不良作业方式

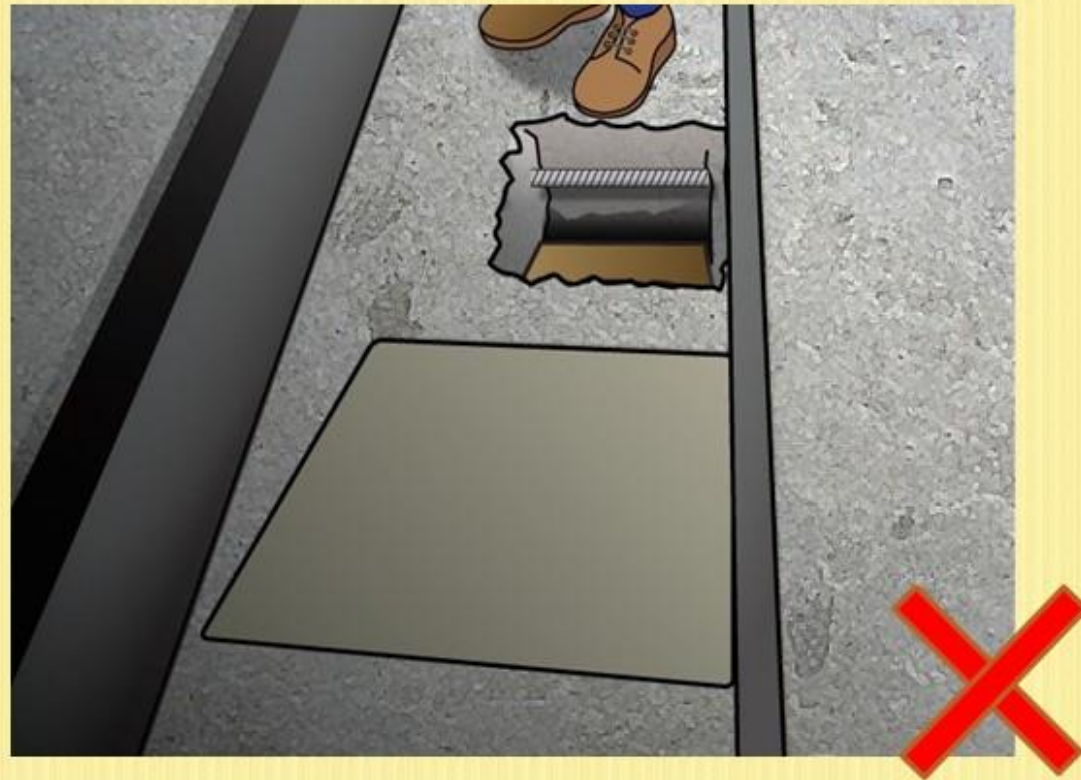
- Floor opening was not protected
- 地洞没有覆盖

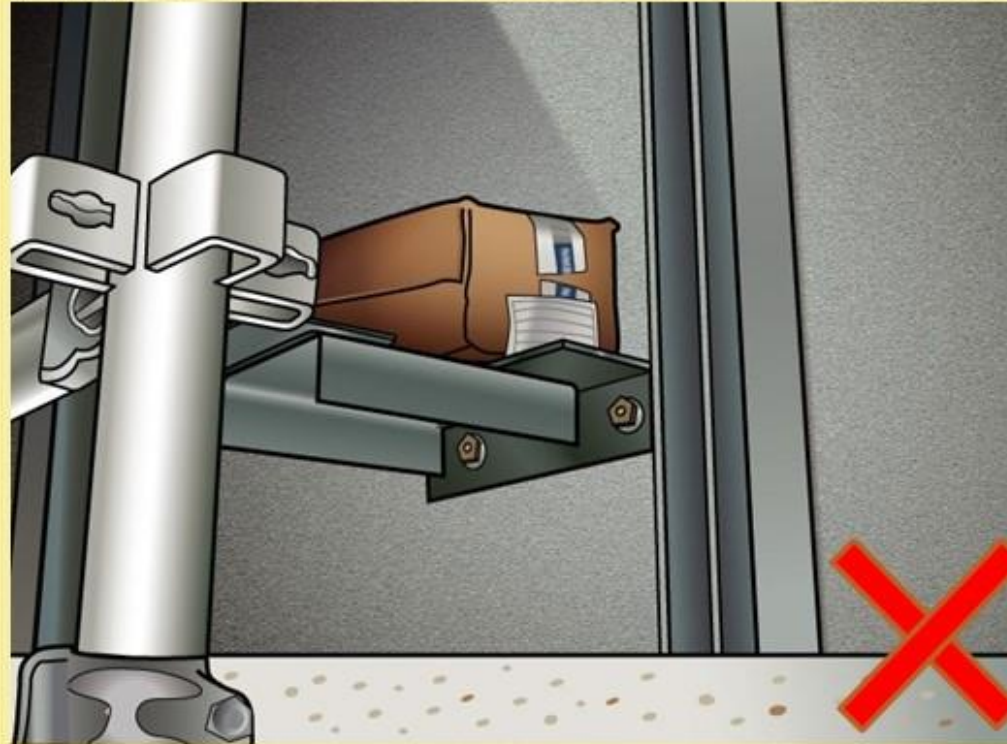
- Materials stacked at high level
- 物料存放于高处

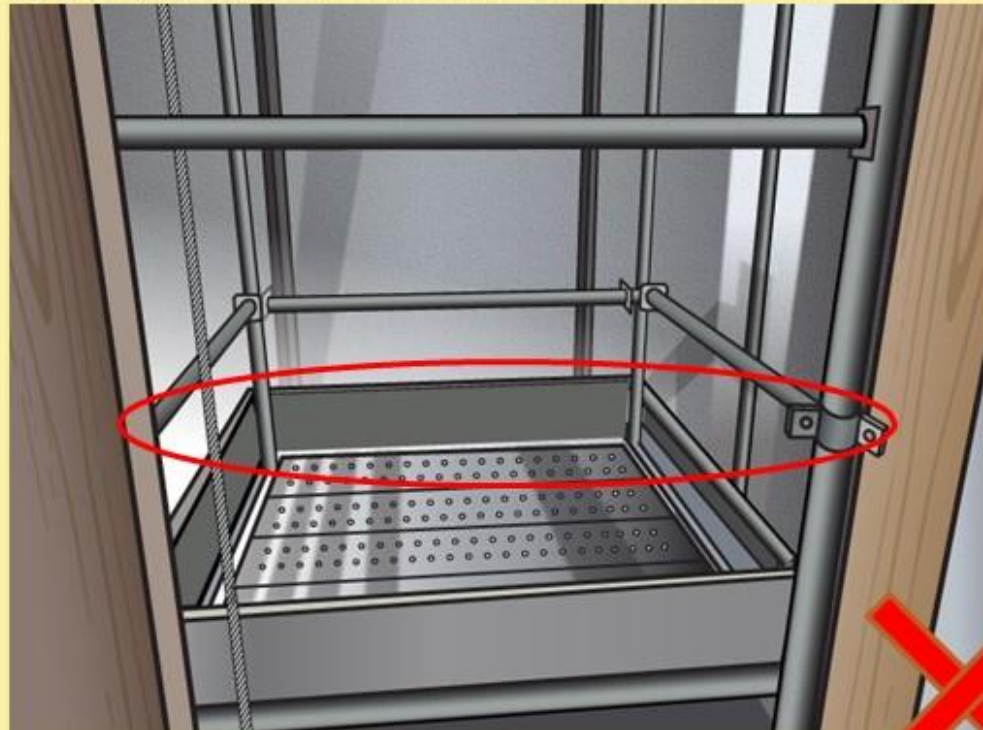
- Absence of mid-rail in the metal scaffold
- 金属棚架没有中围栏

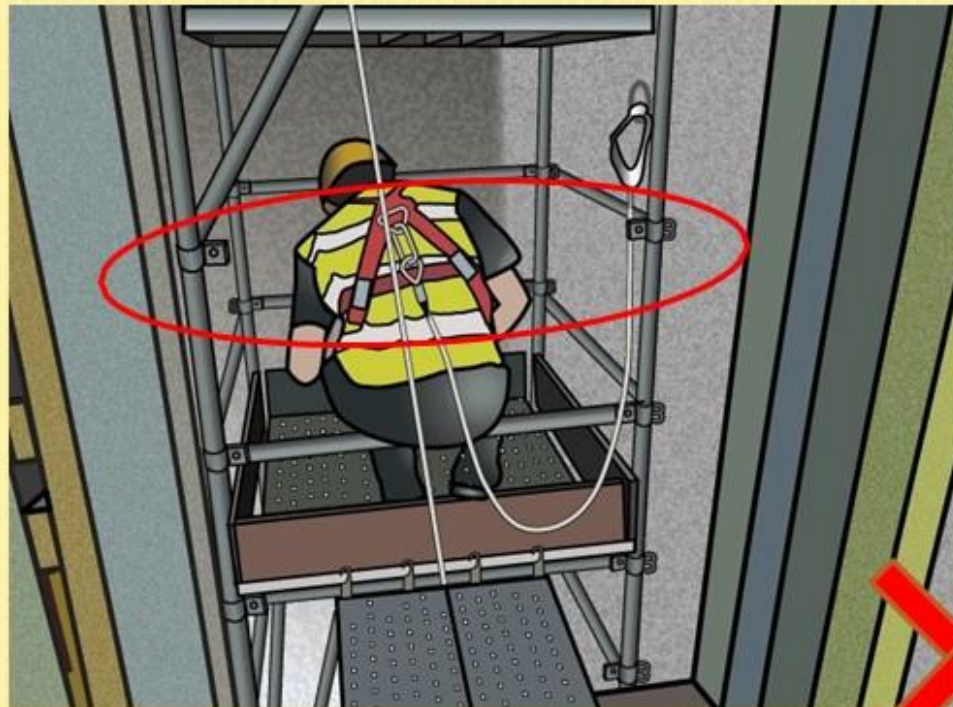
- Absence of top guard-rail in the metal scaffold
- 金属棚架没有高围栏

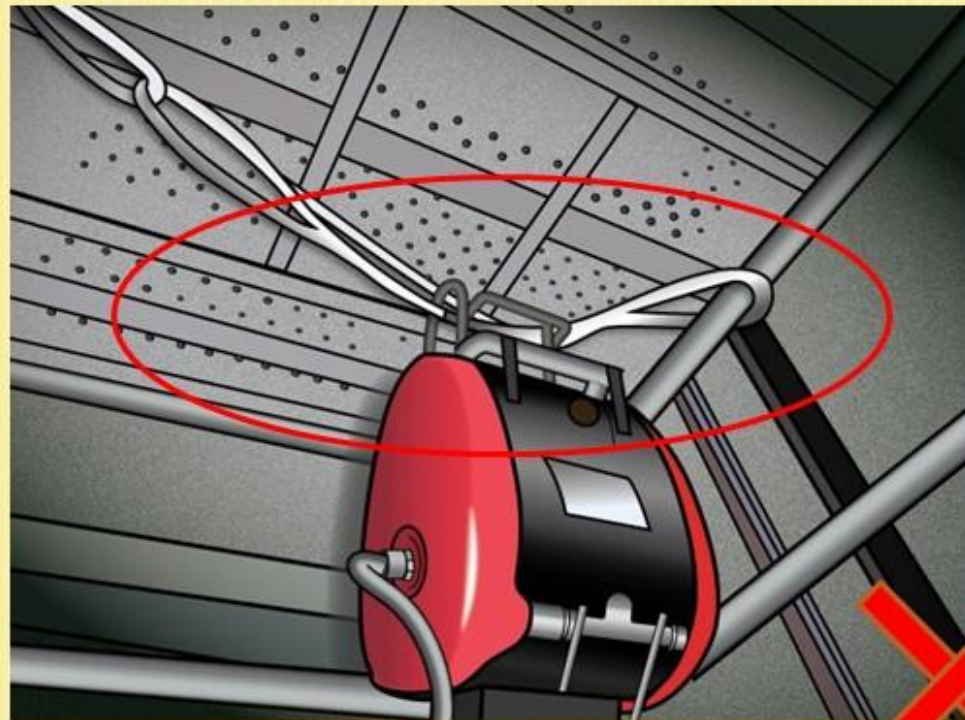
- Hanging block was installed on the metal scaffold
- 安装链滑车在金属棚架

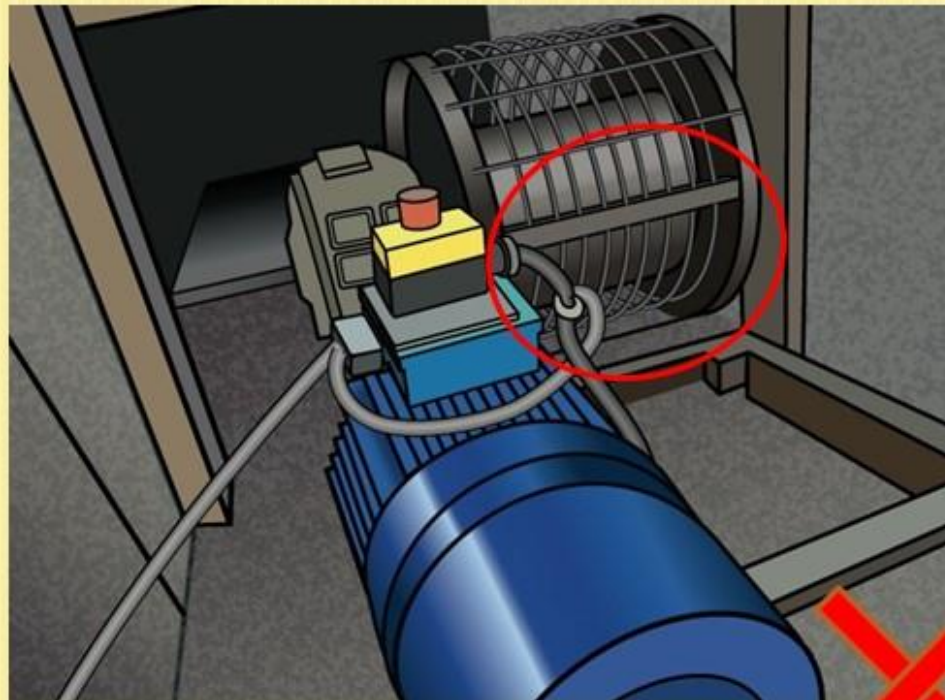
- Improper guarding for electric winch
- 电动绞机的危险部份没有完全隔开

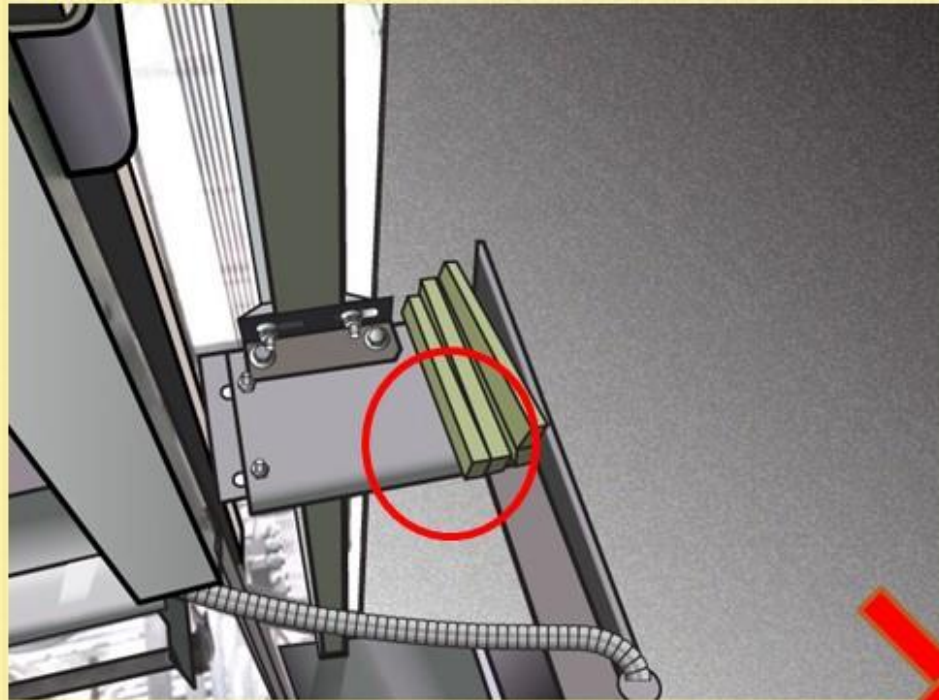
- Material left at high level
- 物料留高处

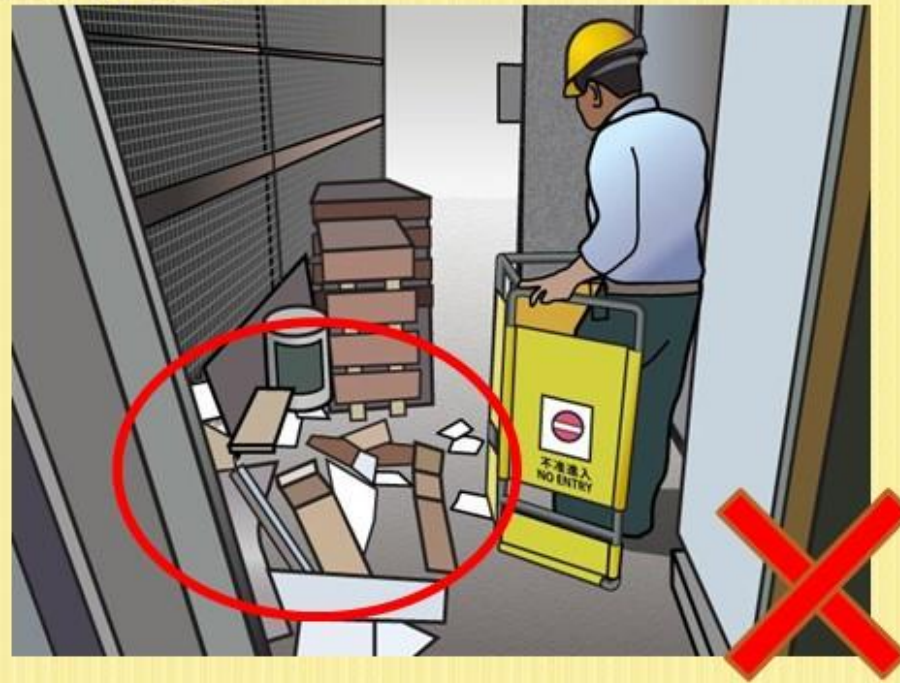
- The access was obstructed by the accumulated rubbish
- 通道被堆积的垃圾阻塞

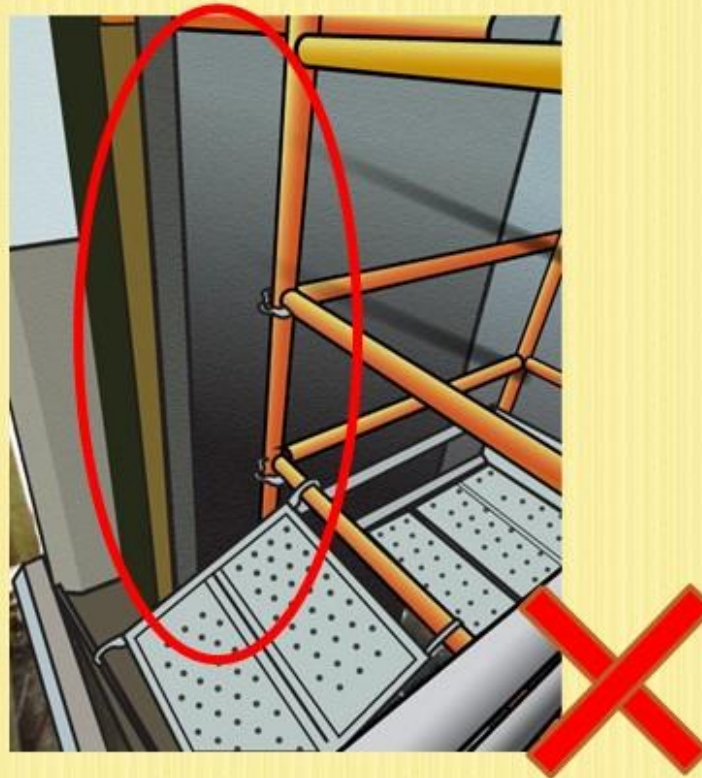
- Floor edge without fencing in lift shaft
- 未有在临边位置安装围栏

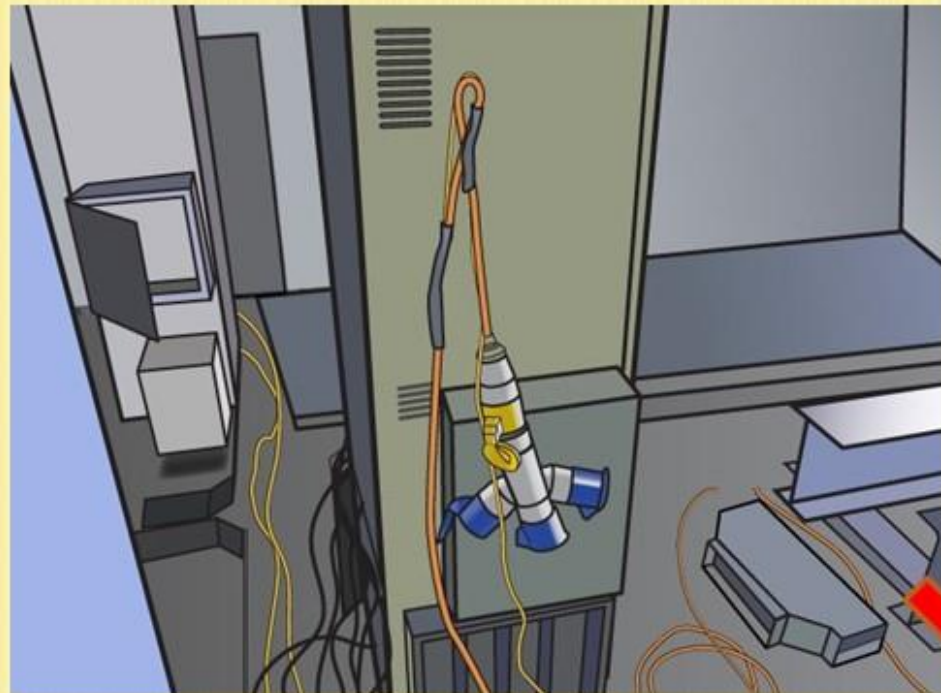
- Electric cable laid on ground floor and invalid cable connector used at work
- 电线没有挂高及使用不恰当的电缆连接器
