ELECTRICAL SUPPLY SYSTEM
供电系统

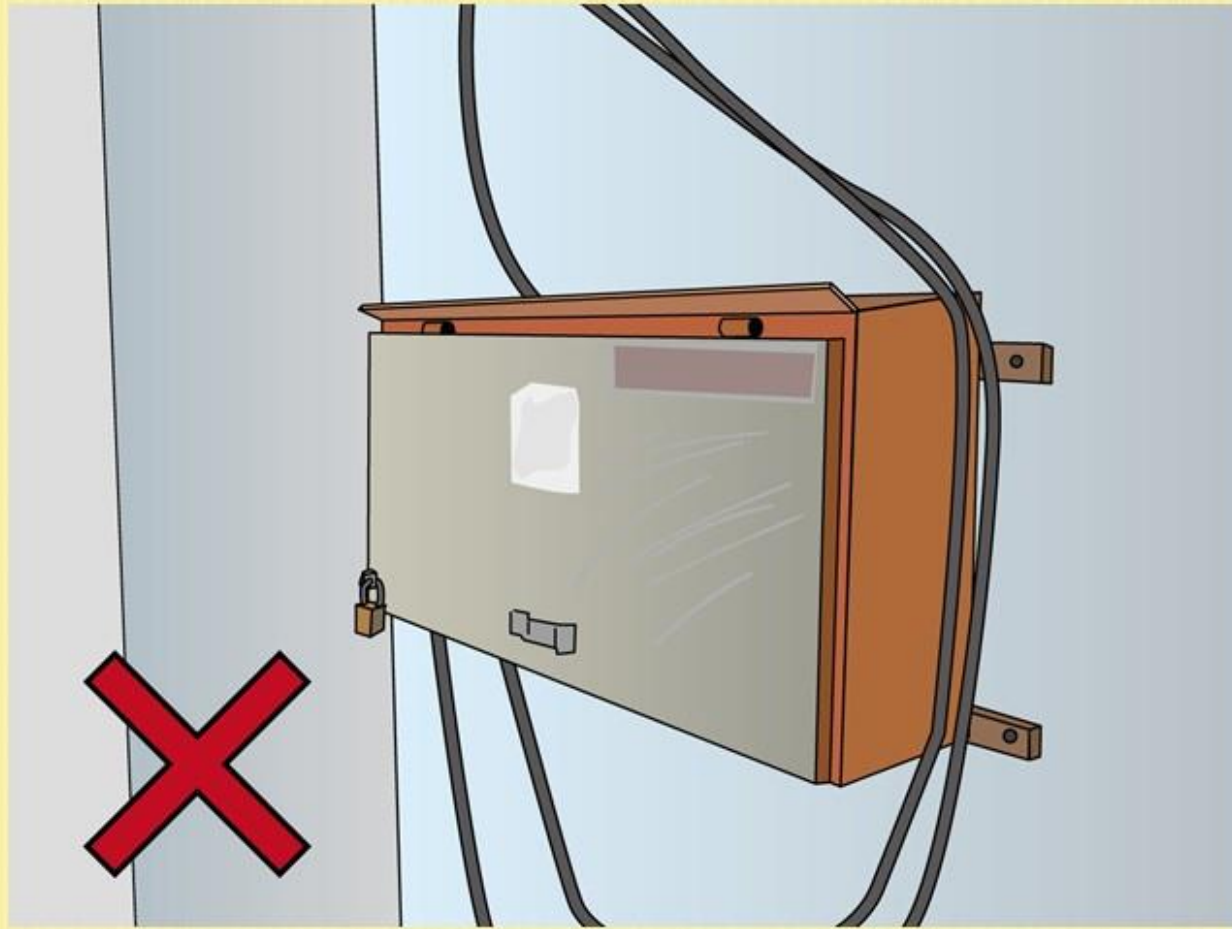
未有张贴电擊告示、注册电工等数据 NOTICE OF ELECTRIC SHOCK, REW NAMES AND CONTACT NOT DISPLAYED

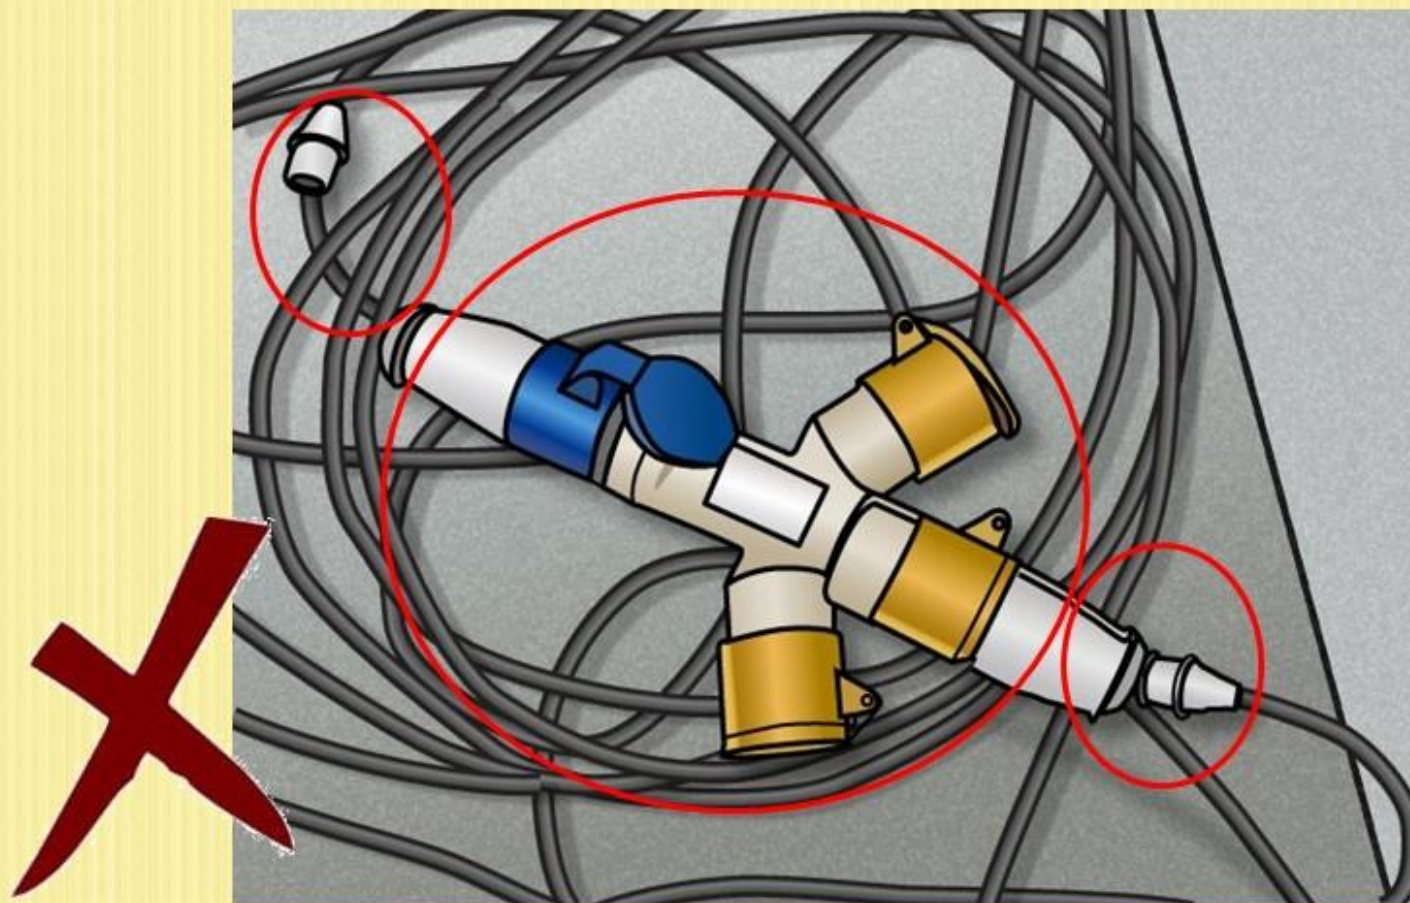
电源线插头损坏。110V 的插头连接到 220V 的插座。

CORD GUARDS WERE DAMAGED AND IMPROPER CONNECTION OF SOCKET PLUG.

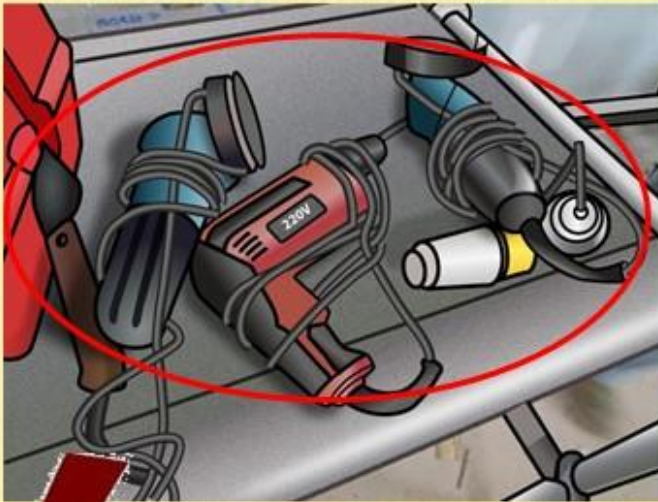
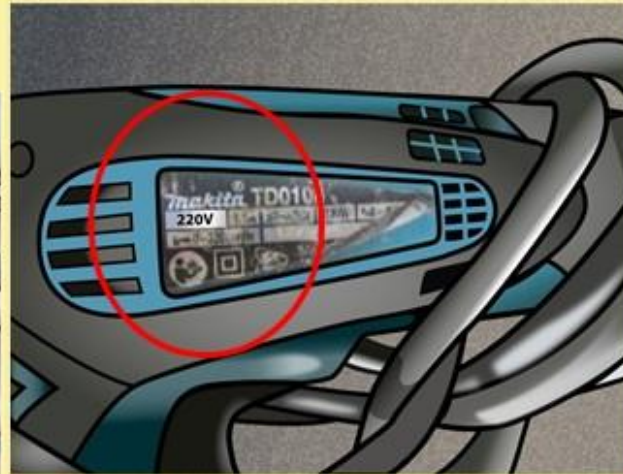
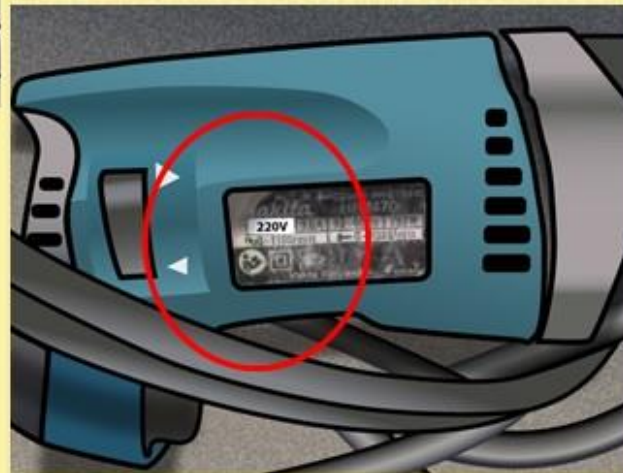
220V的手提工具使用110V的插头。

220V HAND-HELD TOOLS WERE FOUND WITH 110V SOCKET.

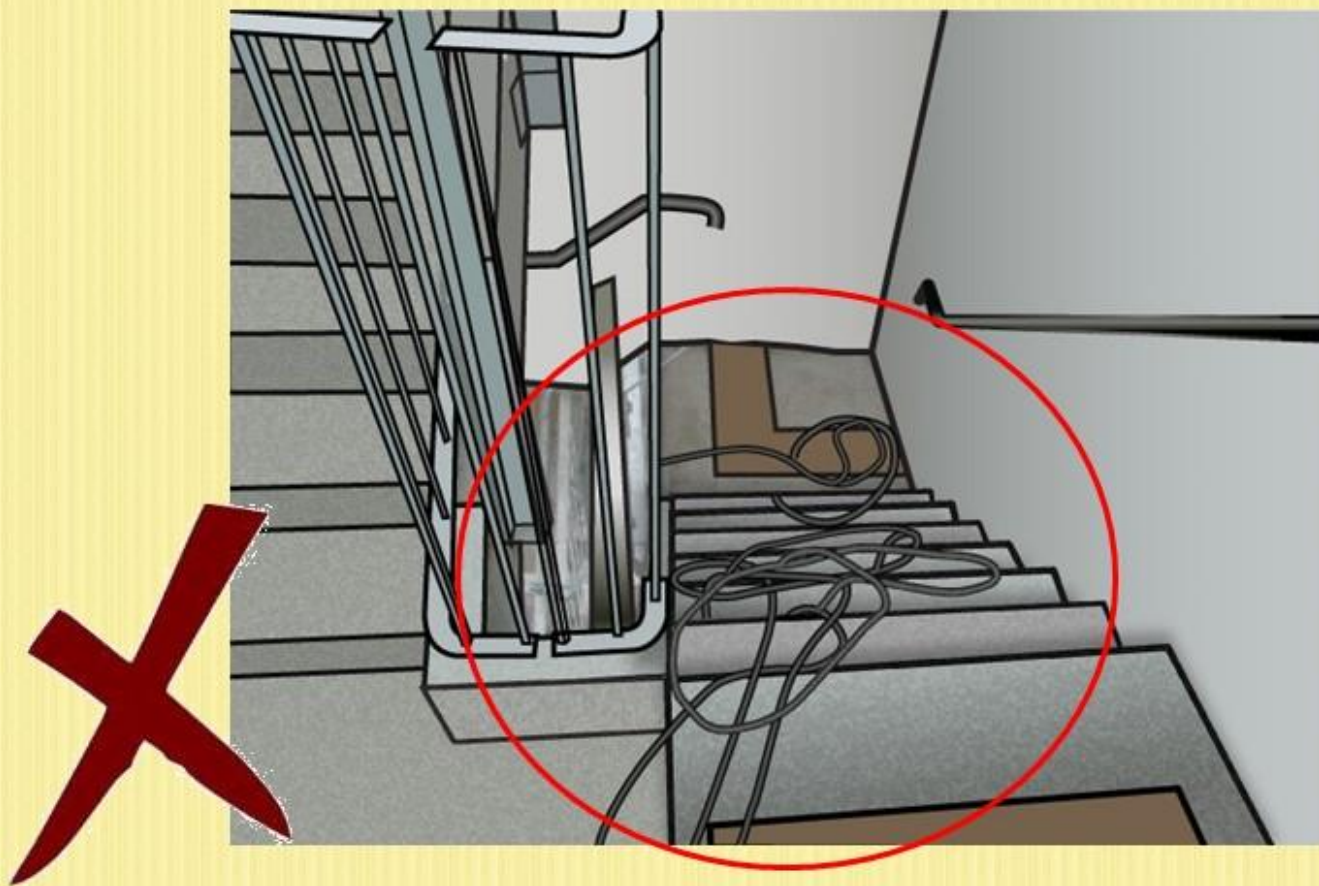
电线拖地，有绊倒的危险。

TRIPPING HAZARD WAS FOUND FOR THE TRAILING CABLE. TRAILING CABLE WAS FOUND.

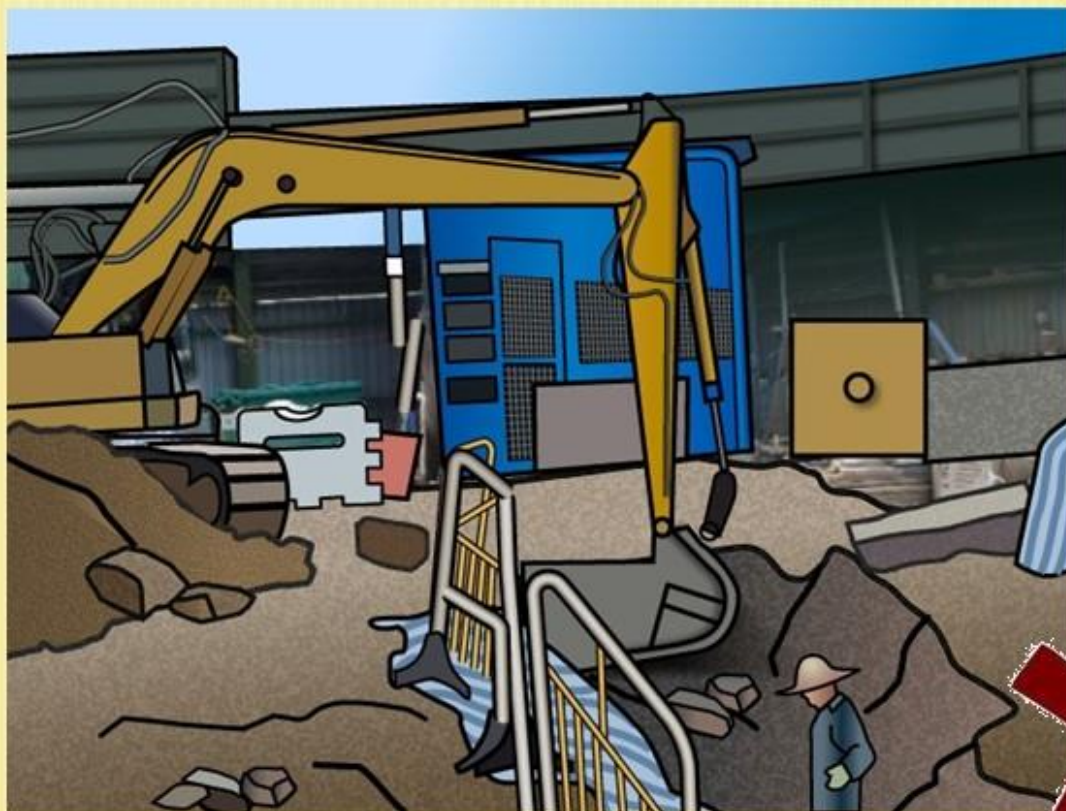
机手可能看不清楚泥坑内情况，但工友在没有讯号员的情况下在泥坑内工作。

OPERATOR OF THE EXCAVATOR MAY NOT HAVE UNOBSTRUCTED VIEW OF THE WHOLE PIT AND THE MOVING BUCKET MAY HIT THE WORKER. WORKER SHOULD AVOID WORKING IN EXCAVATION WHEN EXCAVATOR IS OPERATING NEARBY WITHOUT A SIGNALLER.
