WORKING AT HEIGHT
高空工作

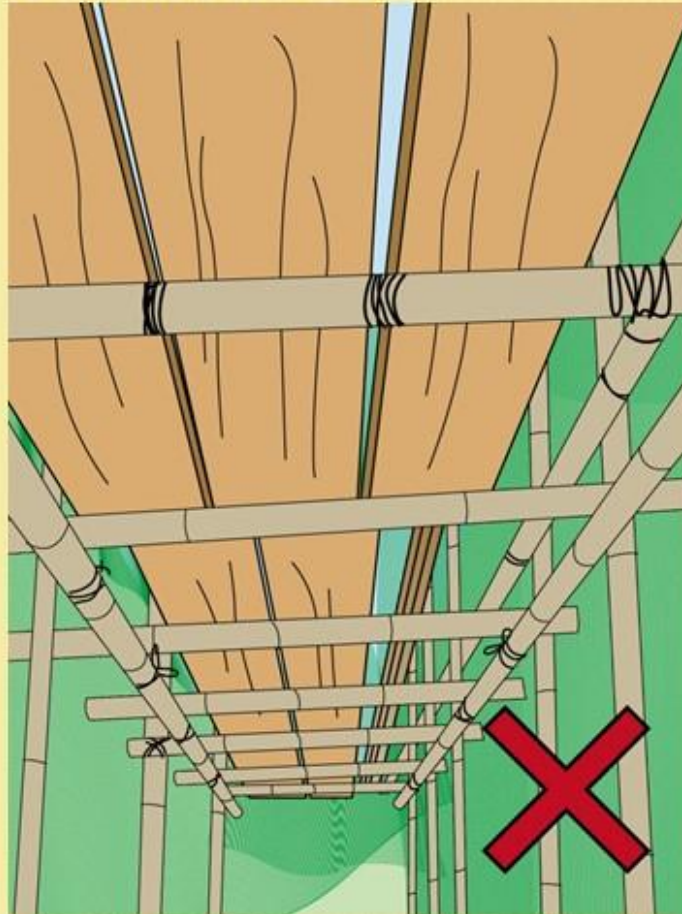
WORKING PLATFORM NOT CLOSELY
BOARDED
工作台之地台没有被密封

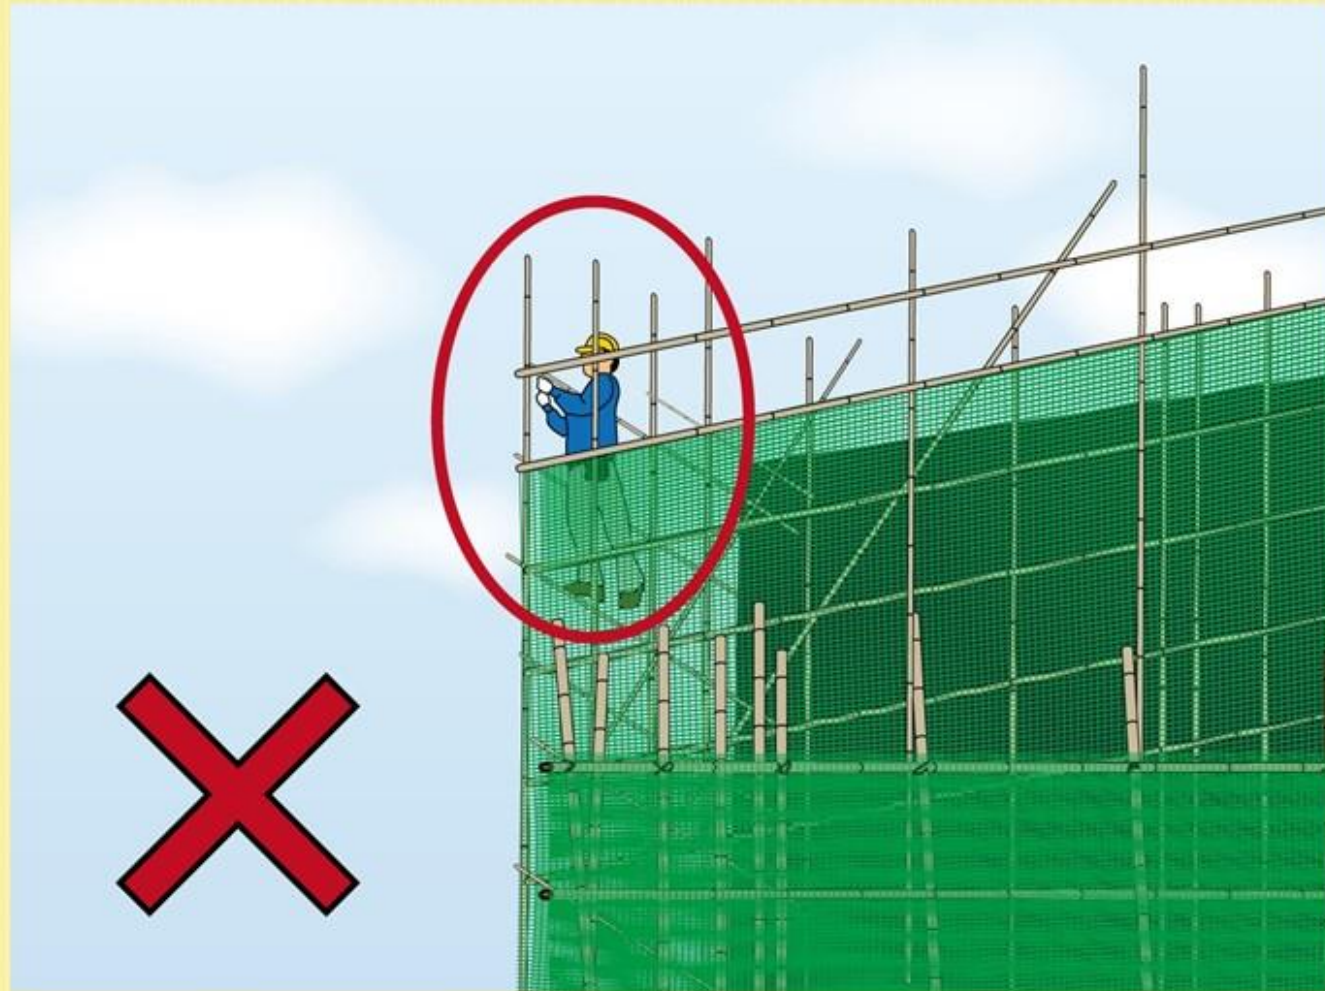
NO FALL ARRESTING MEASURE WHEN
DISMANTLING SCAFFOLD
拆卸棚架时没有任何防堕措施

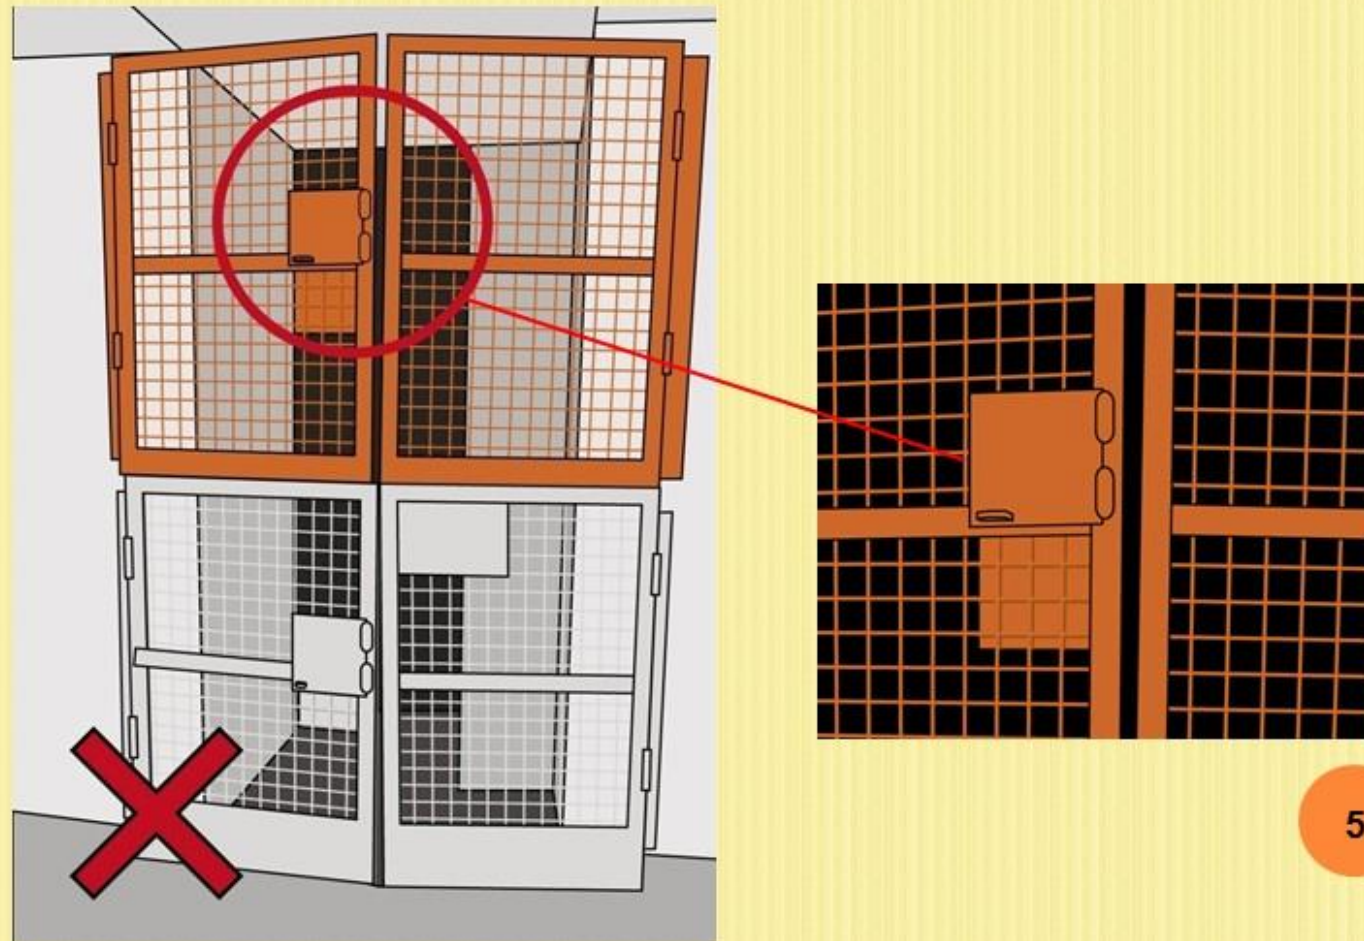
FULL-HEIGHT GATE OF LIFT SHAFT OPENING
NOT LOCKED
升降机井口全高闸门未锁上

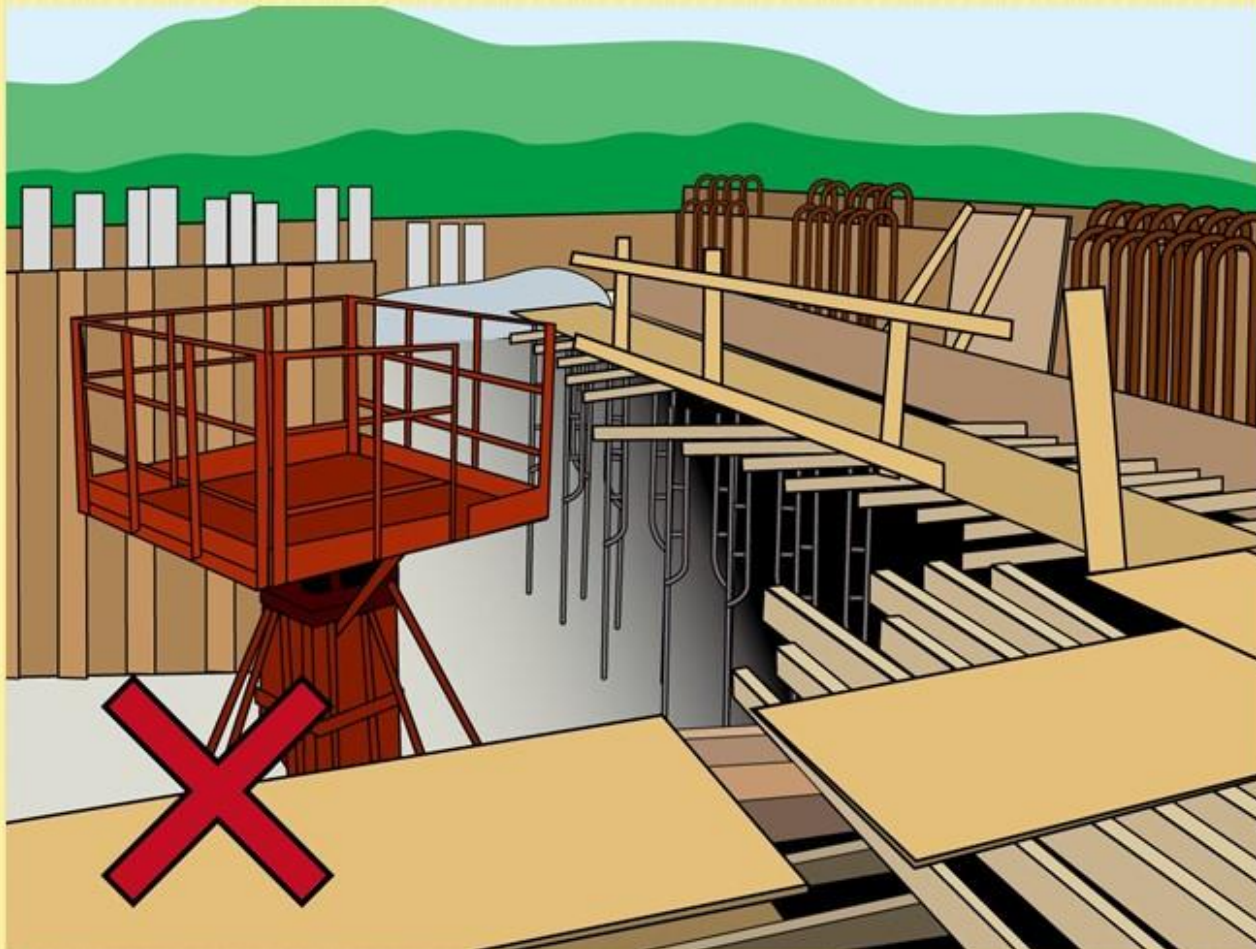
NO GUARD-RAILS WERE INSTALLED

没有围栏

NO FALL ARRESTING MEASURE WAS IN USE

没有使用防坠措施

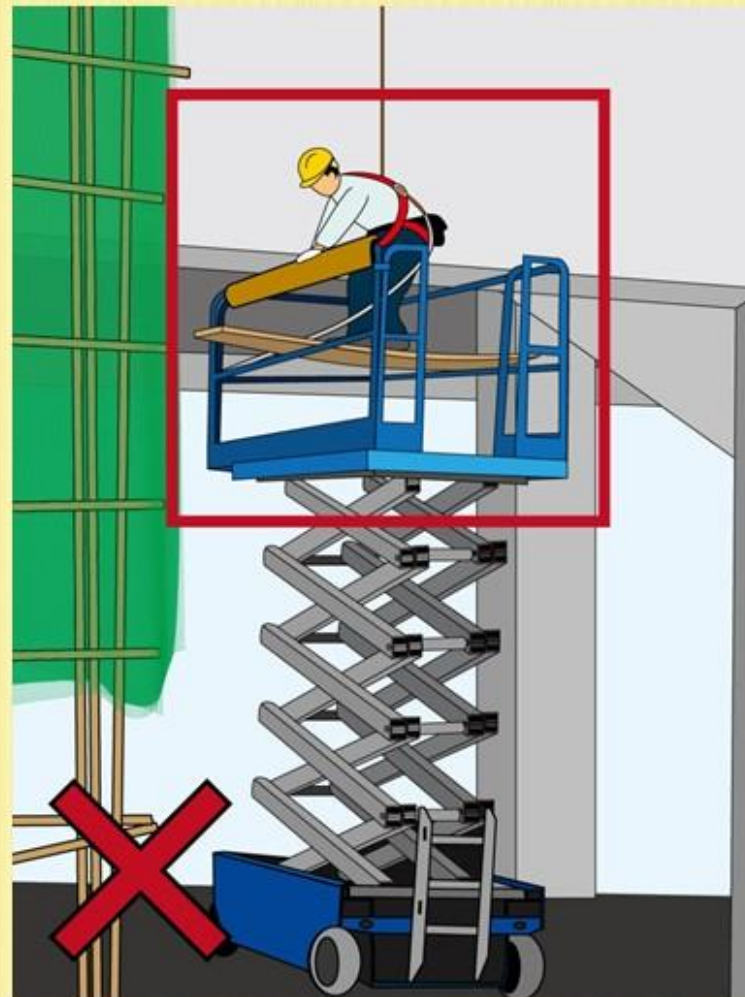
使用时，未有安装围栏

NO GUARD RAILS INSTALLED DURING OPERATION

不正确使用流动升降台

UNSAFE USE OF MOBILE ELEVATED WORKING PLATFORM

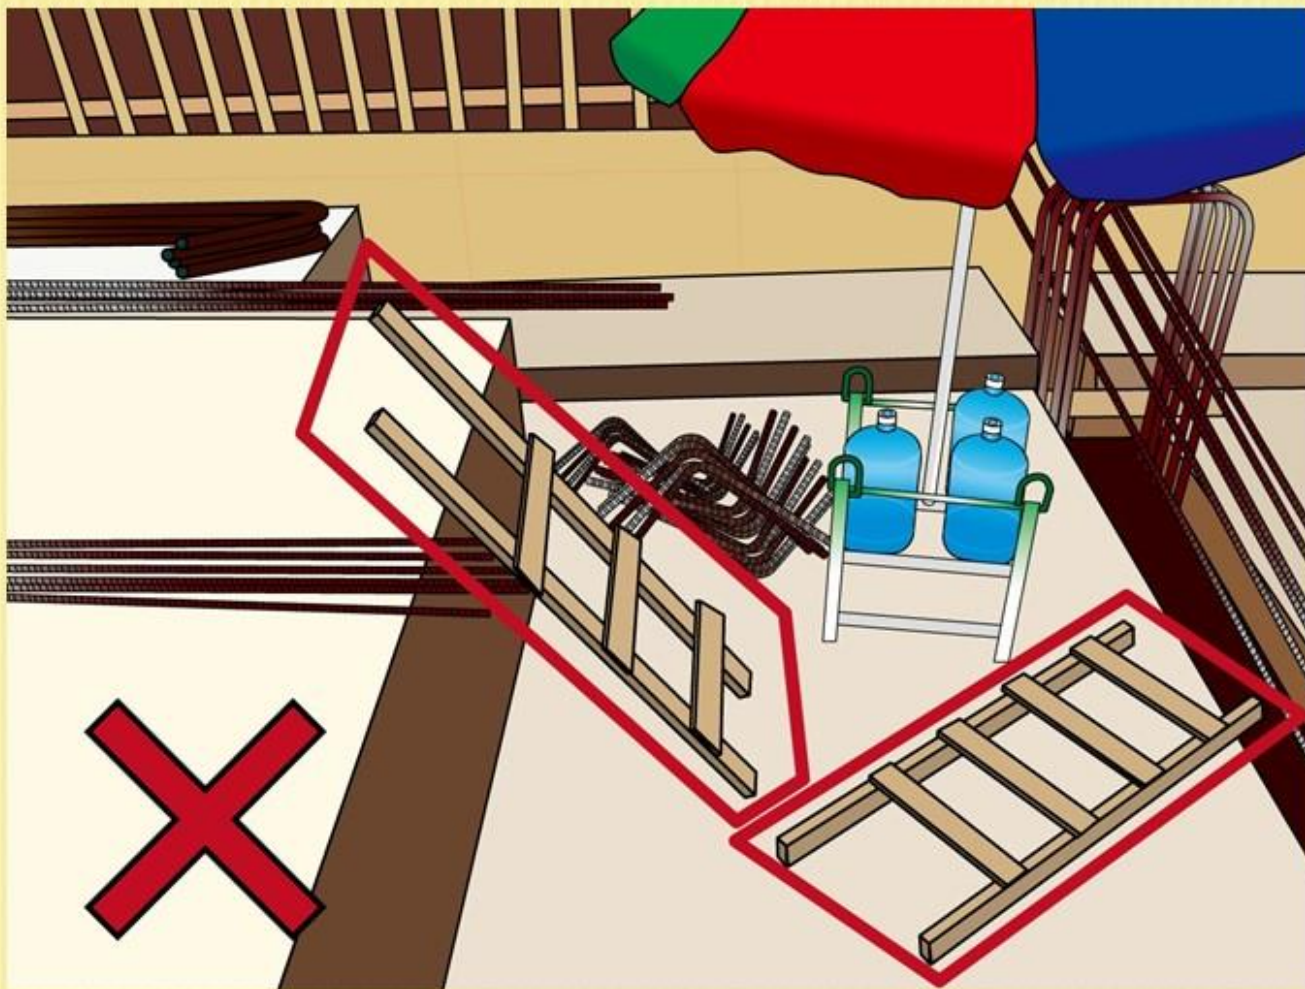
不合乎标准的木梯

SUBSTANDARD WOODEN LADDER

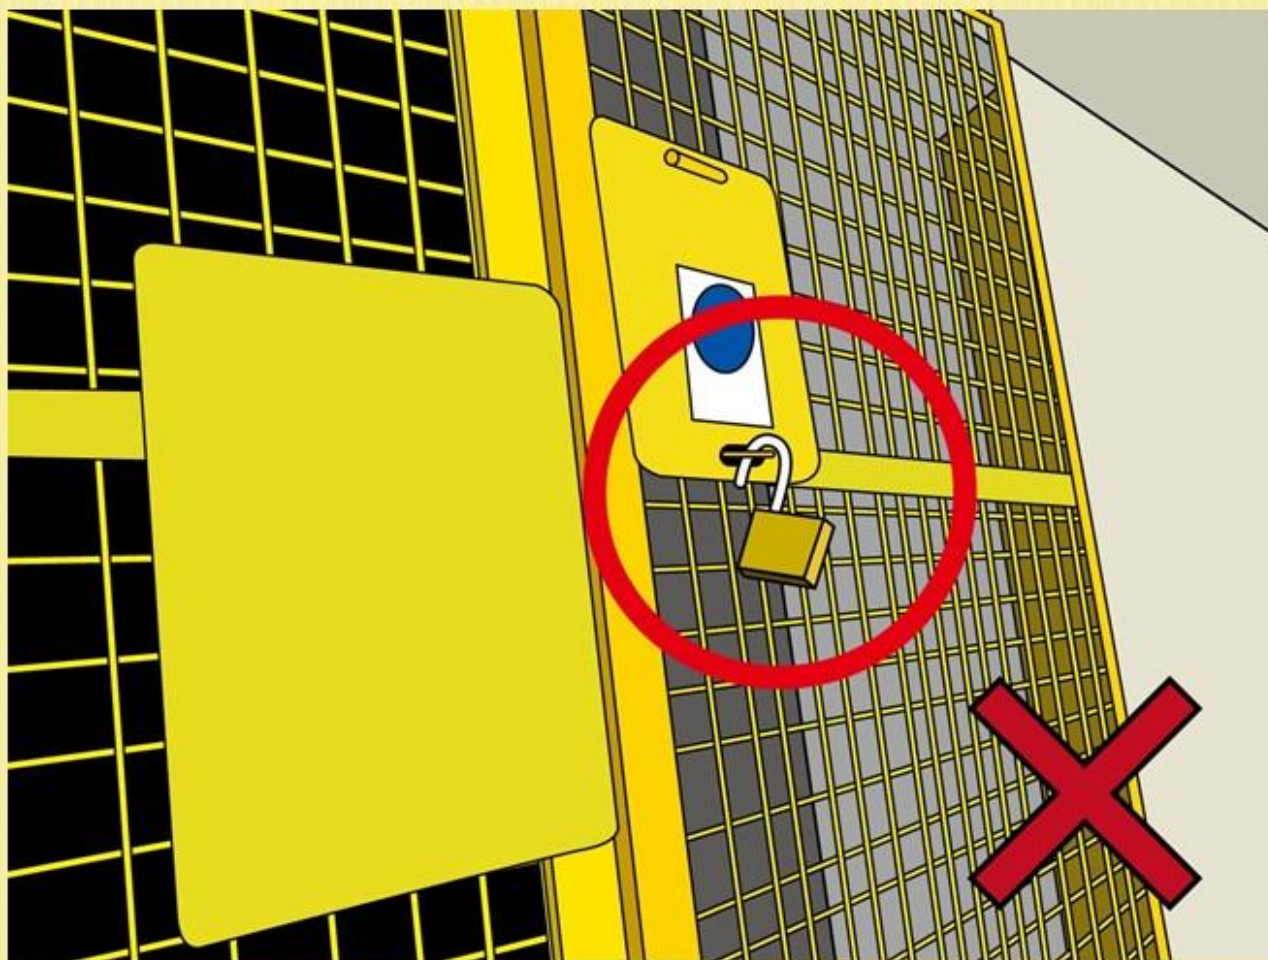
升降机门未有上锁

LIFT METAL GATE UNLOCKED

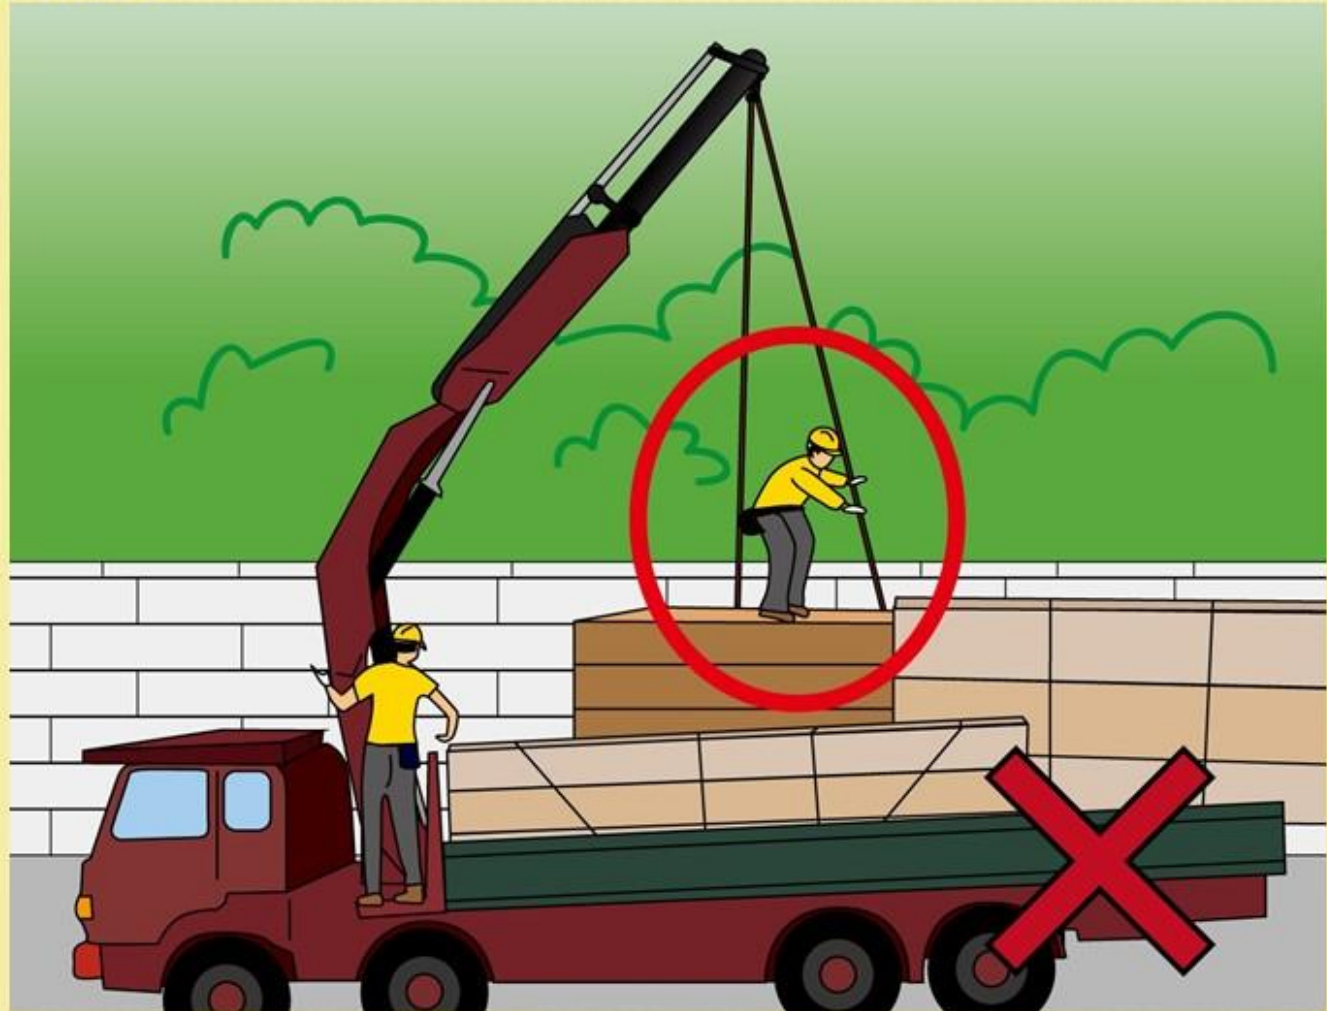
工友未有佩戴安全帶

WORKER DID NOT USE FALL ARRESTING
SYSTEM

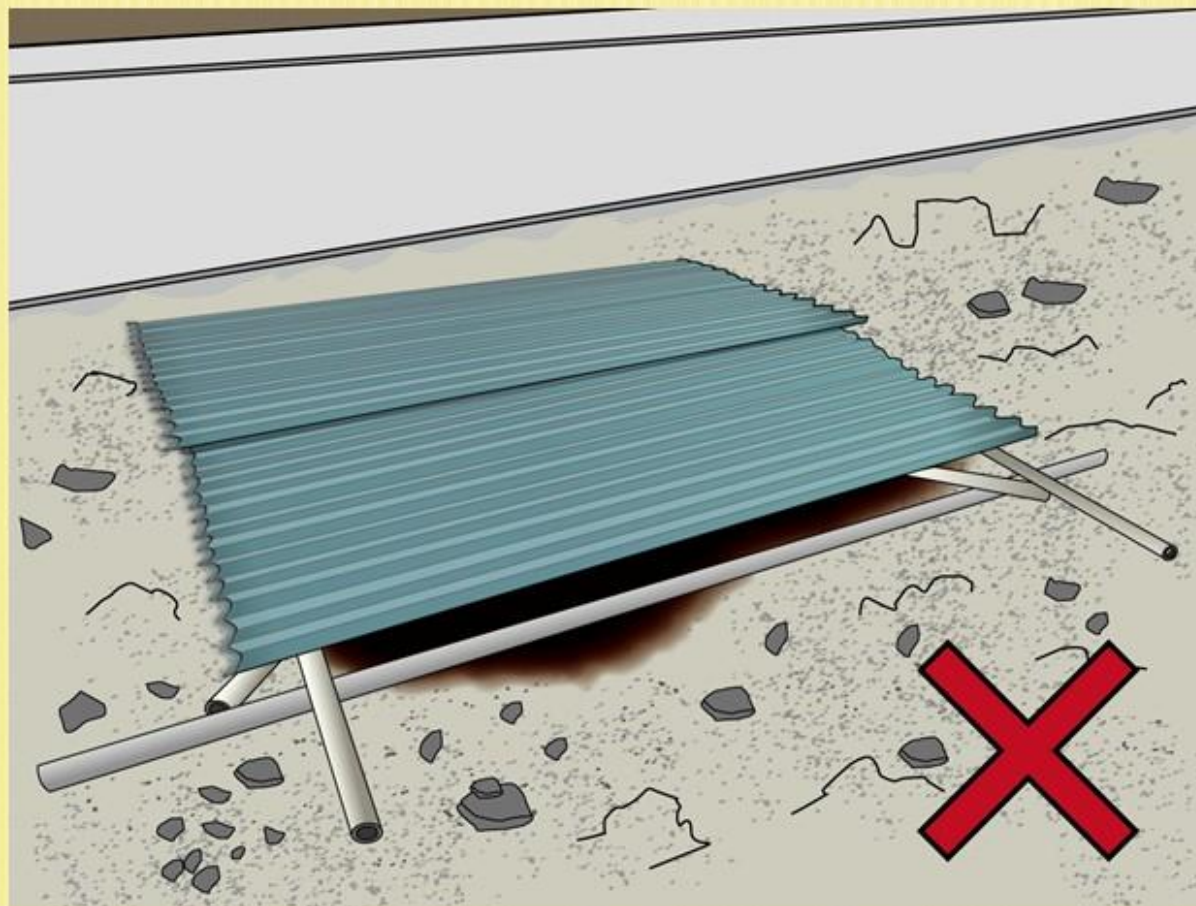
地洞盖没有被稳固

COVER OF FLOOR OPENING WAS NOT SECURELY
FIXED IN POSITION

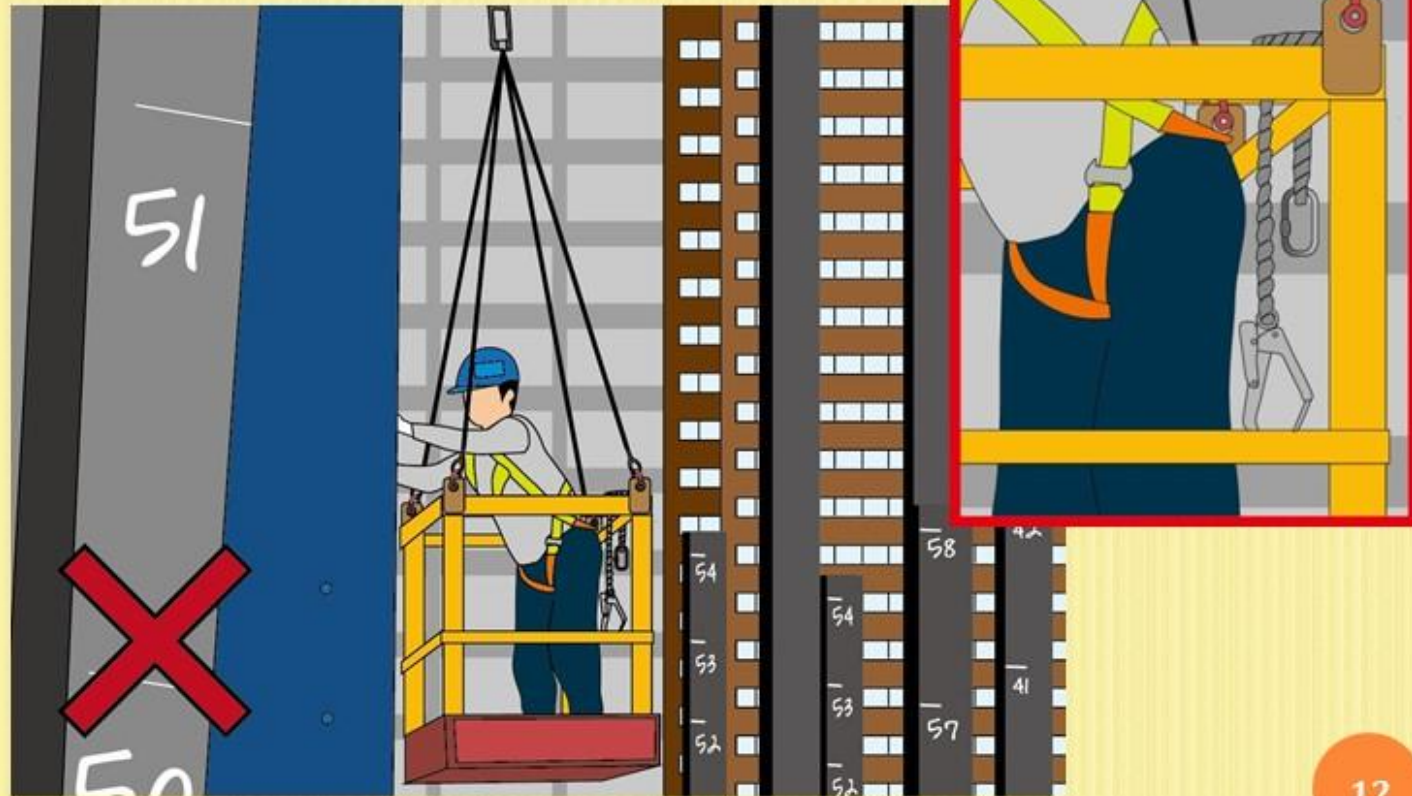
安全带没有连接于系稳点

WORKER'S SAFETY HARNESS WAS NOT
CONNECTED TO ANCHORAGE POINT

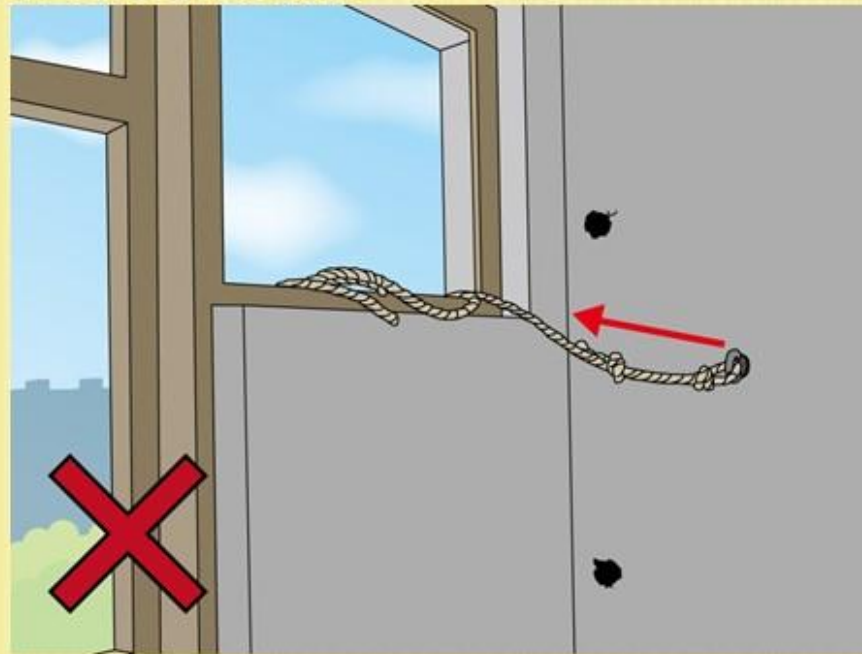
有眼螺栓的方向应与拉力方面一致

THE EYEBOLT SHOULD BE ORIENTED IN LINE WITH THE INTENDED LINE OF FORCE OF THE INDEPENDENT LIFELINE

如果侧身负载，吊环螺栓可能会弯曲。麻袋应放在周围锋利的边缘/角以保护救生绳。If the load is applied sideways, the eyebolt may bend. Sacking should be placed around sharp edge/corner to protect the lifeline.

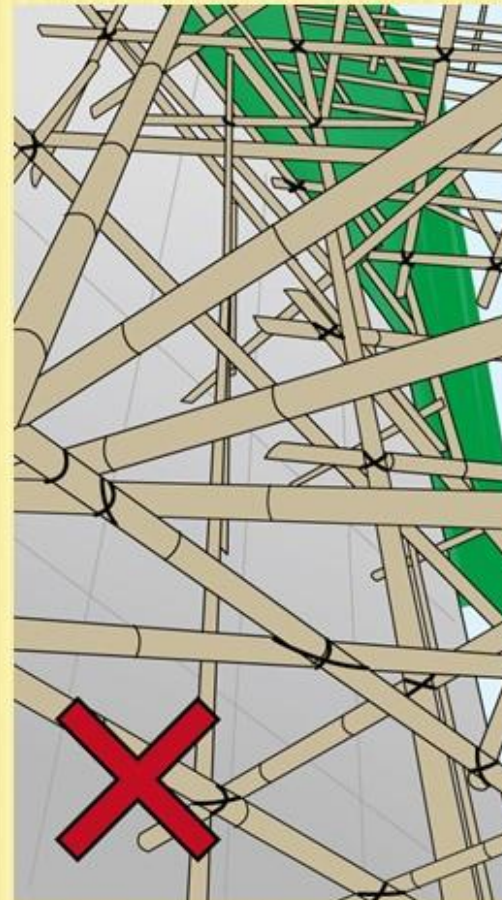
竹棚架没有安装足够的连墙器

THE PUTLOGS INSTALLED ON THE BAMBOO SCAFFOLD WERE INSUFFICIENT

- 縱行每4米或以下，
橫行每7米或以下
- **Every 4m or less rise and
7m or less apart
horizontally**

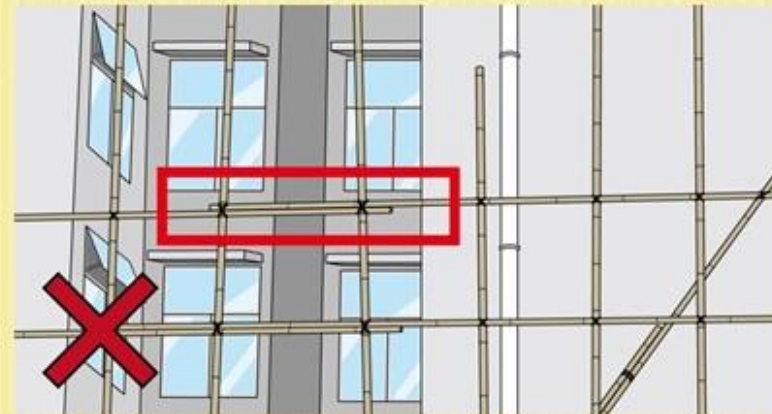
两条连接之竹竿的重迭长度不足

LENGTH OF OVERLAP WAS INSUFFICIENT FOR CONNECTING 2 BAMBOO MEMBERS

- 两条连接之竹竿的重迭长度:
 - 对于直杆，应为1.5米至2米。
 - 对于大横杆及斜杆/斜撑，应不小于2米

- **For connection between 2 bamboo members, the length of overlap should be:**
 - **1.5m to 2m for standards**
 - **at least 2m for ledgers and bracings /rakers**

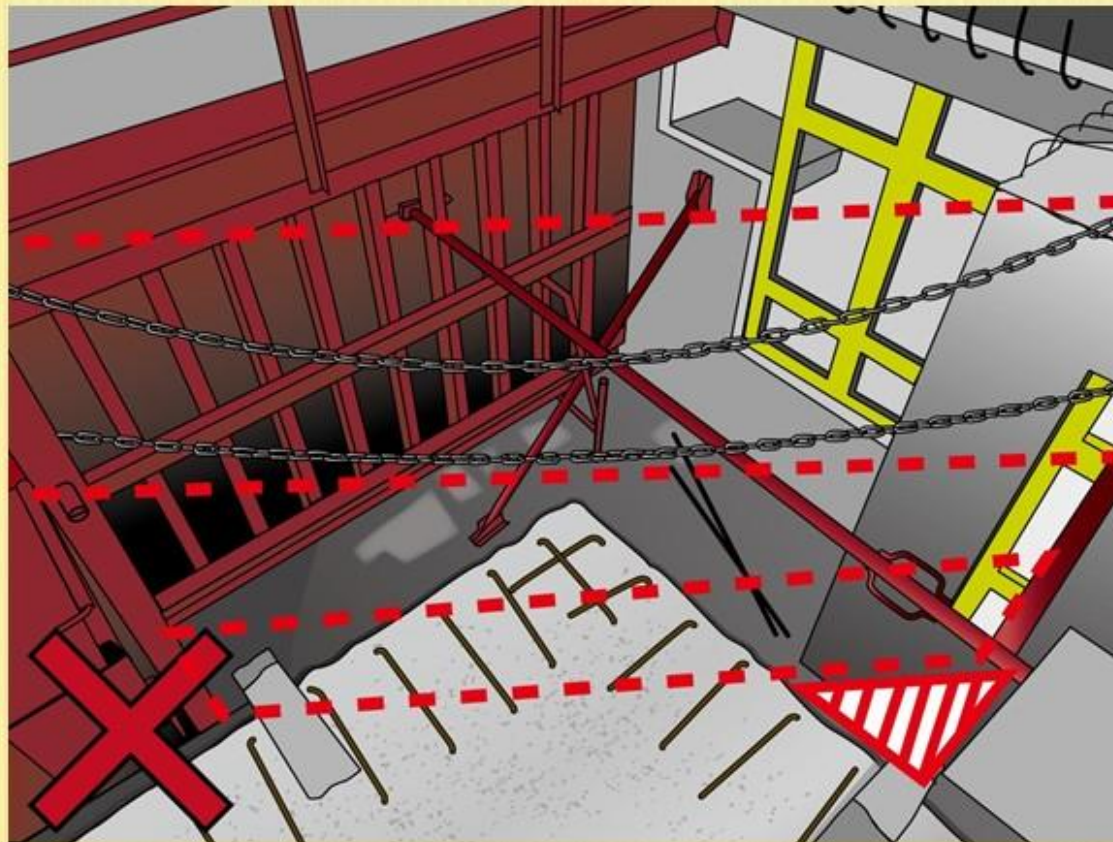
没有符合要求的双行护栏及踢脚板

NO PROPER GUARD-RAILS AND TOE-BOARDS

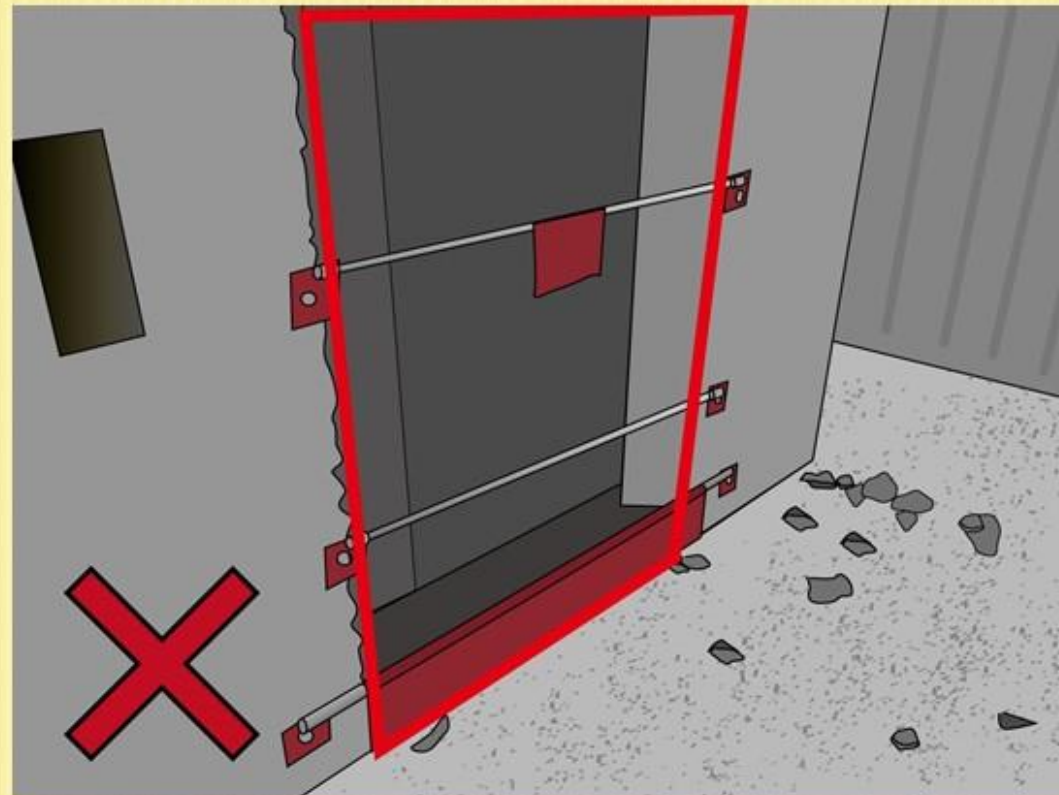
没有在升降机槽开口位置加设完全围封闸门
NO FULL HEIGHT METAL GATES AT LIFT SHAFT
OPENING

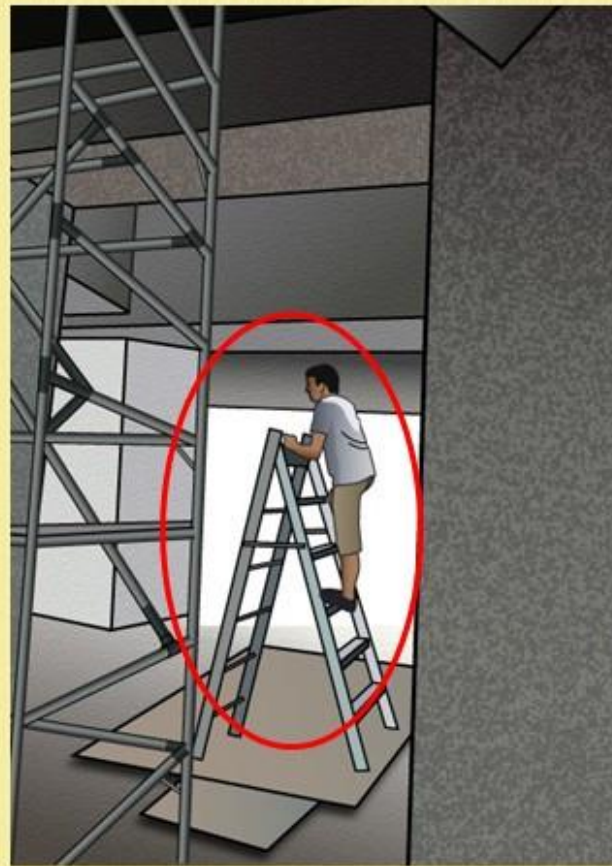
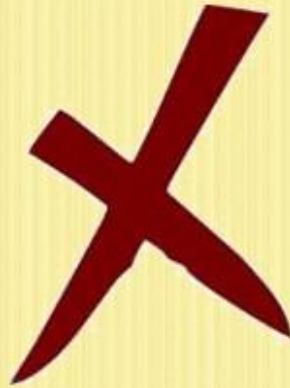
使用梯子在离地两米以上地方工作

LADDER USED FOR WORKING AT 2 METRES OR ABOVE

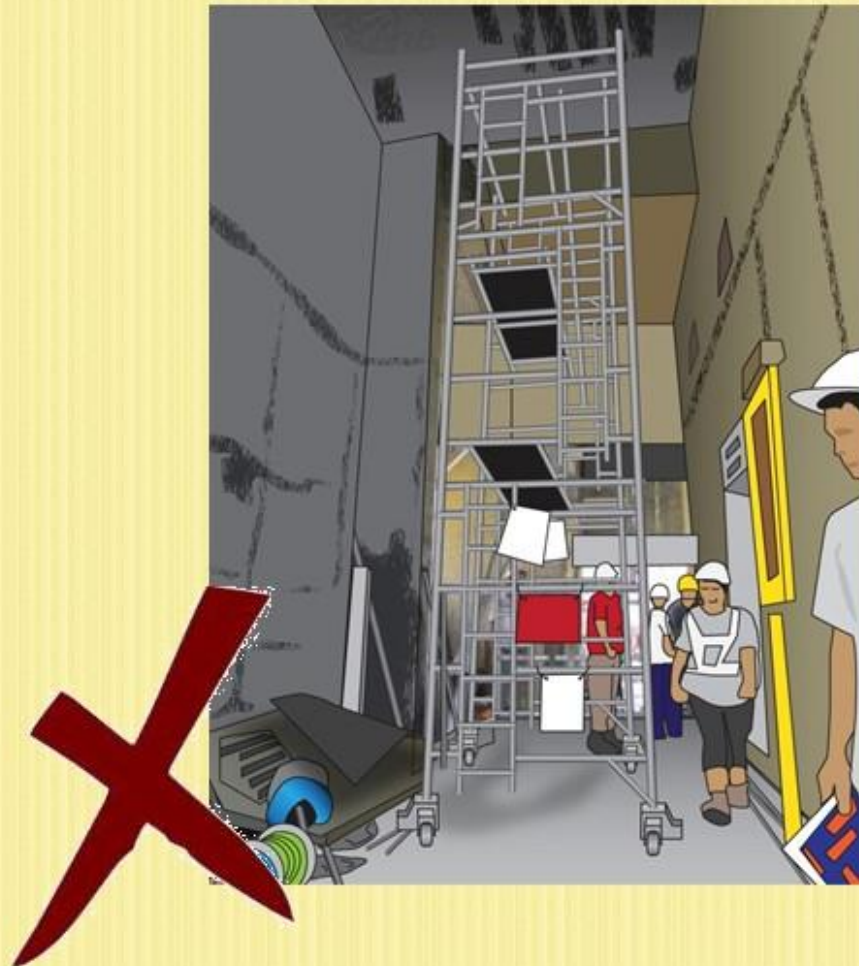
使用中的流动工作台无有效的表格五。没有安装脚架以稳固工作台。

MOBILEWORKING PLATFORM IN USE HAD NO VALID FORM 5. OUTRIGGERS WERE NOT INSTALLED TO STABILIZE THE WORKING PLATFORM.

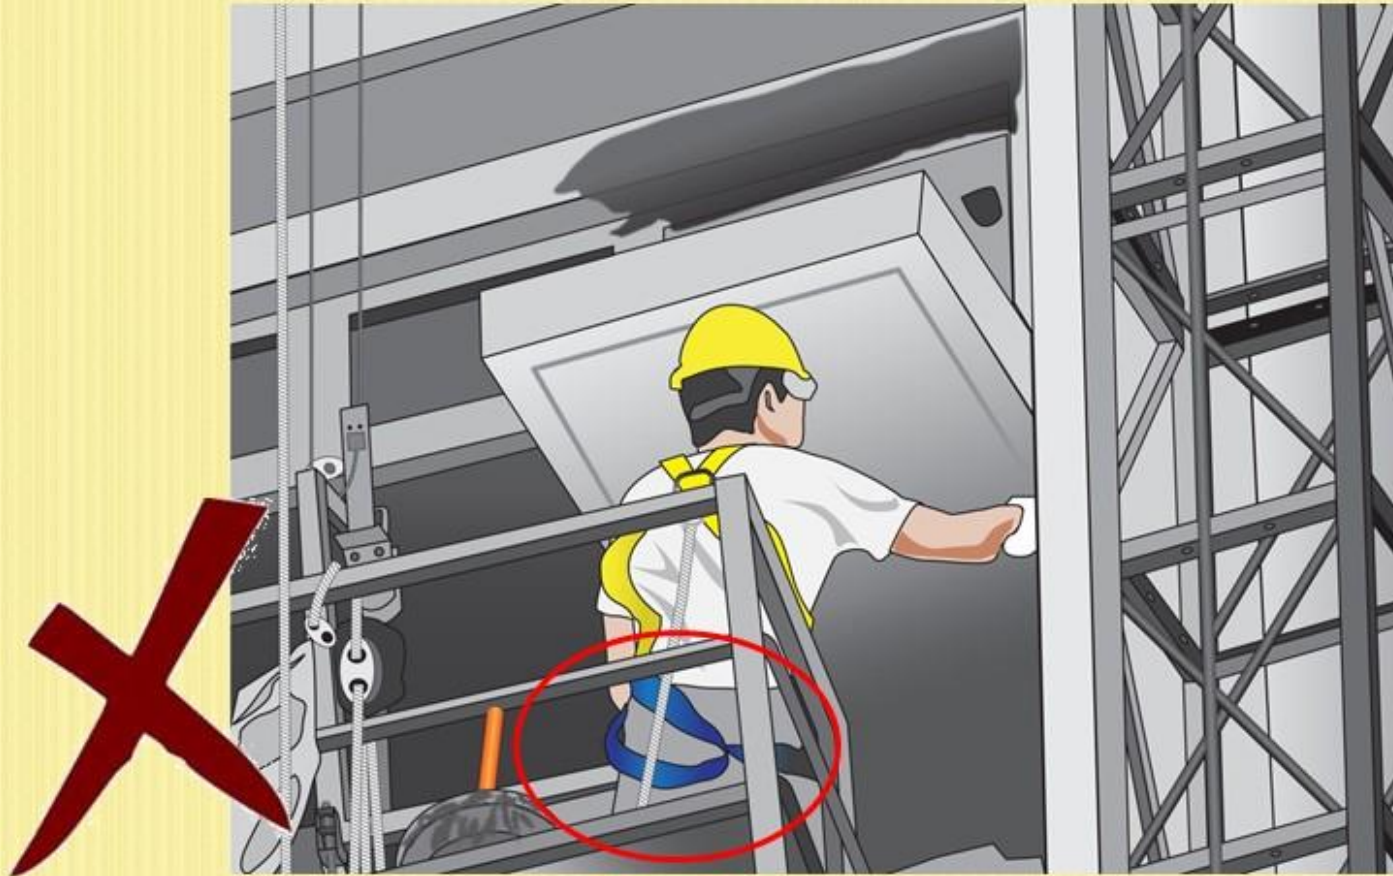
不适当地配戴安全带。配戴腿带的方法不正确。

IMPROPER WEARING OF SAFETY HARNESS ON GONDOLA. THE LEG STRAPS WERE NOT CORRECTLY WORN.

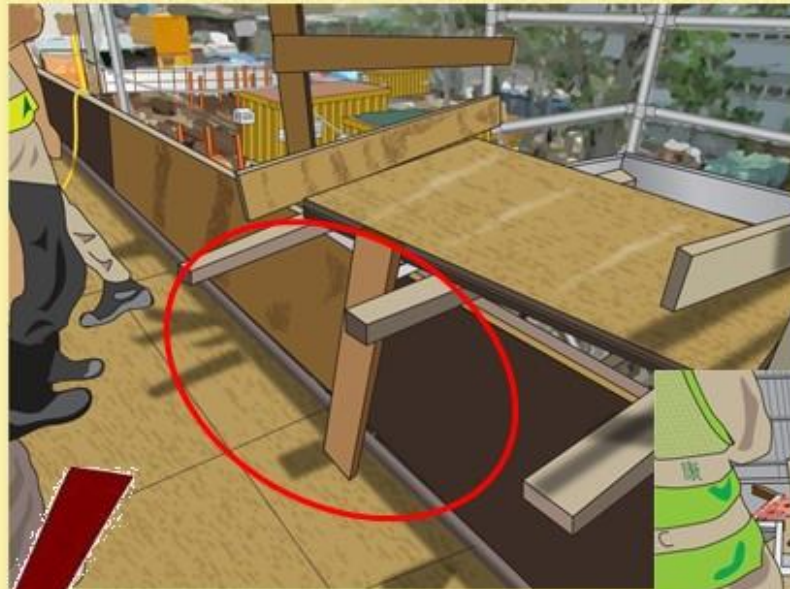
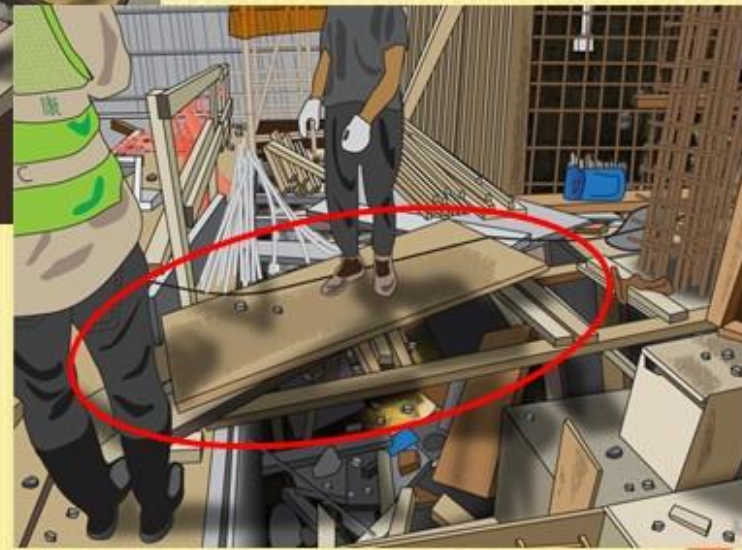
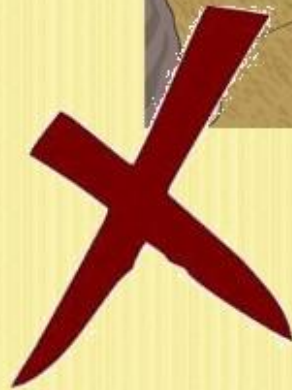
高空工作台及天面间没有进出设备；不安全的木板路。

ACCESS EQUIPMENT WAS MISSING BETWEEN ACCESS TOWER AND THE WORKING FLOOR.
UNSAFE GANGWAY WAS PROVIDED FOR THE SITE.

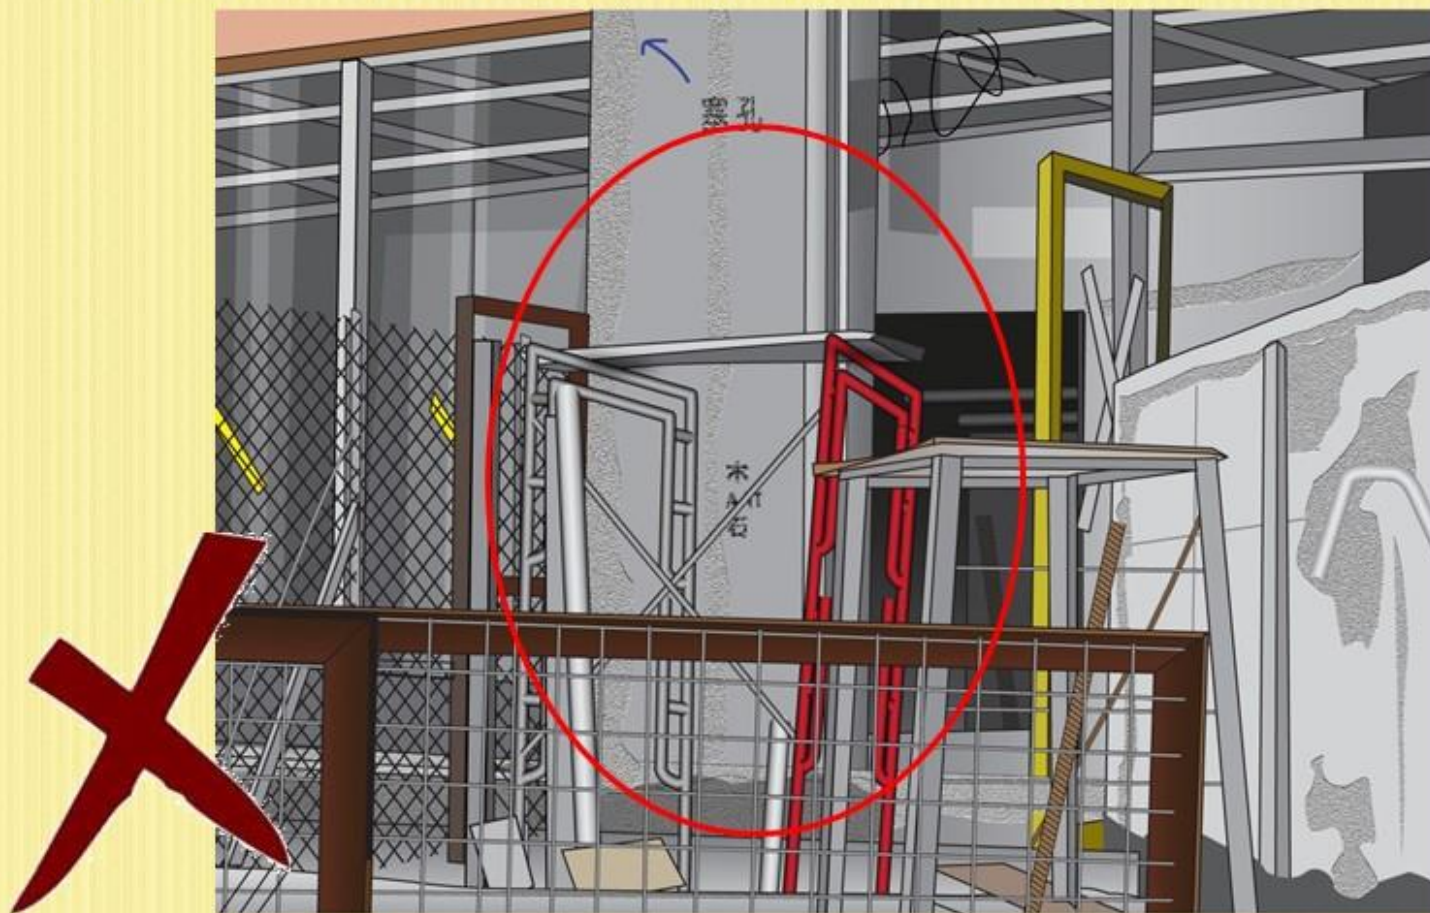
低于2米的工作台处于不安全操作状态。

WORKING PLATFORM BELOW 2M WAS NOT IN GOOD WORKING ORDER.
