HOUSEKEEPING

工作场所整理

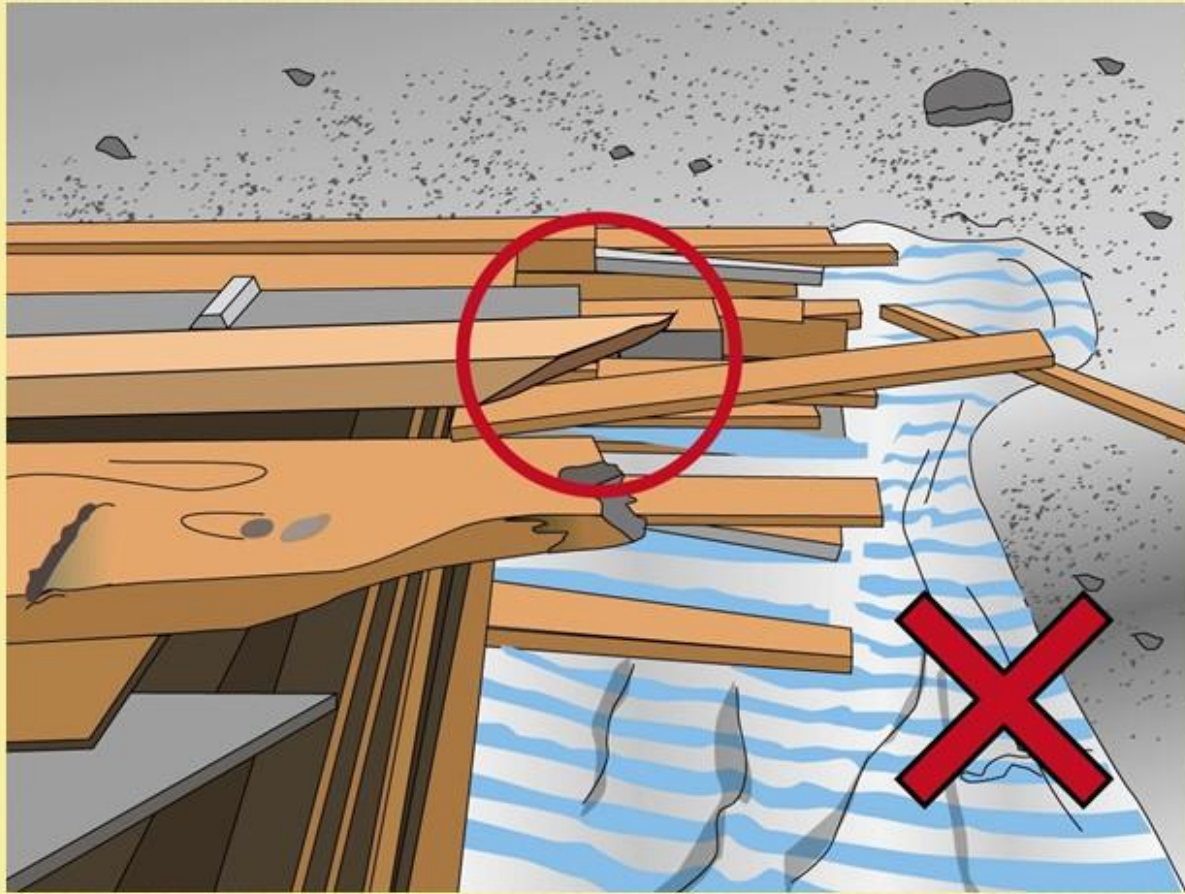
PROJECTING SHARP OBJECT

突出的尖锐物

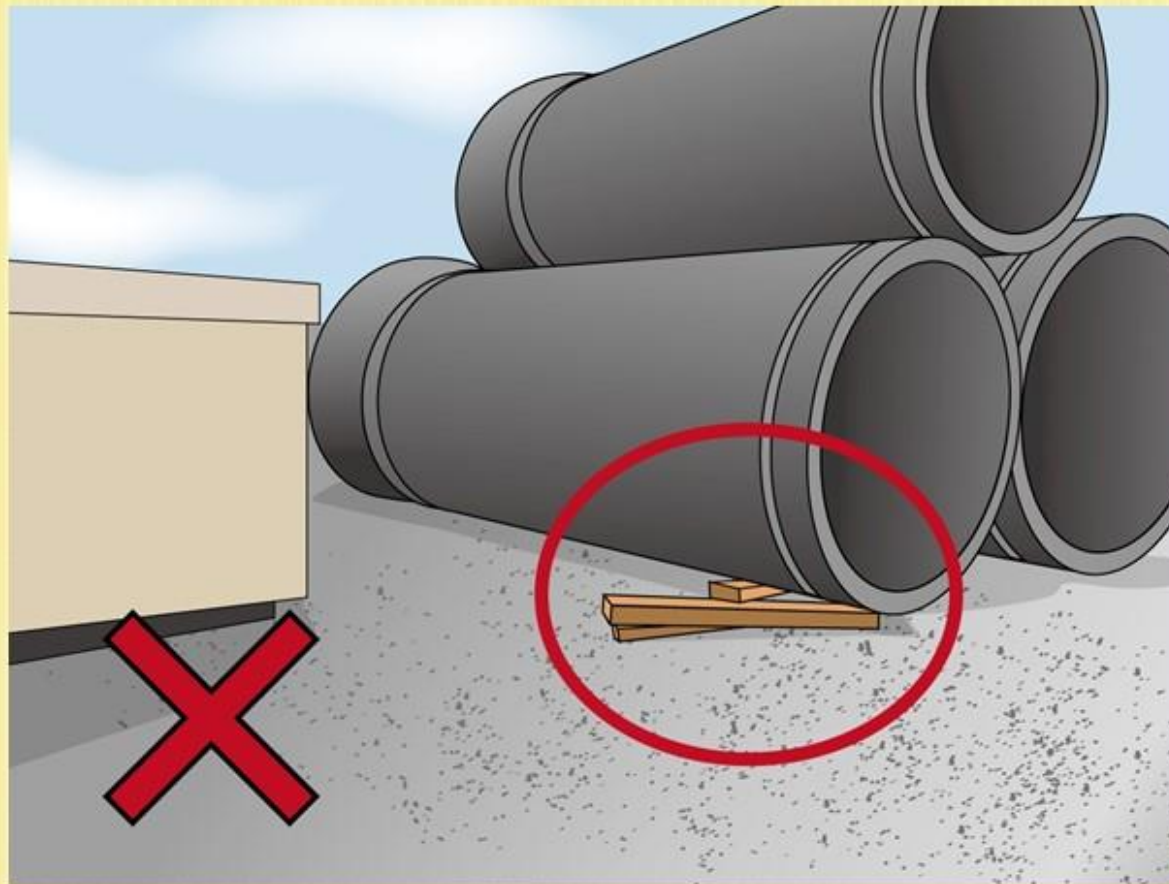
CONCRETE PIPES WITHOUT SECURE STOPPER

大型石矢渠筒没有被妥善楔好

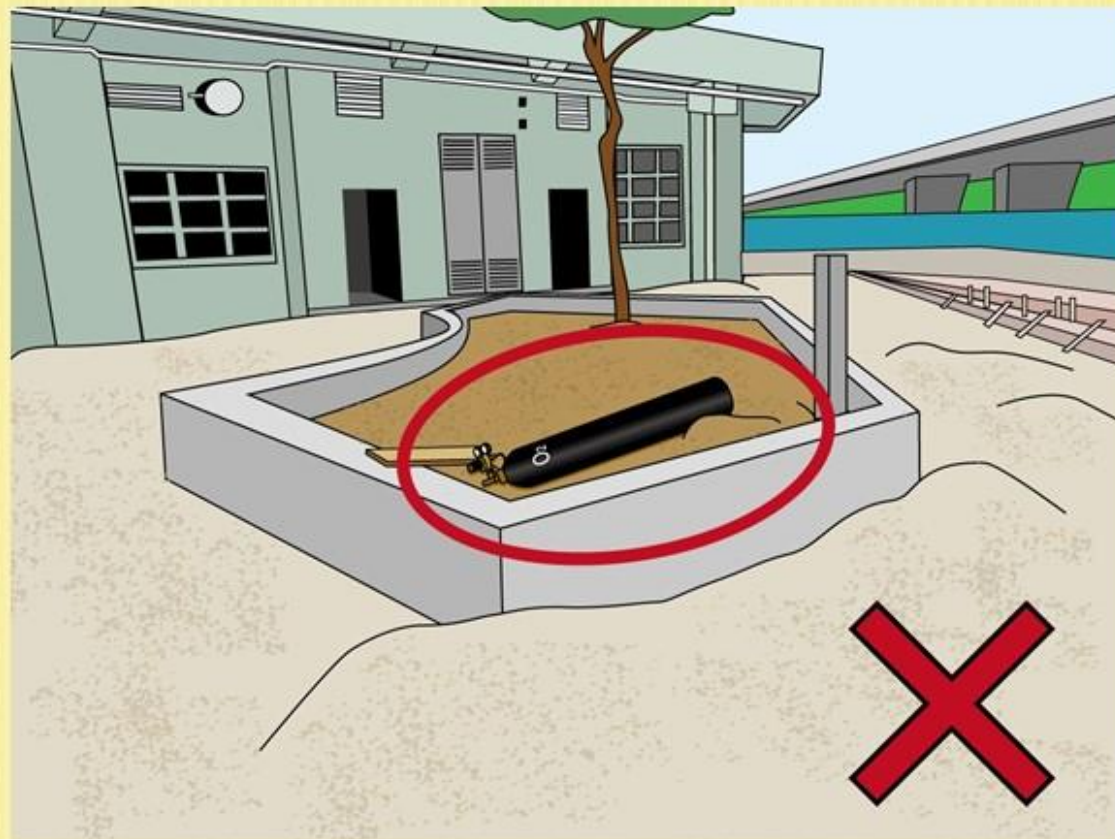
Empty gas container found inside planter
用完的氧气瓶没有被妥善储存

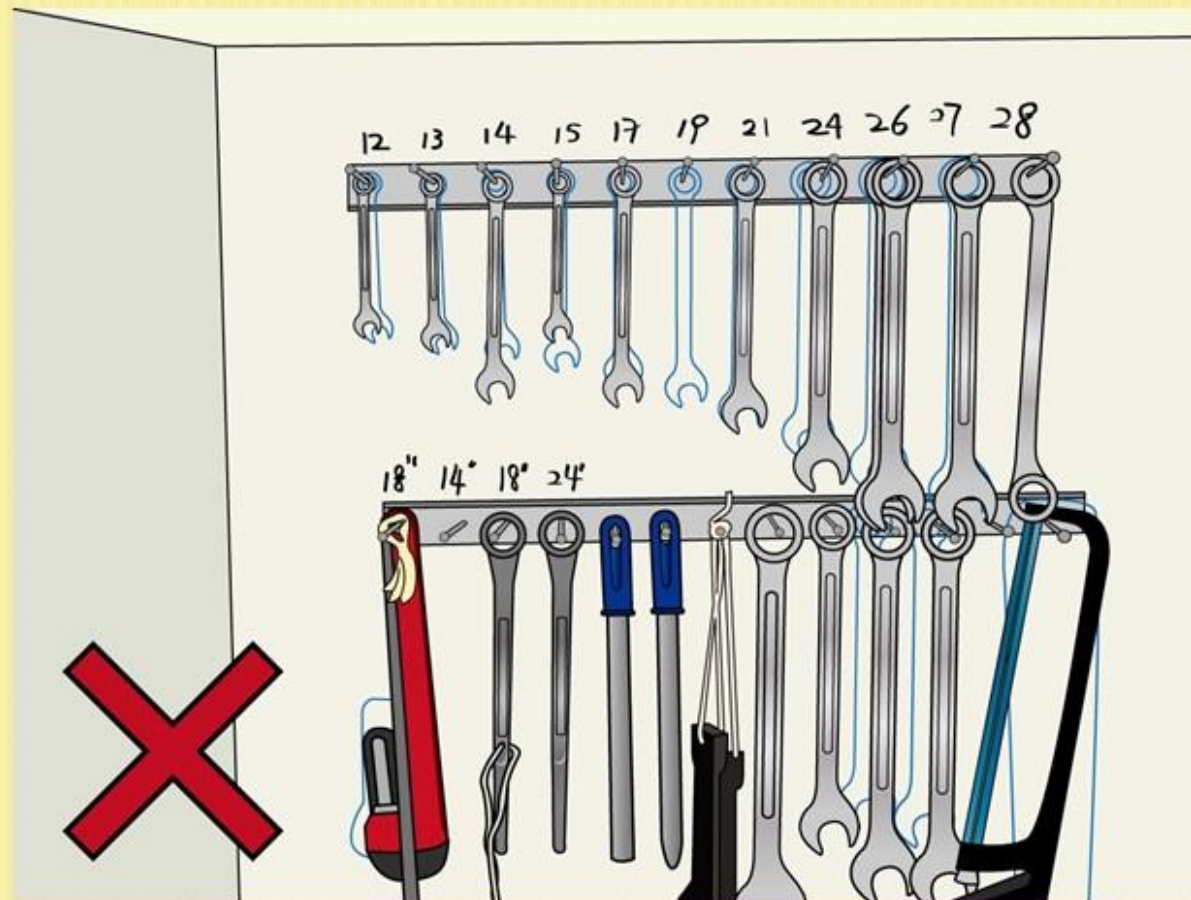
HOUSEKEEPING SYSTEM NOT BEING FOLLOWED

没有依从良好工作场所安排

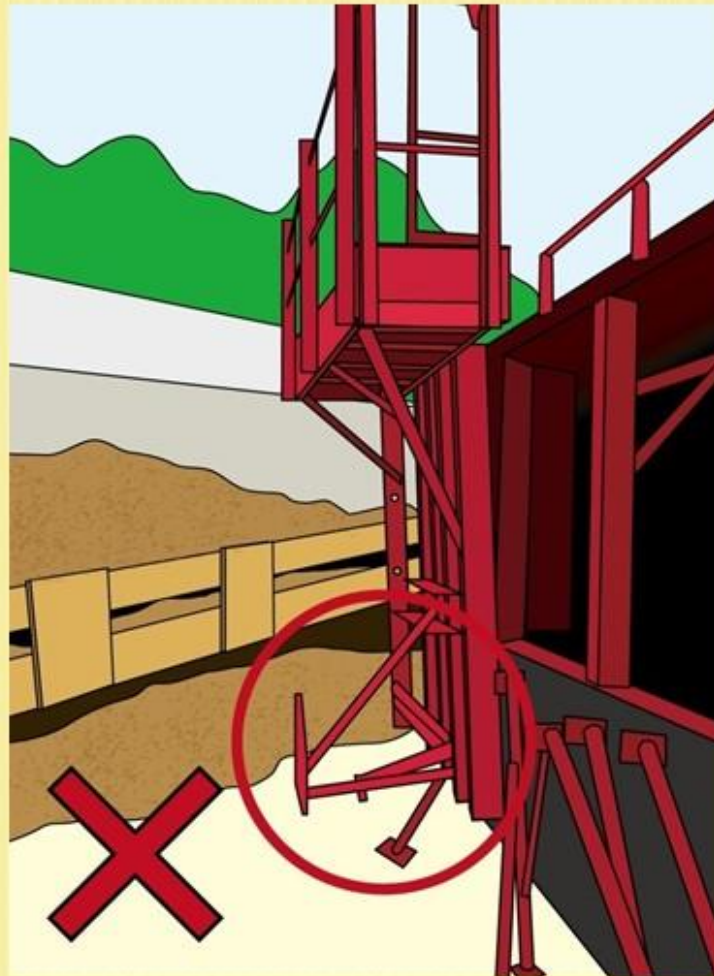
铁模没有足够支撑

**METAL FORMWORK WITHOUT SUFFICIENT
SUPPORT**

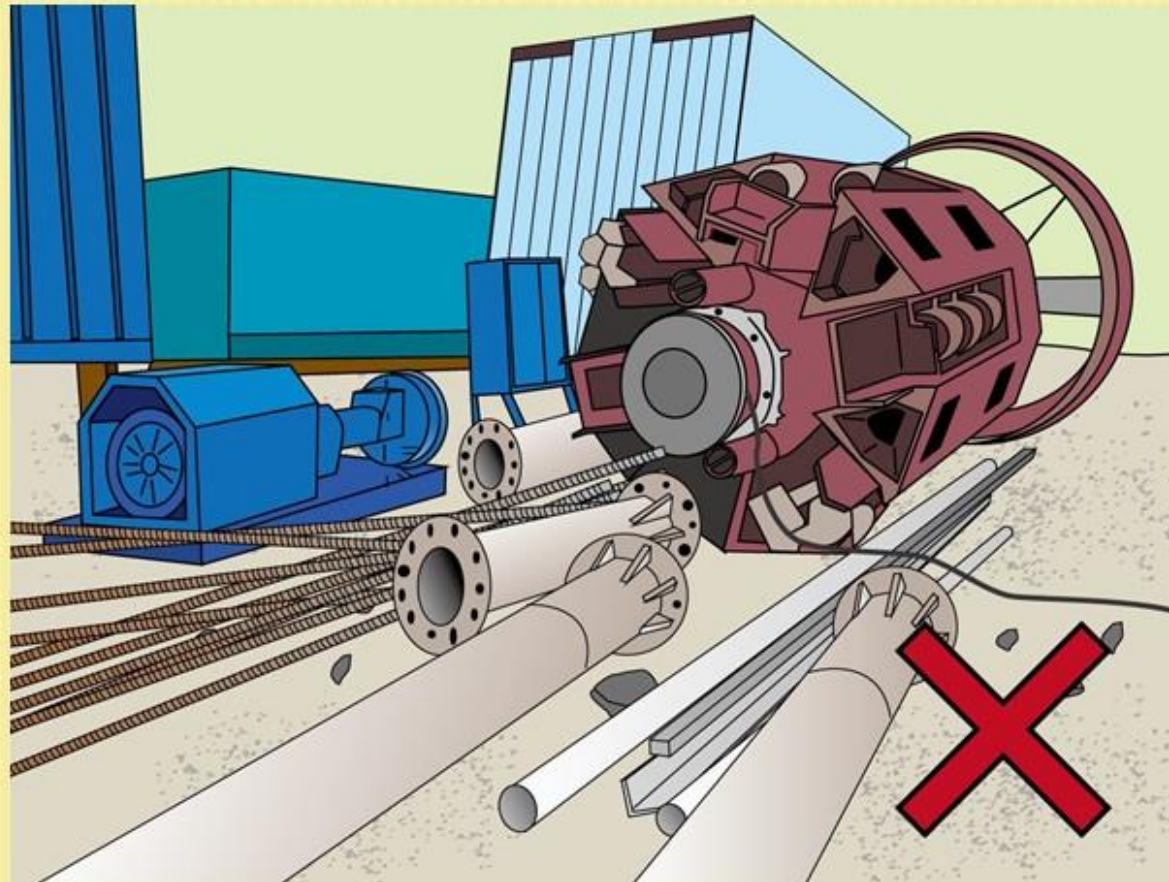
物料随地乱放

MATERIALS STORED IMPROPERLY

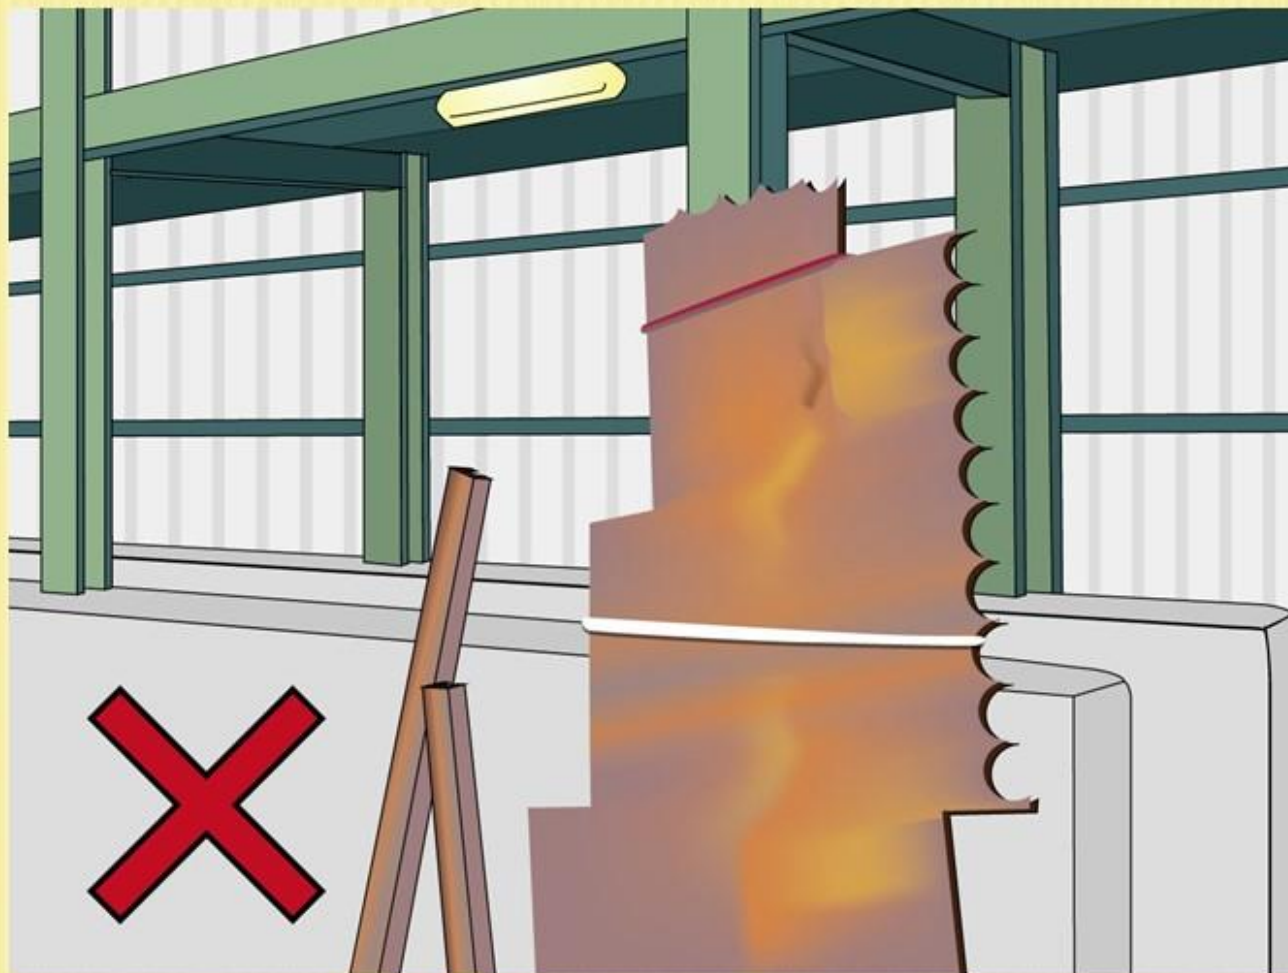
突出的尖锐物

PROJECTING SHARP OBJECT

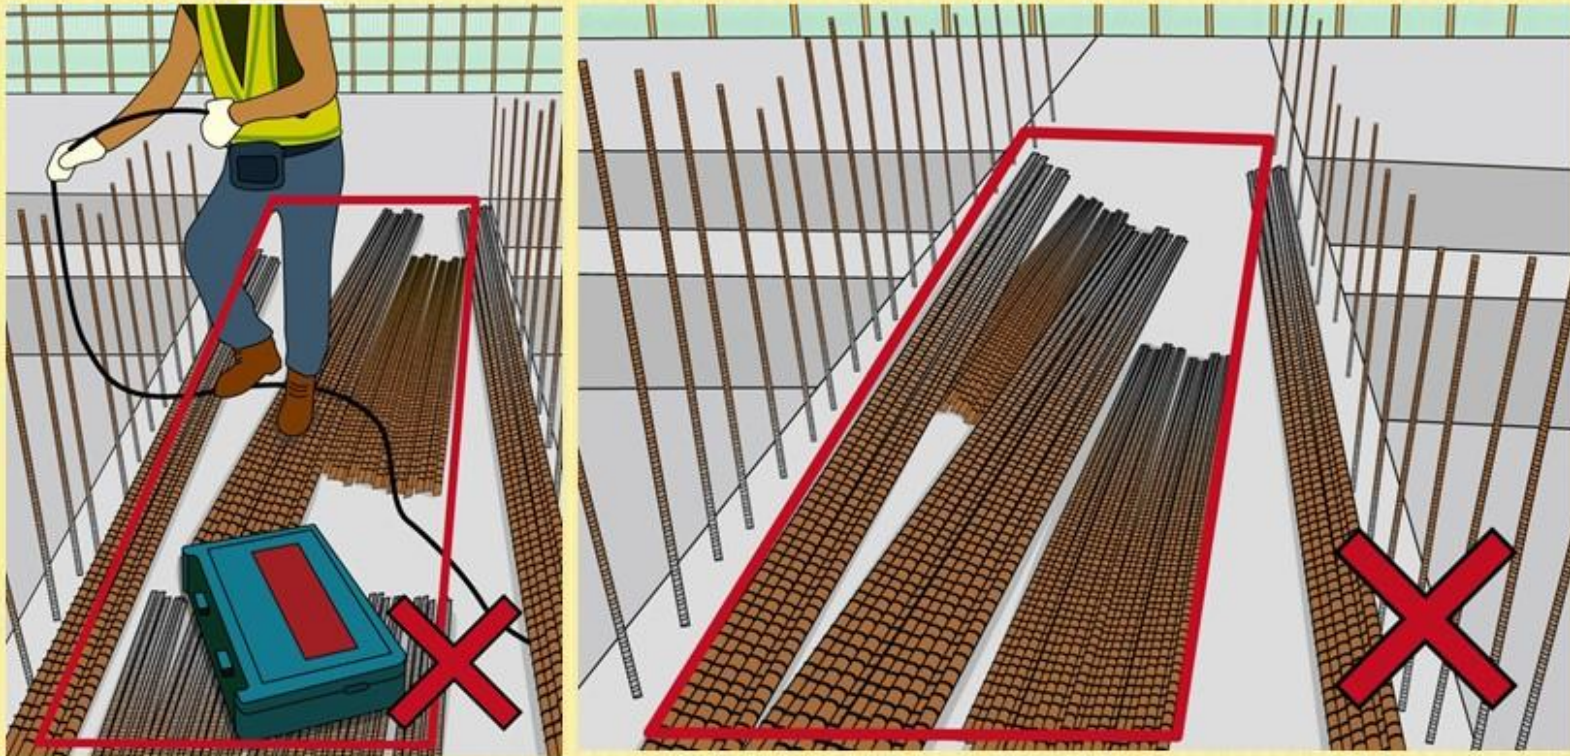
钢筋放置于主要道路或导致绊倒

METAL BARS PLACED ON THE MAIN ACCESS
CAUSING TRIPPING HAZARD

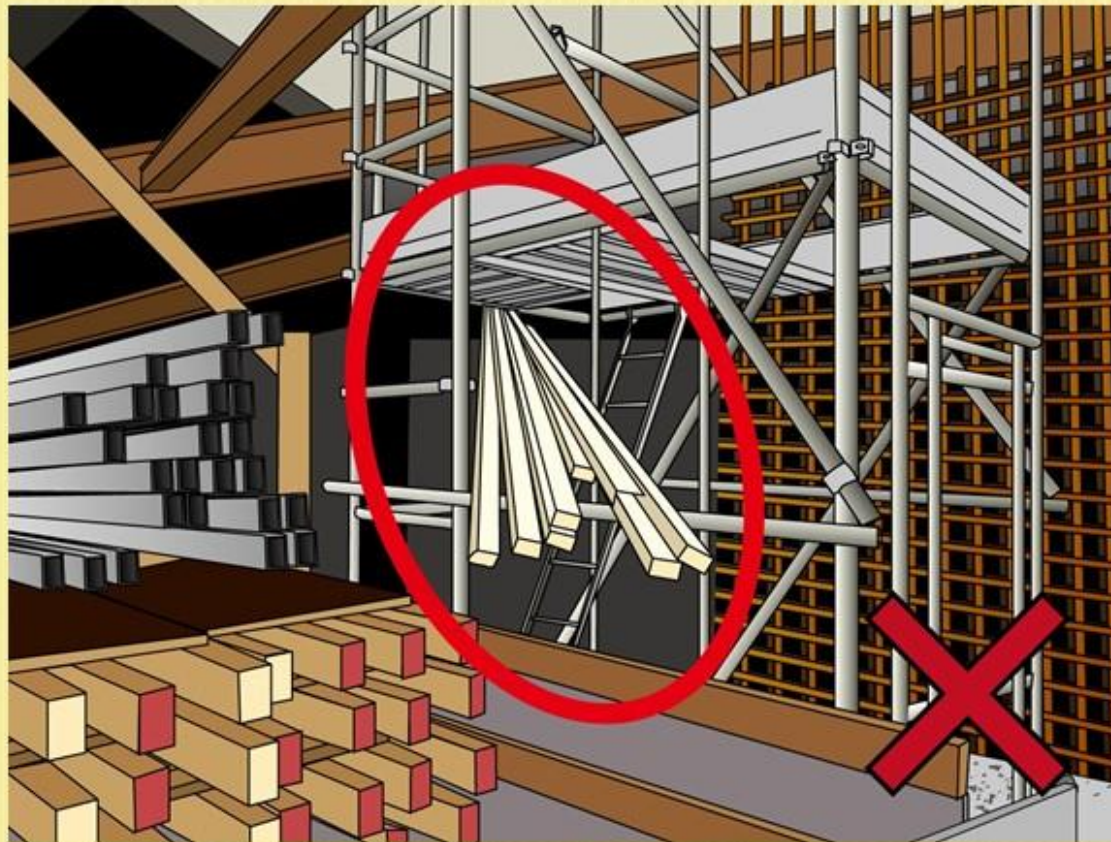
木条不穩固地斜放于通架上

WOOD BATTENS STORED INSECURELY AT
MOBILE SCAFFOLD

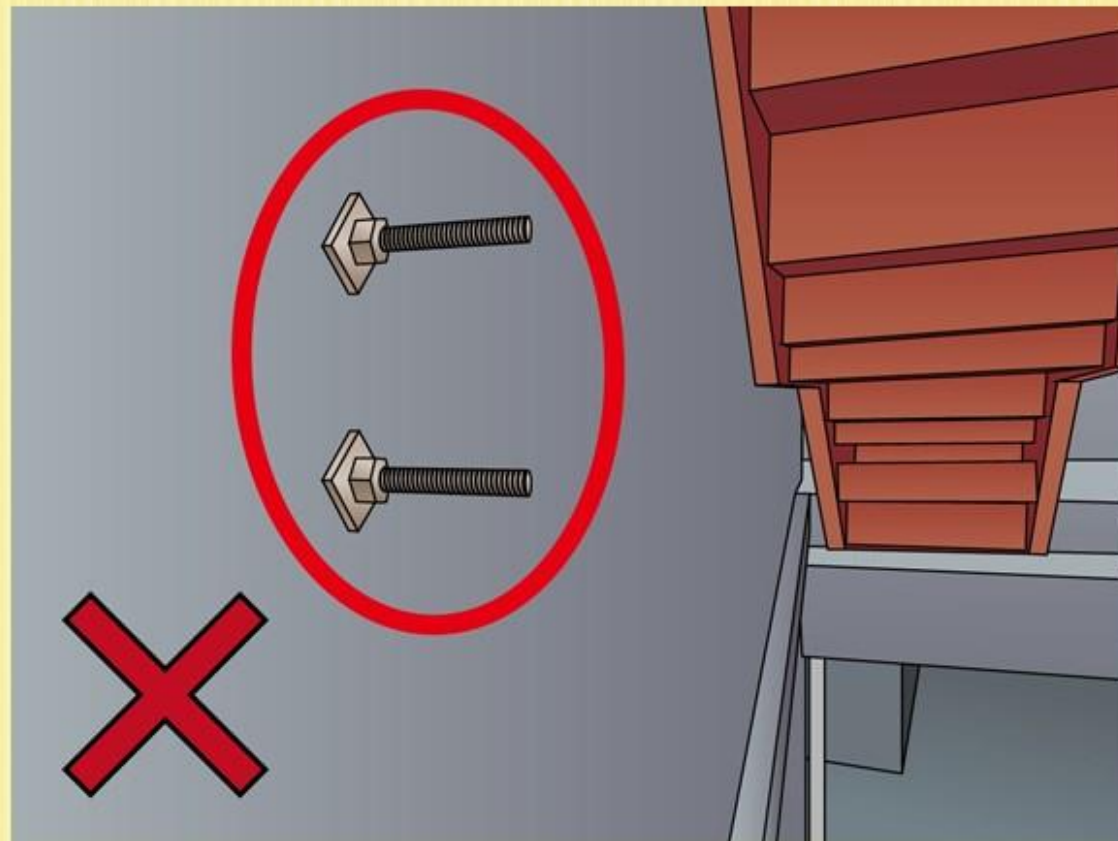
过山缆索凸出于进出路径

PROJECTING BOLTS WERE FOUND ON ACCESS ROUTE

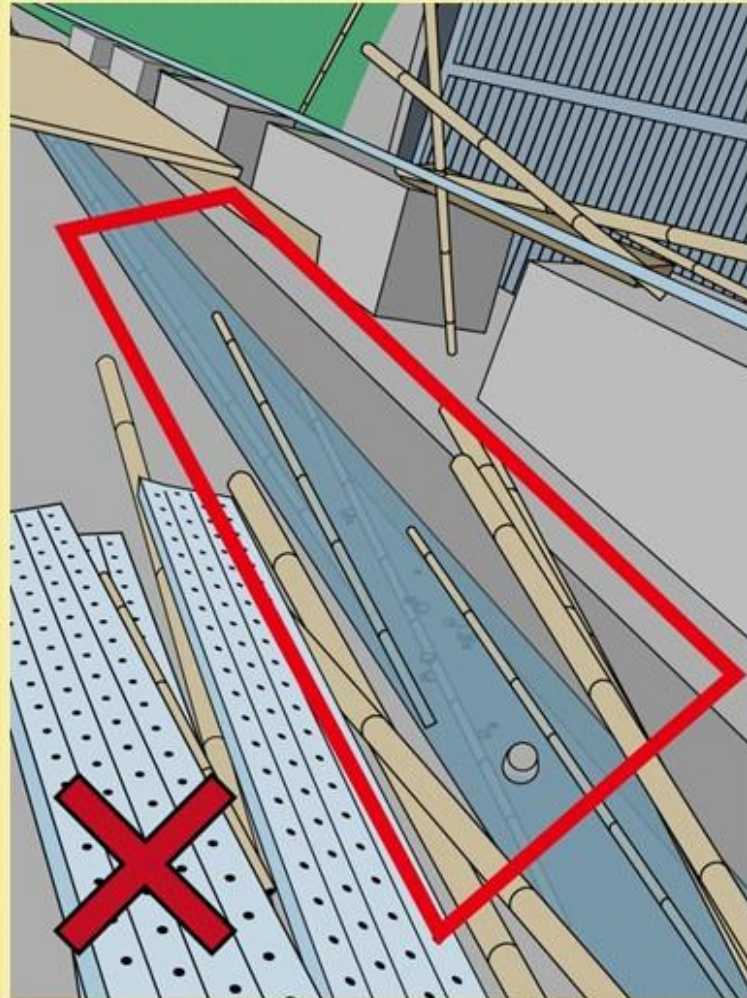
应清除积水以杜绝蚊患

STAGNANT WATER SHOULD BE REMOVED TO
ELIMINATE MOSQUITO BREEDING

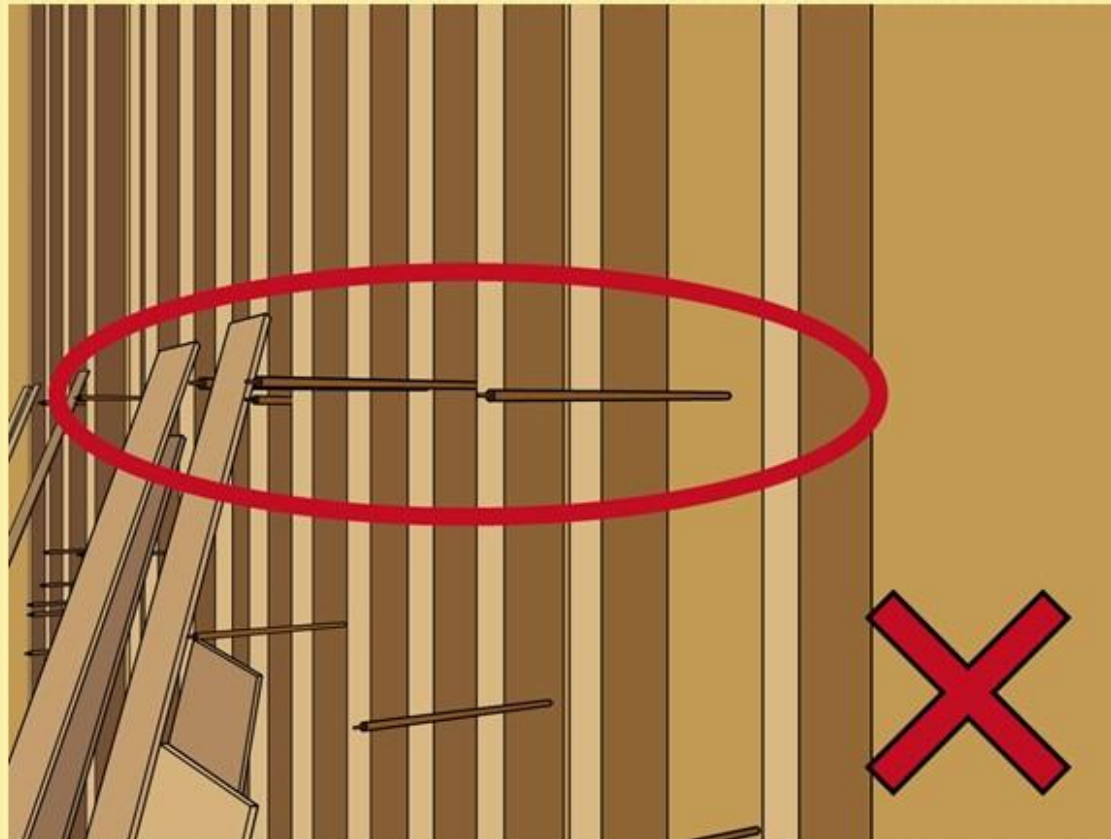
螺栓没有作出保护

PROTRUDED BOLTS WERE NOT COVERED

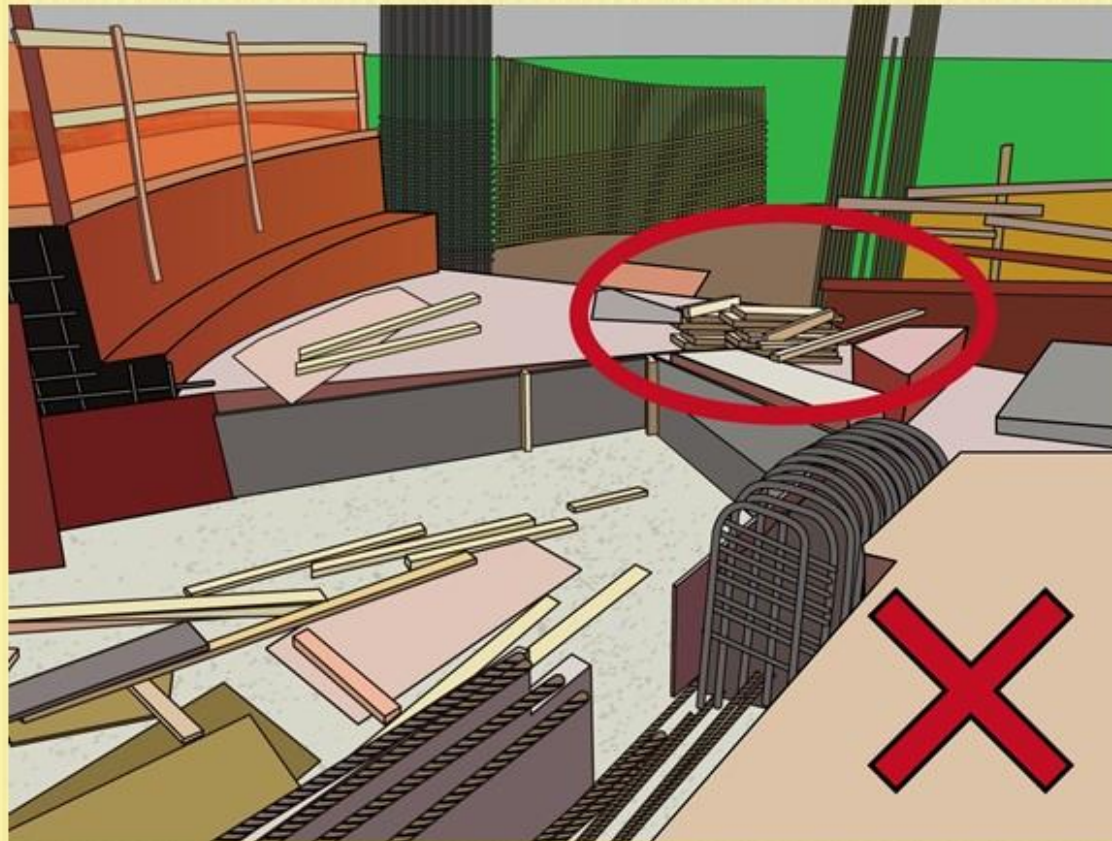
物料阻碍通道

MATERIALS OBSTRUCTED THE WALKWAY

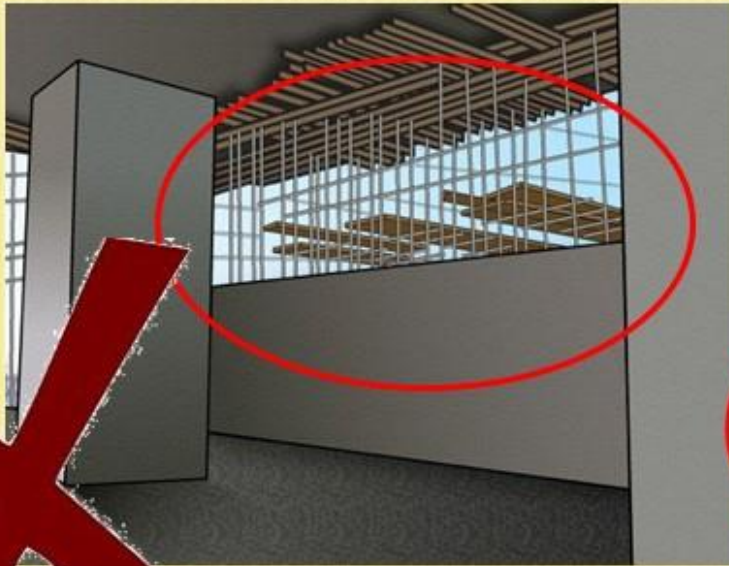
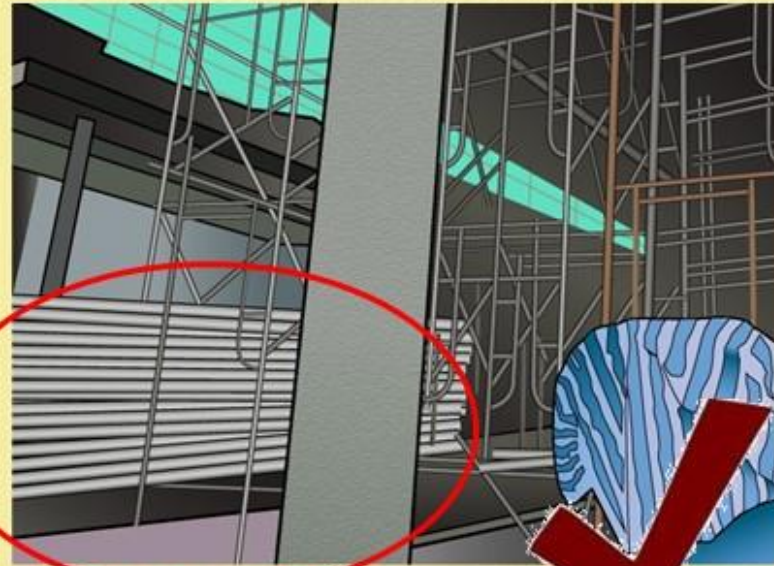
物料存放于临时支架的门架上

MATERIALS WERE STORED ON PLANE FRAMES OF
FALSEWORK

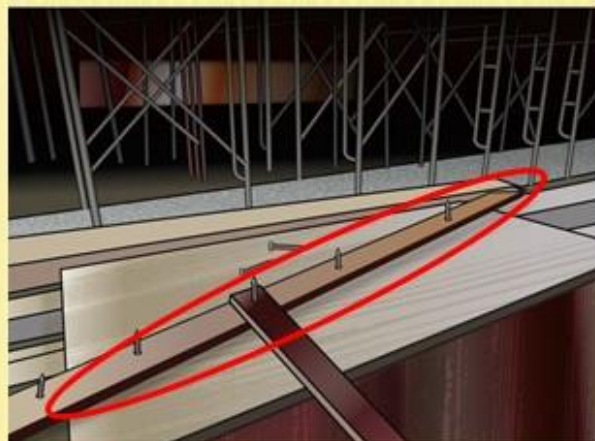
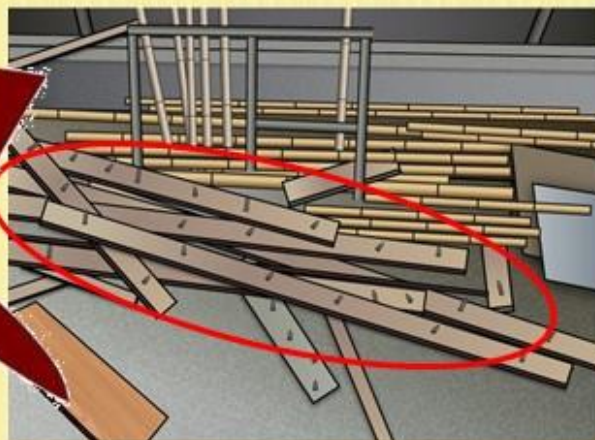
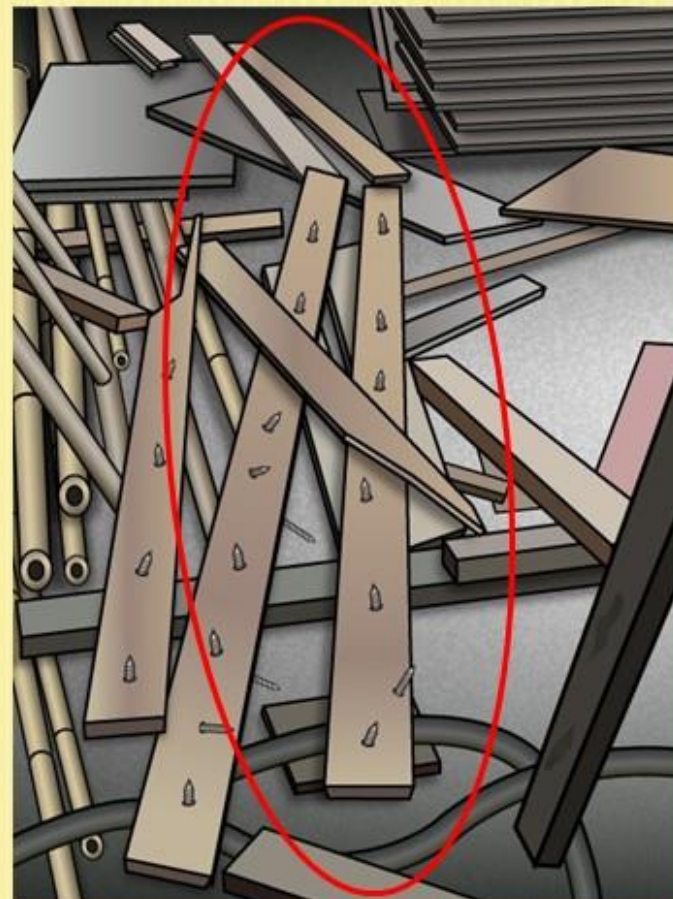
突出的铁钉。

PROJECTING NAILS WERE FOUND.

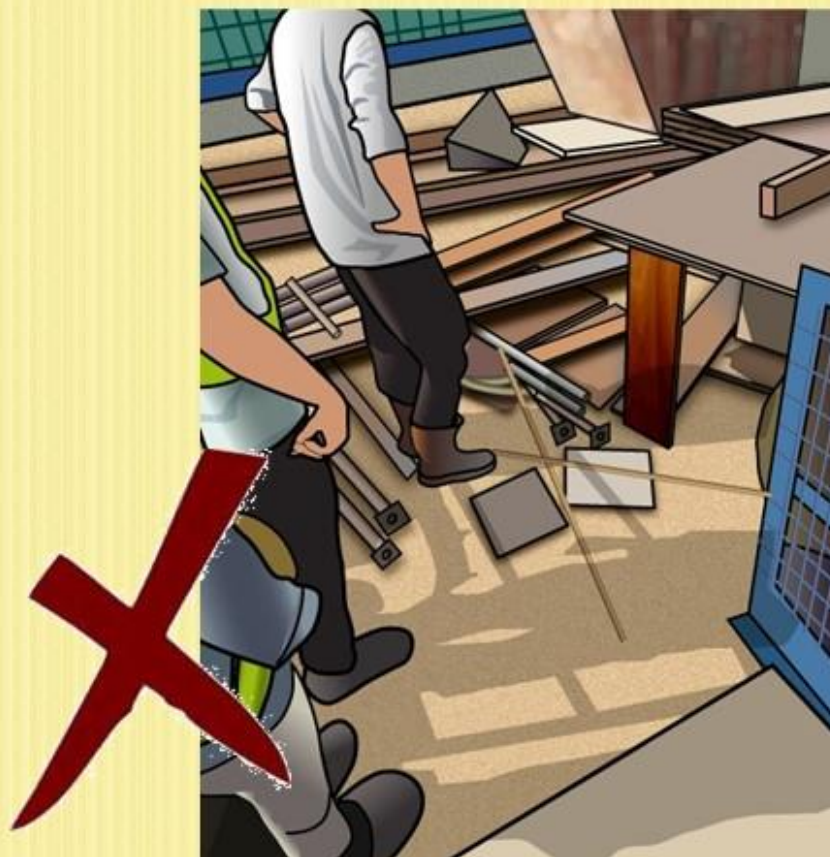
在通道上堆放杂物

MATERIAL WAS STORED ON THE PASSAGEWAY

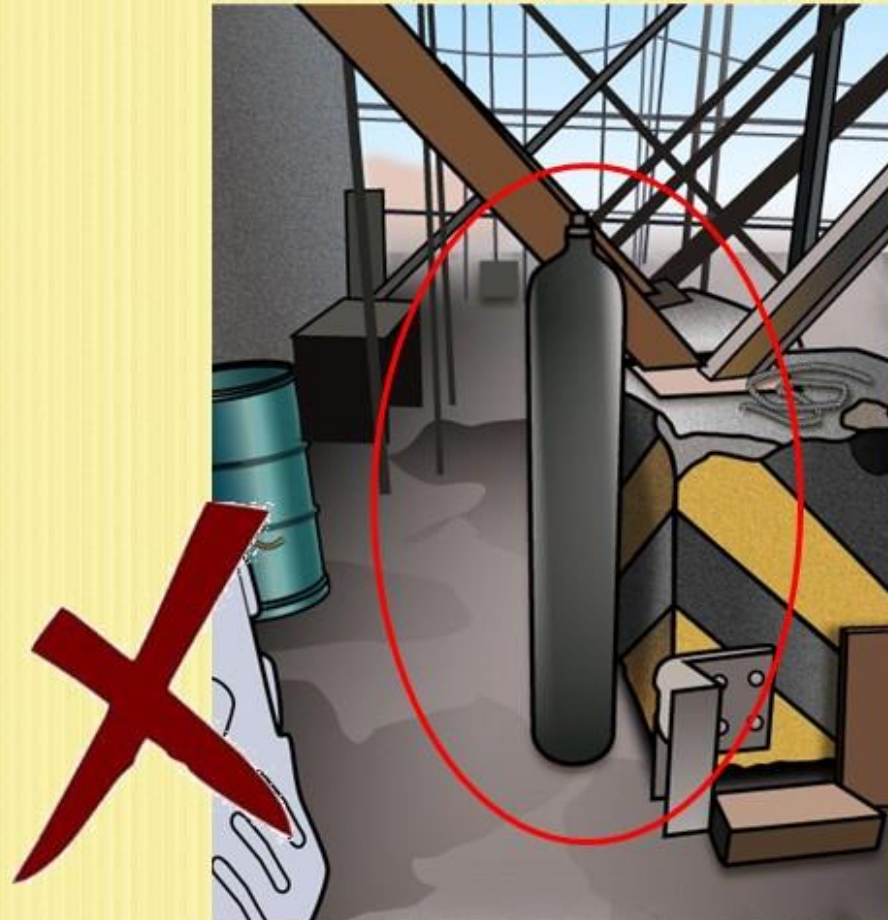
没有为气瓶提供保护以防倒下；气瓶没有存放于指定地方
GAS CYLINDER WITHOUT ANY PROTECTION AGAINST TOPPLING , AND
NOT STORED IN DESIGNATED AREA

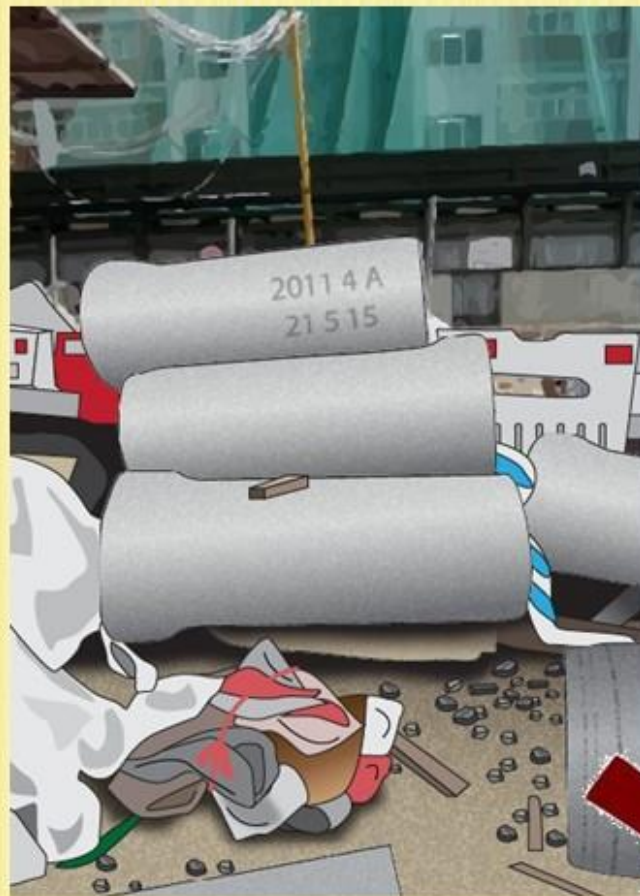
渠筒没有楔好。

STACK OF PIPE SECTIONS WAS NOT WEDGED.

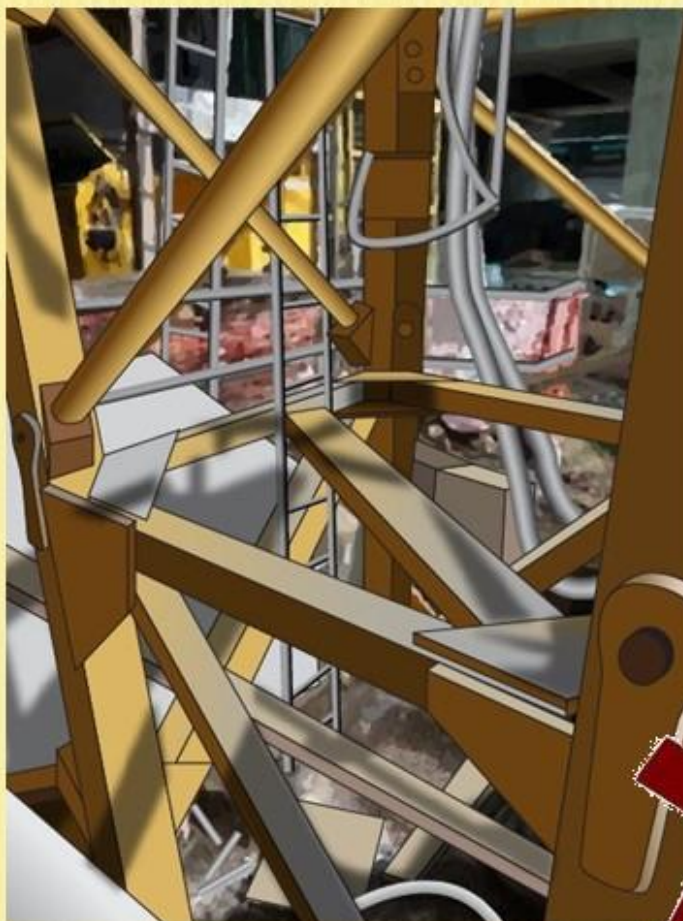
通往塔式起重机的通道有绊倒危害（木板）。

TRIPPING HAZARD/OBSTACLE (WOODEN PLANKS) WAS FOUND ON ACCESS LADDER TO TOWER CRANE.

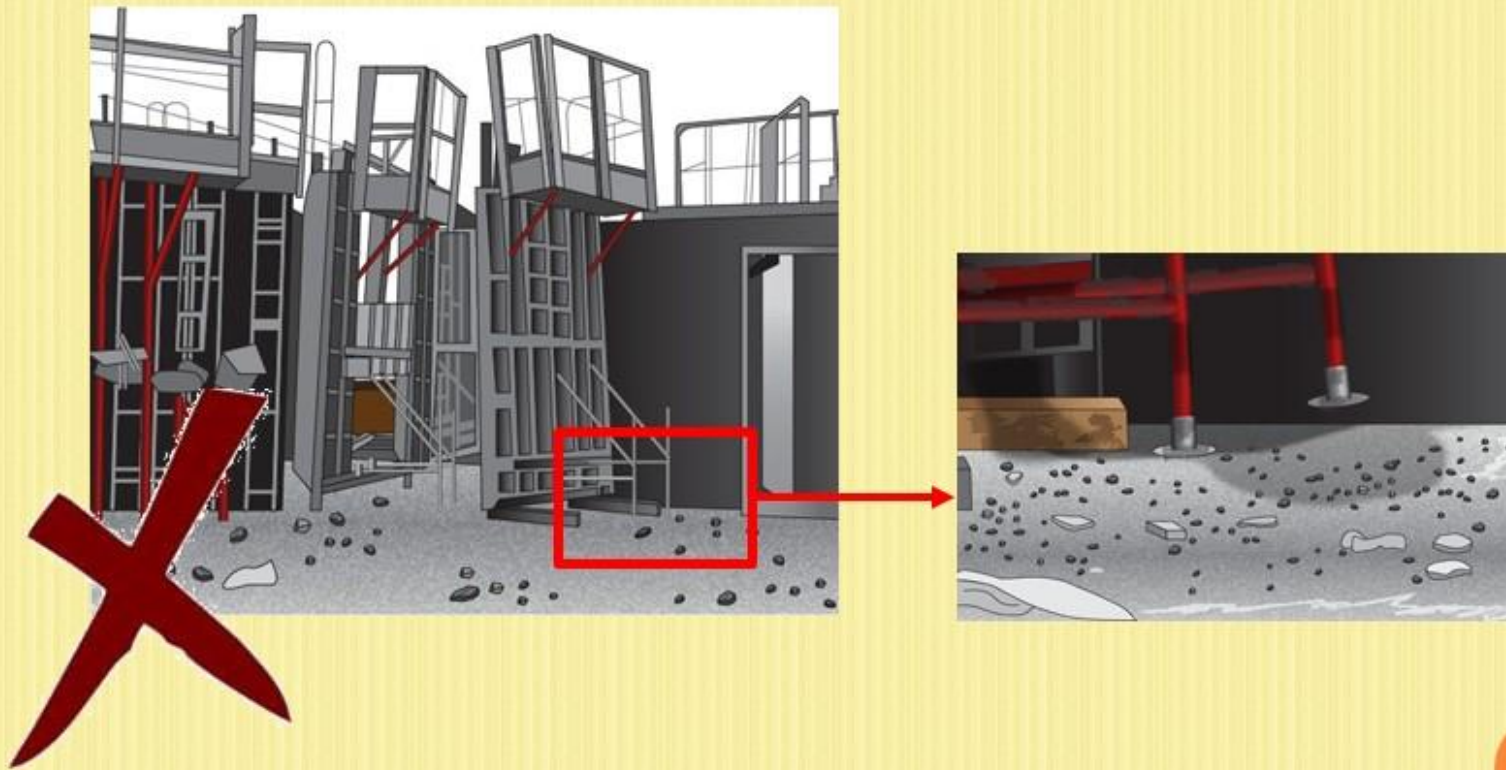
铁范本没有足够支撑。

PANEL FORMWORK WAS NOT SECURELY SUPPORTED.

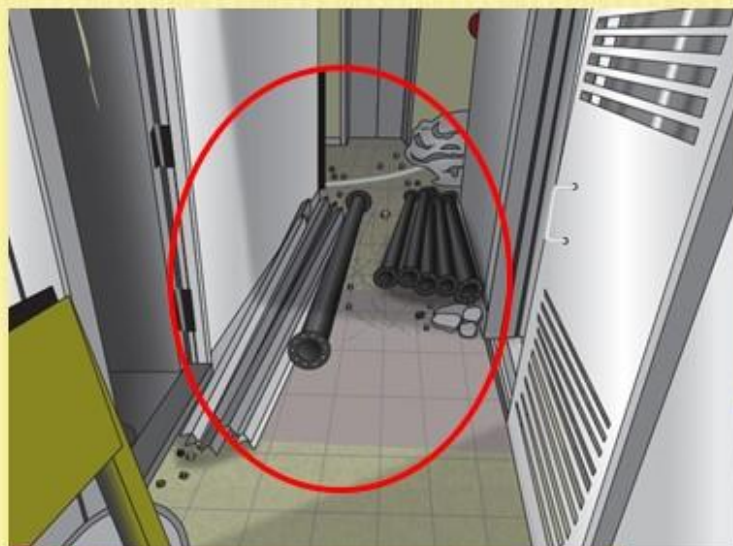
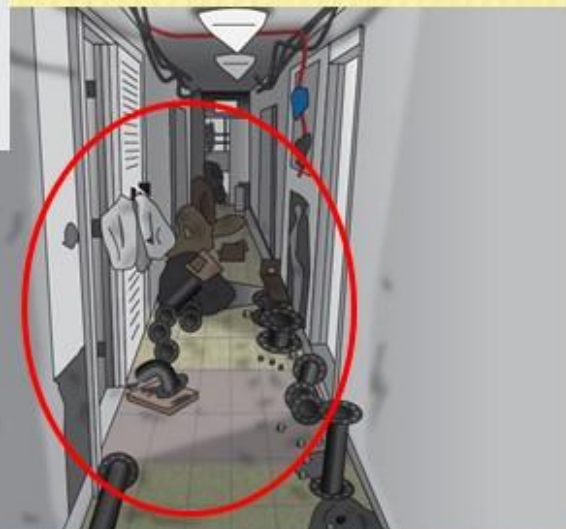
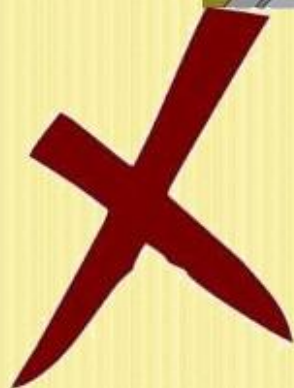
通道上放置物料。

MATERIAL WAS PLACED ON PASSAGEWAY.

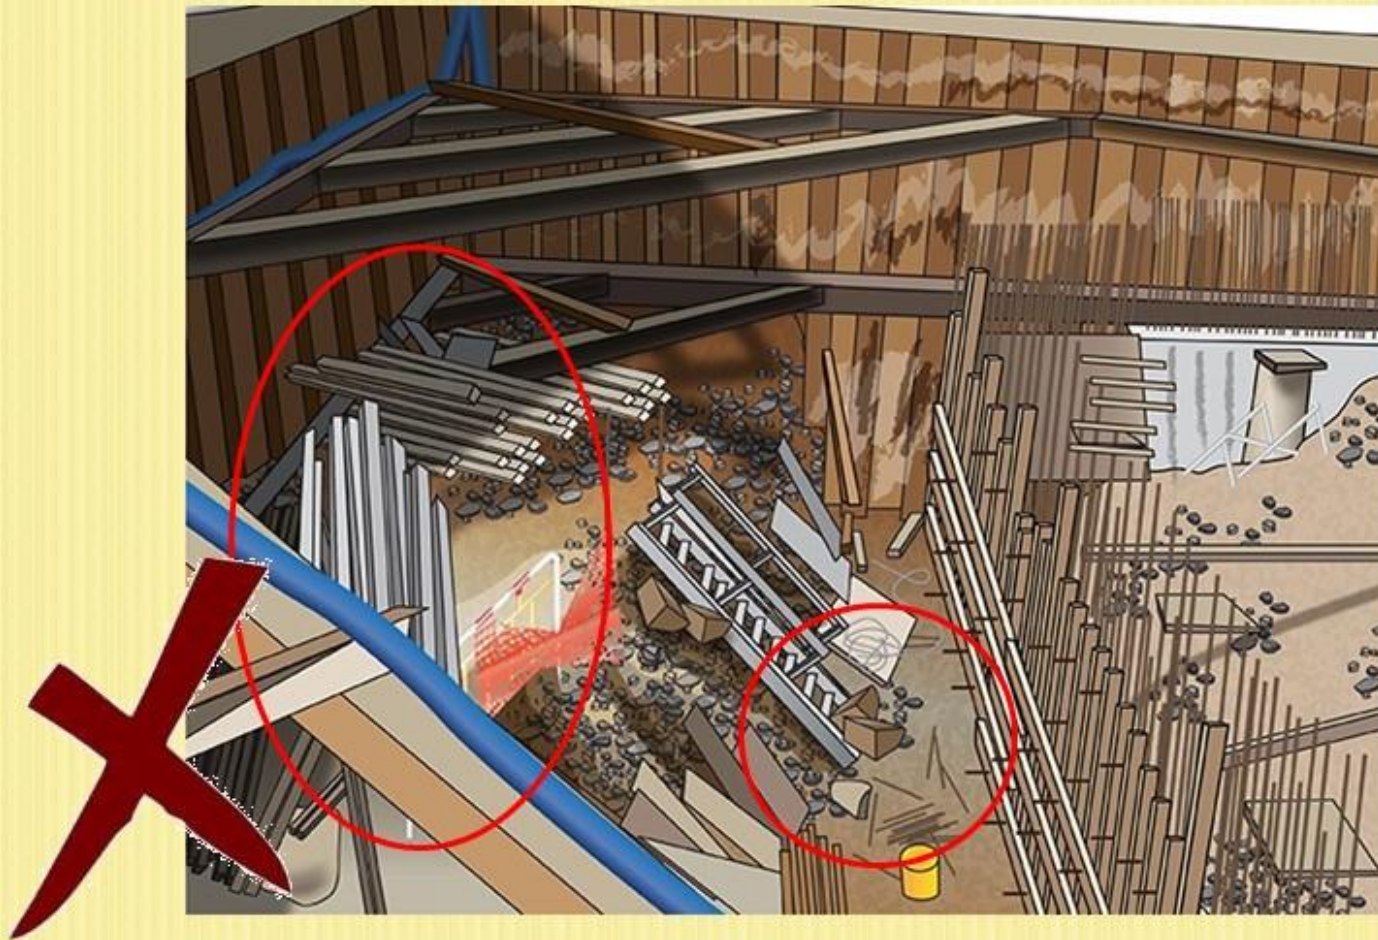
在通道上放置物料。

MATERIALS WERE PLACED ON THE PASSAGEWAY.
