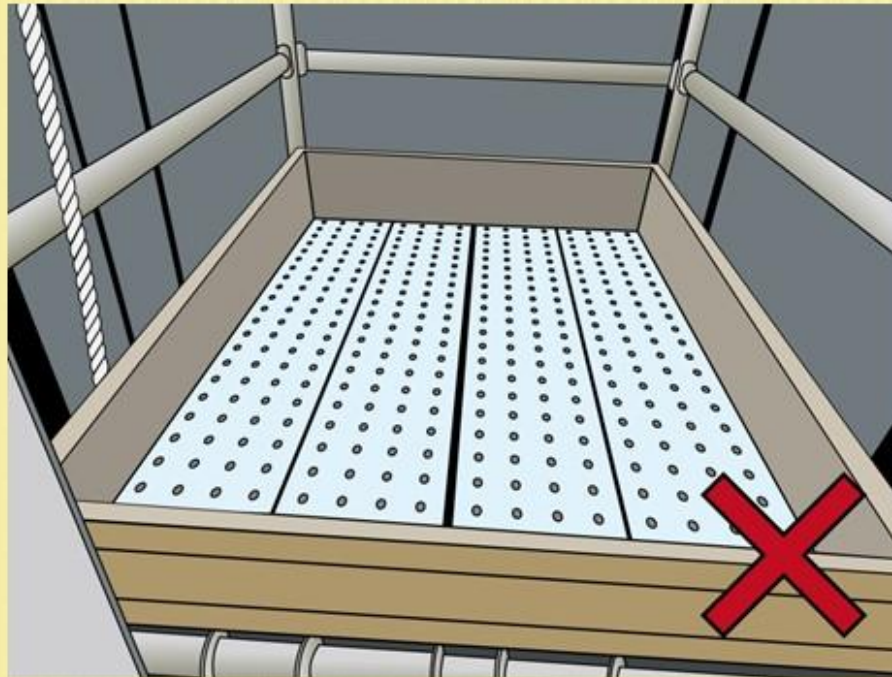
**No stairs / ladders were observed as the safe means of access and egress to the lift pit.**

沒有提供安全的樓梯/梯子進出升降機槽底。

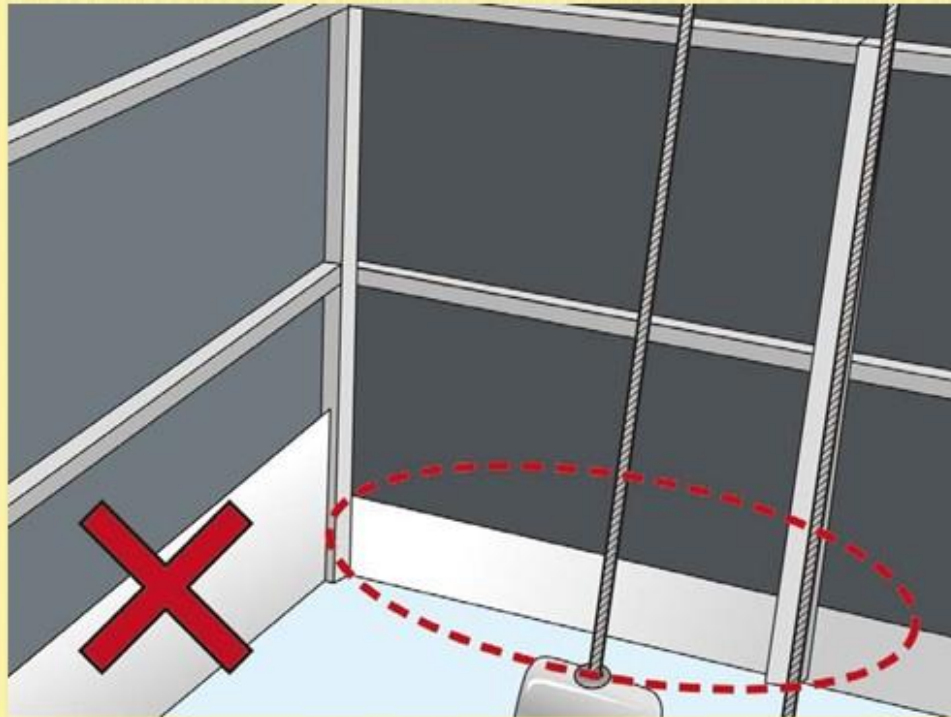
A portion of toe-board was found not up to the required 200MM height

部分踢腳板發現不夠所需的200MM高度。

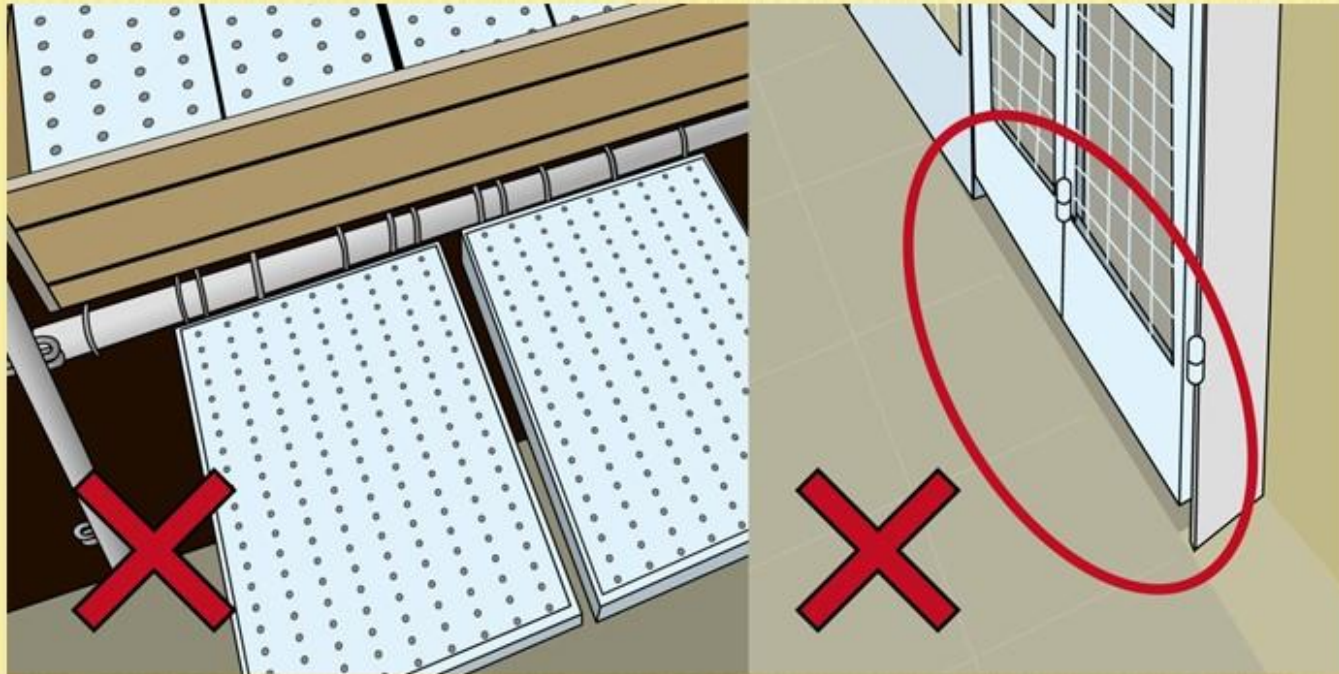
**Gaps were found at the access and the toeboard of the gate - room to improvement**

通道及踢腳板上發現空隙

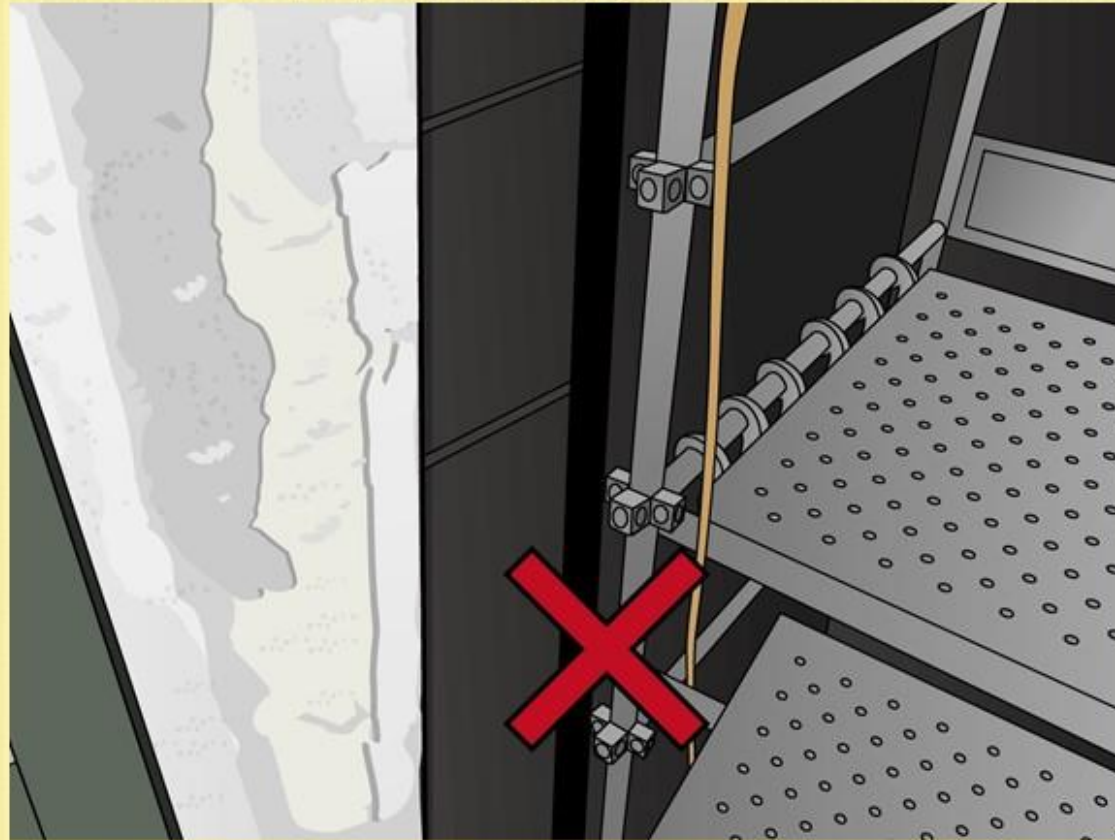
Dangerous edge was not guarded and toeboard was found missing 危險的邊緣未有保護好及沒有踢腳板

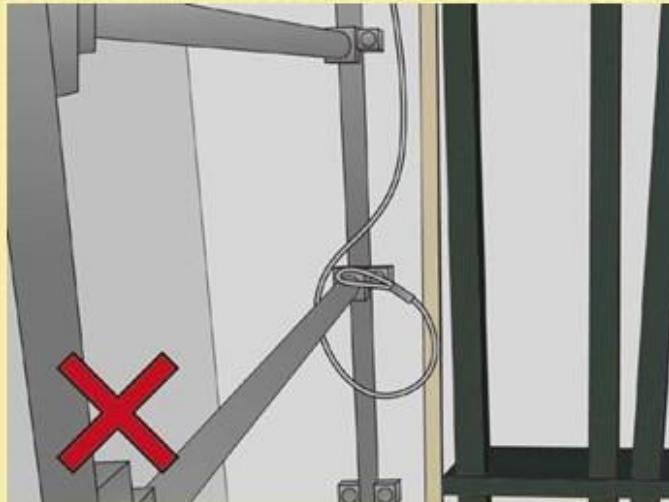
Wire sling was found without colour code 吊索被發現沒有噴上顏色代碼。

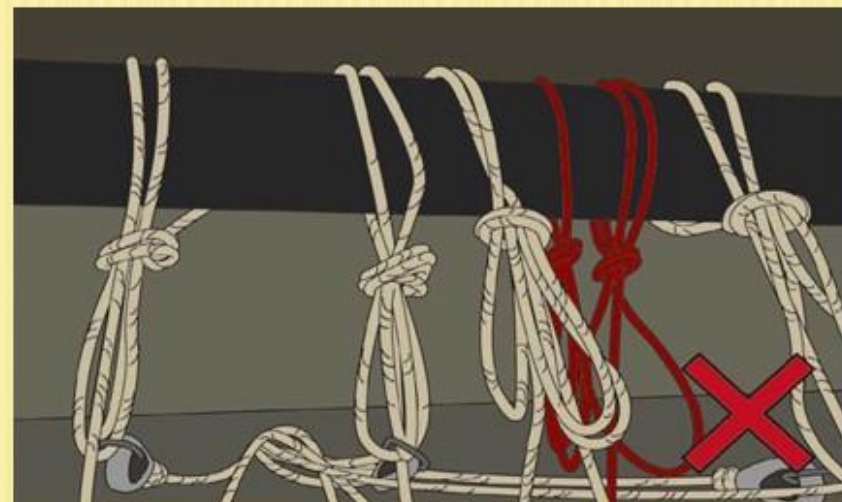
Independent life line provided at lift shaft. However, the loading capacity should be further checked and confirmed to meet the COP requirement 雖然升降機槽已提供獨立救生繩，但承載能力應進一步檢查和確認。

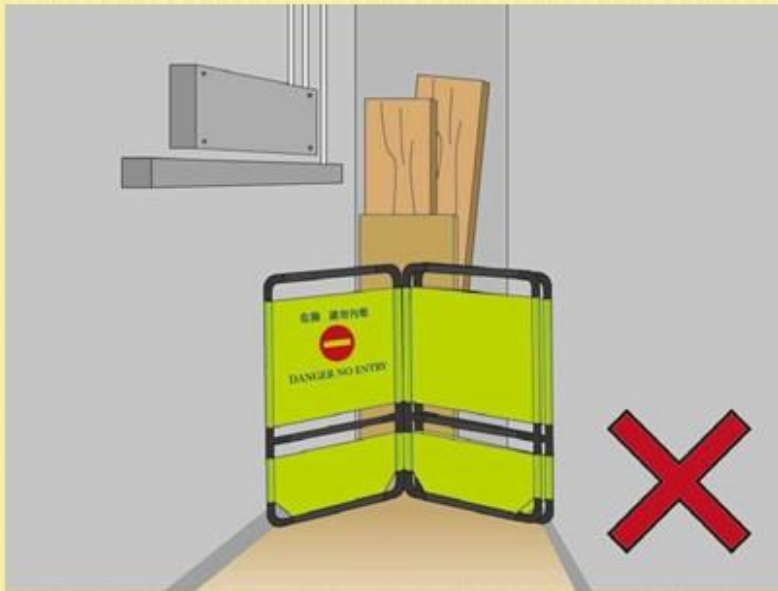
Materials should be cleared off  
in the public area 物料不應該  
堆放在公共區域

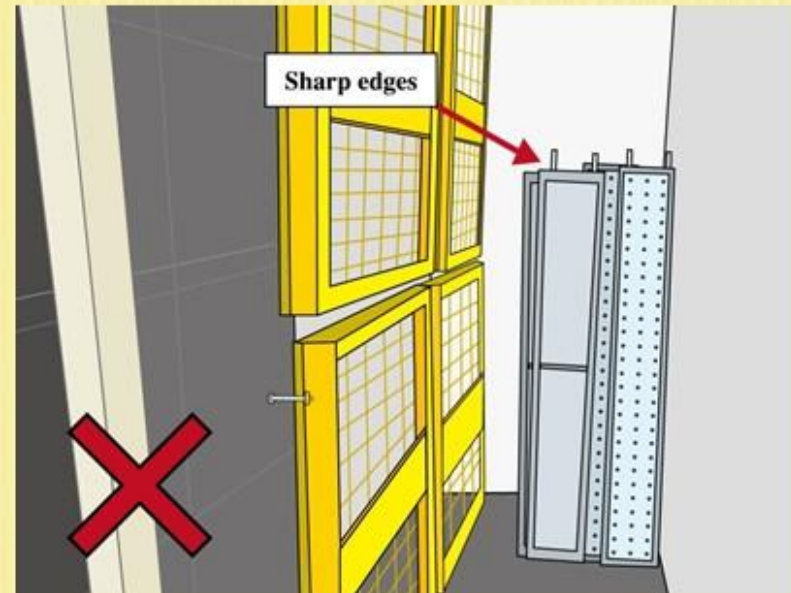
Stored materials were not fixed  
properly.  
不安全的物料堆放

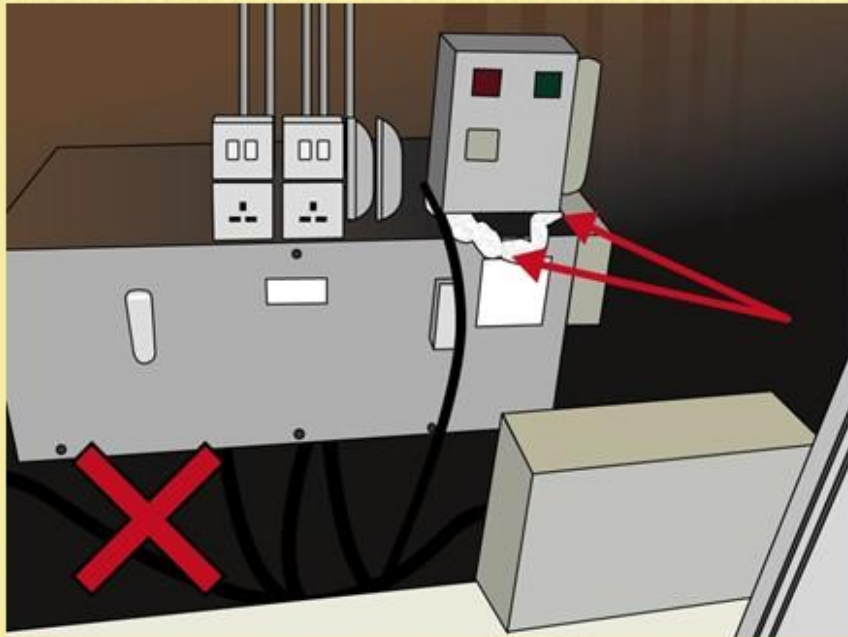
Improper waste disposal on top of the lift car was observed 電梯轎廂的頂部有廢物堆放。

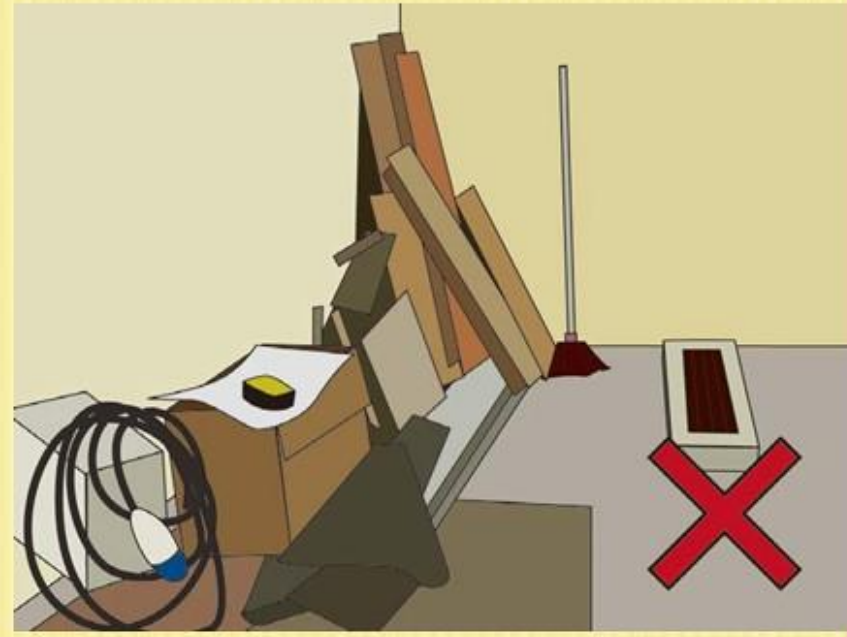
Construction materials should be stored properly in the machine room 在機房施工材料應妥善保存。

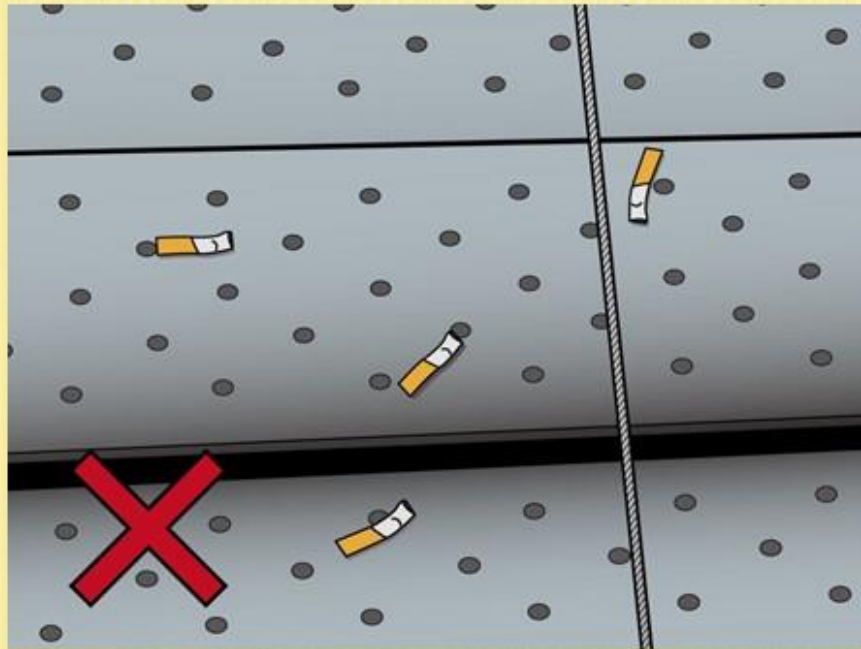
Cigarette ends in workplace  
在工作場所棄置煙蒂

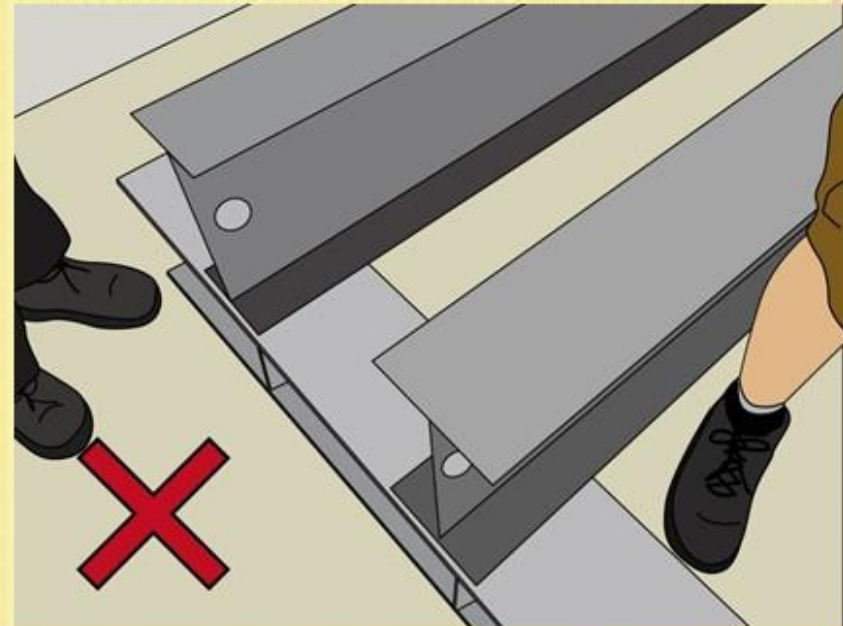
Sharp edges of H-beams in lift machine  
room should be adequately protected.  
在電梯機房的鋒利的邊緣應得到充分保護。

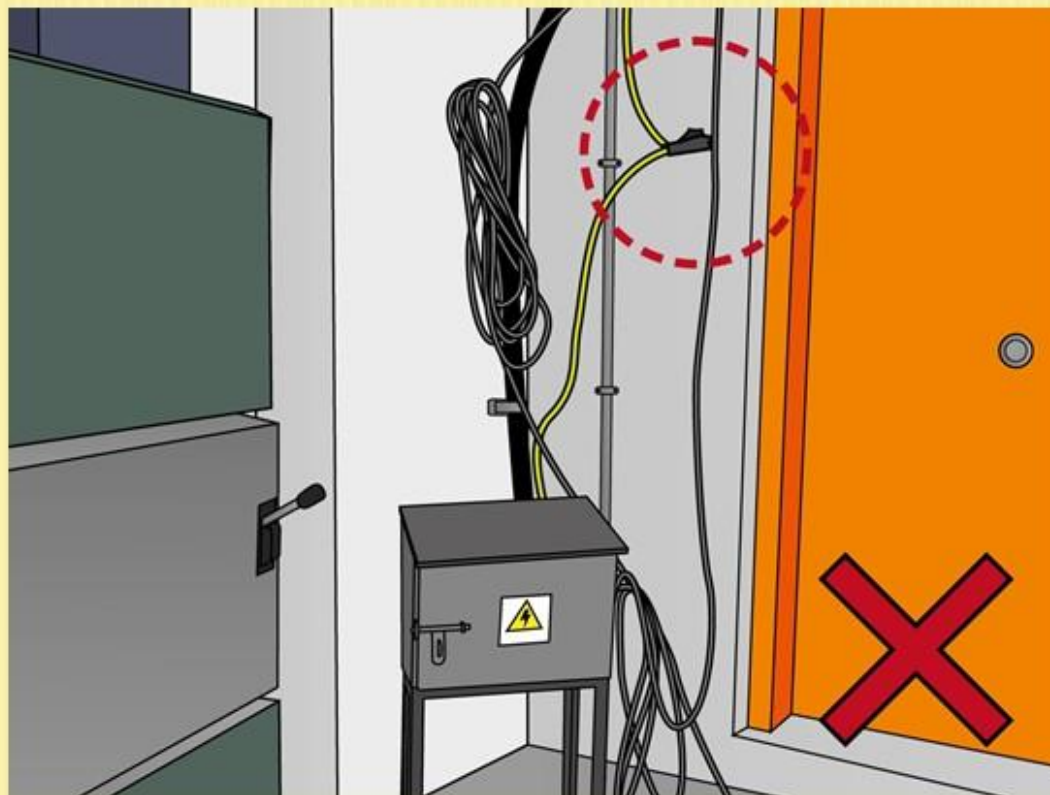
**The bonding line should be maintained in a good condition** 接合線應保持在良好狀態

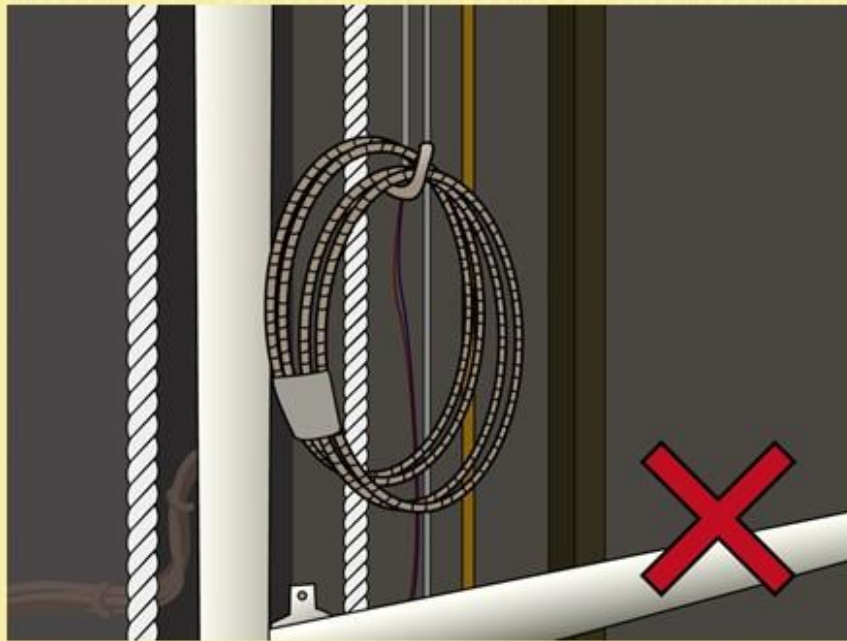
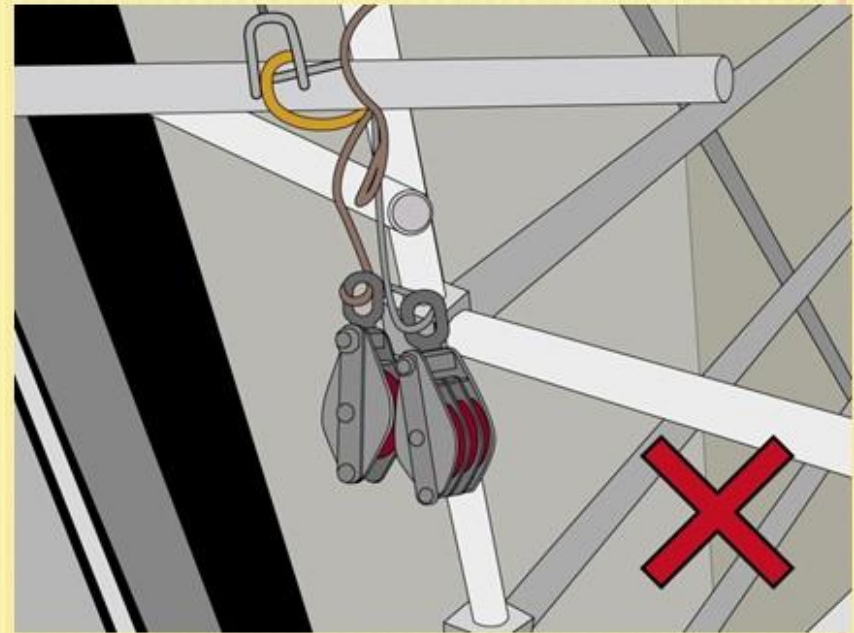
Lifting gear inside the lift shaft did not have proper colour code

升降機槽內的起重裝置欠缺顏色代碼

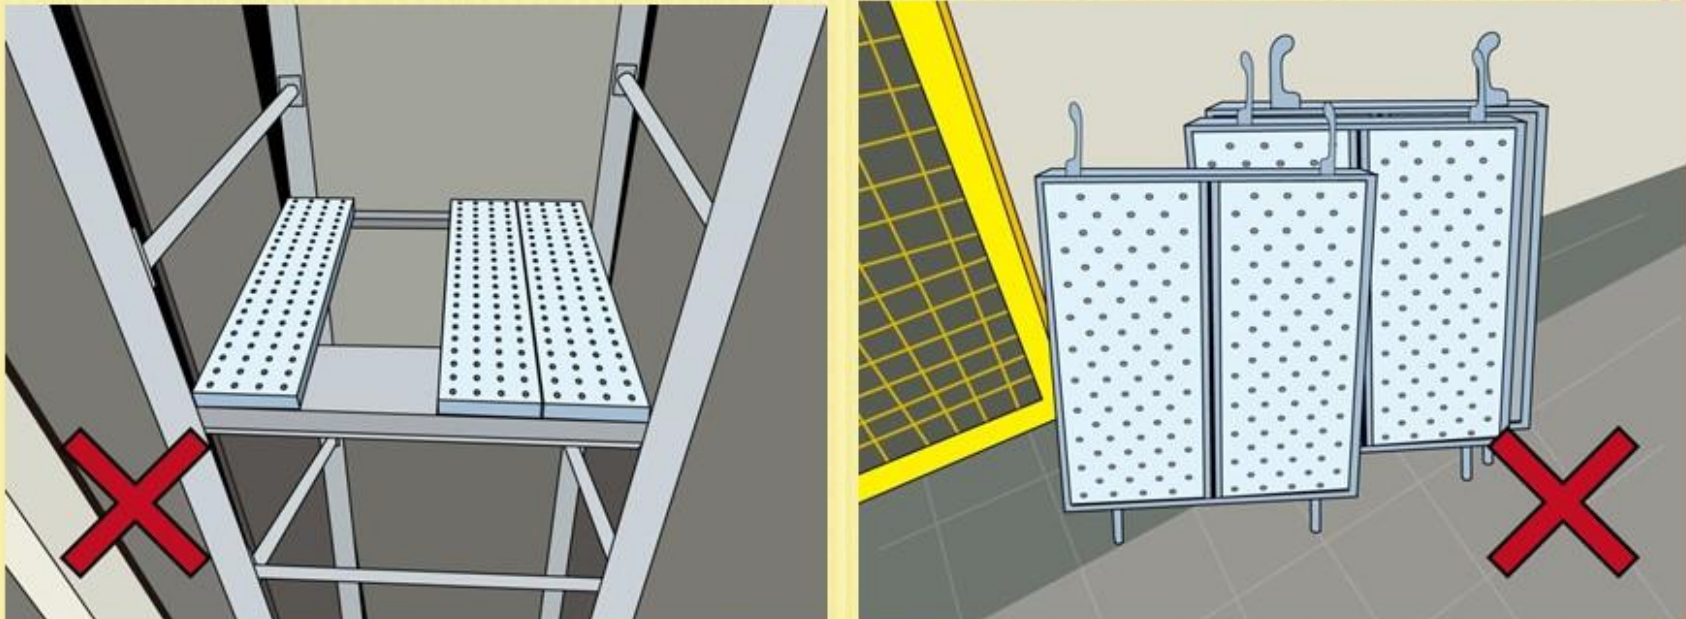
Working platform of the metal scaffold inside the lift shaft was not provided with full set of planking / toe-boards / guard-rails 未有裝好地台板/ 踢腳板/ 安全圍欄的工作平台

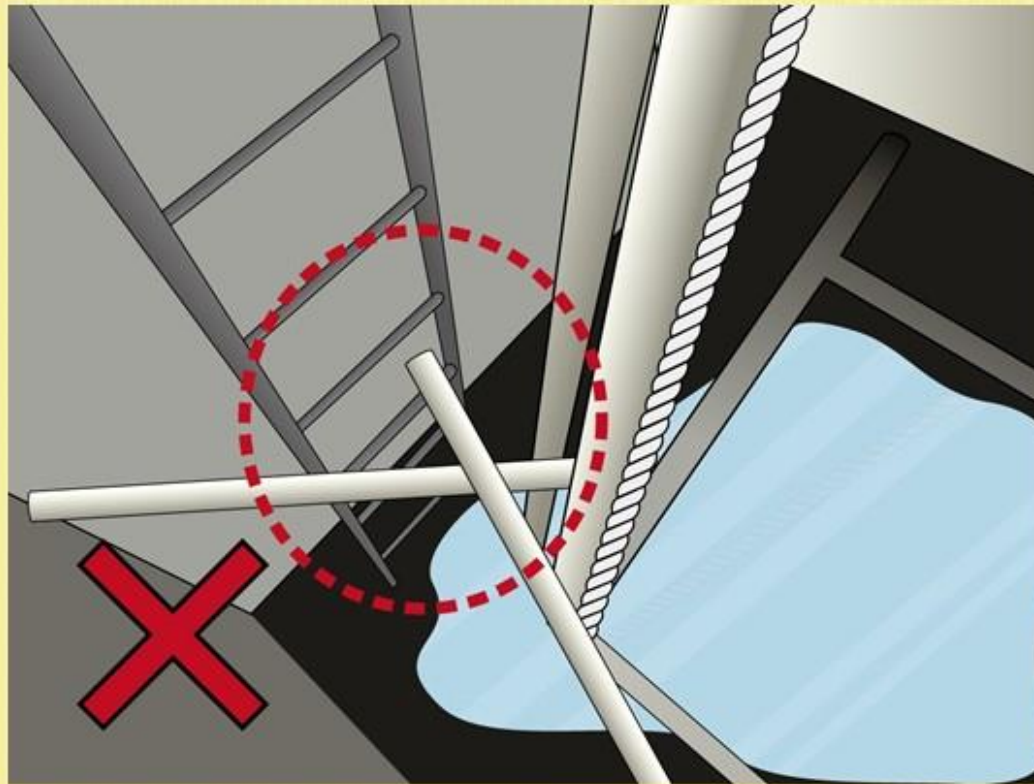
Cat-ladder was obstructed by the tieback. Stagnant water was observed in the lift pit

爬梯(貓梯)被繫桿阻塞, 升降機槽底部有積水

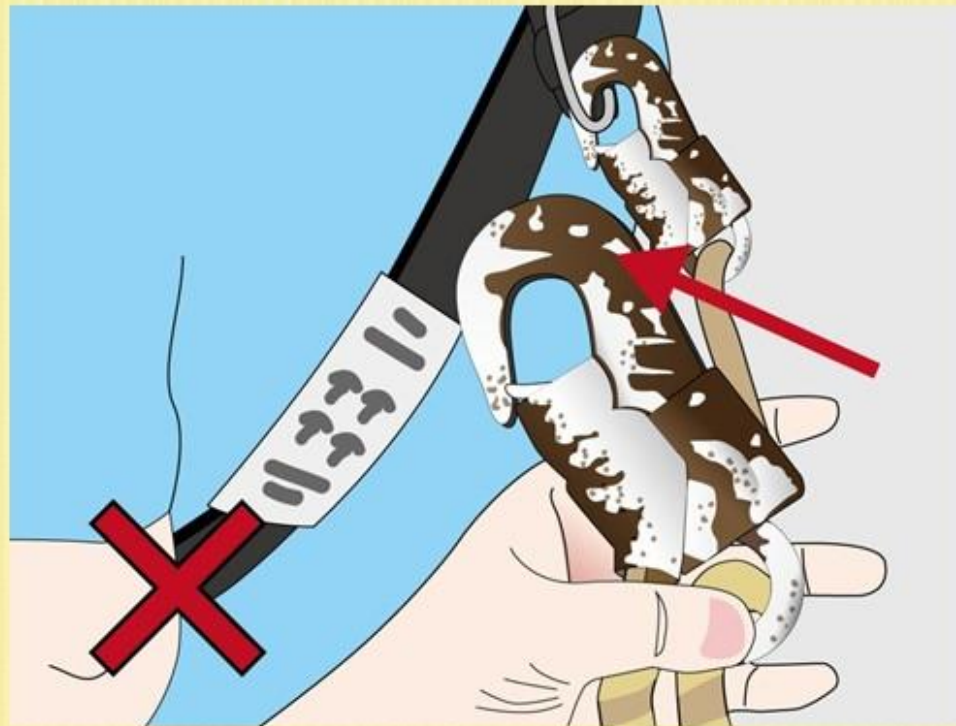
Substandard Lanyard of Safety Harness  
防墮裝置(安全帶防墮扣)未有保養好

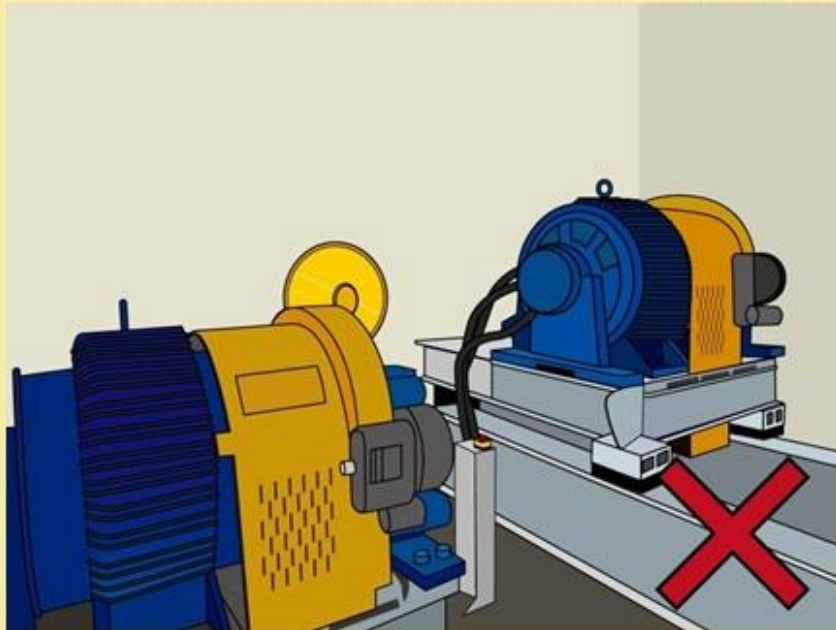
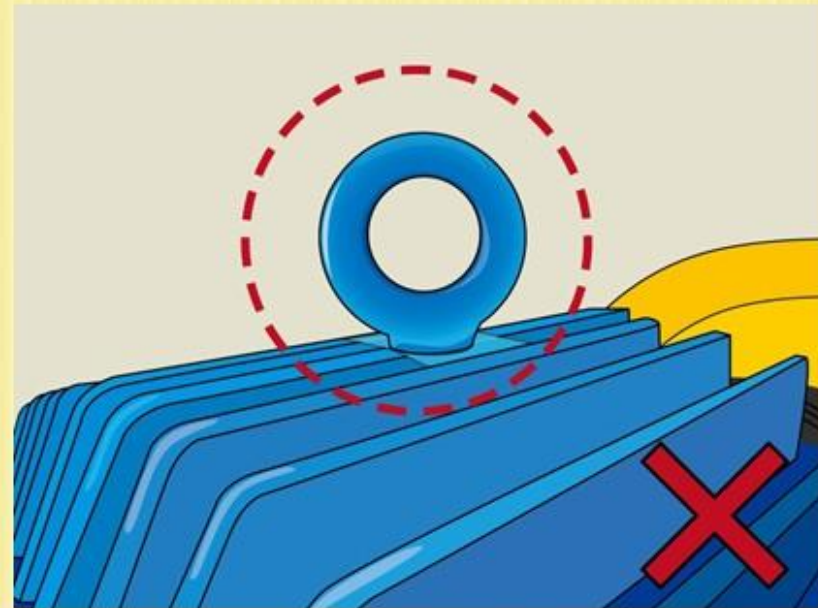
Unable to present the test certificate of the lifting eye during the audit verification on site 未能出示防墮裝置錨固點的檢驗證書

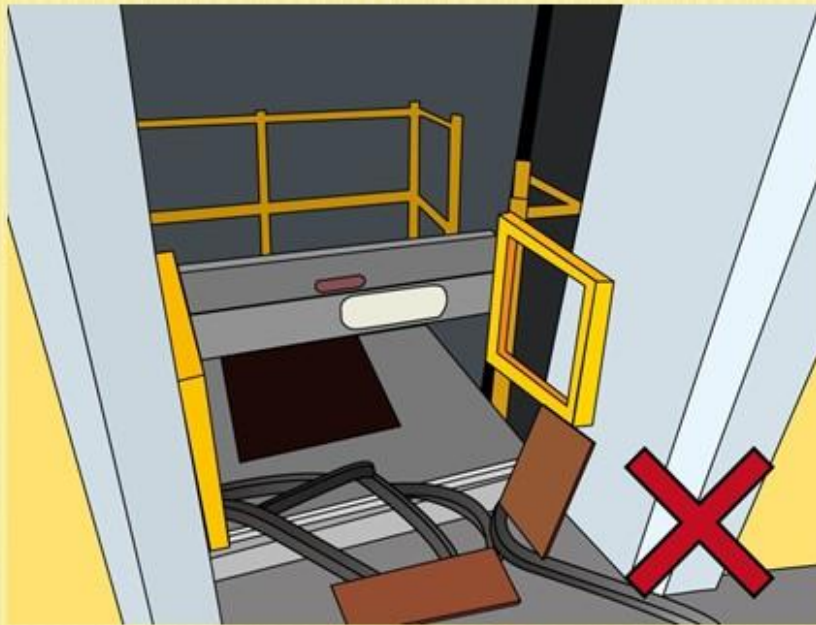
Poor Housekeeping at the access  
升降機槽出入口欠妥善整理

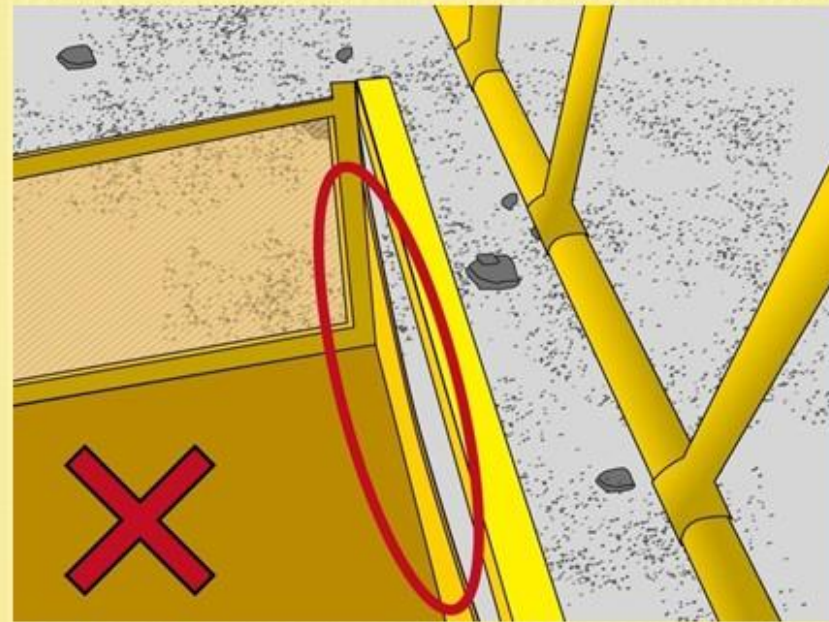
Improper Protection of Sharp Material  
鋒利物料保護不當

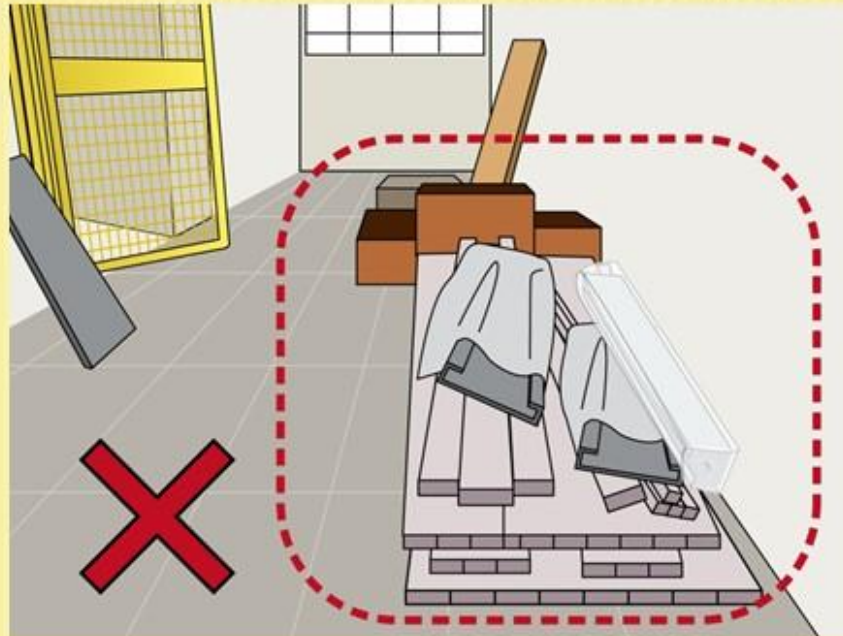
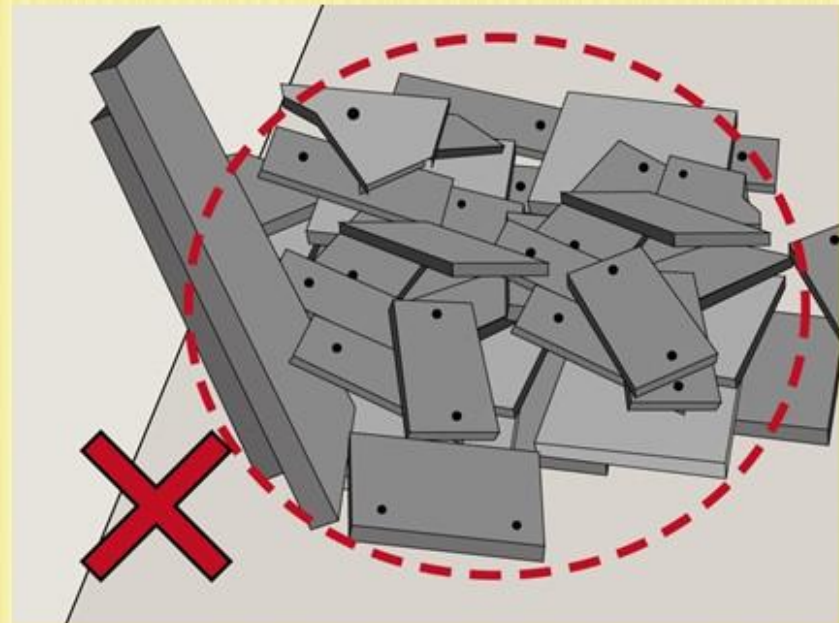
Workplace was not Maintained in Good Condition

工地設施欠妥善整理

- 1) add barrier to separate the storage area
- 2) container should be provided to store small objects

- 1)使用圍欄分隔物料儲存區域
- 2)提供存箱子儲較小的物料

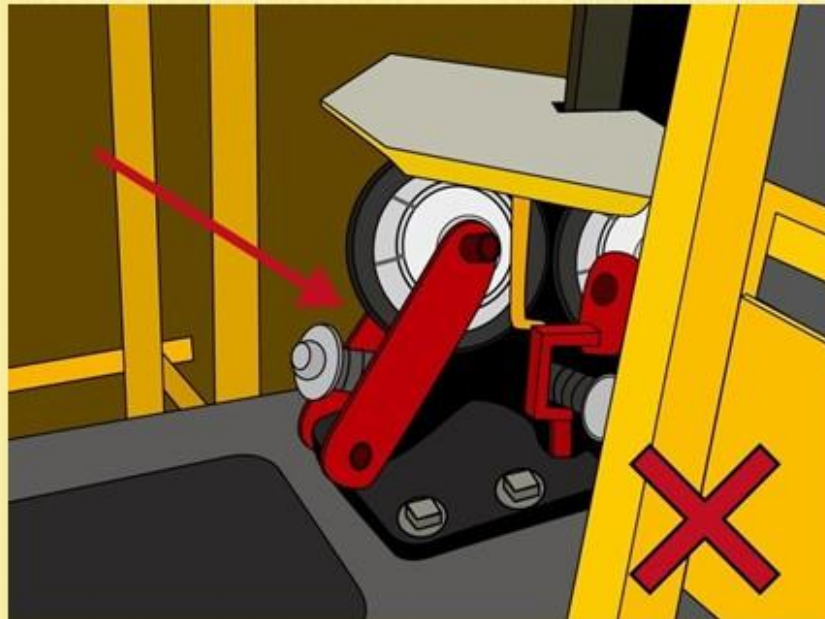
In-running roller have gap with proper protection 運行中滾軸有縫隙，保護不當

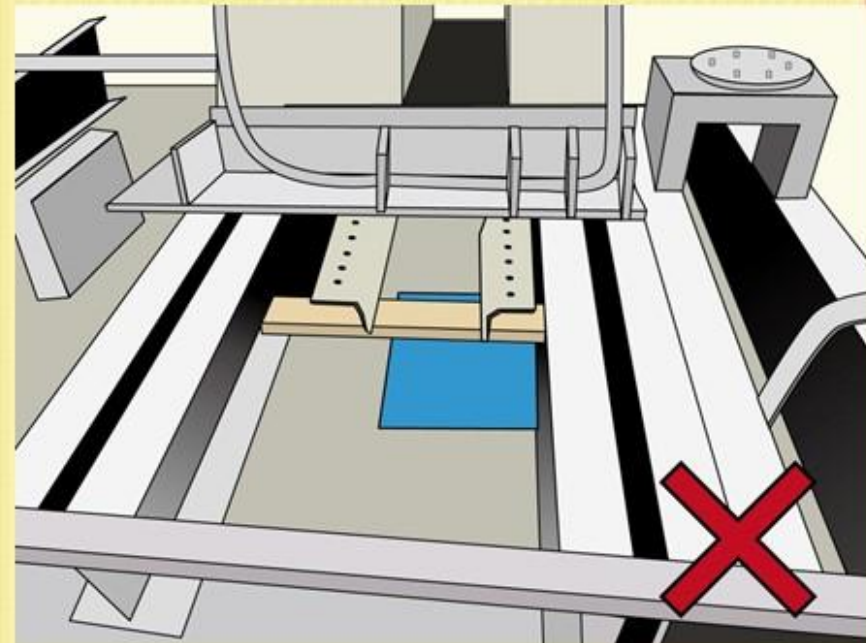
The small openings should be protected by the timber plates instead of the poly-foam

開口保護不當，應用較堅固料蓋好

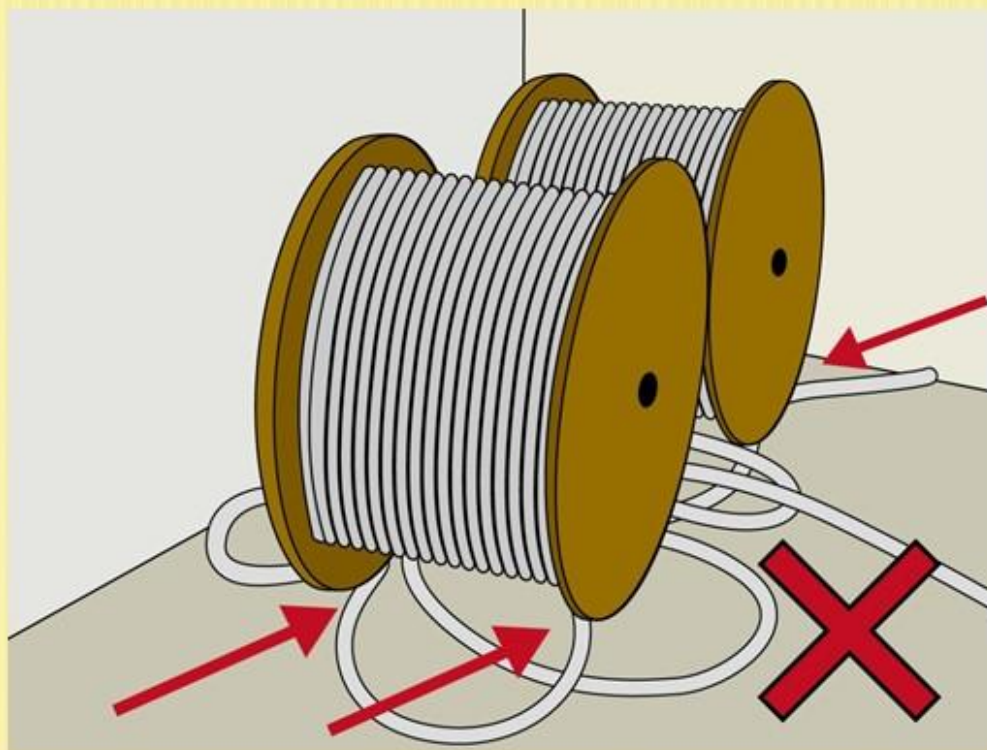
Improper Wedge of Cable Drums  
電纜滾筒欠妥善整理

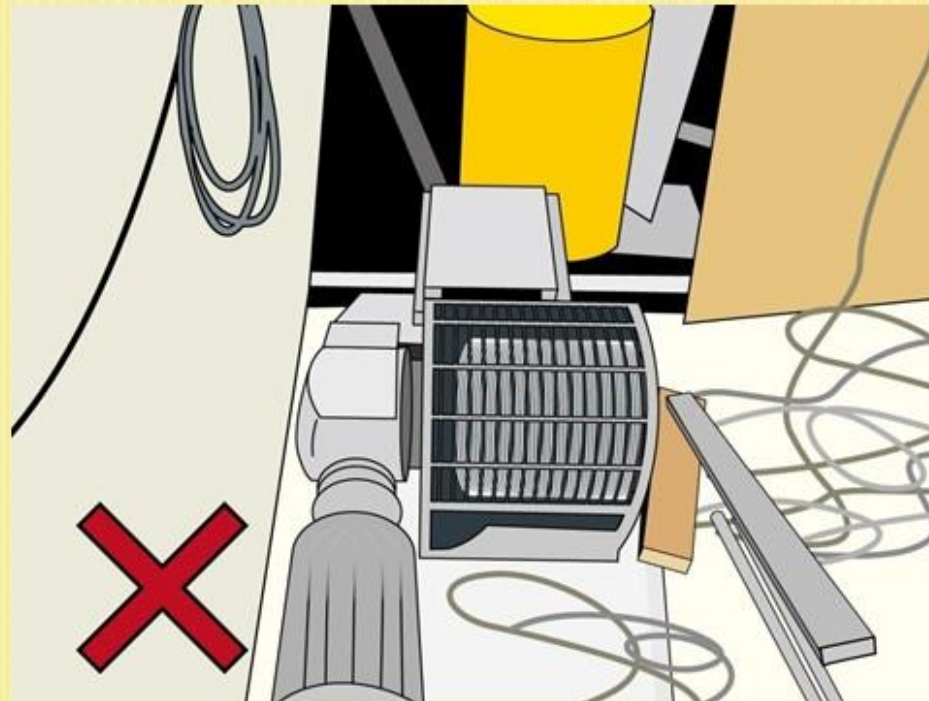
Improper Guarding on Electrical Winch  
電器絞盤保護不當

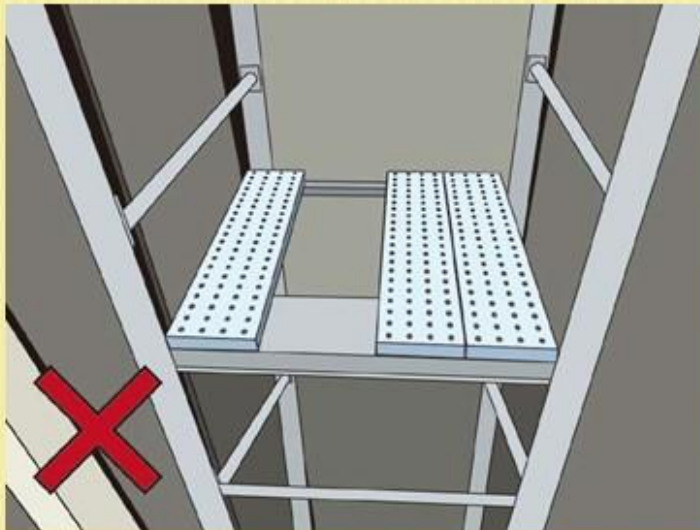
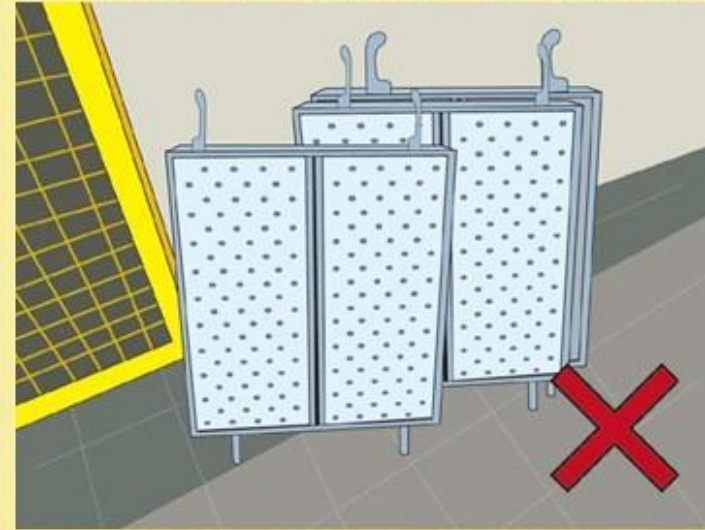
- Working platform was not provided together with full set of planking / toe-boards / guard-rails in the metal scaffold inside the lift shaft
- 未有裝好工作平台的地台板/ 踢腳板/ 安全圍欄

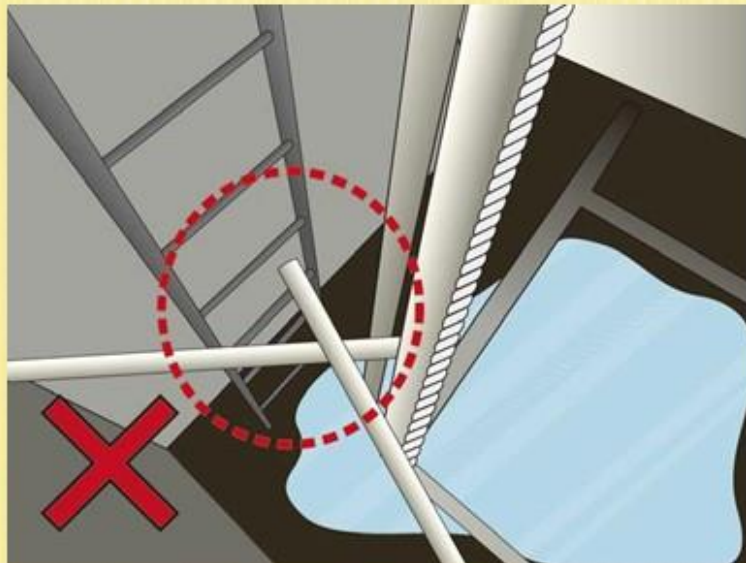
- Cat-ladder was obstructed by the tieback, stagnant water was observed in the lift pit
- 爬梯(貓梯)被回接管阻塞, 電梯槽底部有積水

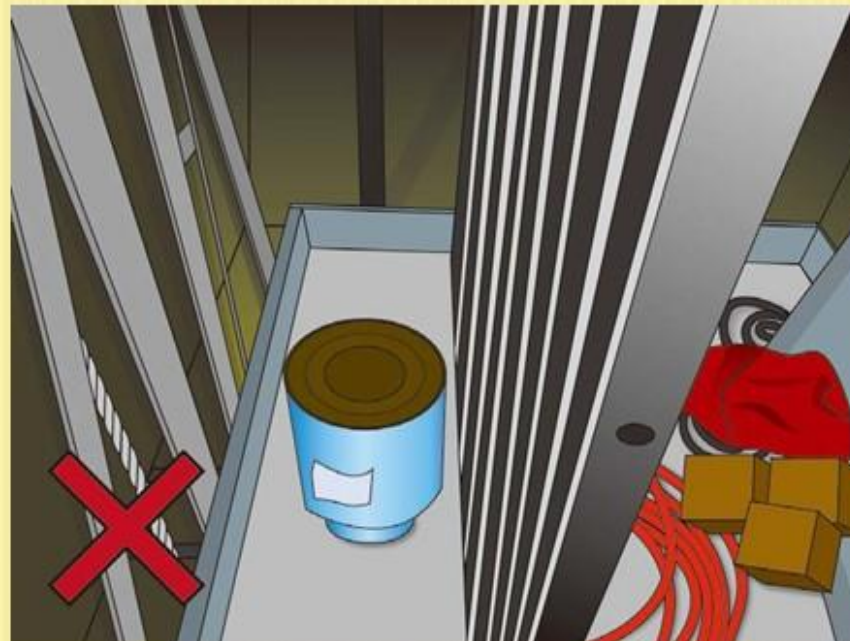
- Improper working platform
- 不當工作台

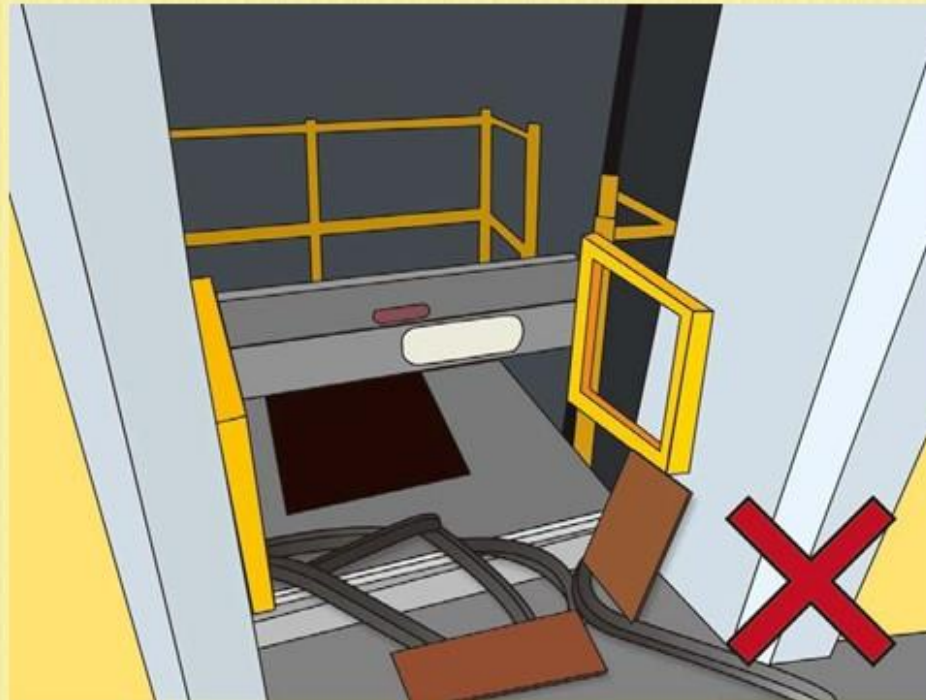
- Poor housekeeping at the access
- 升降機槽出入口欠妥善整理

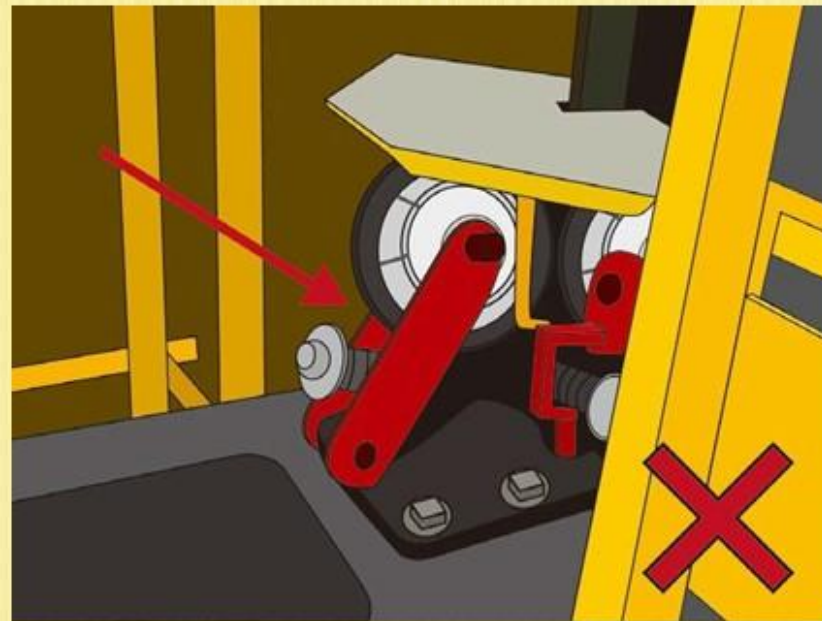
- Inadequate protective guard to the in-running roller
- 運行中滾軸有縫隙，保護不當

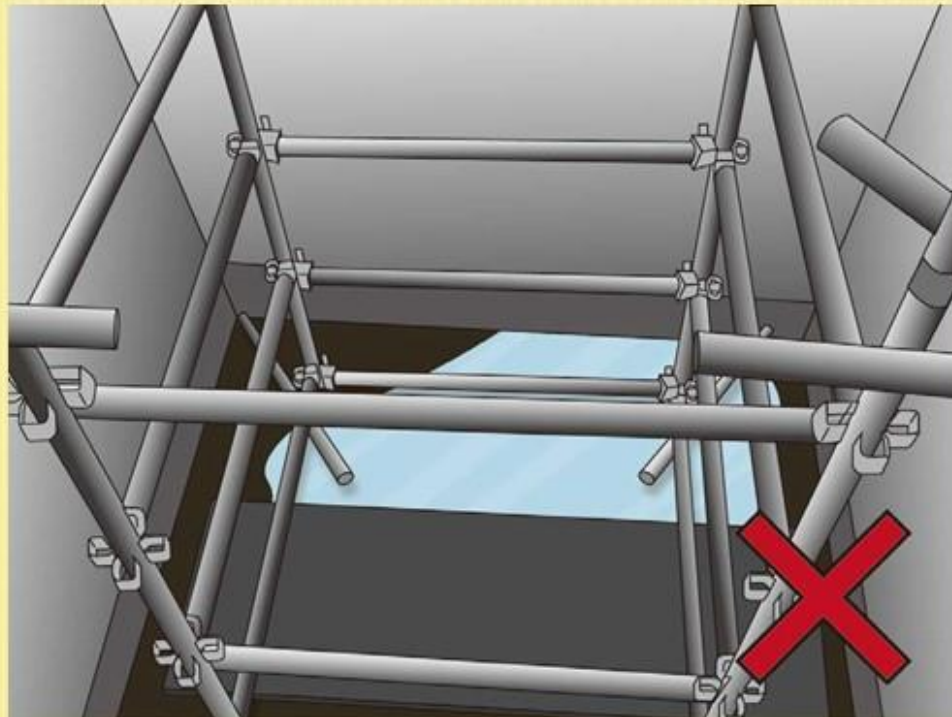
- Water contained in lift shaft
- 升降機槽內有積水

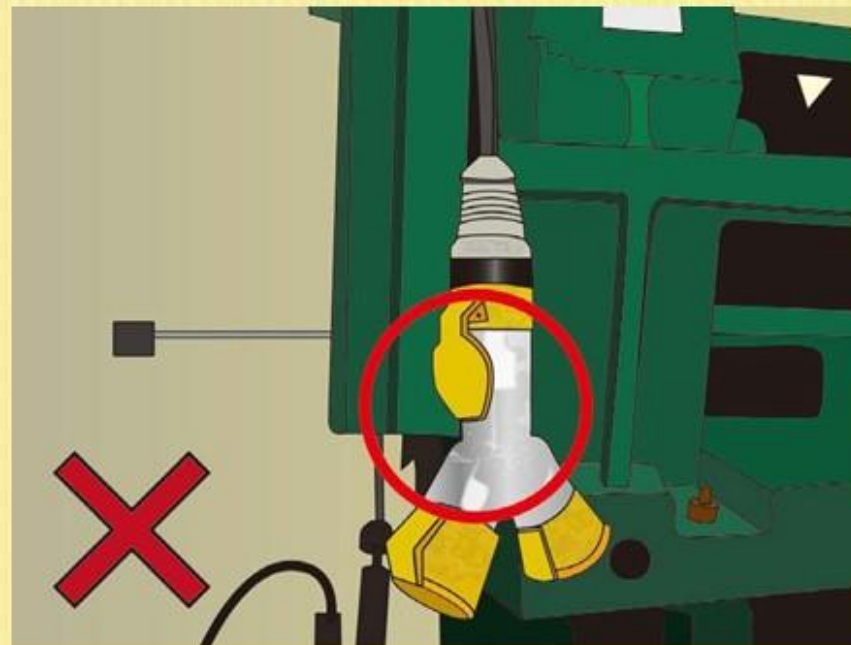
- Damaged electrical connector
- 損壞的接頭

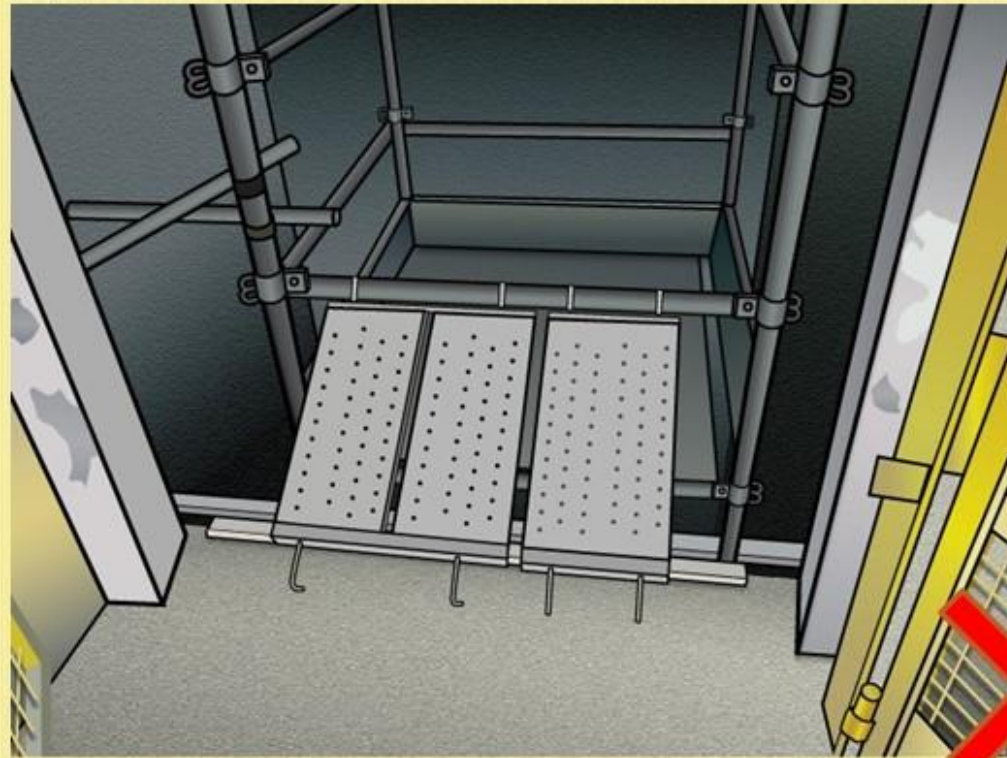
- Unsafe access to working platform
- 不安全進出口
