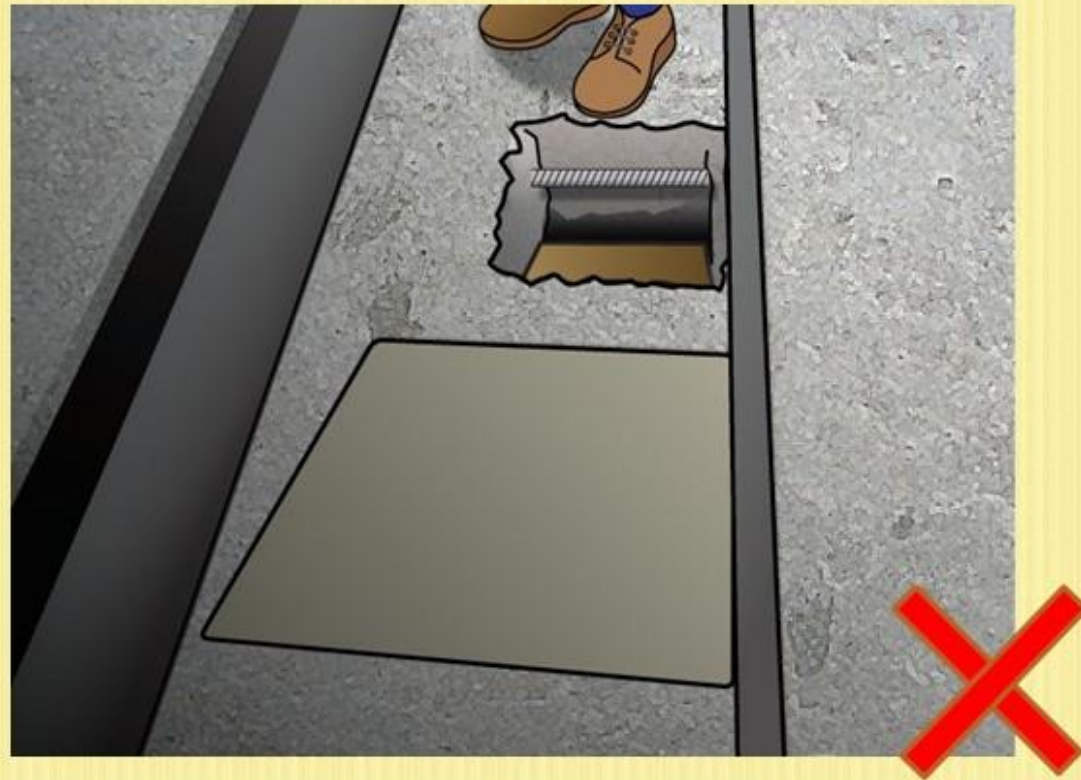
- Floor opening was not protected
- 地洞沒有覆蓋

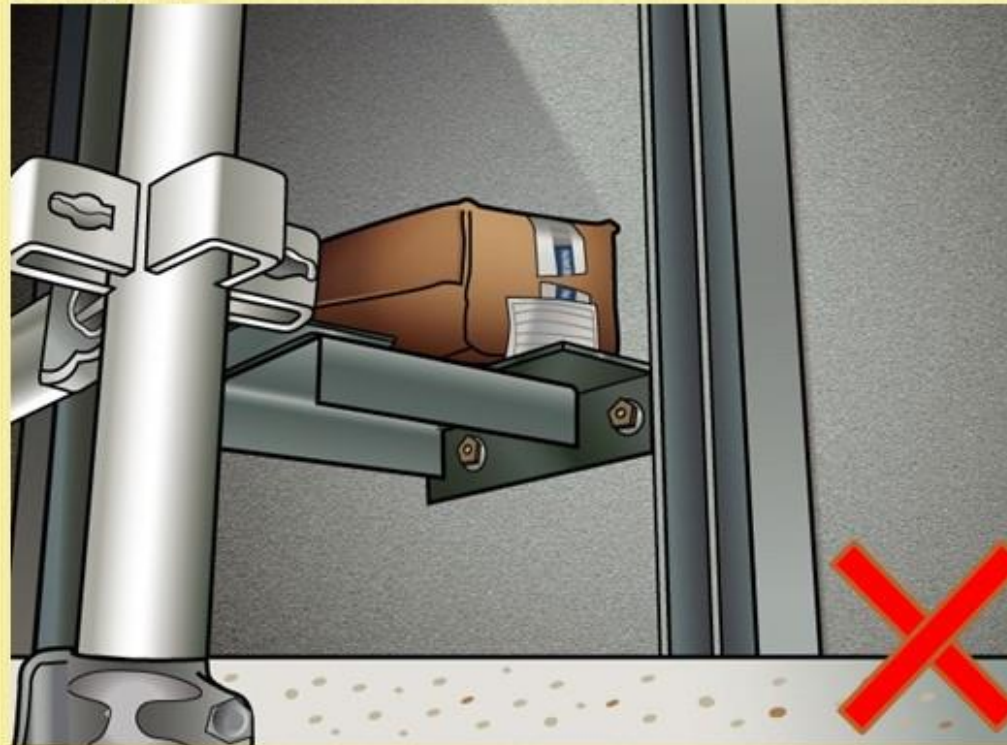
- Materials stacked at high level
- 物料存放於高處

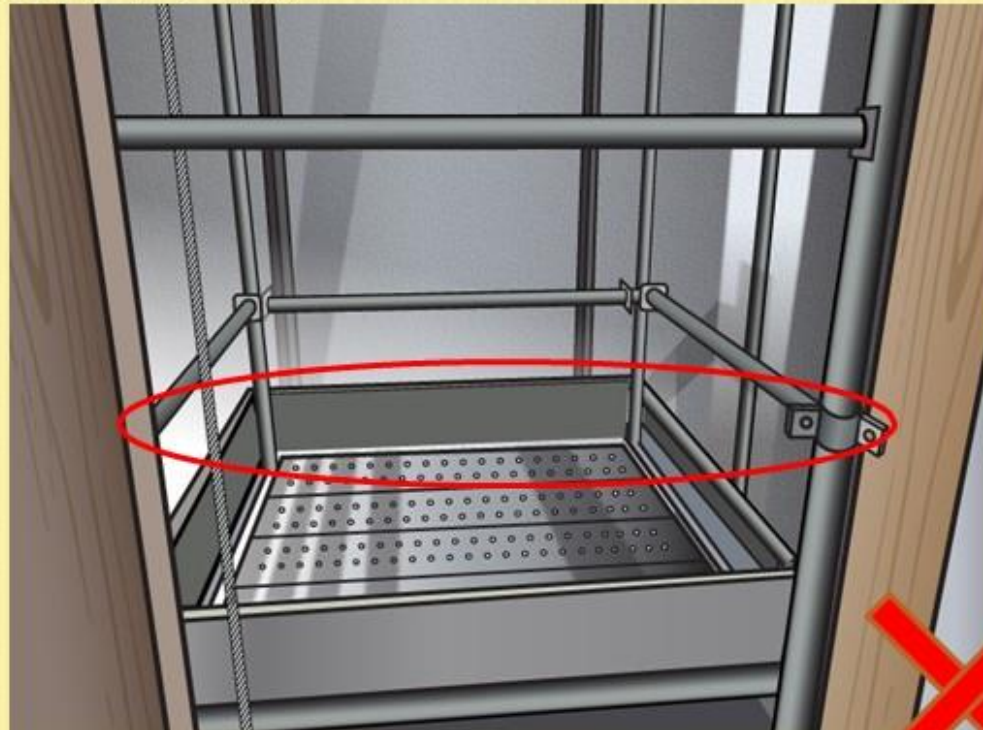
- Absence of mid-rail in the metal scaffold
- 金屬棚架沒有中圍欄

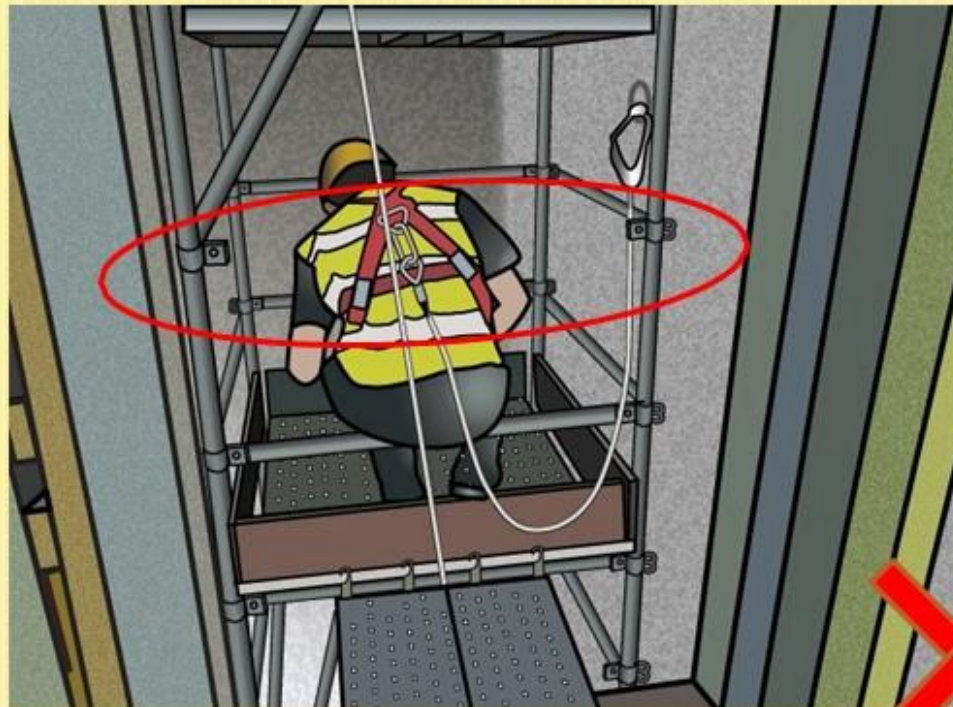
- Absence of top guard-rail in the metal scaffold
- 金屬棚架沒有高圍欄

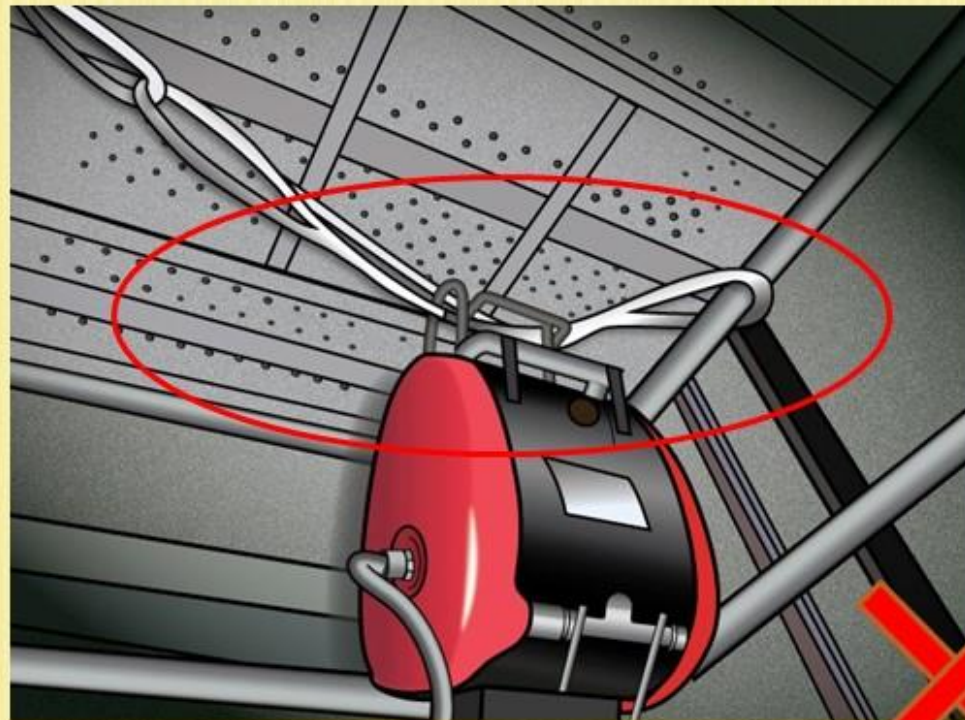
- Hanging block was installed on the metal scaffold
- 安裝鏈滑車在金屬棚架

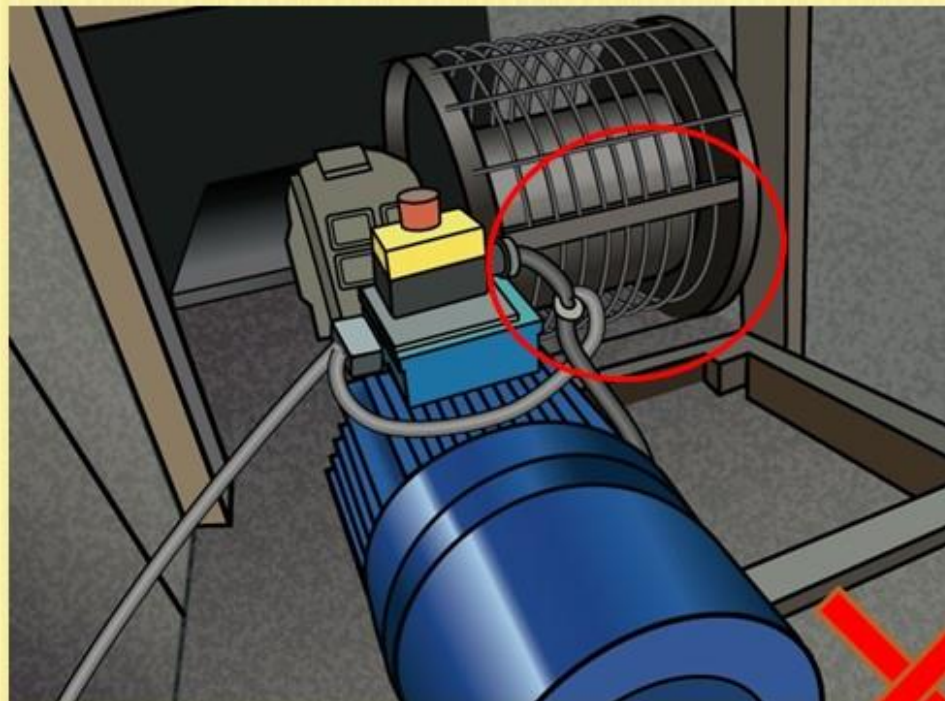
- Improper guarding for electric winch
- 電動絞機的危險部份沒有完全隔開

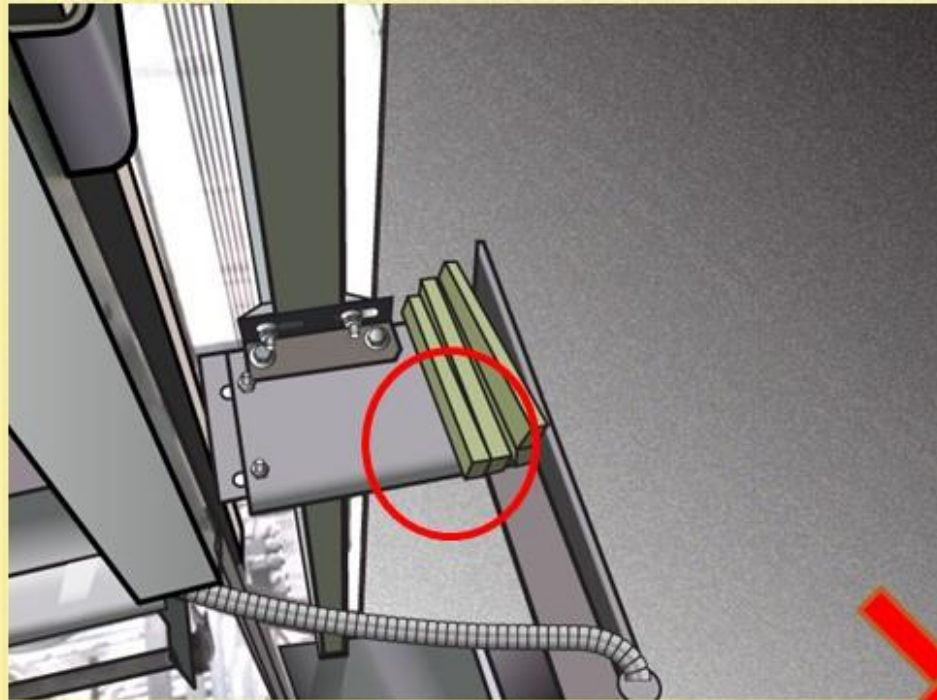
- Material left at high level
- 物料留高處

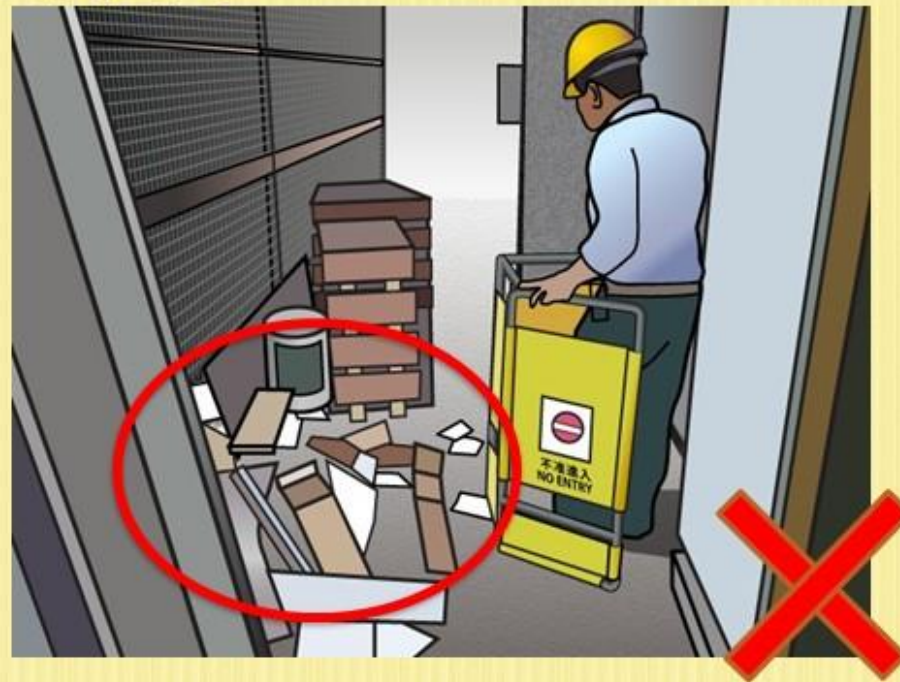
- The access was obstructed by the accumulated rubbish
- 通道被堆積的垃圾阻塞

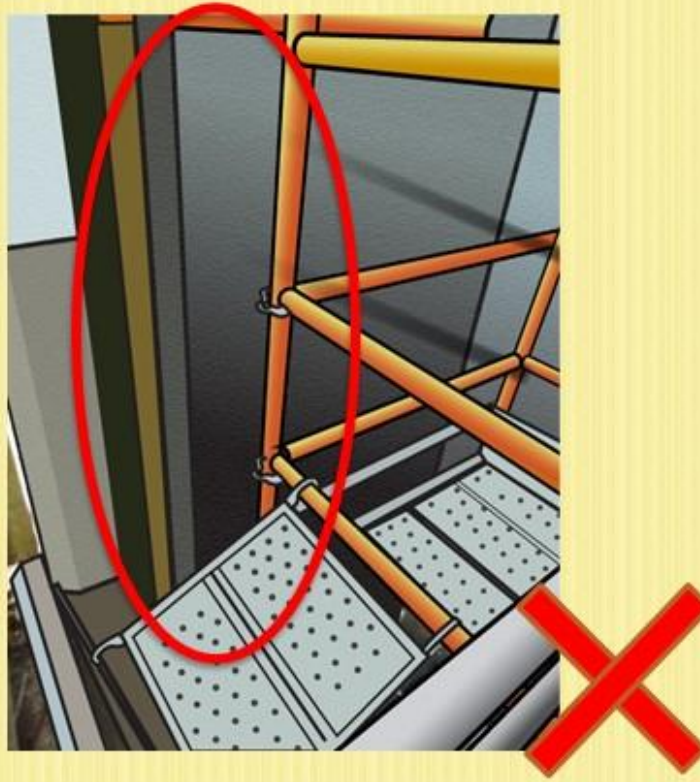
- Floor edge without fencing in lift shaft
- 未有在臨邊位置安裝圍欄

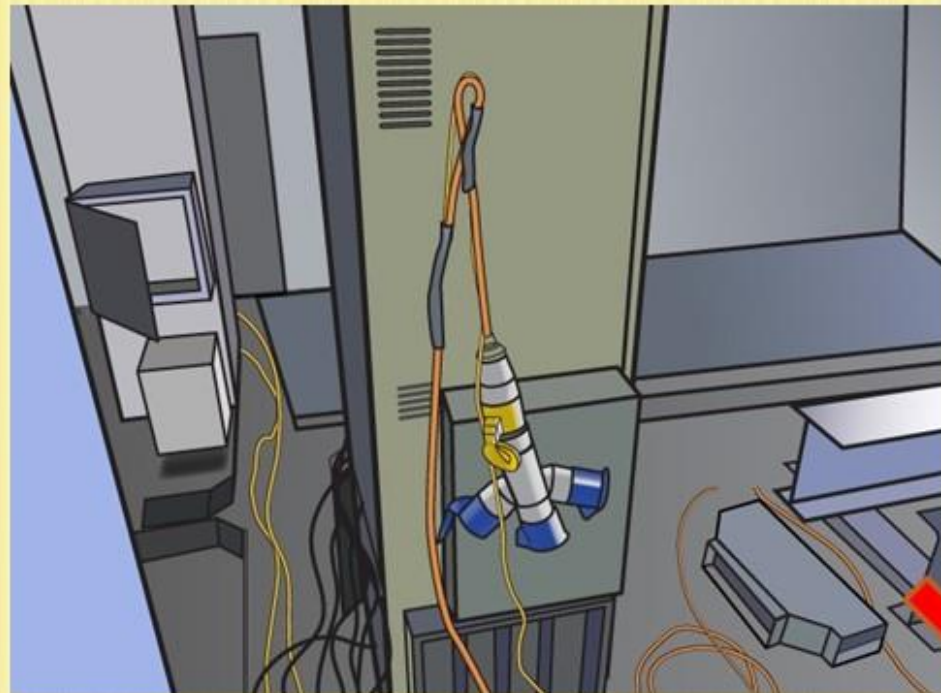
- Electric cable laid on ground floor and invalid cable connector used at work
- 電線沒有掛高及使用不恰當的電纜連接器
