WORKING AT HEIGHT 高空工作

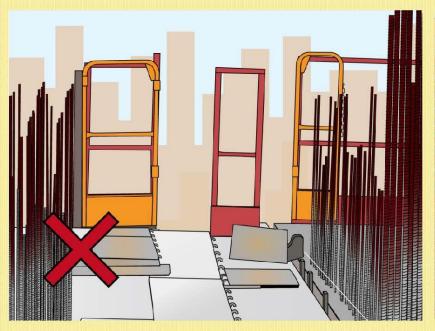
Guard-rail on Working Platform at Wall Form Panel not Securely Closed 工作台圍欄未有鎖好

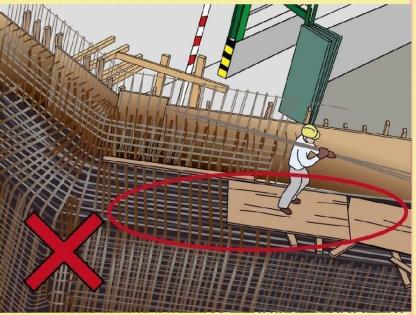
Guard-rail at Edge of Retaining Wall was not Properly Installed 未有裝好圍欄

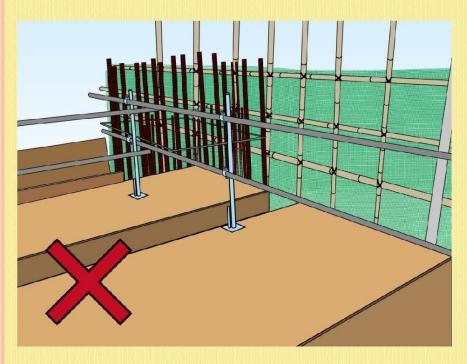
Safety Guard-rail without Toe Board 圍欄欠缺踢腳板

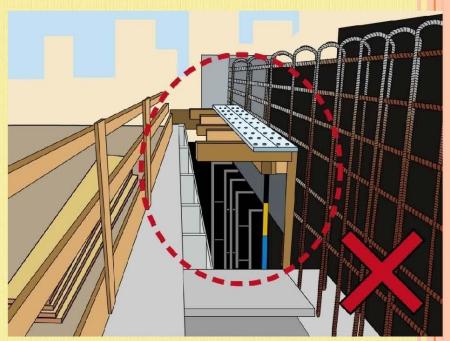
Unsafe Working Platform 不安全的工作平台

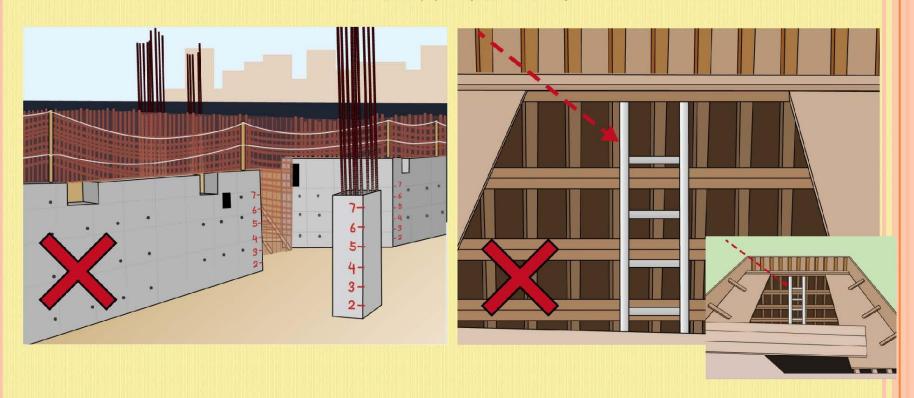
Improper Guard-rails Found at the Ladders was not 1 Meter over the Landing Floor Edges as a Hand-rail

欠缺安全圍欄

梯子頂部未有預留高於平台1米以上作為扶手

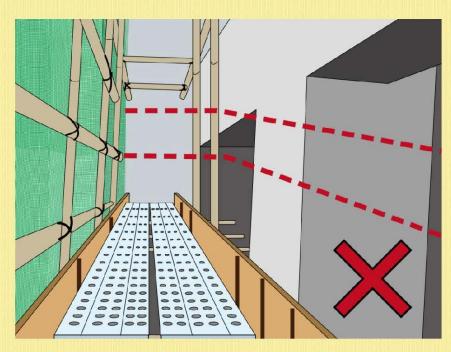
Missing of Guard-rails at Edges of Scaffolding Platform 棚架工作平台欠缺安全圍欄

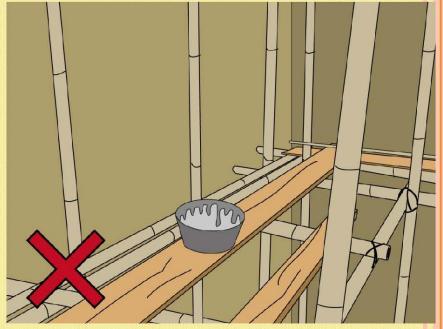
Working Platform on Internal Bamboo Scaffolding was not Closely Boarded 未有裝好棚架工作平台

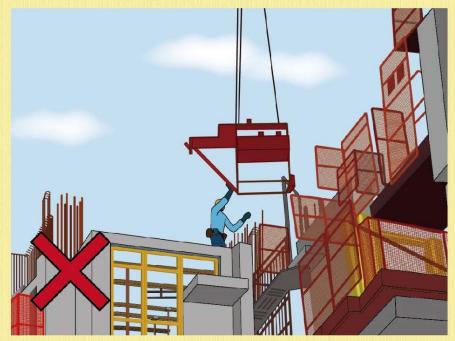
- No safety harness worn by worker/No tagline or Push/ Pullstick used to move metal formwork
- · 工人沒有佩戴安全帶/沒有拉繩移動組件

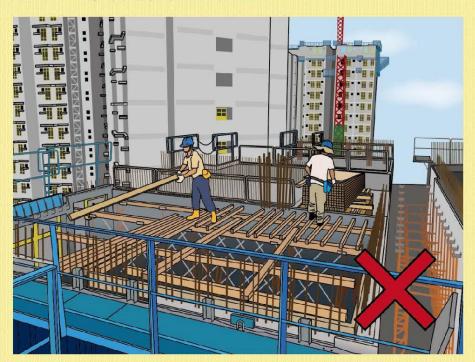
- · Unsafe working location No fall arresting device
- · 不安全工作地點 沒有防墮裝置

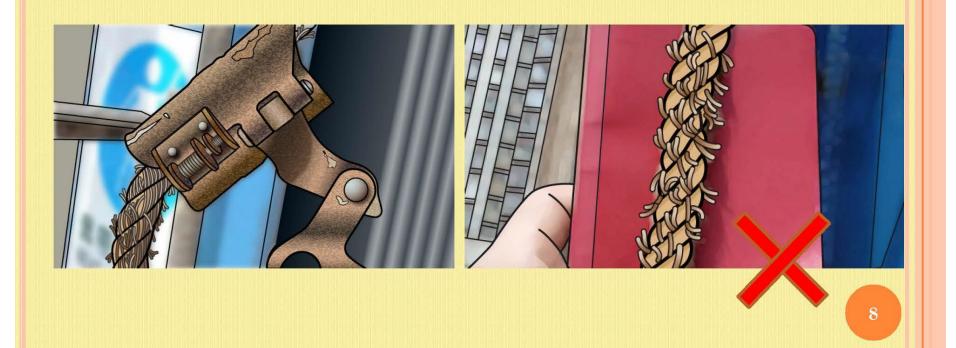
- Rusted fall arrestor / worn lifeline
- 生銹的防墮器/ 損壞的救生繩

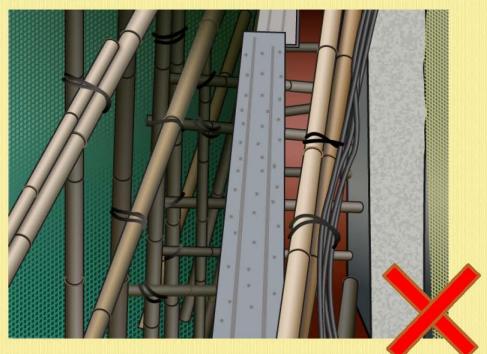
- Working platform on external bamboo scaffolding was found not closely boarded
- ·棚架工作台沒有密封

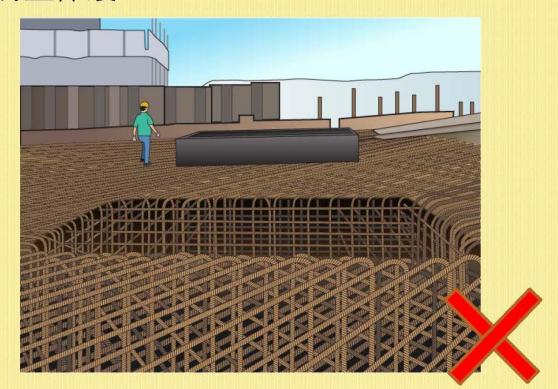
- Opening was not securely protected
- 開口沒有防墮保護

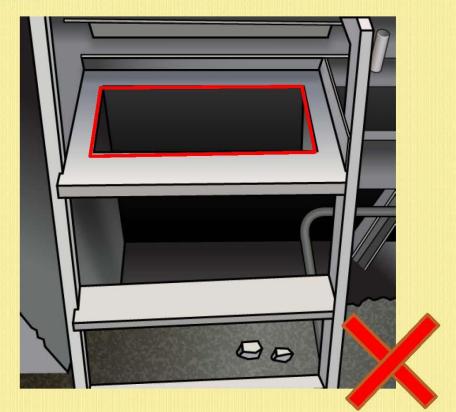
- Unsafe access to working floor
- 不安全進出通道

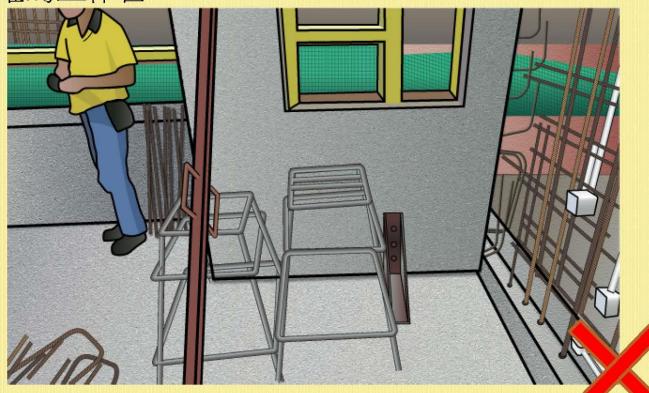
- Improper working platform
- 不正確的工作台

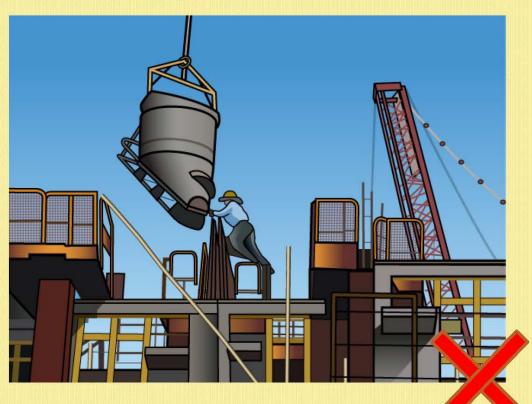
- No protection was adopted for working at height
- 欠缺保護措施進行高處工作

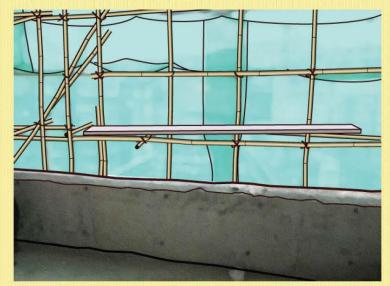
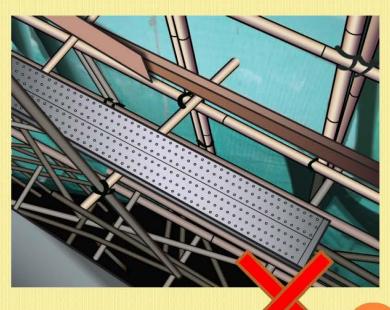
- Provision of substandard working platform for working at height
- 沒有提供符合標準的工作平台

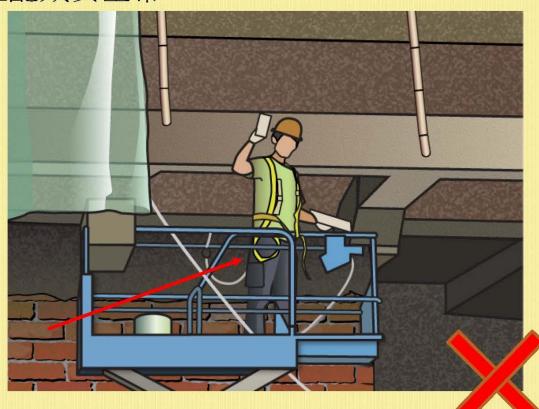
- Safety harness was not worn properly
- 沒有正確配戴安全帶

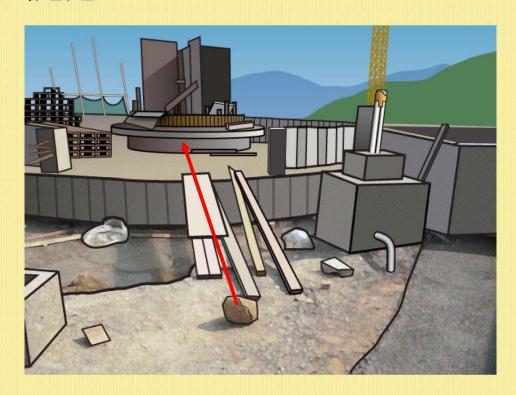
- Unsafe access to the workplace
- 不安全進出通道
