ELECTRICAL SUPPLY SYSTEM
供電系統

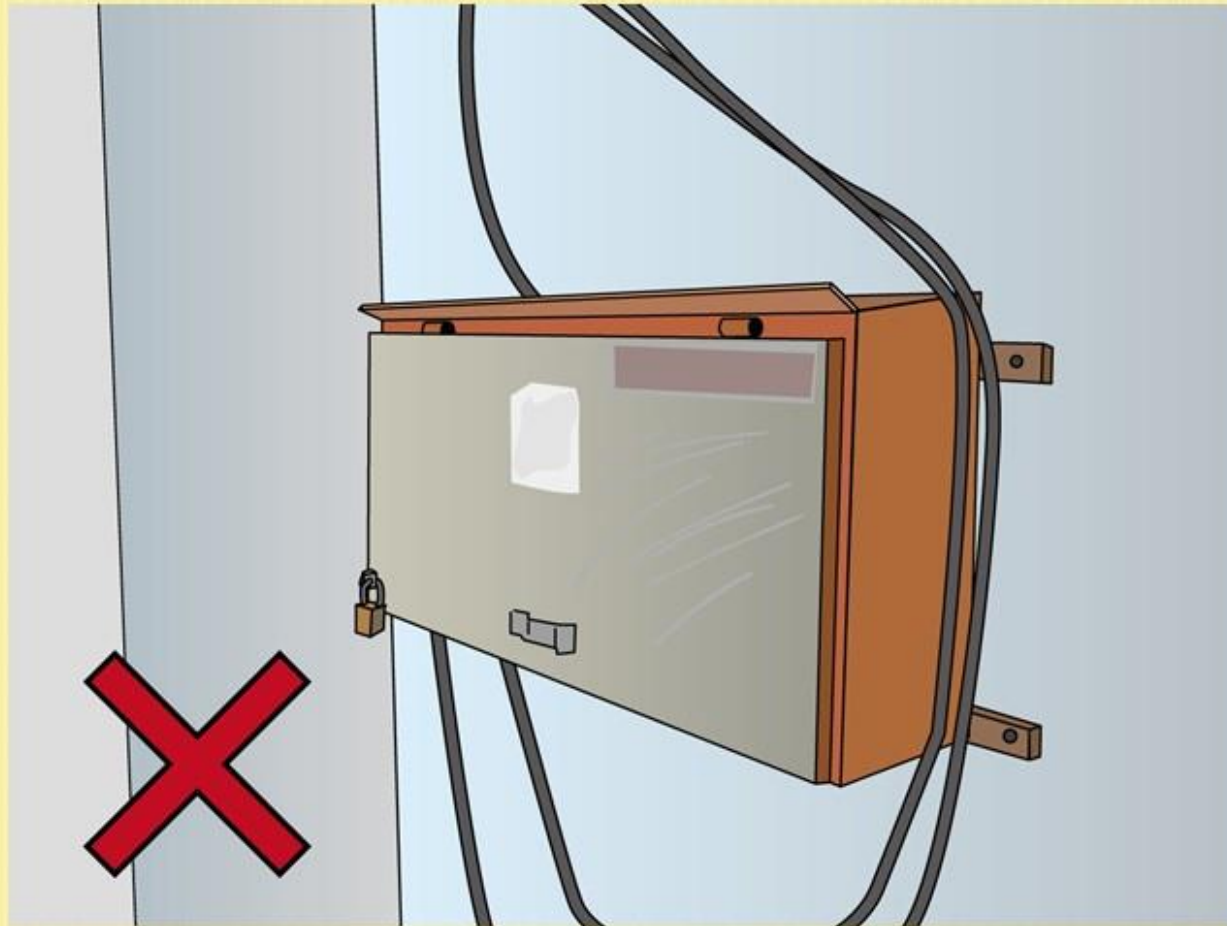
未有張貼電擊告示、註冊電工等資料 NOTICE OF
ELECTRIC SHOCK, REW NAMES AND CONTACT NOT
DISPLAYED

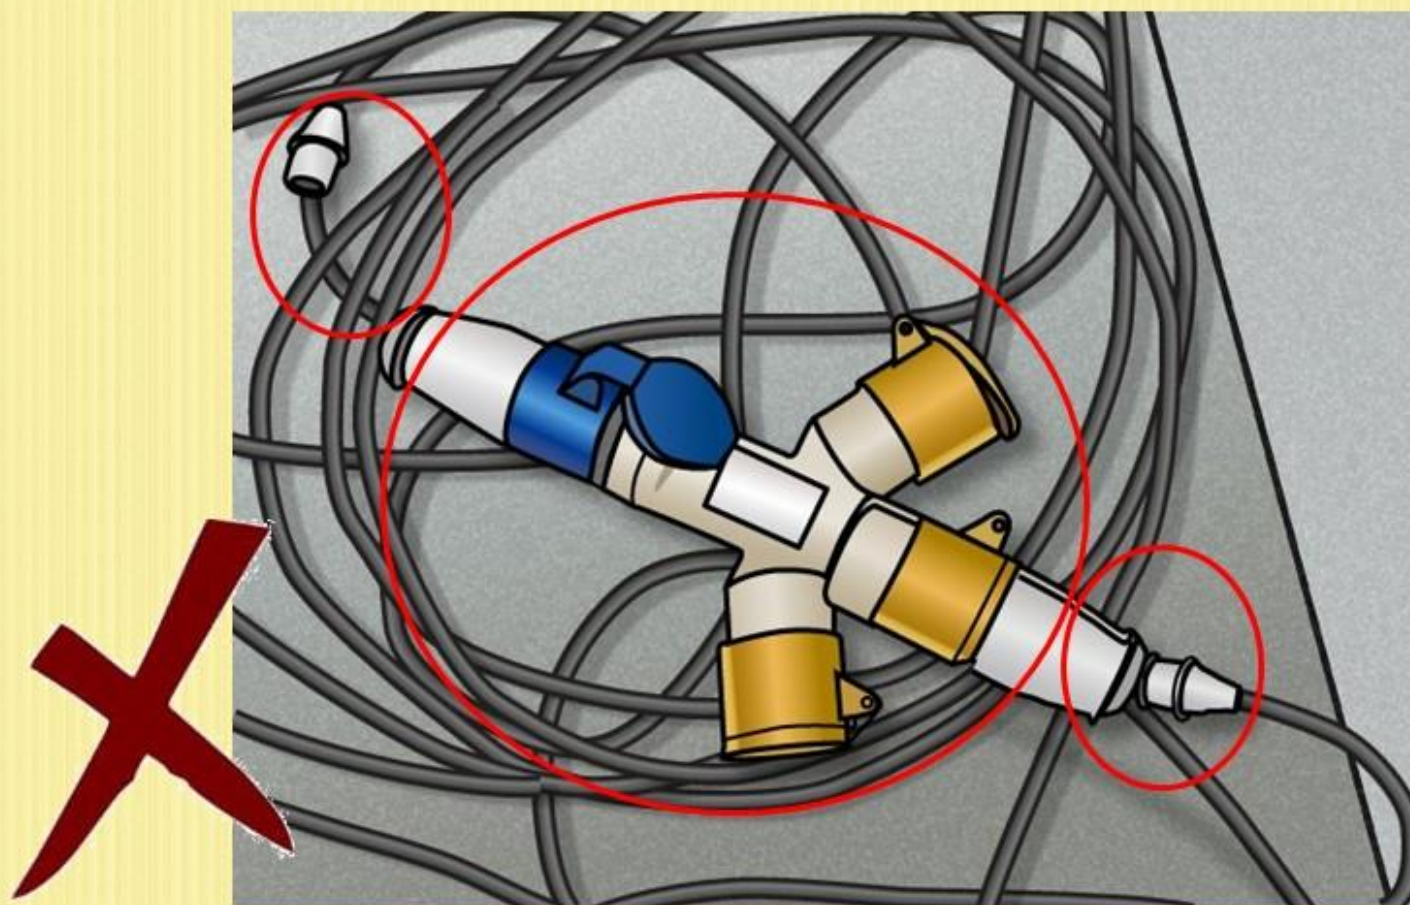
電源線插頭損壞。110V 的插頭連接到 220V 的插座。

CORD GUARDS WERE DAMAGED AND IMPROPER CONNECTION OF SOCKET PLUG.

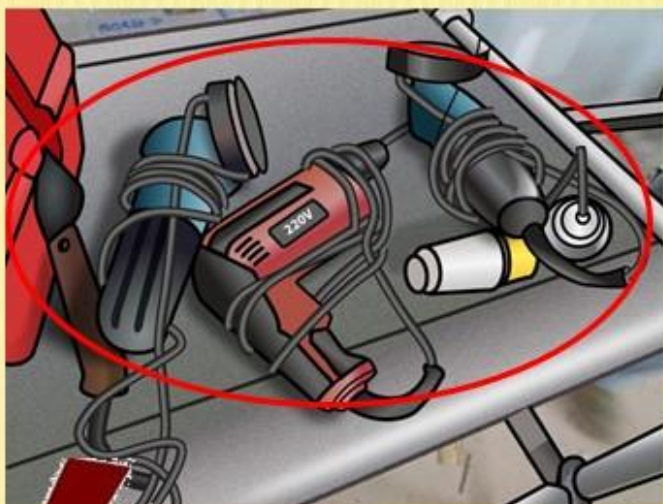
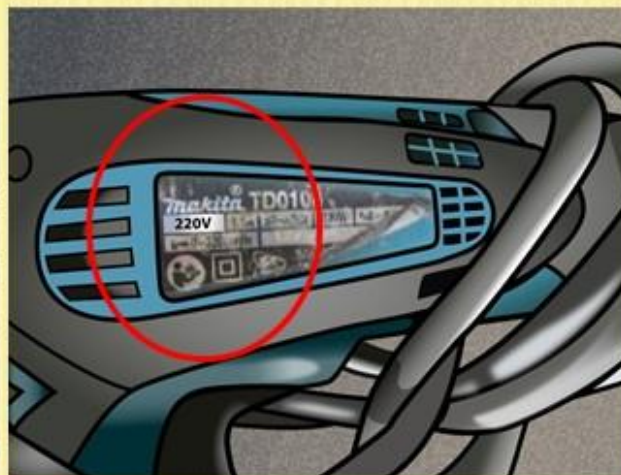
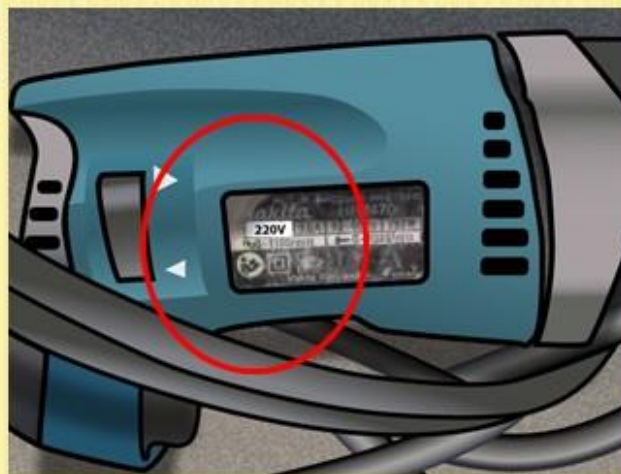
220V的手提工具使用110V的插頭。

220V HAND-HELD TOOLS WERE FOUND WITH 110V SOCKET.

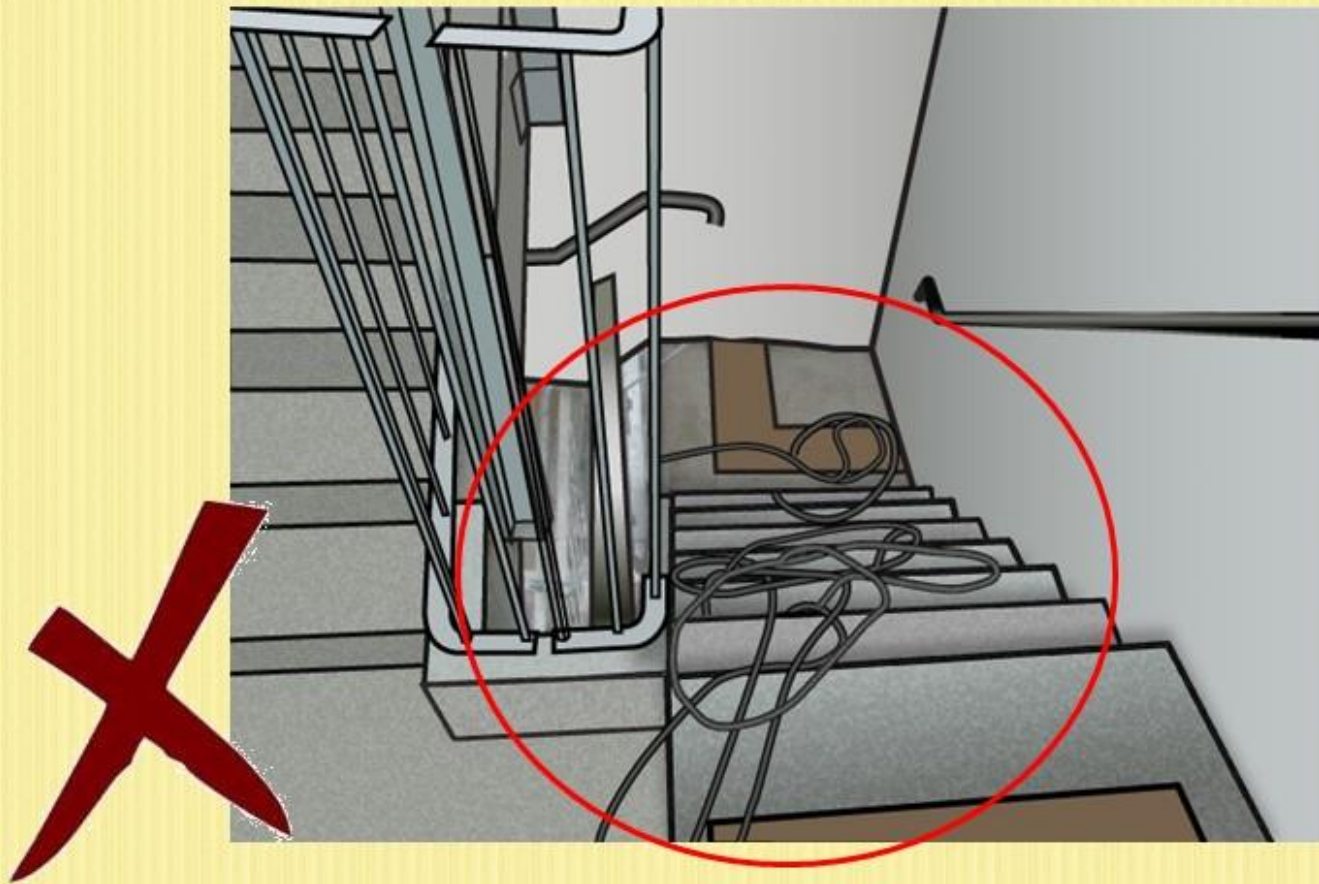
電線拖地，有絆倒的危險。

TRIPPING HAZARD WAS FOUND FOR THE TRAILING CABLE. TRAILING CABLE WAS FOUND.

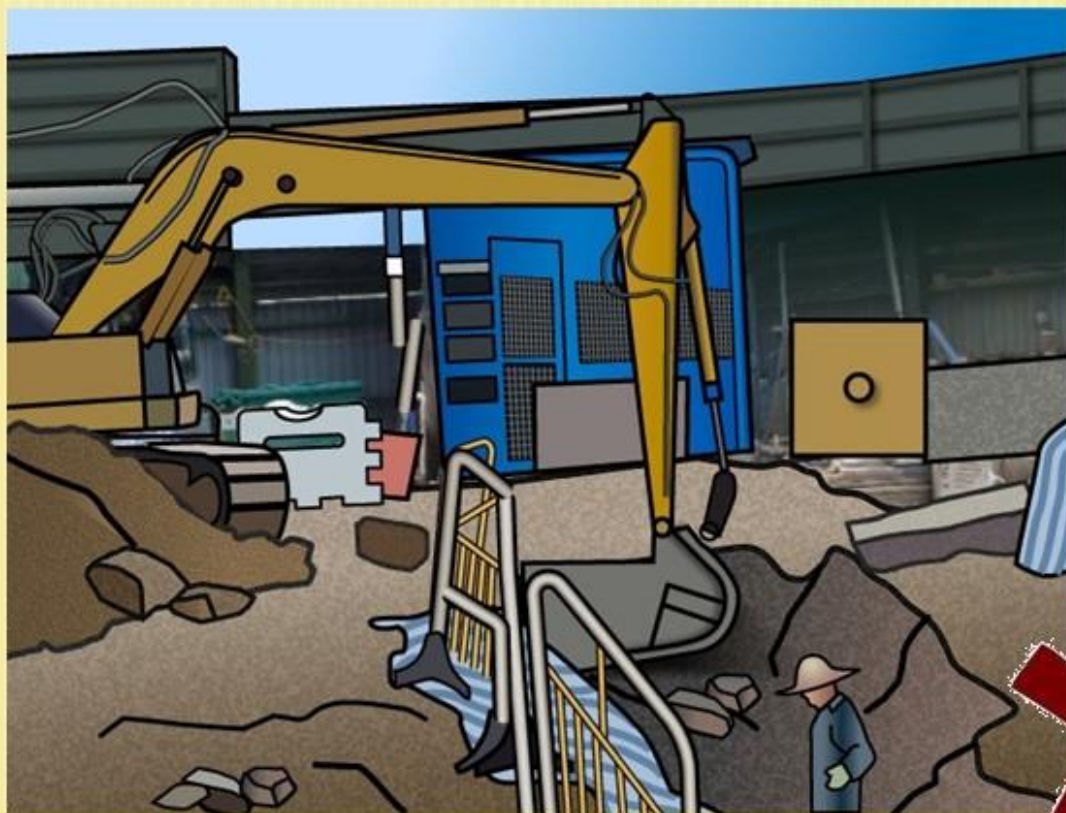
機手可能看不清楚泥坑內情況，但工友在沒有訊號員的情況下在泥坑內工作。

OPERATOR OF THE EXCAVATOR MAY NOT HAVE UNOBSTRUCTED VIEW OF THE WHOLE PIT AND THE MOVING BUCKET MAY HIT THE WORKER. WORKER SHOULD AVOID WORKING IN EXCAVATION WHEN EXCAVATOR IS OPERATING NEARBY WITHOUT A SIGNALLER.
