WORKING AT HEIGHT
高空工作

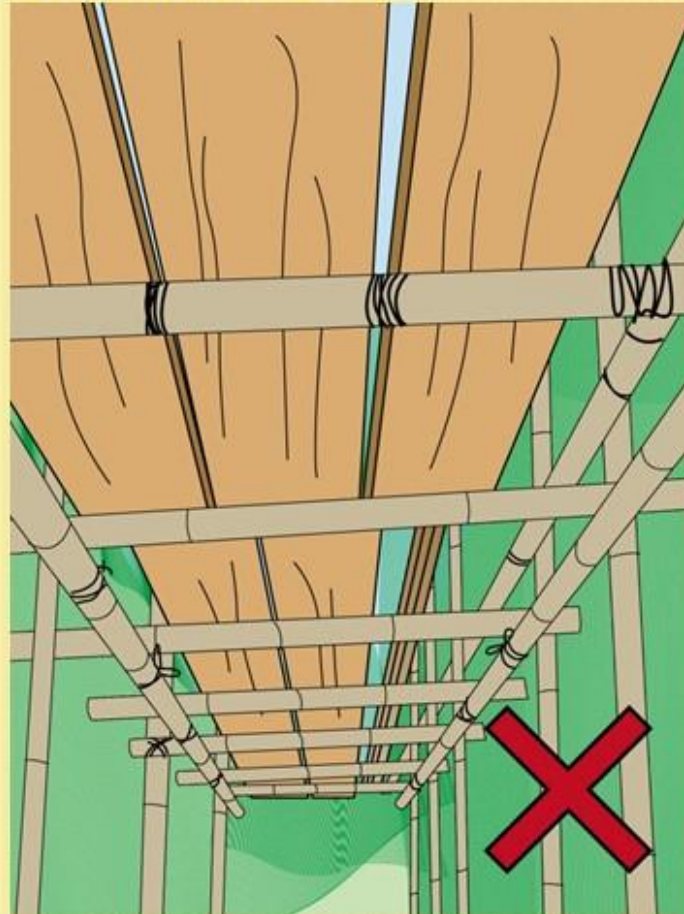
WORKING PLATFORM NOT CLOSELY
BOARDED
工作台之地台沒有被密封

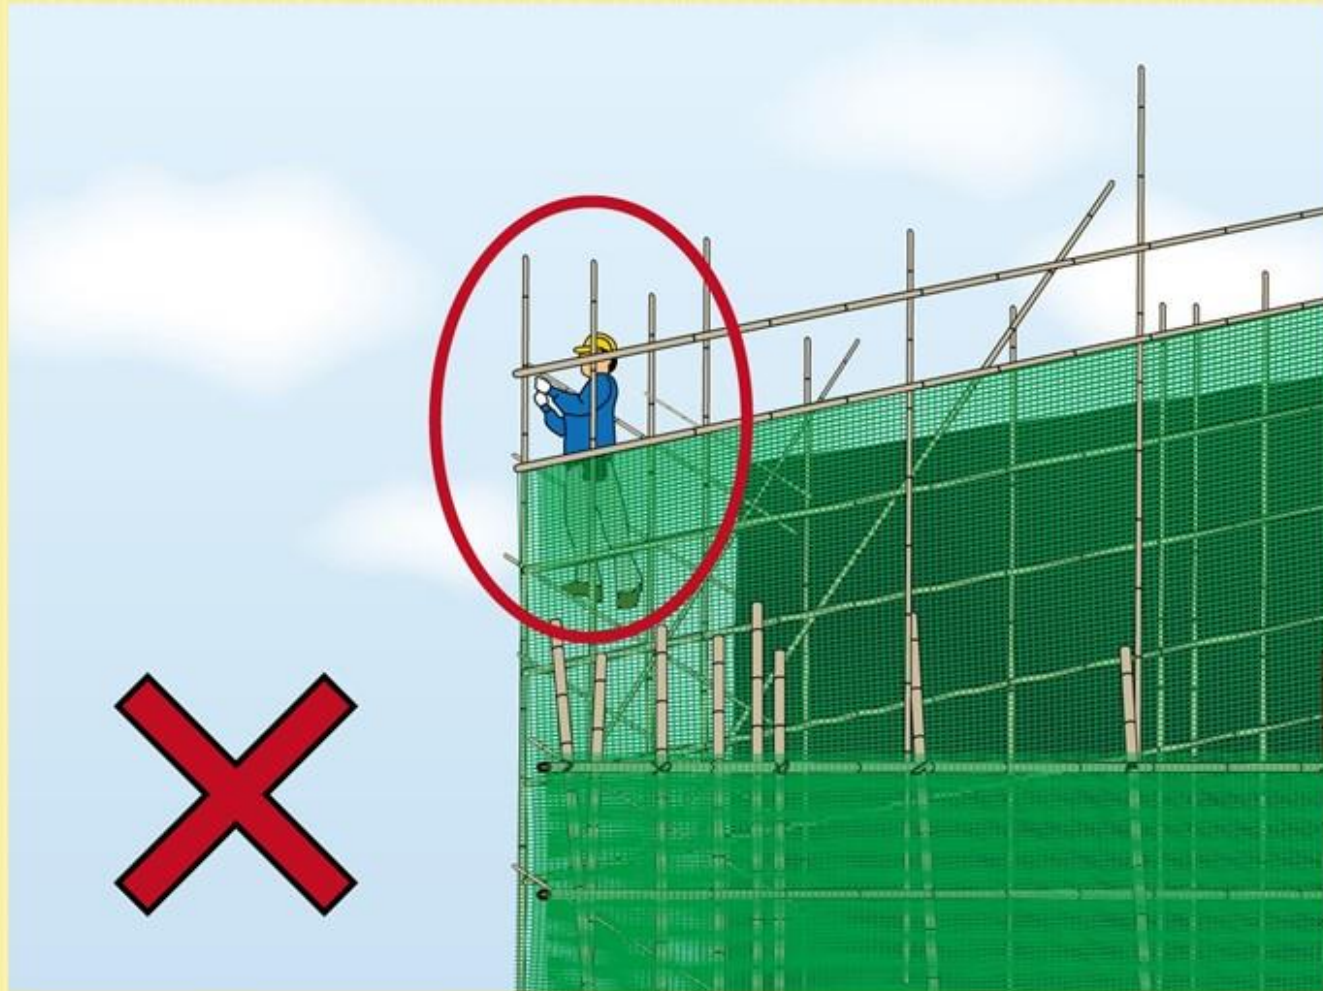
NO FALL ARRESTING MEASURE WHEN
DISMANTLING SCAFFOLD
拆卸棚架時沒有任何防墮措施

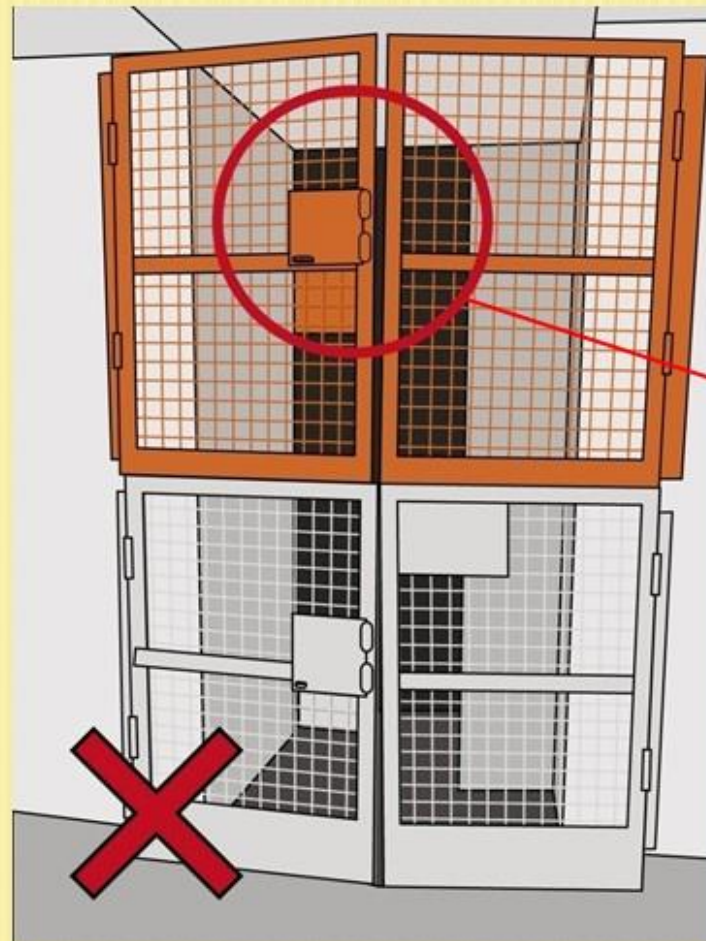
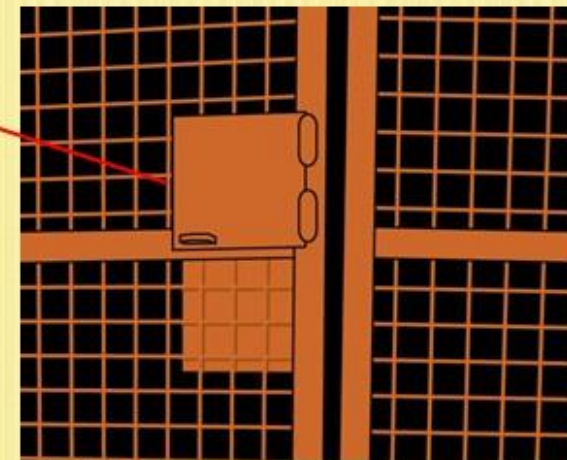
FULL-HEIGHT GATE OF LIFT SHAFT OPENING

NOT LOCKED

升降機井口全高閘門未鎖上

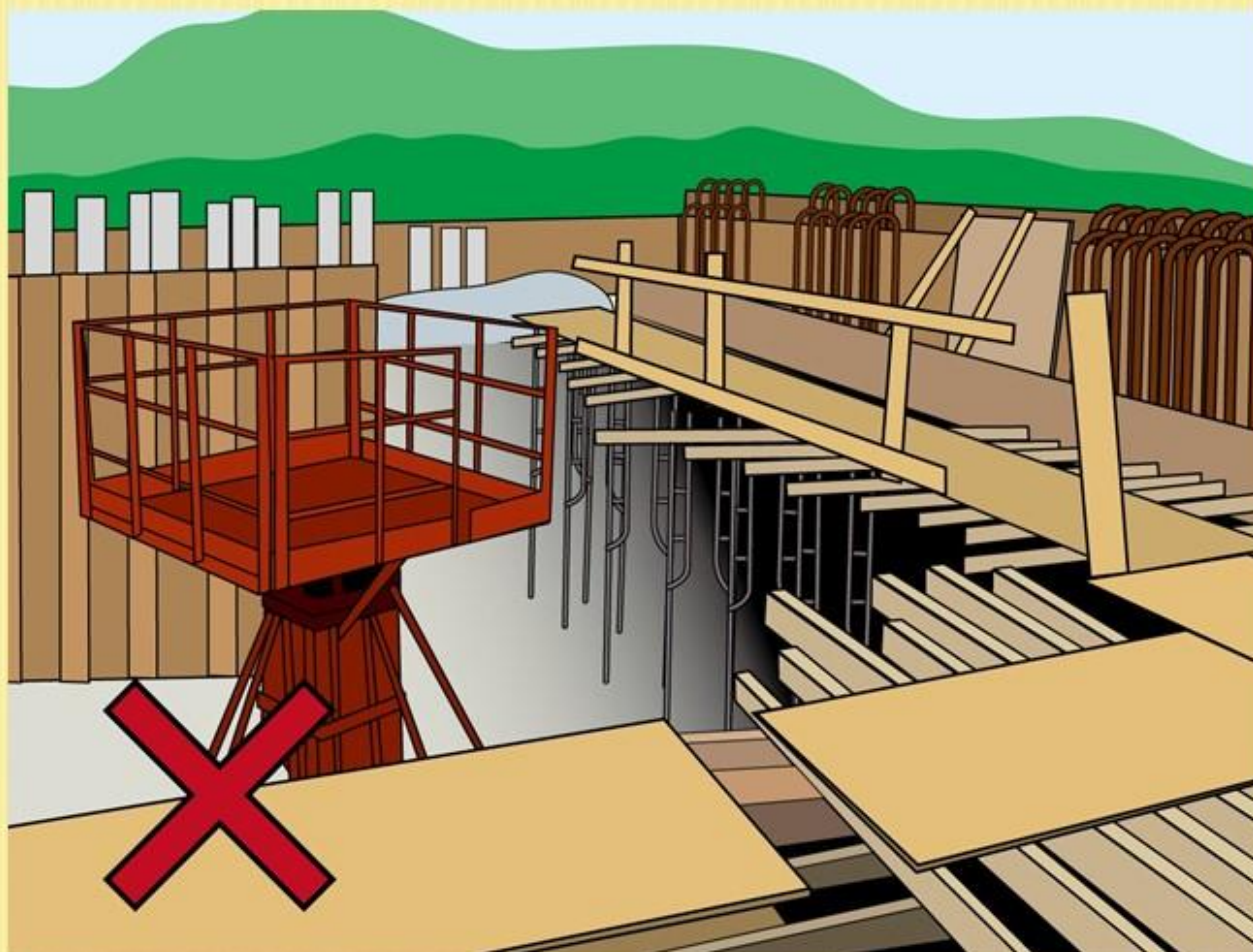
NO GUARD-RAILS WERE INSTALLED

沒有圍欄

NO FALL ARRESTING MEASURE WAS IN USE

沒有使用防墮措施

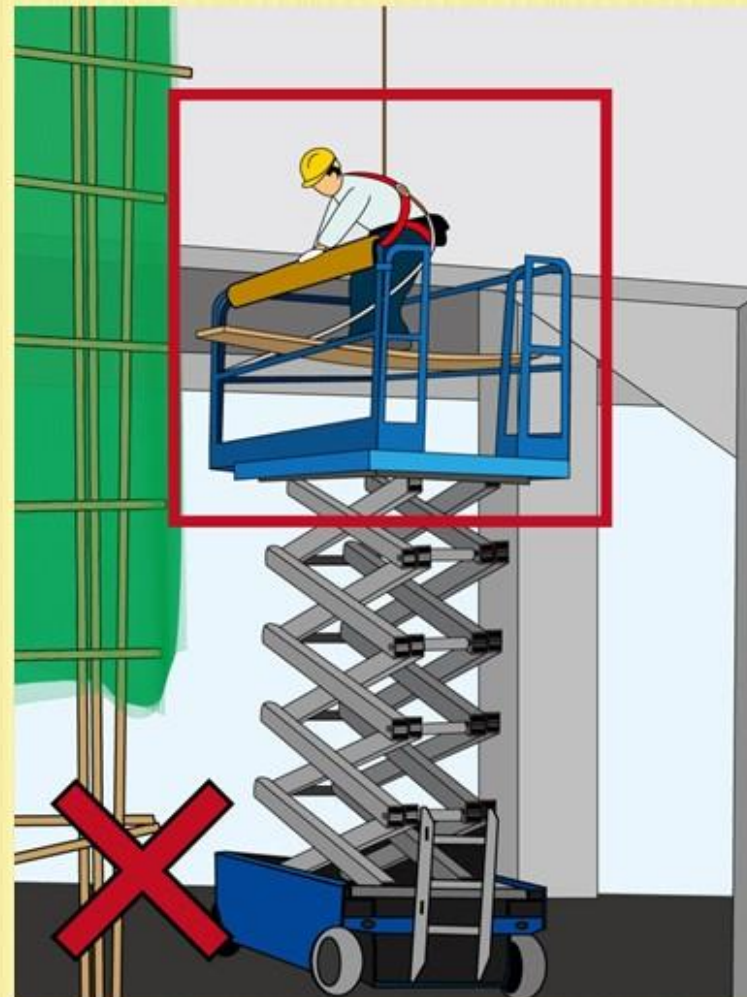
使用時，未有安裝圍欄

NO GUARD RAILS INSTALLED DURING OPERATION

不正確使用流動升降台

UNSAFE USE OF MOBILE ELEVATED WORKING PLATFORM

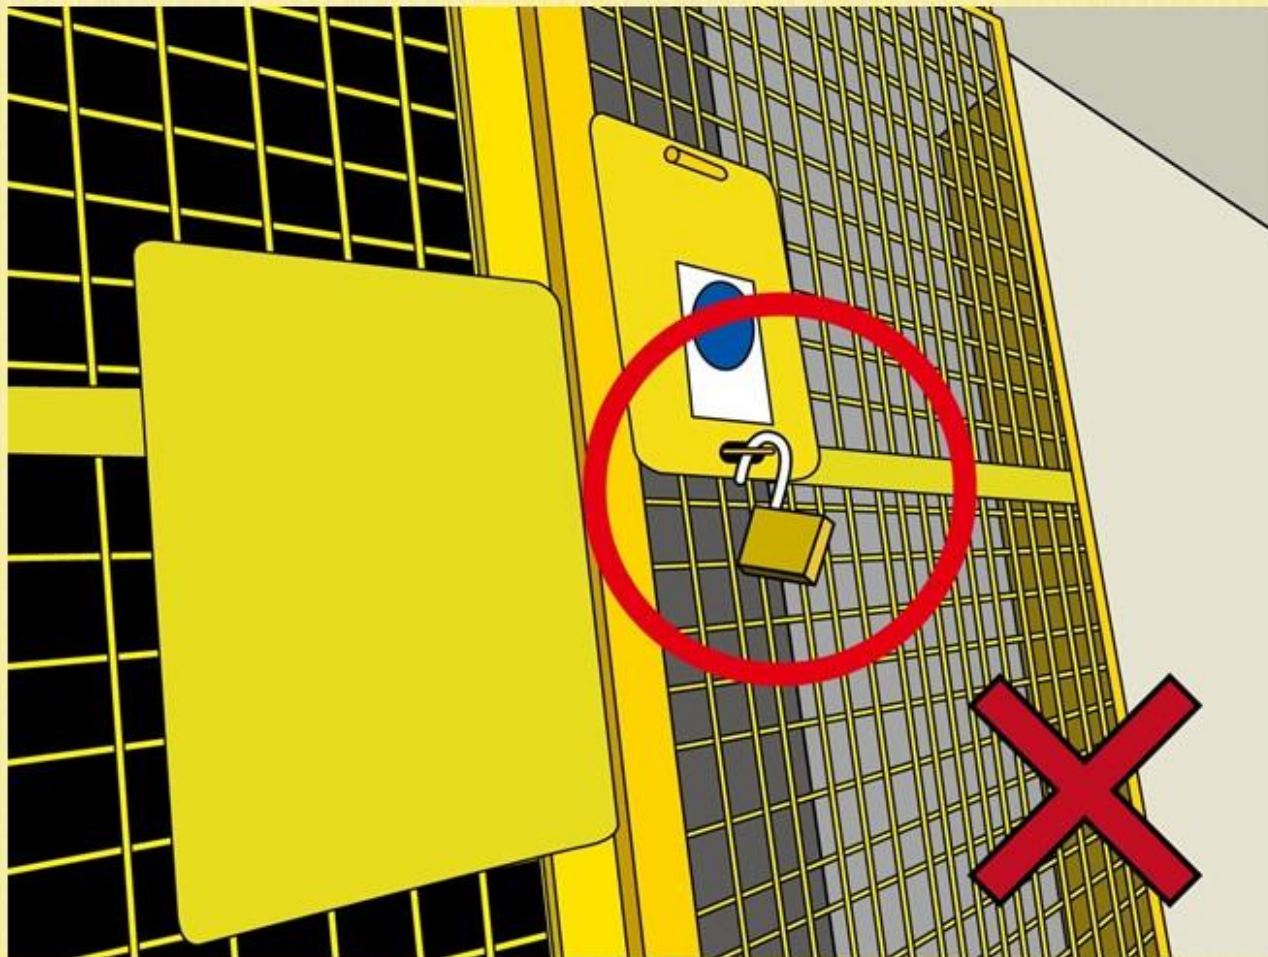
升降機門未有上鎖

LIFT METAL GATE UNLOCKED

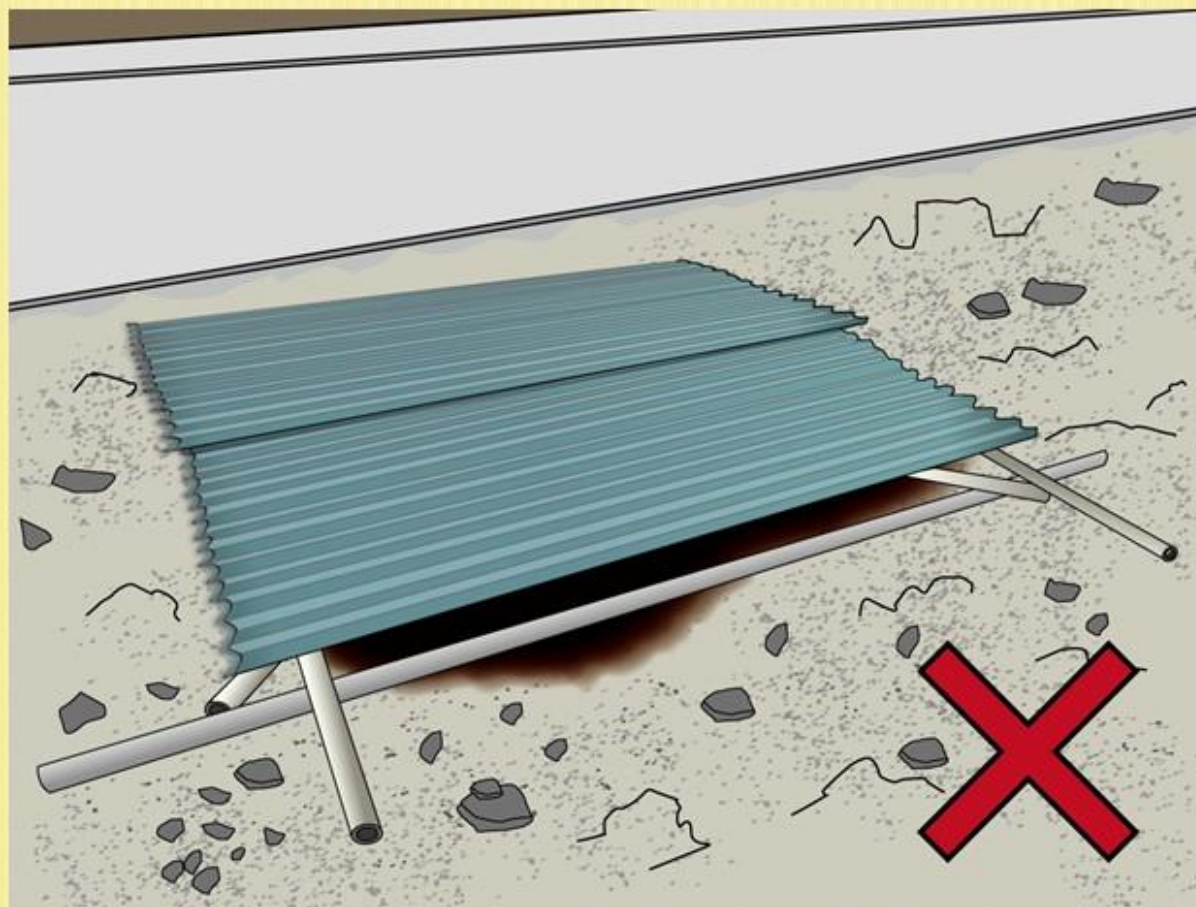
地洞蓋沒有被穩固

COVER OF FLOOR OPENING WAS NOT SECURELY
FIXED IN POSITION

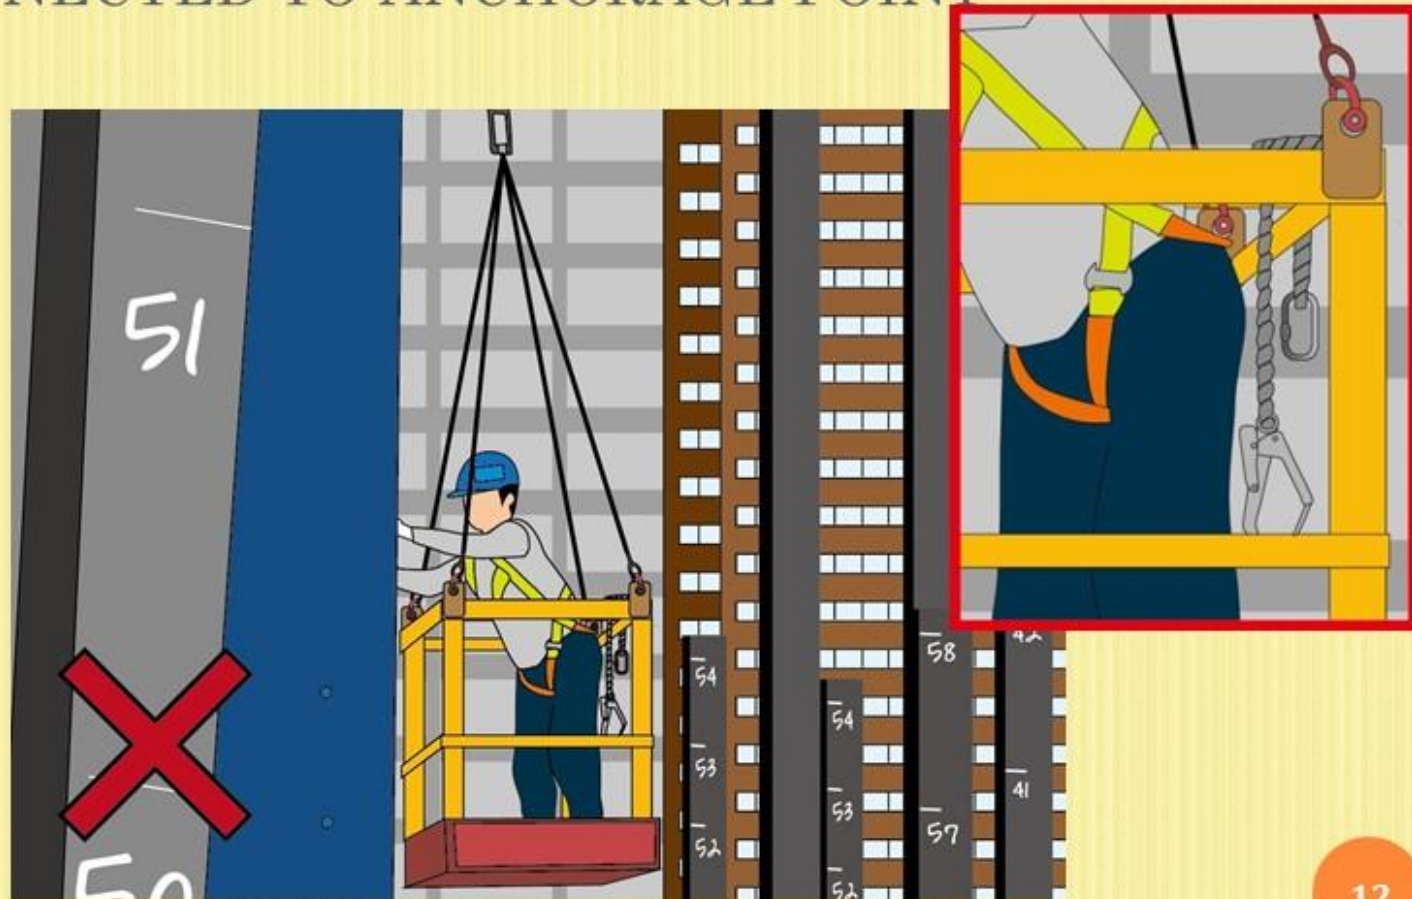
安全帶沒有連接於繫穩點

WORKER'S SAFETY HARNESS WAS NOT
CONNECTED TO ANCHORAGE POINT

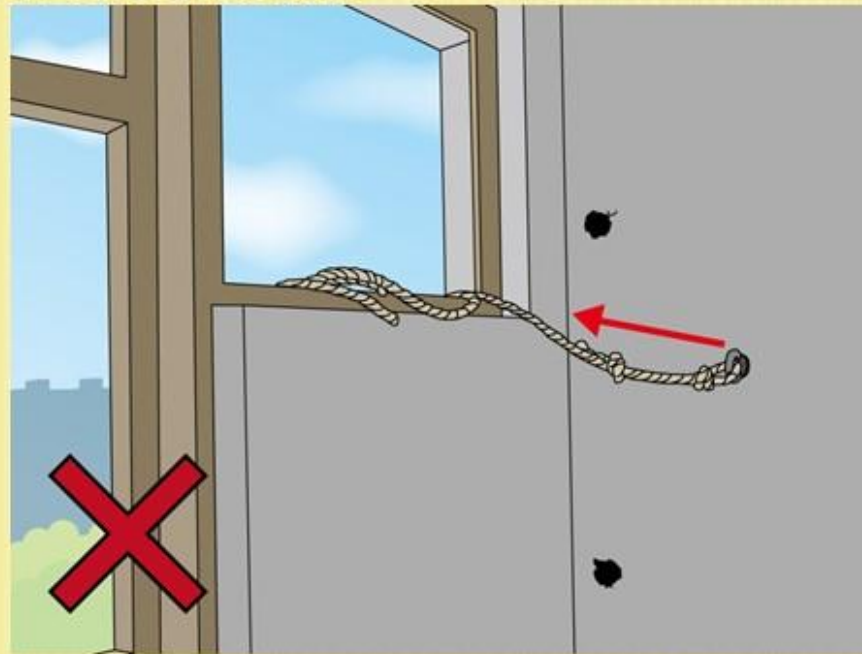
有眼螺栓的方向應與拉力方面一致

THE EYEBOLT SHOULD BE ORIENTED IN LINE WITH THE INTENDED LINE OF FORCE OF THE INDEPENDENT LIFELINE

如果側身負載，吊環螺栓可能會彎曲。麻袋應放在周圍鋒利的邊緣/角以保護救生繩。If the load is applied sideways, the eyebolt may bend. Sacking should be placed around sharp edge/corner to protect the lifeline.

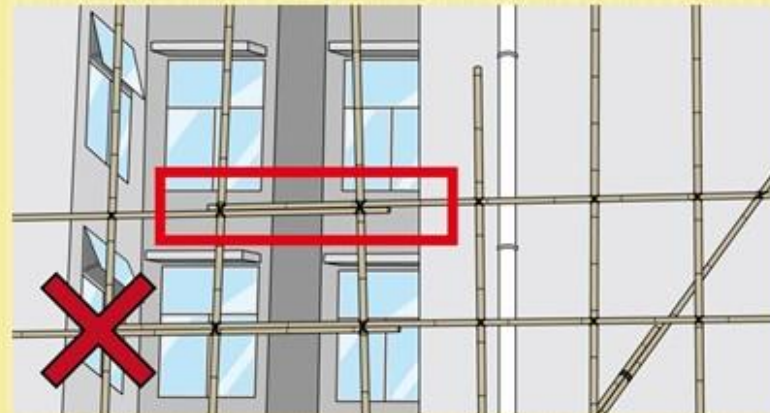
兩條連接之竹竿的重疊長度不足

LENGTH OF OVERLAP WAS INSUFFICIENT FOR CONNECTING 2 BAMBOO MEMBERS

- 兩條連接之竹竿的重疊長度:
 - 對於直杆，應為1.5米至2米。
 - 對於大橫杆及斜杆/斜撐，應不小於2米

- **For connection between 2 bamboo members, the length of overlap should be:**
 - **1.5m to 2m for standards**
 - **at least 2m for ledgers and bracings /rakers**

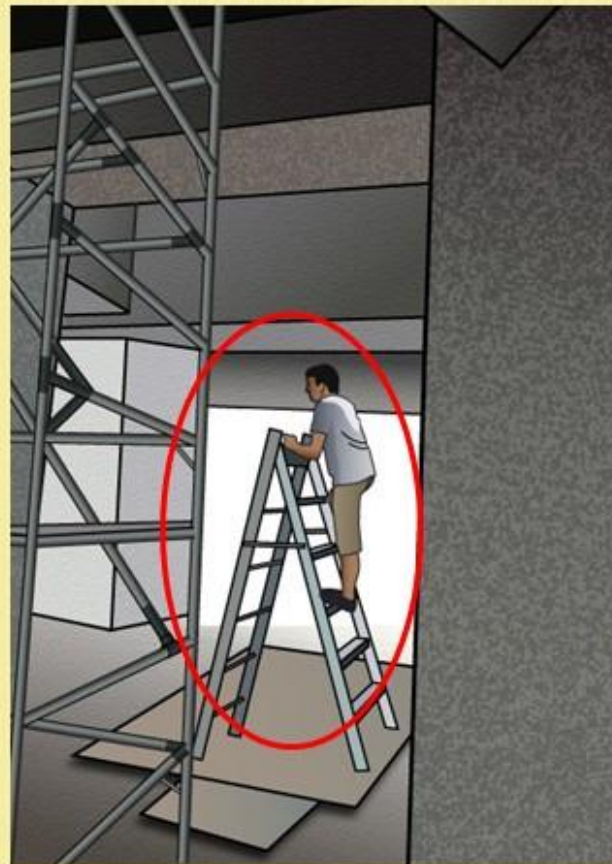
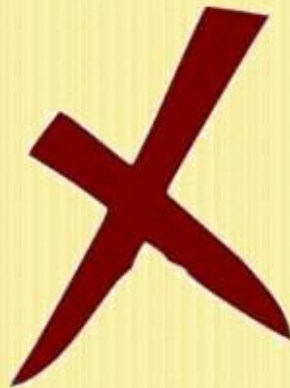
使用梯子在離地兩米以上地方工作

LADDER USED FOR WORKING AT 2 METRES OR ABOVE

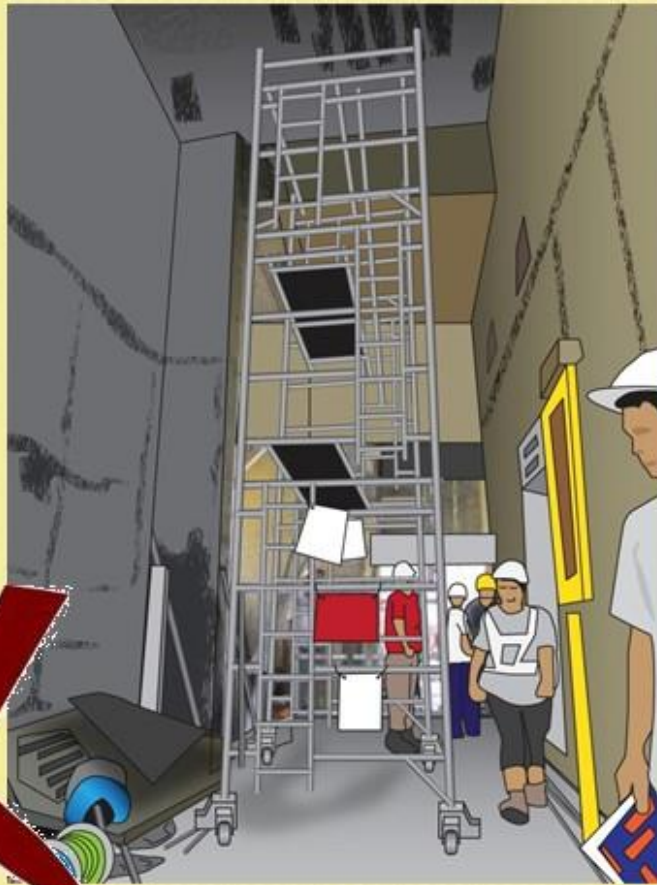
使用中的流動工作台無有效的表格五。沒有安裝腳架以穩固工作台。

MOBILEWORKING PLATFORM IN USE HAD NO VALID FORM 5. OUTRIGGERS WERE NOT INSTALLED TO STABILIZE THE WORKING PLATFORM.

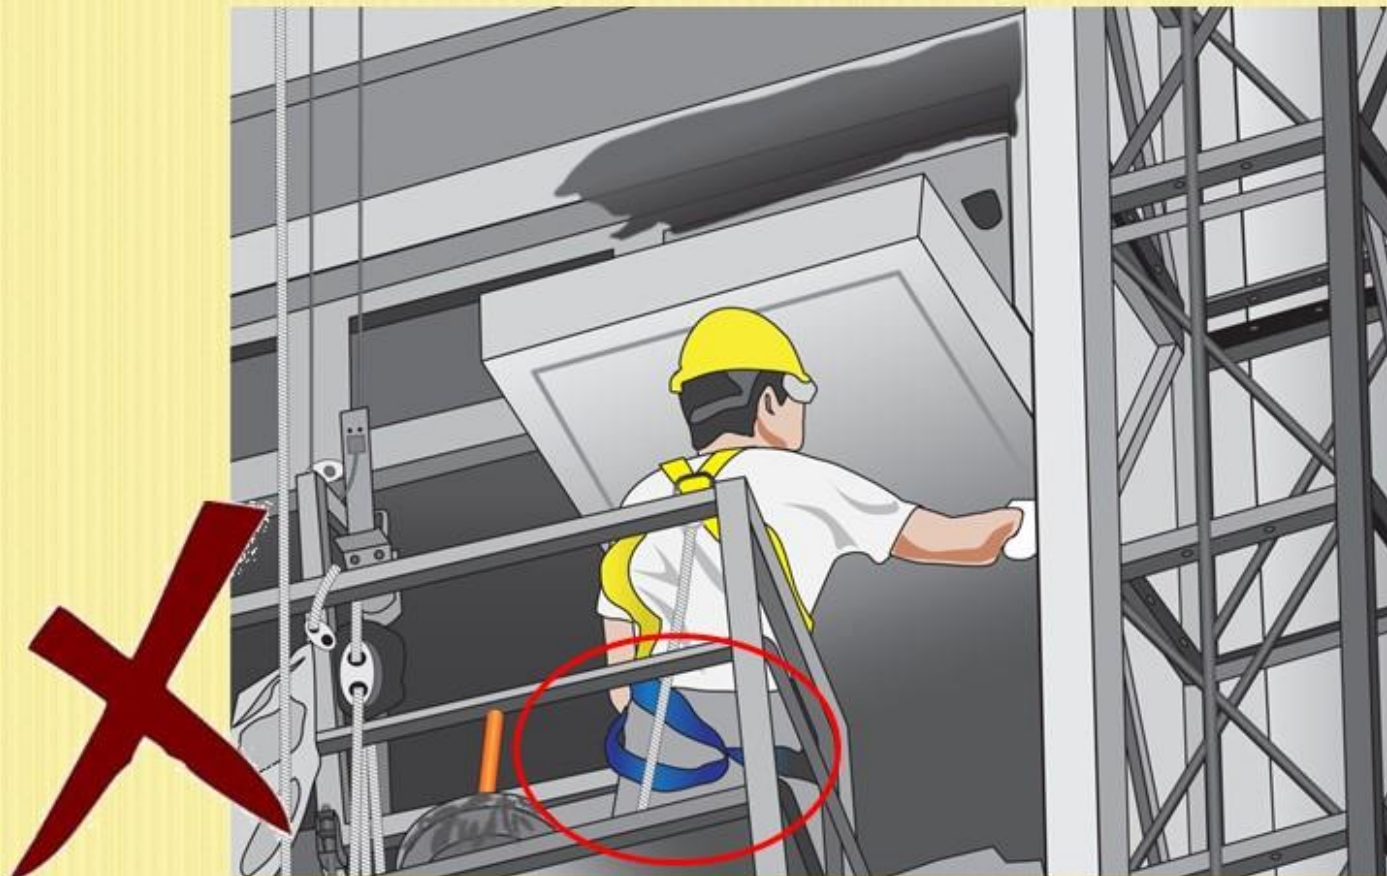
不適當地配戴安全帶。配戴腿帶的方法不正確。

IMPROPER WEARING OF SAFETY HARNESS ON GONDOLA. THE LEG STRAPS WERE NOT CORRECTLY WORN.

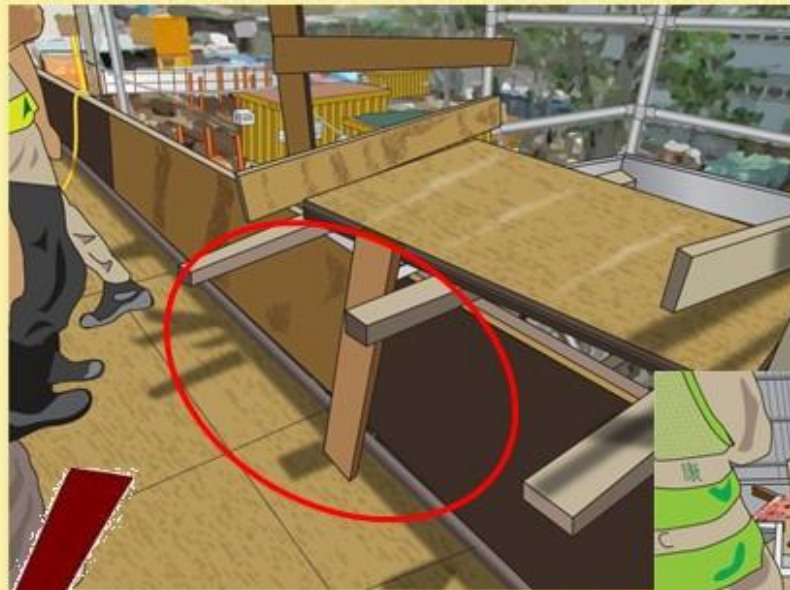
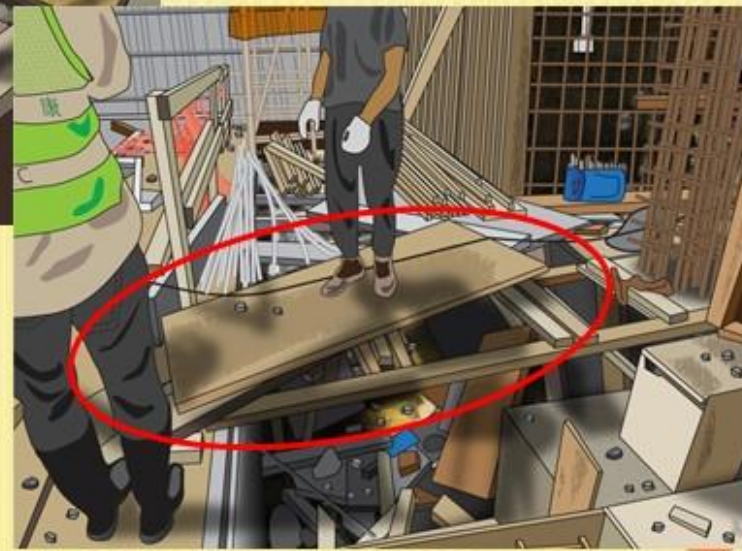
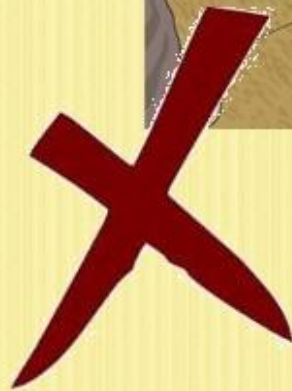
高空工作台及天面間沒有進出設備；不安全的木板路。

ACCESS EQUIPMENT WAS MISSING BETWEEN ACCESS TOWER AND THE WORKING FLOOR.
UNSAFE GANGWAY WAS PROVIDED FOR THE SITE.

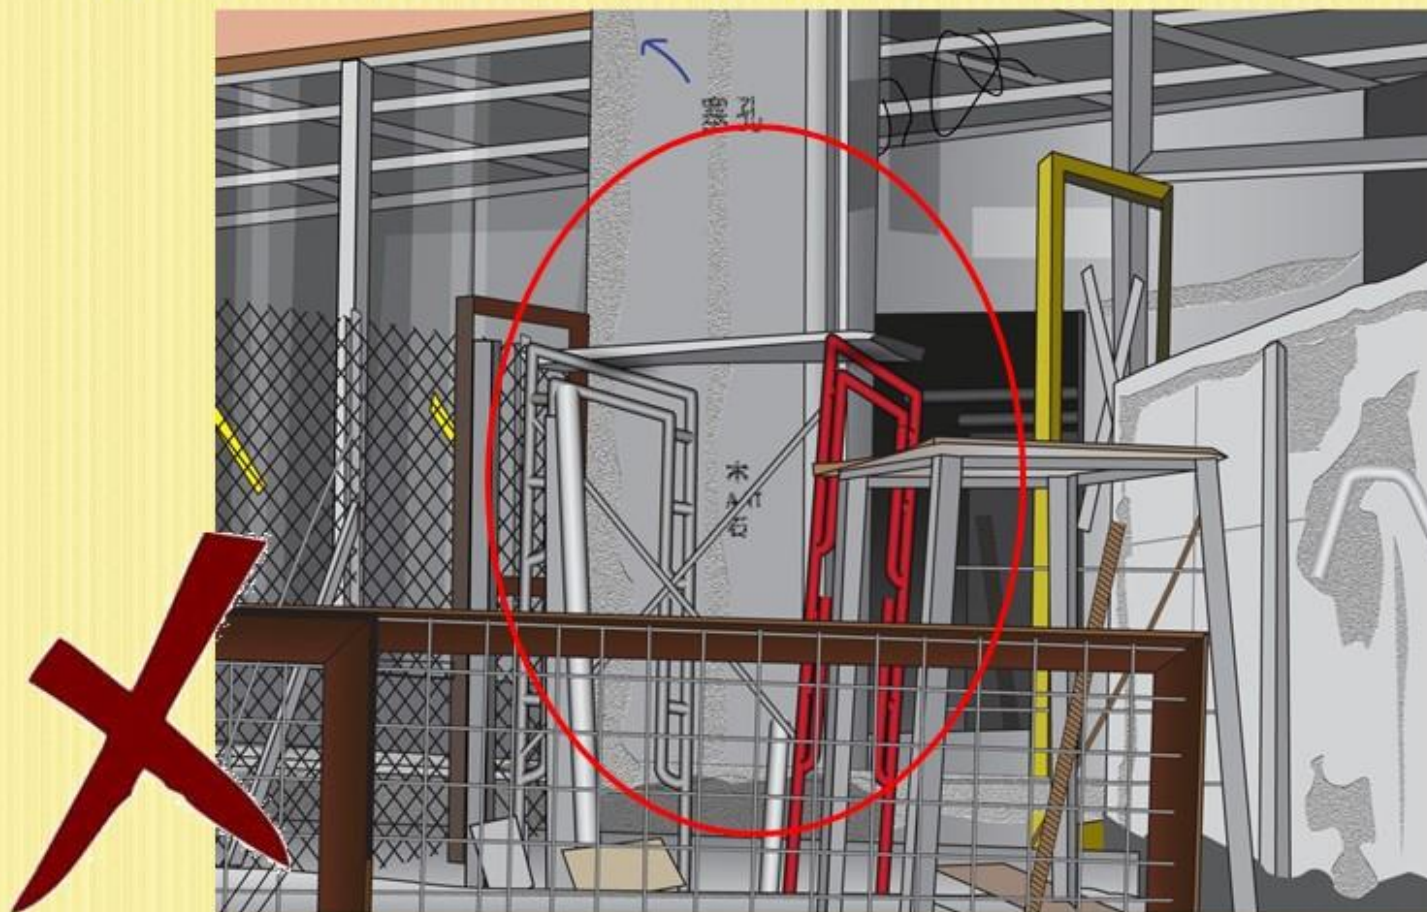
低於2米的工作台處於不安全操作狀態。

WORKING PLATFORM BELOW 2M WAS NOT IN GOOD WORKING ORDER.
