HOUSEKEEPING

工作場所整理

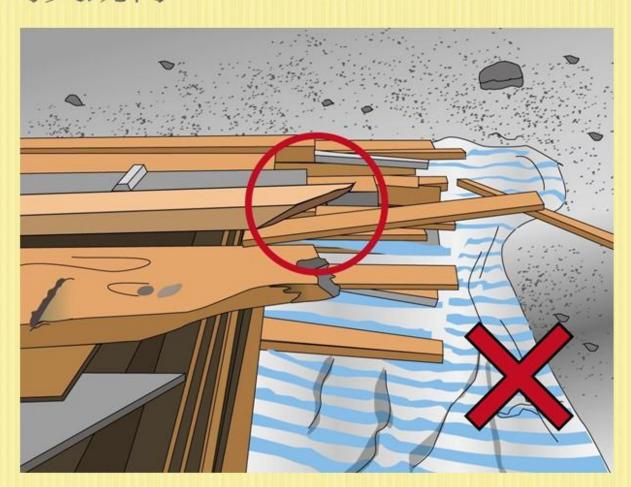
PROJECTING SHARP OBJECT 突出的尖銳物

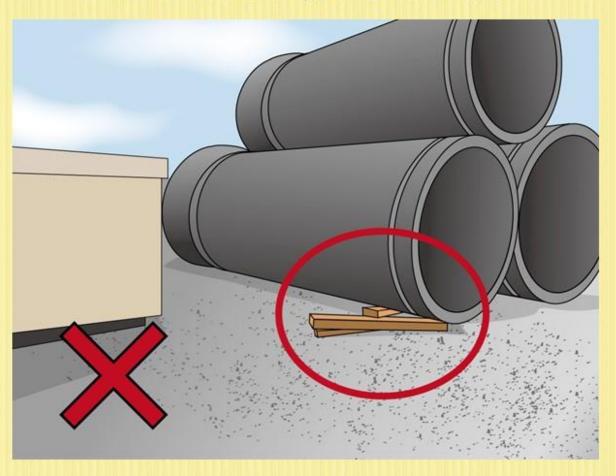
CONCRETE PIPES WITHOUT SECURE STOPPER

大型石矢渠筒沒有被妥善楔好

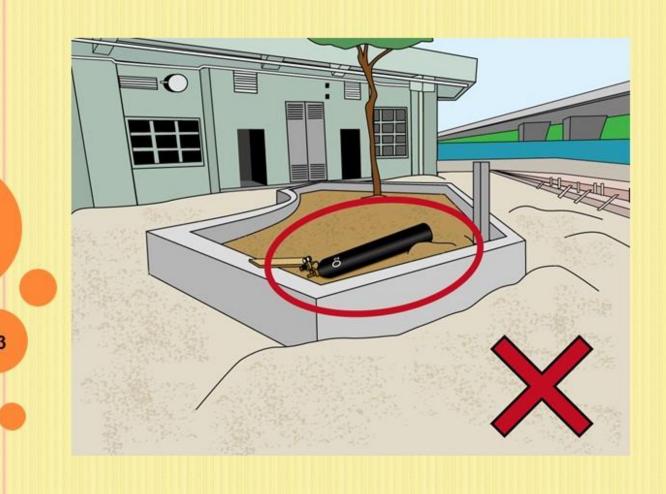
Empty gas container found inside planter 用完的氧氣瓶沒有被妥善儲存

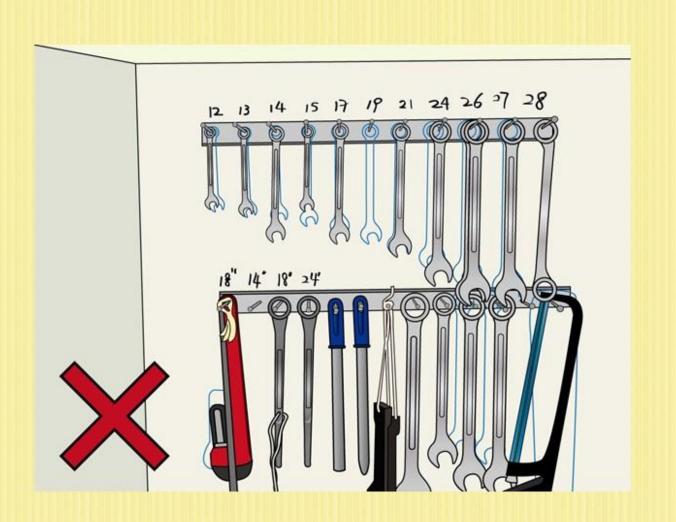
HOUSEKEEPING SYSTEM NOT BEING FOLLOWED

沒有依從良好工作場所安排

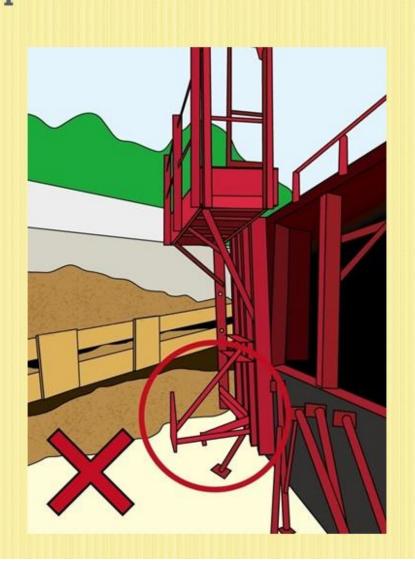
鐵模沒有足夠支撐 METAL FORMWORK WITHOUT SUFFICIENT SUPPORT

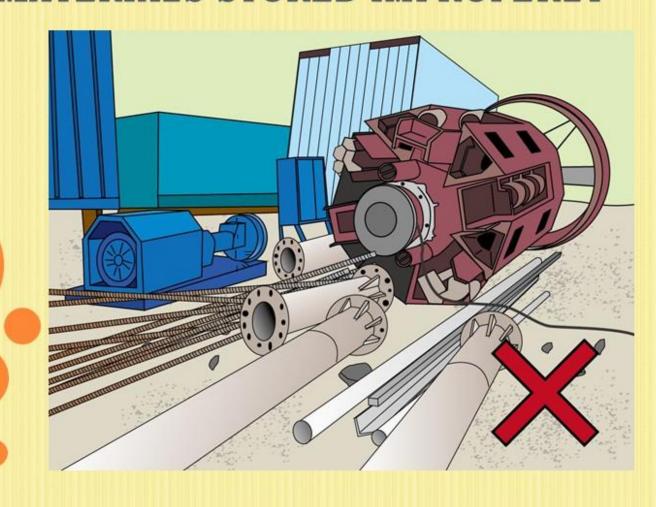
物料隨地亂放 MATERIALS STORED IMPROPERLY

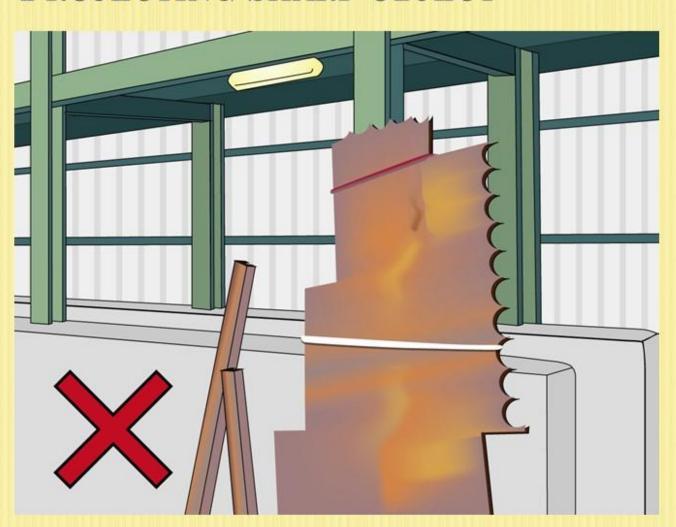
突出的尖銳物 PROJECTING SHARP OBJECT

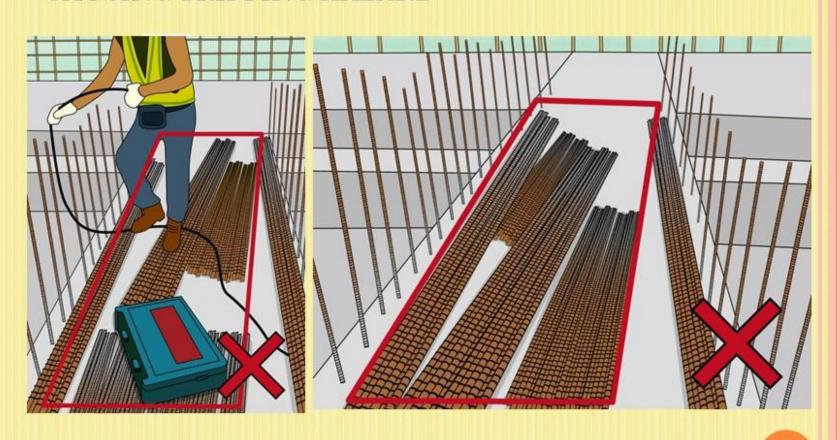
鋼筋放置於主要道路或導致絆倒 METAL BARS PLACED ON THE MAIN ACCESS CAUSING TRIPPING HAZARD

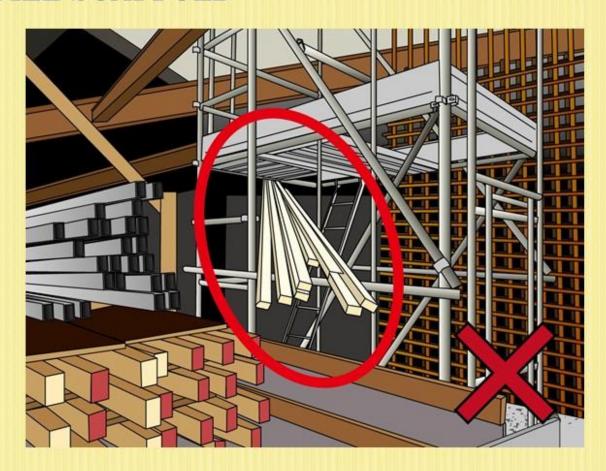
木條不穩固地斜放於通架上 WOOD BATTENS STORED INSECURELY AT MOBILE SCAFFOLD

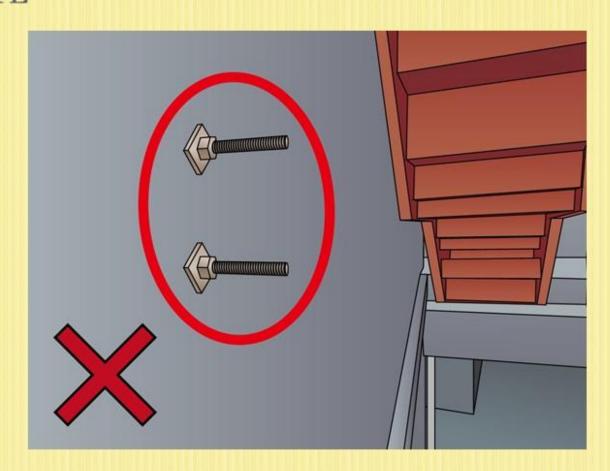
過山縲絲凸出於進出路徑 PROJECTING BOLTS WERE FOUND ON ACCESS ROUTE

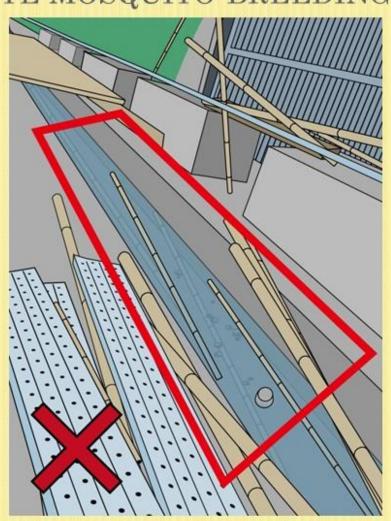
應清除積水以杜絕蚊患 STAGNANT WATER SHOULD BE REMOVED TO ELIMINATE MOSQUITO BREEDING

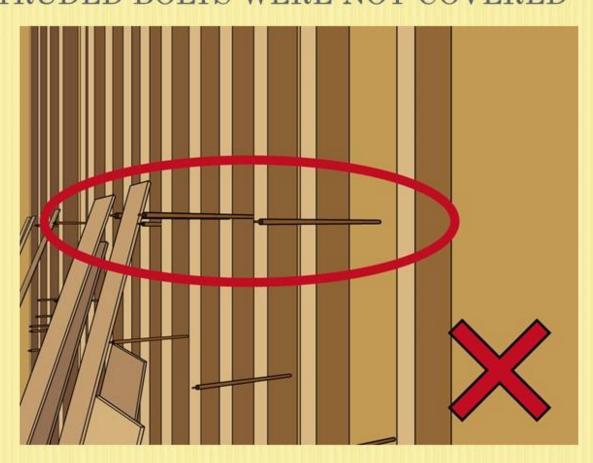
螺栓沒有作出保護 PROTRUDED BOLTS WERE NOT COVERED

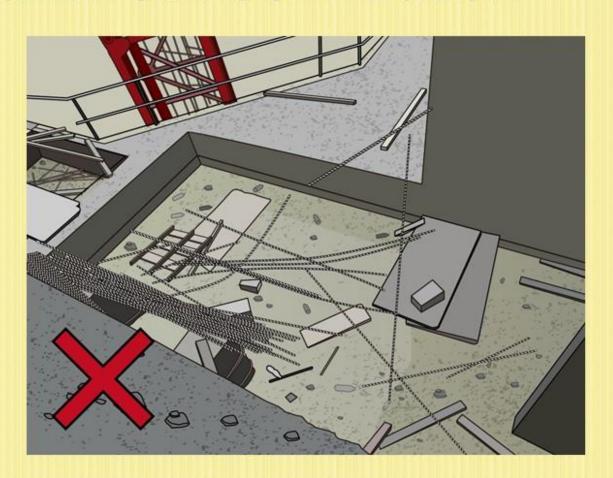
簷篷上有積水 WATER PONDING ON THE CANOPY

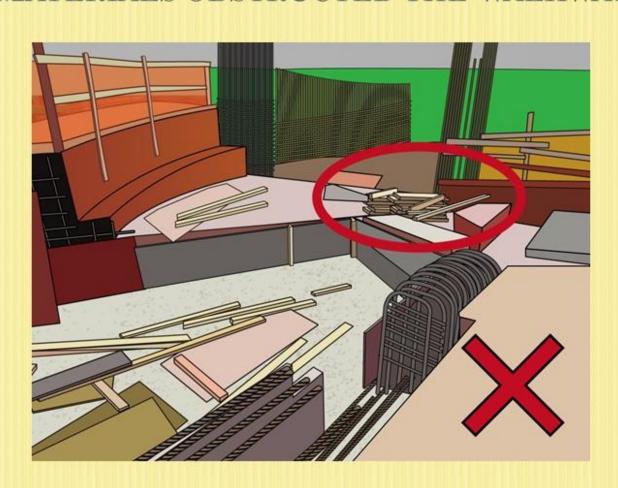
物料阻礙通道 MATERIALS OBSTRUCTED THE WALKWAY

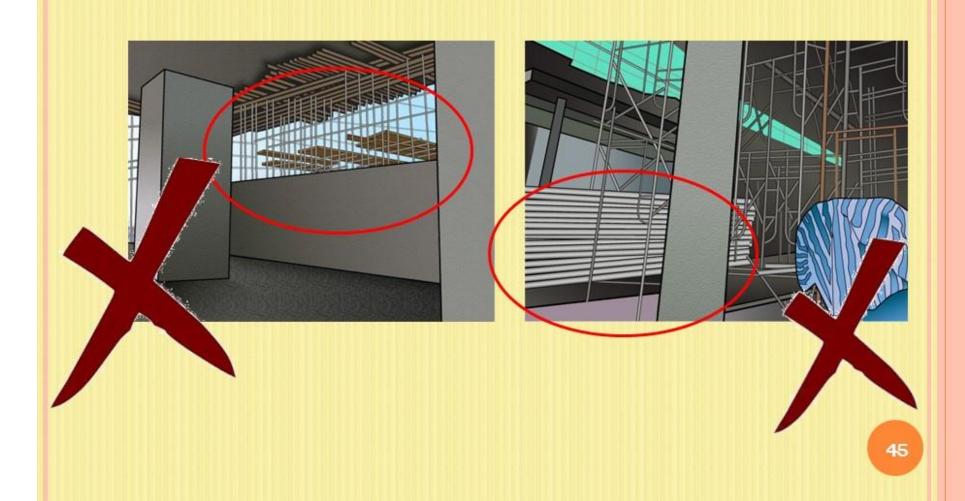
物料存放於臨時支架的門架上 MATERIALS WERE STORED ON PLANE FRAMES OF FALSEWORK

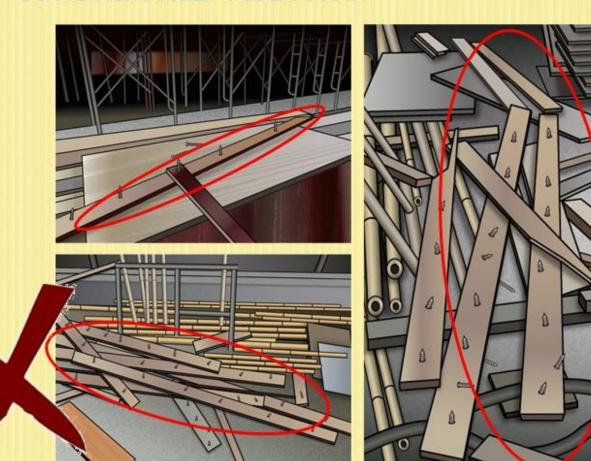
突出的鐵釘。

PROJECTING NAILS WERE FOUND.

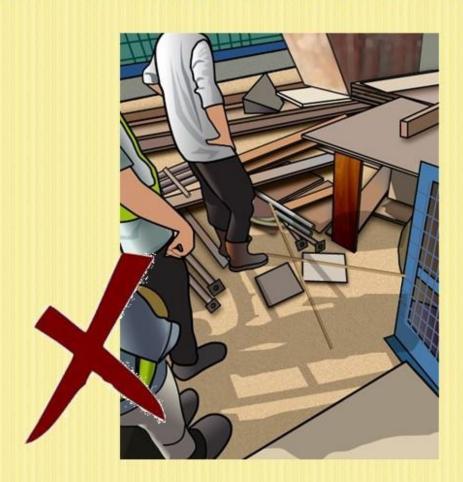
在通道上堆放雜物

MATERIAL WAS STORED ON THE PASSAGEWAY

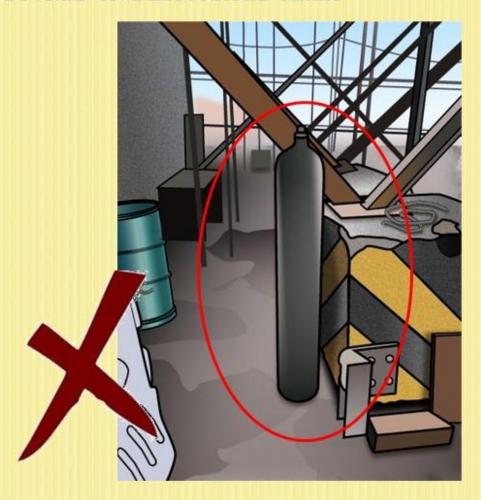
沒有為氣瓶提供保護以防倒下;氣瓶沒有存放於指定地方 GAS CYLINDER WITHOUT ANY PROTECTION AGAINST TOPPLING, AND NOT STORED IN DESIGNATED AREA

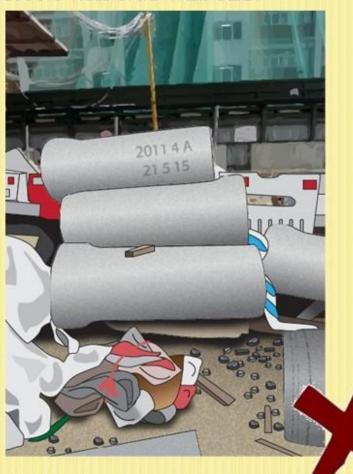
渠筒沒有楔好。

STACK OF PIPE SECTIONS WAS NOT WEDGED.

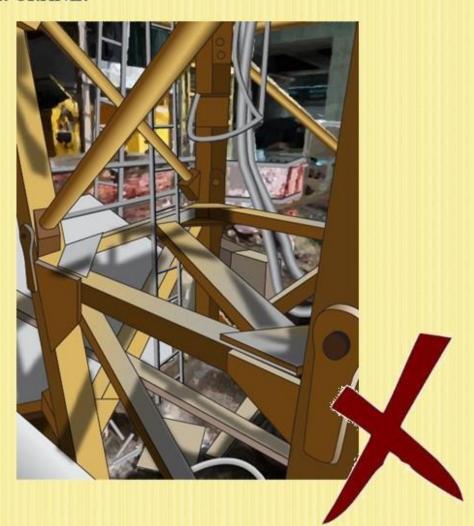
通往塔式起重機的通道有絆倒危害(木板)。

TRIPPING HAZARD/OBSTACLE (WOODEN PLANKS) WAS FOUND ON ACCESS LADDER TO TOWER CRANE.

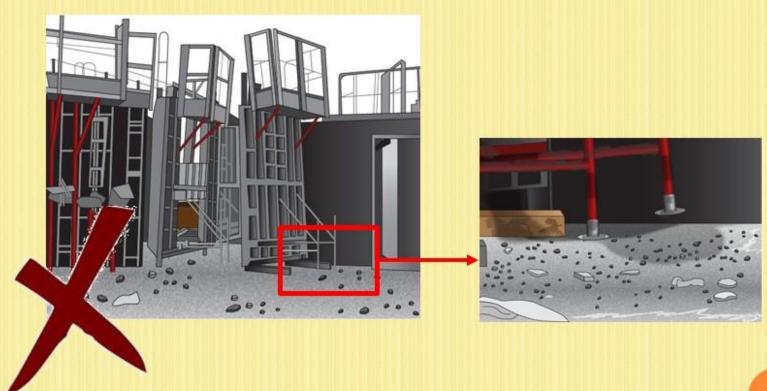
鐵模板沒有足夠支撐。

PANEL FORMWORK WAS NOT SECURELY SUPPORTED.

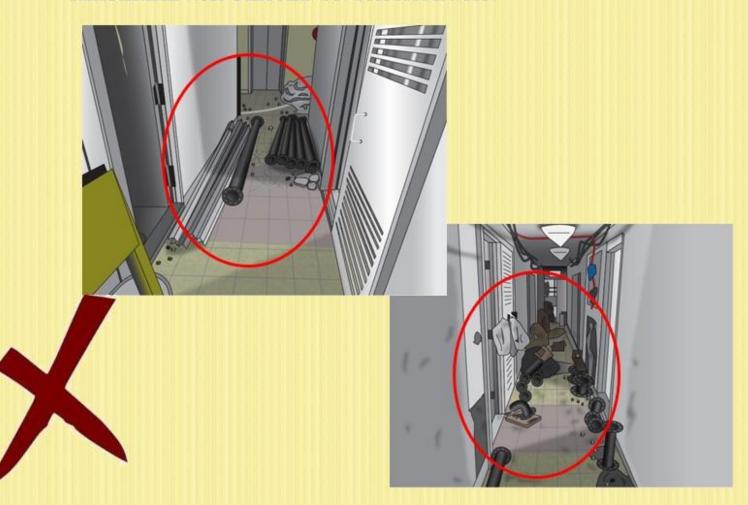
通道上放置物料。

MATERIAL WAS PLACED ON PASSAGEWAY.

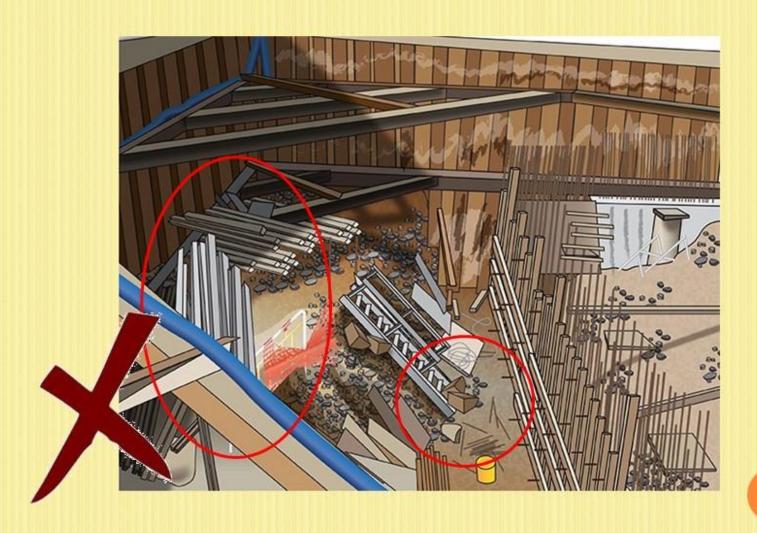
在通道上放置物料。

MATERIALS WERE PLACED ON THE PASSAGEWAY.
