Audit Unit Development & Construction Division
Experience Sharing Session with Building Contractors Mar 2008

EXPERIENCE SHARING SESSION on SITE SAFETY, QUALITY & WORKMANSHIP

with
Building
Contractors
4 March 2008

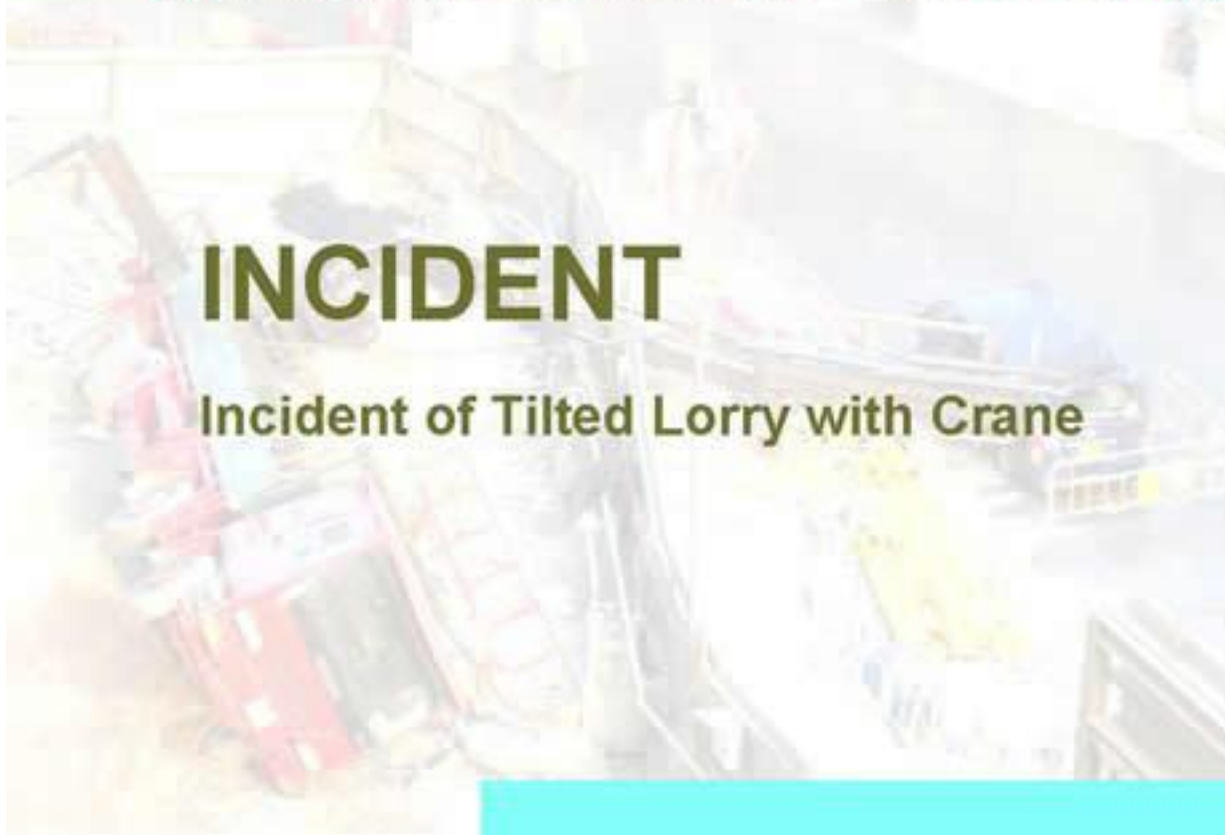
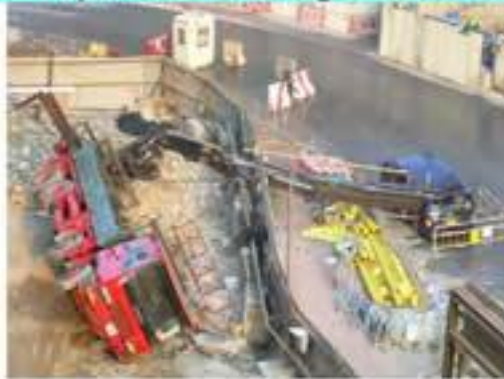
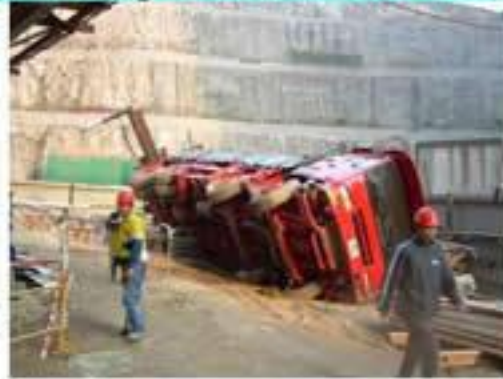
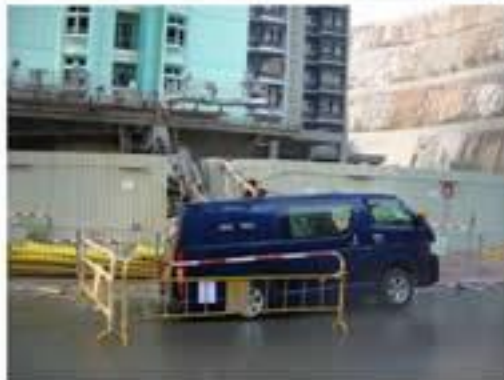
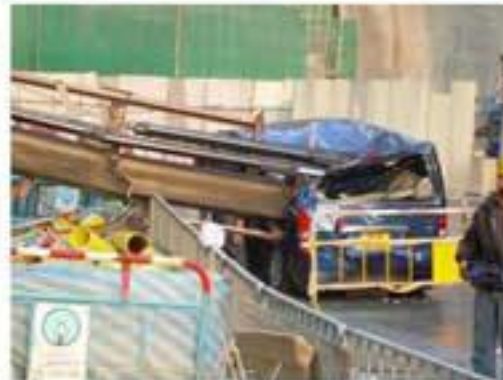
8 Case 1

Incident of Tilted Lorry with Crane

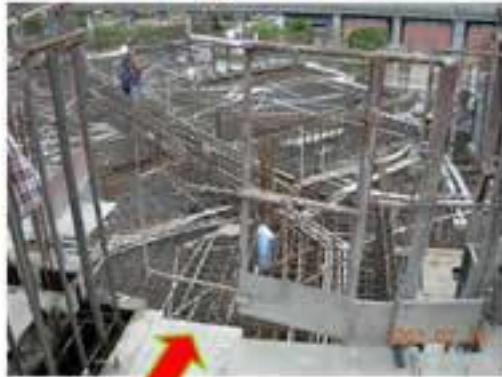
NO Toeboard

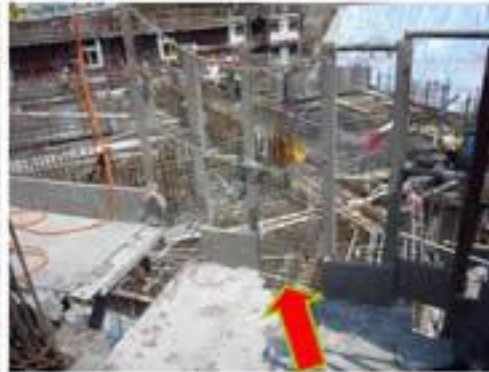
No close boarding
at floor opening

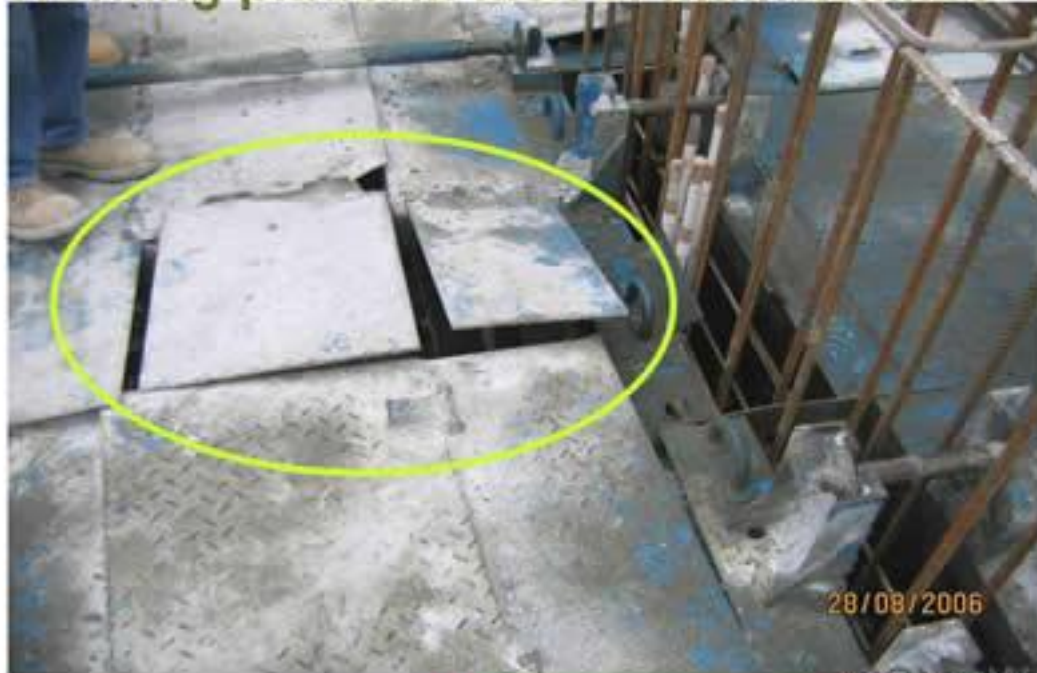
[CON 2.WT020.4]

Working platform lack of maintenance

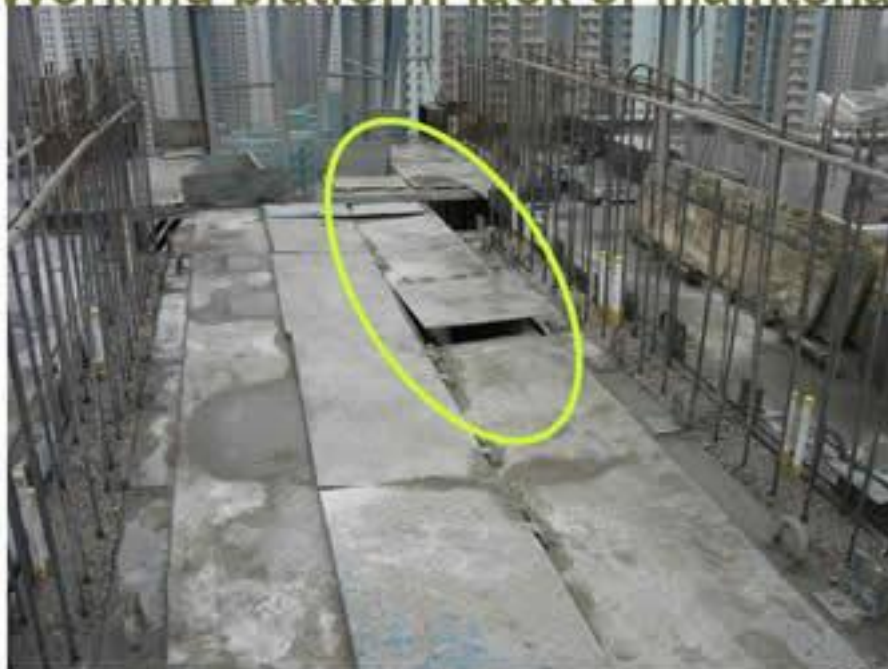
[CON 2.W1020.4]

Working platform lack of maintenance

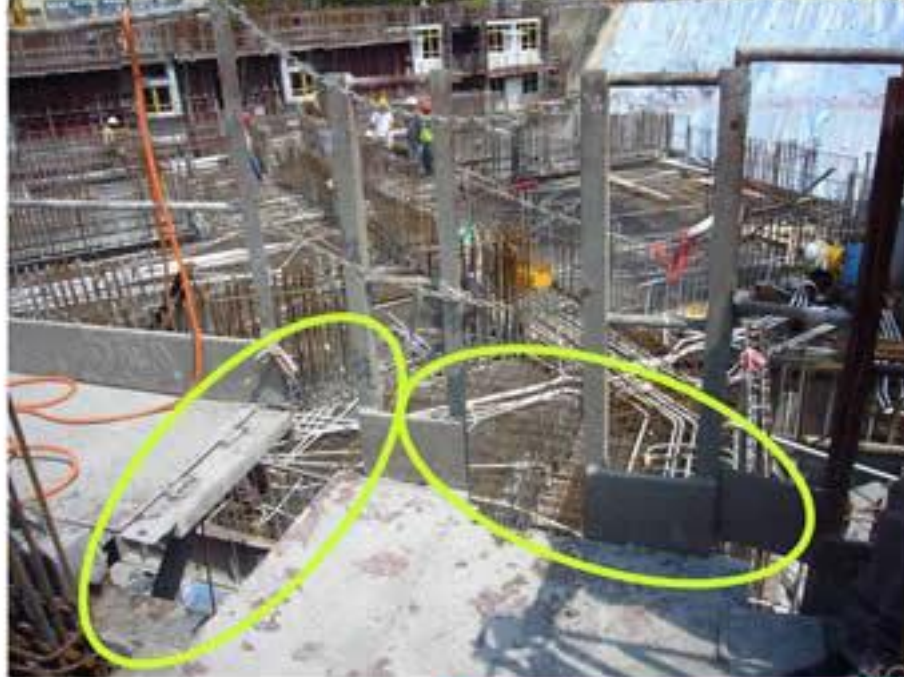
[CON 2.D420.4]

Toe board missing at several locations

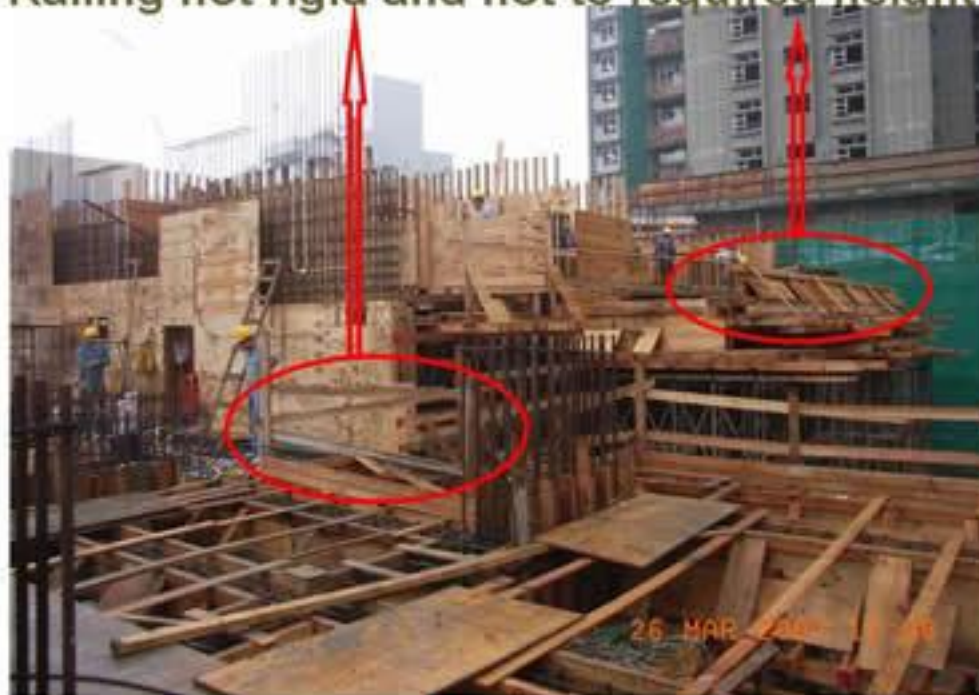
Railing not rigid and not to required height

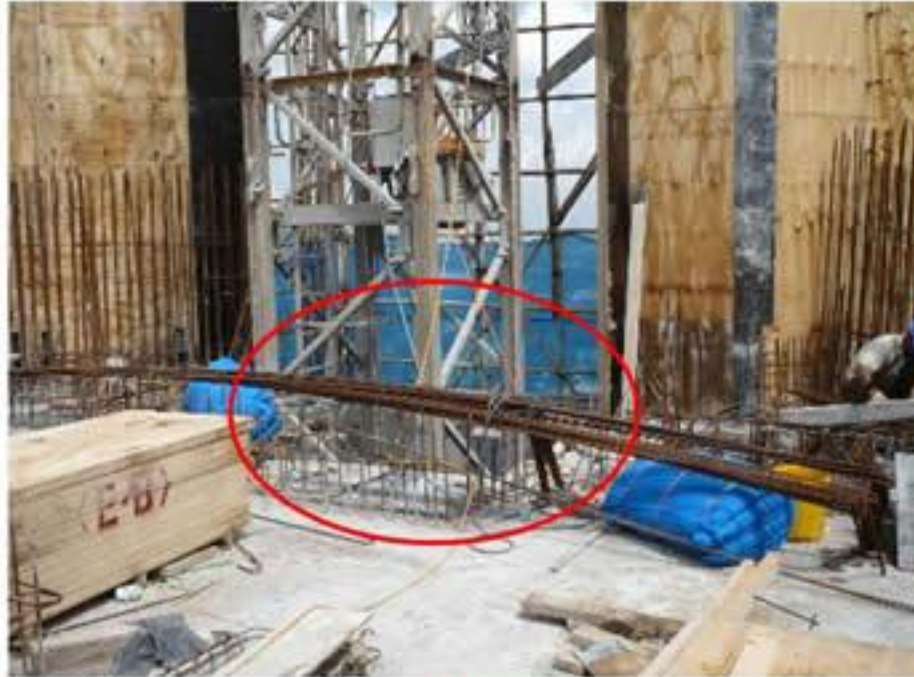
No fencing at tower crane opening

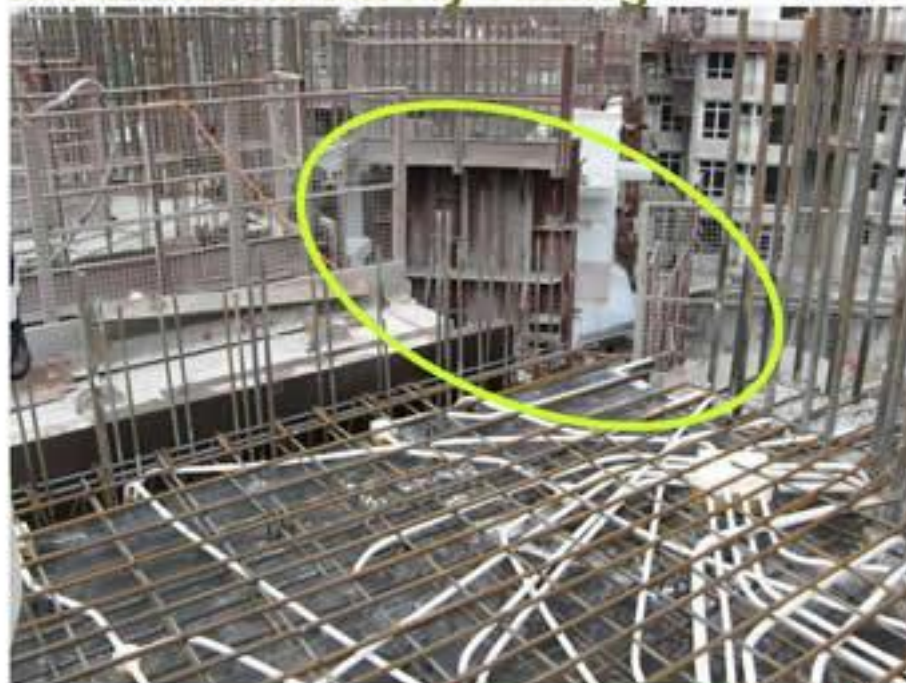
[PRE.B10.1010.4]

Working Floor / Safety Insufficient safety railing

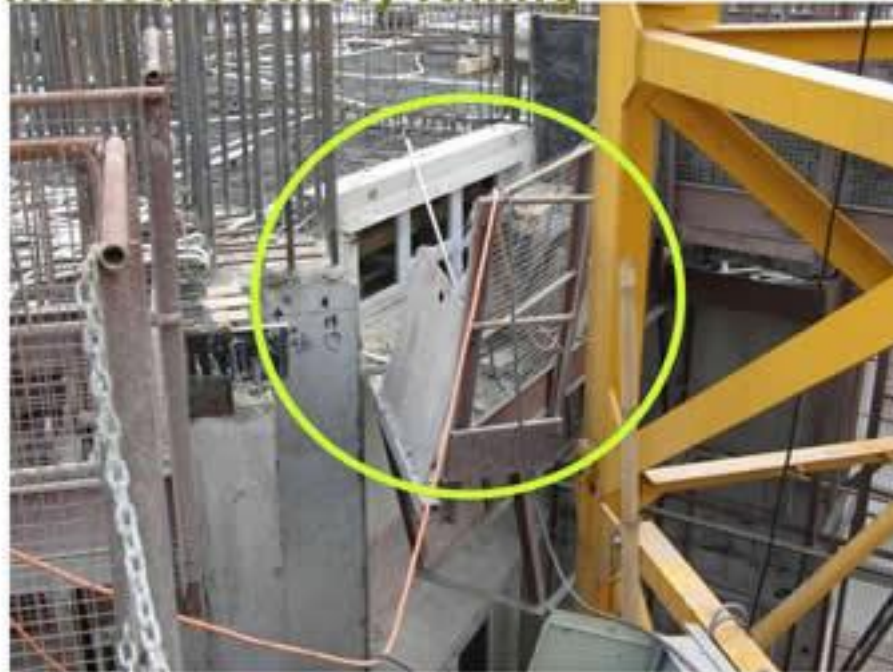
[PRE.B10.1010.4]

Working Floor / Safety Insecure safety railing

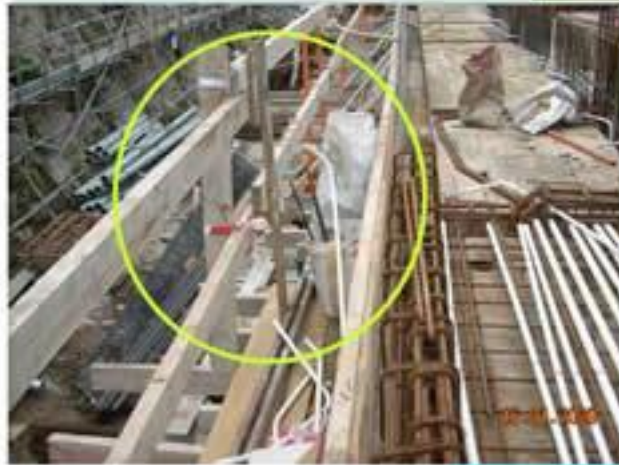
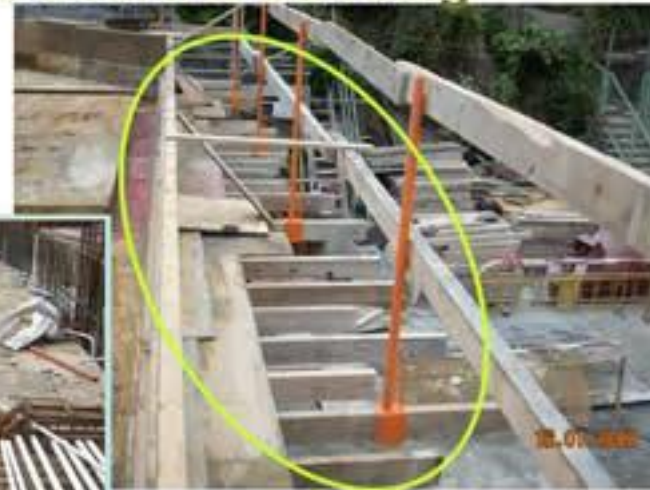
No planking and toe board & building materials stacked

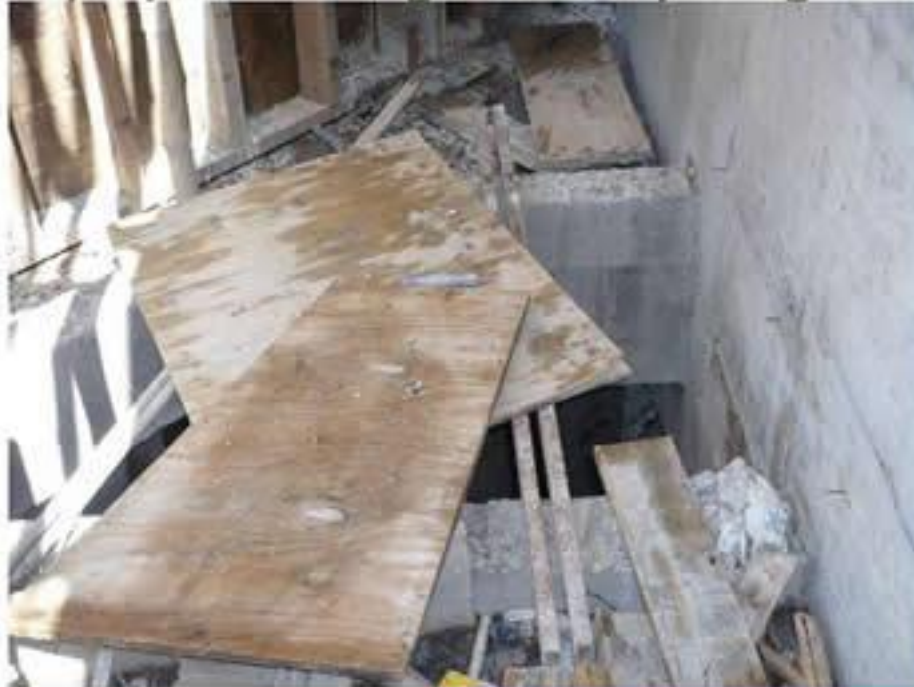
Improper boarding to floor opening

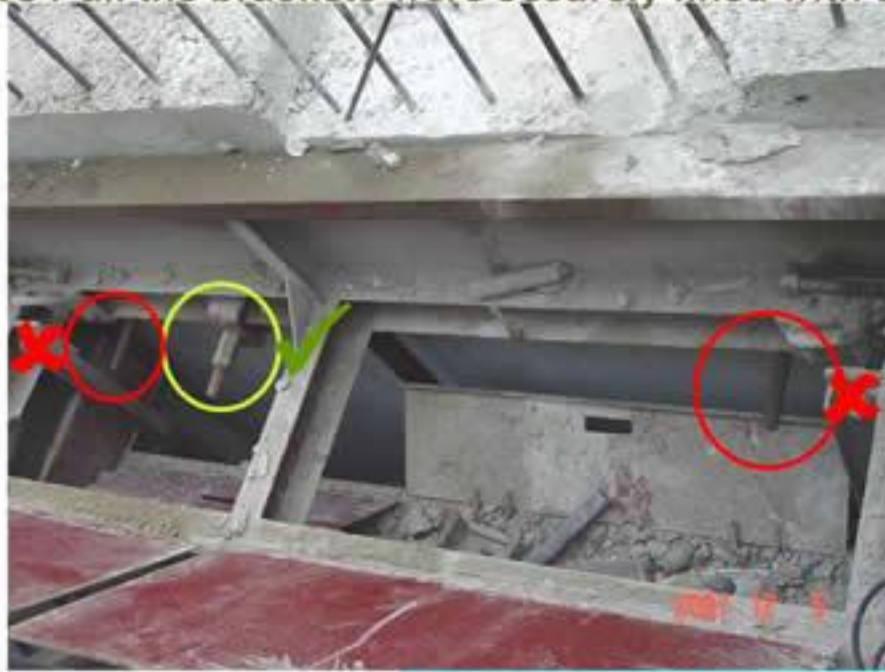
Lift Shaft Working Platform

NOT all the brackets were securely fixed with tie bolts

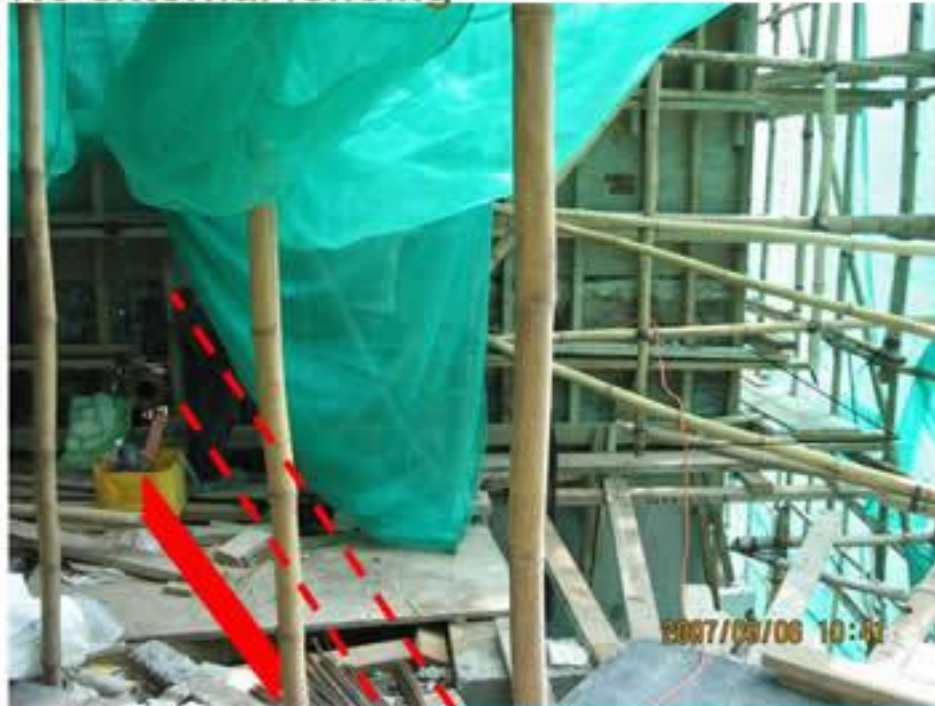
No external fencing

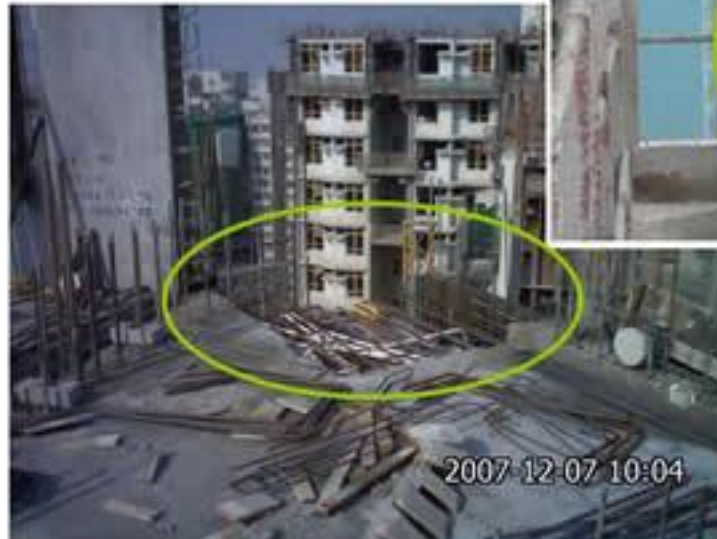
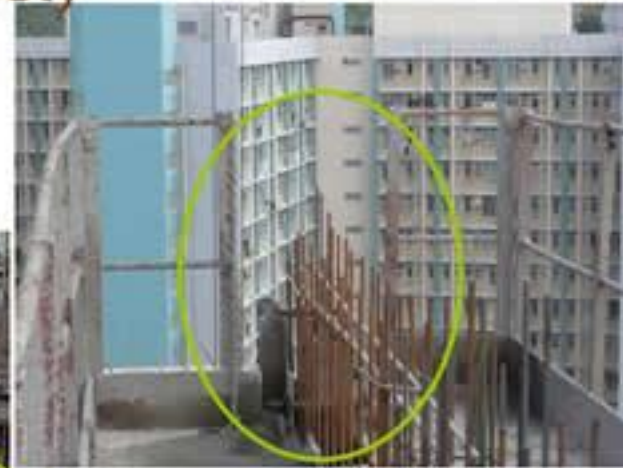
No external railing provided

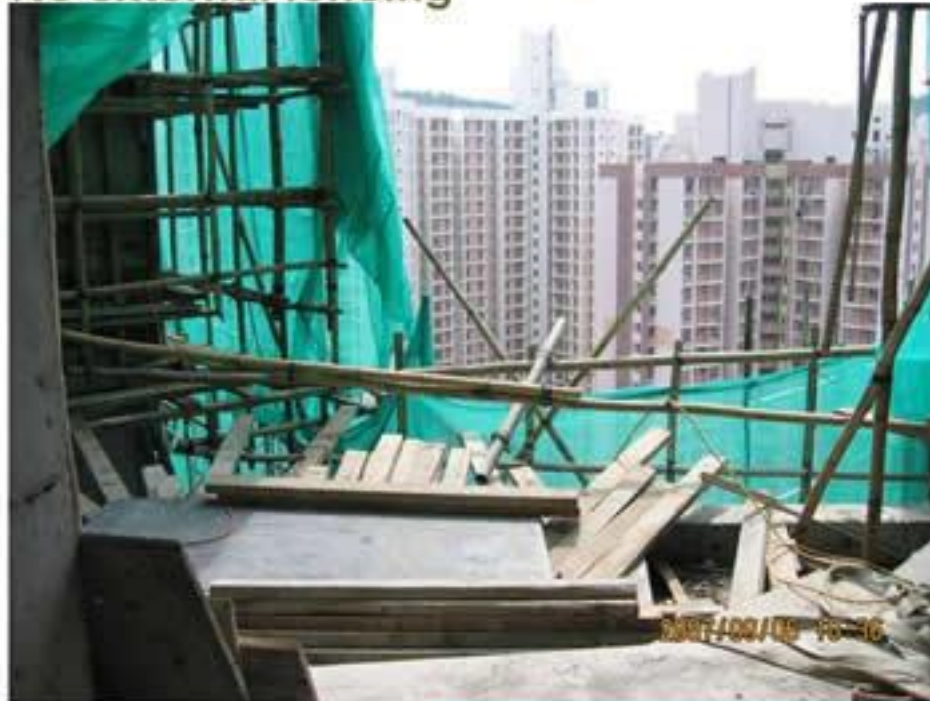
No external fencing

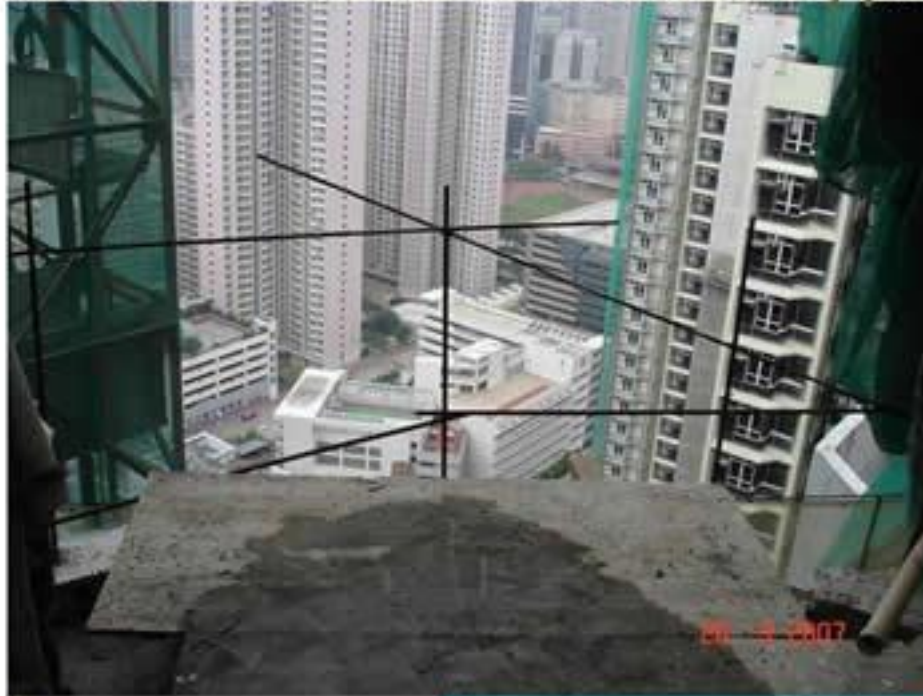
No external fence to material delivery platform

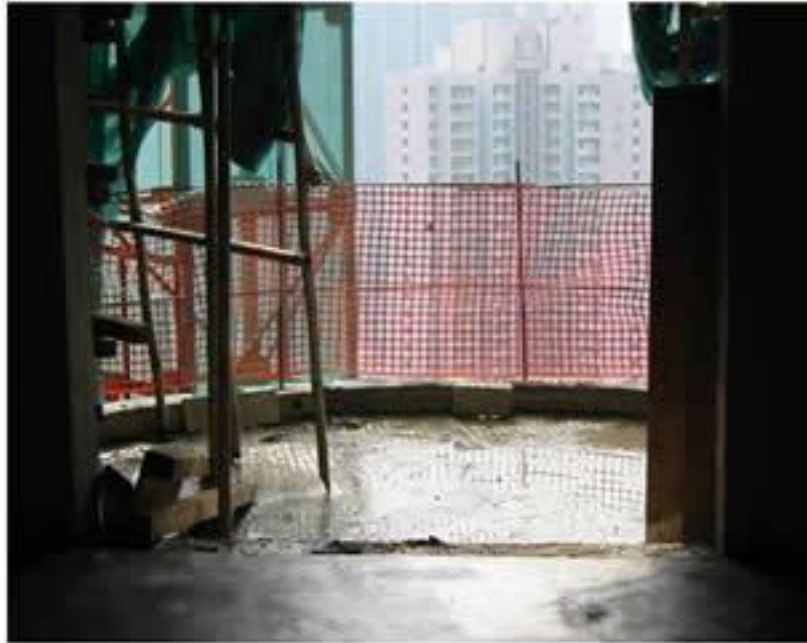
External fence provided but NOT acceptable

Suggest to require contractor's Method Statement of Material Delivery to ensure safety

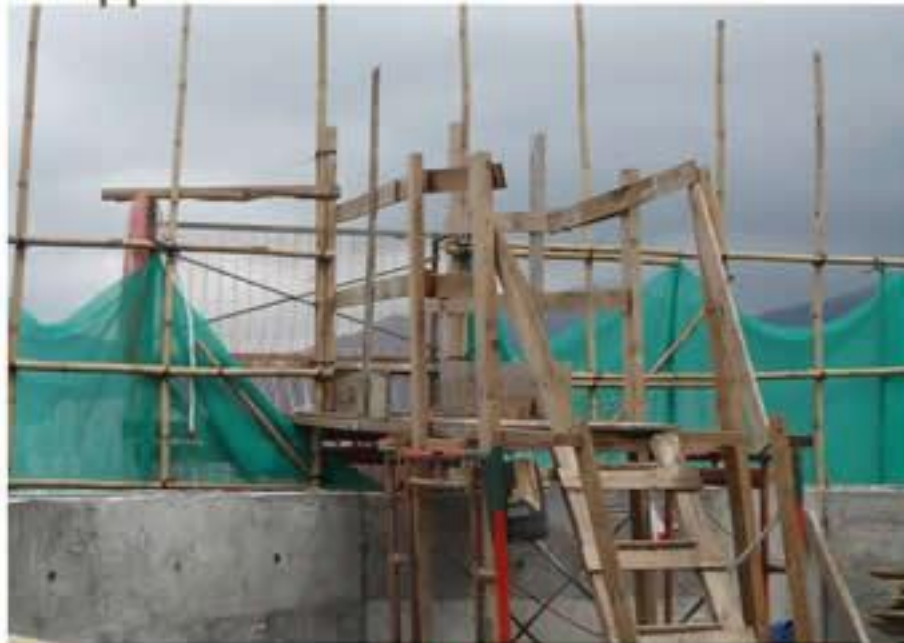
Insecure access walkway from main roof to upper roof

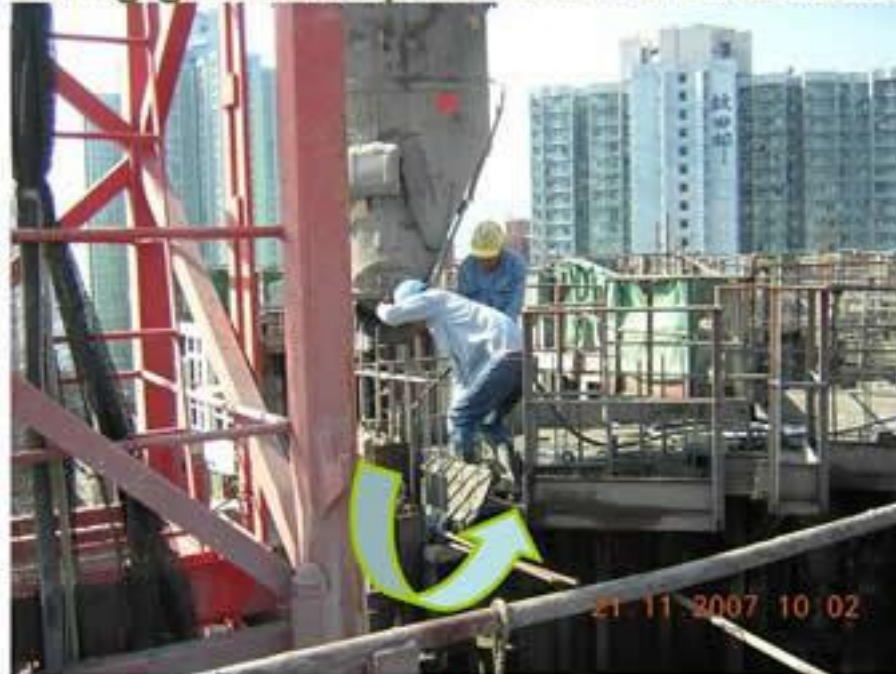
Swing gate left open for ease of concreting

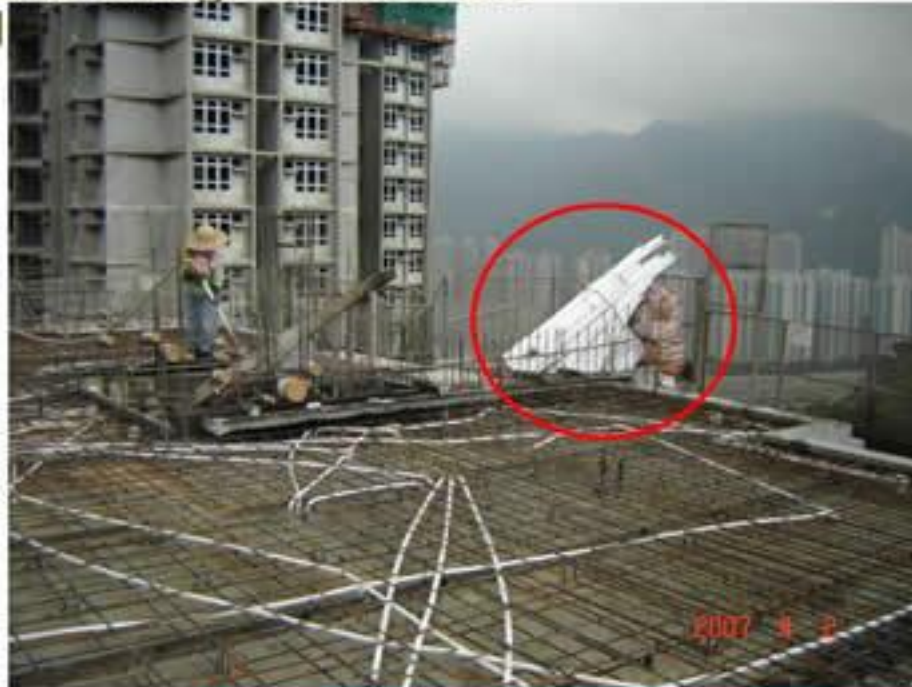
PVC conduits & bags of materials stockpiled

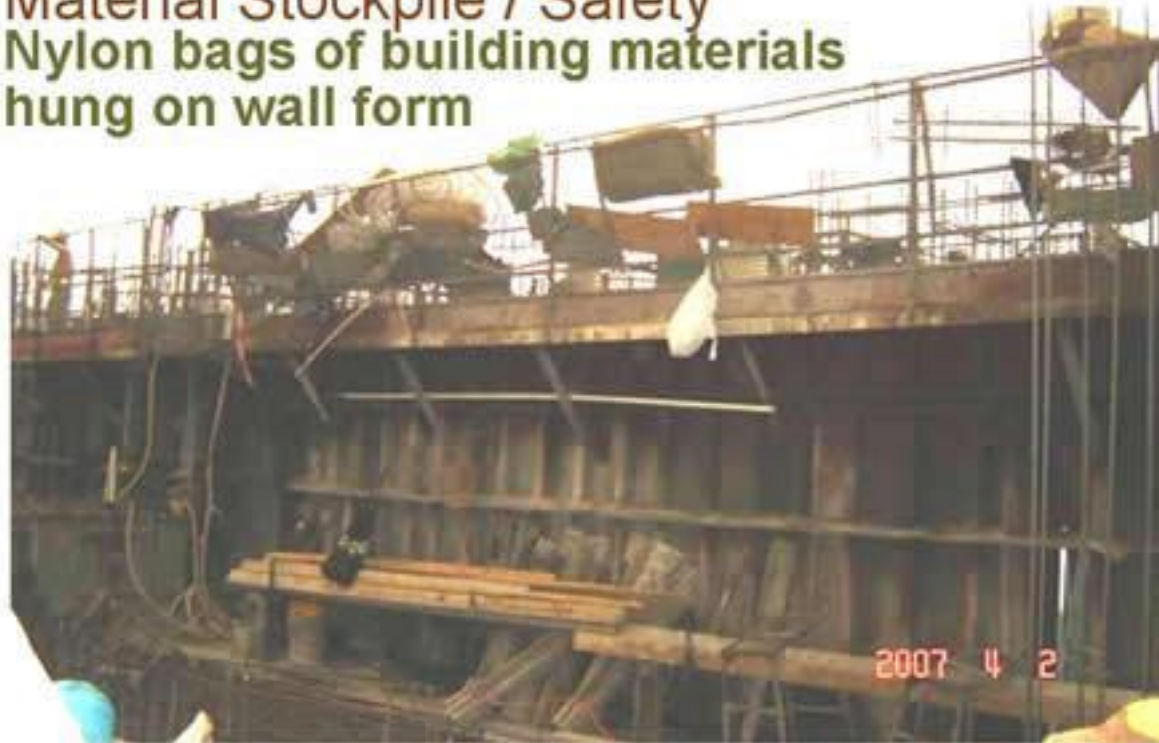
[CON2.W110.4]

Material Stockpile / Safety Nylon bags of building materials hung on wall form

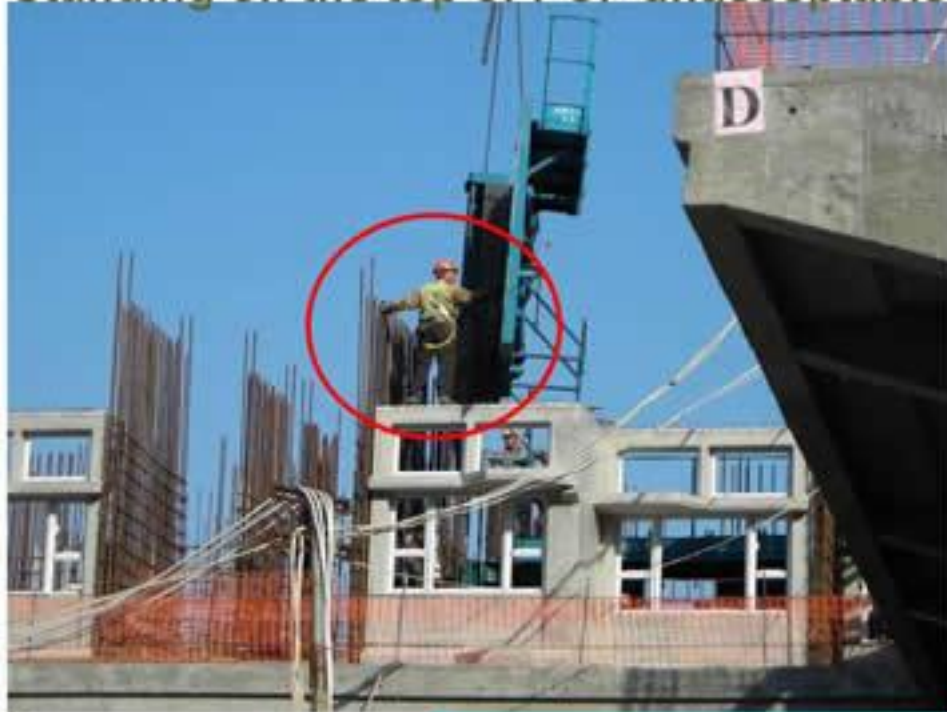
Standing on the top of PCF unacceptable

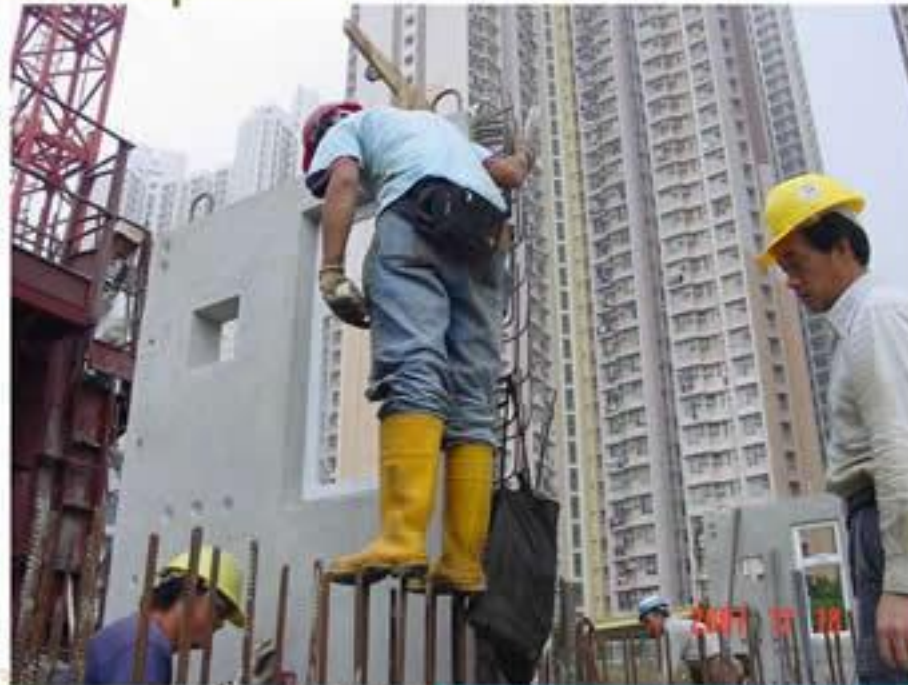
Standing on the top of the steel bars was unacceptable

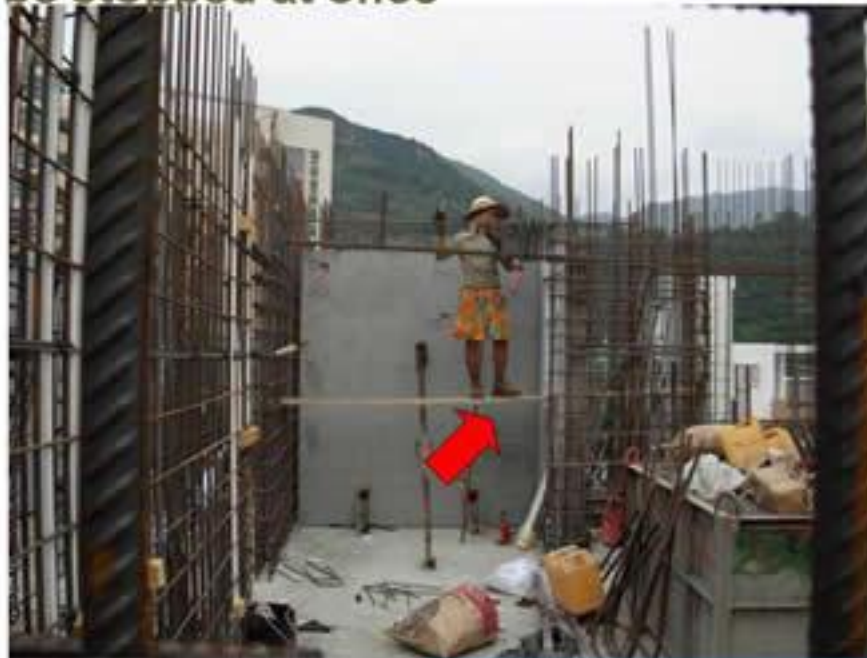
Using timber plank as working platform should be stopped at once
