# SCAFFOLDING

## Scaffolding Support / Safety

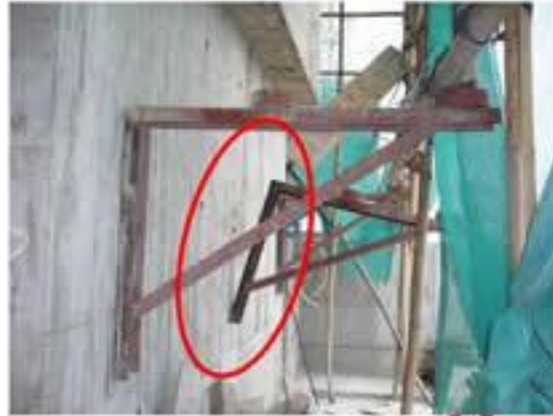
Supporting bracket for roof water tank scaffold  
NOT fixed properly

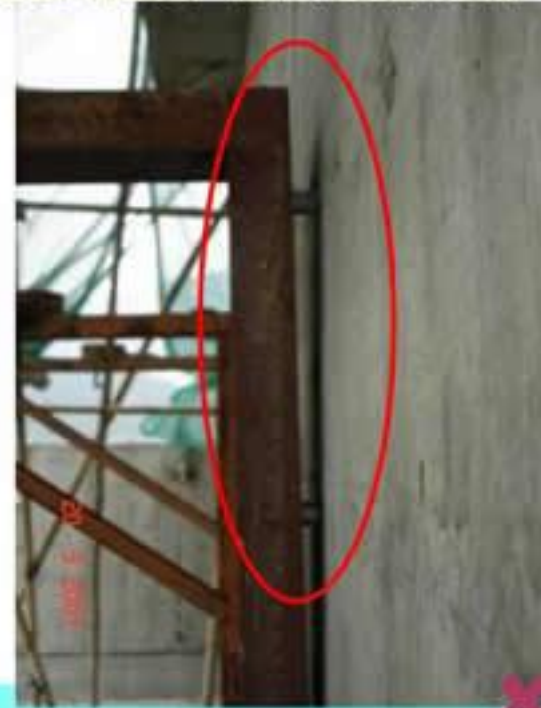
Supporting bracket  
detached from structure

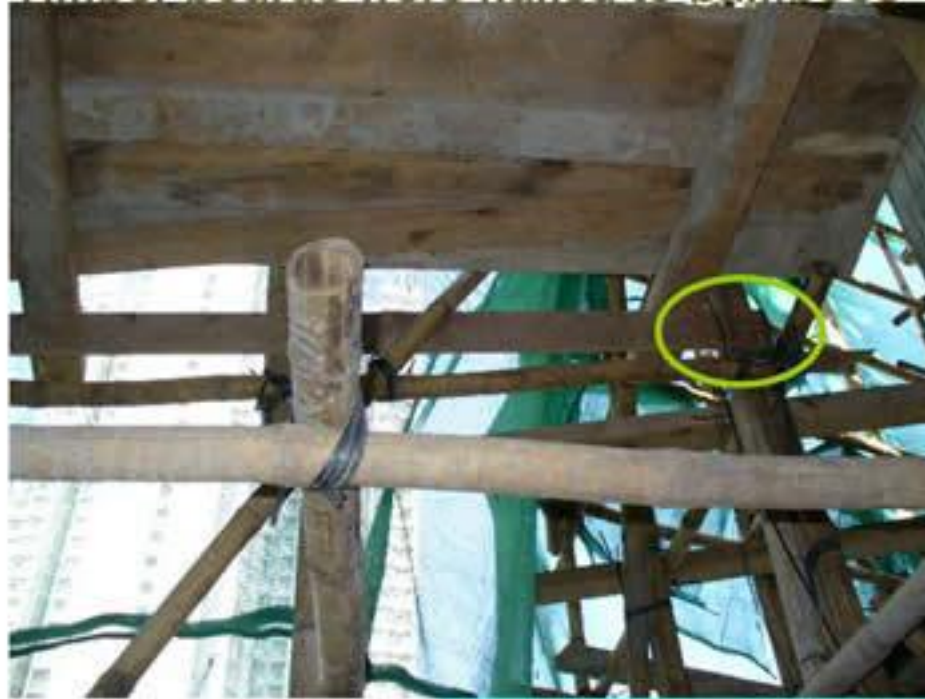
Timber boards were nailed to bamboos

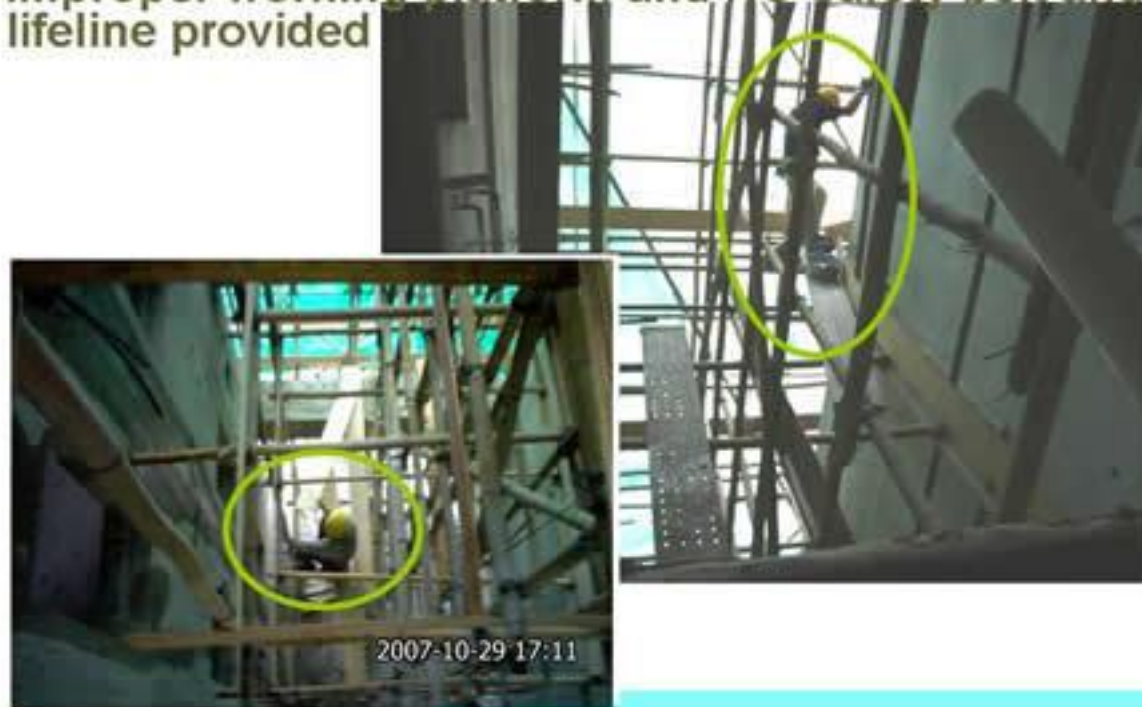
Improper working platform and NO safety belt and lifeline provided

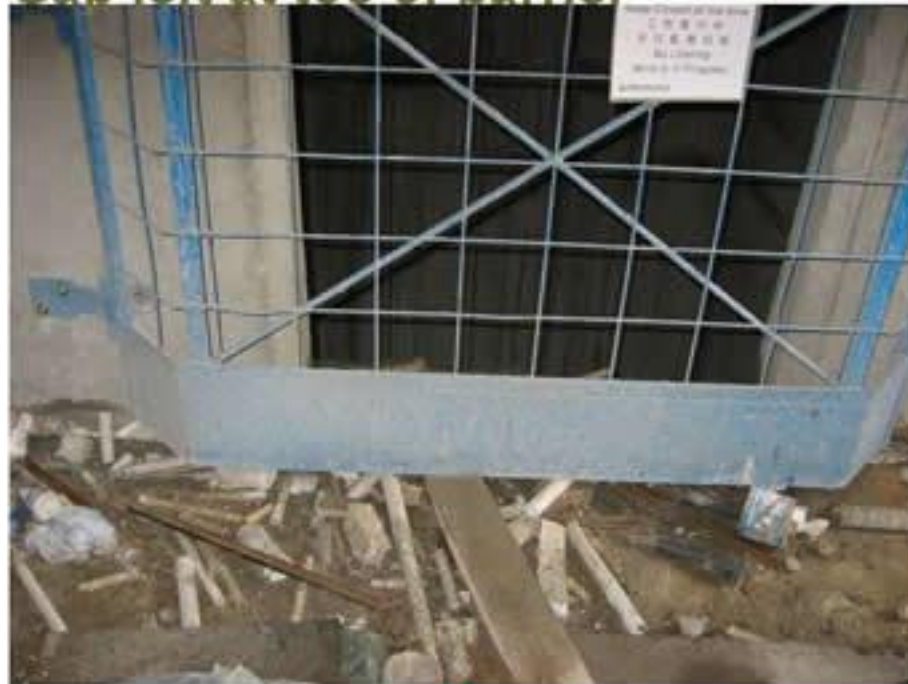
### Gap left at toe of barrier

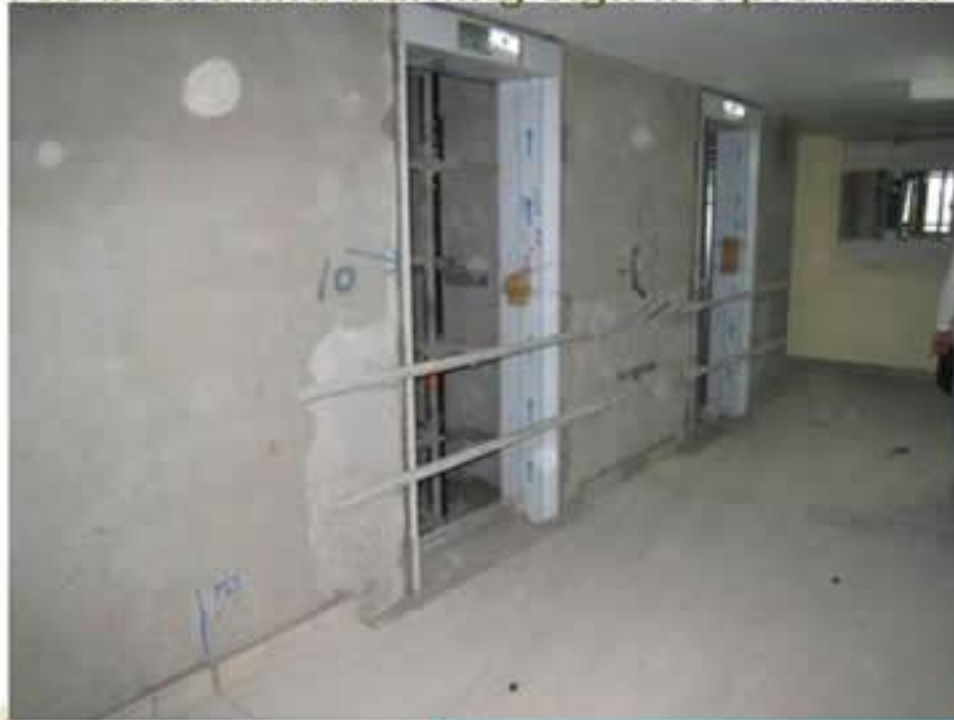
Toe board and warning sign not provided

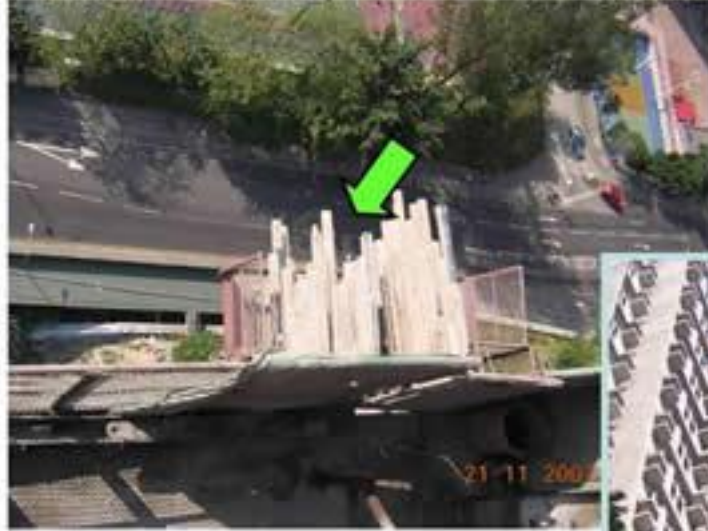
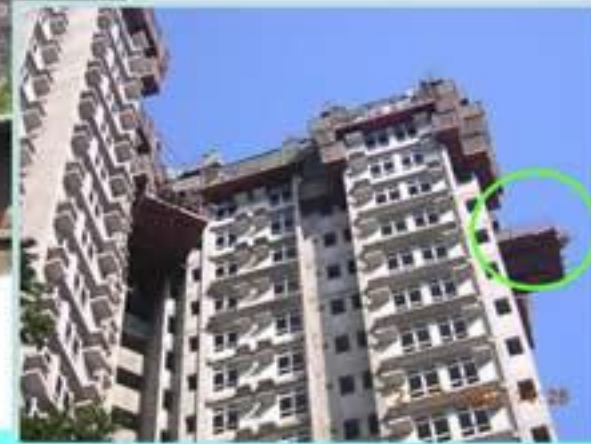
## Platform over public road without end gate

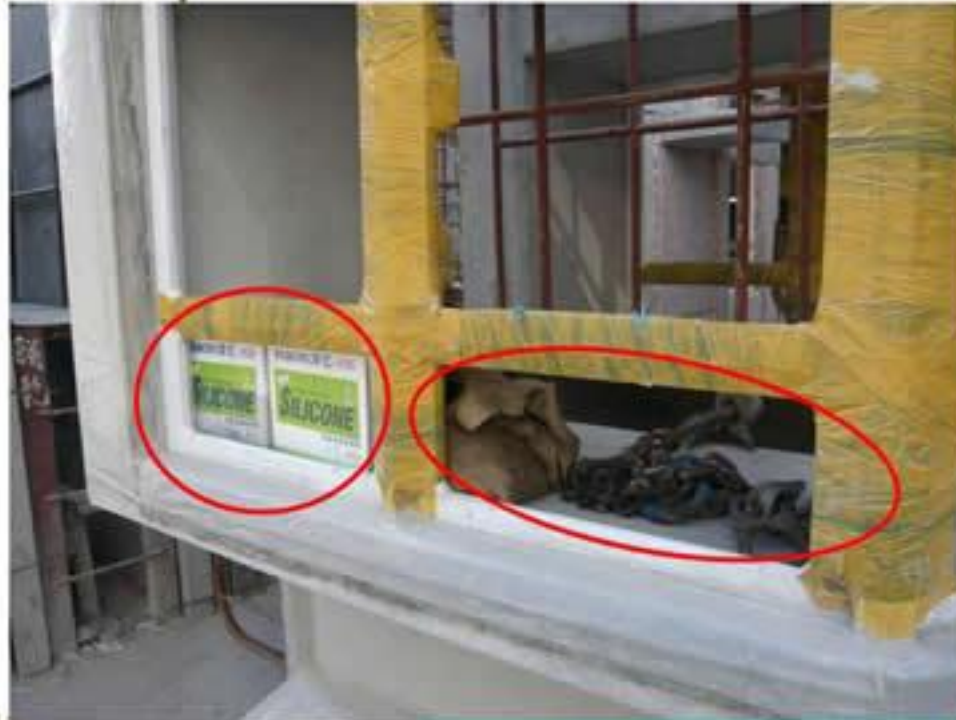
## NOT to put other materials at PCF

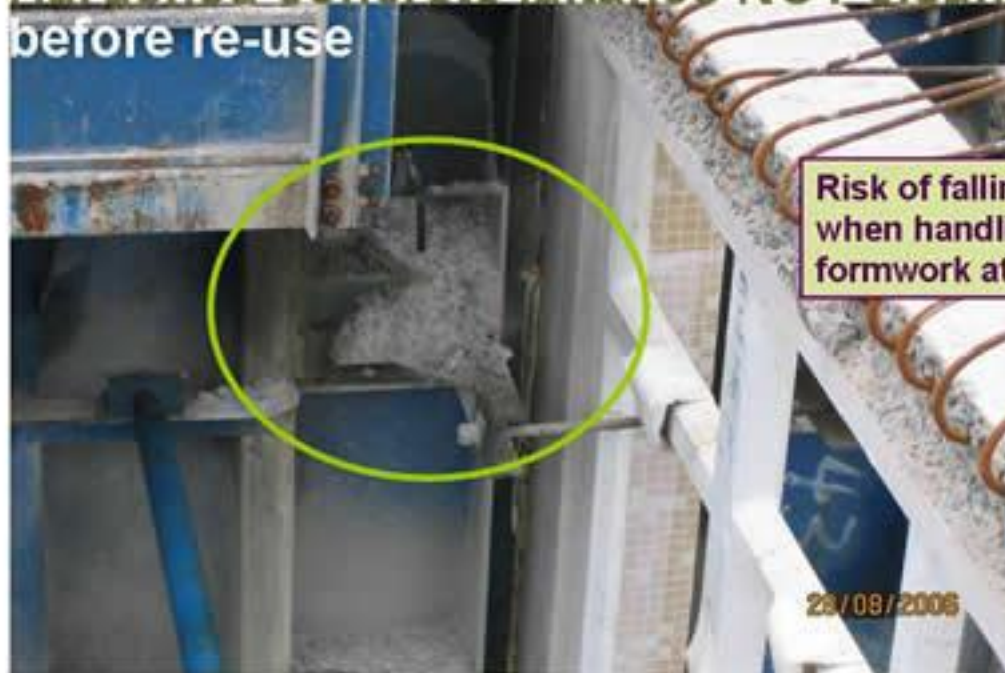
**Hardened concrete laitance NOT cleaned  
before re-use**

**Risk of falling object  
when handling  
formwork at height**

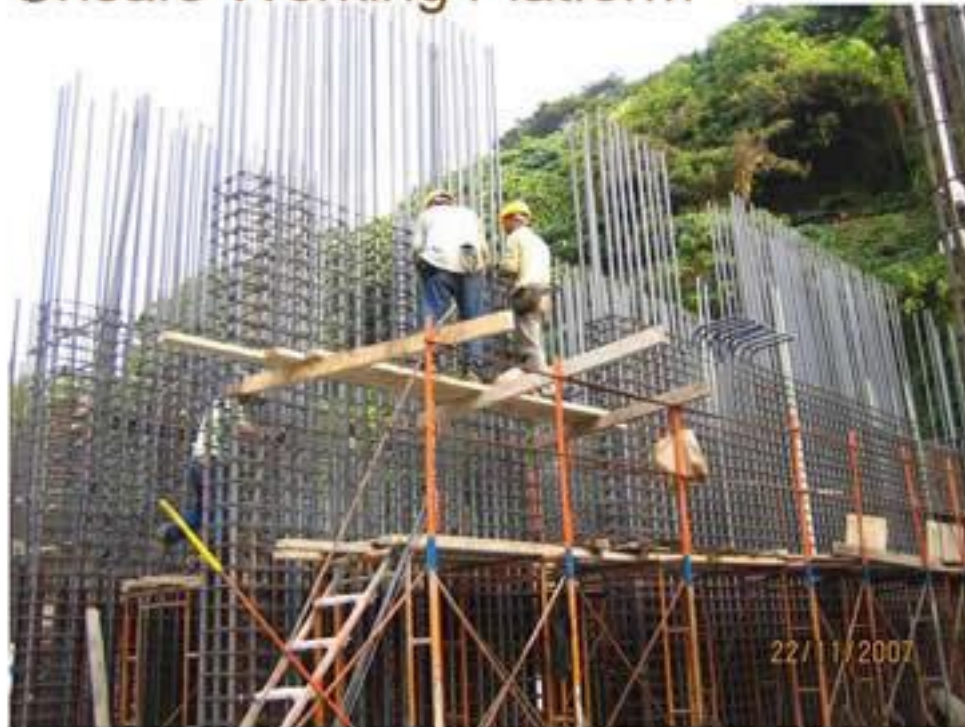
## Unsafe Working Platform

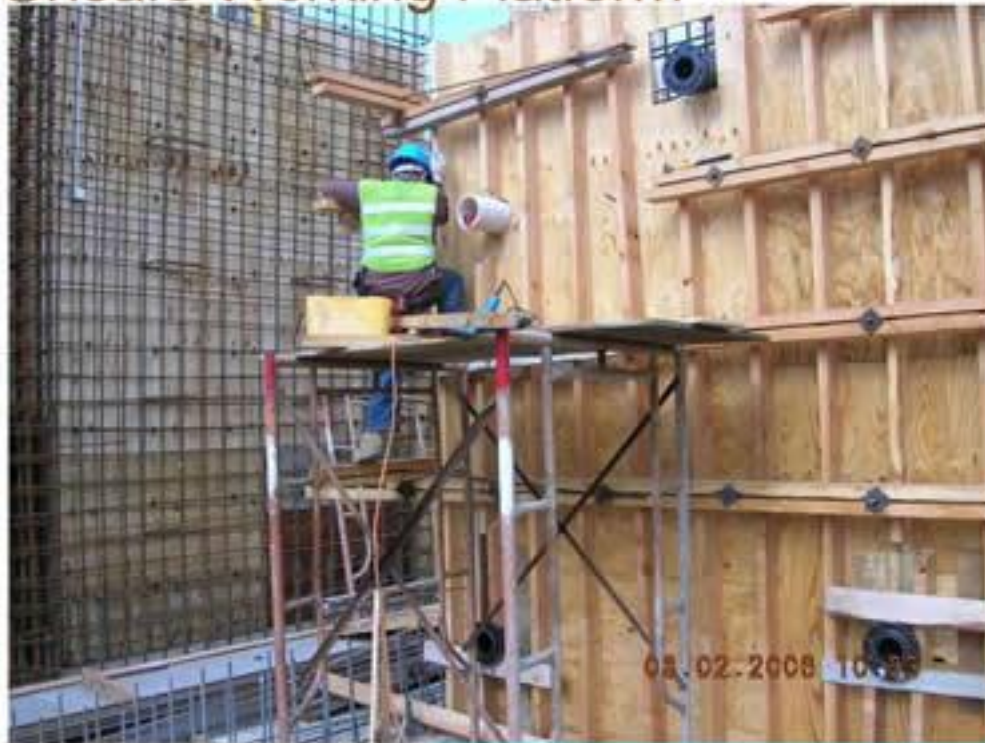
## Unsafe Working Platform

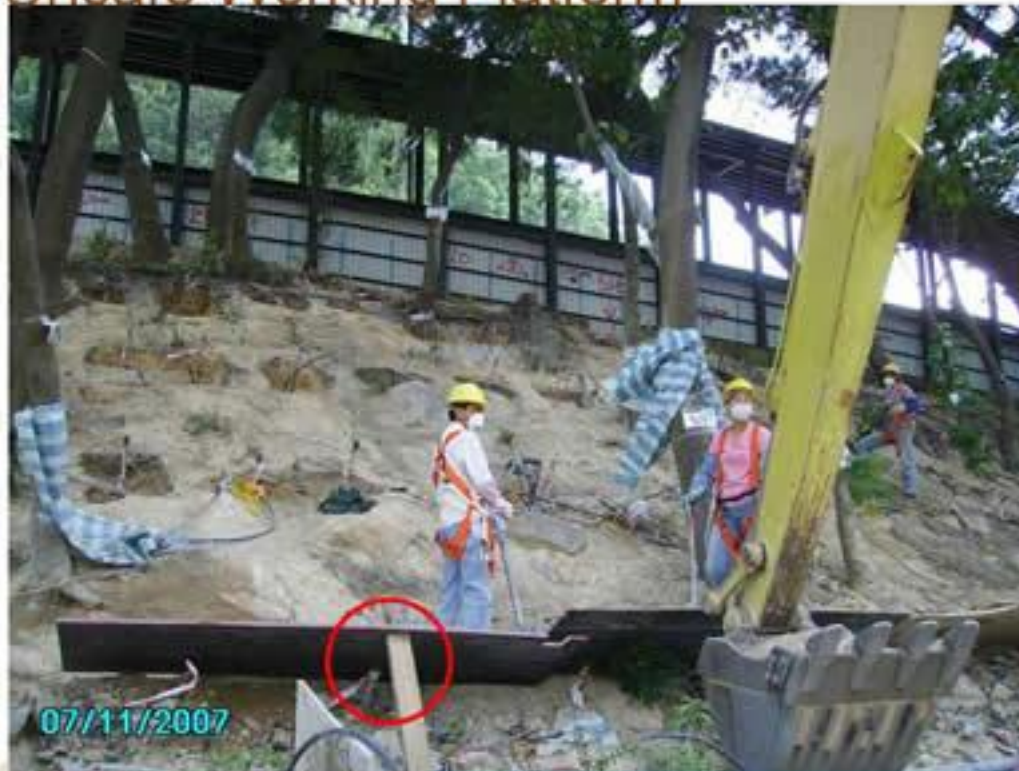
## Unsafe Working Platform

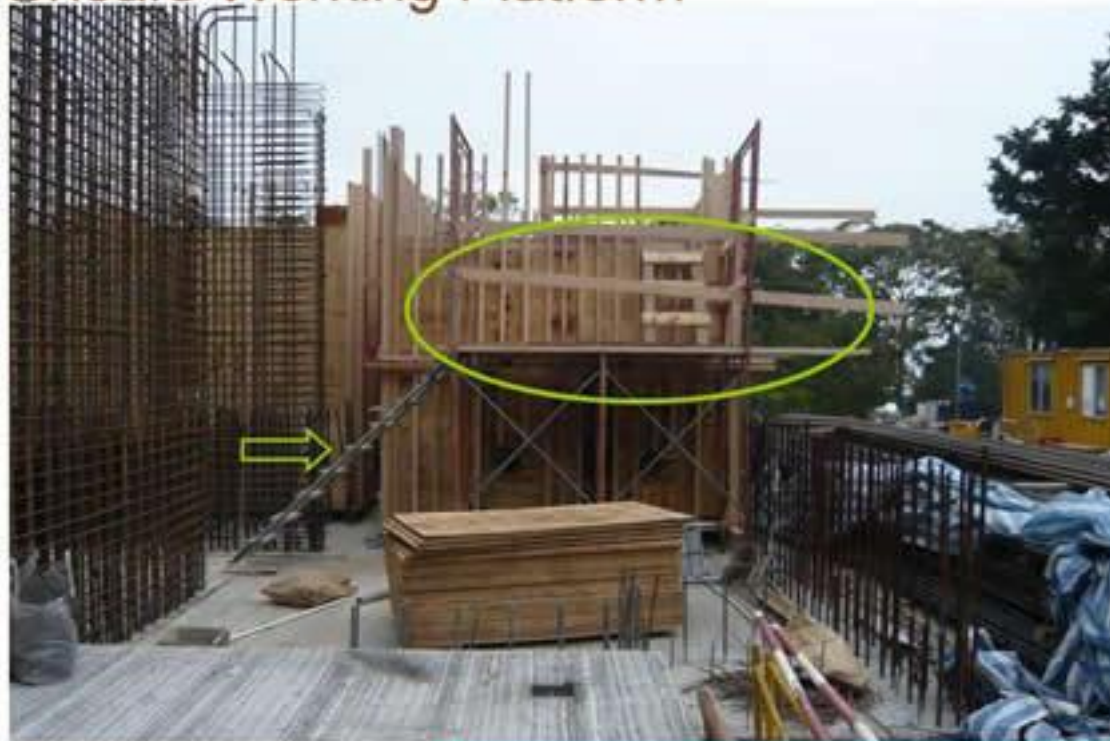
## Unsafe Working Platform

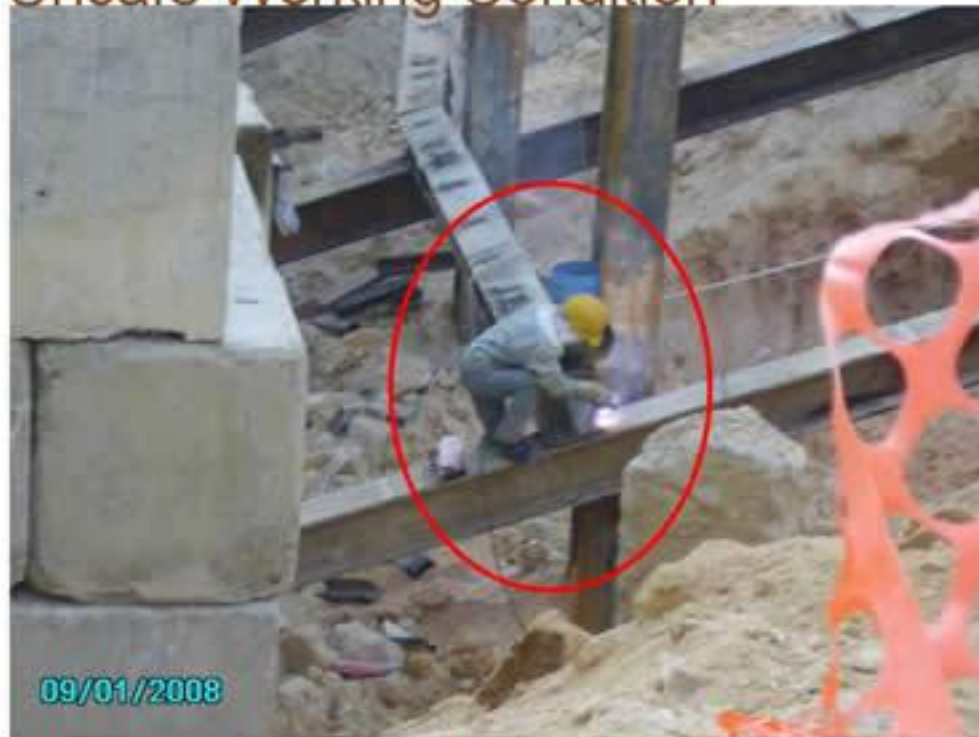
## Unsafe Working Condition

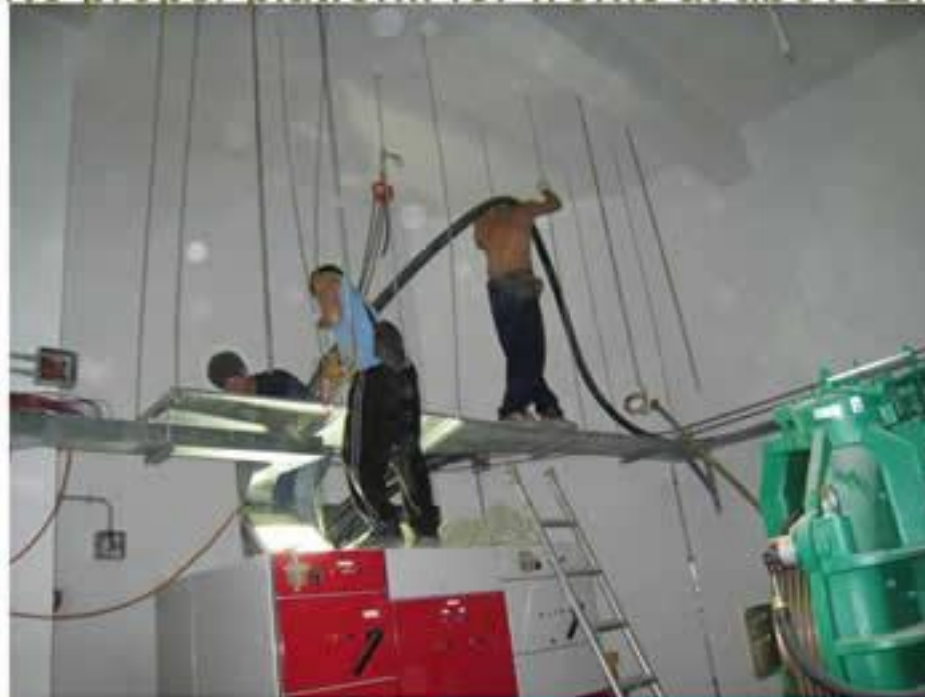
No proper platform for works at above 2m high

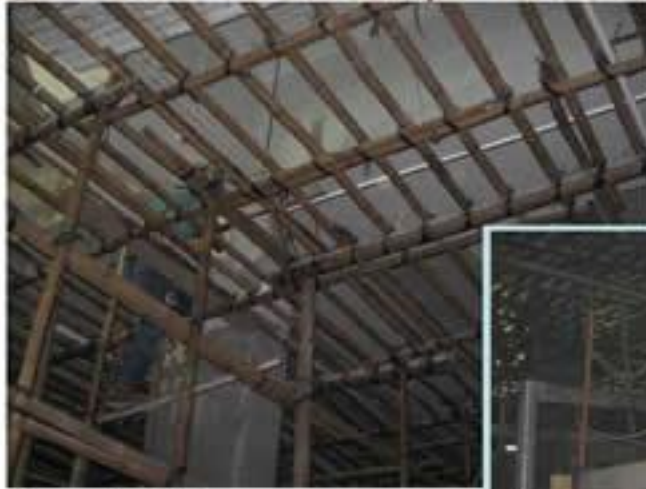
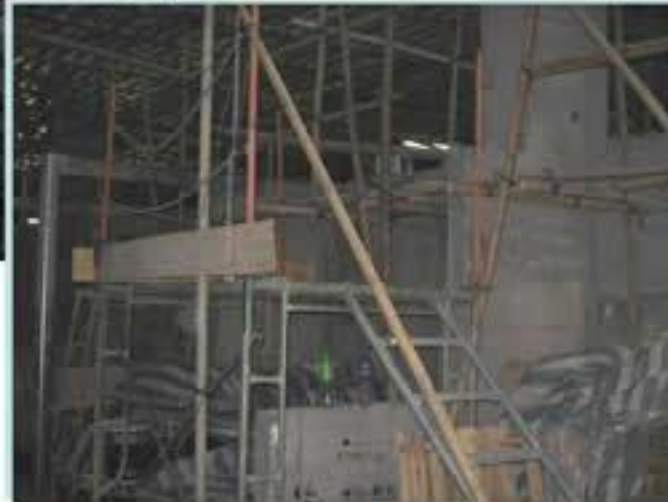
## Unsafe Working Platform

No planking

No railing

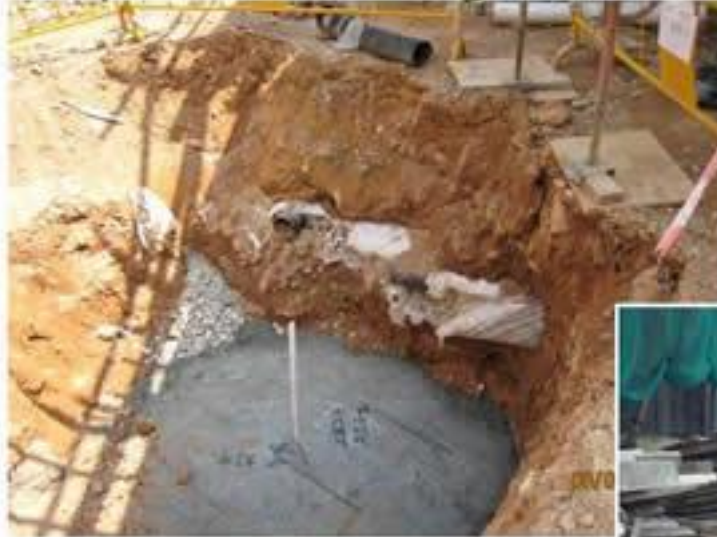
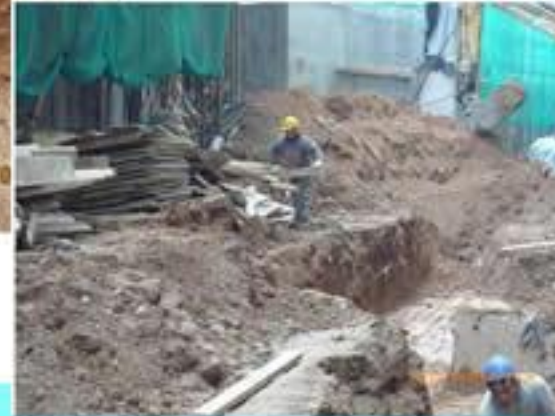
### No protection to edge of excavation

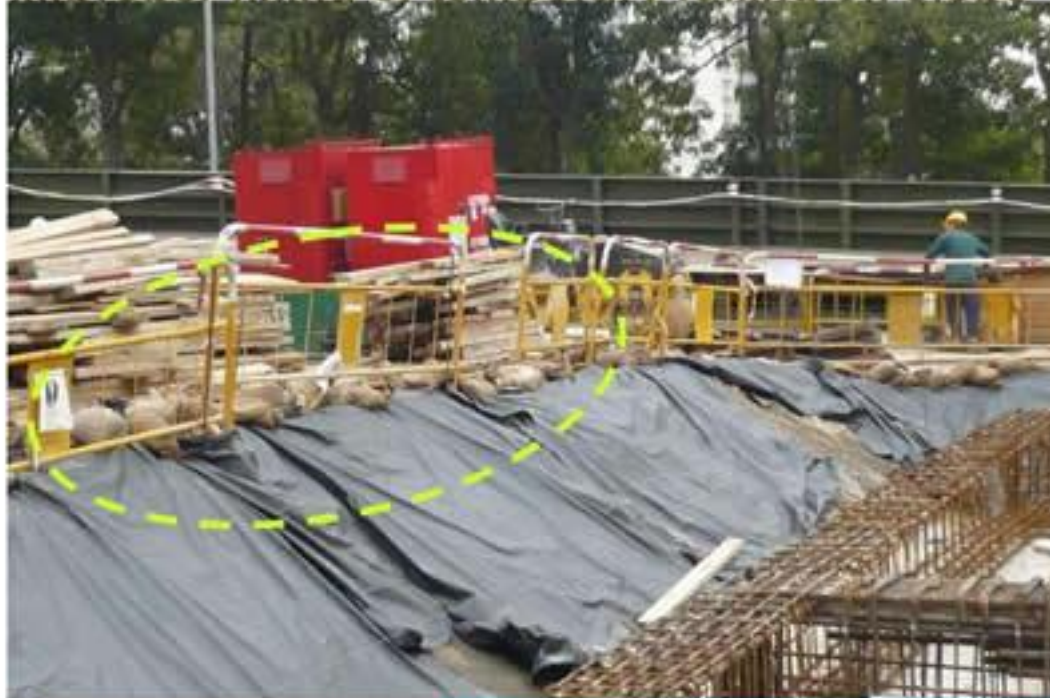
### Improper fixing of temporary railing on slope

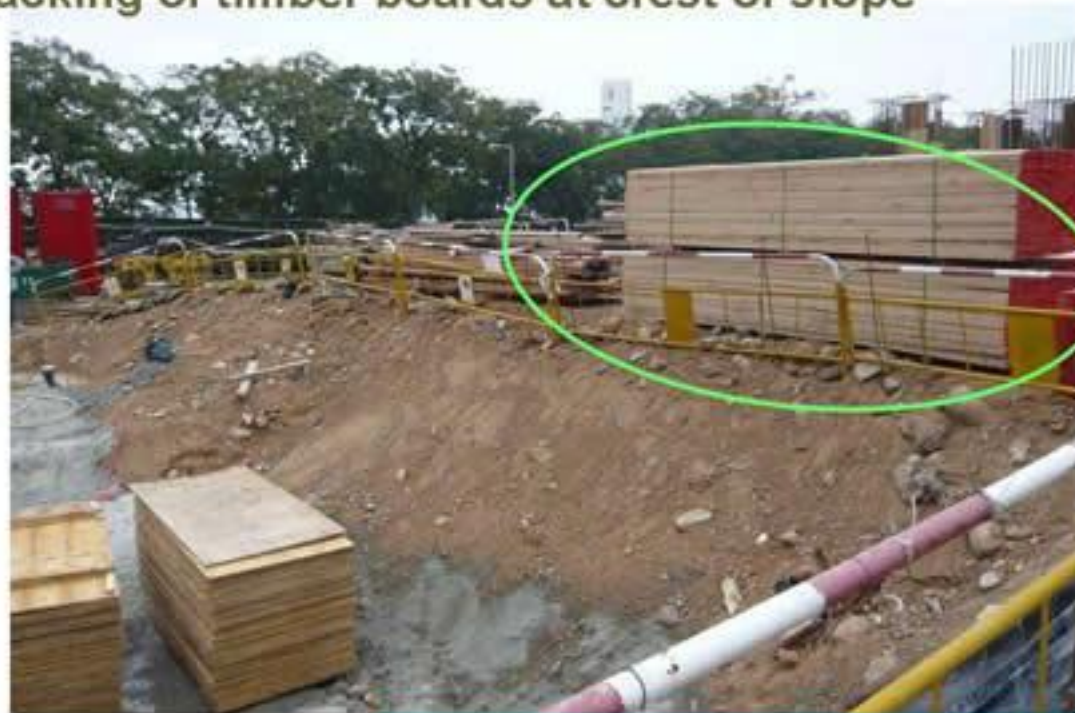
### Stacking of timber boards at crest of slope

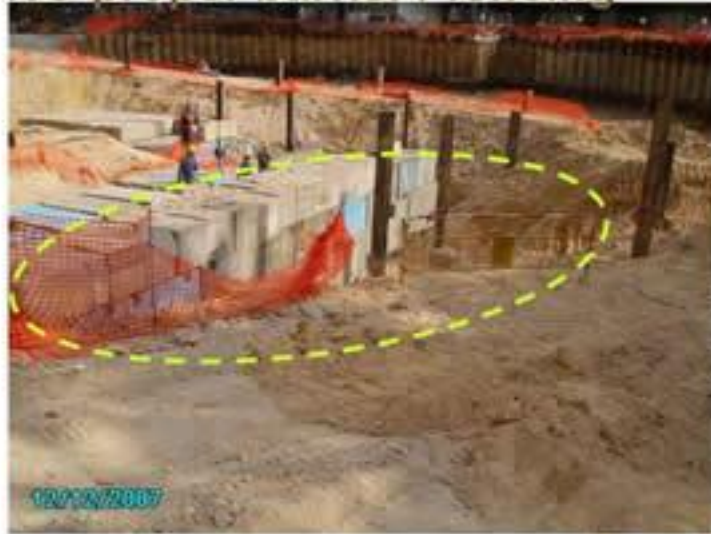
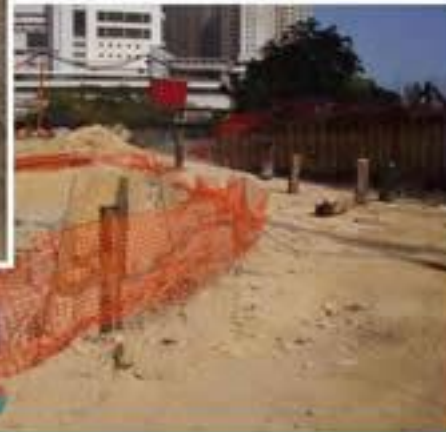
NO proper barrier / fencing

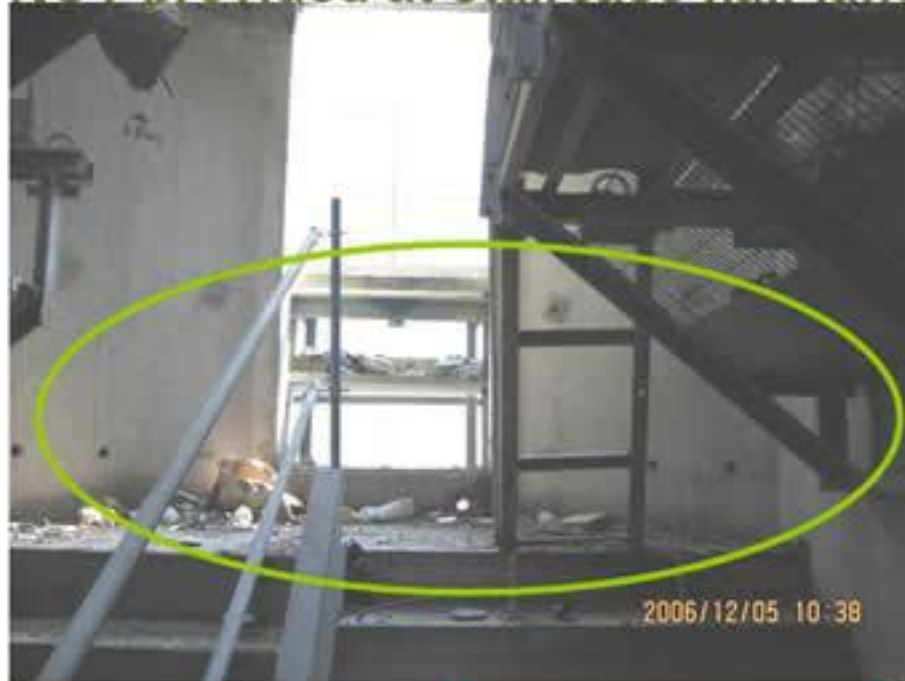
# Protective Railing to Slab Edge NOT provided at staircase half landing

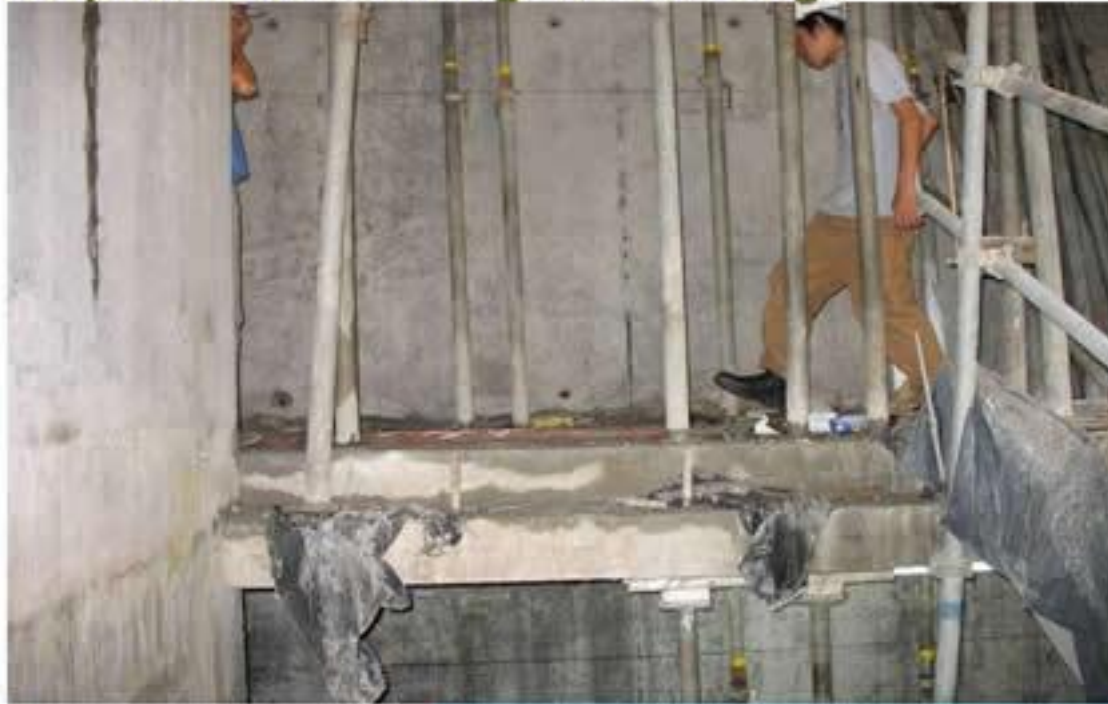
## Site Safety no protective railing at slab edge

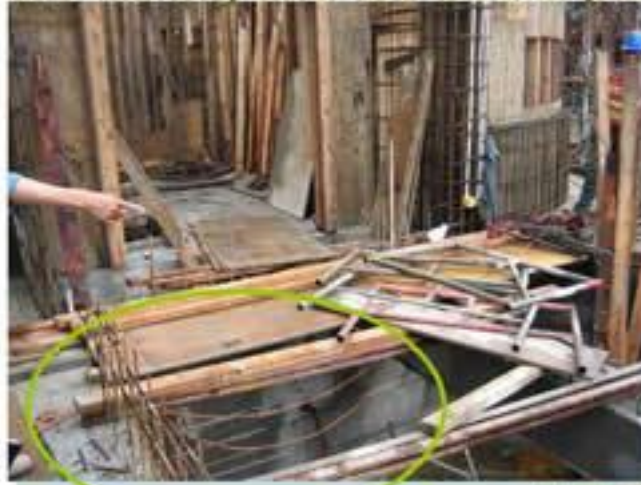
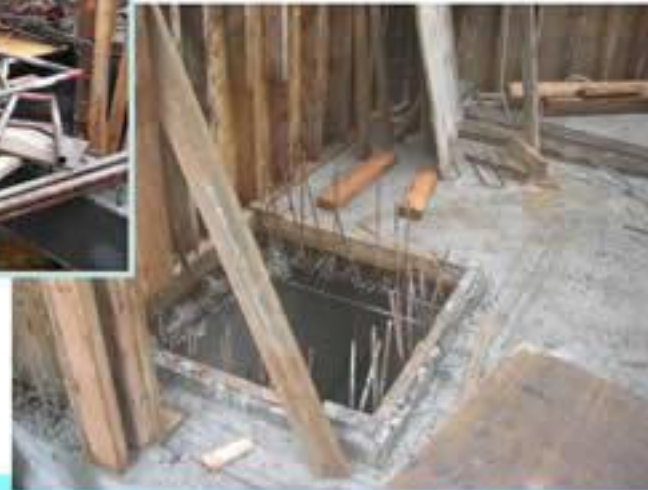
NO railing and toe board provided

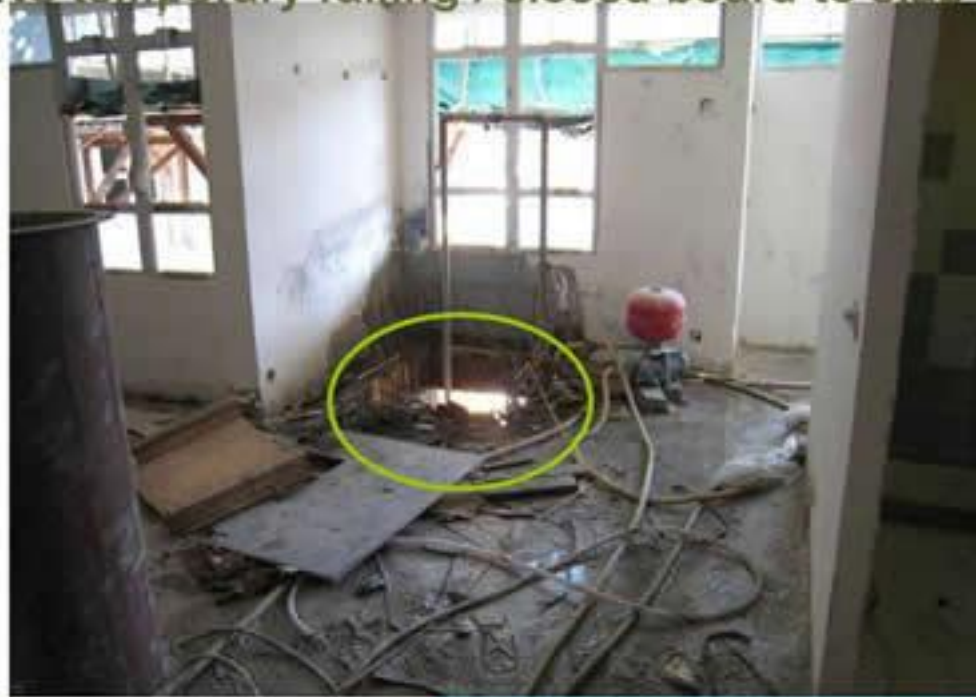
No temporary railing / closed board to slab opening

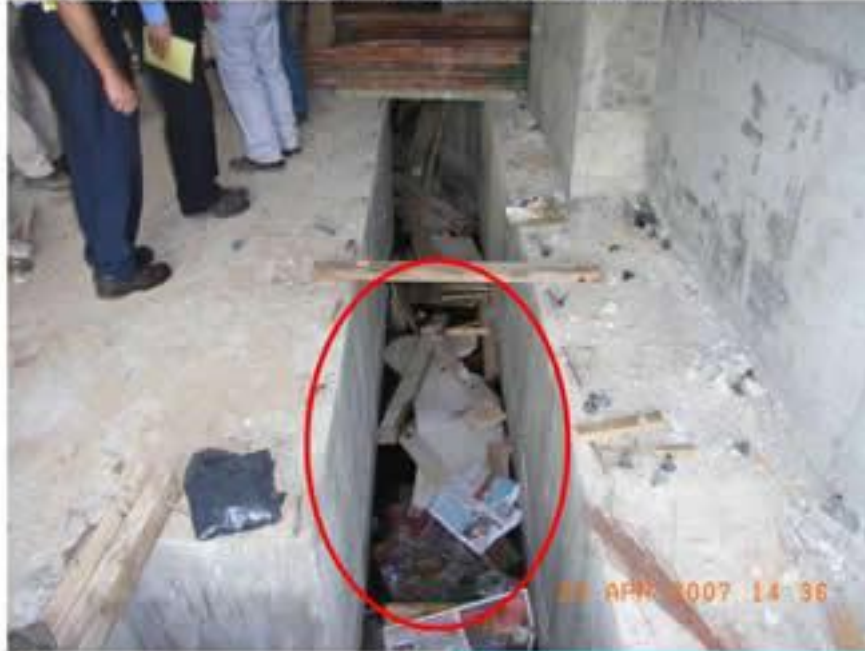
The trench was not covered up properly by timber boards or other suitable material

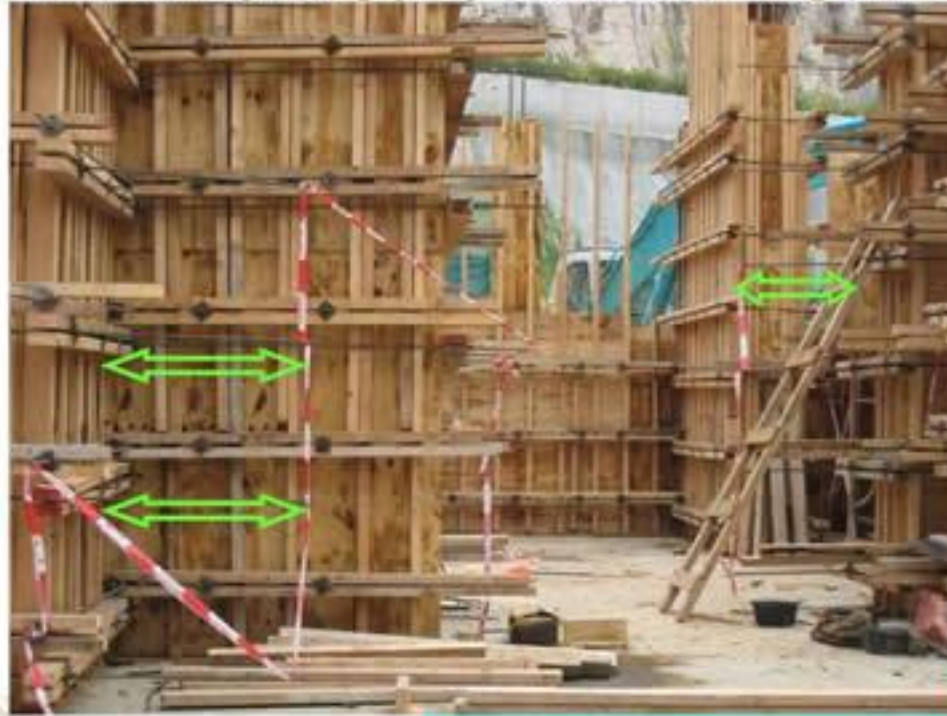
Excessively long projection / endanger workers

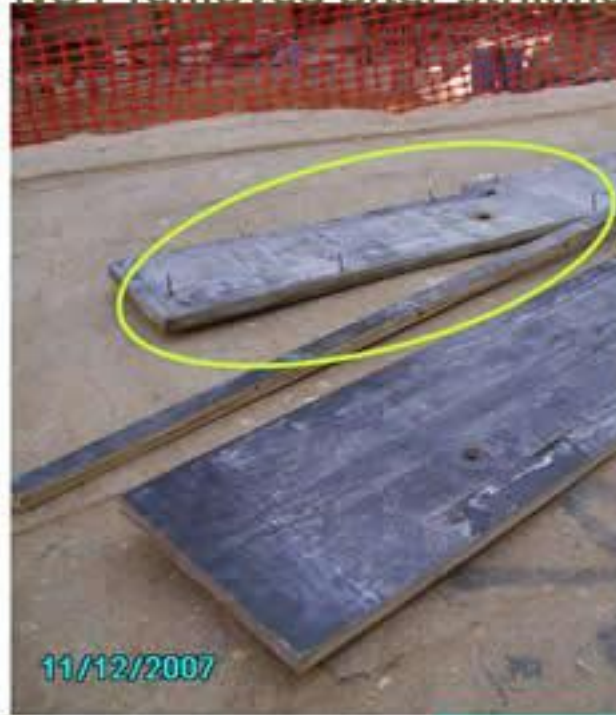
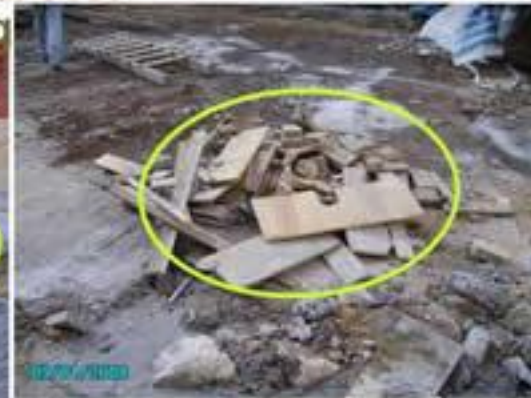
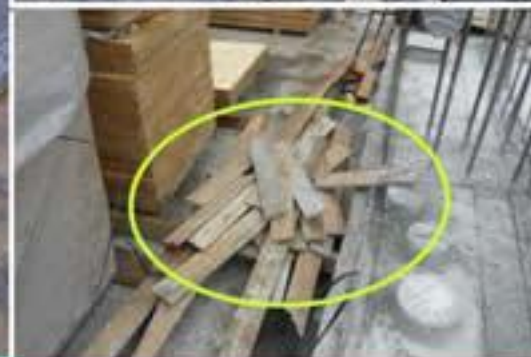
# Nails on Timber Formwork NOT removed after striking

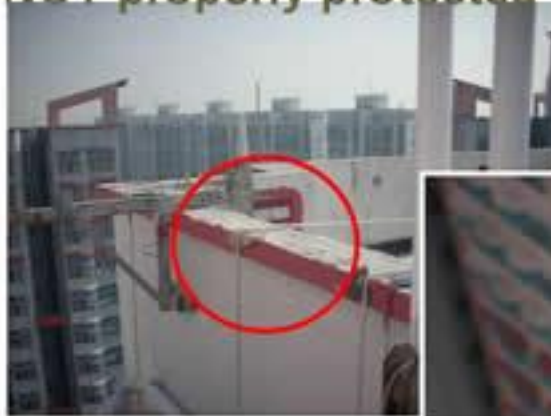
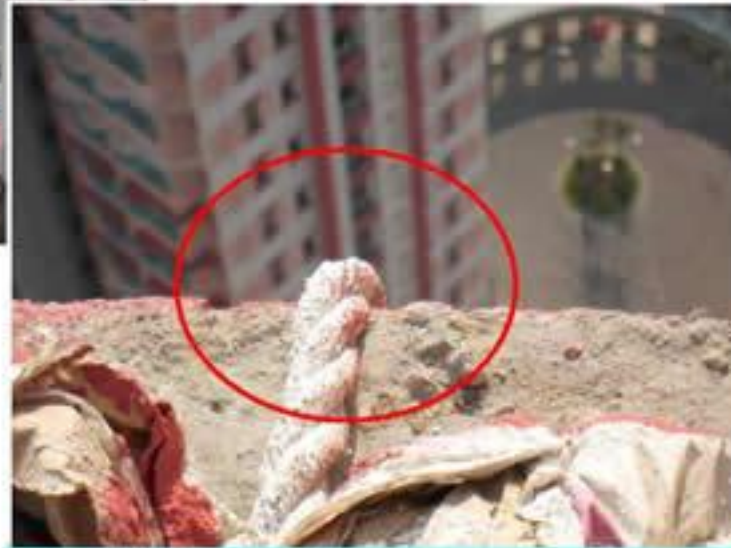
## Gondola Wire / Safety NOT properly protected

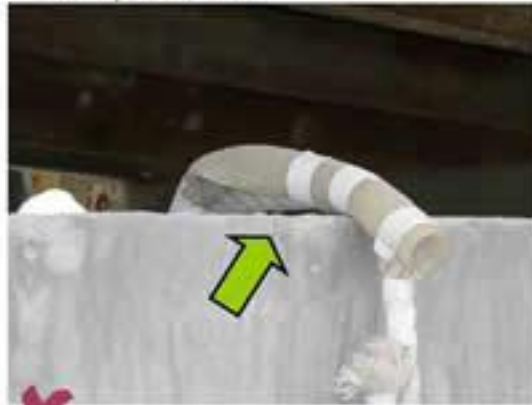
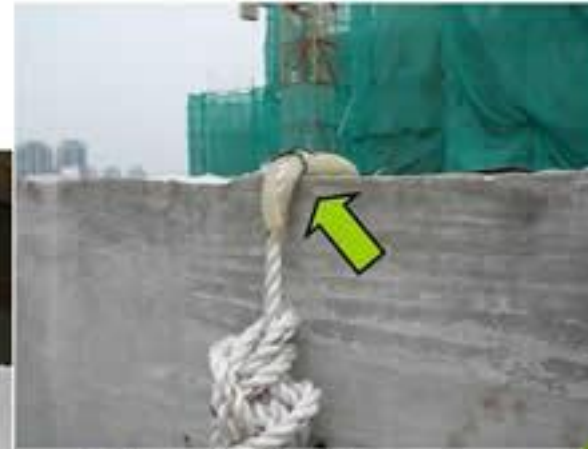
### Protective rubber wrong way installed

Cut end of tubing  
not protecting  
the wire from the  
sharp corner

Cut end of tubing  
facing upwards  
can protect  
the wire from the  
sharp corner

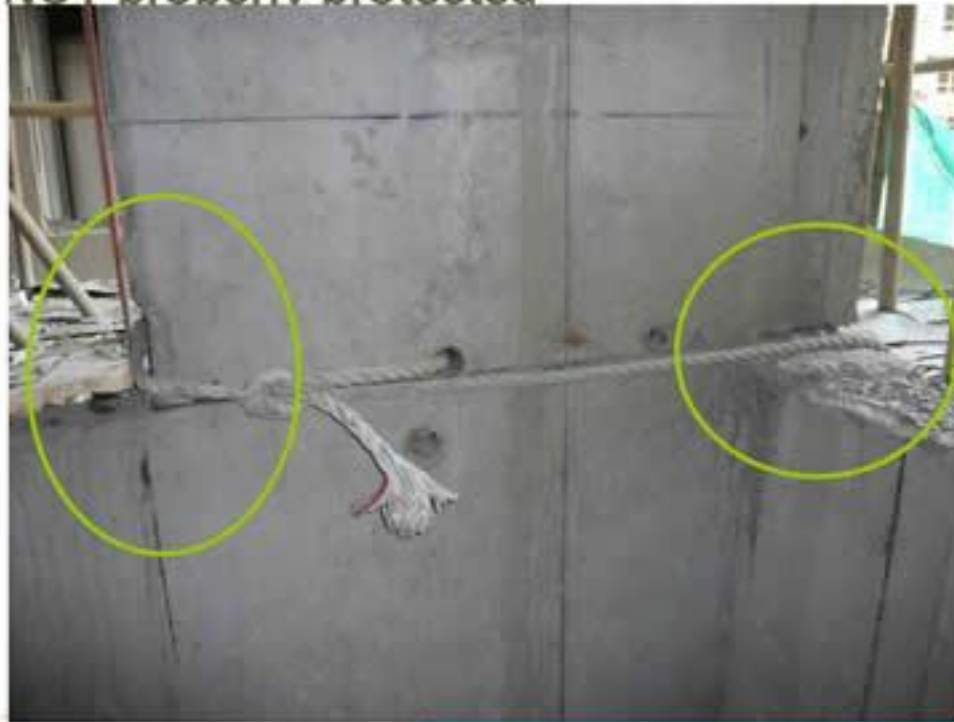
# Safety Lifeline NOT properly protected

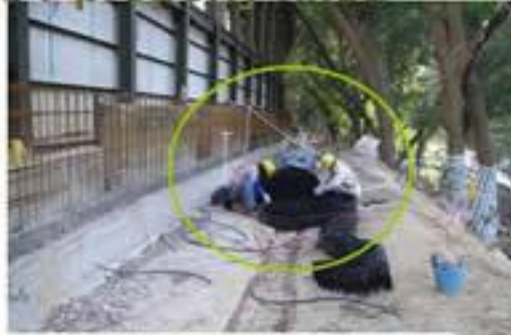
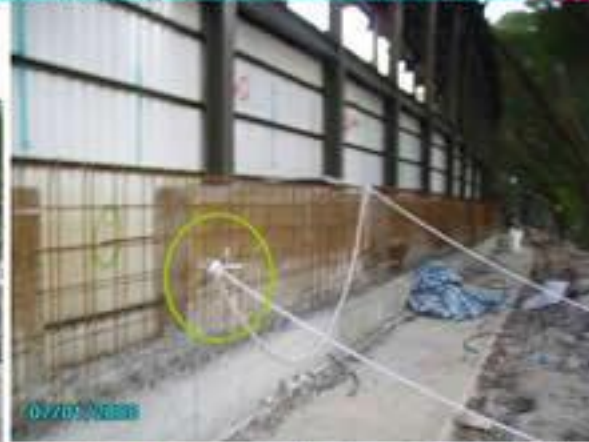
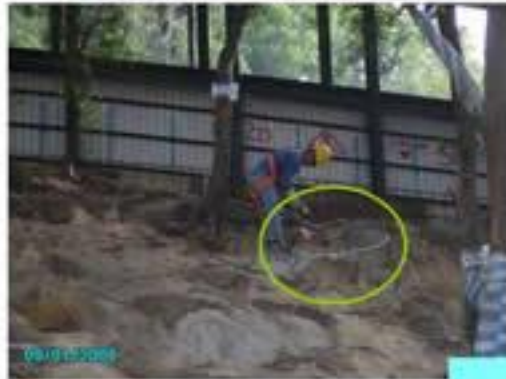
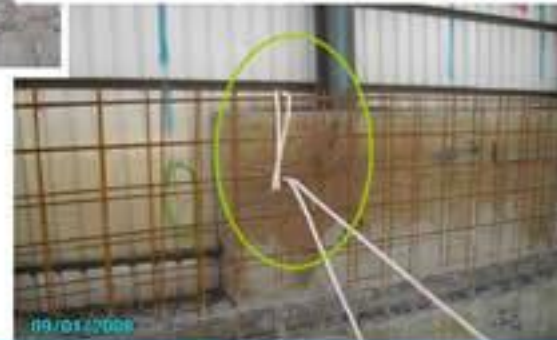
# Safety Lifeline NOT properly fixed

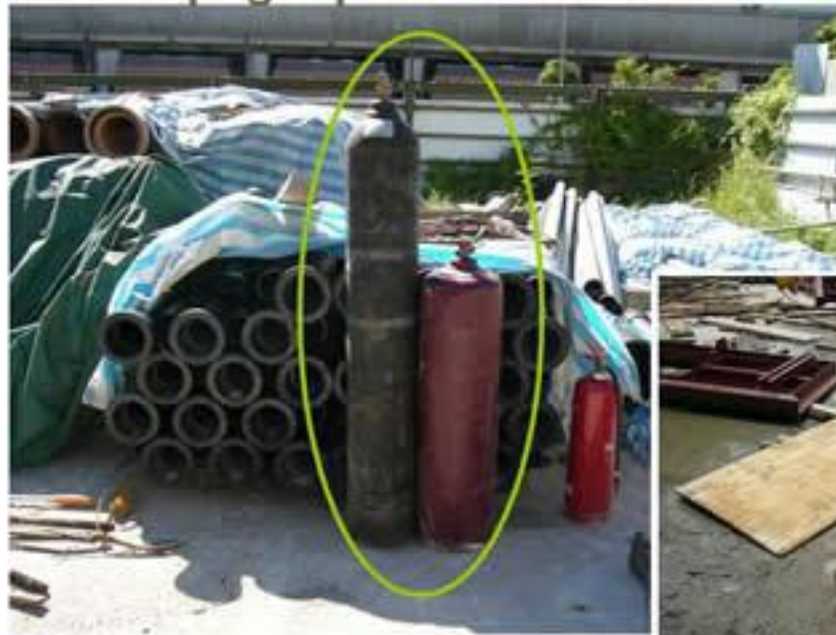
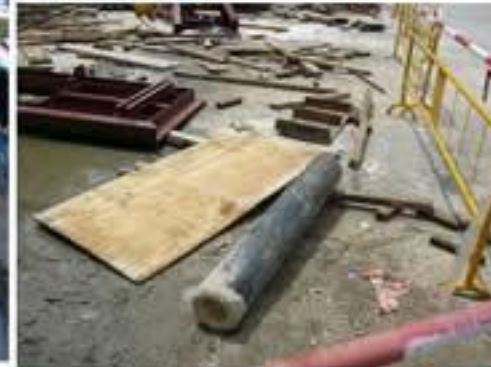
## Protection to Dangerous Materials

The gas cylinders to be kept locked and at upright position at all time

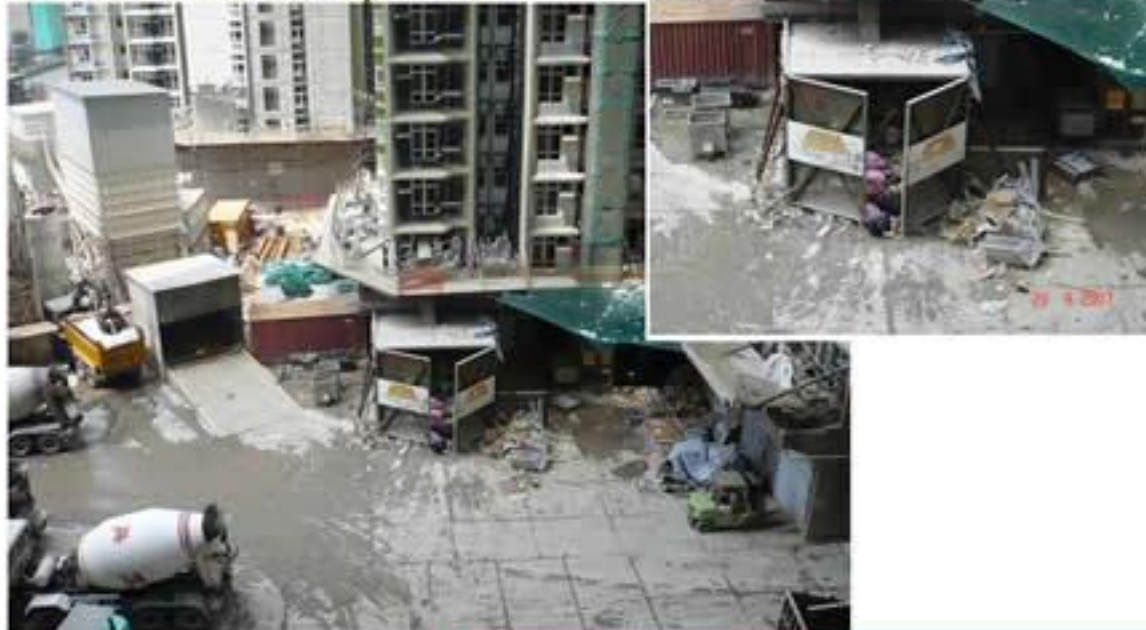
Metal door of debris discharge point at G/F  
unlocked and opened

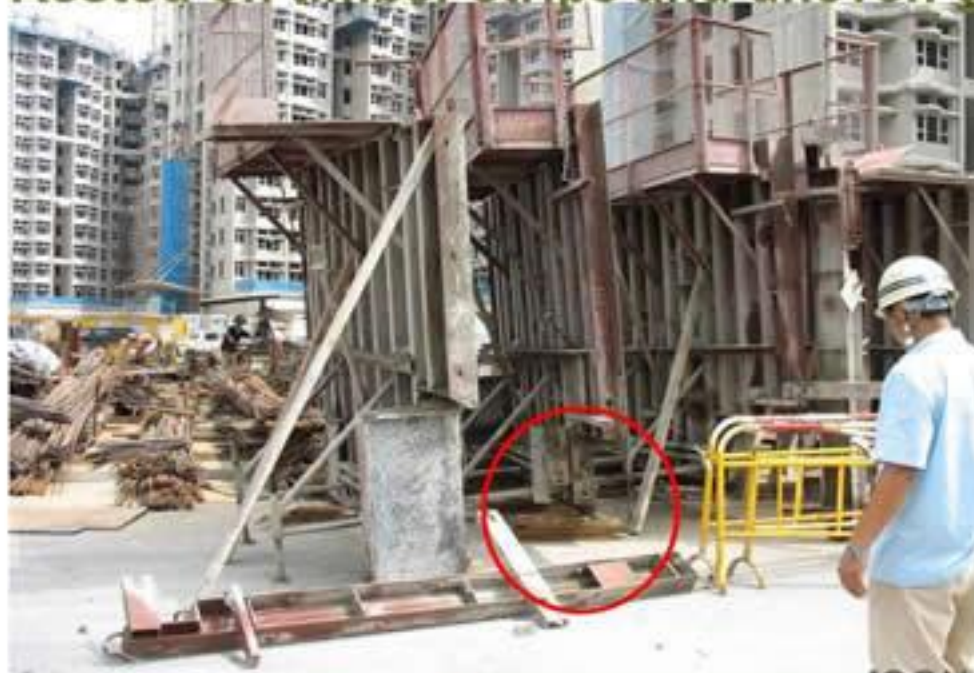
## Storage of Large Panel Formwork Rested on timber strips and uneven ground
