# SCAFFOLDING

## Scaffolding Support / Safety

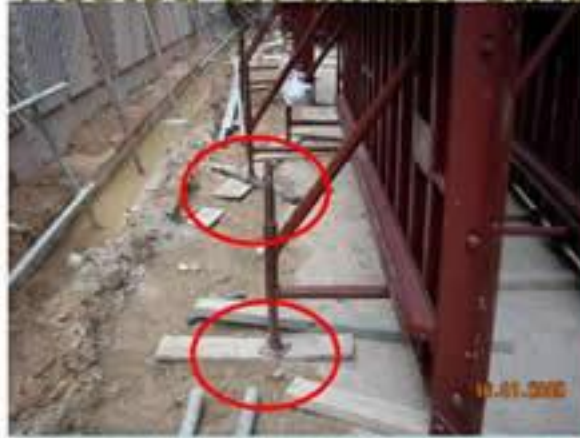
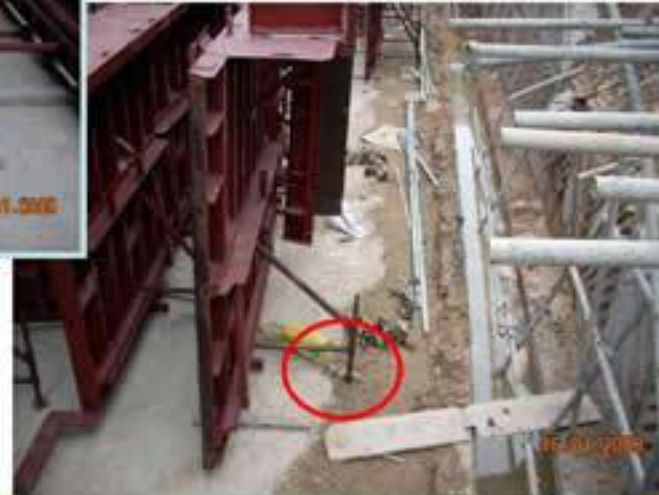
## Storage of Large Panel Formwork Rested on timber strips and uneven ground

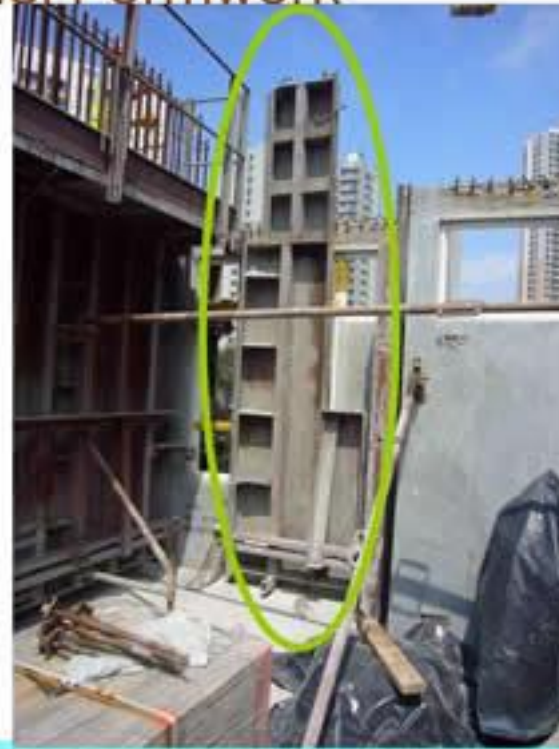
A large panel formwork was found loosely lean on a precast facade causing danger to nearby workers

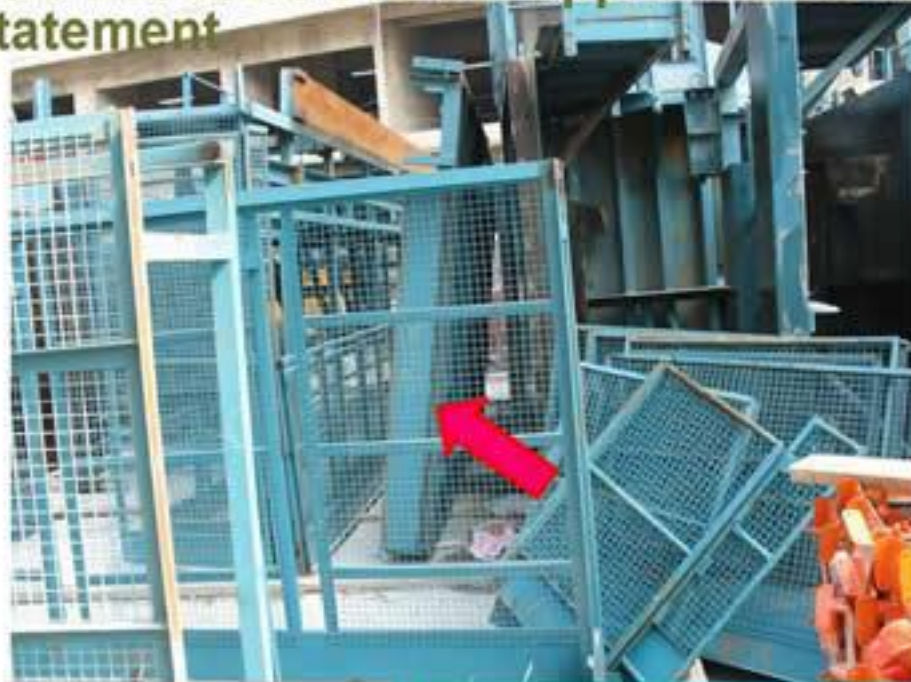
One not stored to the approved method statement

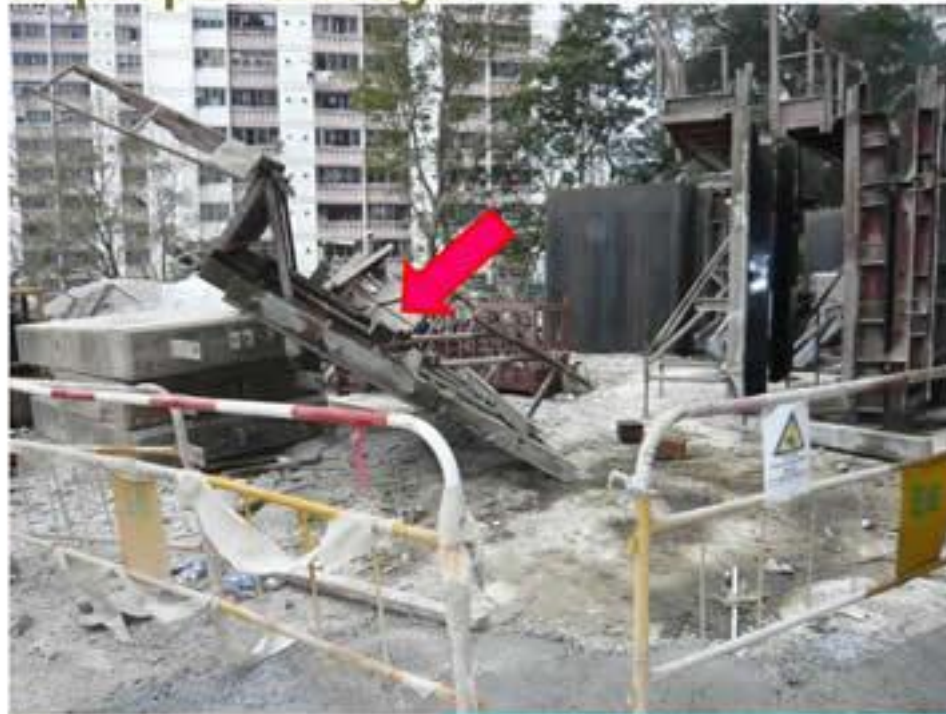
### Improper storage

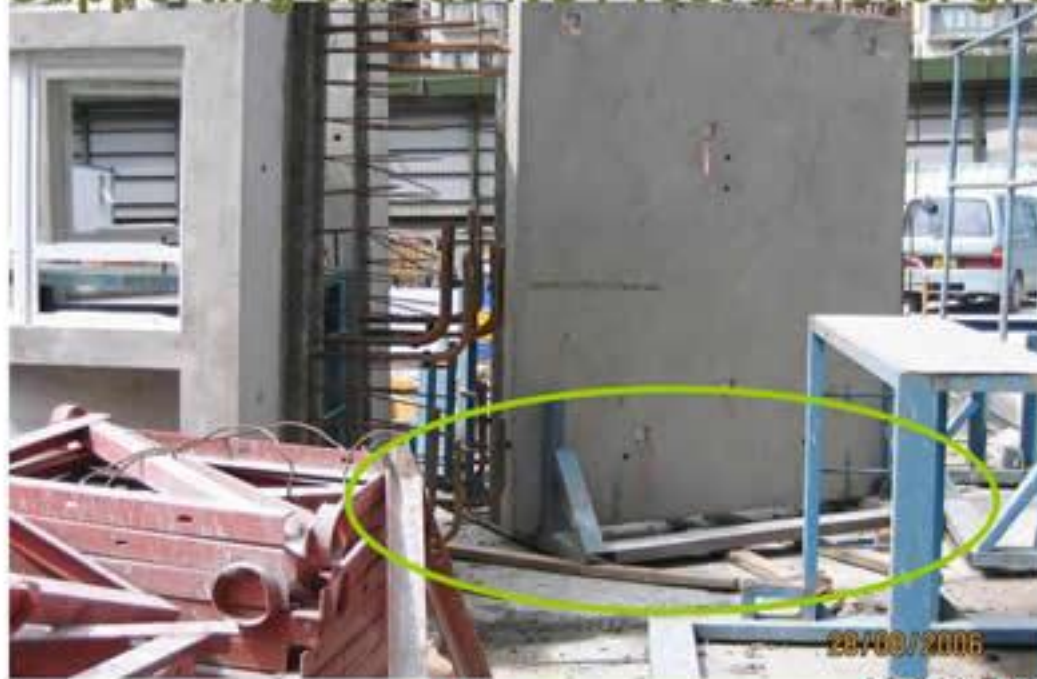
**Supporting stands NOT rest on level ground**

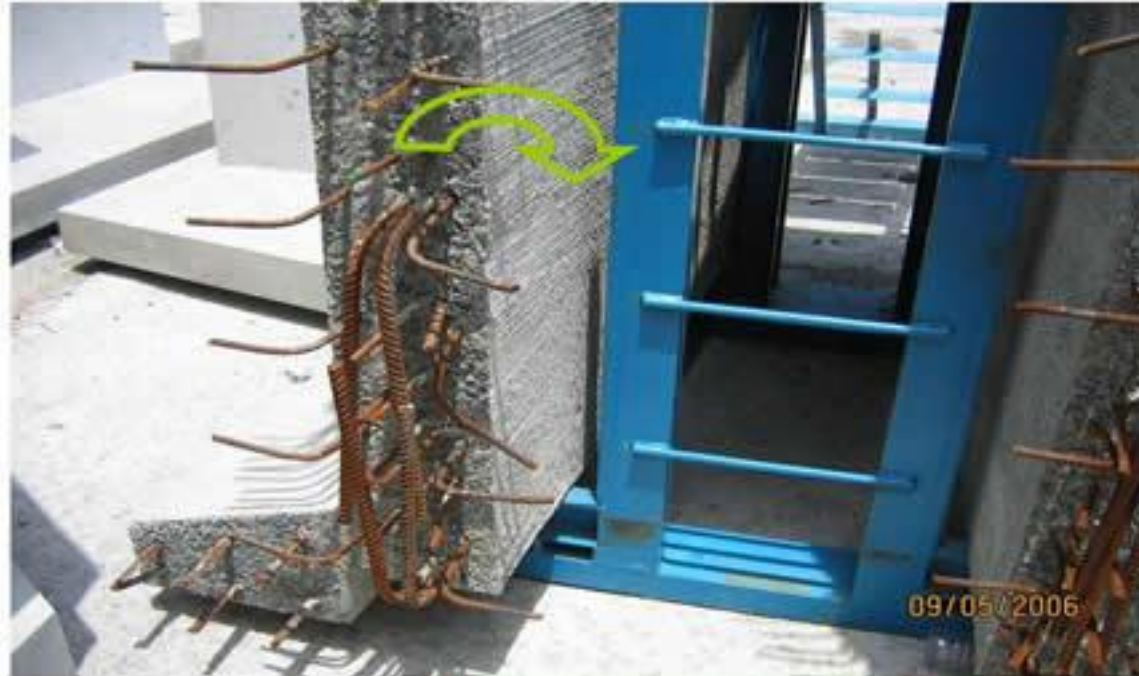
## Storage of Precast Facade Units Stored NOT against the stand

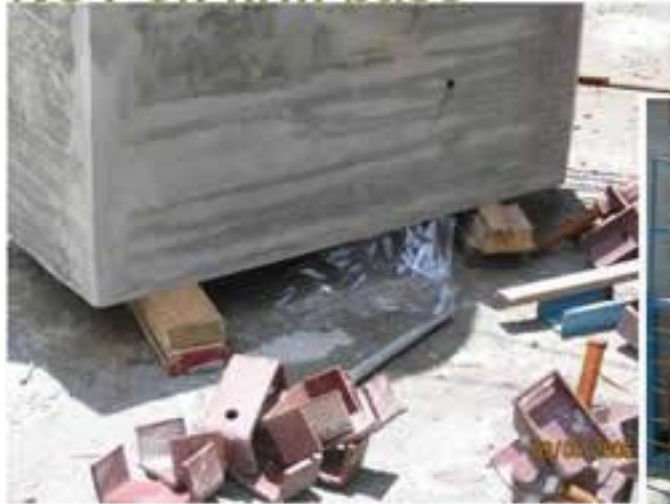
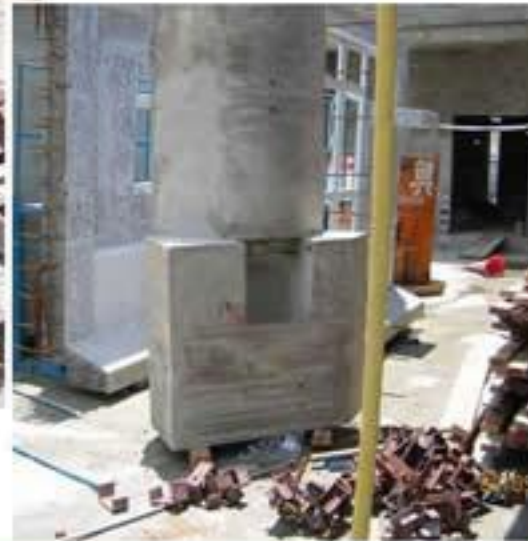
## Precast refuse chutes stored NOT on firm base

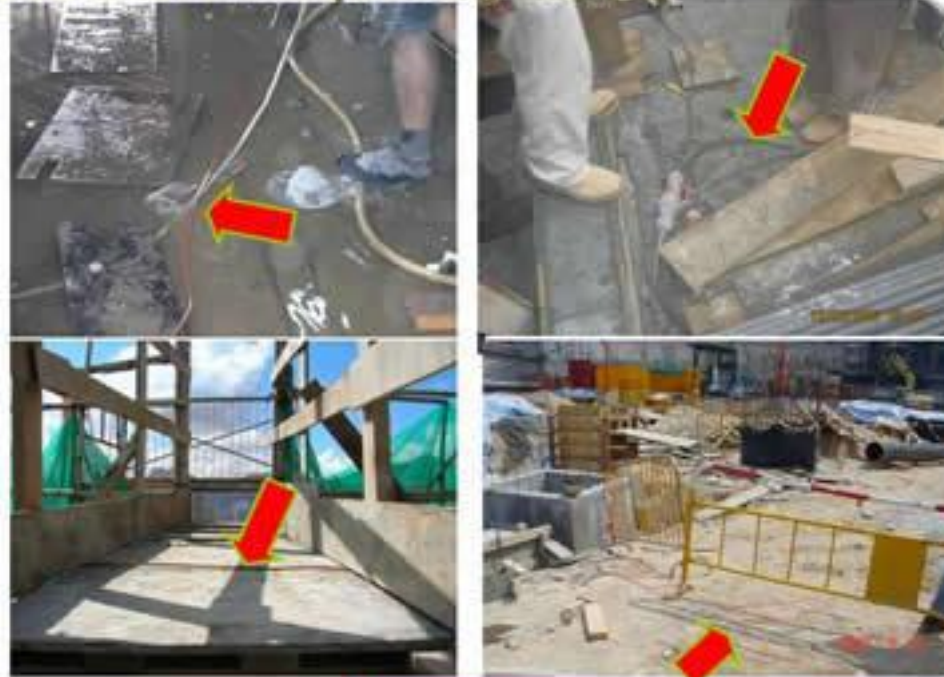
## Electric Cables Lying on Ground Cases more frequently noted

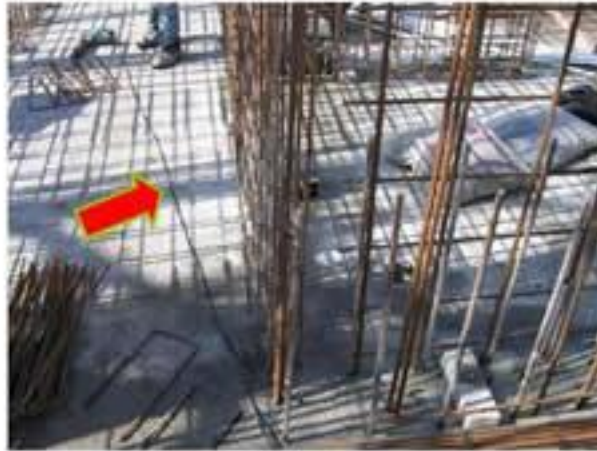
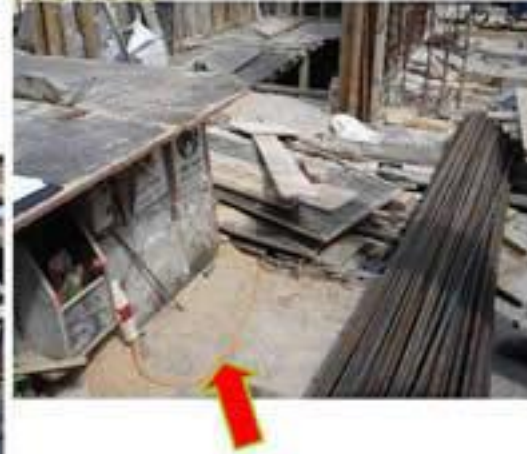
## Electric Cables Lying on Ground Cases more frequently noted

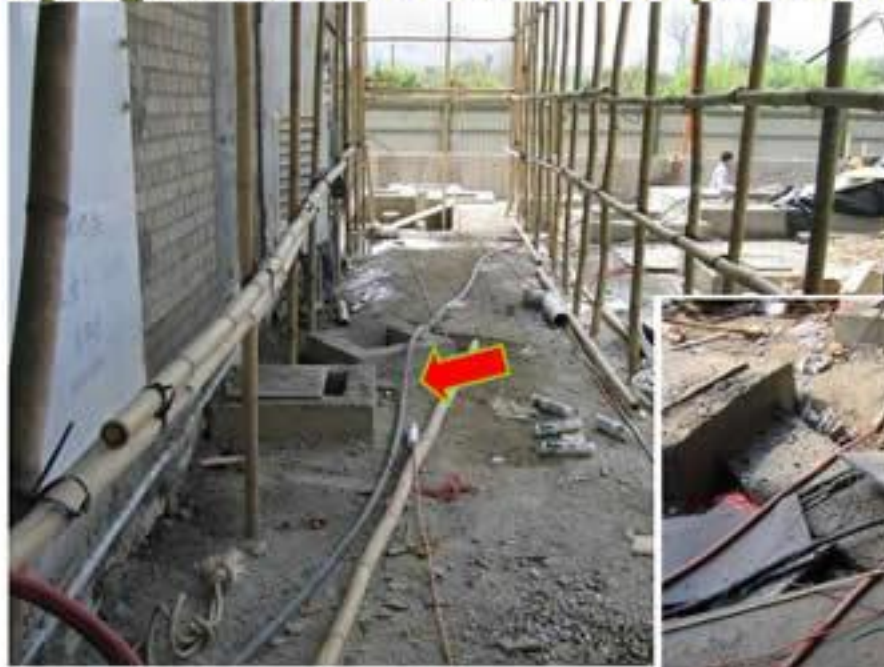
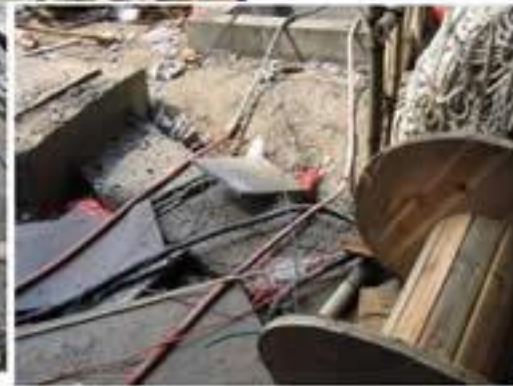
## Temporary Electric Cables Lying on the floor without protection

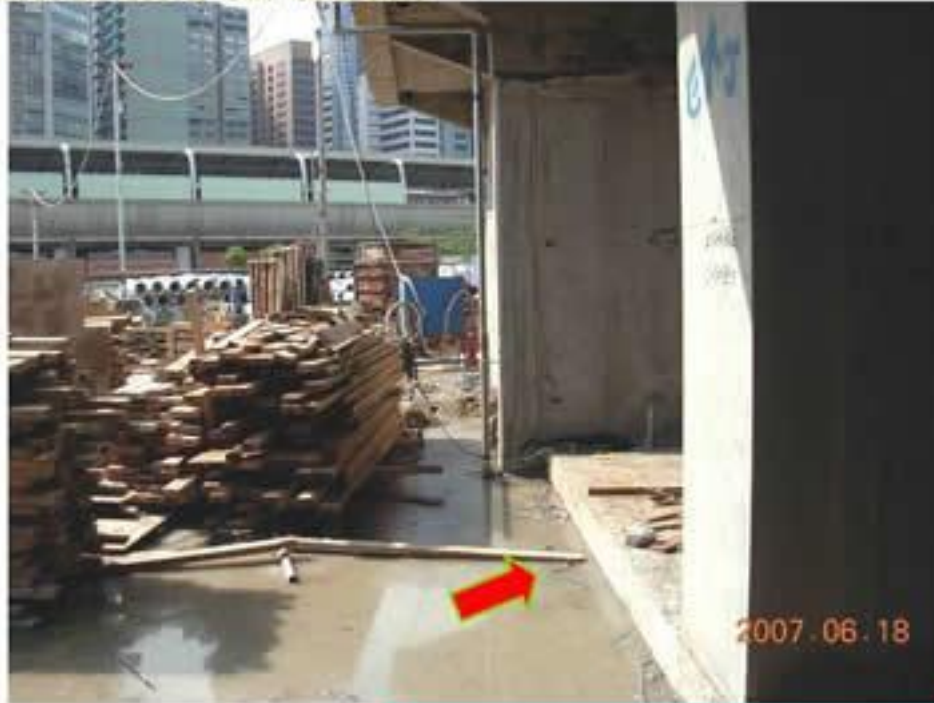
## Electric Cables Lying on Ground Immersed in water

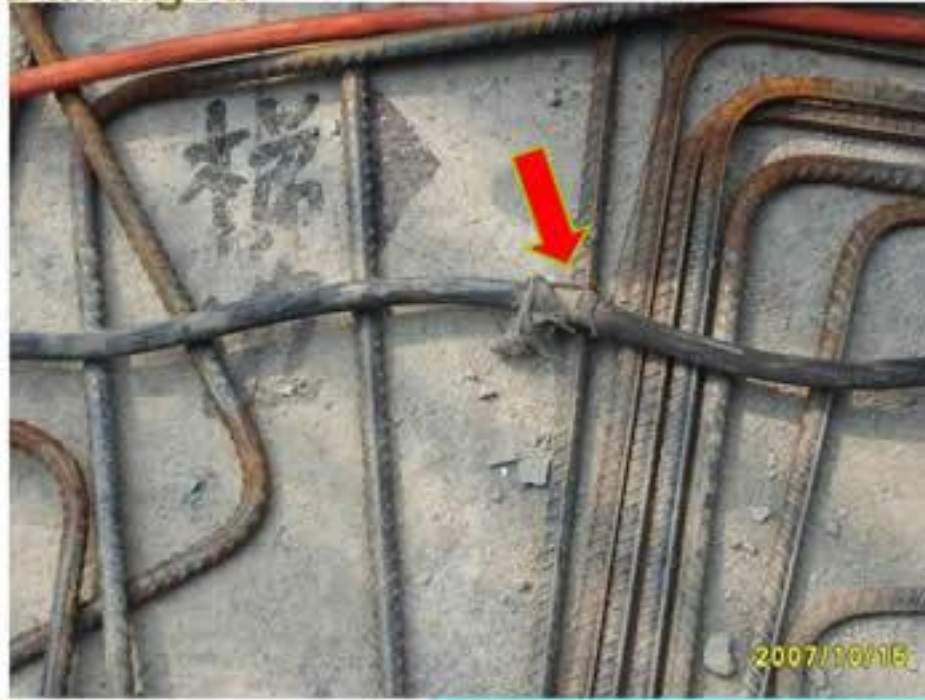
## Electric Cables Lying on Ground Damaged
