Audit Unit Development & Construction Division

Experience Sharing Session with Building Contractors

QUALITY & WORKMANSHIP

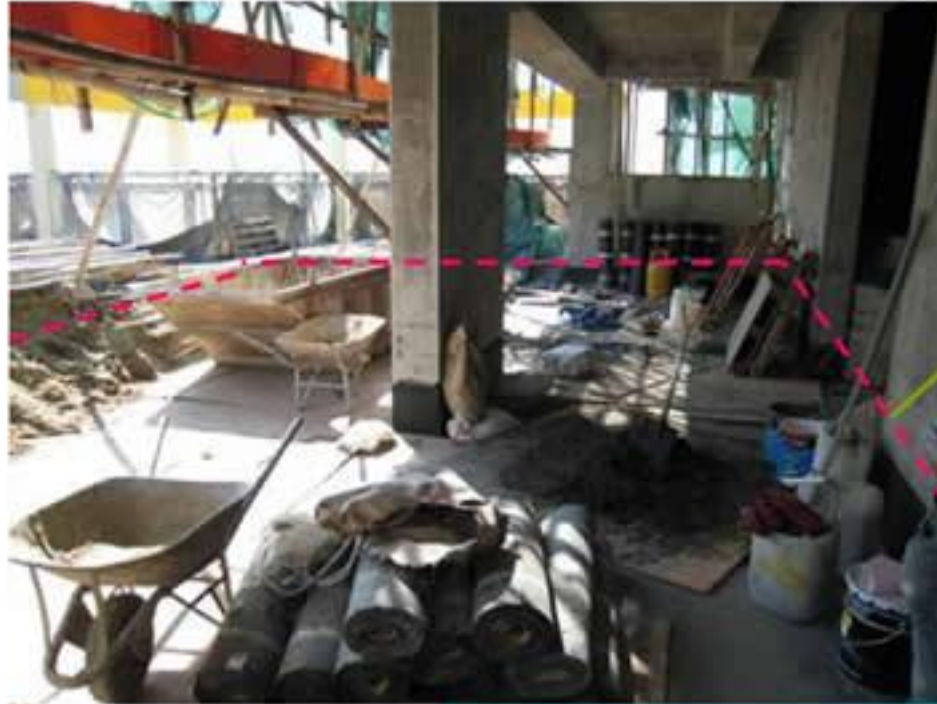
Site Housekeeping

Materials stocked onto roof waterproof membrane

Area of completed waterproofing

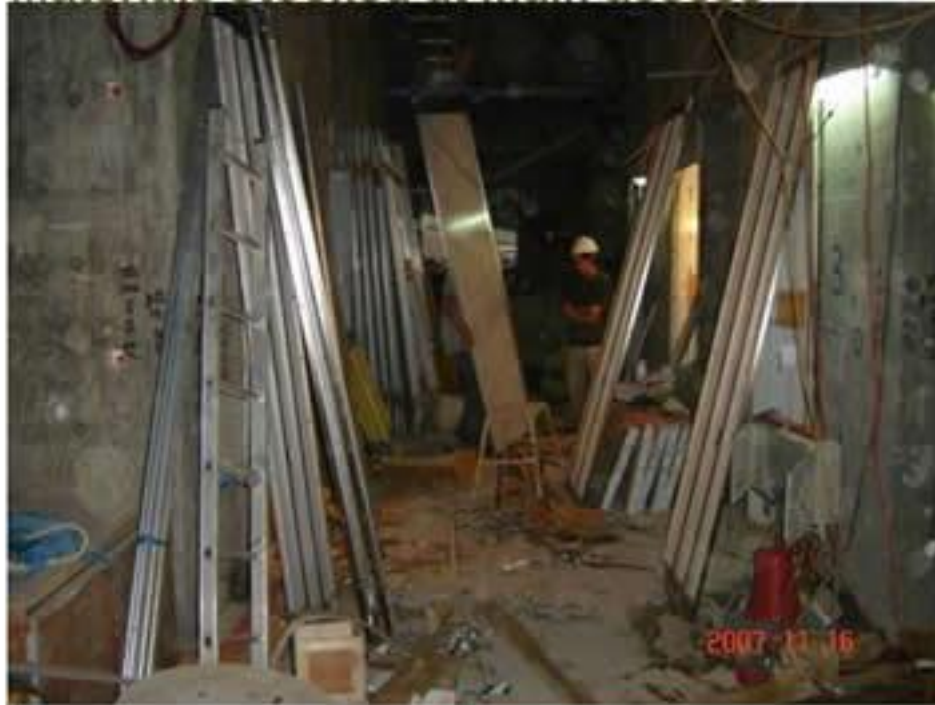
Materials stocked at main access

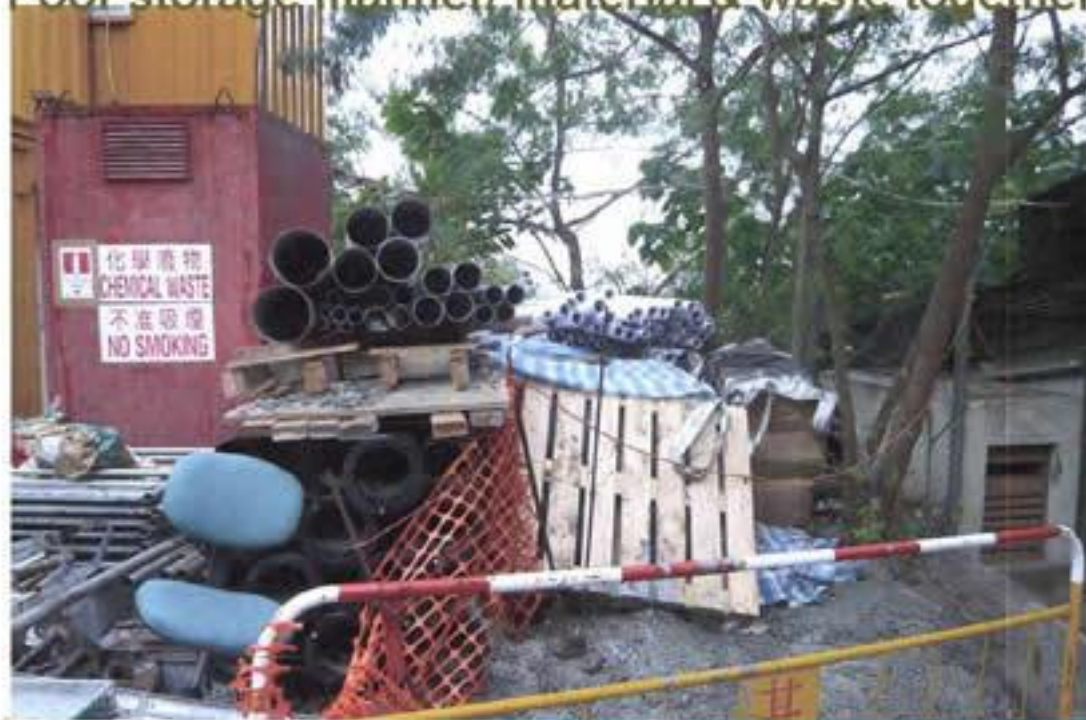
Poor storage manner/ material & waste together

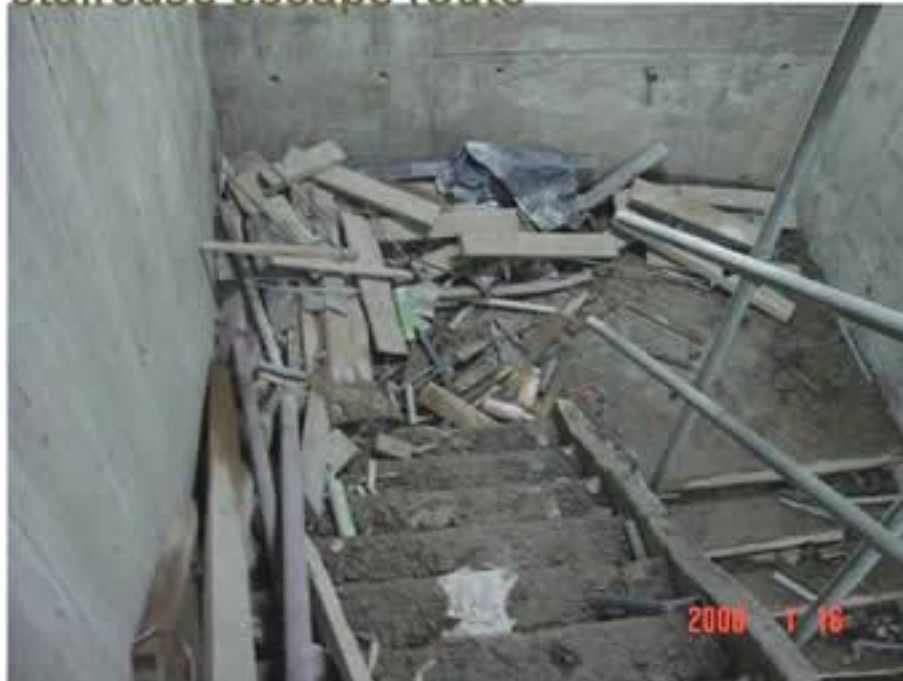
Rubbish and timber planks stacked at staircase escape route

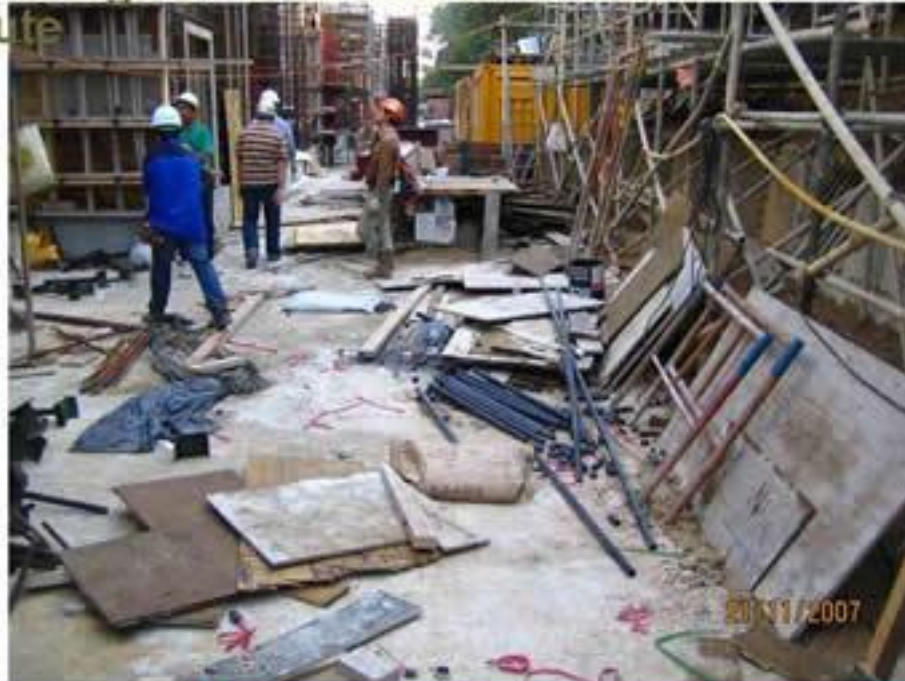
Improper storage of construction material on access route

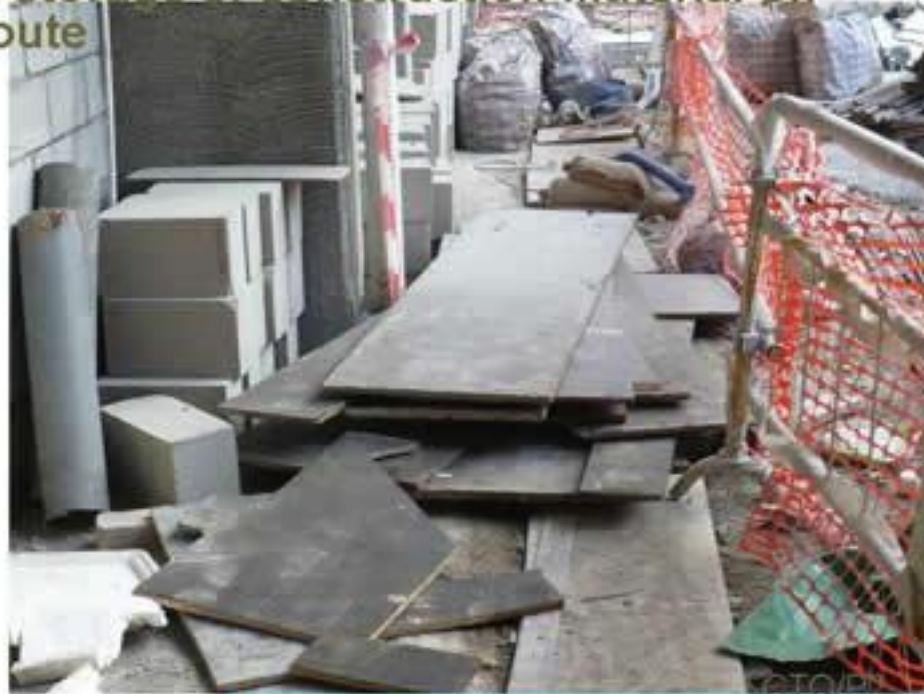
Improper storage of construction material on access route

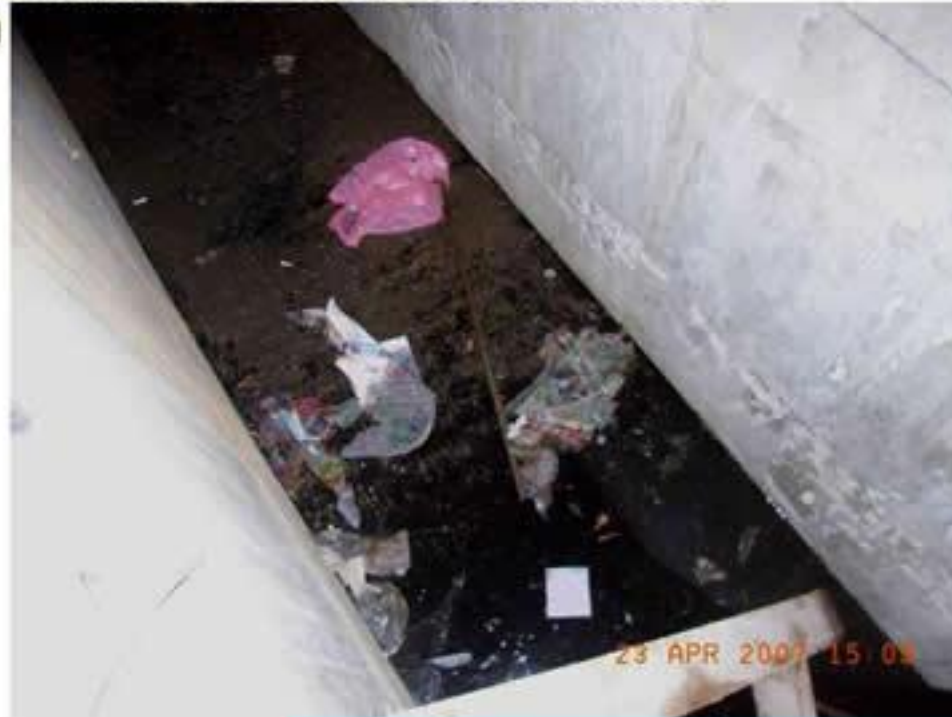
Water & rubbish accumulated at cable trench

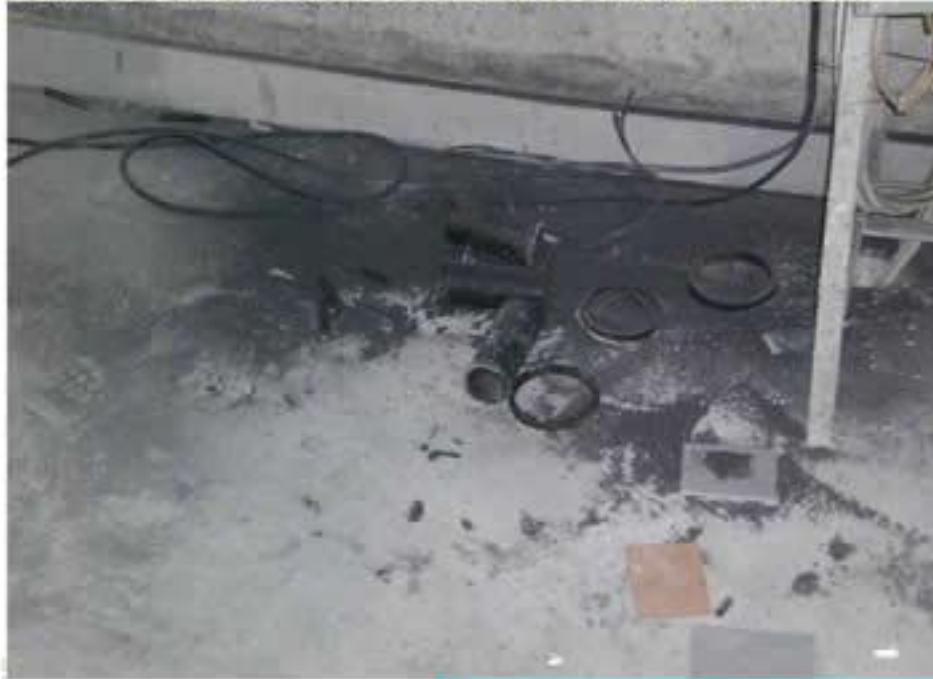
Residue left on floor after high speed cutting may cause rust stains if not moved at once

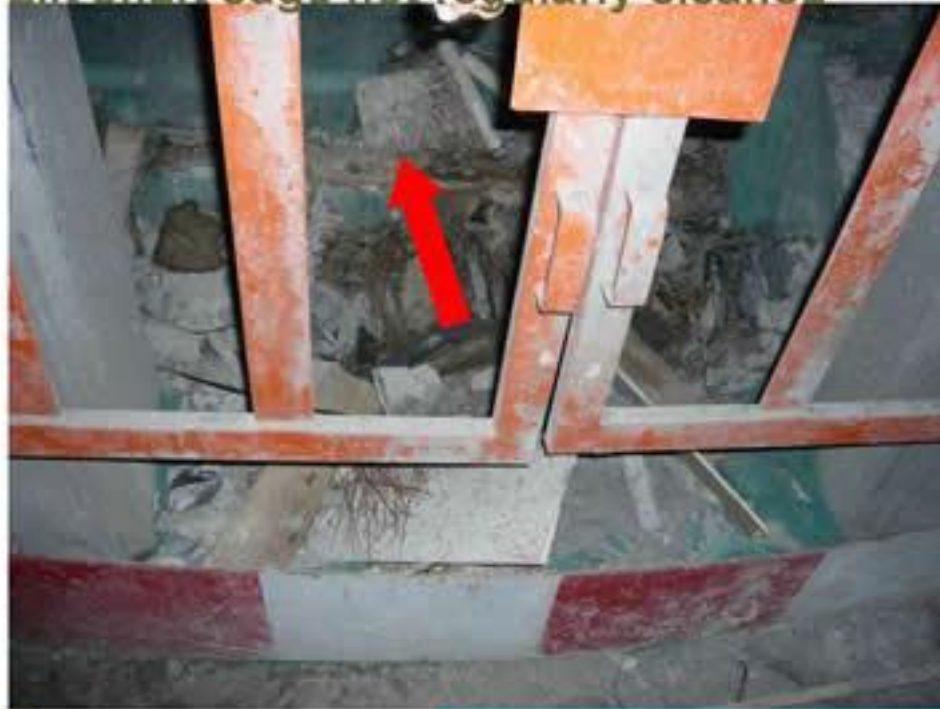
Lift shaft edge not regularly cleaned

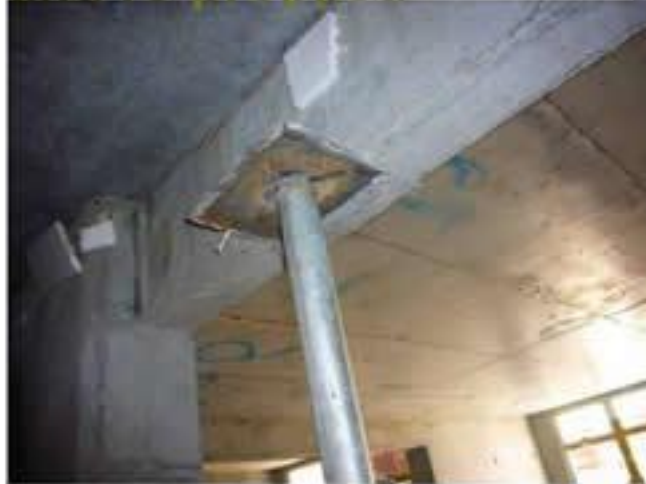
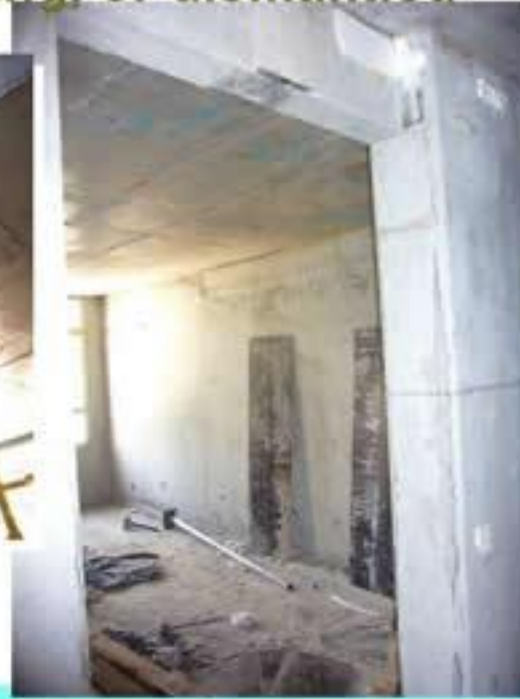
Beam Soffit Formwork

Steel props either missing, or dismantled and re-propped

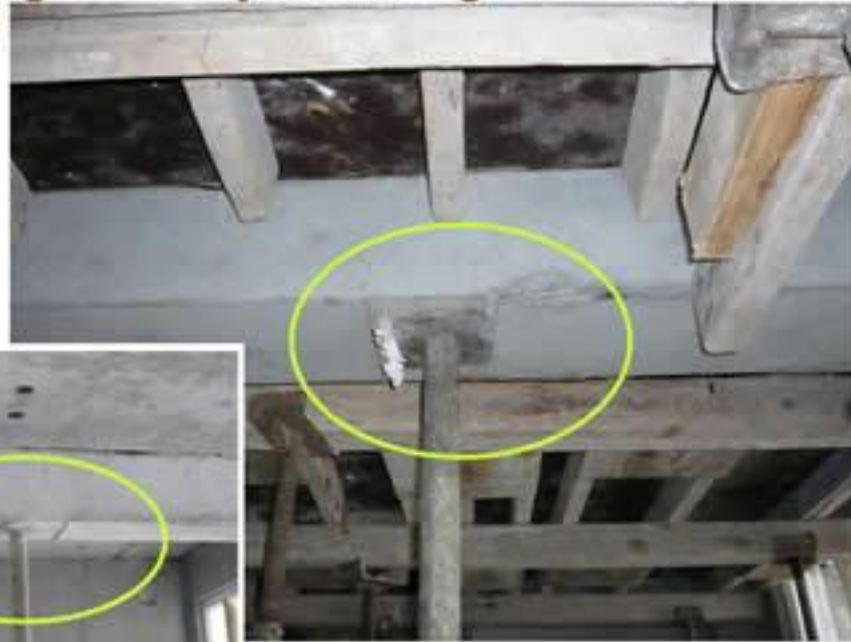
Re-propping & Early Striking of Formwork NOT allowed

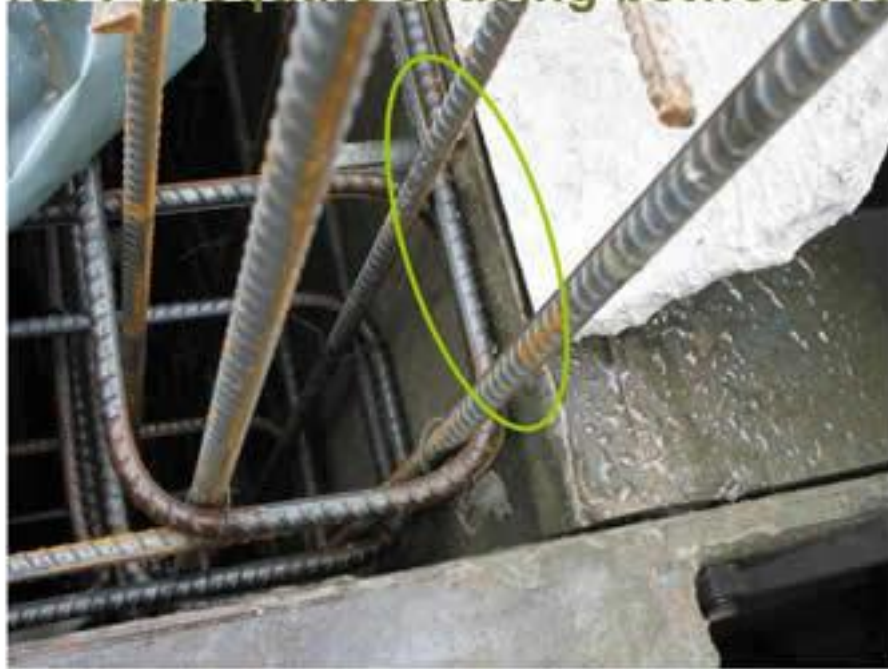
Concrete Spacers

NOT adequate spacing between formwork

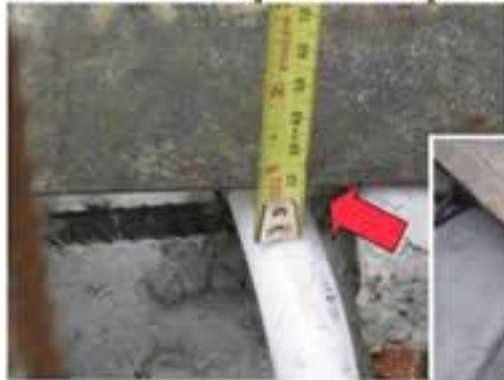
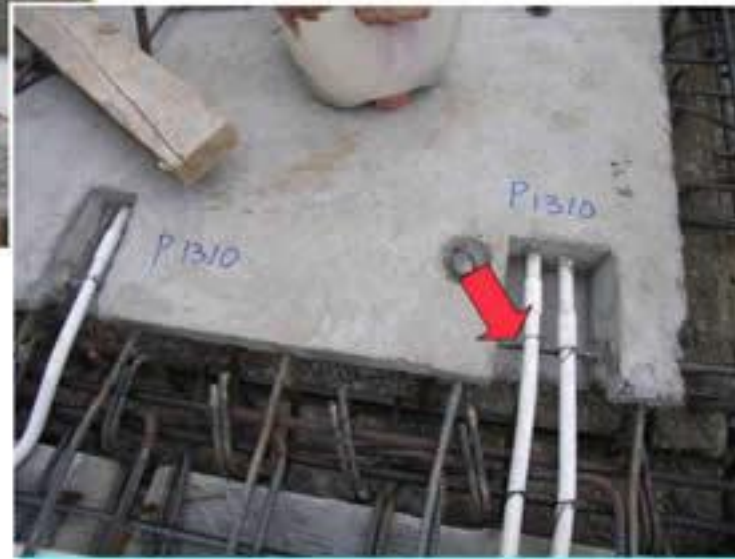
Concrete Cover to conduits NOT adequate spacing between formwork

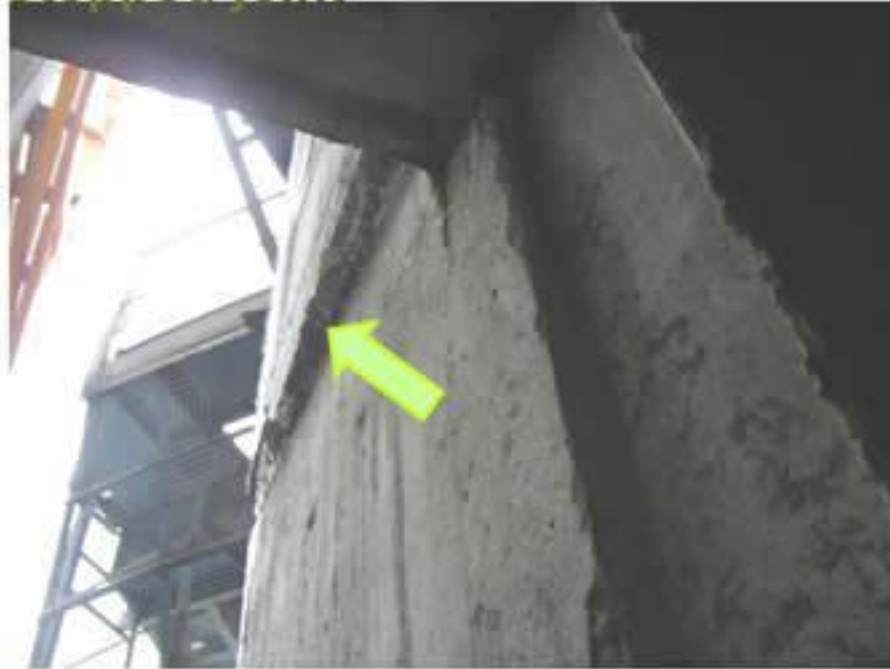
Stepped joint

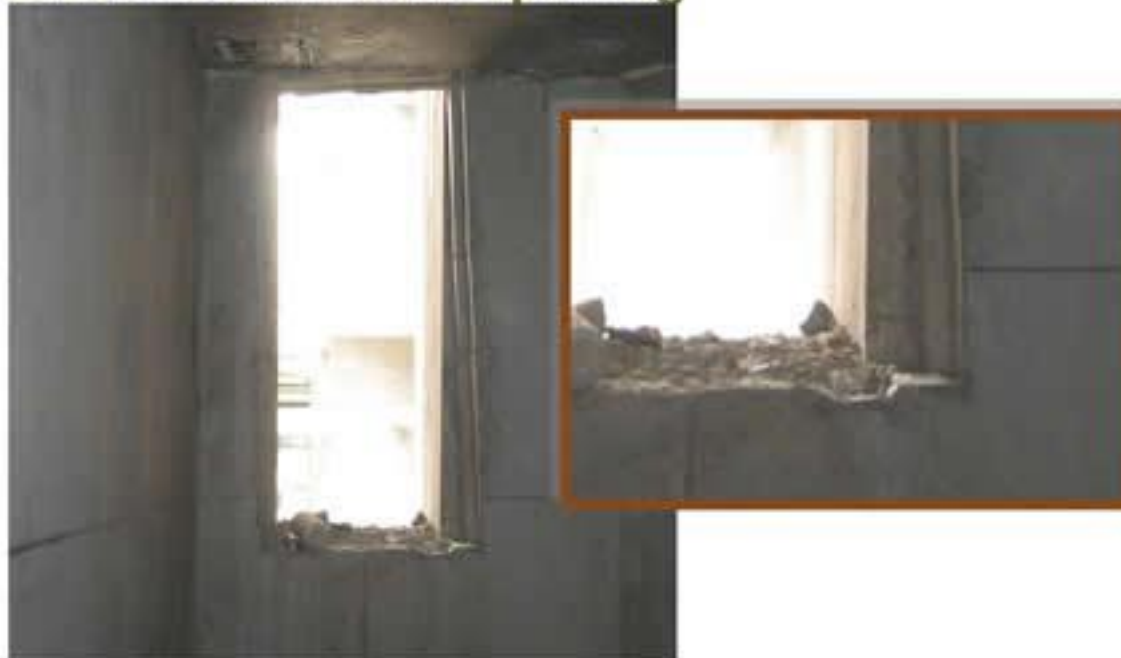
Distorted window opening

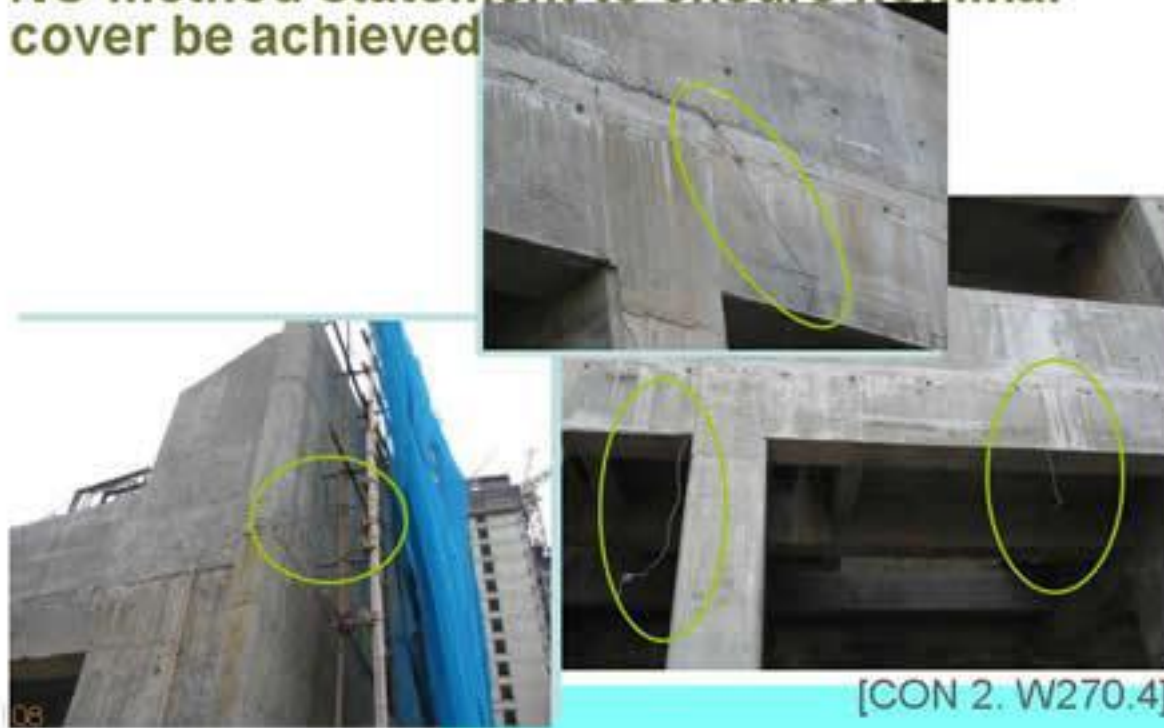
Scaffolding Ties

NO method statement to ensure nominal cover be achieved

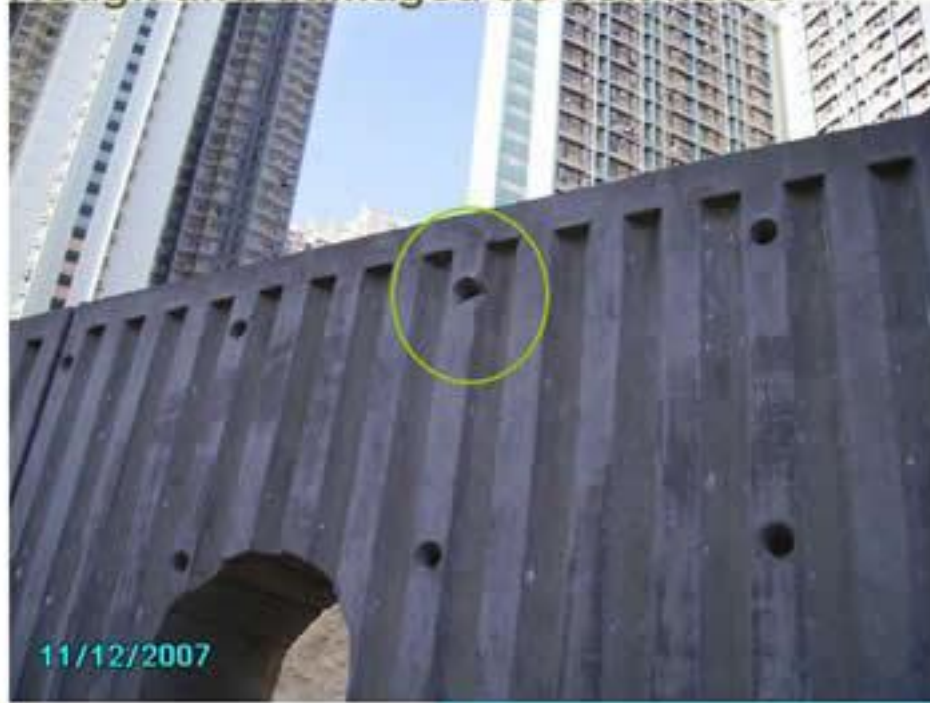
Quality of Concrete Retaining Wall

Rough and damaged tie bolt holes

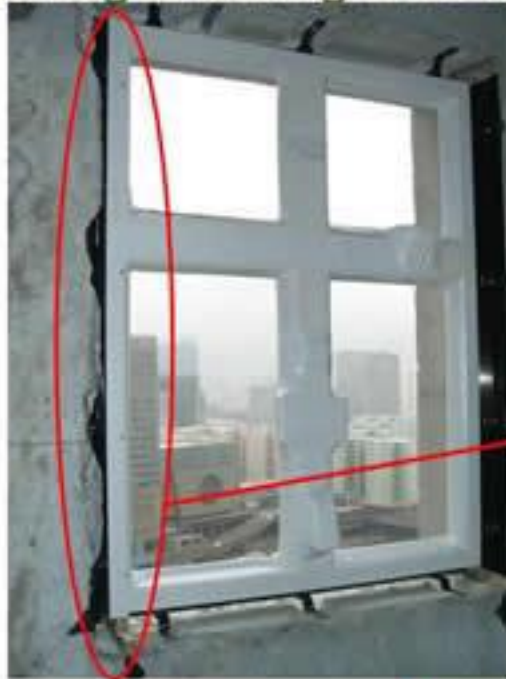
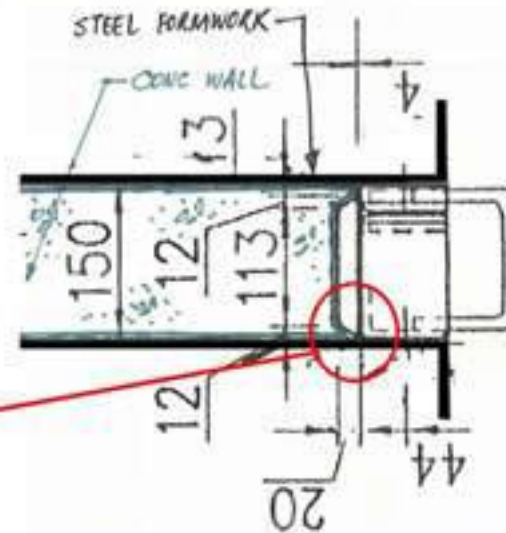
Wall Corners at the Insitu Window Jamb Damaged during removal of formwork

Sharp corners at wall edge

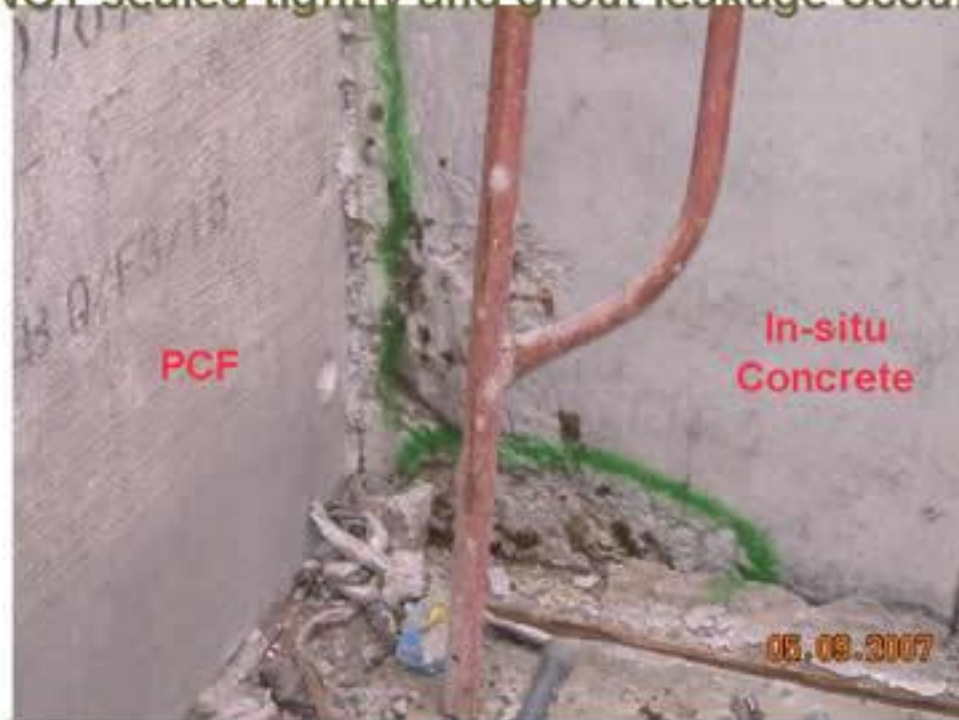
Junction between Formwork and PCF NOT sealed tightly and grout leakage occurred

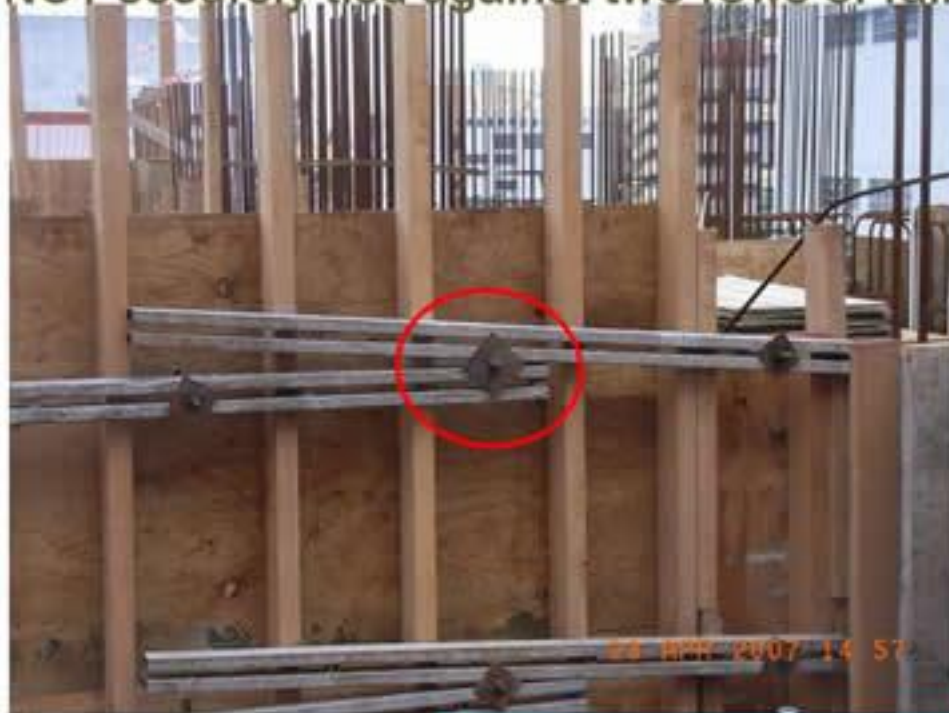
Tie Bolts of Formwork

NOT securely tied against two rows of railing

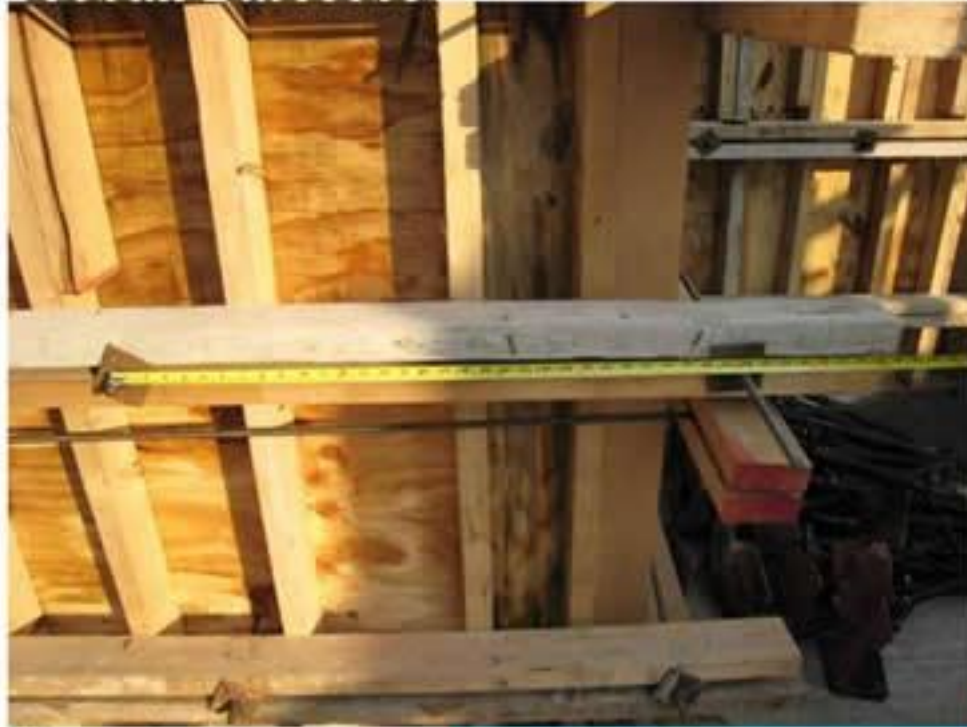
Tie Bolts of Formwork Spacing exceeded

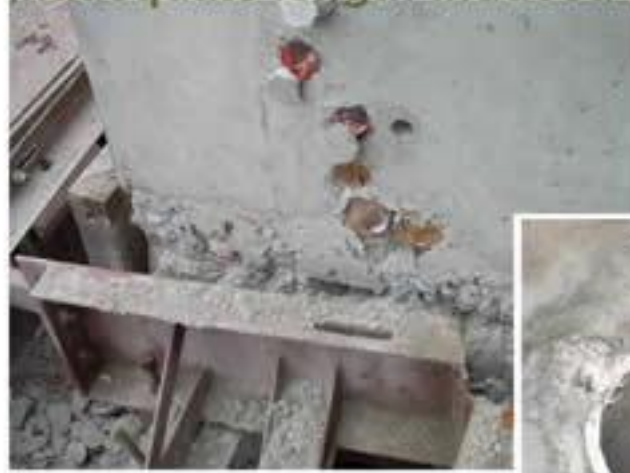
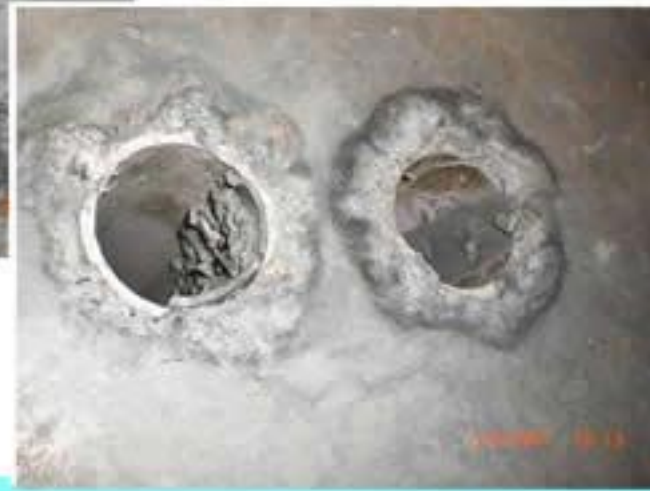
Pipe Sleeves at Formwork

Inadequate length induced leakage of concrete

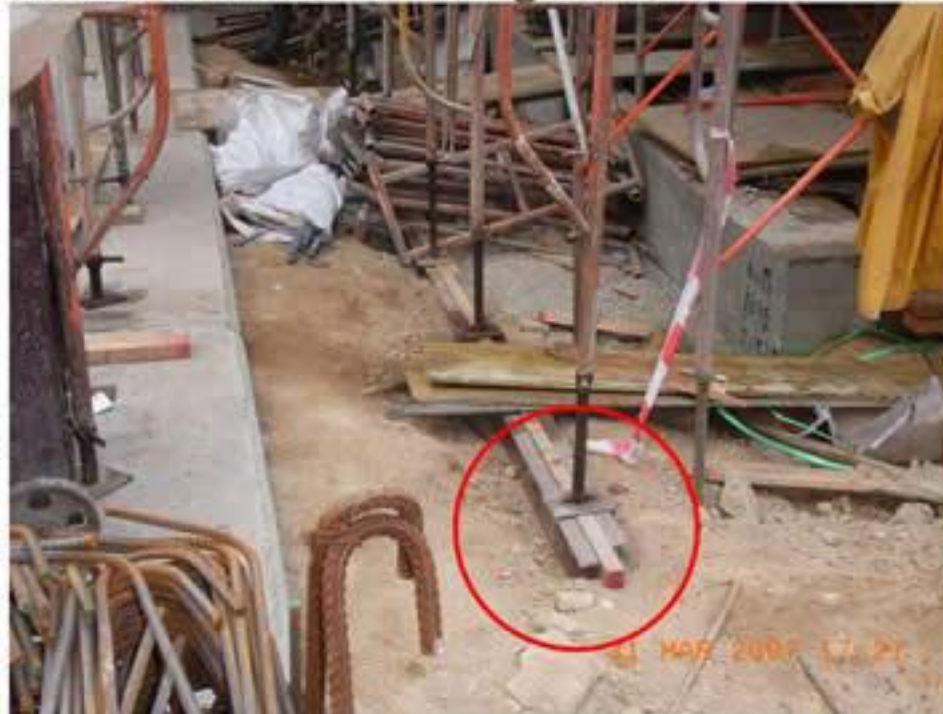
Supports of scaffolds for Formwork NOT sit on firm / solid ground

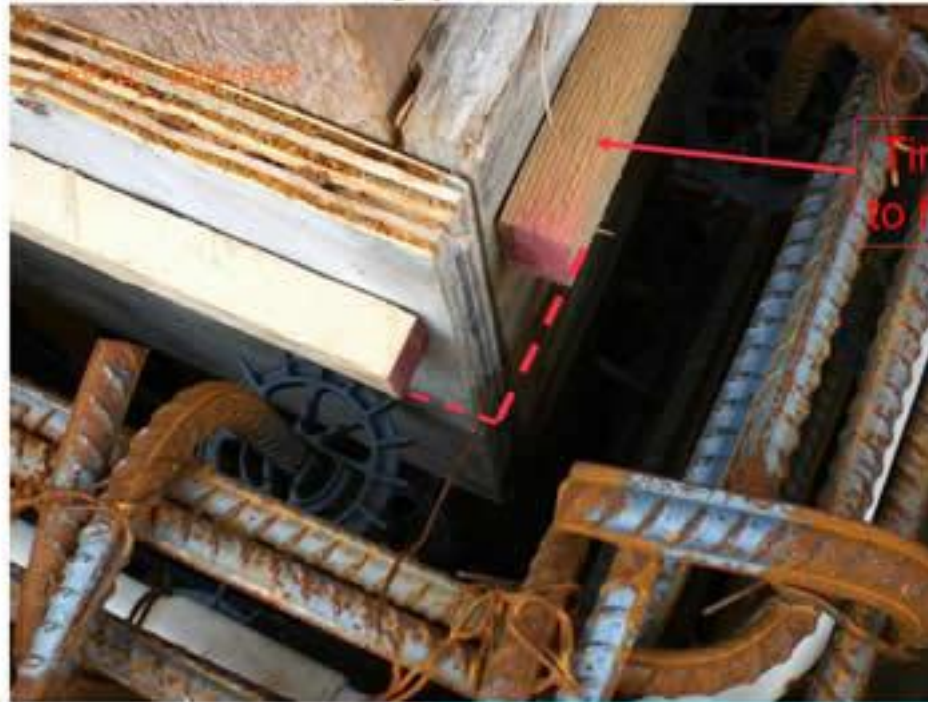
Chase for Waterproofing at Formwork NOT continuously provided

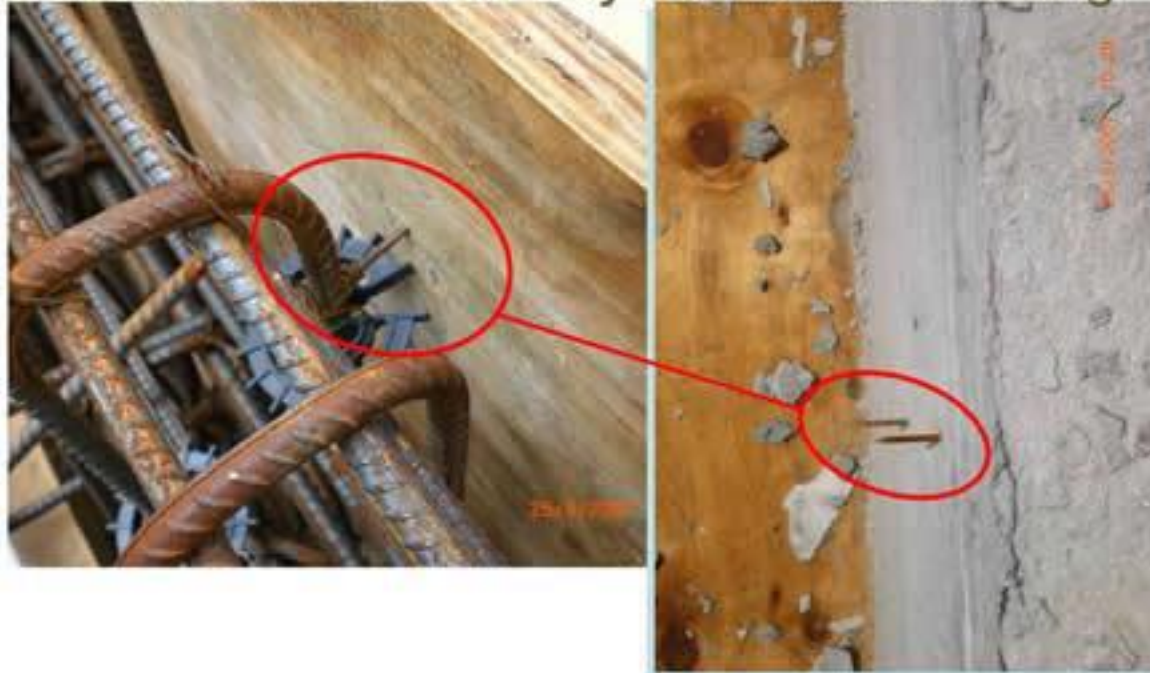
Embedded in concrete may lead to future rusting

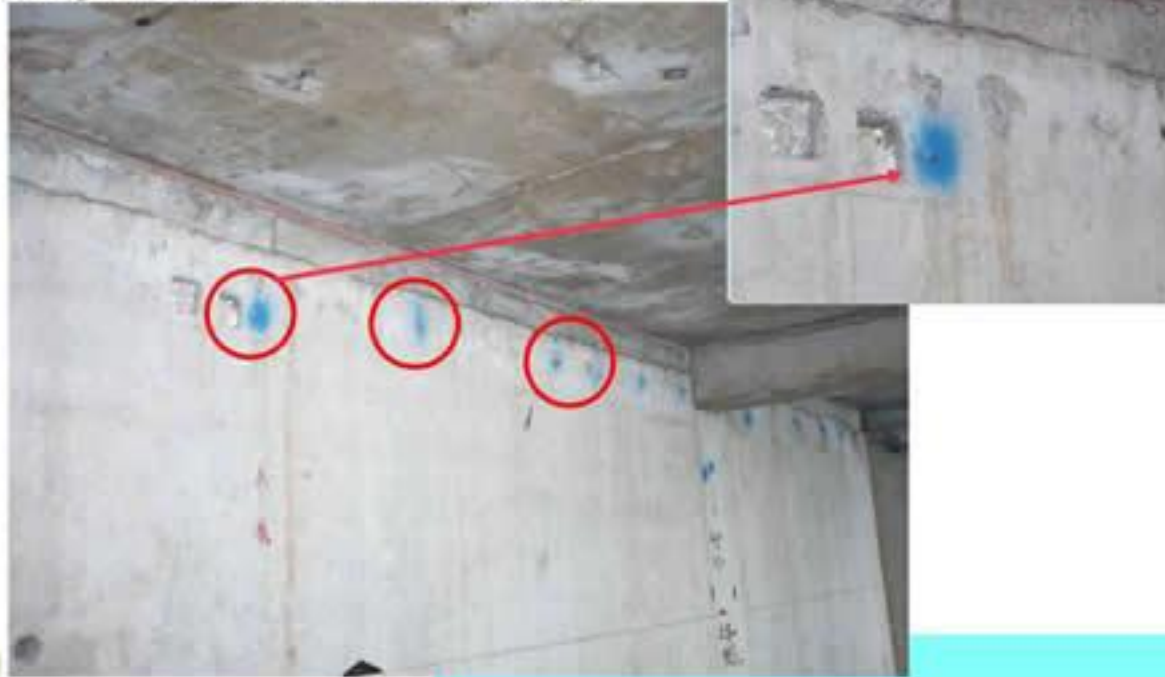
Steel Nails for Fixing Formwork Embedded in concrete / corridor wall may lead to future rusting

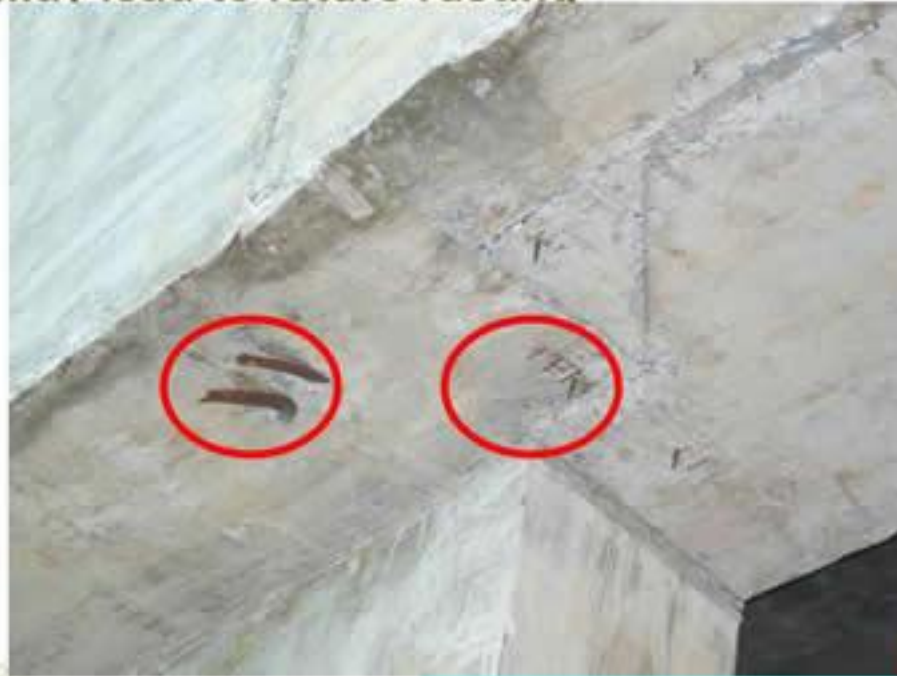
Steel Nails for Fixing Formwork Embedded in concrete / roof water tank may lead to future rusting

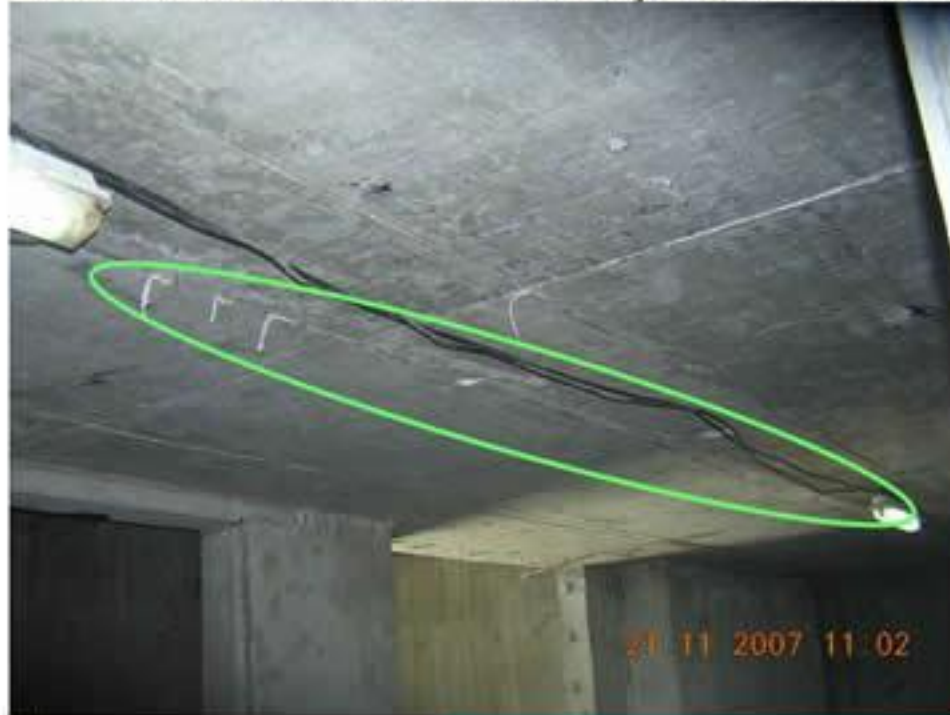
Embedded in concrete / lift lobby slab construction joint

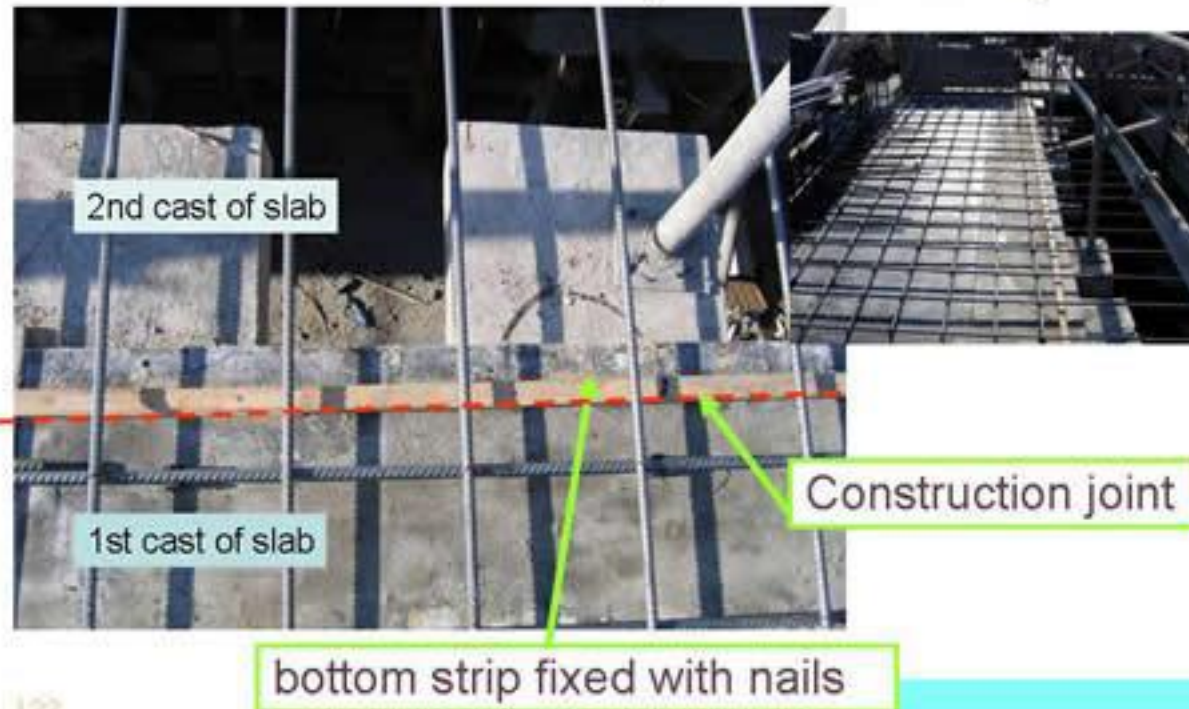
Embedded in concrete / lift lobby slab construction joint

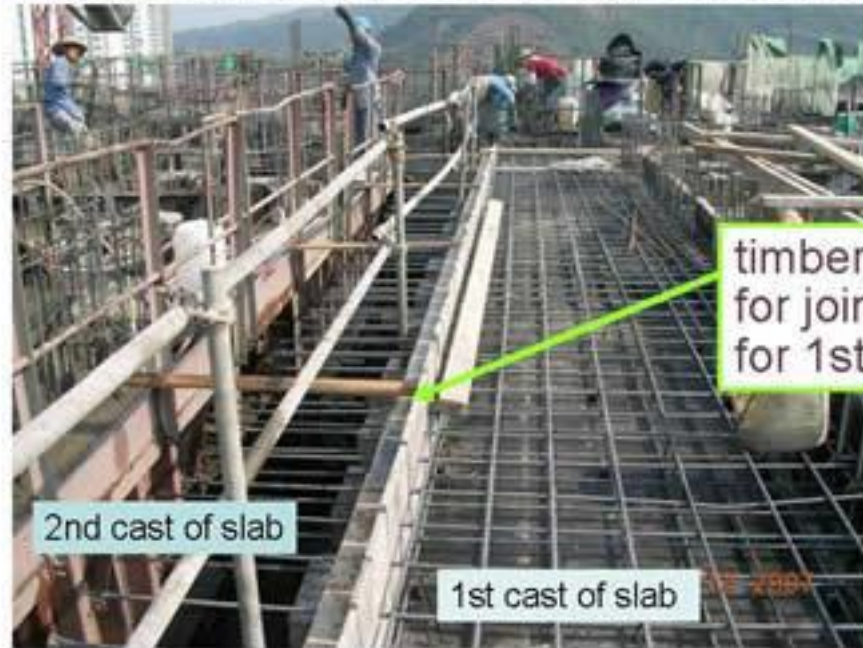
Embedded in concrete / lift lobby slab construction joint

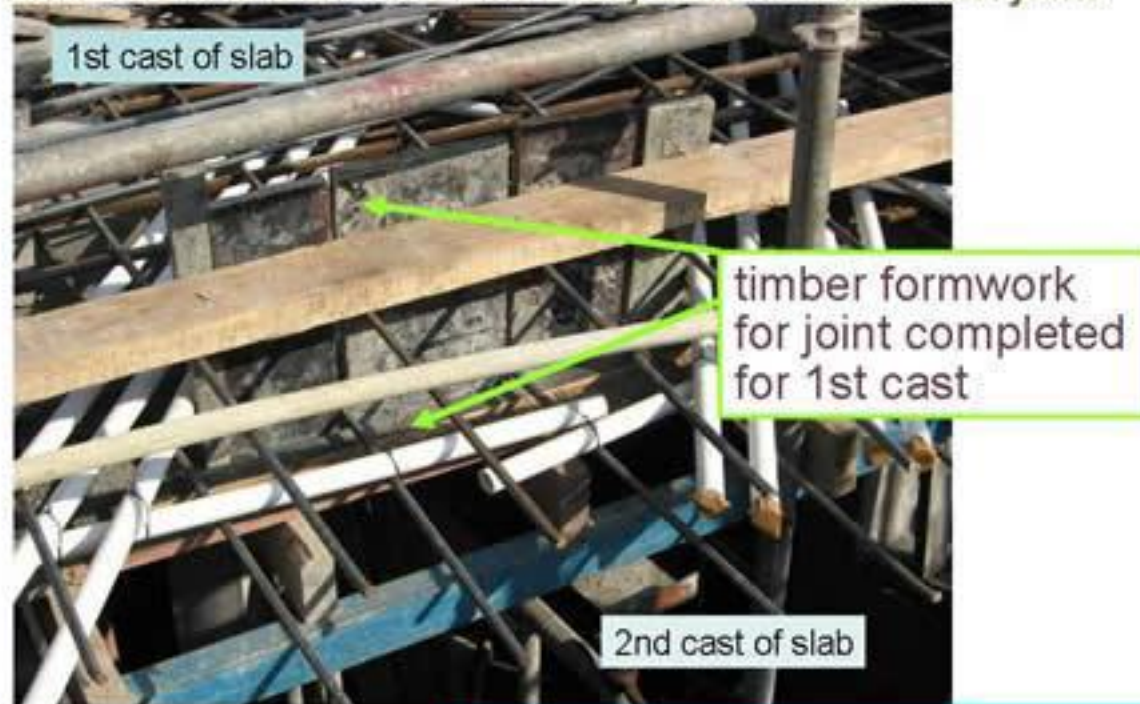
Embedded in concrete / lift lobby slab construction joint

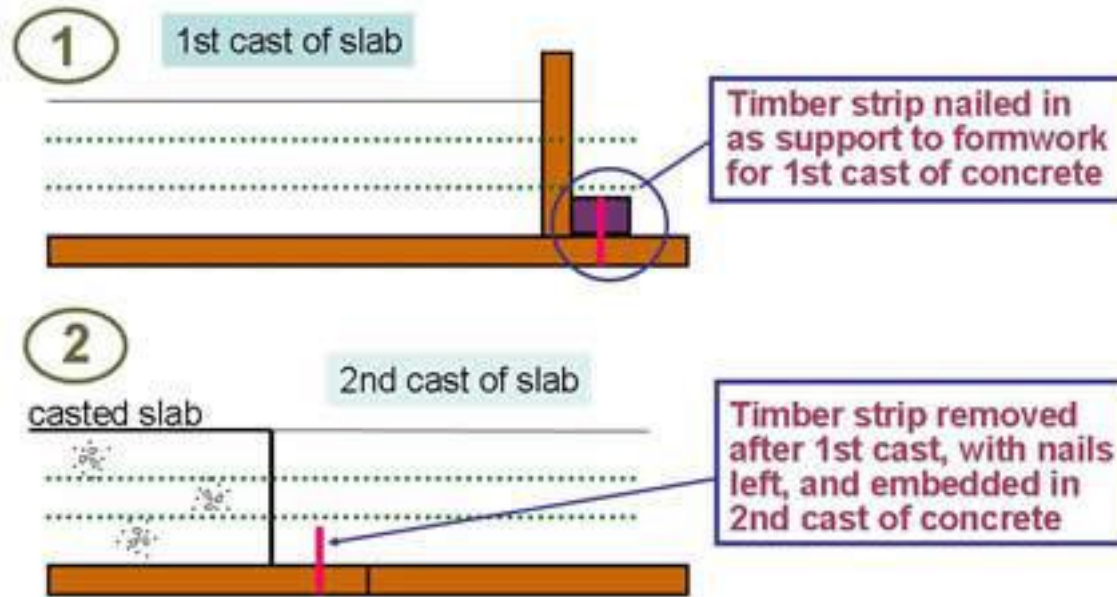
Sequence of work – casting of in-situ floor slab

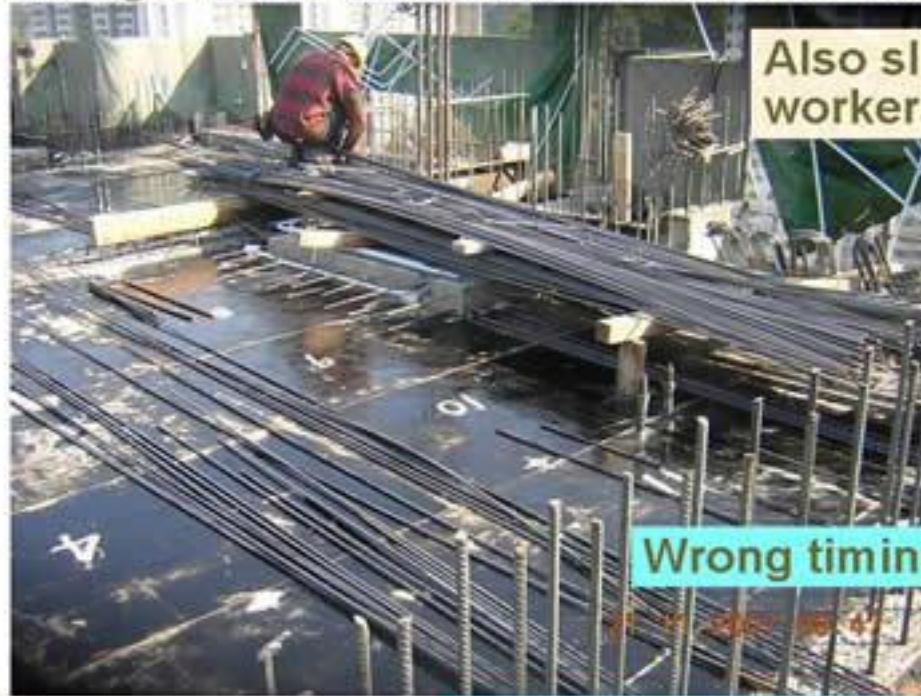
Steels contaminated by Mould Oil

Fixing of steel started while mould oil still wet

Also slippery to workers

Wrong timing of work
