Audit Unit Development & Construction Division

Experience Sharing Session with Building Contractors

QUALITY & WORKMANSHIP

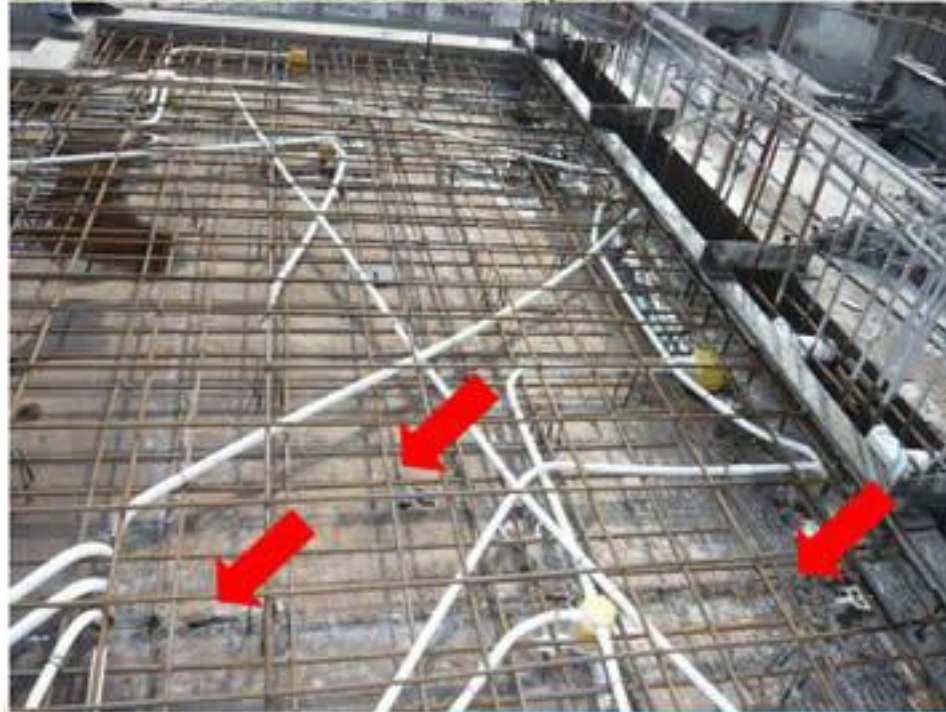
Plywood for Formwork Deteriorated and damaged

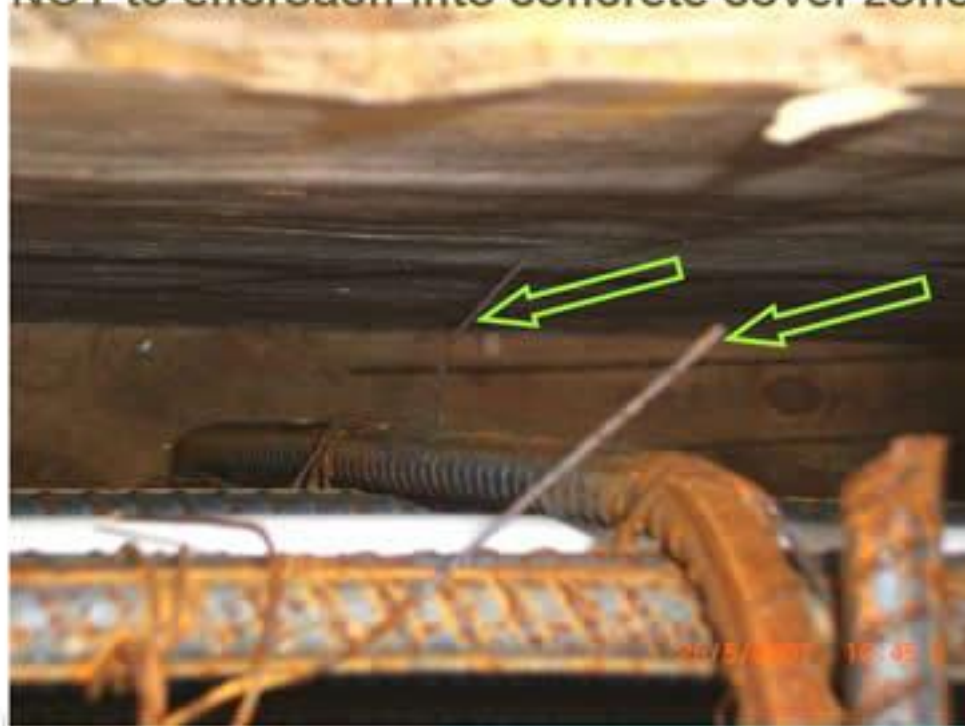
Steel Tying Wires for Reinforcement NOT to encroach into concrete cover zone

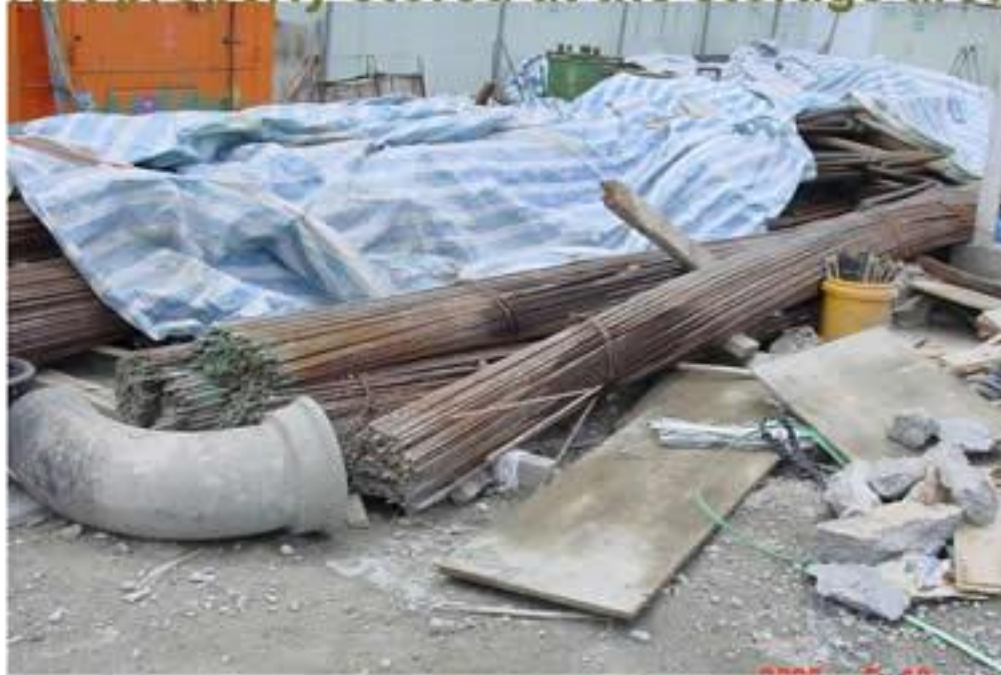
Stockpile of Reinforcement Not properly stored at the storage areas

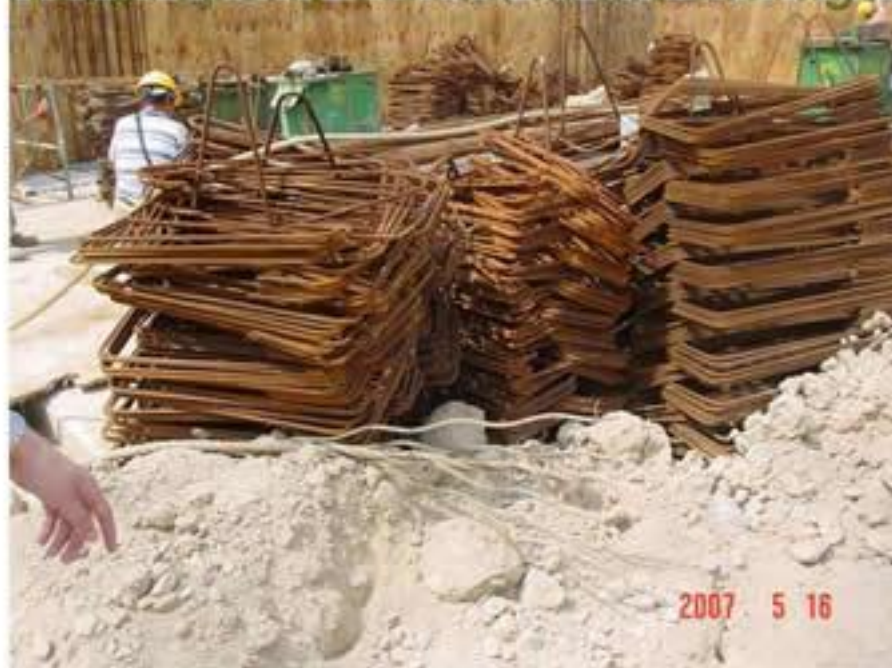
Stockpile of Reinforcement Not properly stored at the storage areas

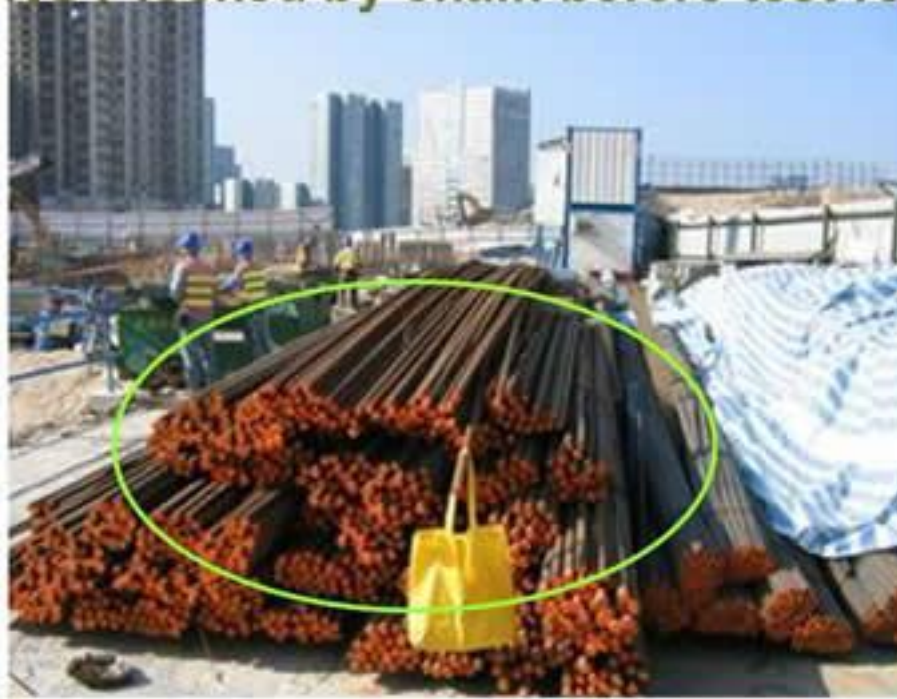
Control for Use of Reinforcement **NOT** locked by chain before test results

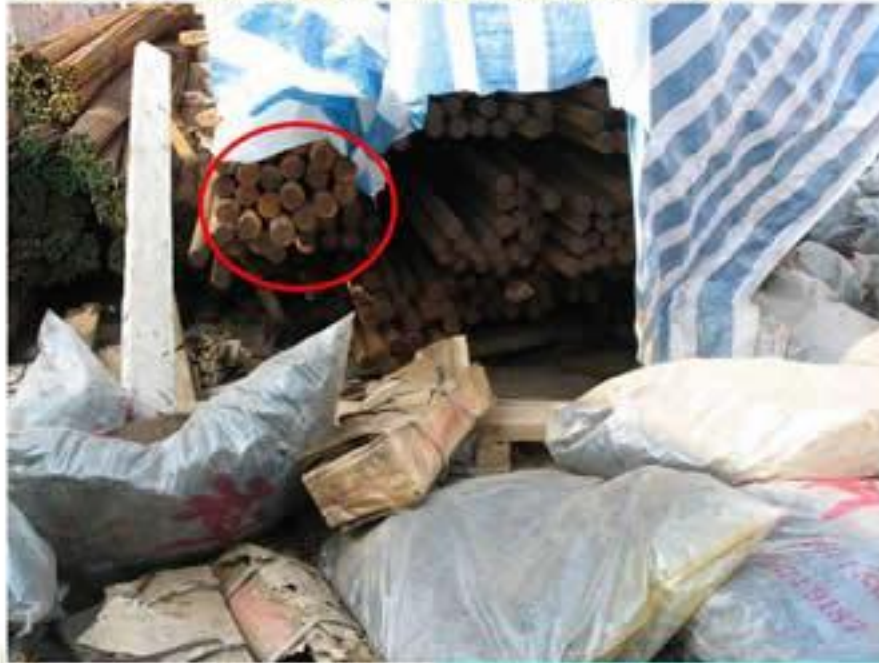
Reinforcement Identification

Brown colour used too close to the original colour of the reinforcement

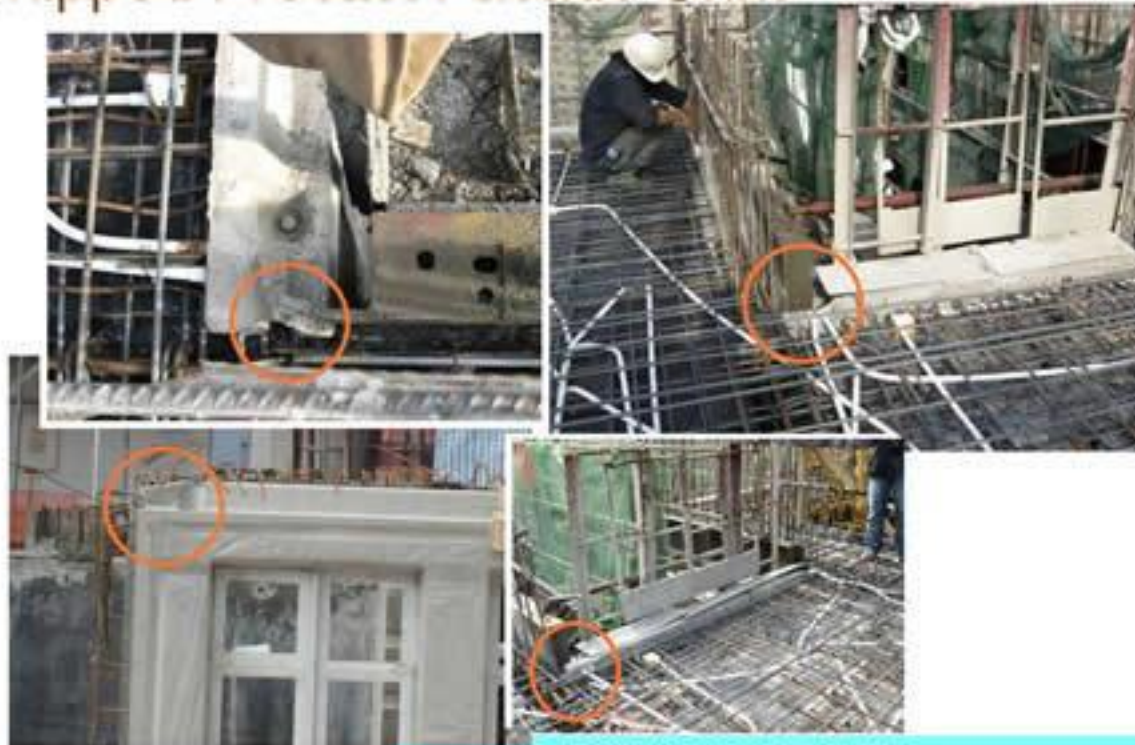
Chipped Precast Facade Units

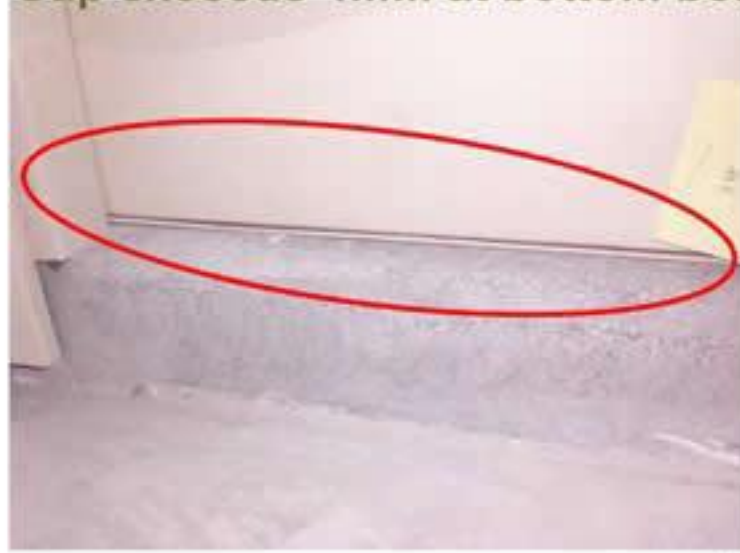
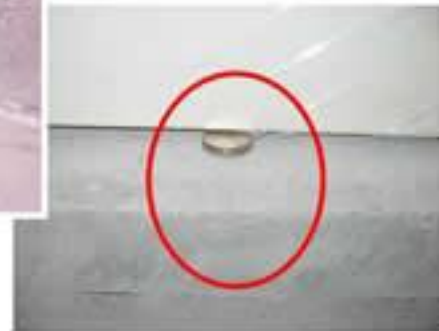
Installation of Fire Door Set

Gap exceeds 4mm at bottom between kerb

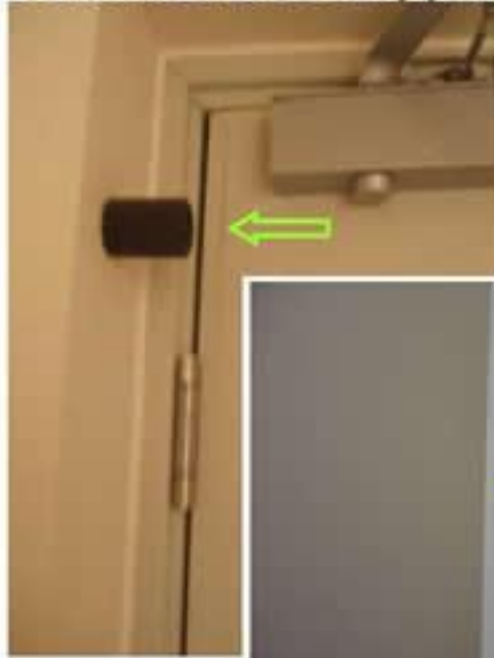
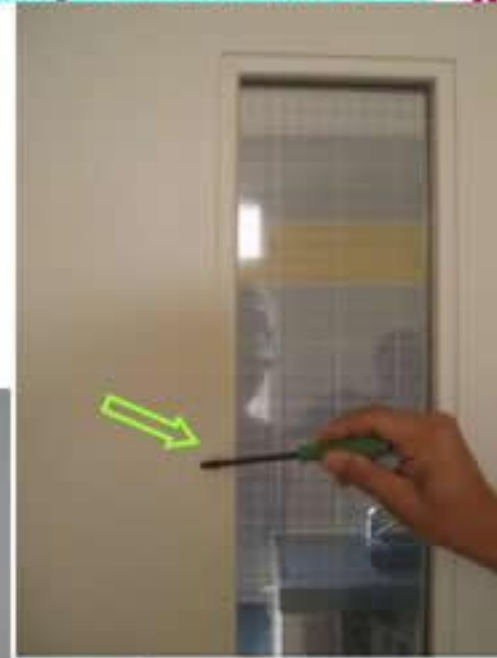
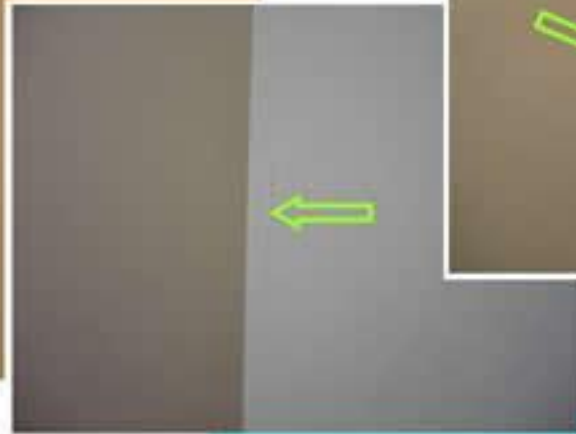
Timber Doorset Cracks at door lipping

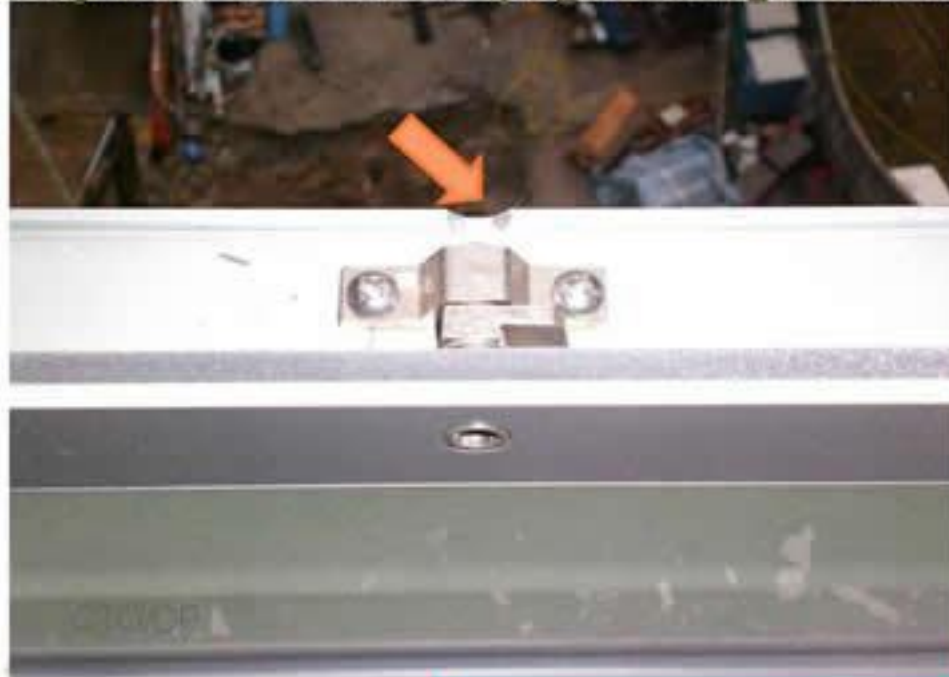
Drain Hole at Aluminium Window Frame

Too close to the Allen lock
may lead to water seepage through the lock

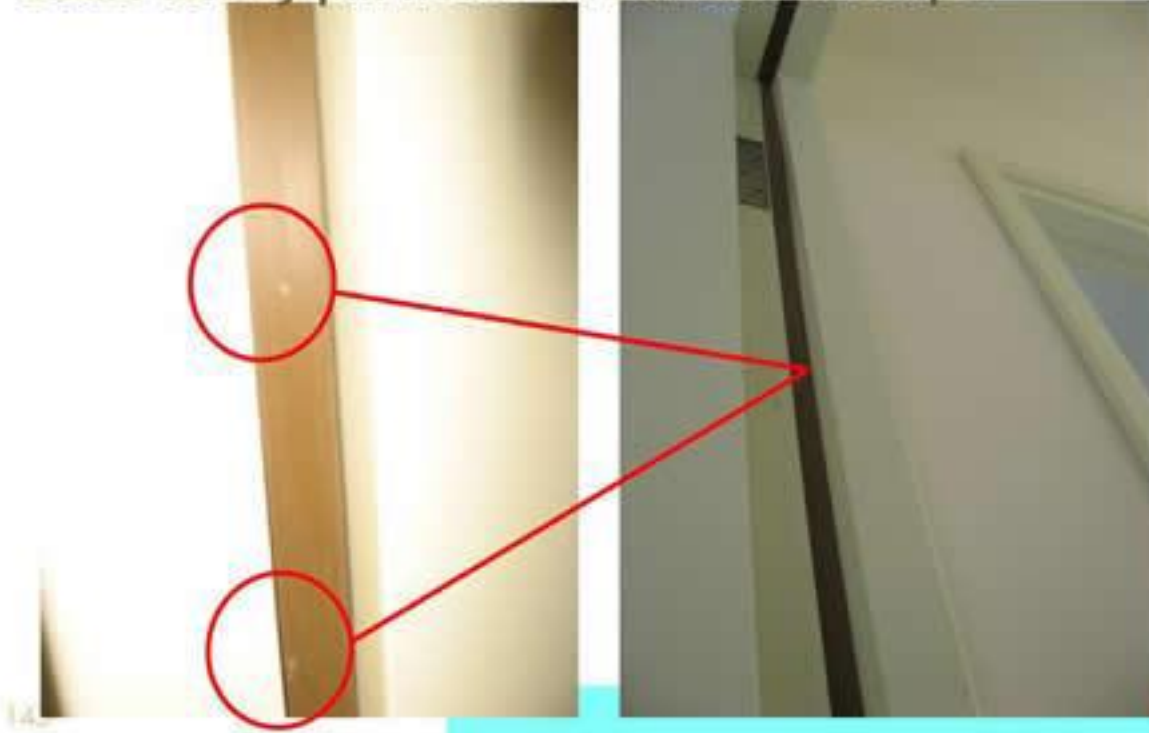
Intumescent Strip at Fire Door

Scars left by pin holes on surface of strips

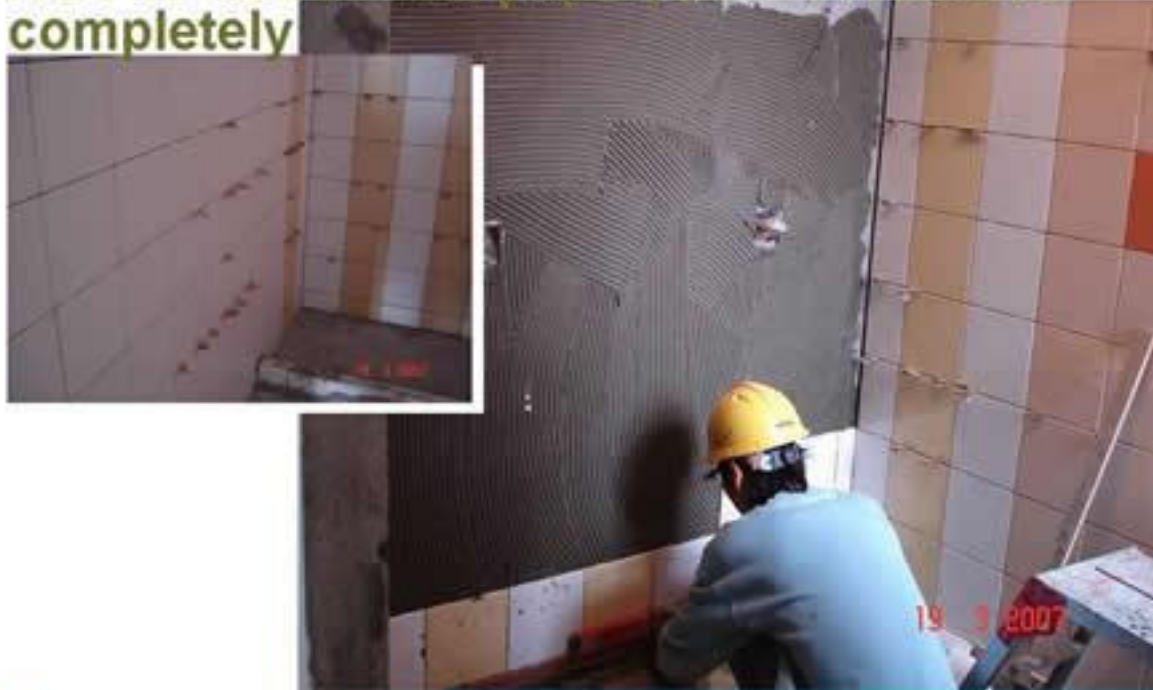
NOT to use carton paper, cannot remove completely

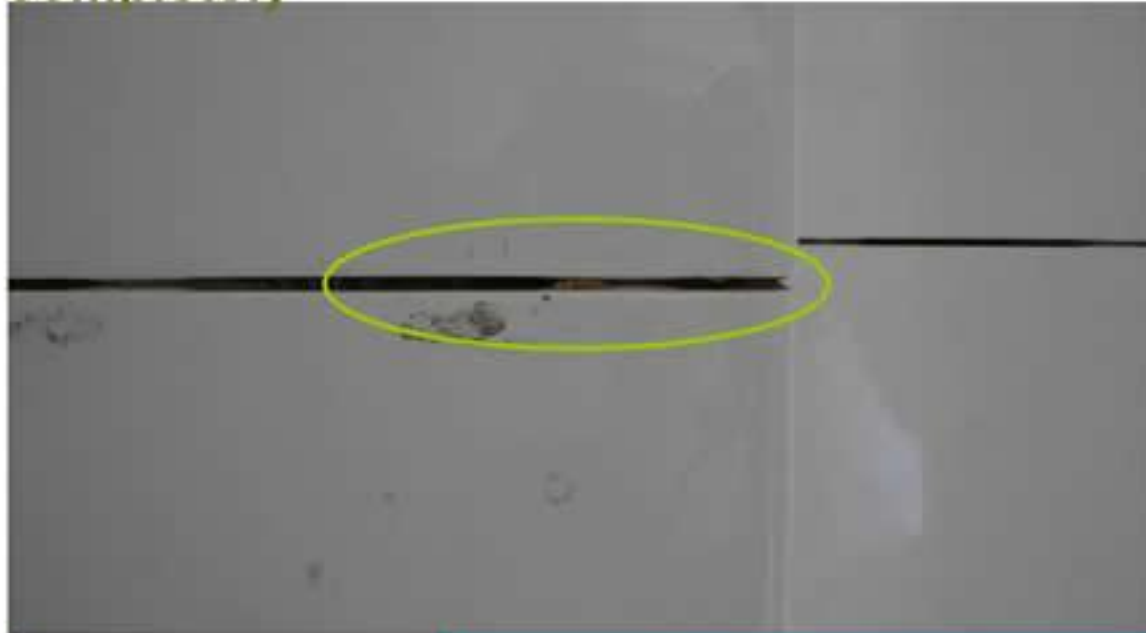
NOT to use carton paper, cannot remove completely

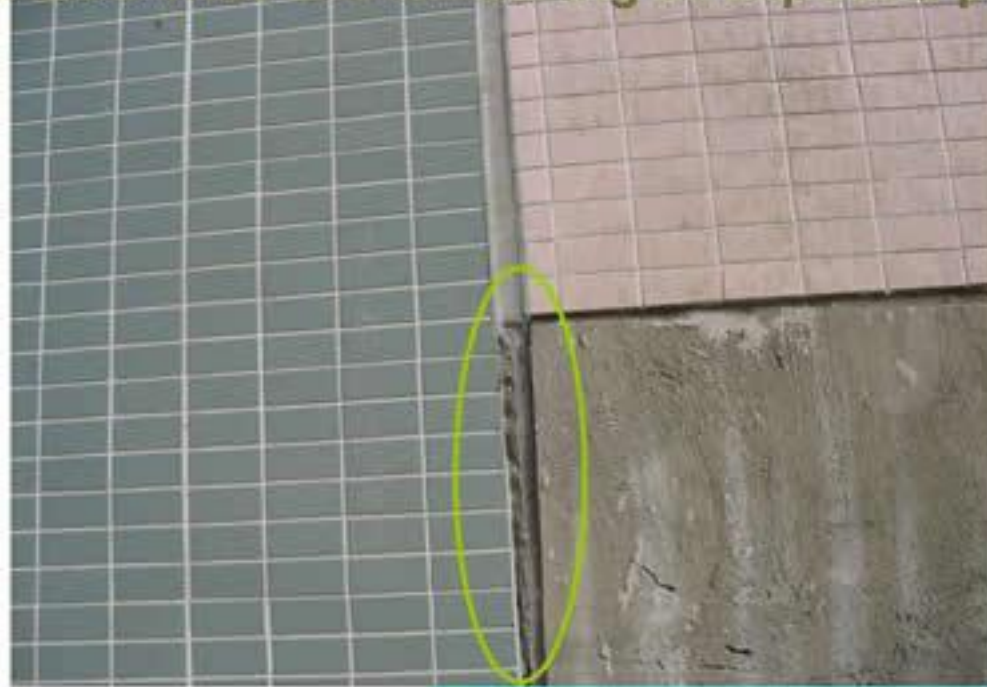
Covering Up of Expansion Joint Filled with C/S rendering at exposed portion

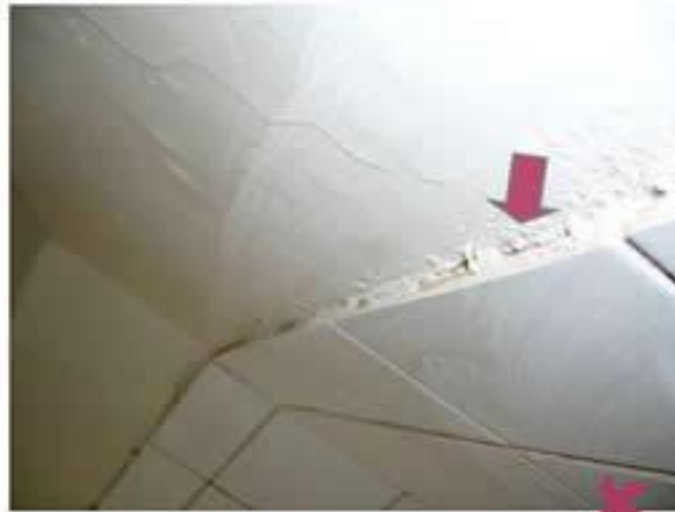
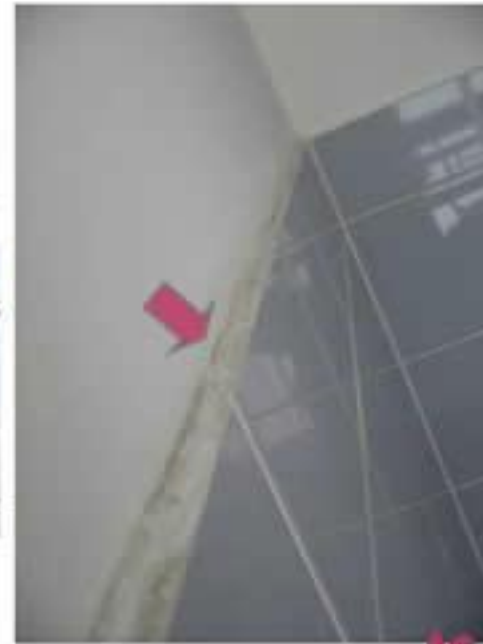
Improper Sealing at Top of Wall Tiles At kitchen / bathroom walls

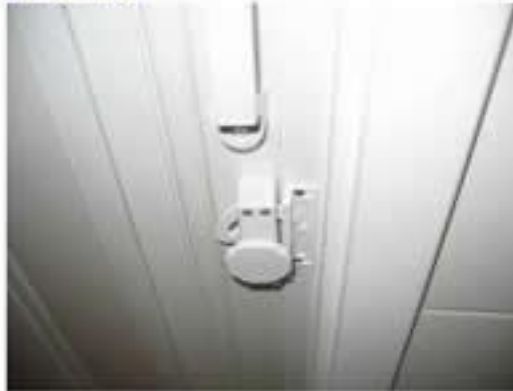
Door lock bracket fixed
by screws to plastic
frame

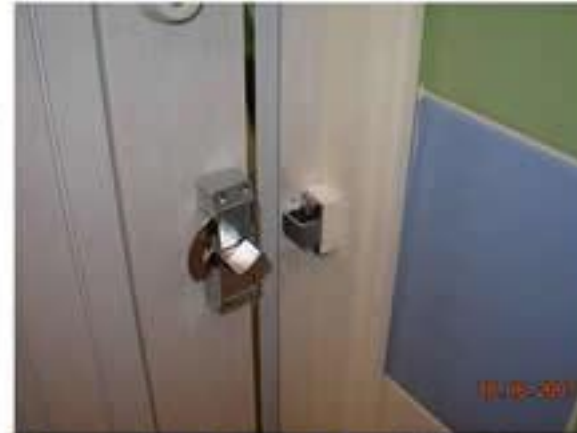
NOT rigid, easy to
become loose and
fall off

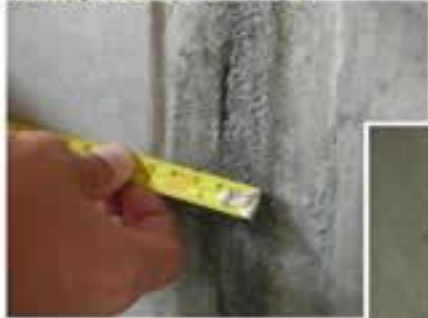
Width of joint exceeded
designed tolerance

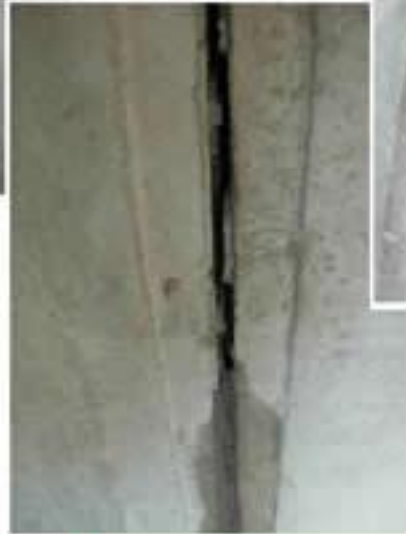
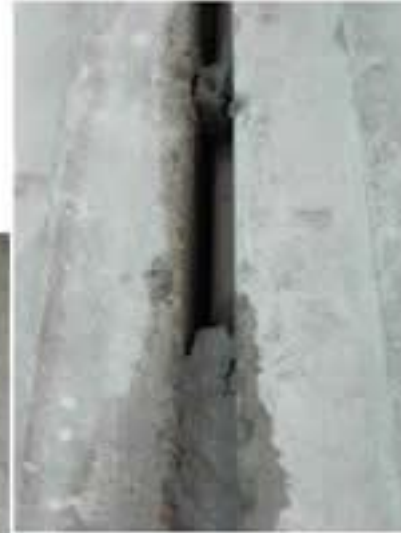
Loose material
found inside the
joint during cover up

Joint not fully
grouted during
construction

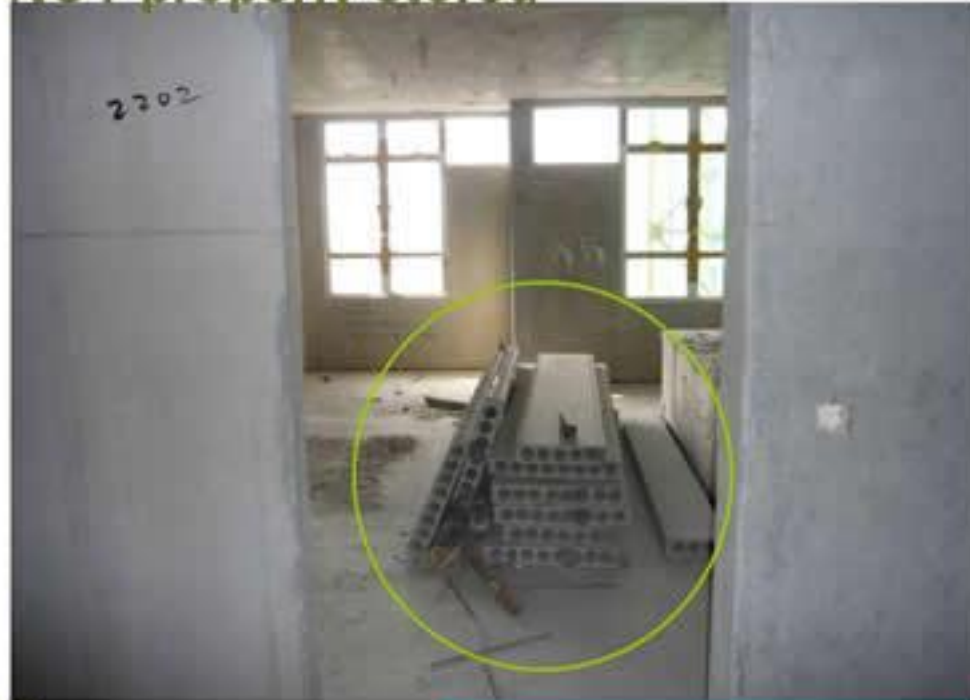
NOT properly stored

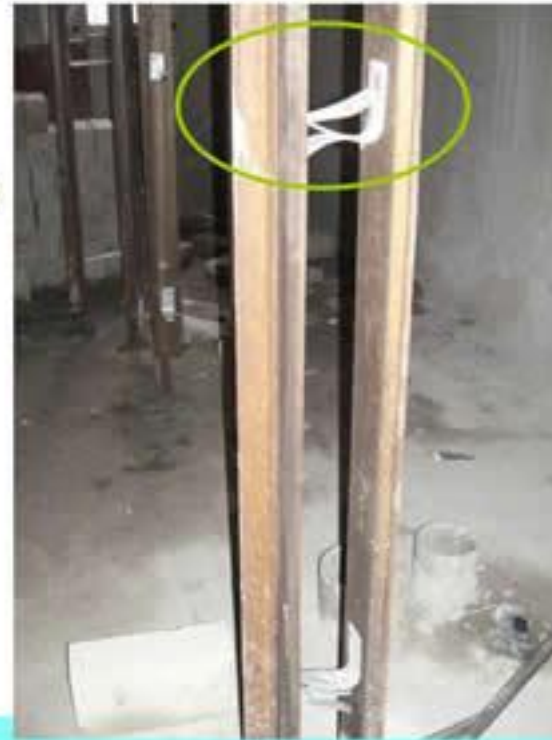
Cramps for Door Sub-frames

Offset with adjacent cramp to increase rigidity

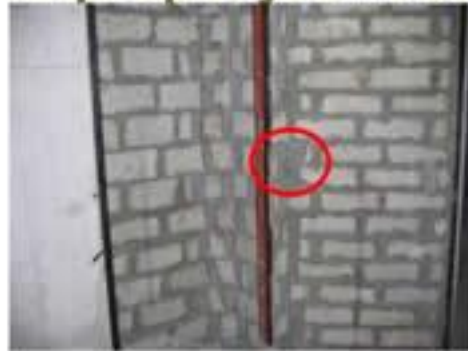
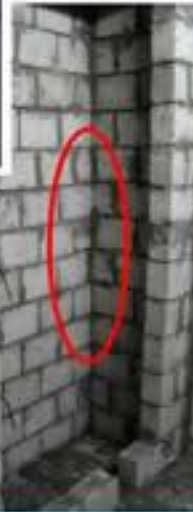
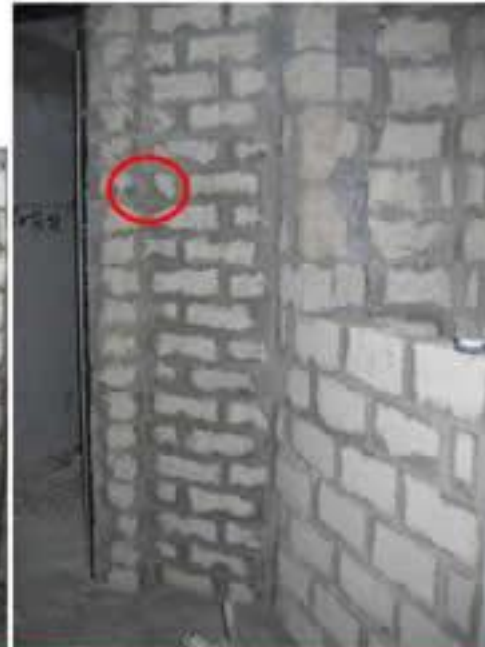
Concrete Block Wall Improper joints at corner

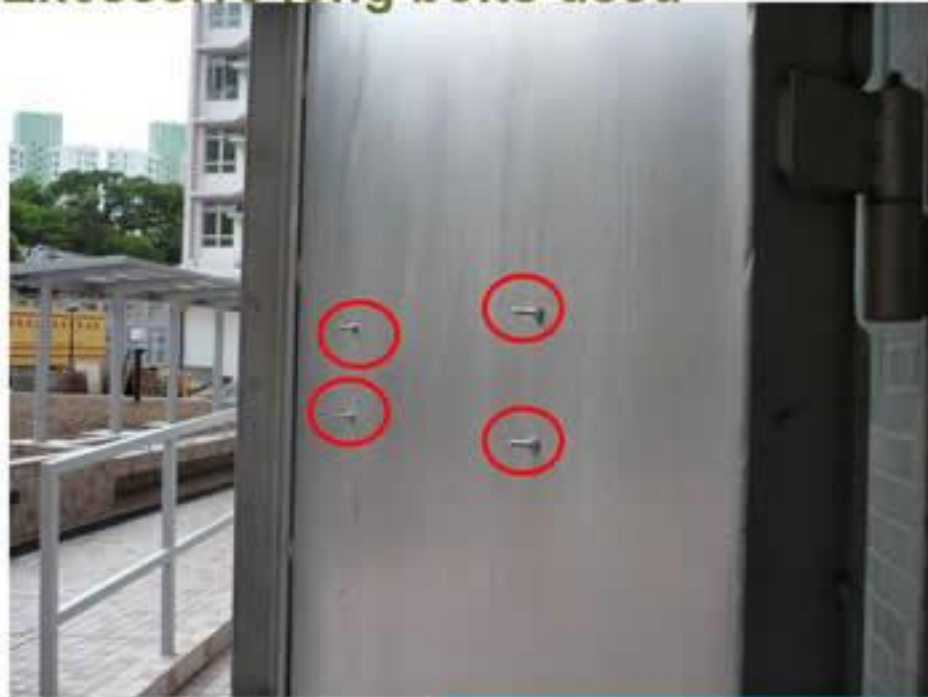
Fixing of Steel Door Plates

Excessive long bolts used

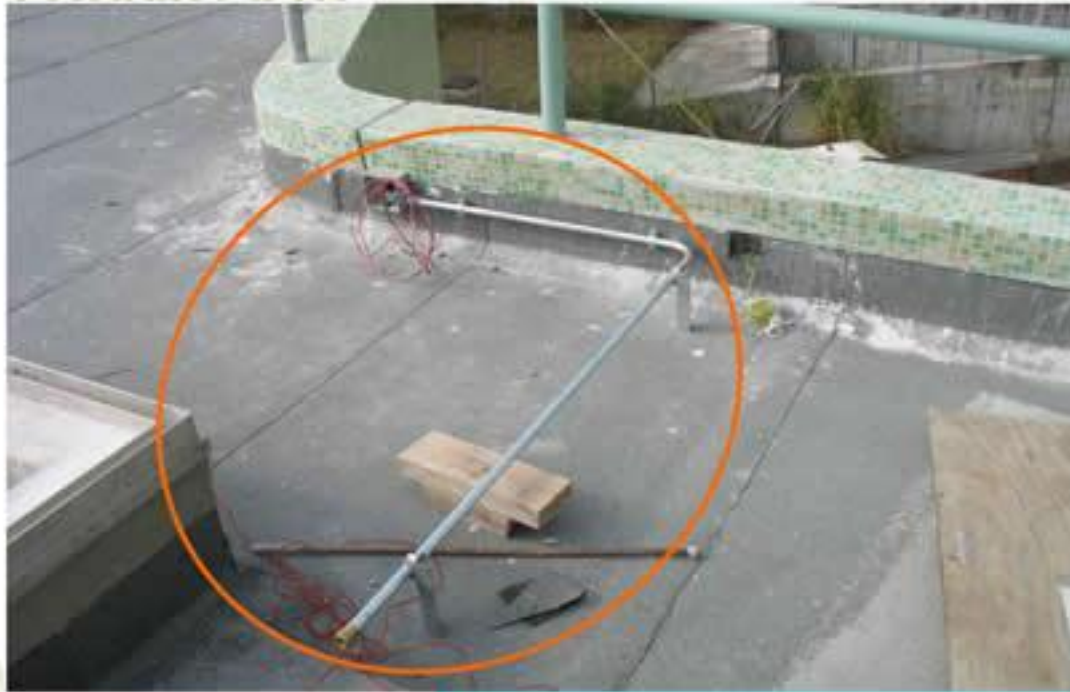
Waterproof Membrane at Roof Damaged by fixing screws for electrical conduit / box

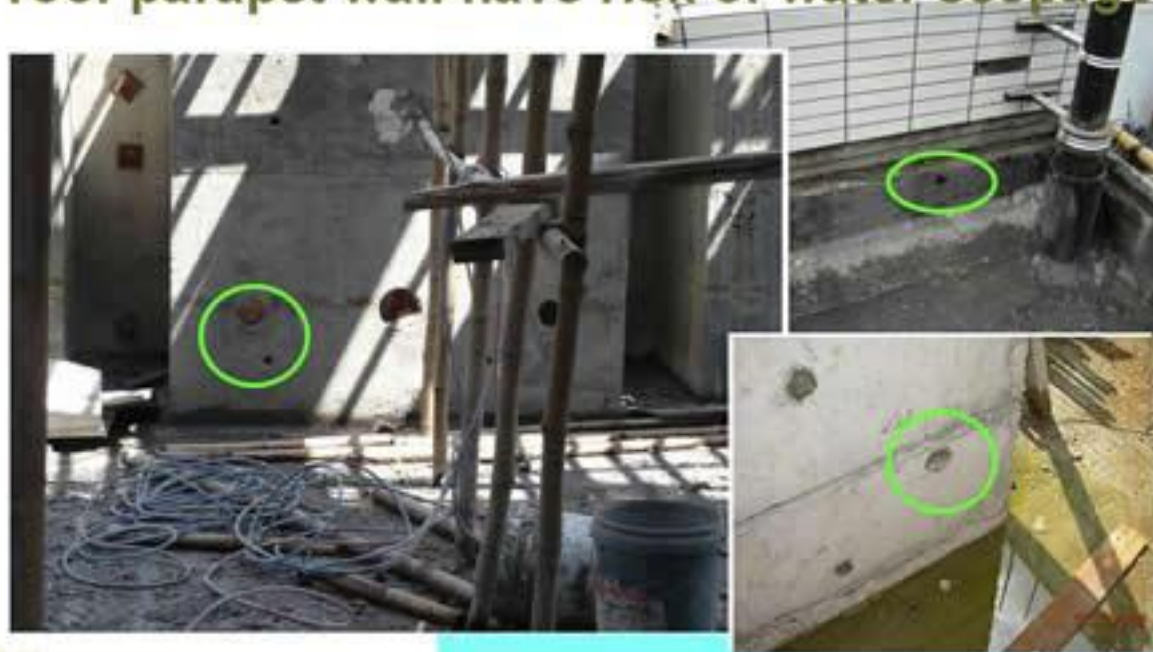
Tie bolt holes and sleeves at skirting level of roof parapet wall have risk of water seepage
