SANITARY FITTINGS

[Experience Sharing Sheet PLU-3]

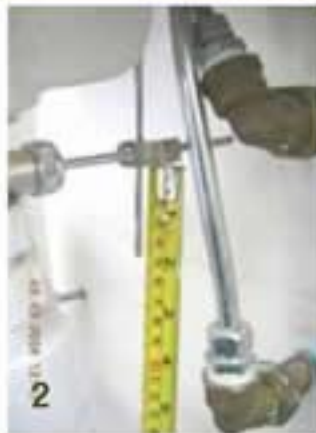
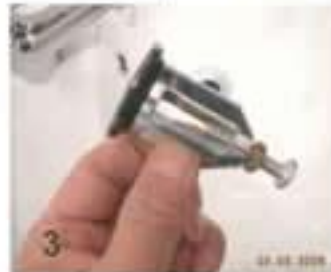
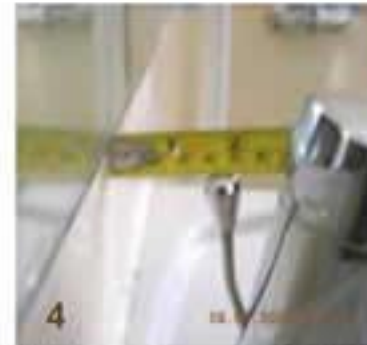
Insufficient space for pop-up of basin

1. Choose slim mixers, mixers inclined from wall or basin with greater space
2. Adjust length of pop-up rod
3. Adjust screws in drain plug to suit pop-up length
4. Bend the projected part of pop-up rod

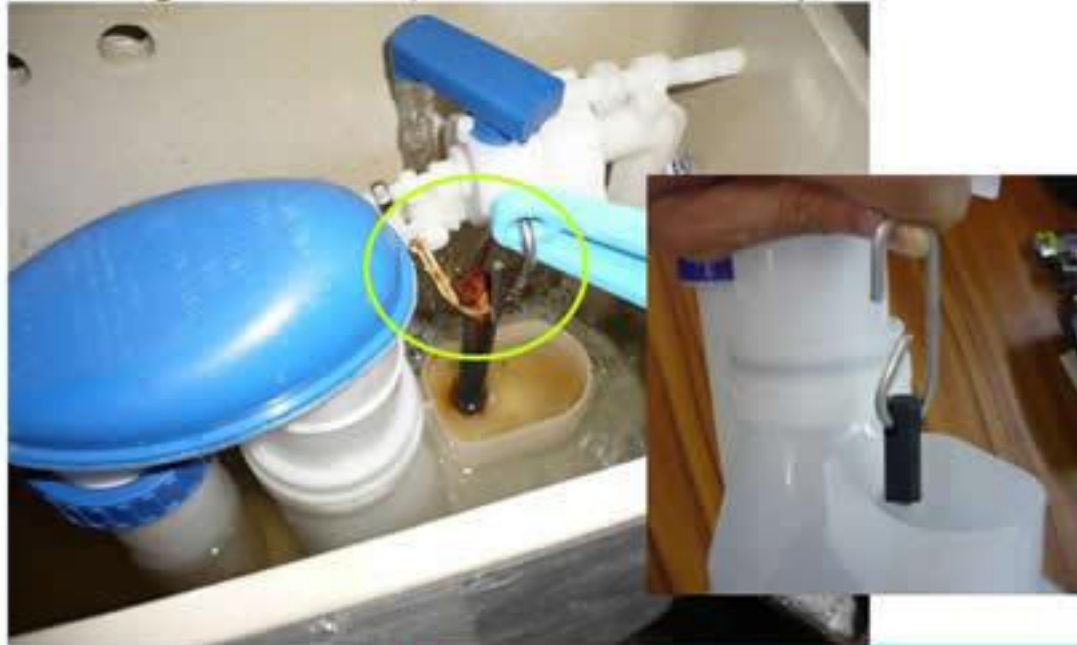
WC Cistern – Rust at Piston Rod

Temporary tie wrap NOT removed after installing the C-Link, causes RUST at piston rod

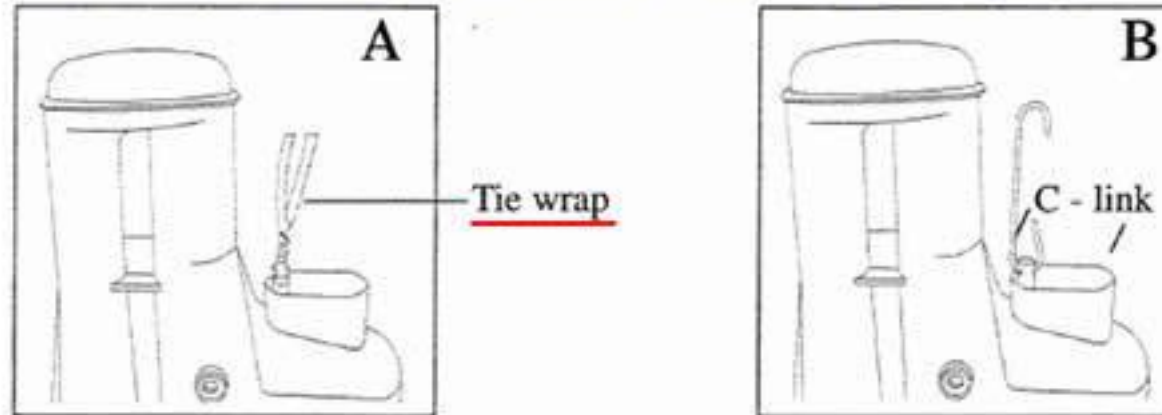
WC Cistern – Rust at Piston Rod

Temporary tie wrap HAVE to be removed after installing the C-Link, causes RUST at piston rod

Push the piston assembly from the bottom, inside the housing of the siphon and remove the tie wrap from the piston rod (shown in picture 'A'), insert the c-link into the piston rod as shown in picture 'B'.

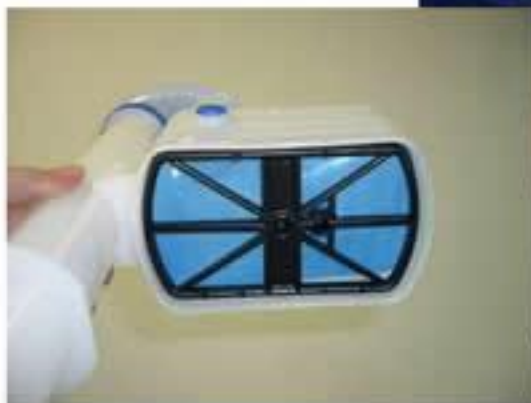
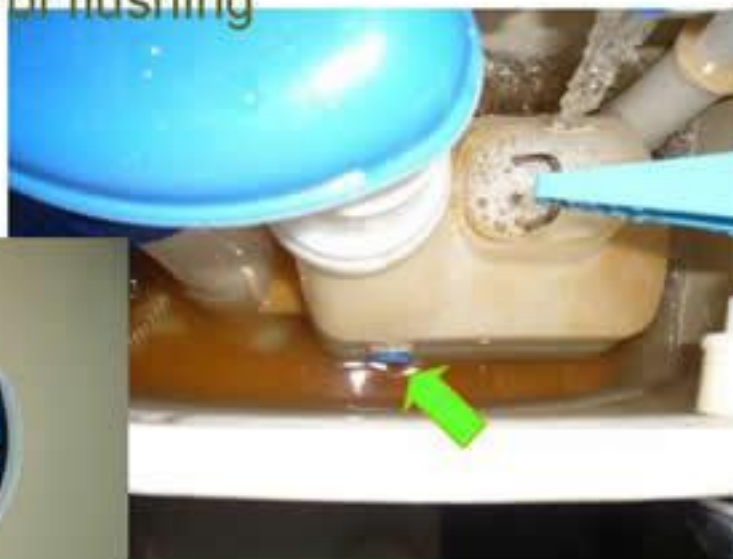
WC Cistern - Inadequate Flushing

Water level adjusting valve
controls volume of flushing

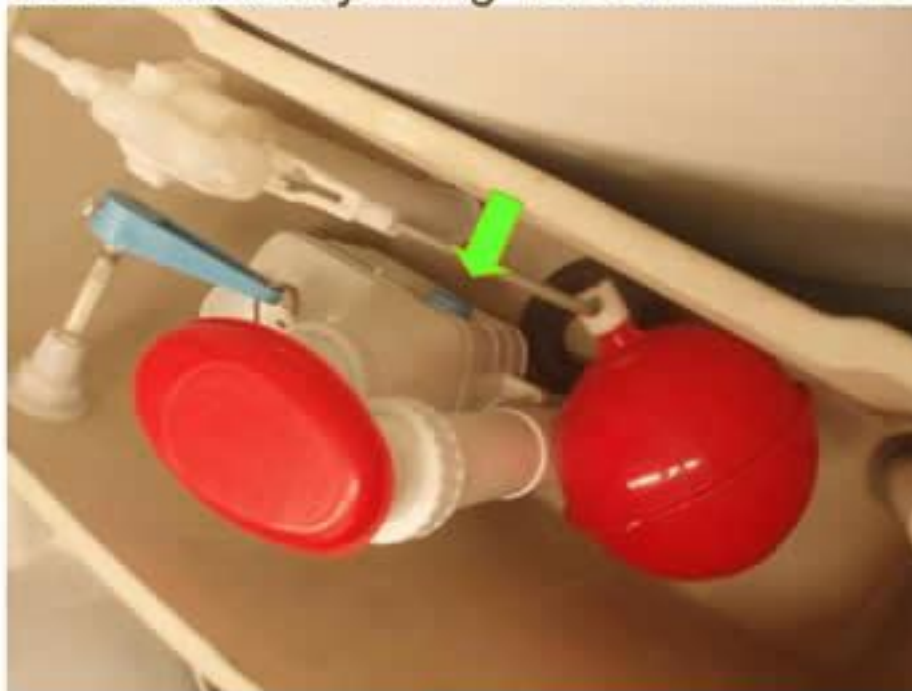
WC Cistern - Inadequate Flushing

Water level adjusting valve IN PLACE

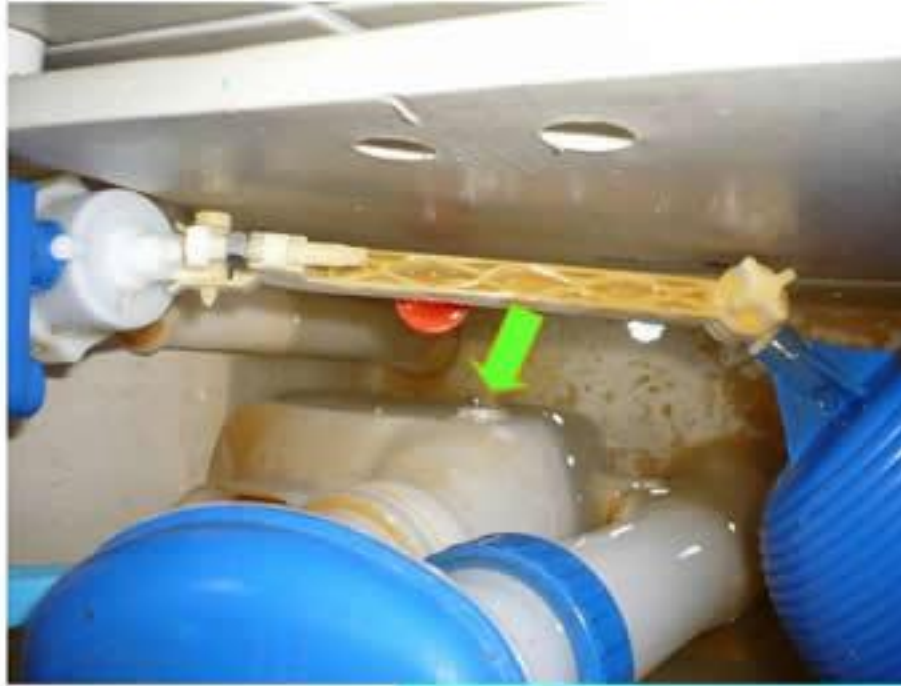
WC Cistern - Inadequate Flushing

Water level adjusting valve LOST

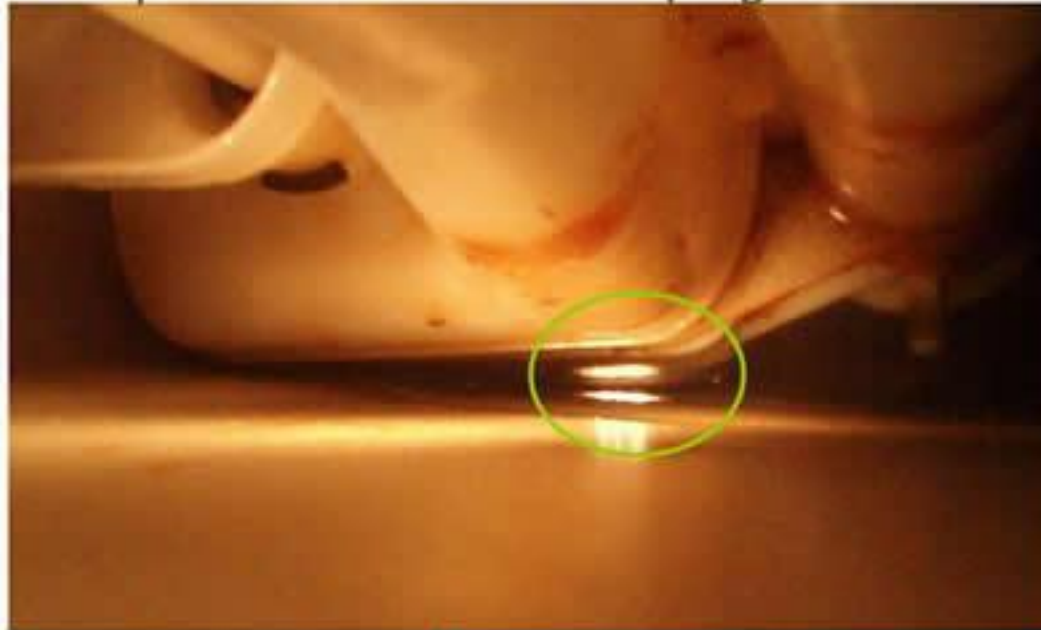
WC Cistern - Inadequate Flushing

Flushing device too big,
no space to access to the plug

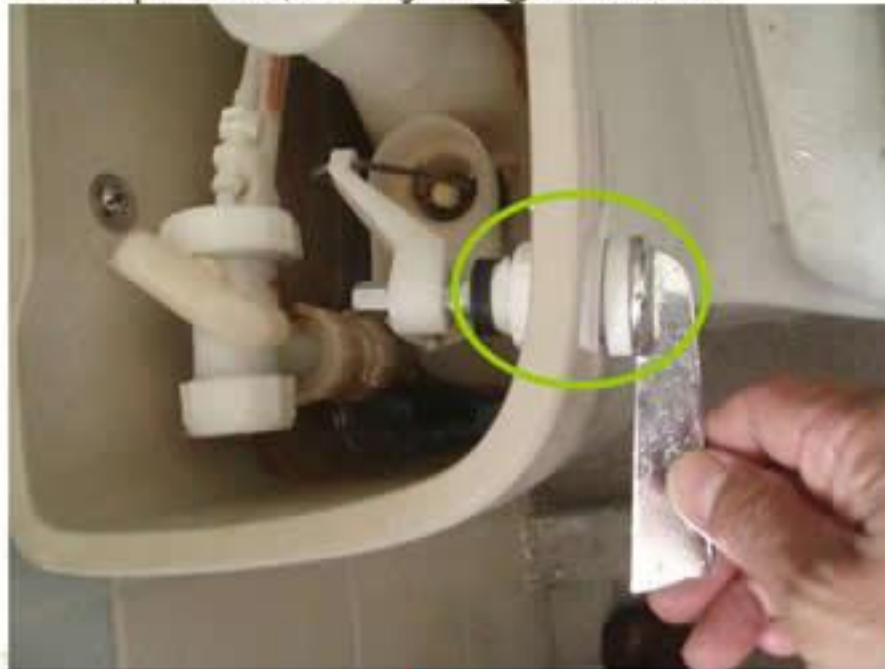
Cistern Lever not Properly Fixed

Lever fixing gasket outside NOT follow the tank profile, easy to get loose

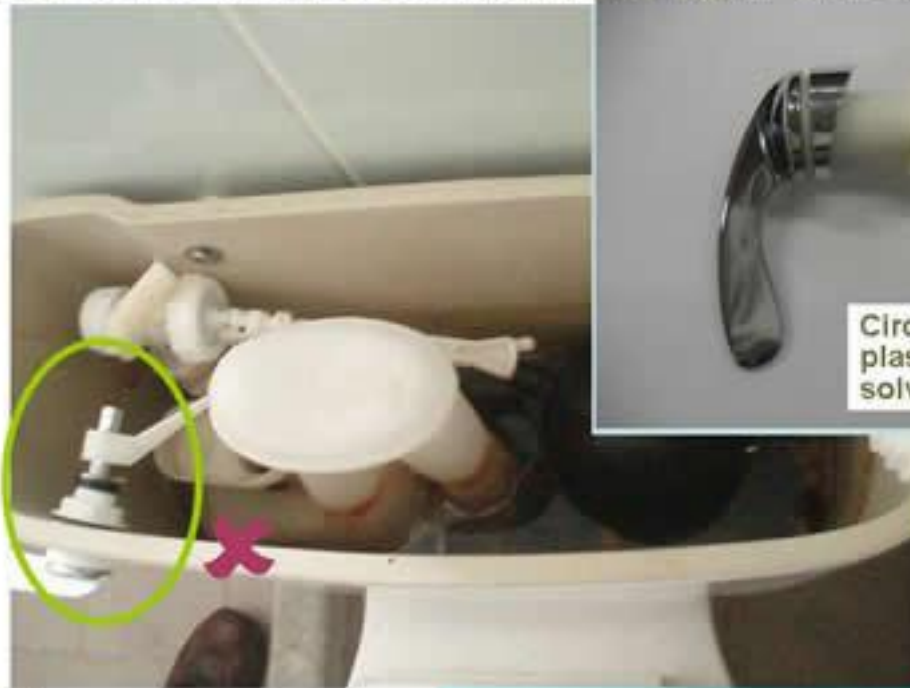
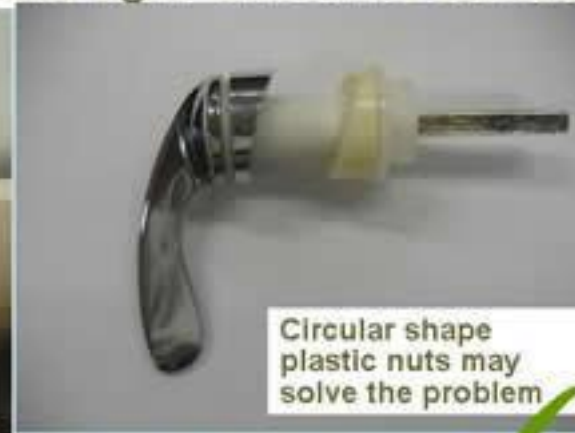
Cistern Lever not Properly Fixed

Flat bolts inside cannot hold tight on curve surface

Circular shape
plastic nuts may
solve the problem

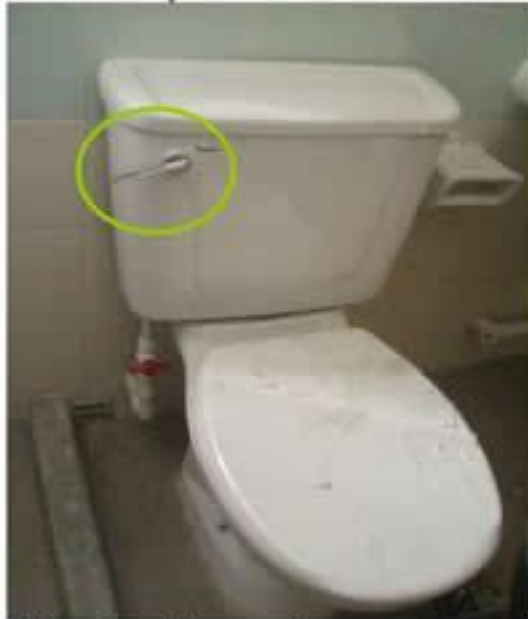
Cistern Lever not Properly Fixed

Lever position affects turning action

Need a bigger turn

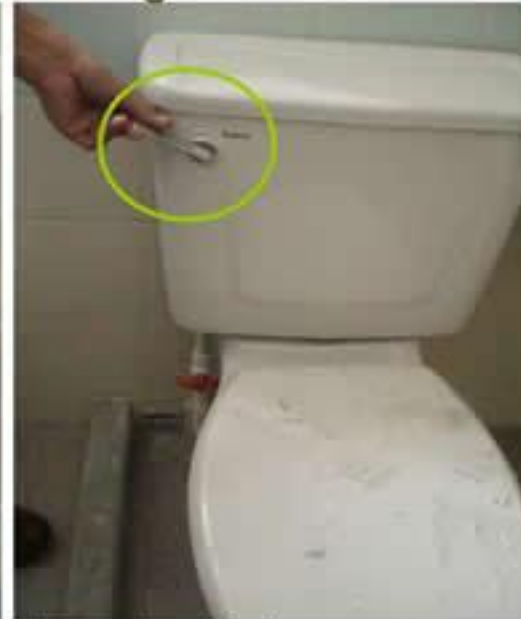
Lever too high,
obstructed by the lid

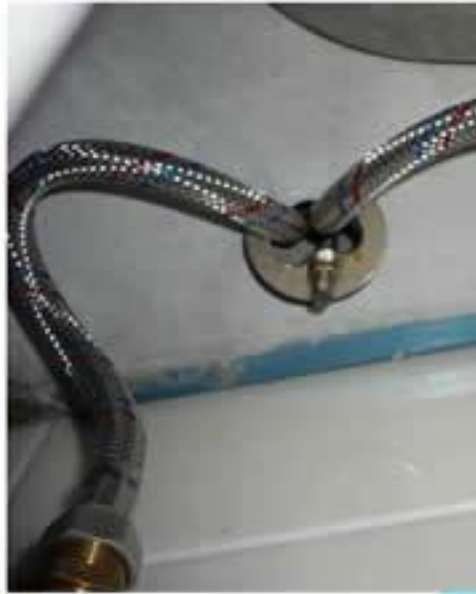
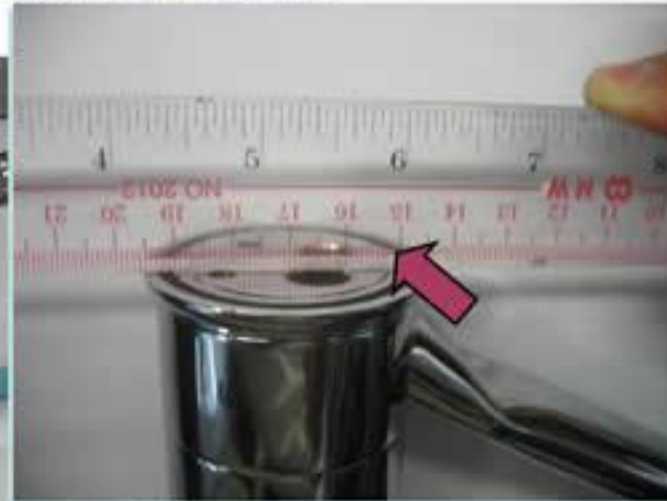
Mixer Connection Leakage

Diameter of rubber ring too small, flush with surface. No gasket function

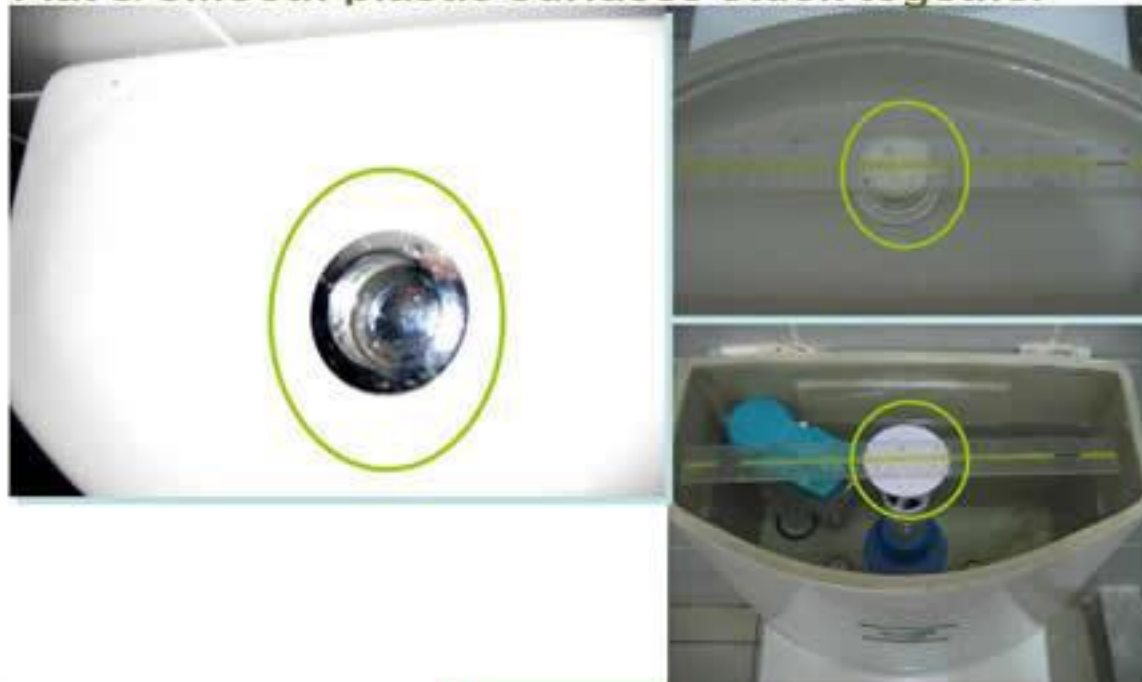
Press Button Not Released after Flushing

Flat & smooth plastic surfaces stuck together

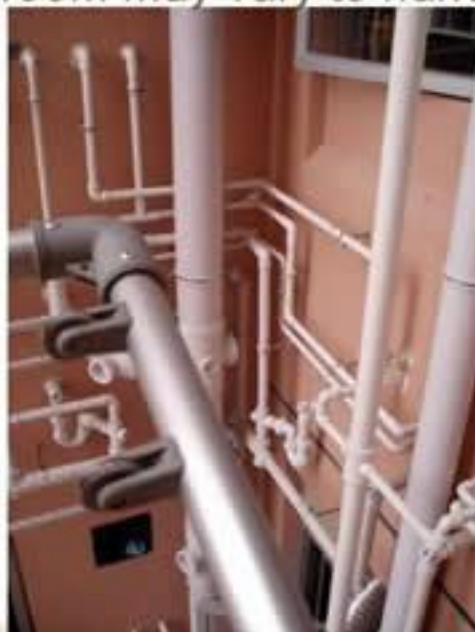
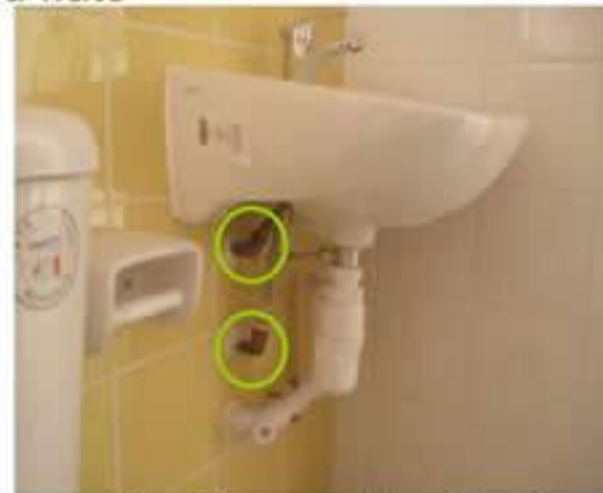
Wrong Connection of Hot/Cold Water at Wash Hand Basin

Level of pipe connections from re-entrant to bath room may vary to handed flats

Plumber need to check incoming pipes before fixing

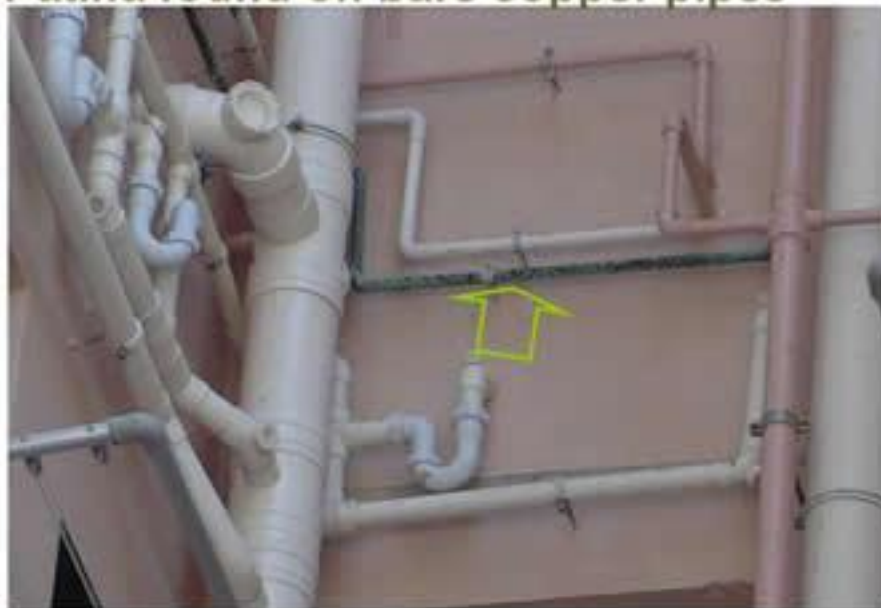
Copper Pipes

Patina found on bare copper pipes

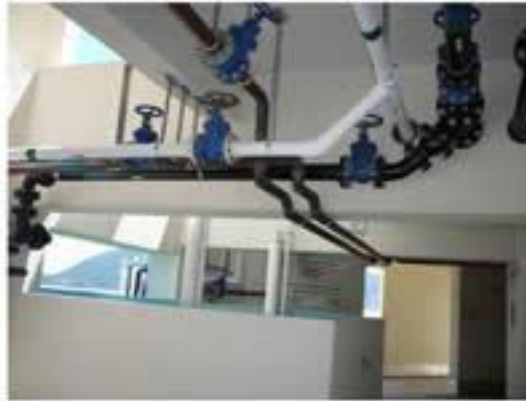
Copper Pipes Inadequate Workmanship

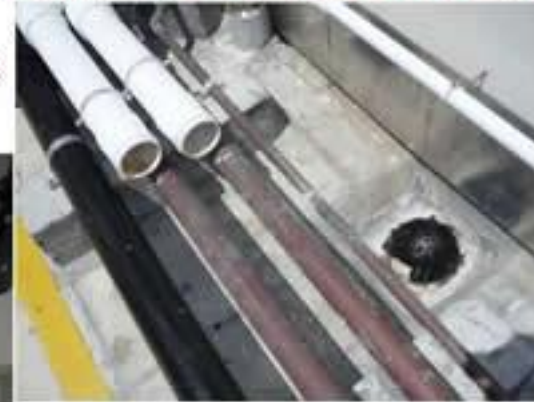
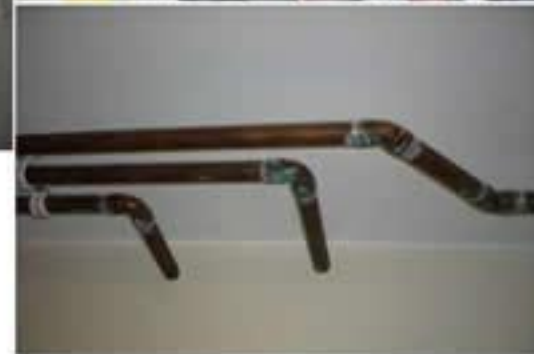
Not properly cleaned

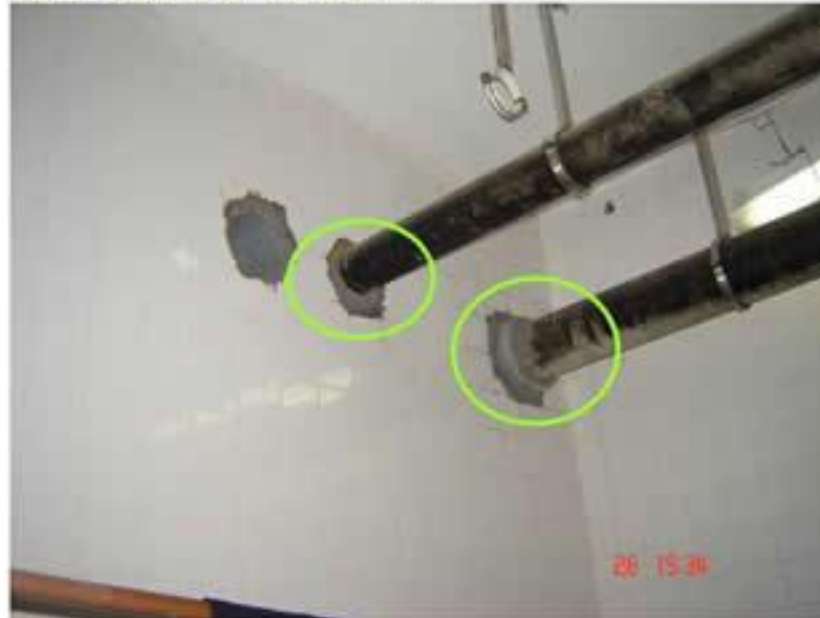
Pipes through Structure from Pump Room **NOT** caulked with mineral wool and fire-rated mastic

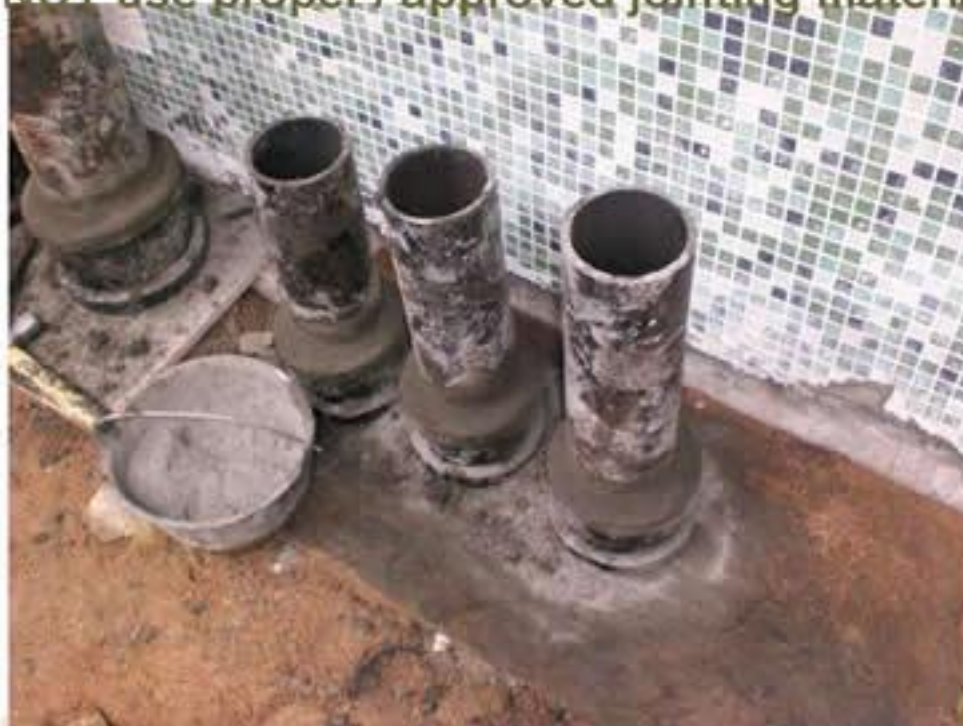
Pipes Through Floor Slab

NOT use proper / approved jointing materials

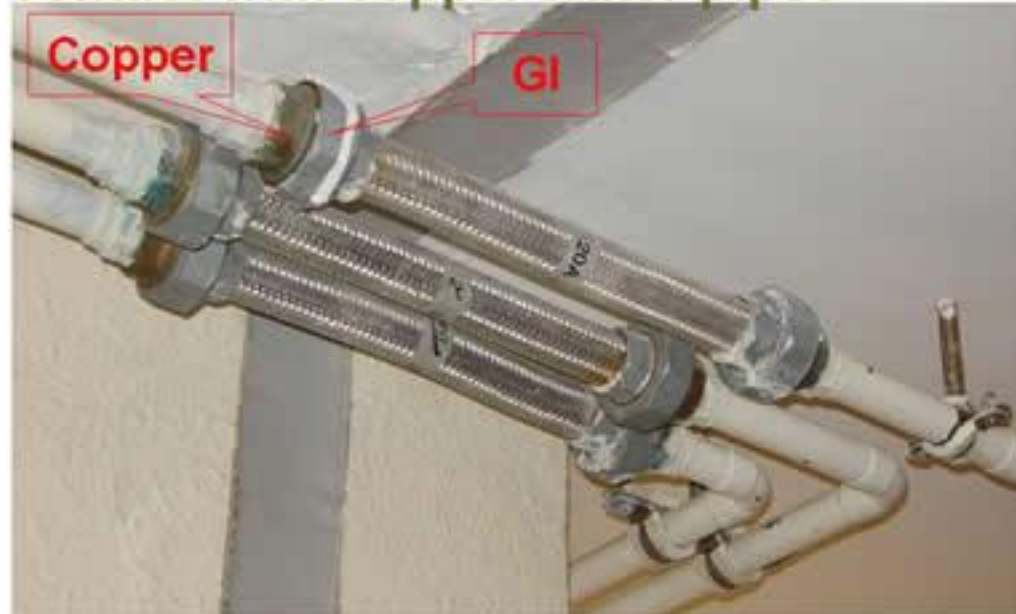
Flexible Pipe Connector

G.I. nuts of flexible connector in direct contact with copper water pipes

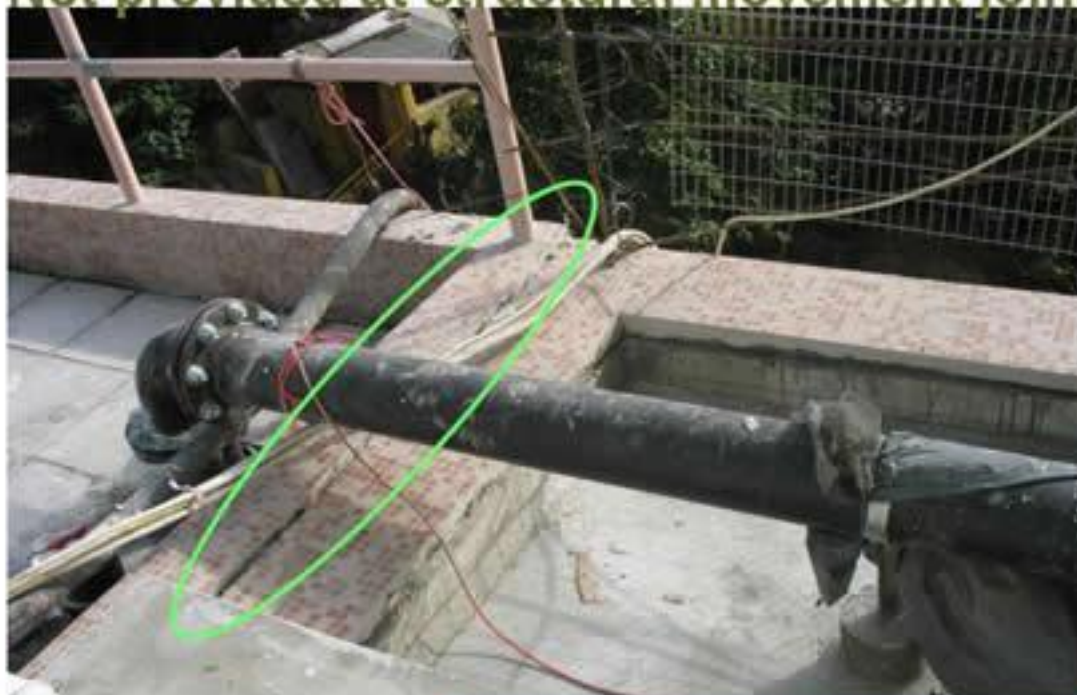
Flexible Connector for Pipeworks

Not provided at structural movement joint

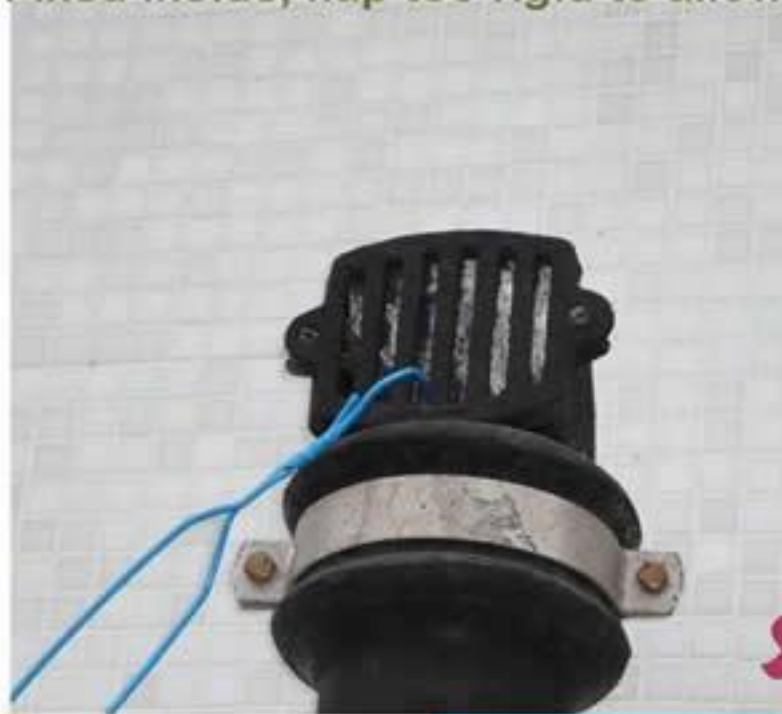
Mica Flap at Fresh Air Inlet

Fixed inside, flap too rigid to allow fresh air intake

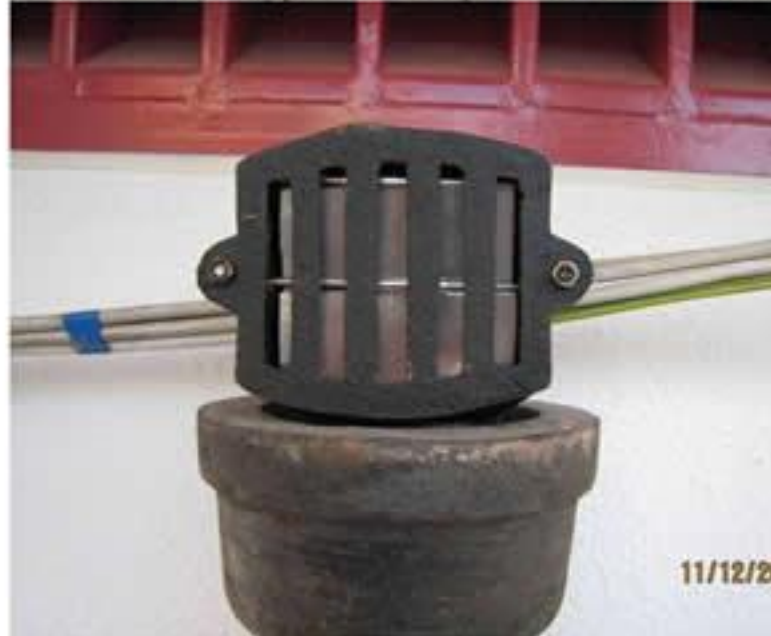
Mica Flap at Fresh Air Inlet

Hinged ss flaps allow fresh air intake

But not air tight to stop foul air emission

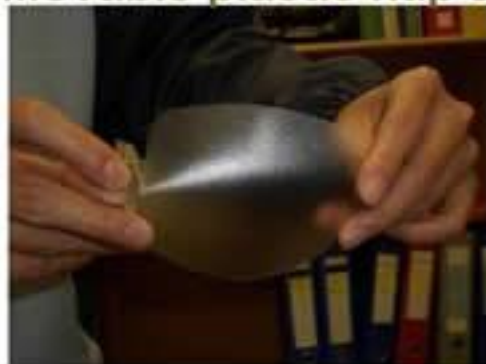
Mica Flap at Fresh Air Inlet

Movable plastic flap allows air intake

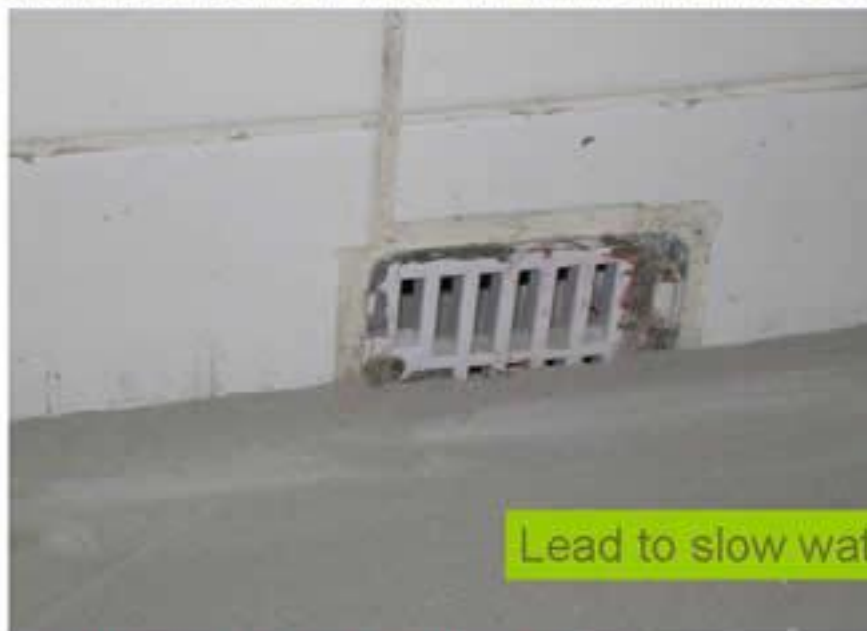
Kitchen/Bathroom* Floor Drain Grating Installed lower than the finished floor level

Lead to slow water discharge

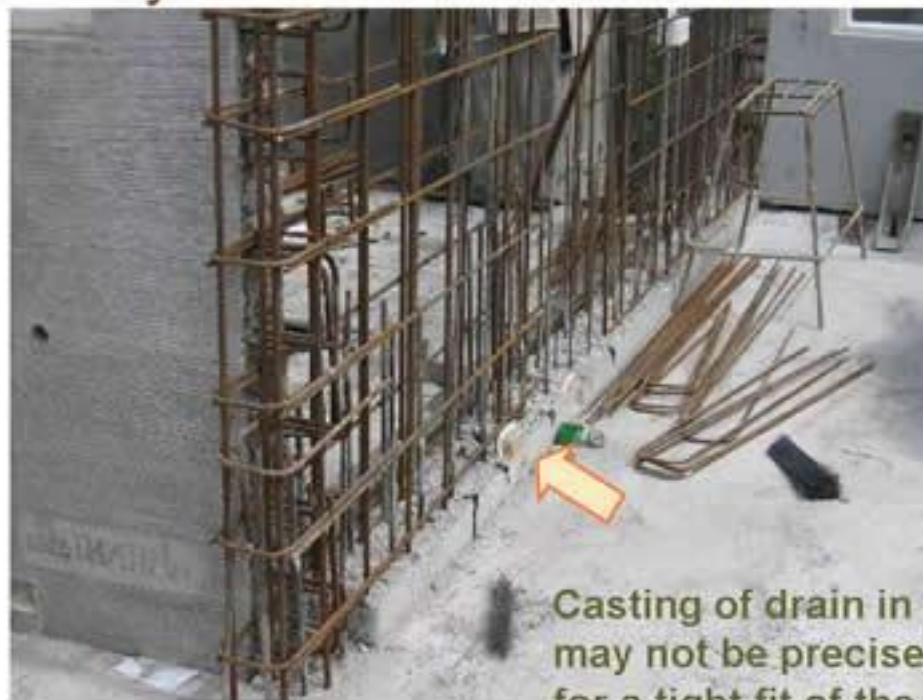
2-Way Floor Drain Installation

Casting of drain in concrete may not be precisely in position for a tight fit of the grating

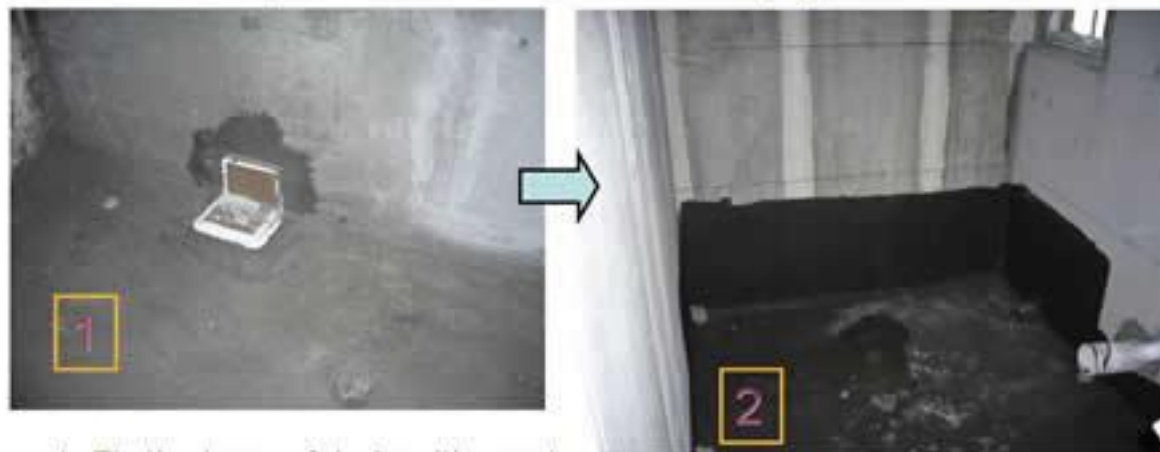
2-Way Floor Drain Installation

Contractor Proposal A – risk of water seepage

1. Fix the base of drain with grout
2. Apply overall waterproofing
No waterproofing at base of drain
Water may seep through the joint of the drain
3. Apply overall screeding

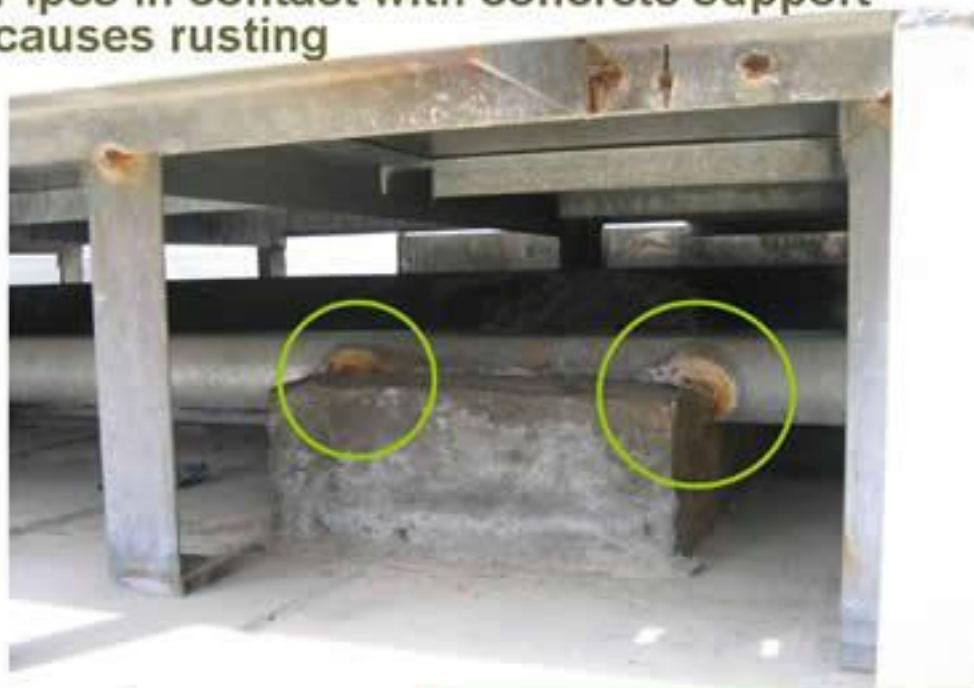
Pipe Support on Roof

Pipes in contact with concrete support causes rusting

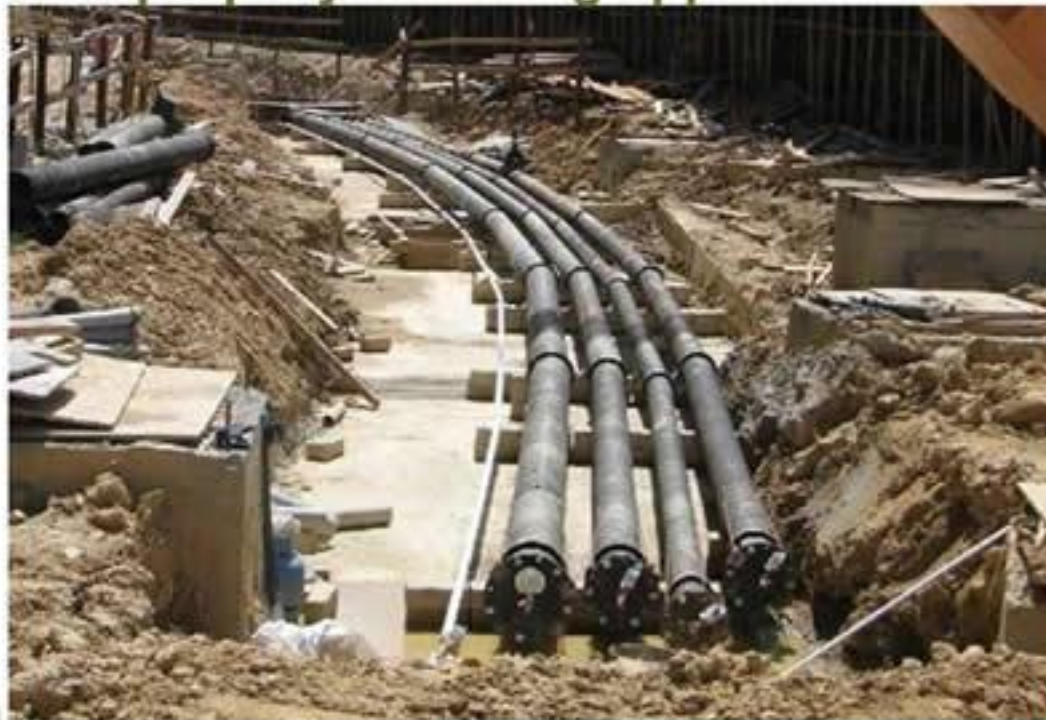
Laying of Underground Pipes

NOT proper joint fitting applied

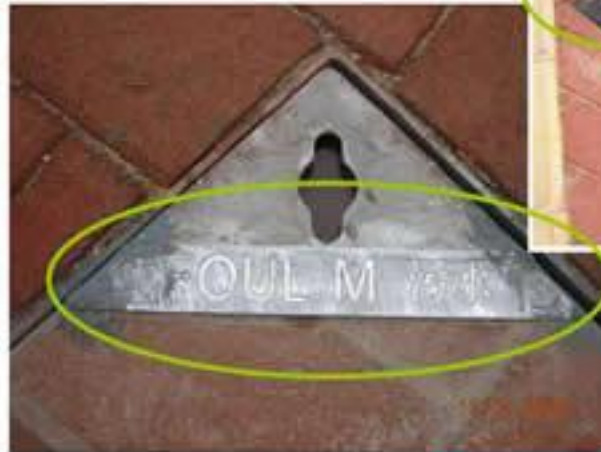
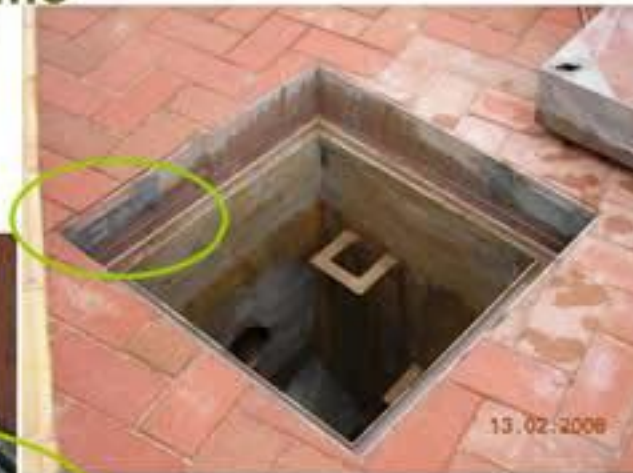
Identification of Manhole Type

Not engraved to frame
but by metal plates
as remedial work

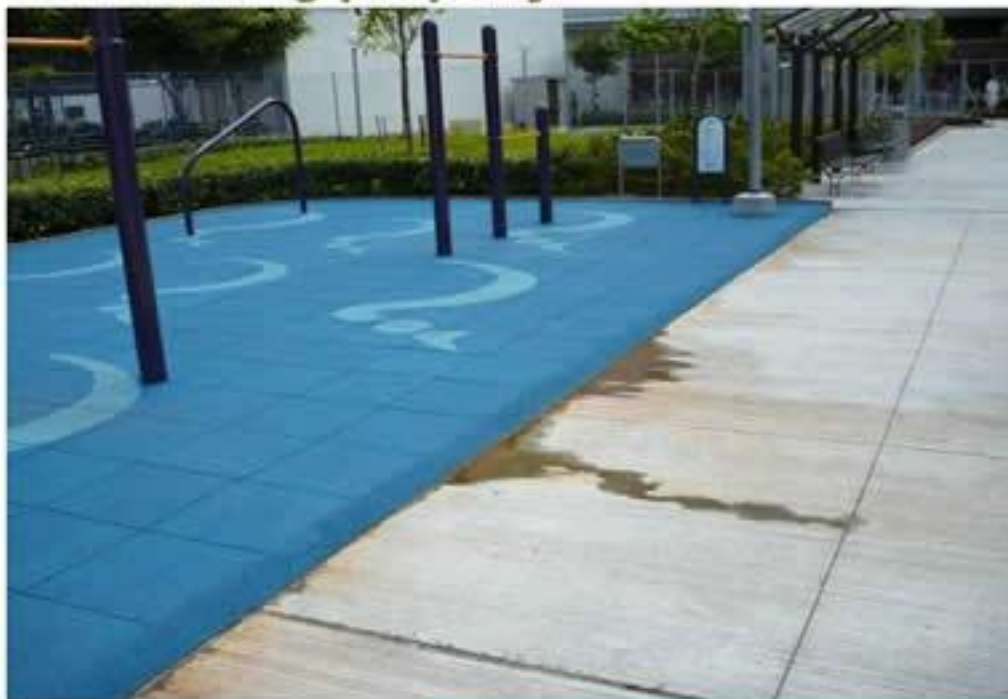
Drainage under Safety Mat Not working properly

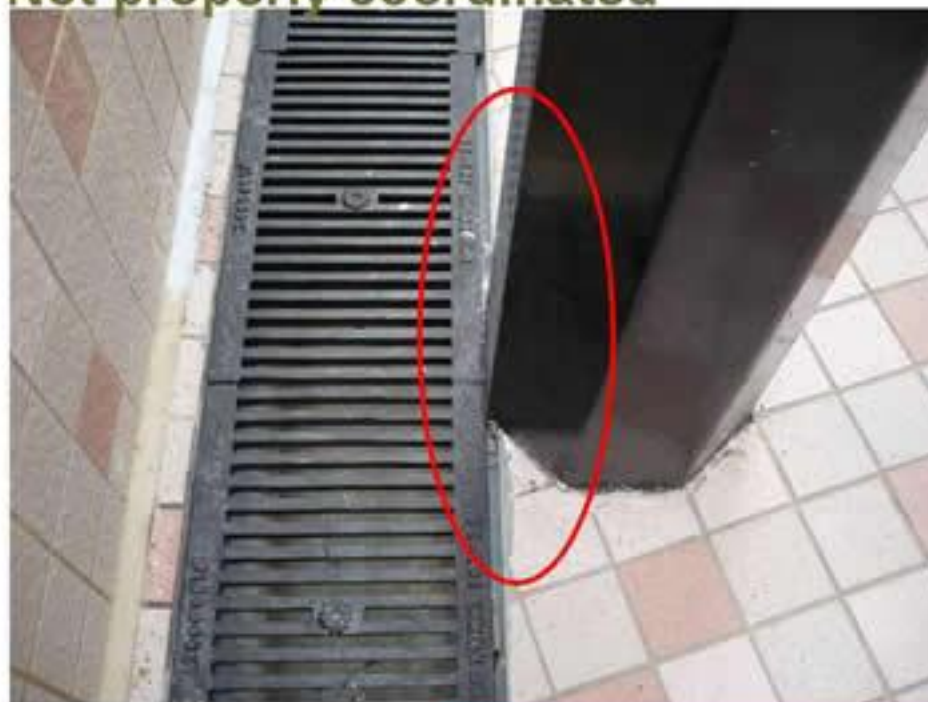
Lamp Pole and U-channel Not properly coordinated

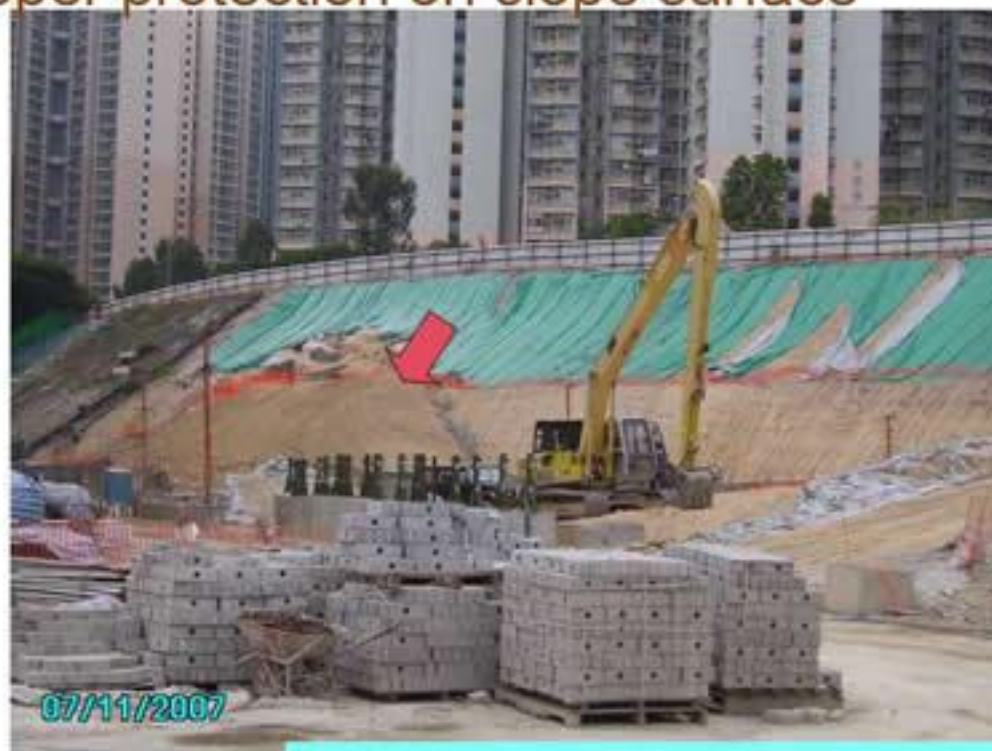
Improper protection on slope surface

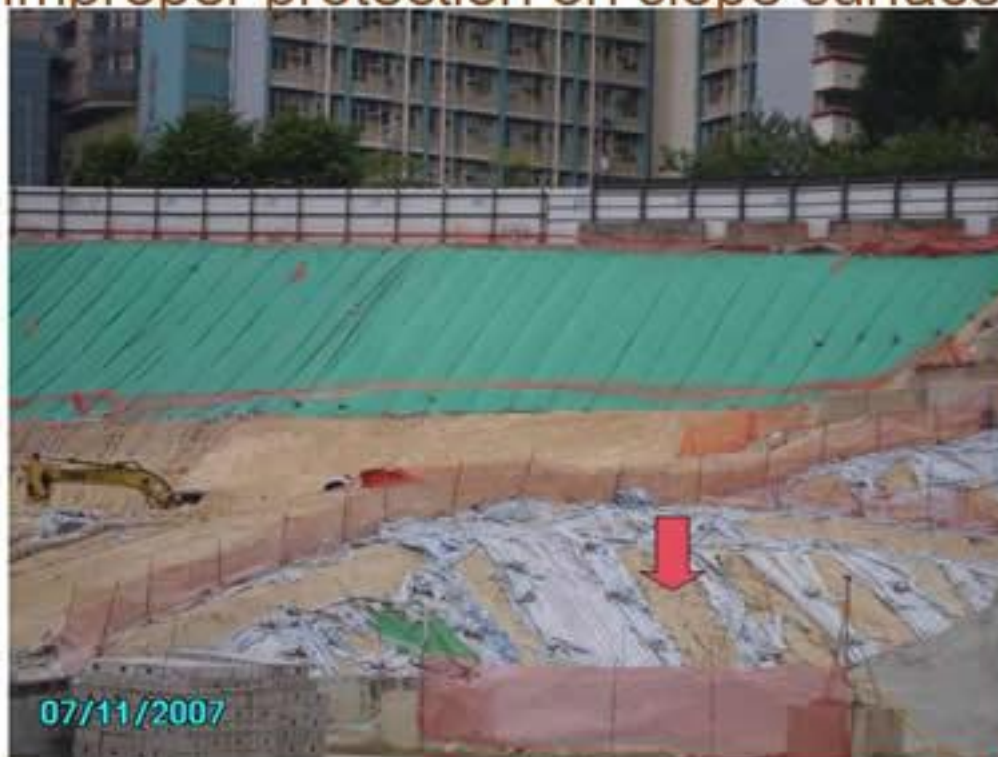
Improper protection on slope surface
