# **SITE SAFETY Focus Seminar**

on New Works of  
Housing Department

**Site Safety** issues at -

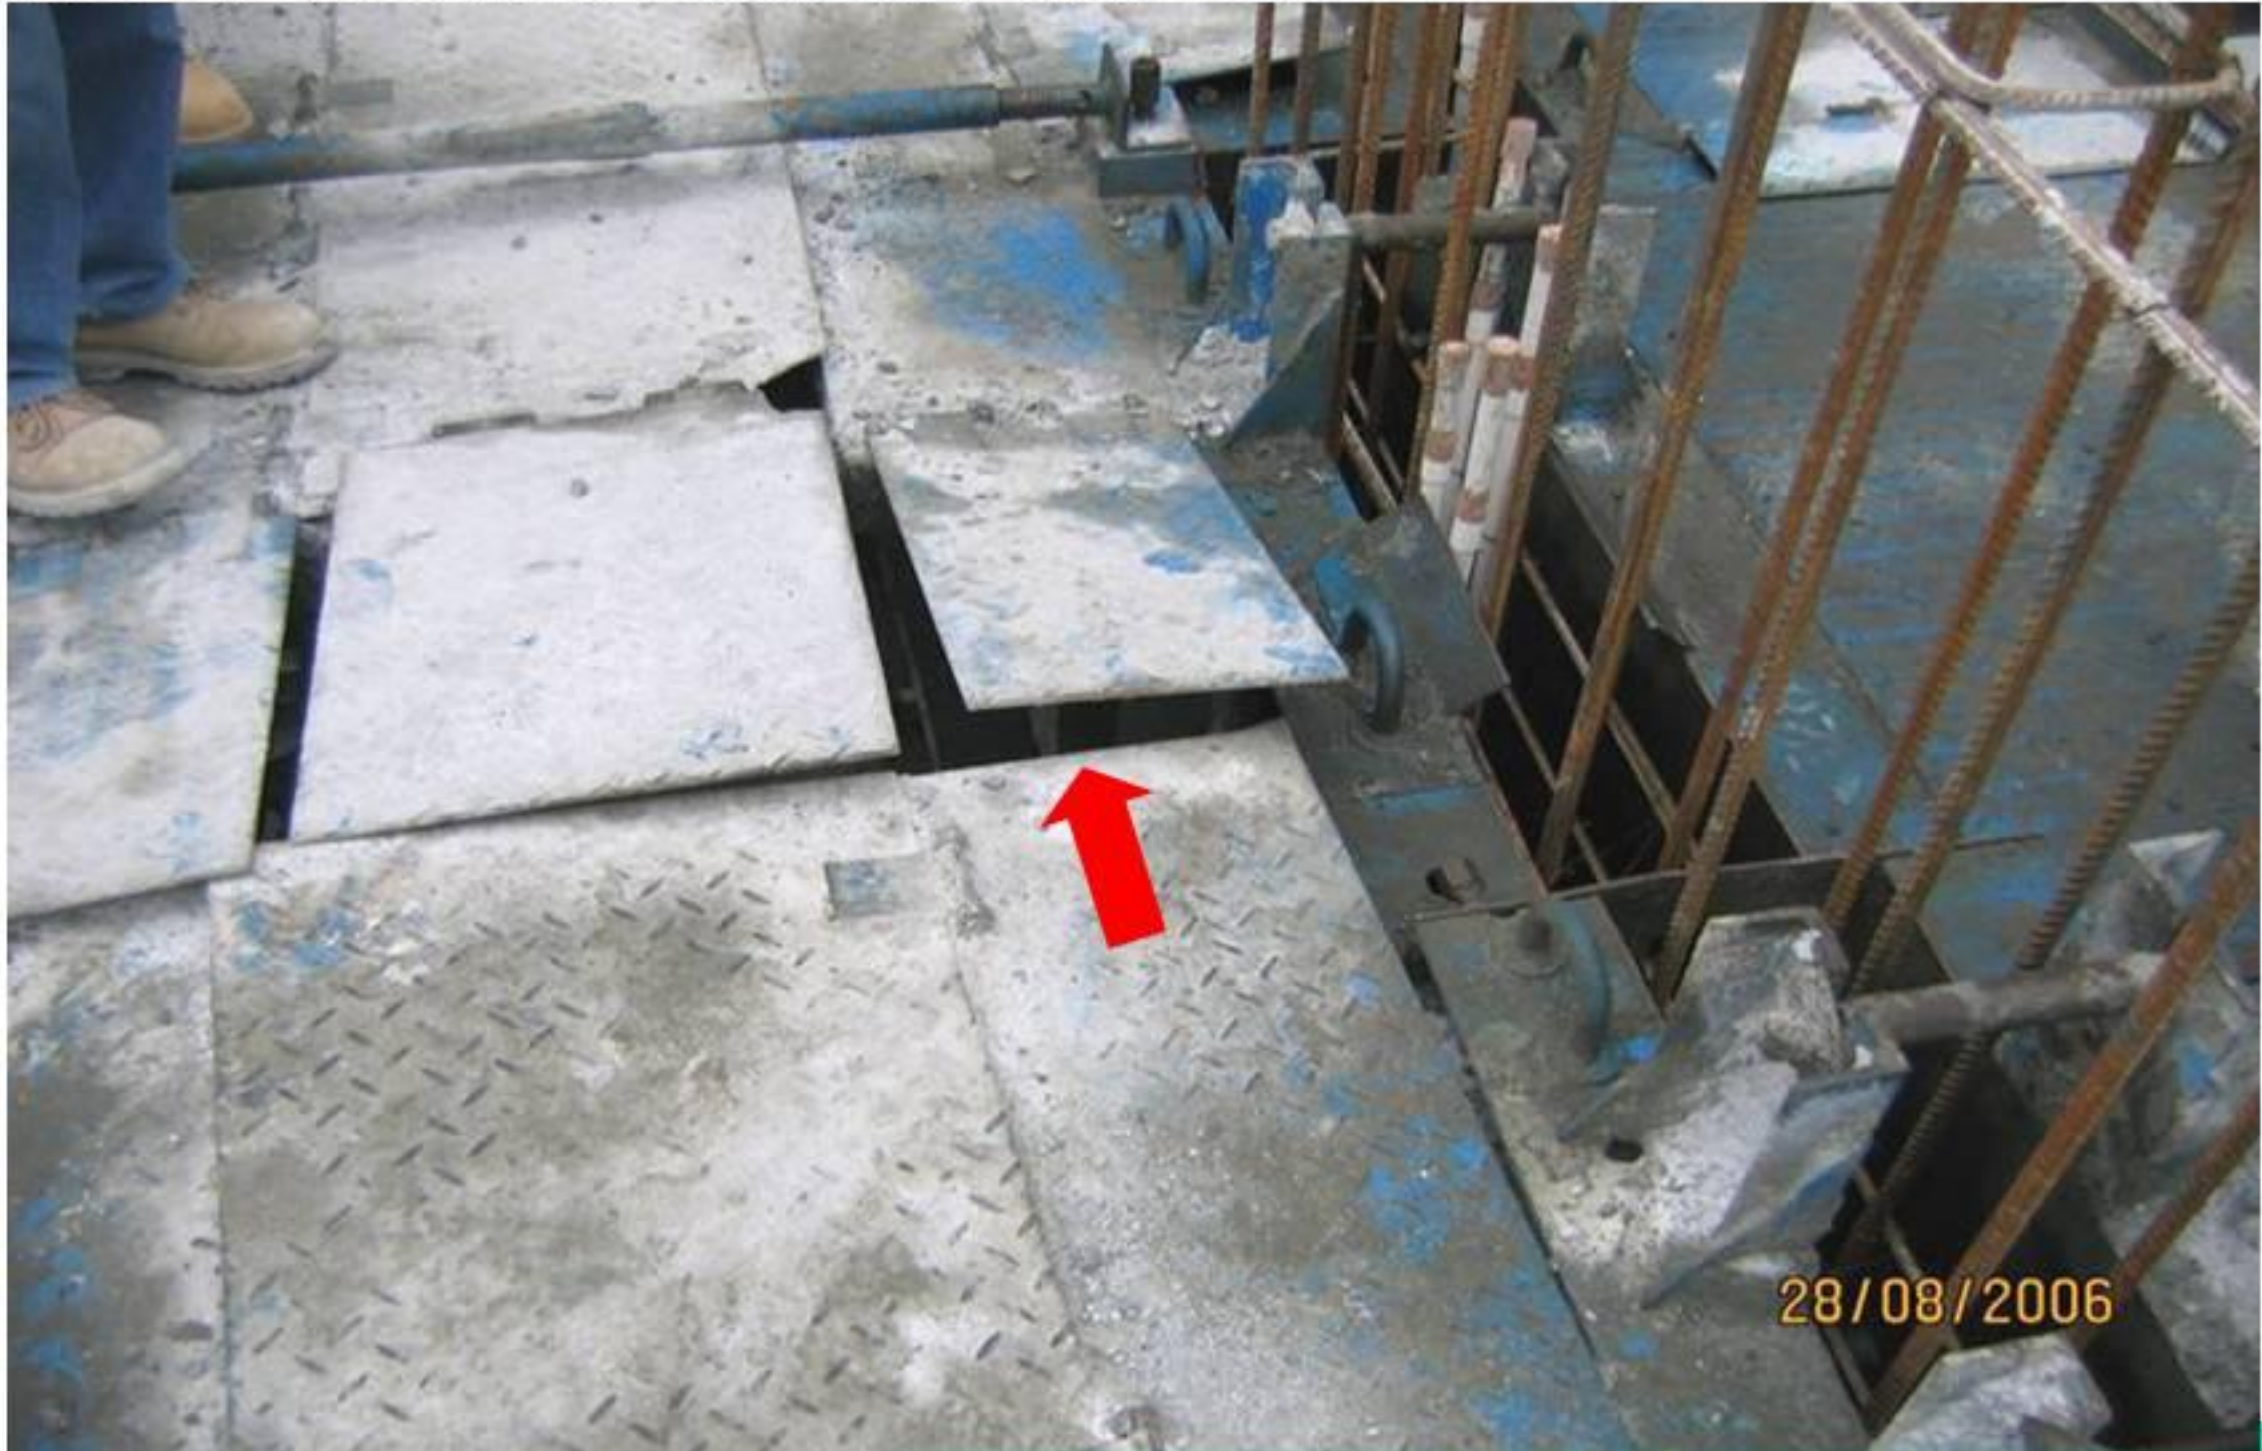
# Steel Working Platform floor board stuck / tilted

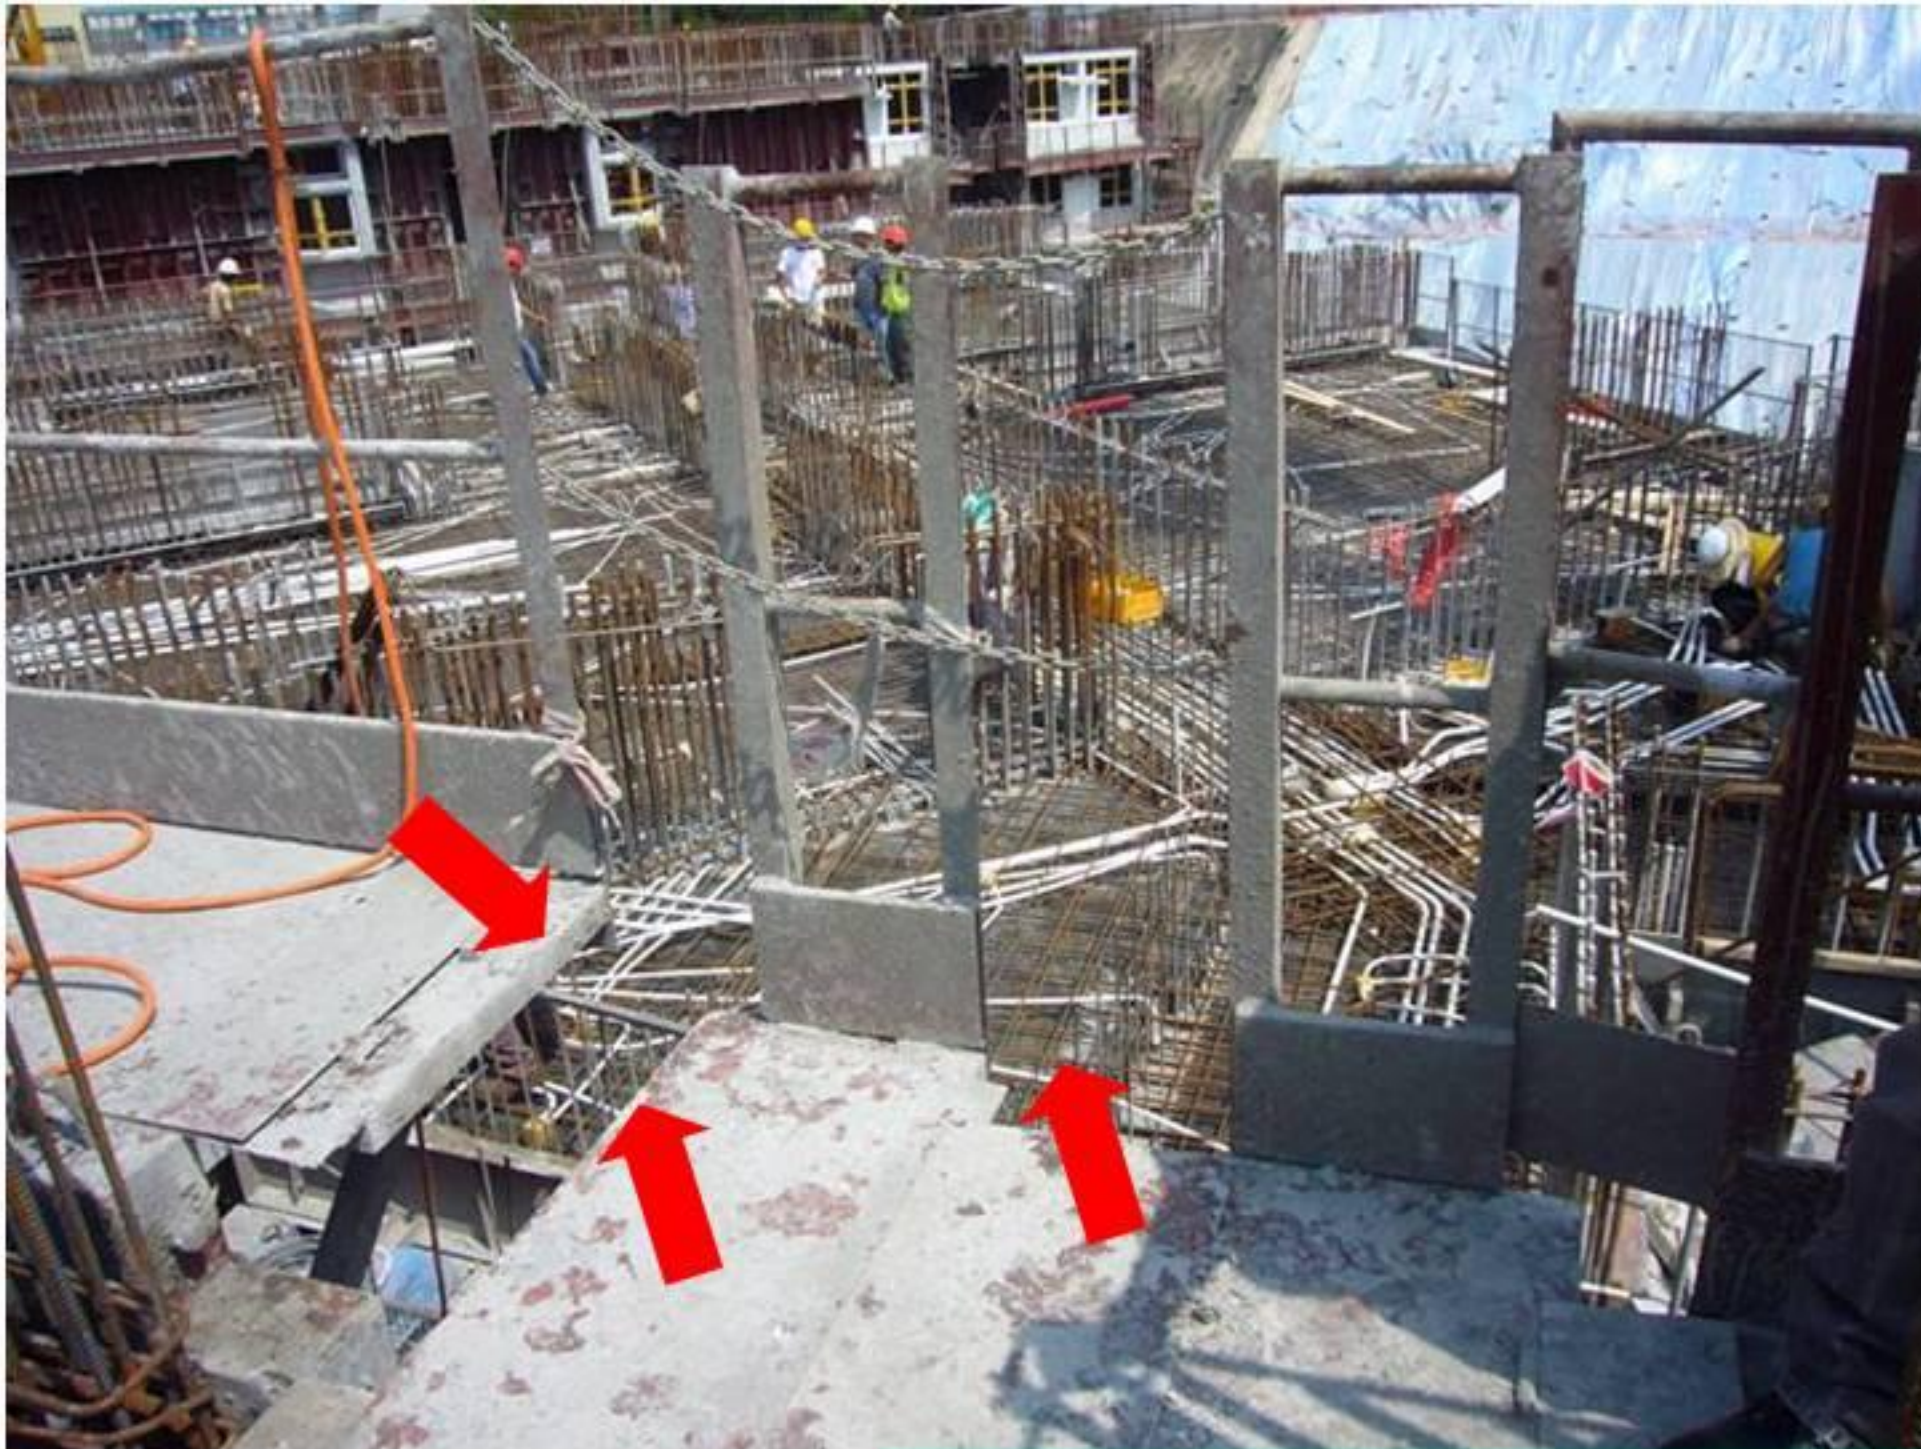
# Steel Working Platform

## **NO toe board at several locations**

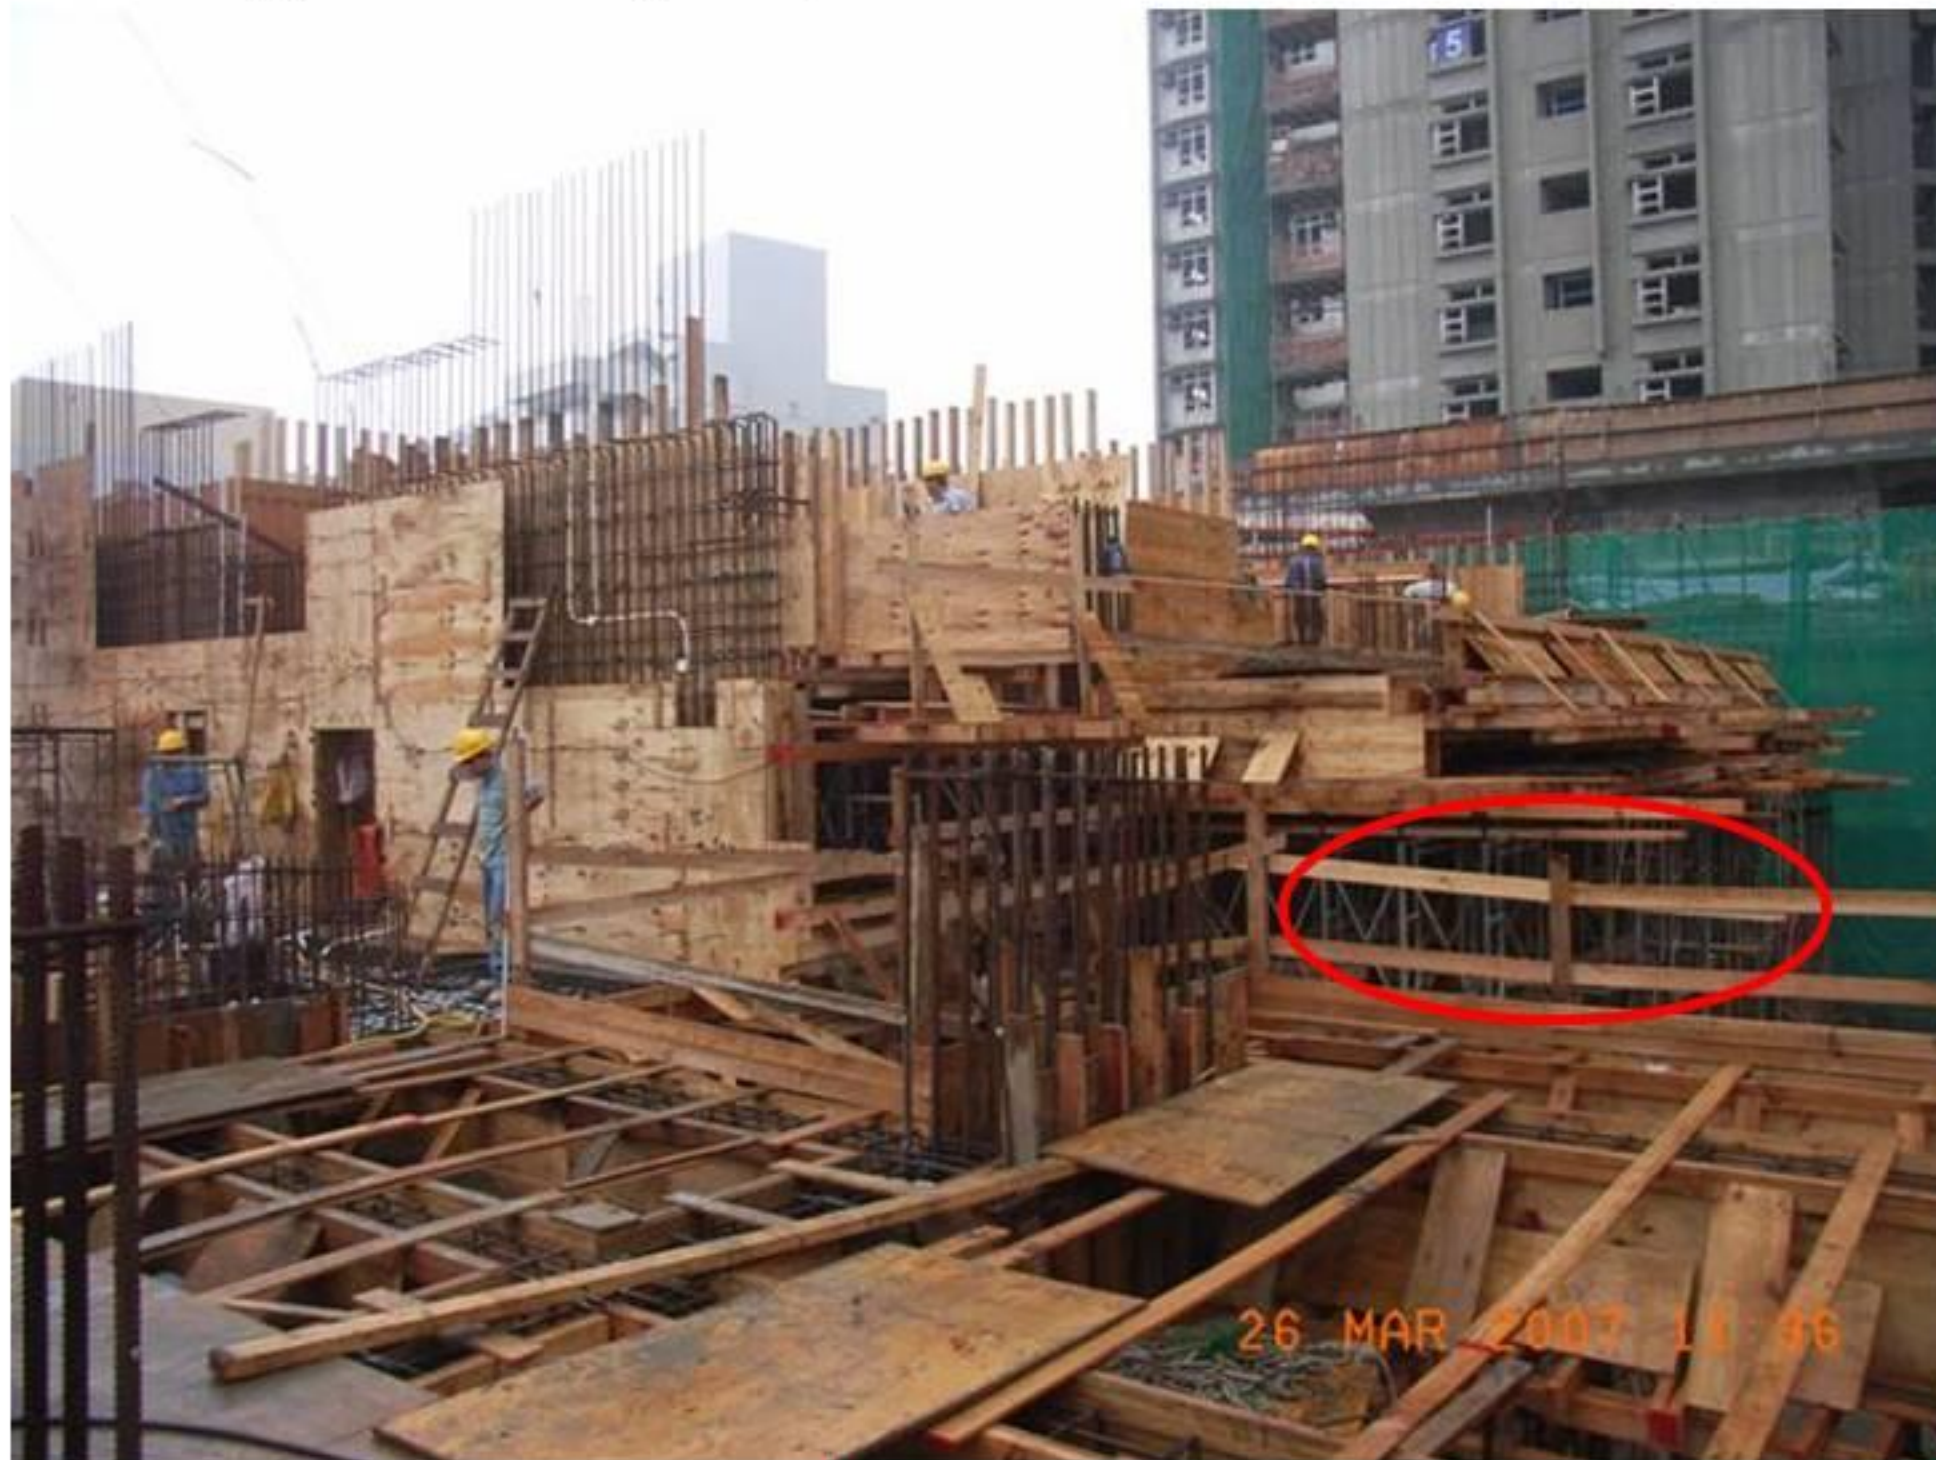
# External Railing NOT rigid and proper

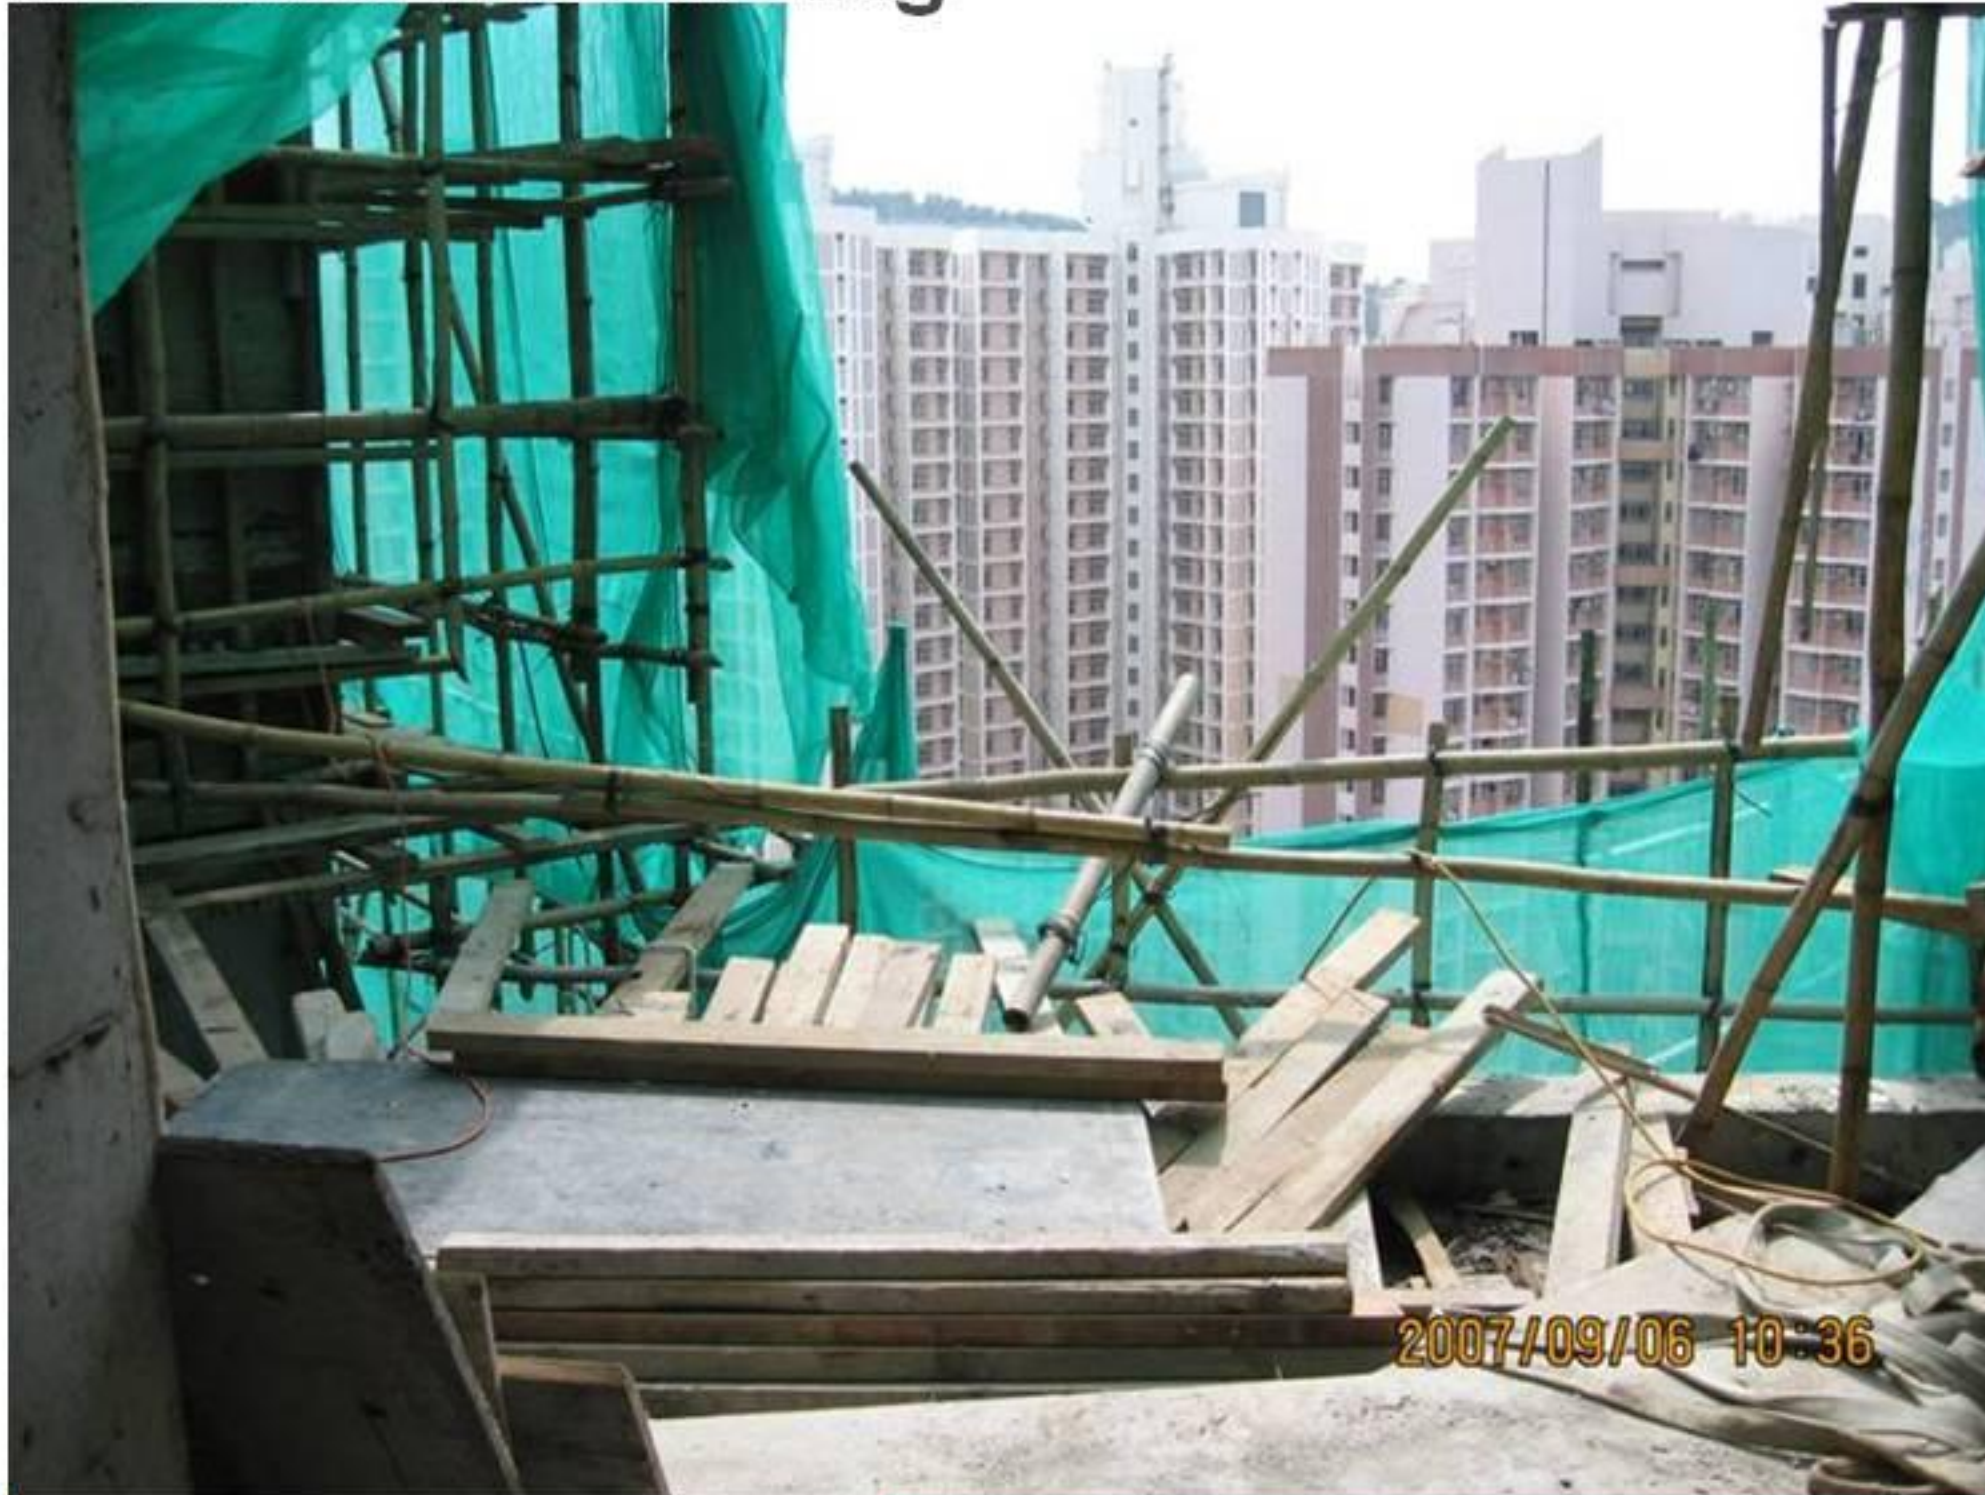
# External Fencing

## NO external fencing

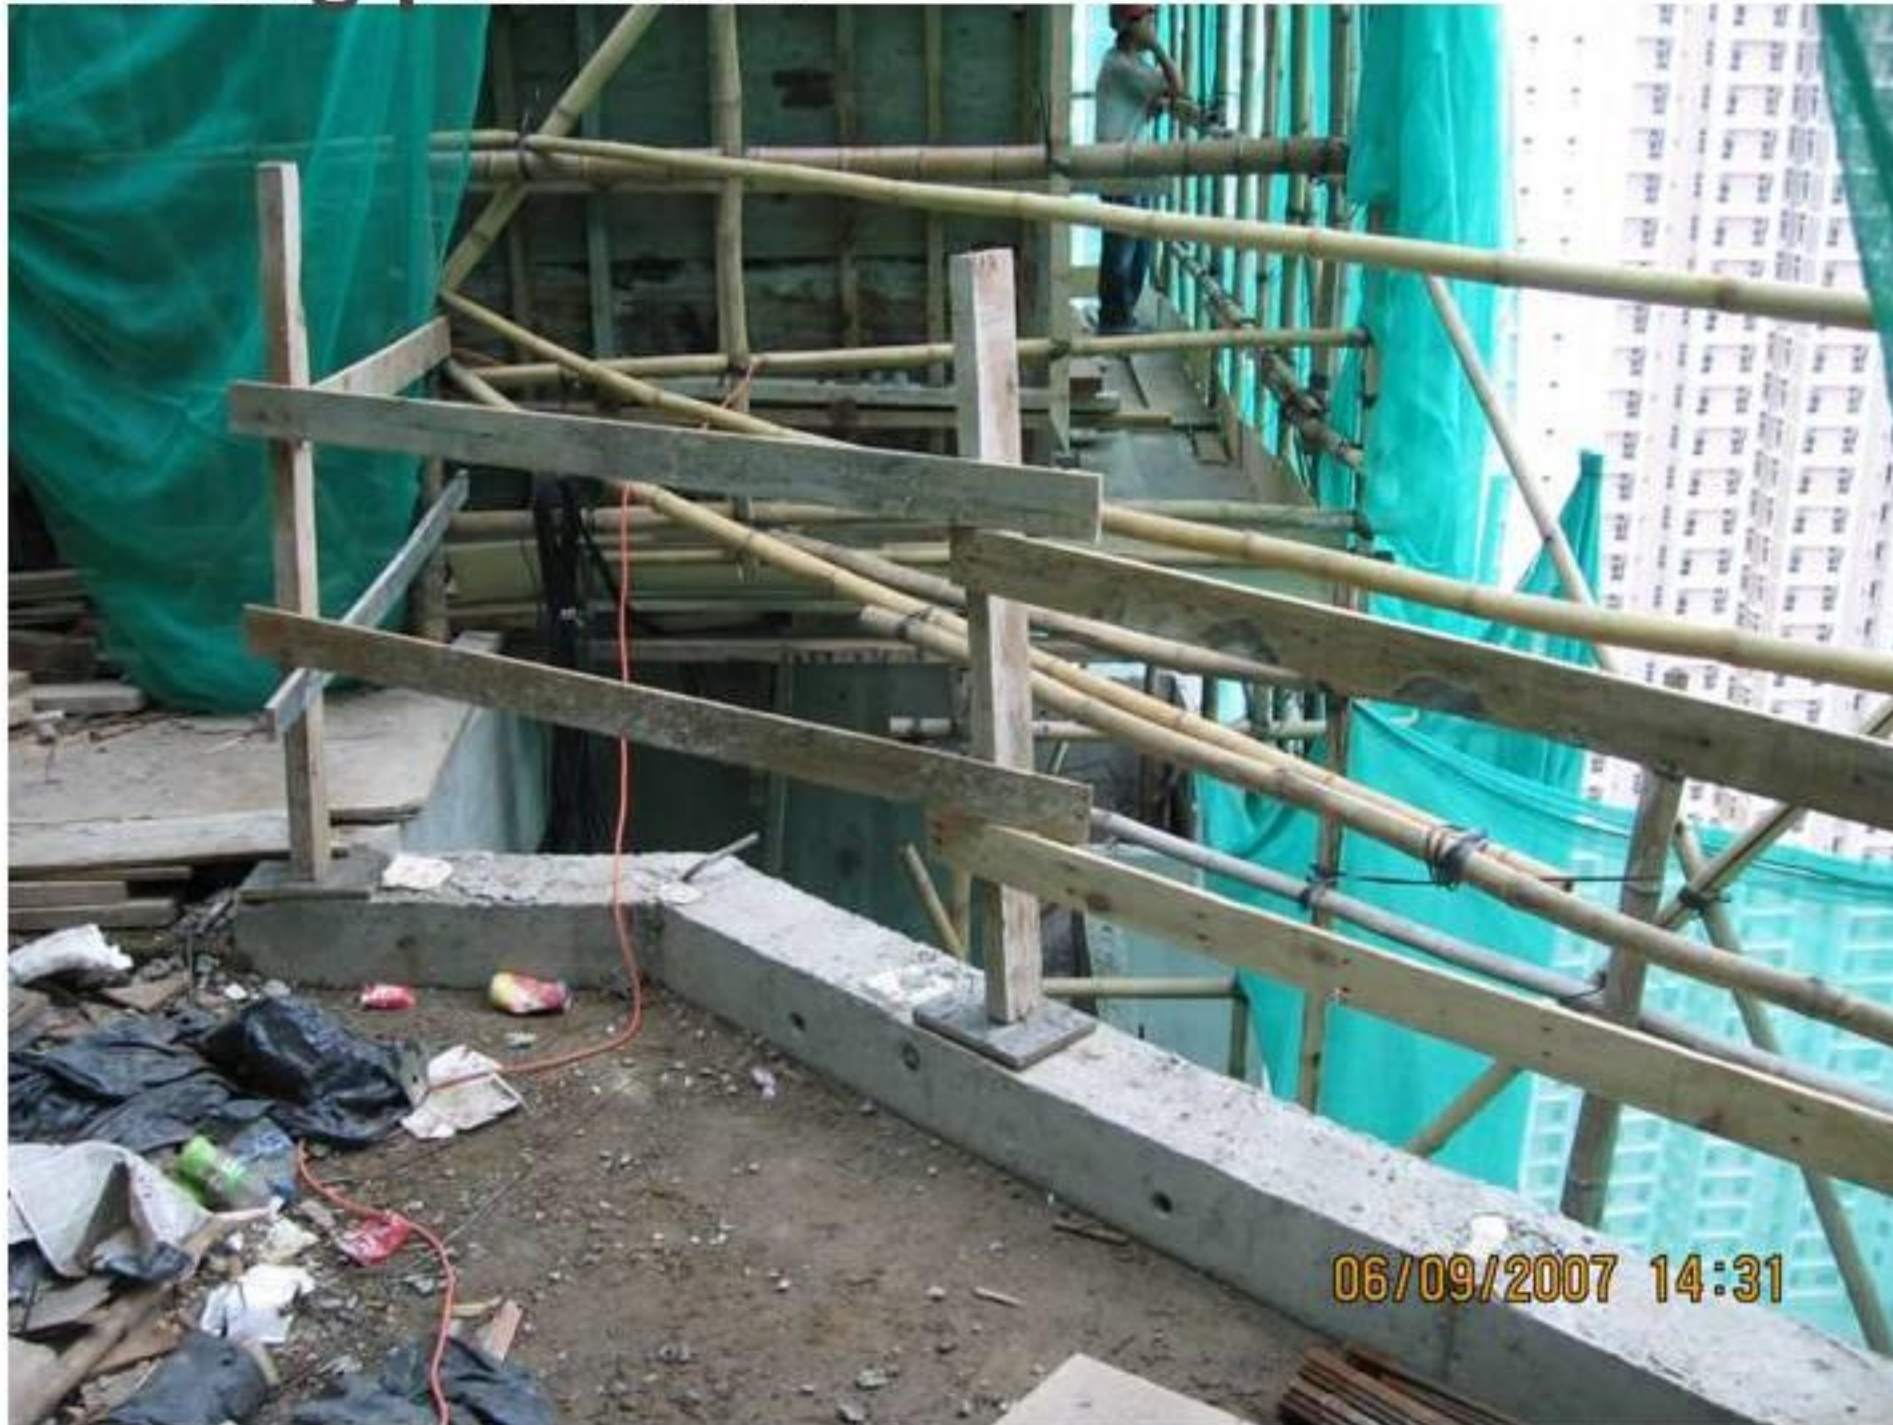
# External Fencing fencing provided

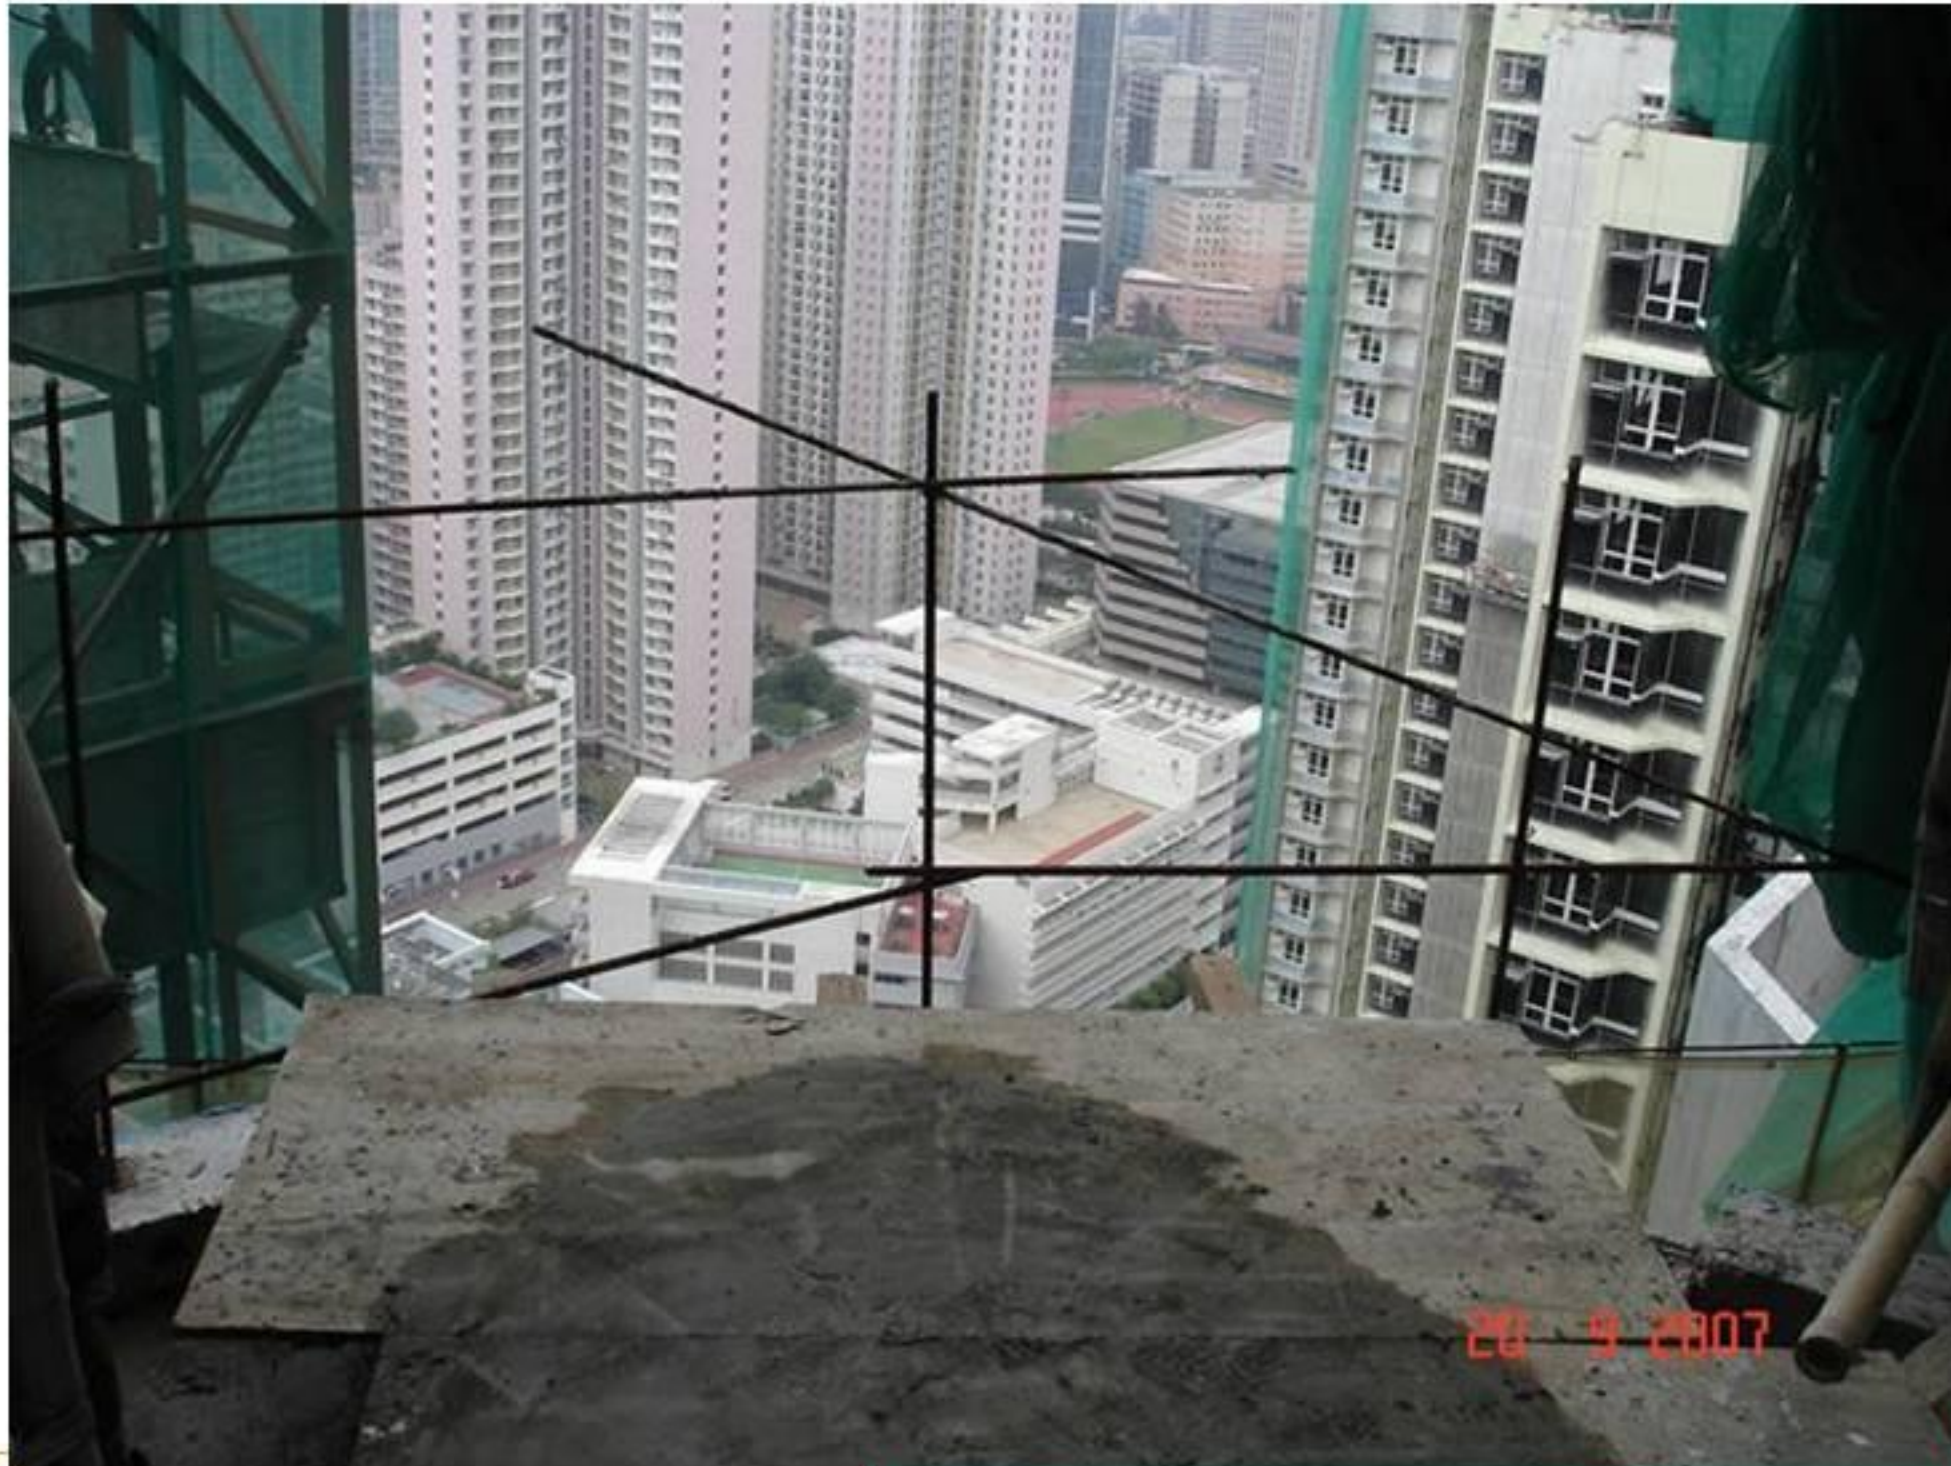
# External Fencing NOT provided to material delivery platform

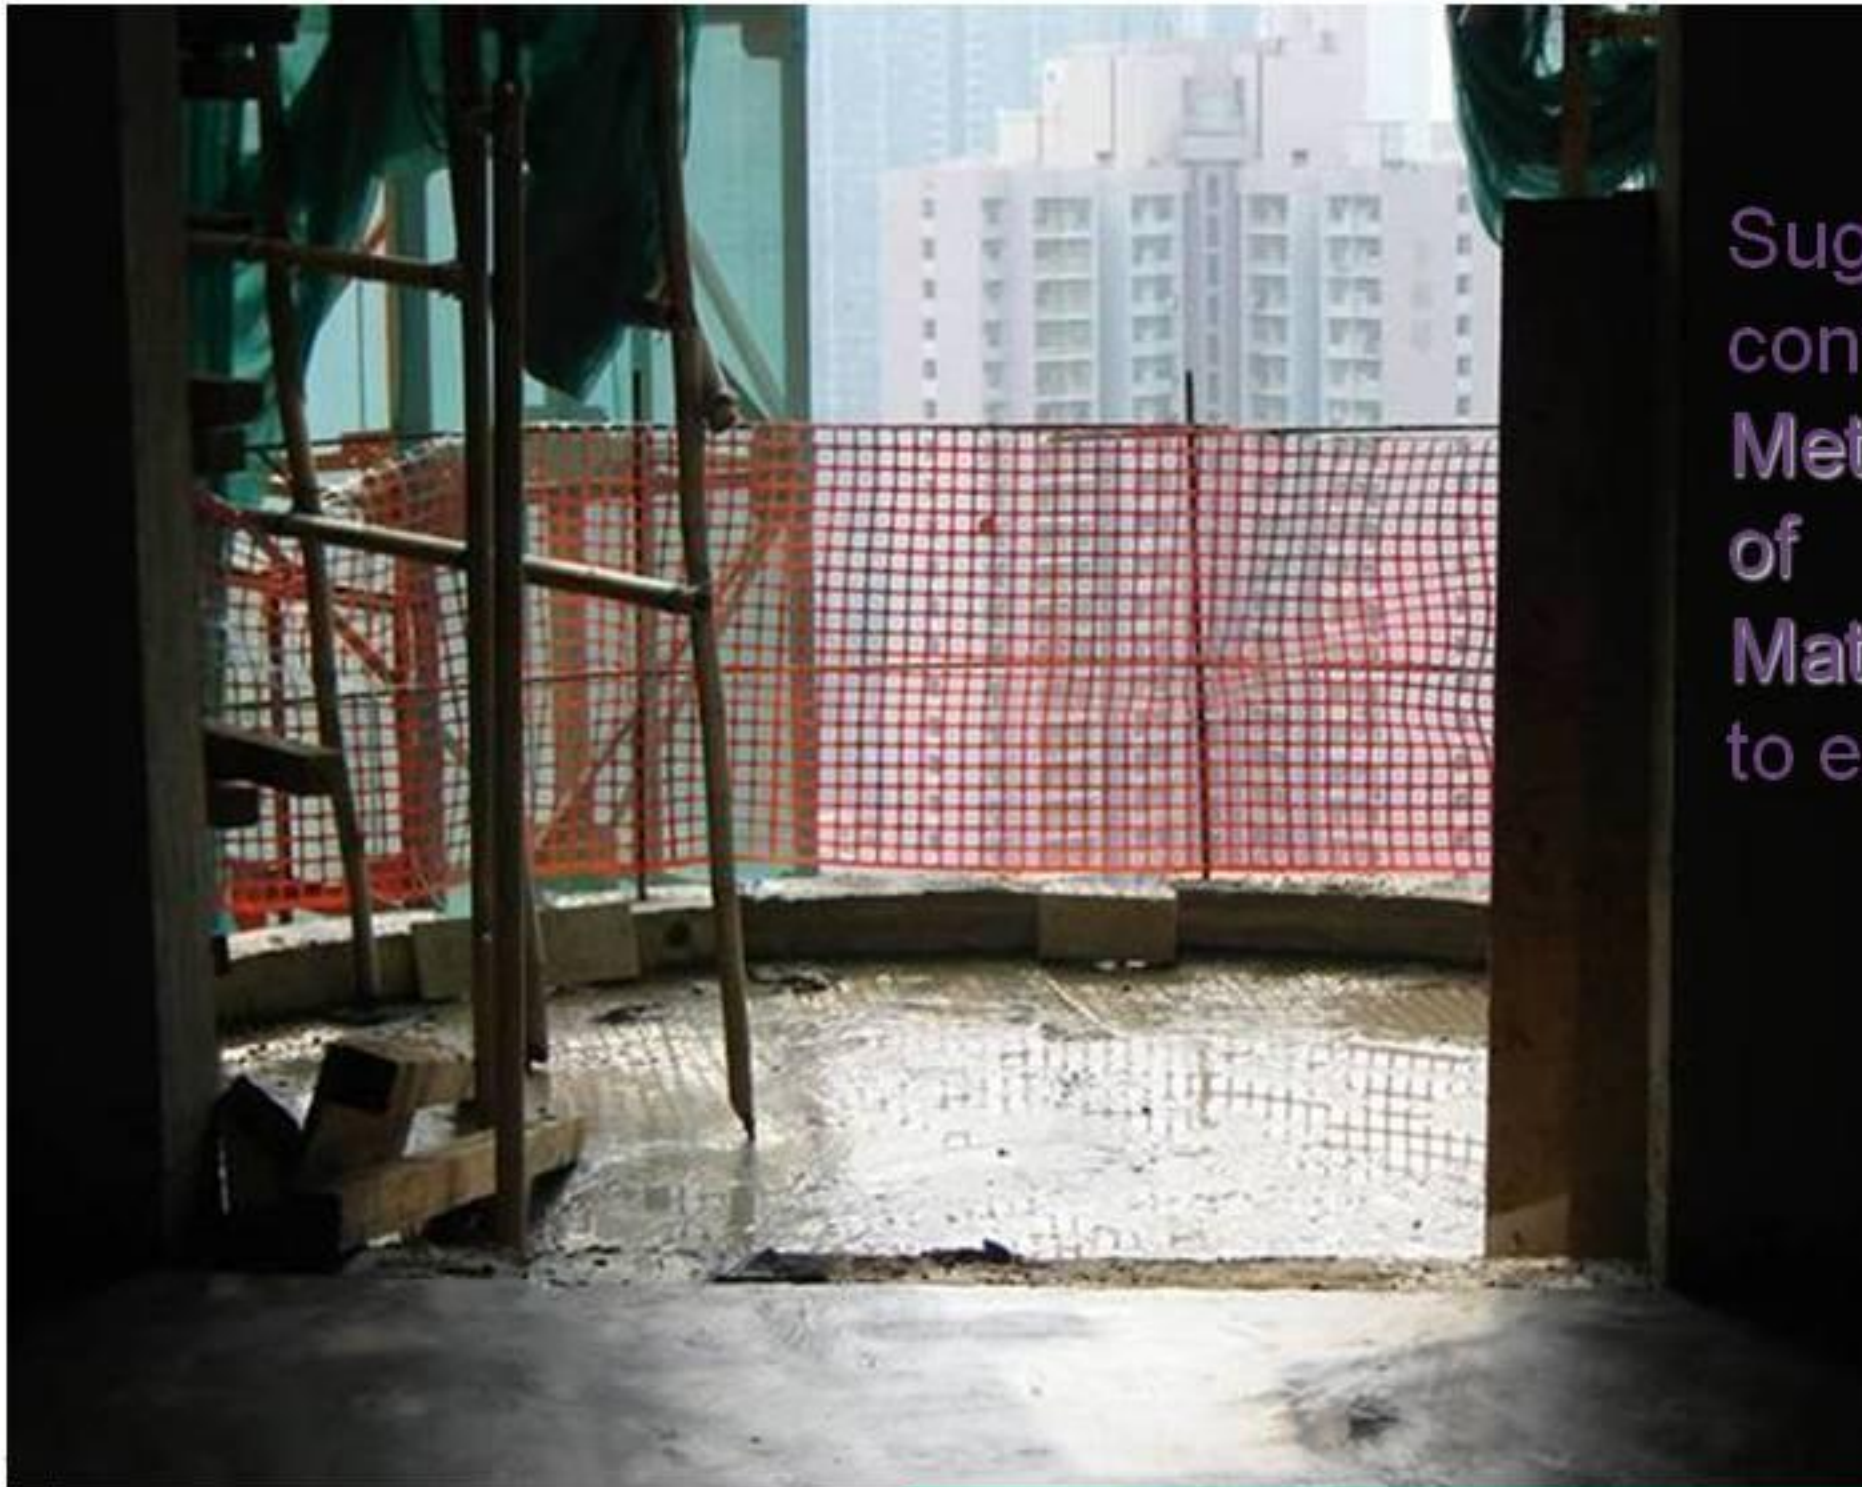
# External Fencing provided

Suggest to submit  
contractor's  
**Method Statement  
of  
Material Delivery**  
to ensure safety

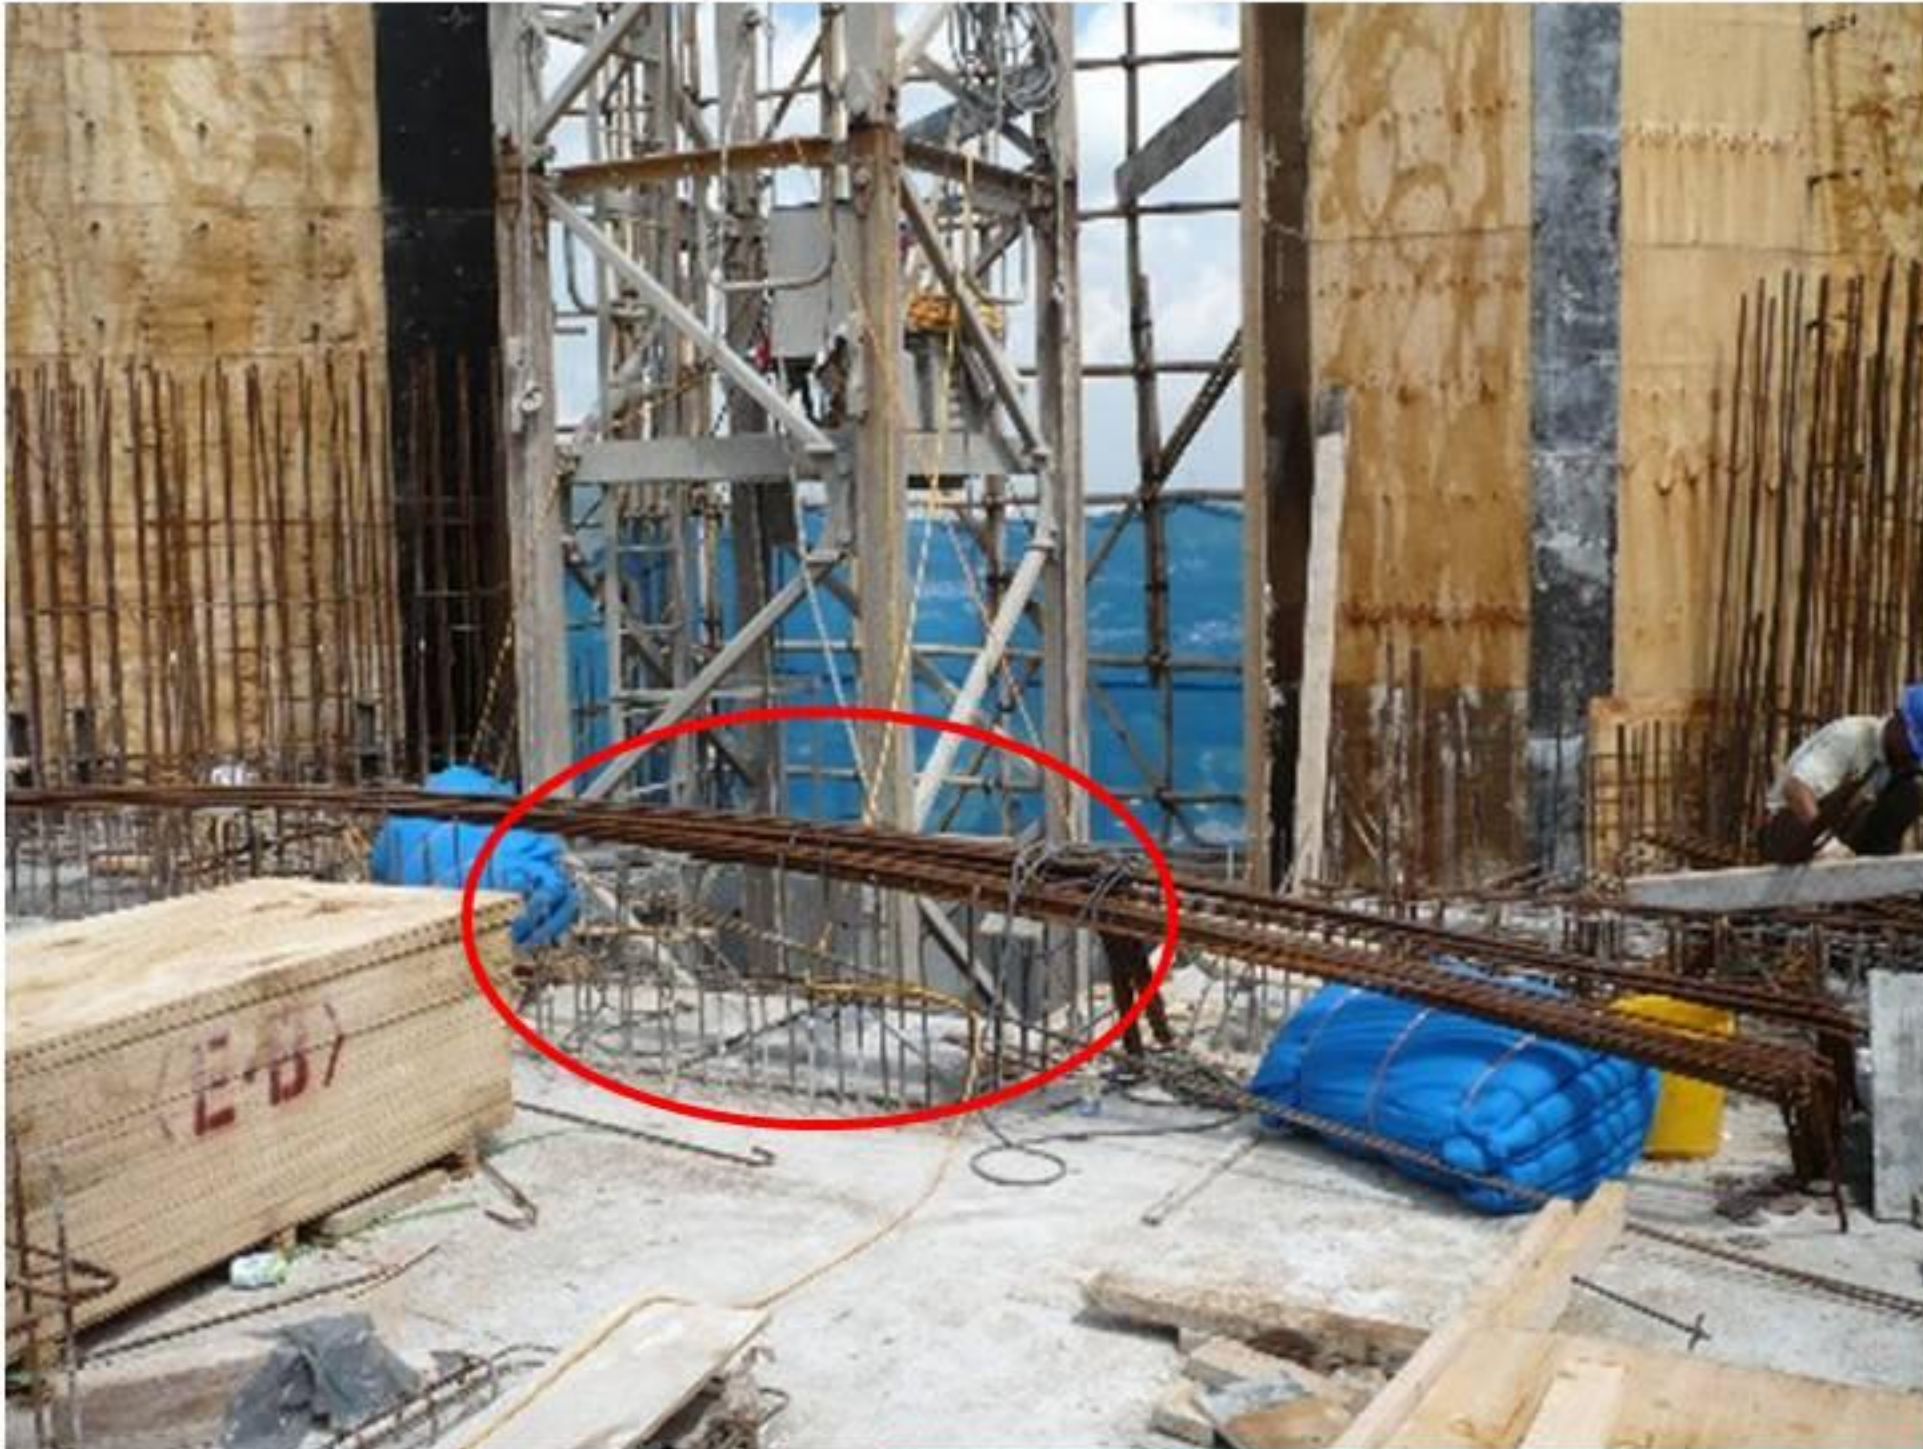
# Tower Crane Opening

## NO fencing
