# **SITE SAFETY Focus Seminar**

on New Works of  
Housing Department

**Site Safety** issues at -

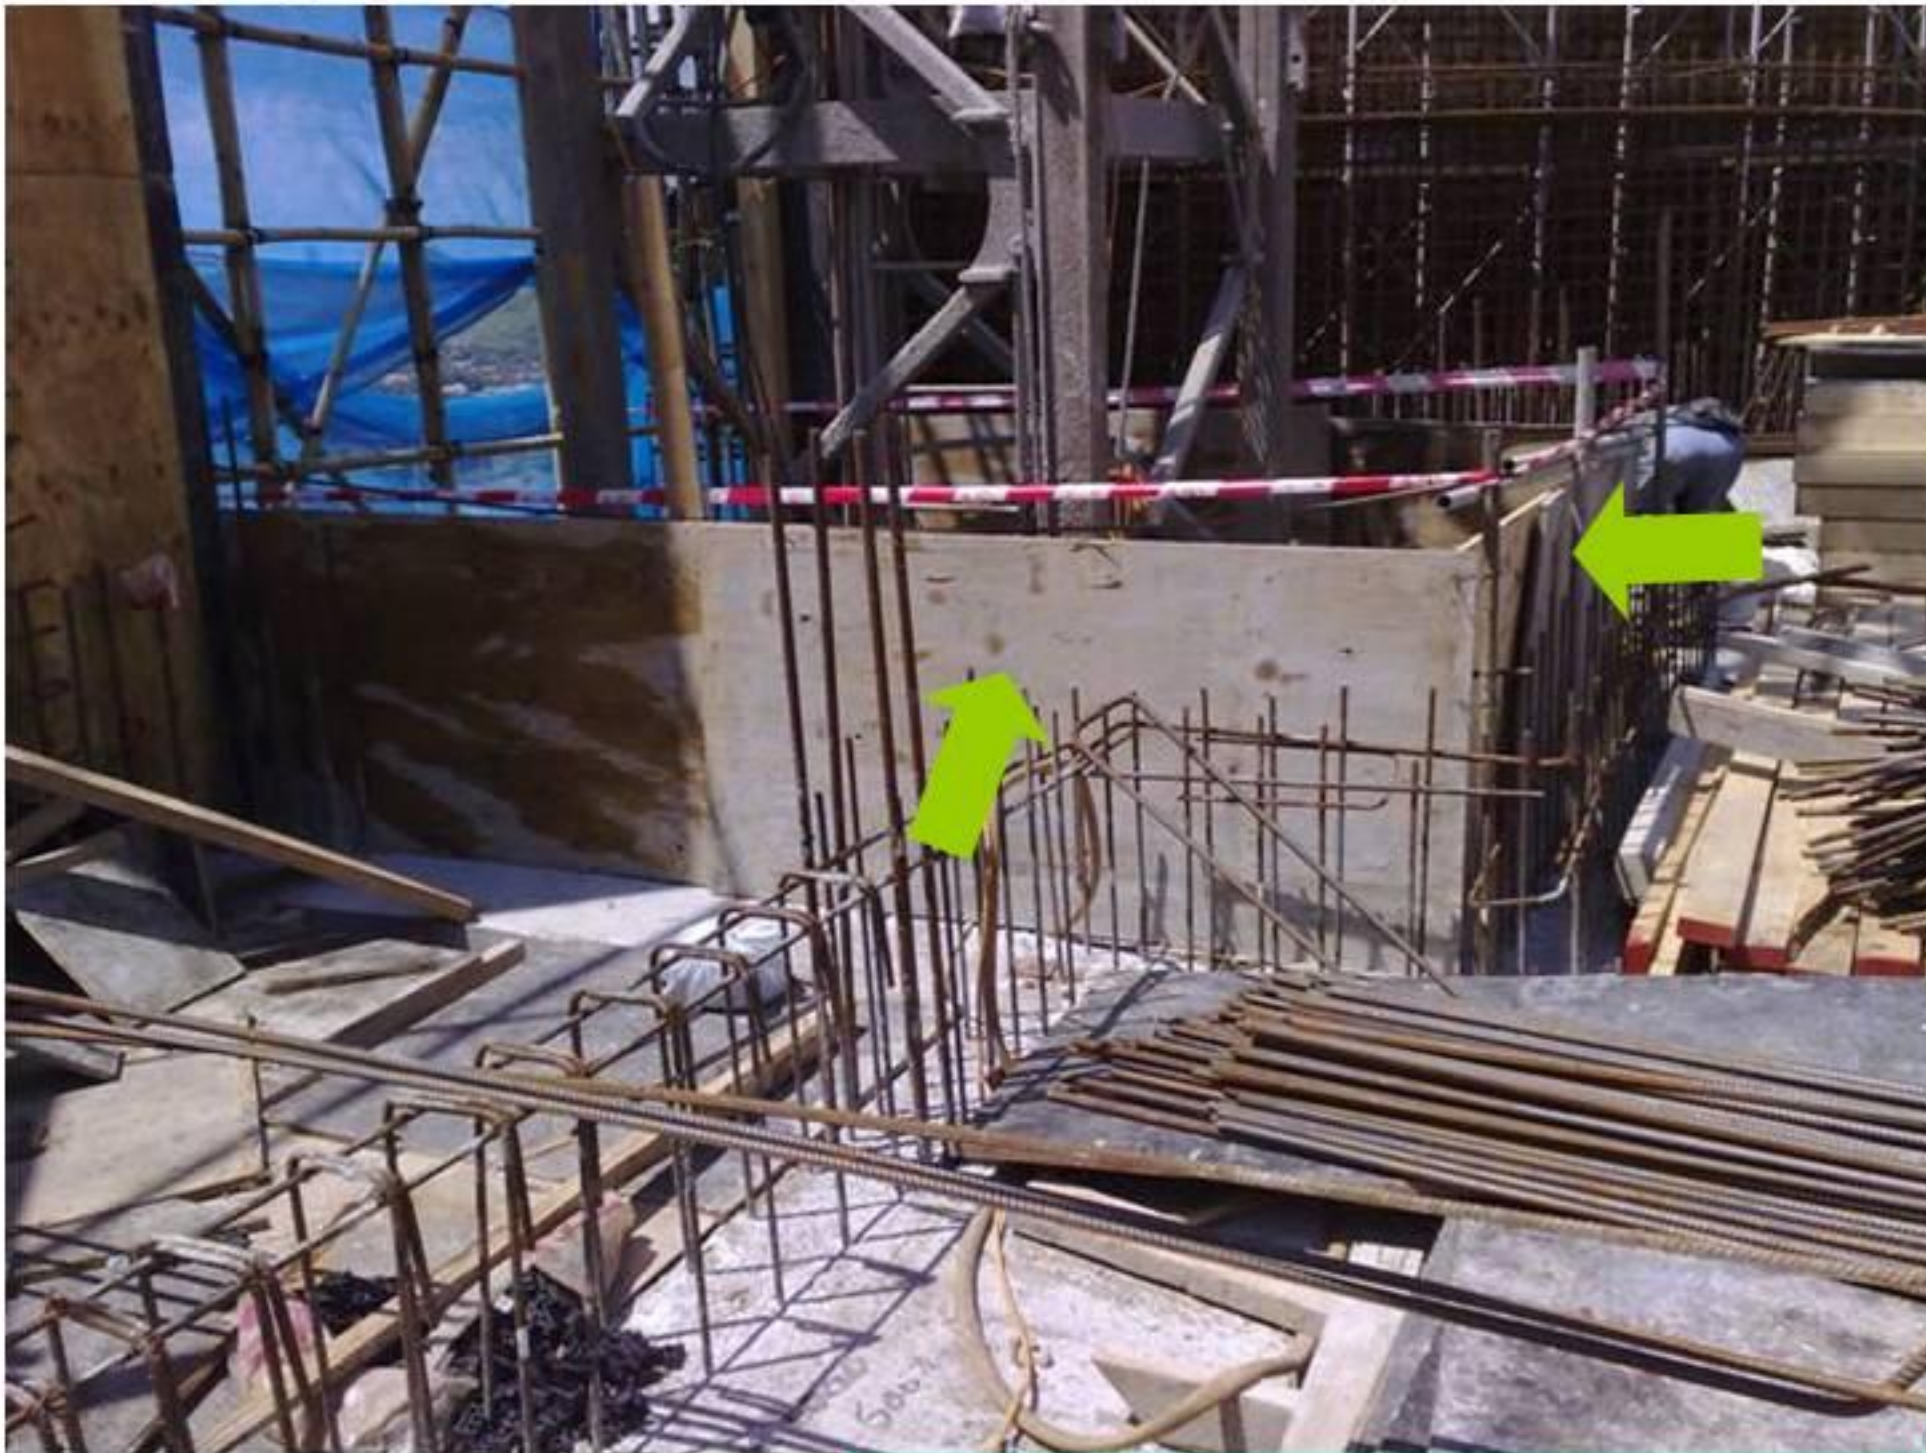
# Tower Crane Opening fencing provided

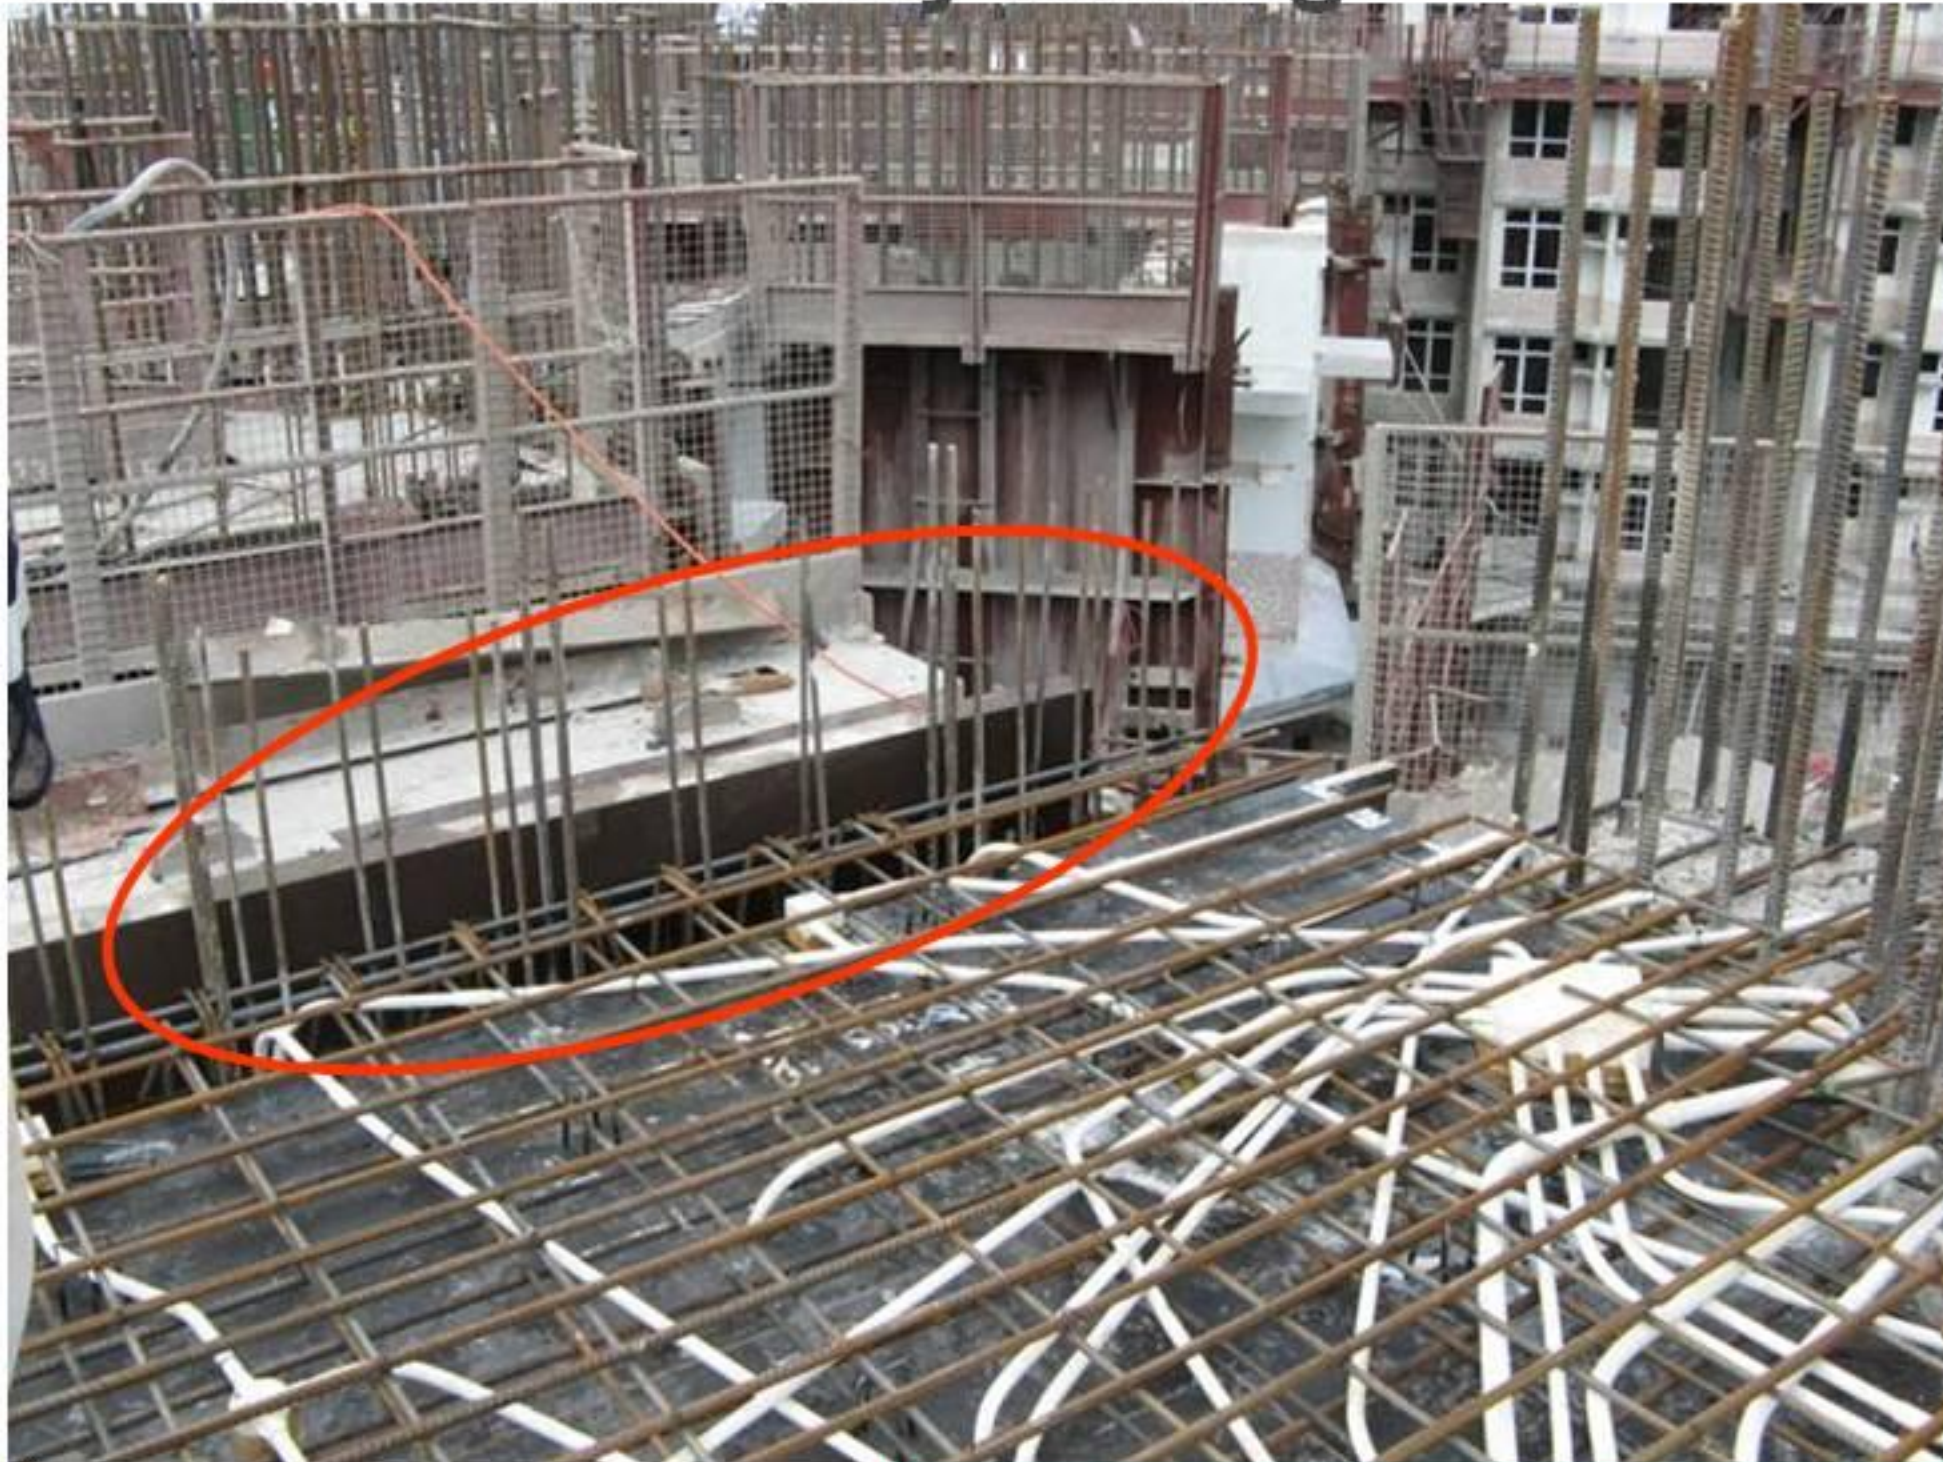
# External Railing insufficient safety railing

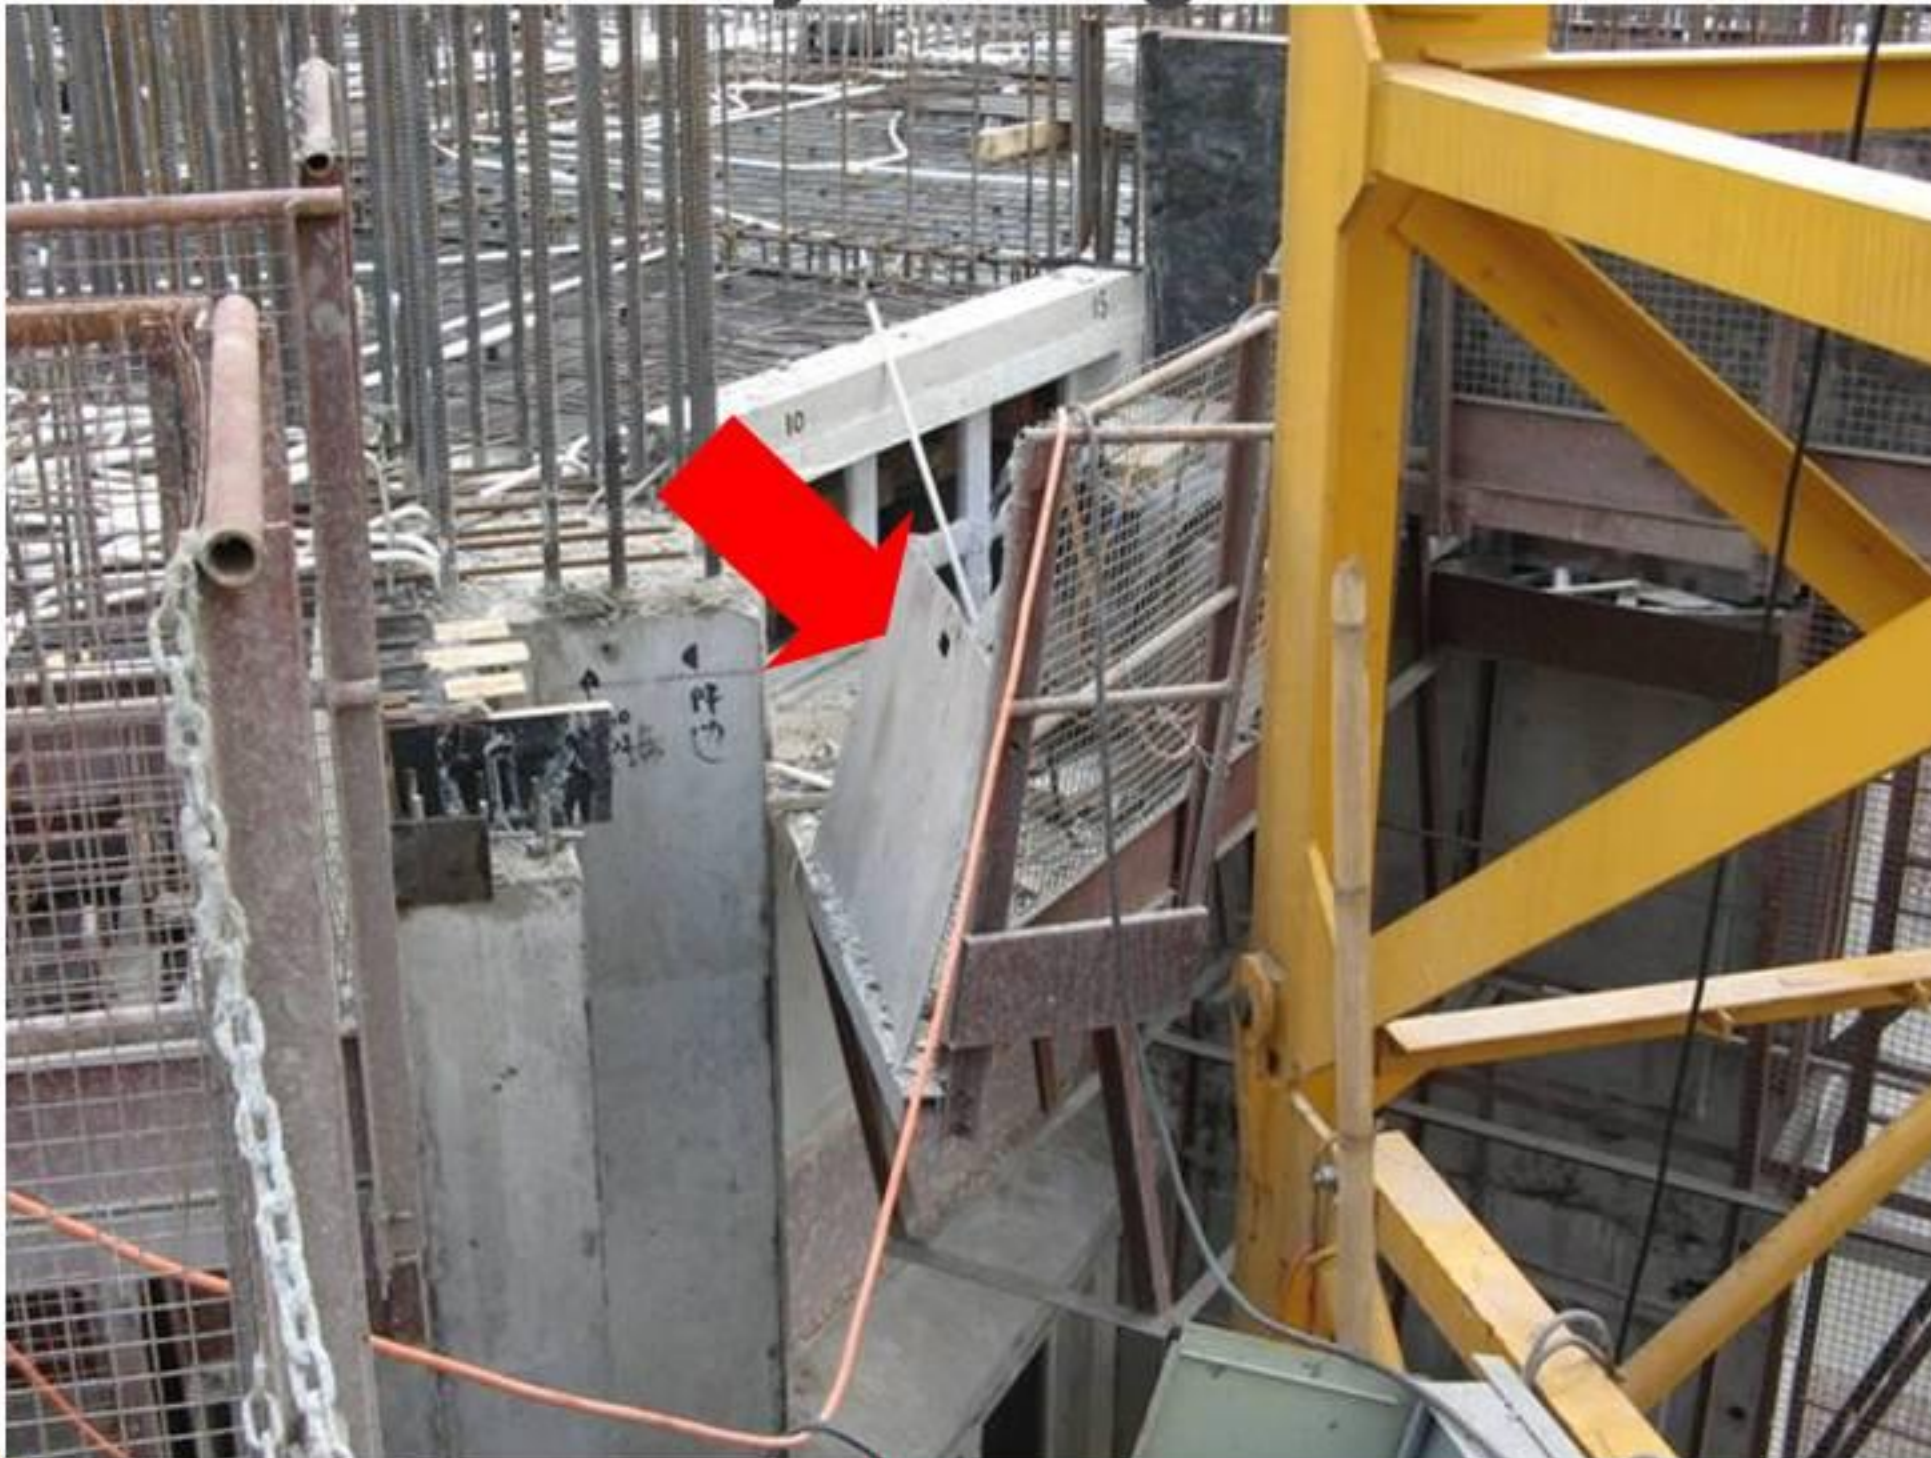
# External Railing

## **insecure safety railing**

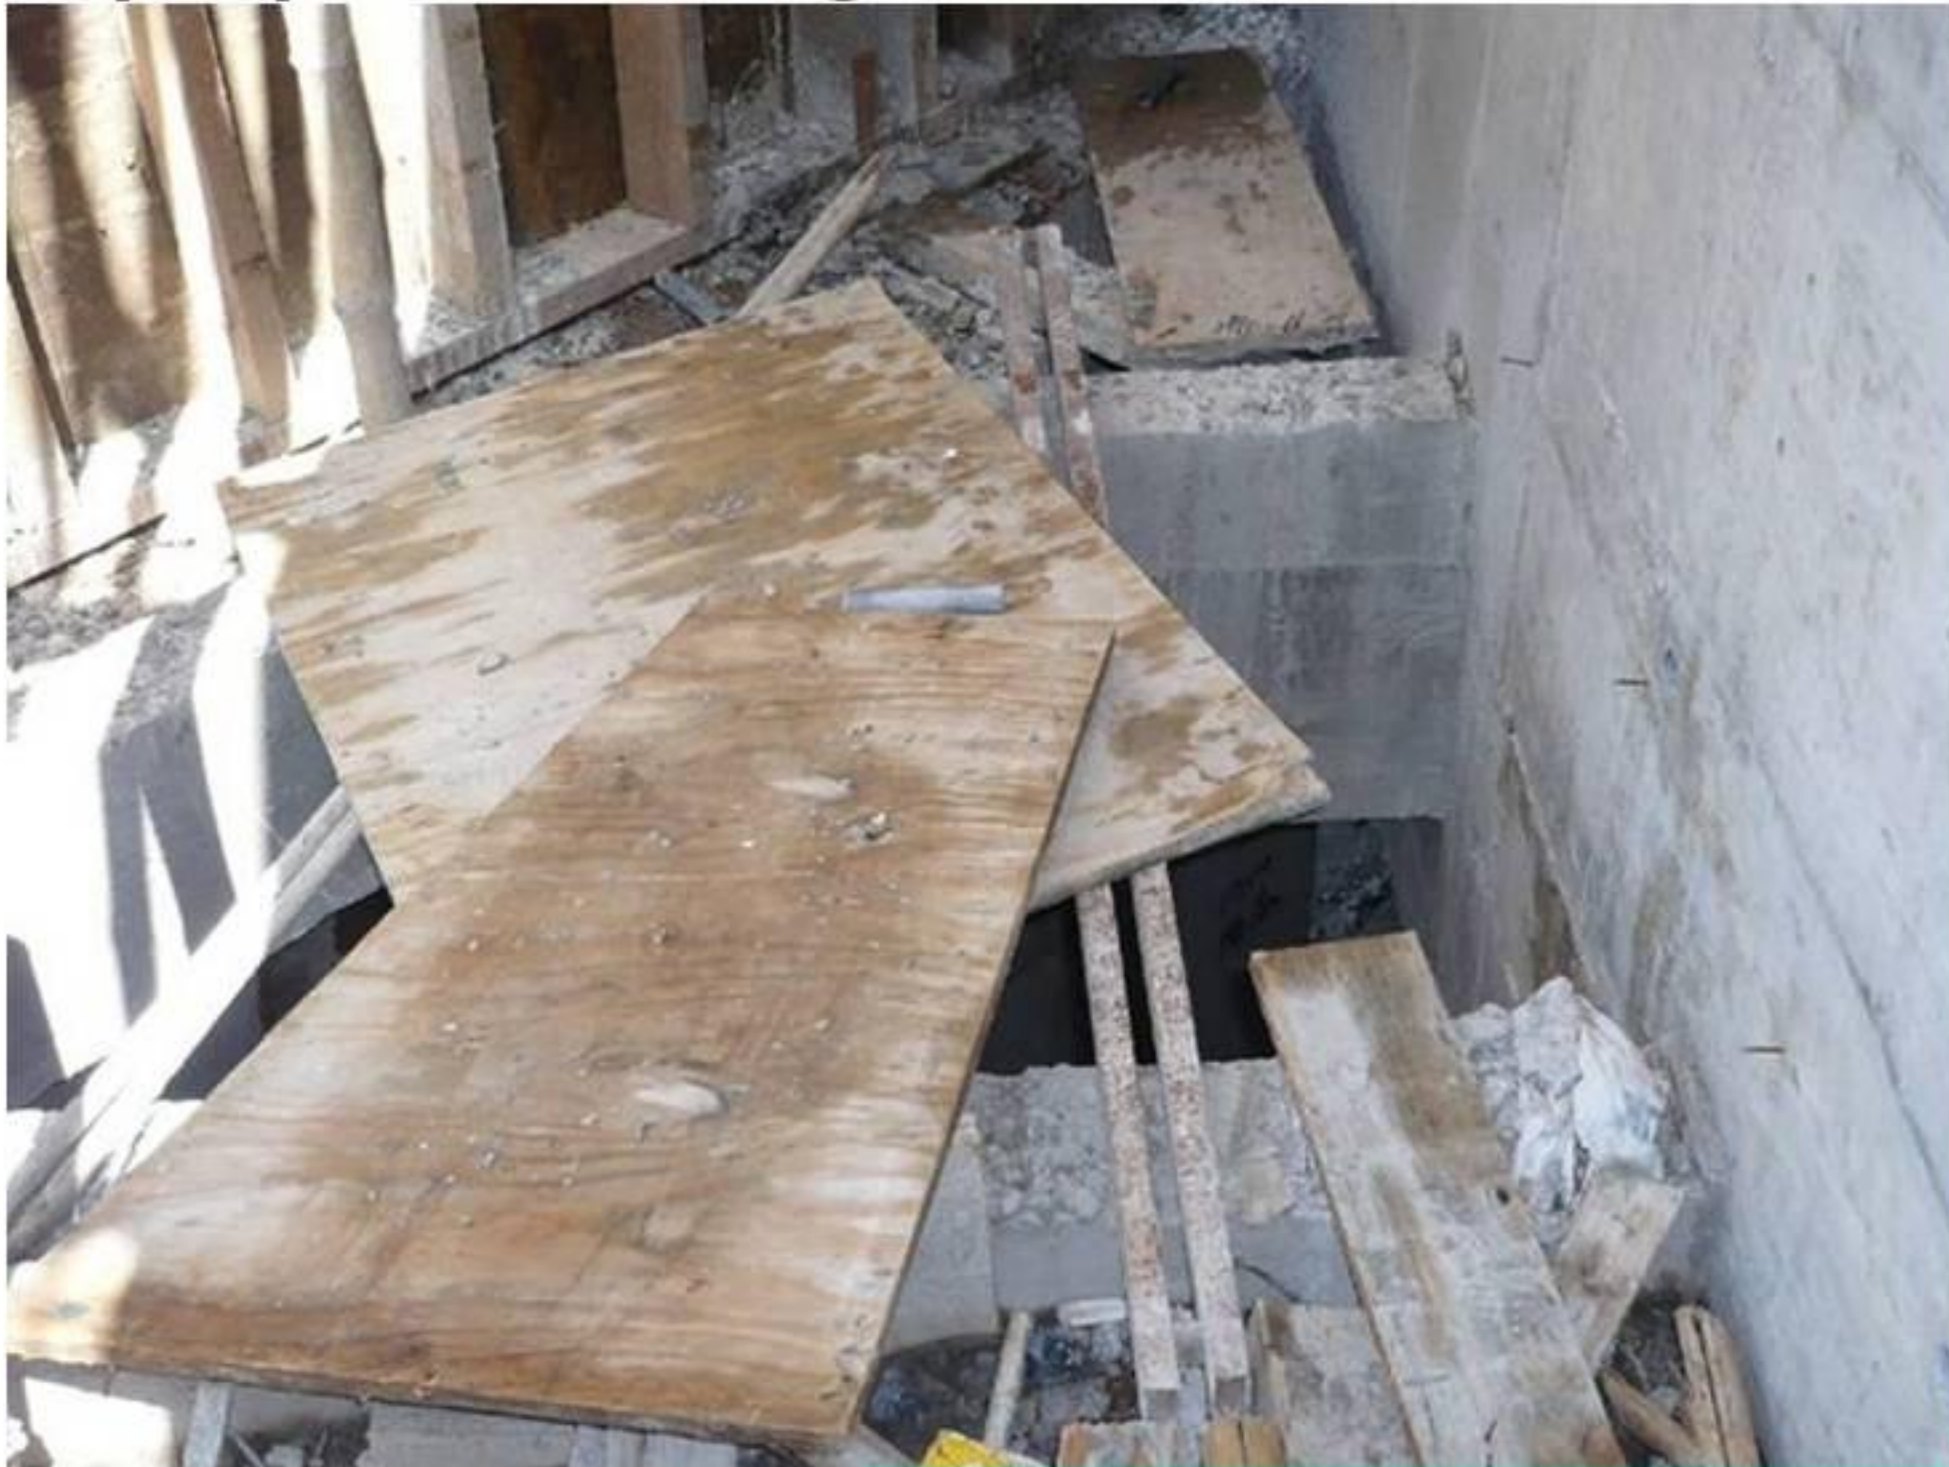
# Floor Opening improper boarding

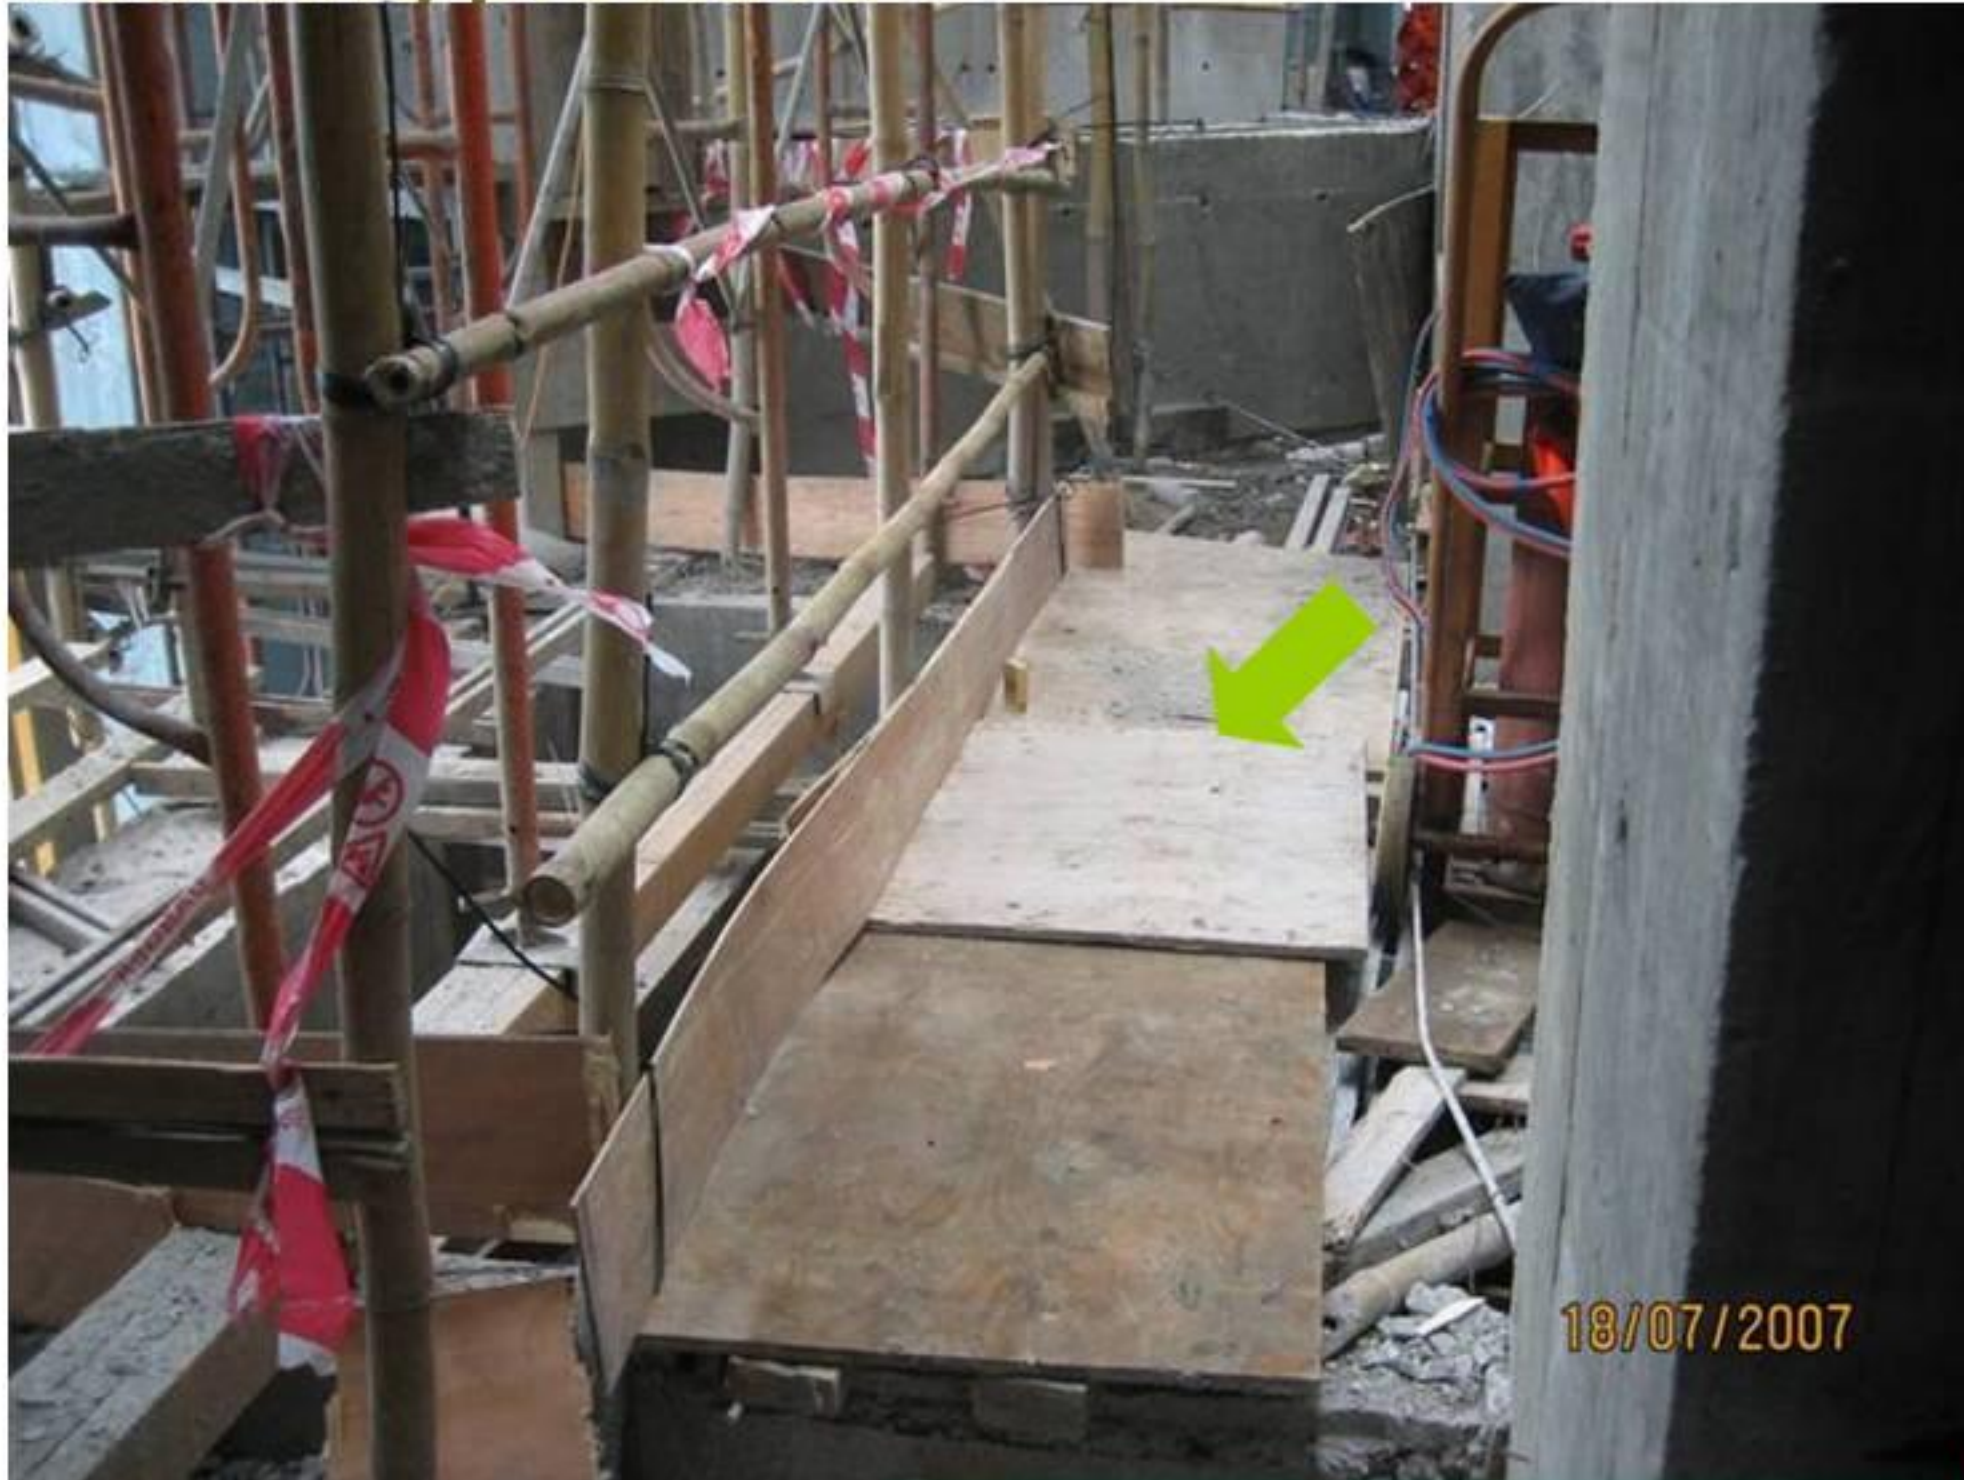
# Floor Opening boarding provided

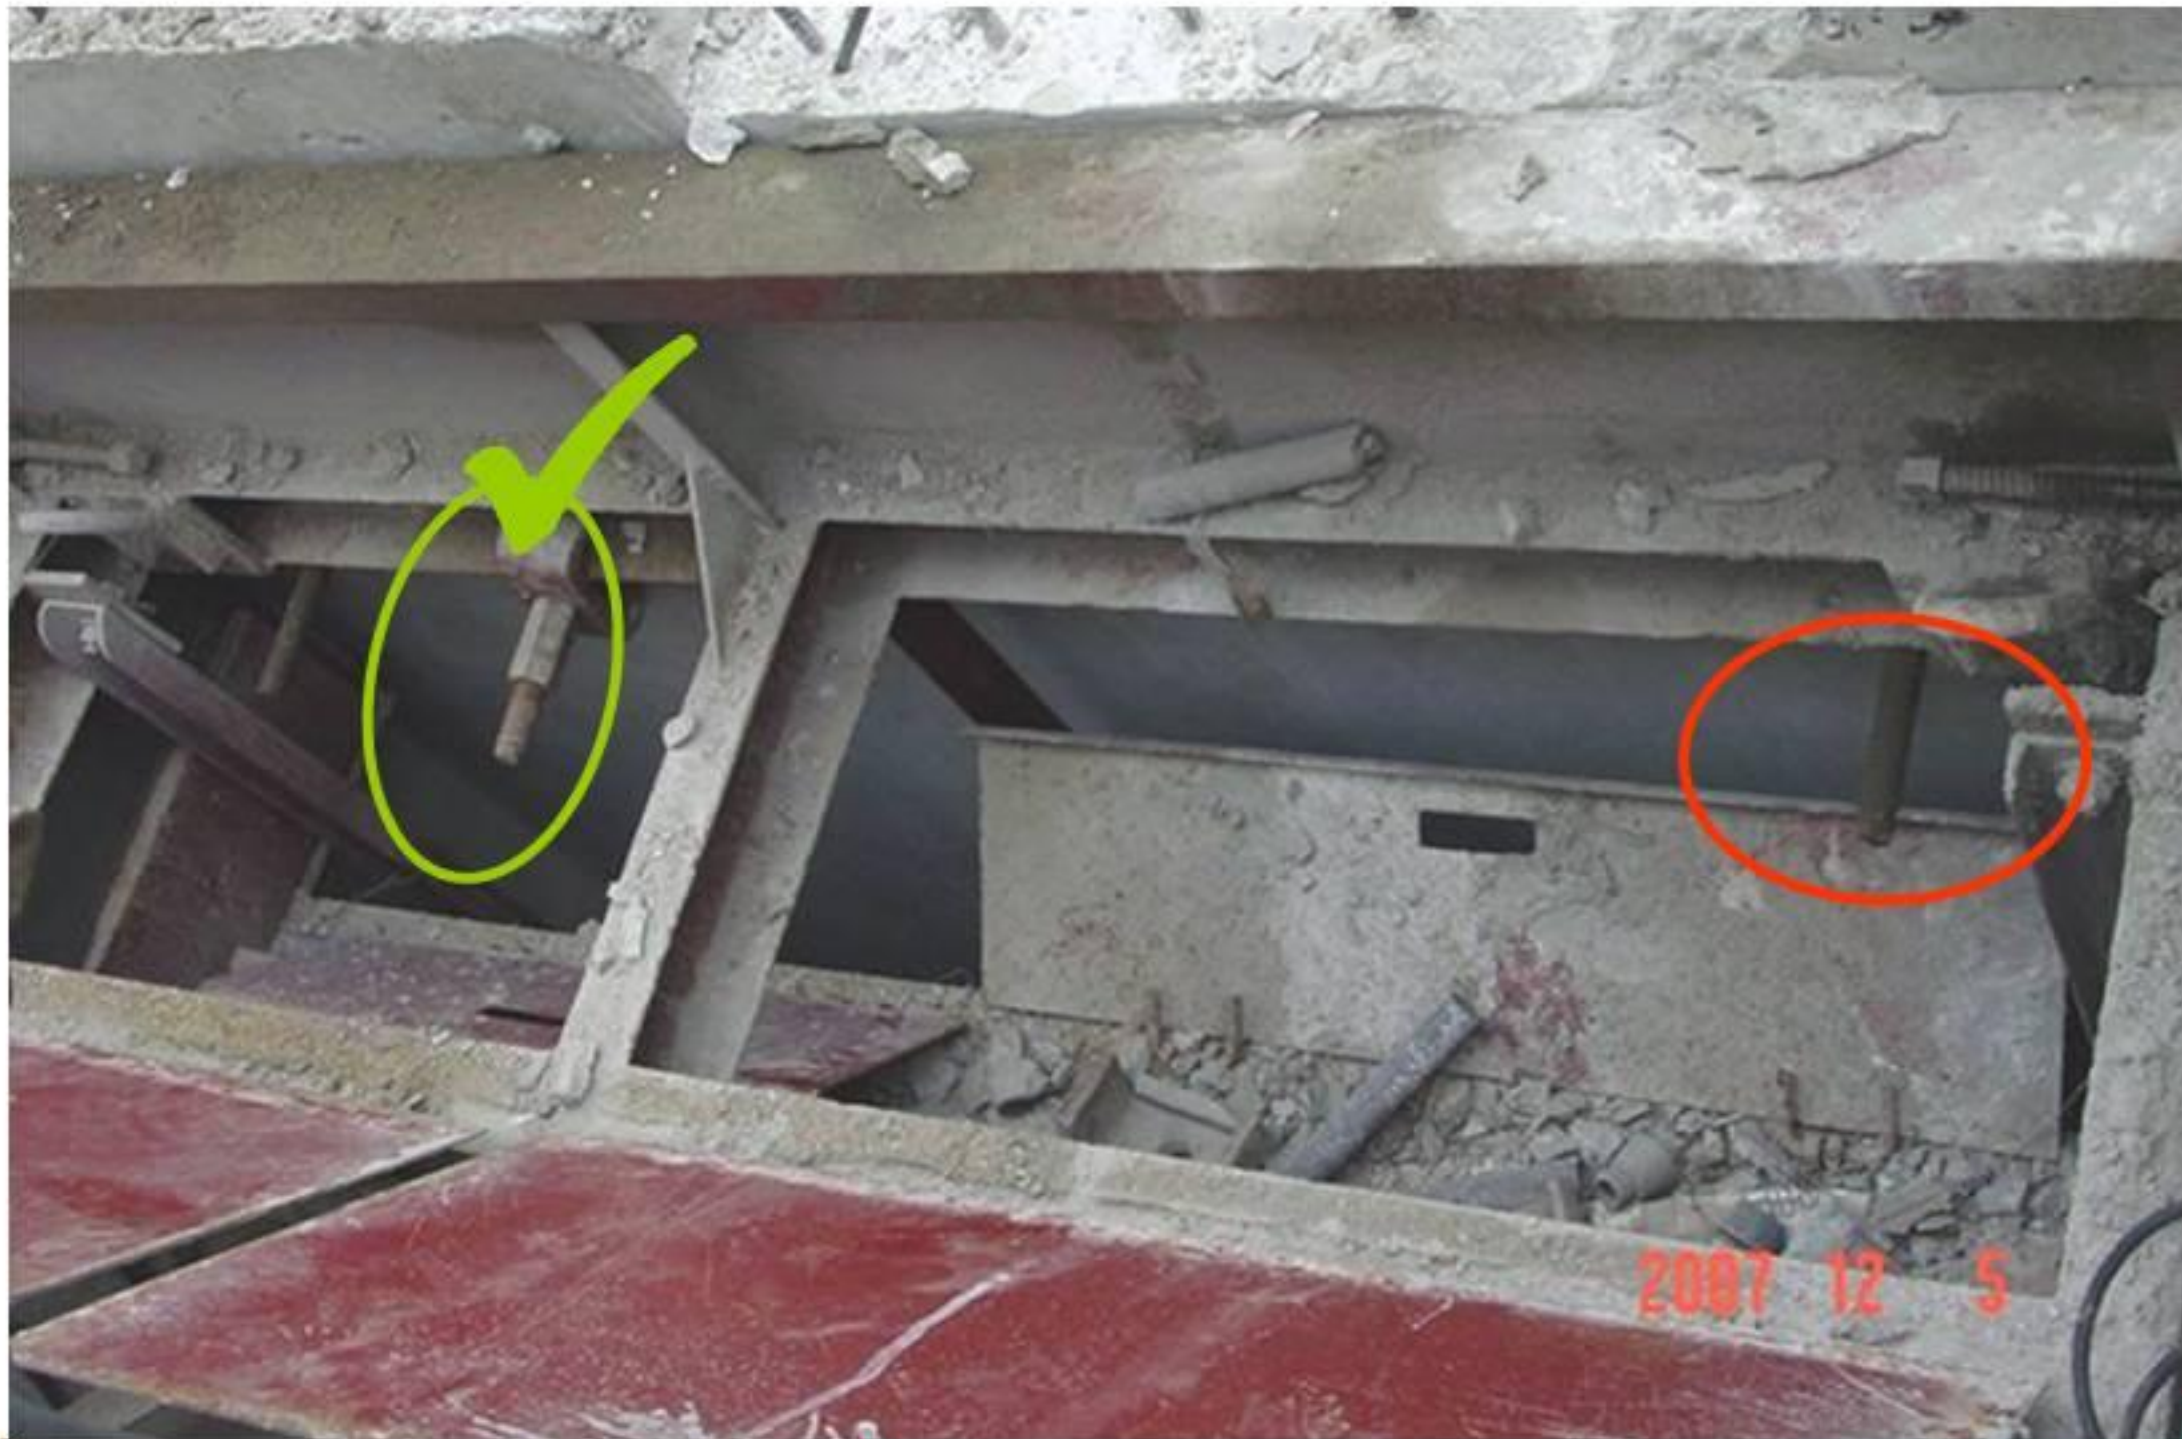
# Lift Shaft Opening / Platform

not all brackets securely fixed with tie bolts

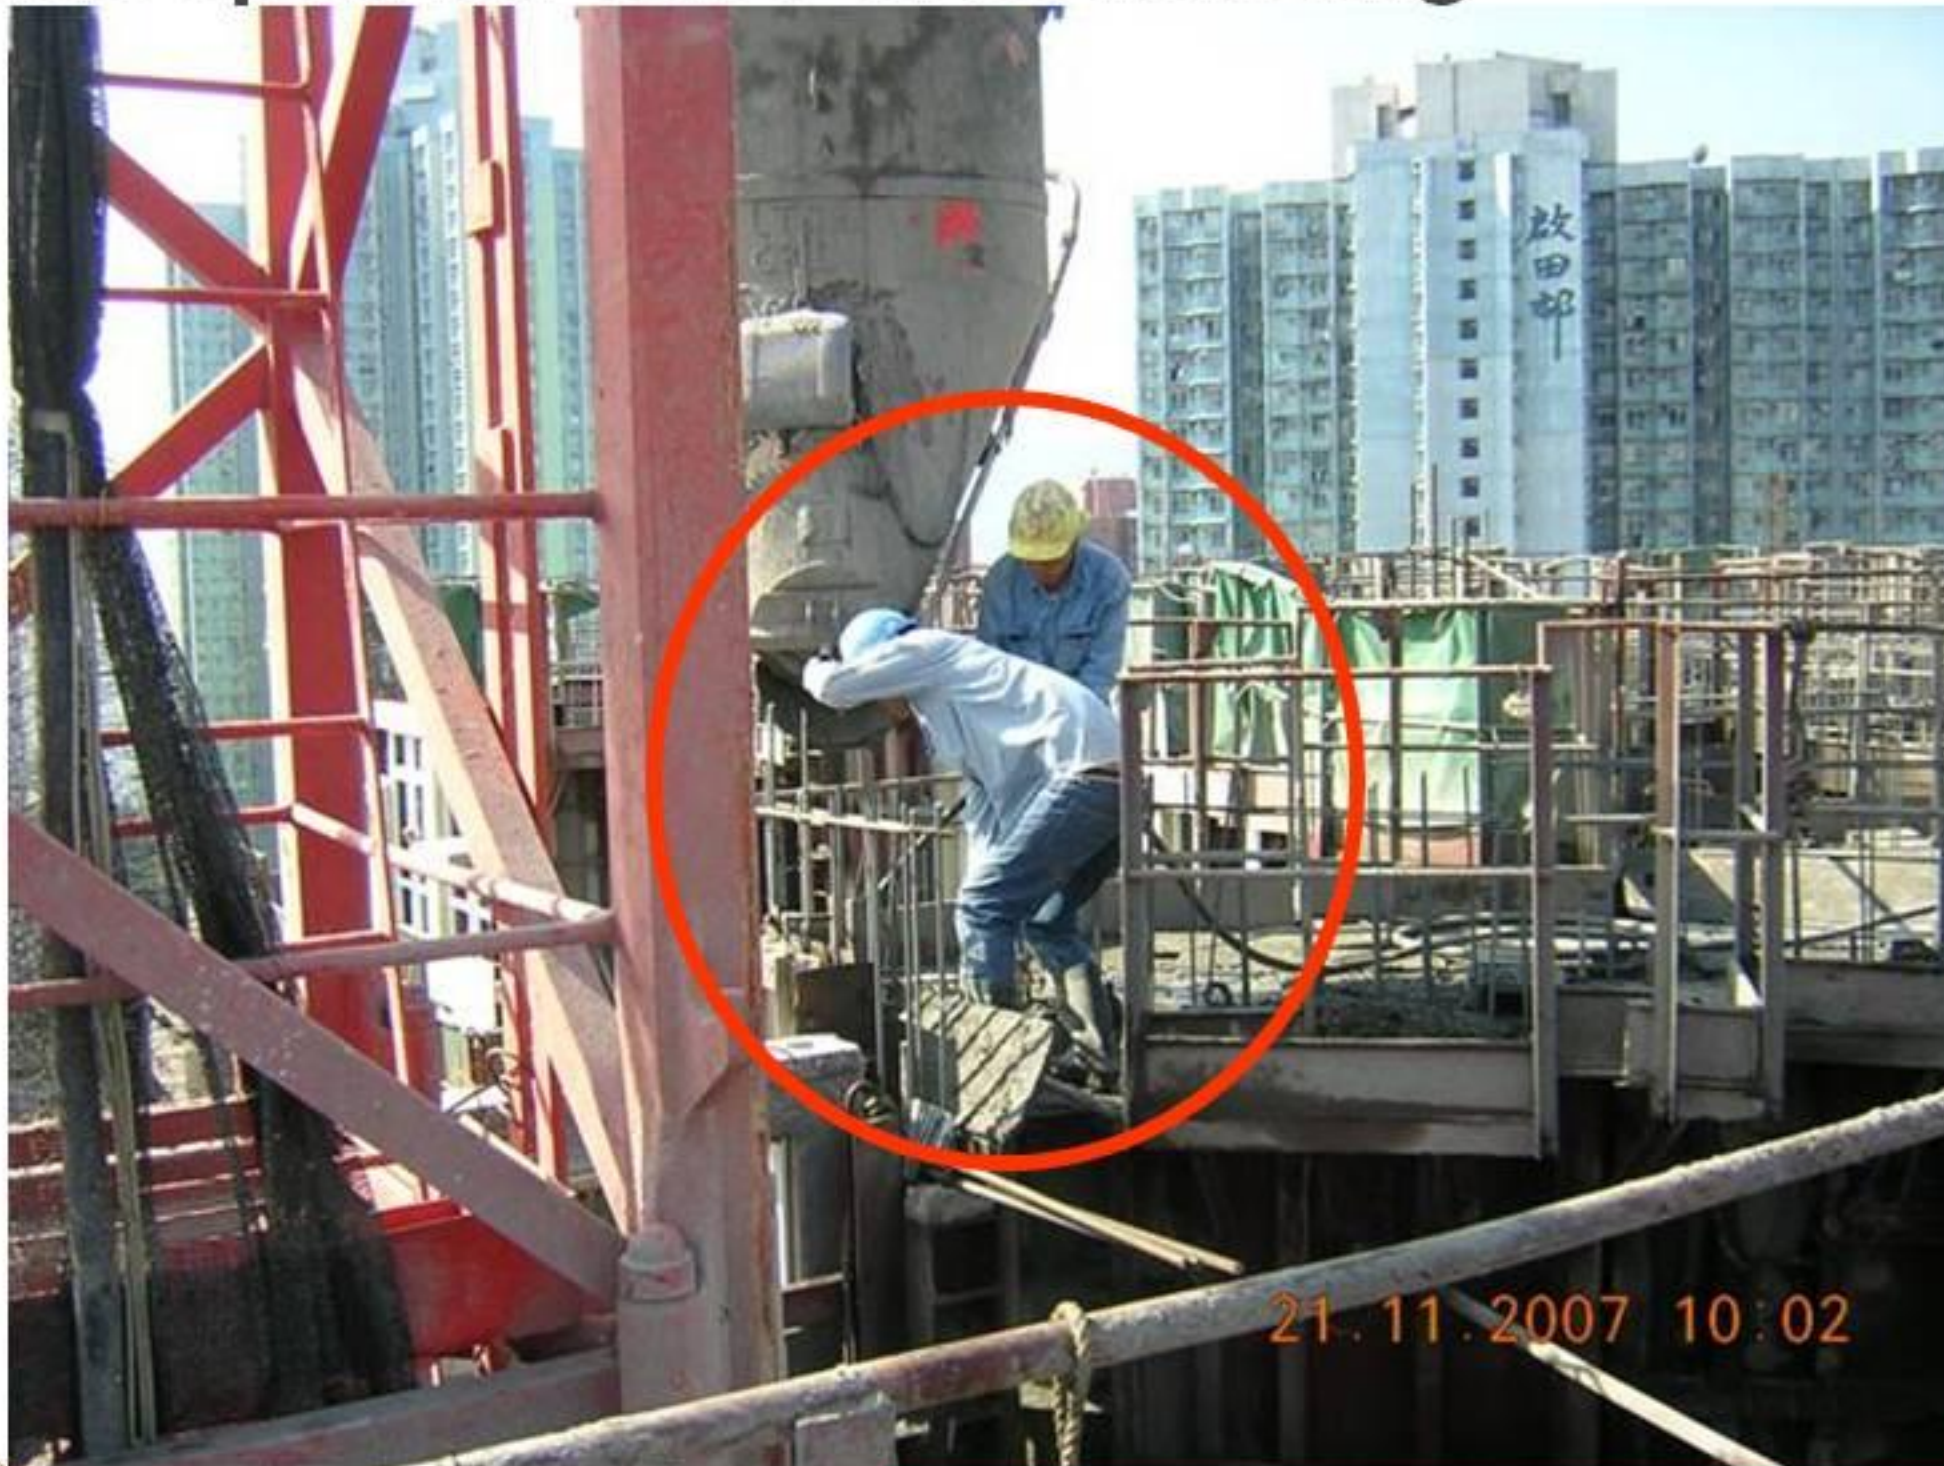
# Swing Gate at Working Floor left open for ease of concreting

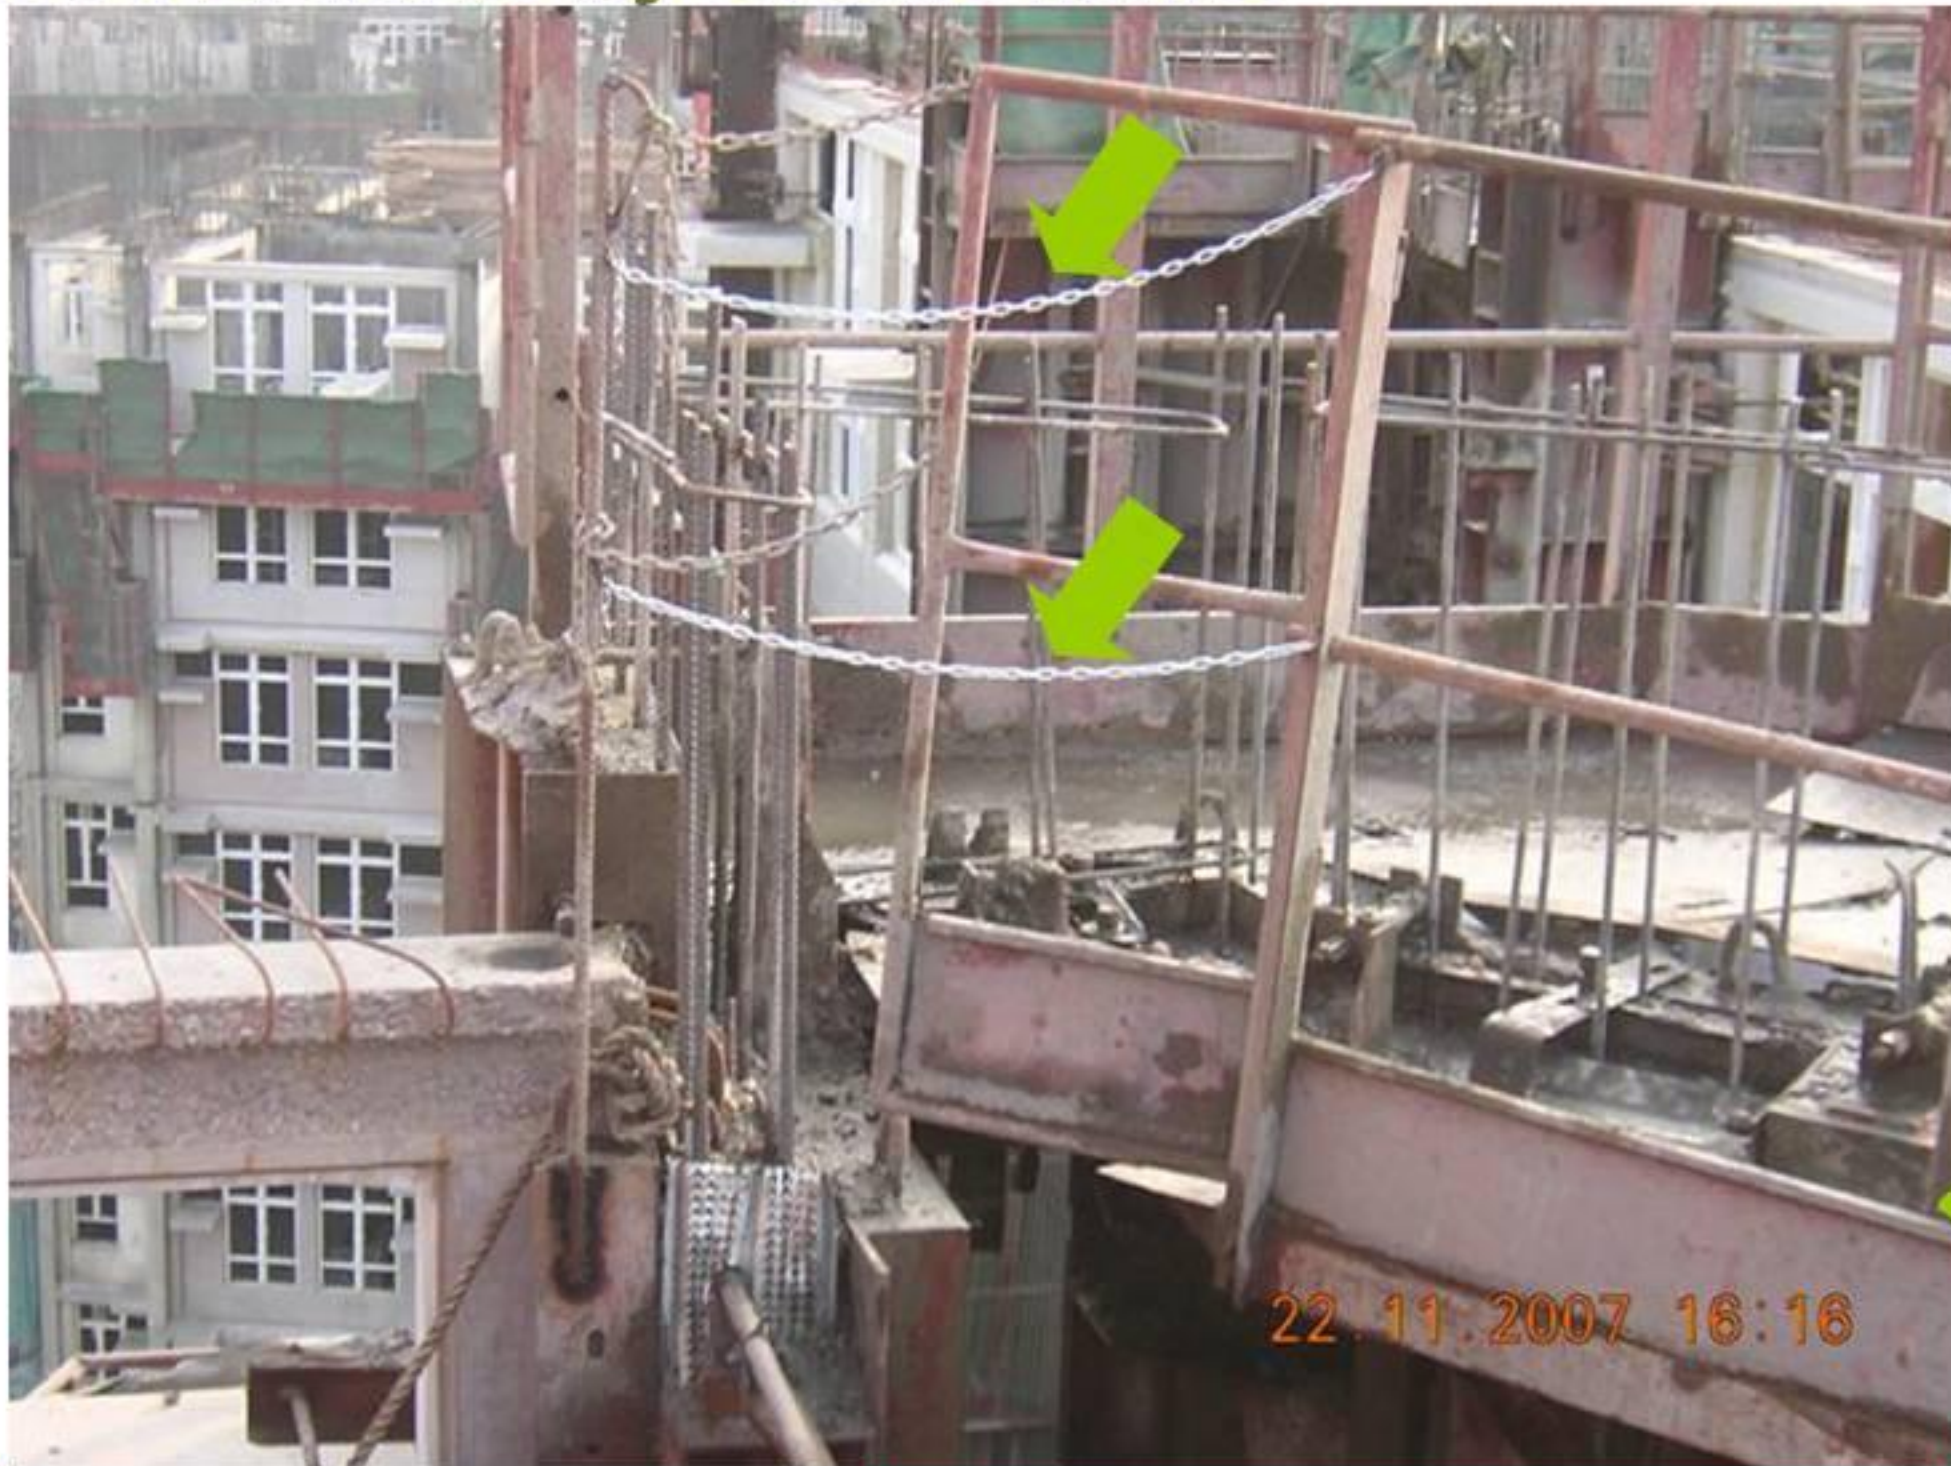
# Swing Gate at Working Floor

## GOVERNED by steel chains
