# **SITE SAFETY Focus Seminar**

on New Works of  
Housing Department

**Site Safety** issues at -

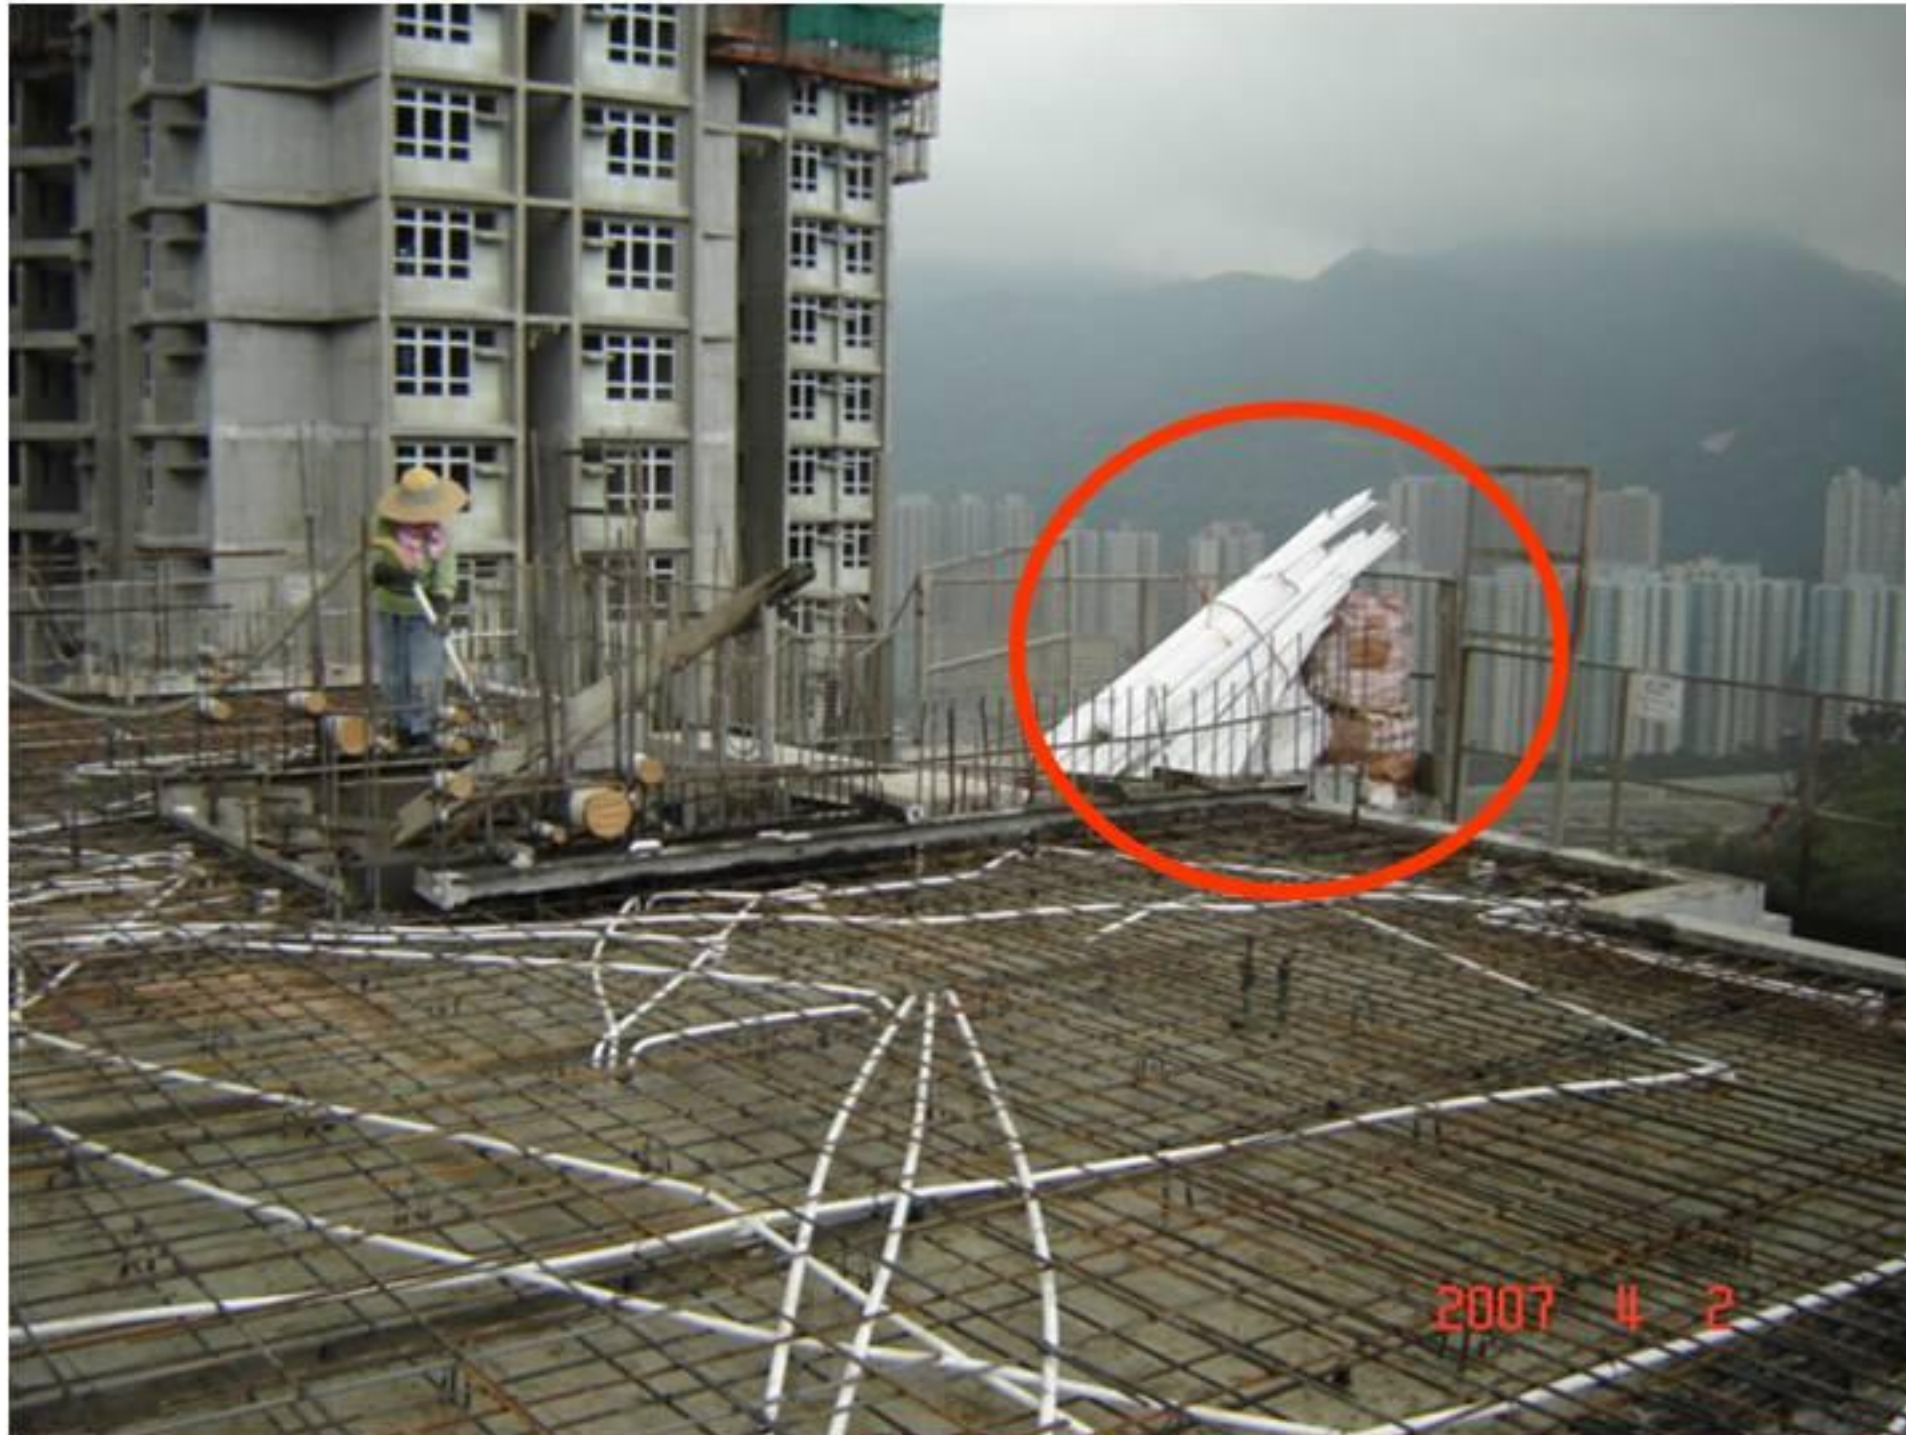
# Materials Stockpile at Working Floor

## PVC conduits & bags of materials stockpiled

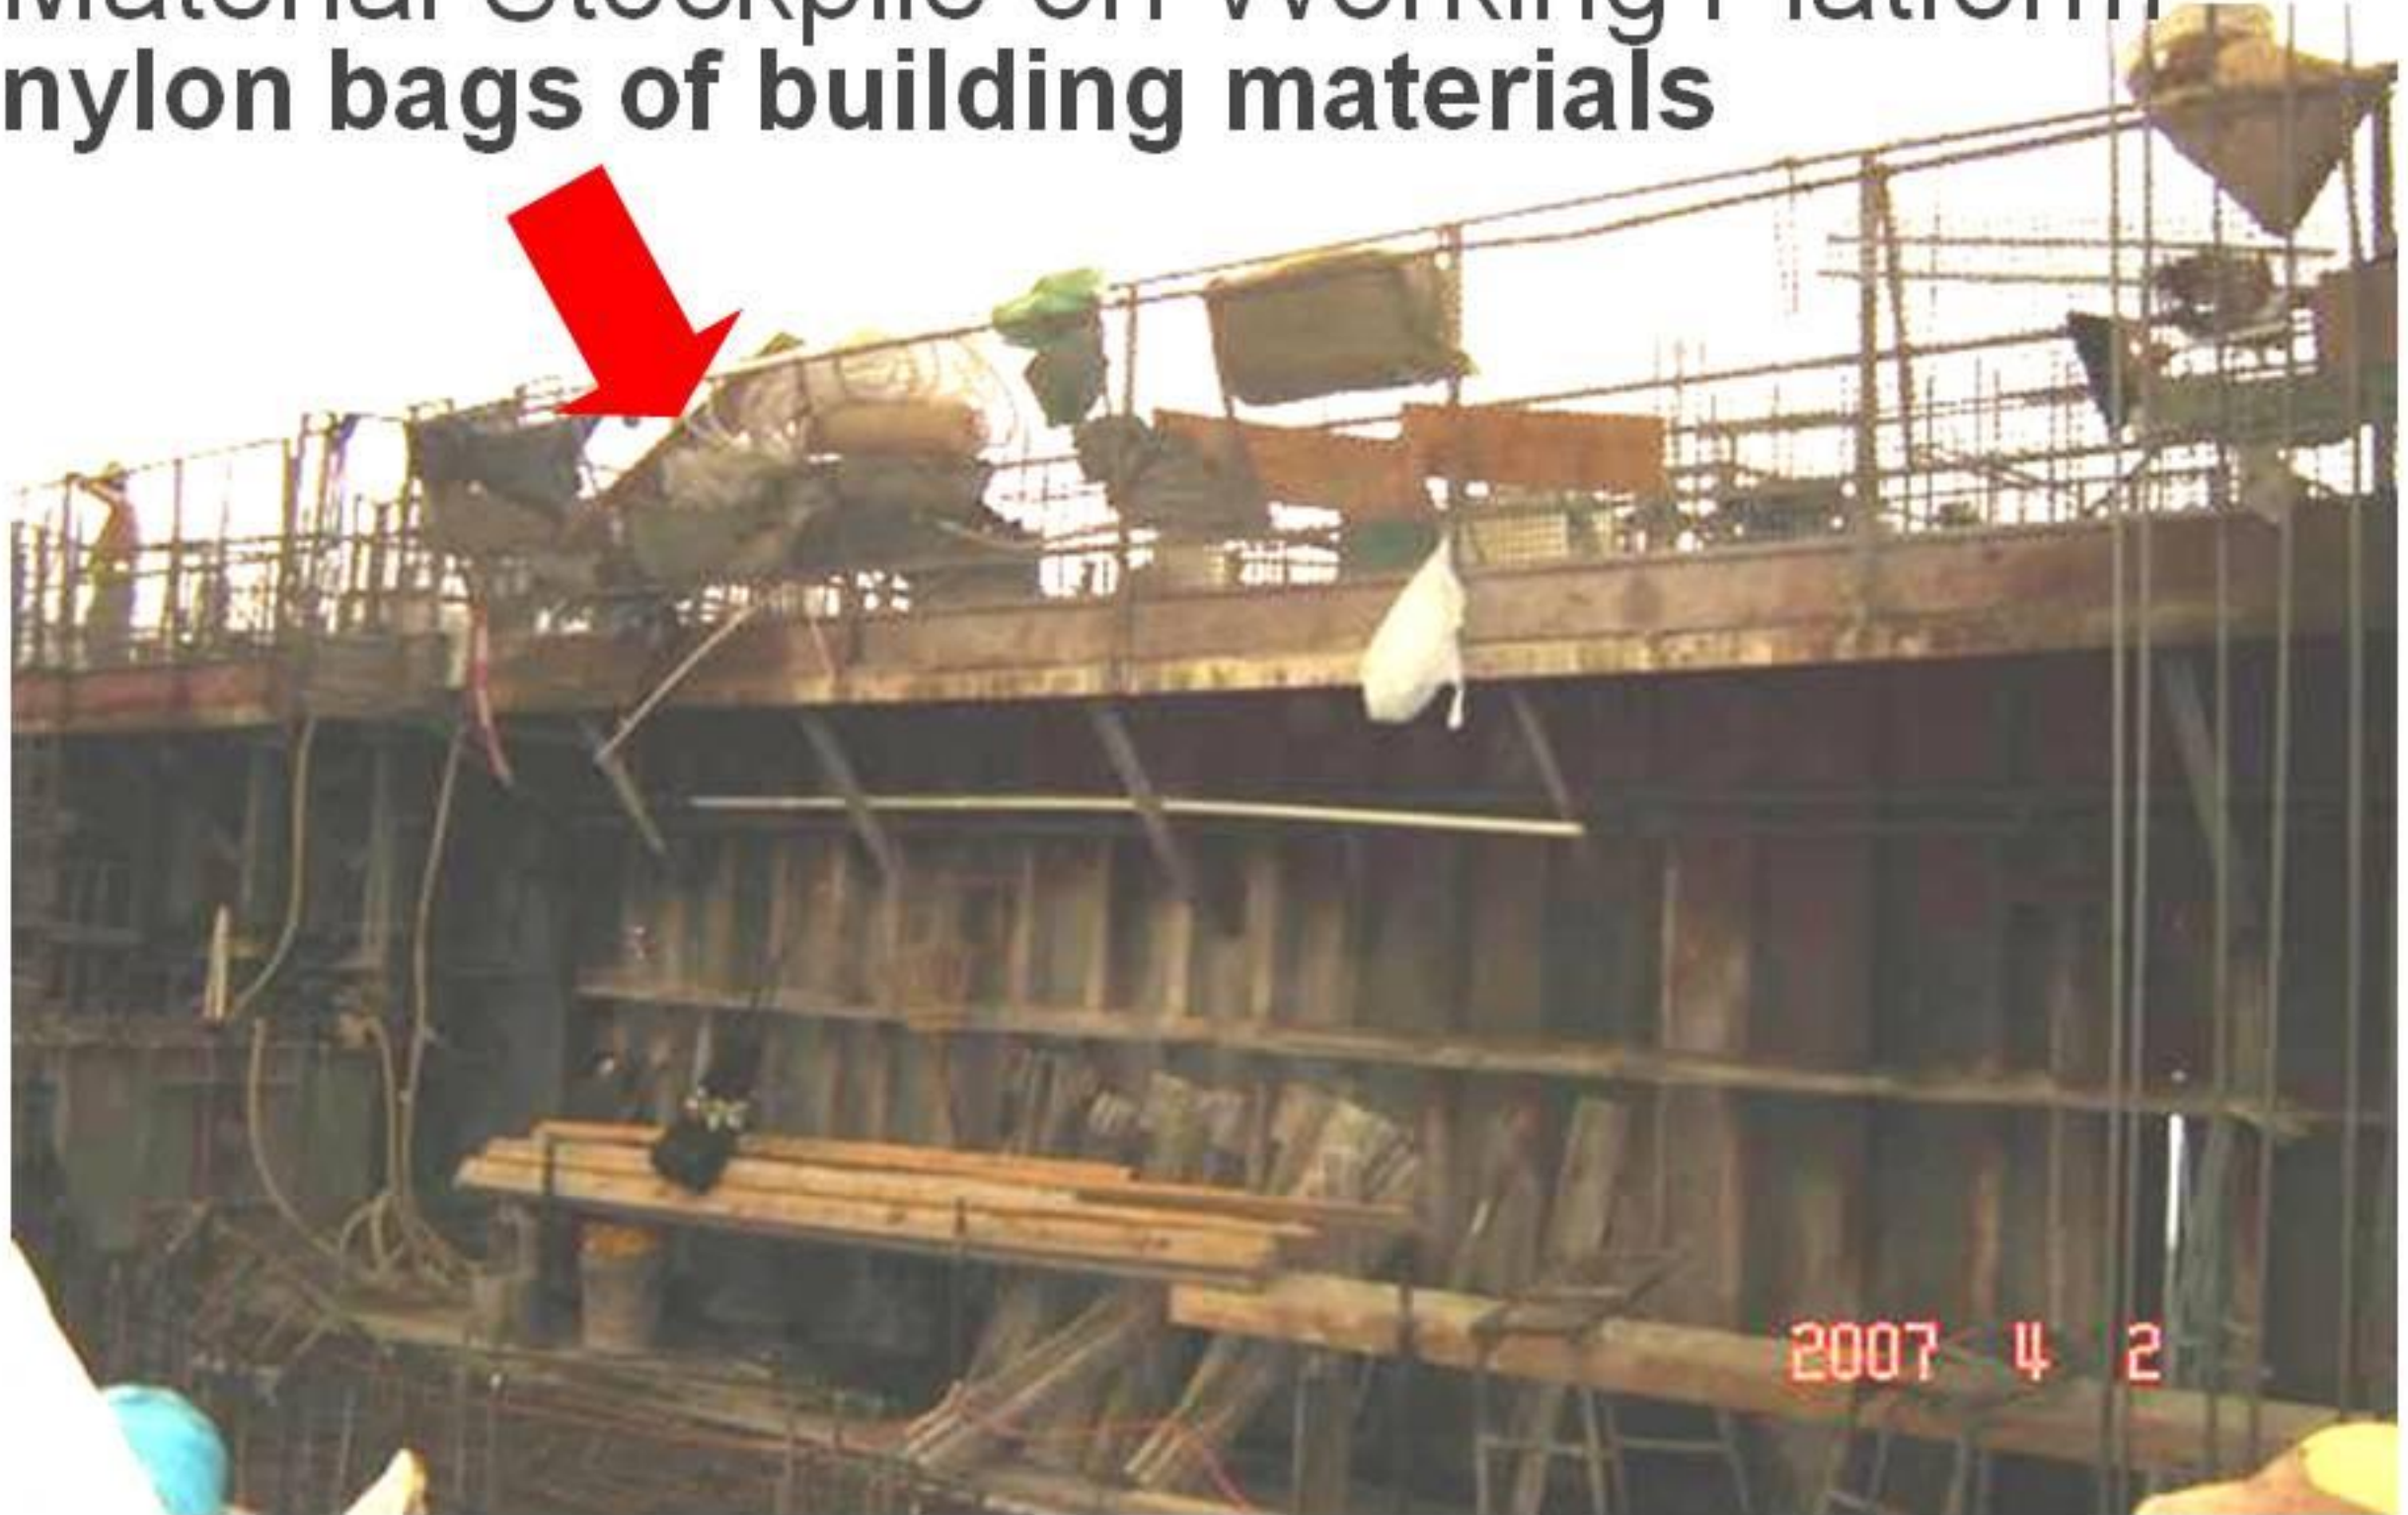
# Material Stockpile on Working Platform nylon bags of building materials

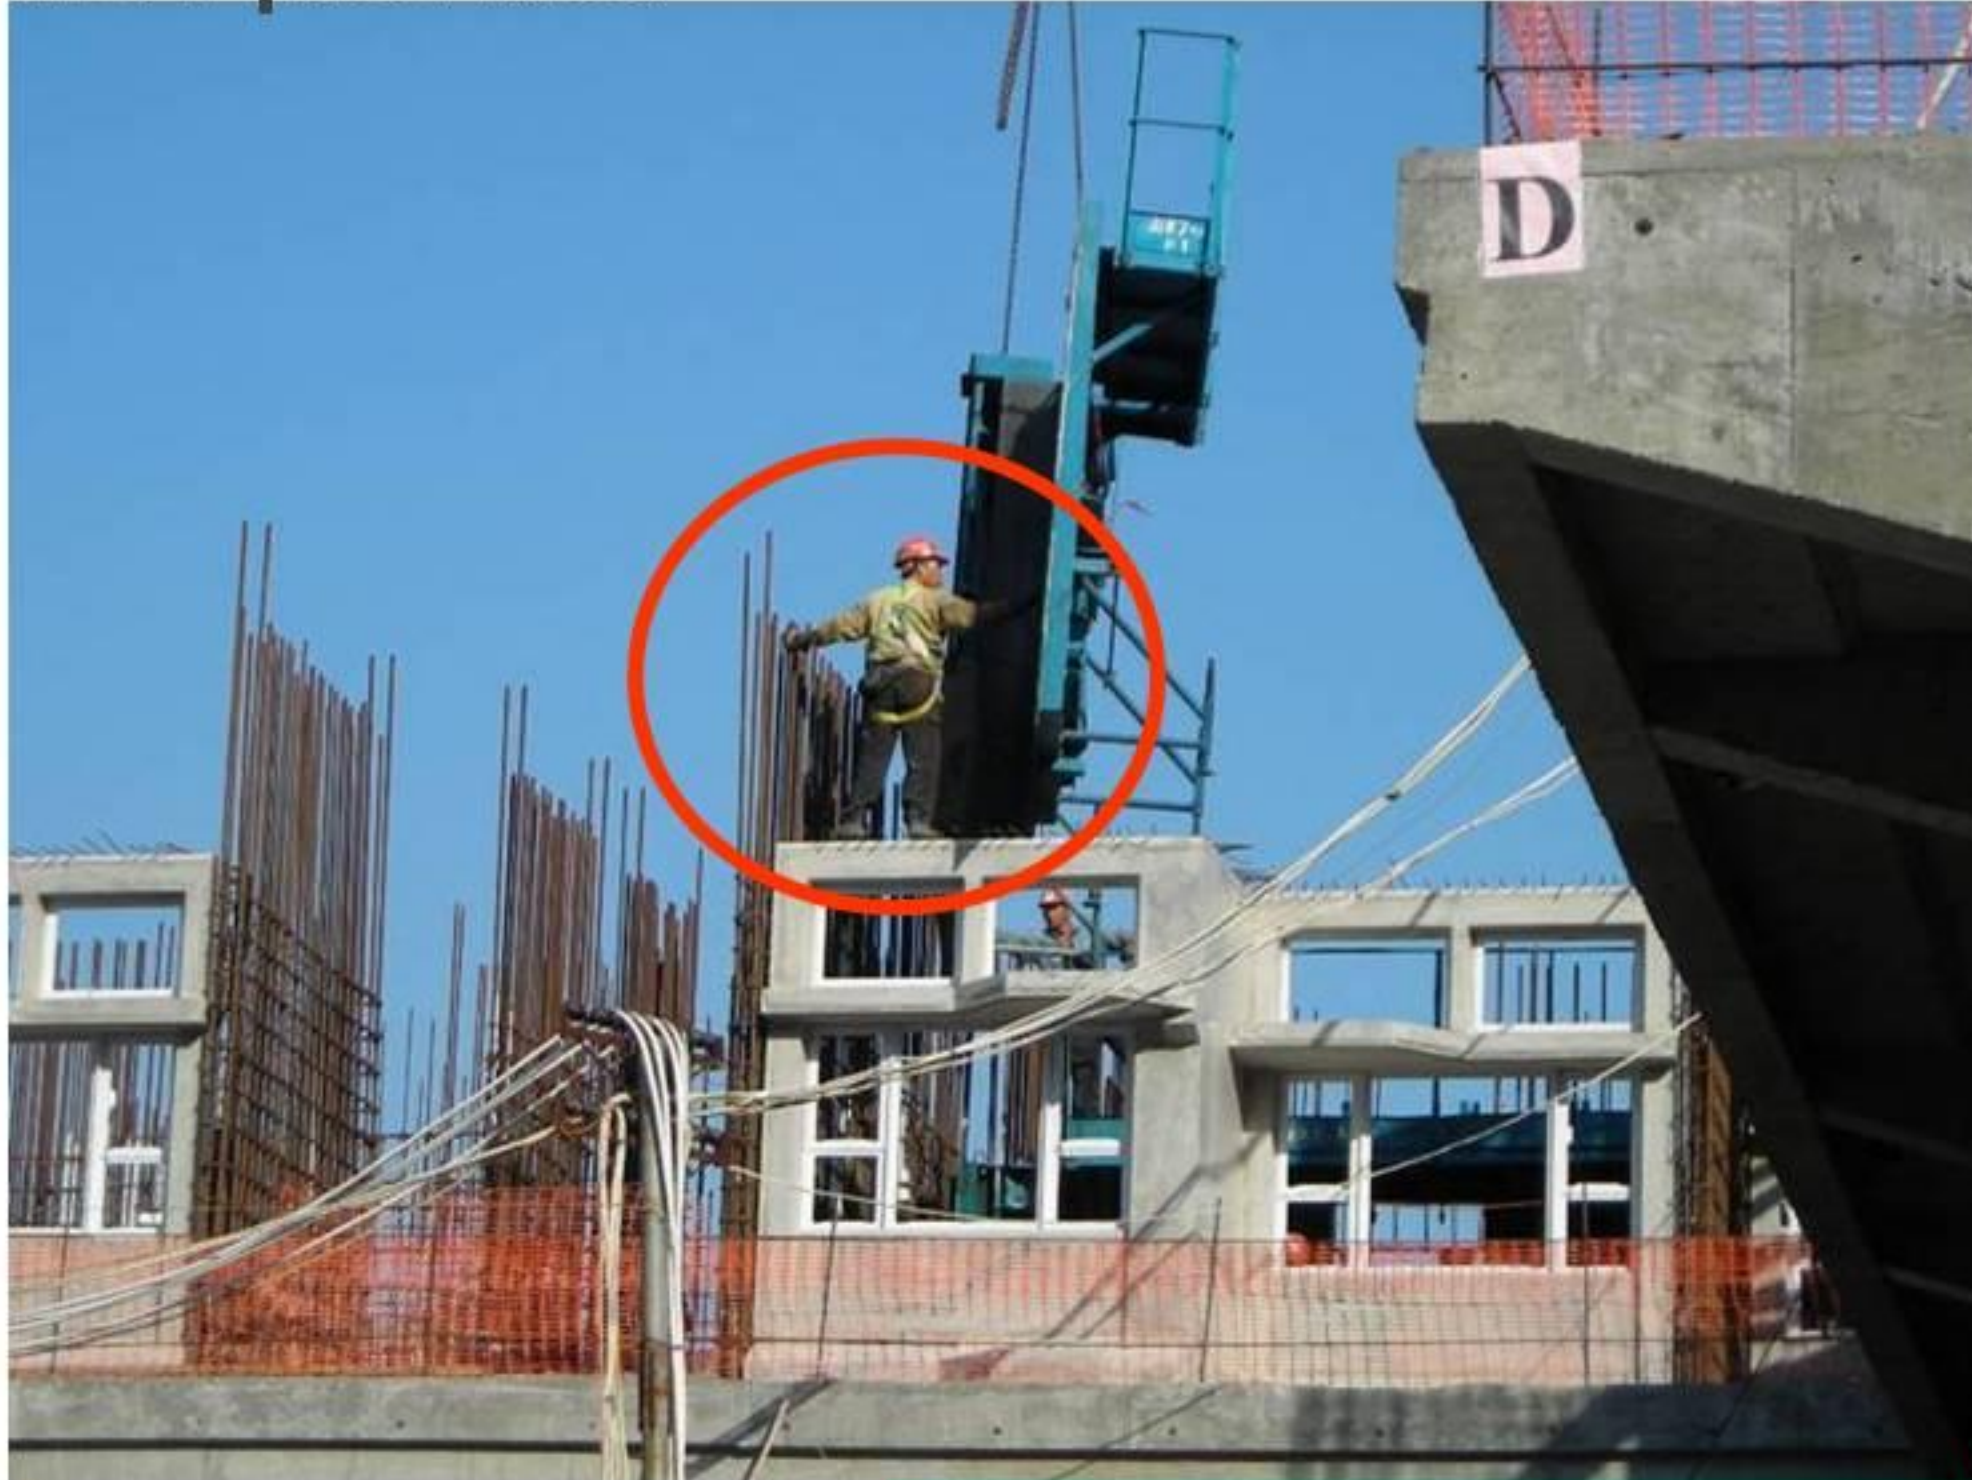
# Working Platform NOT provided

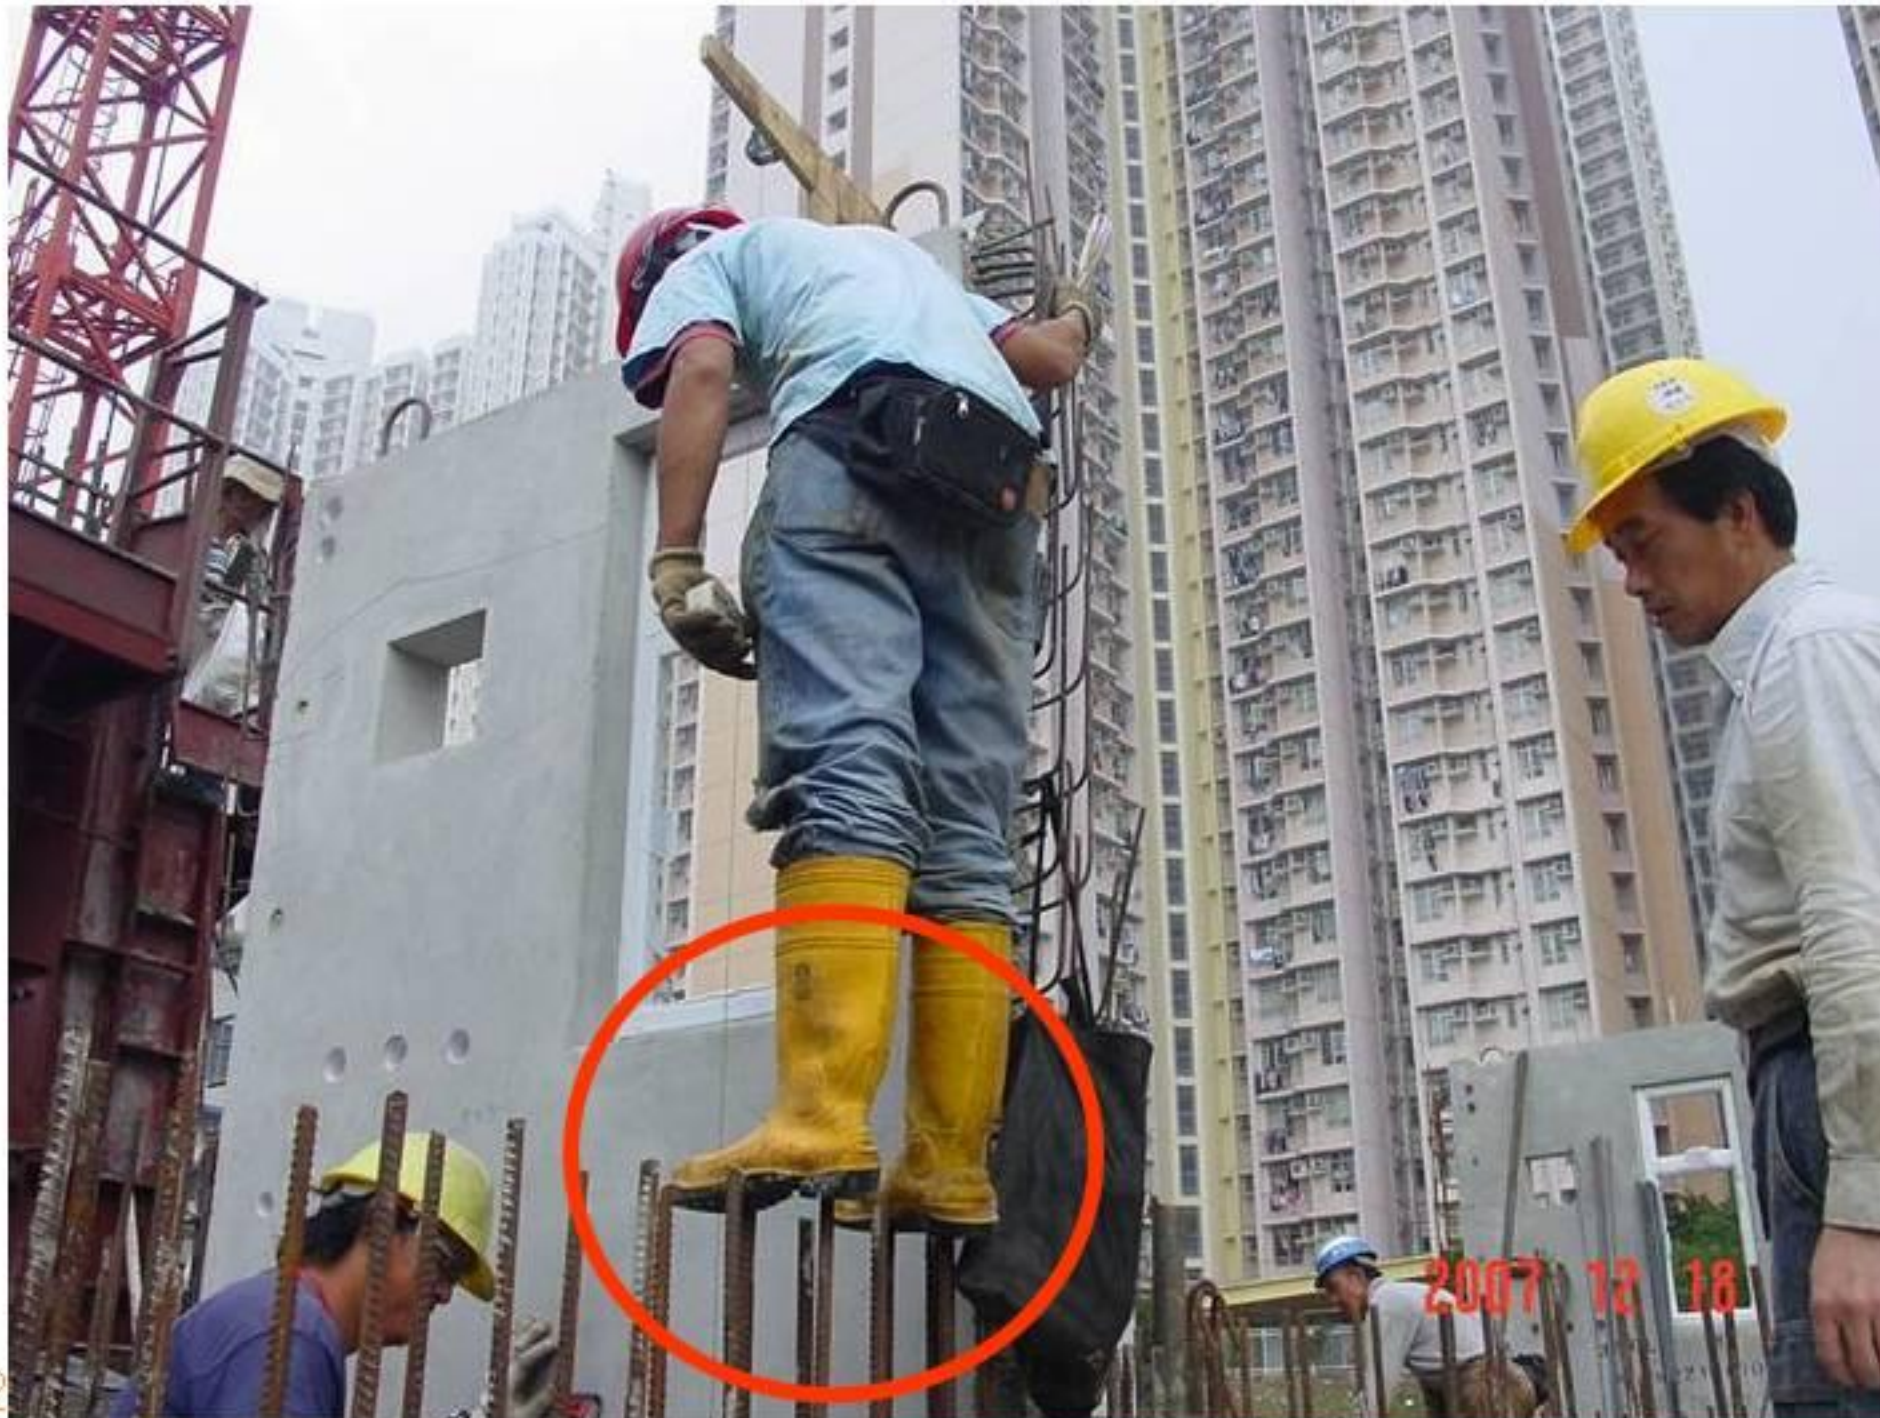
# Working Platform standing on the top of the steel bars absolutely unacceptable

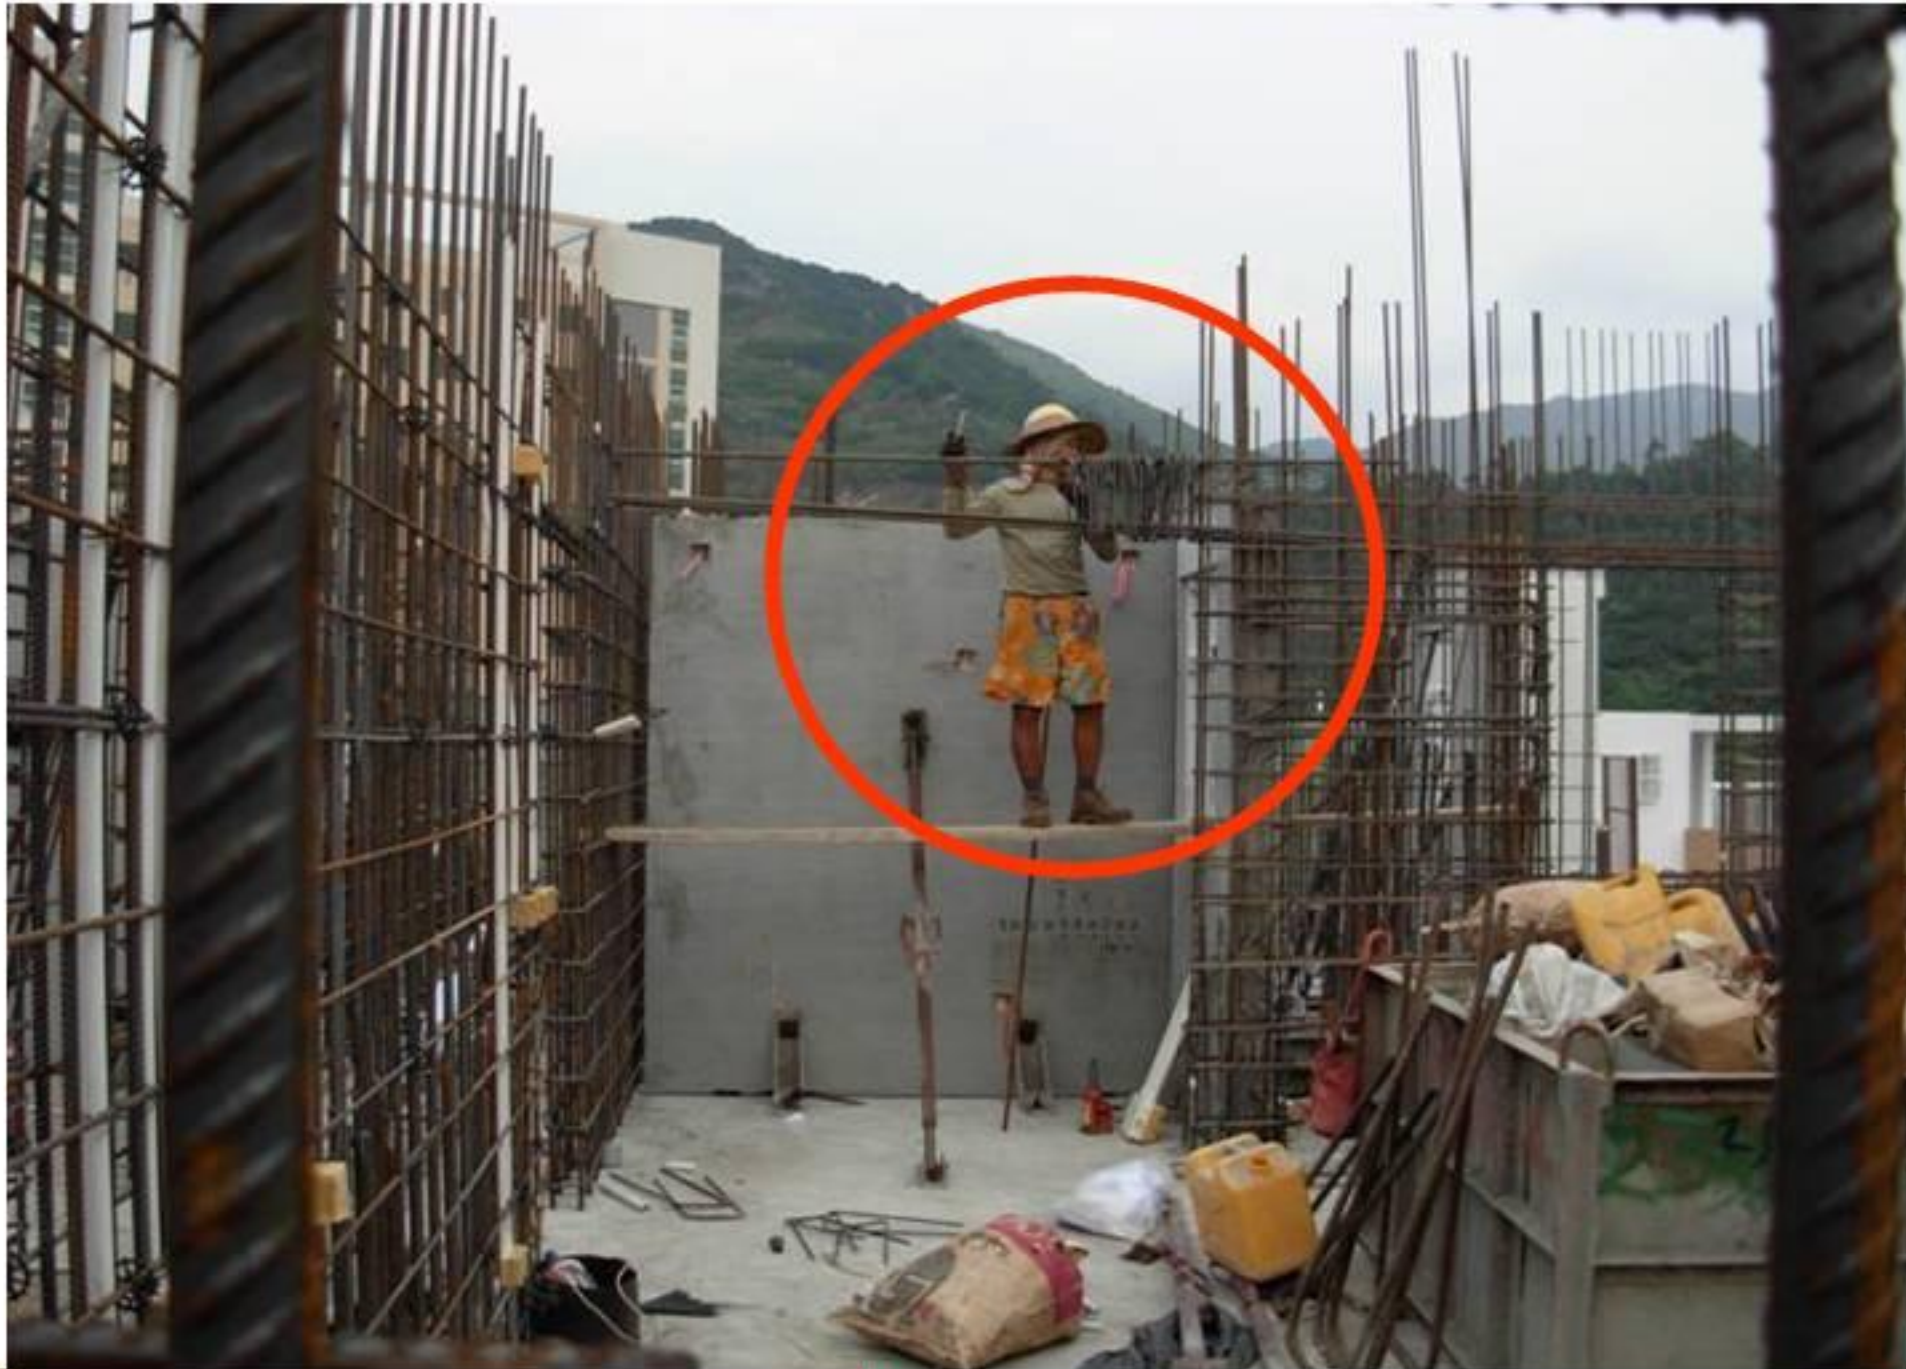
# Working Platform using timber plank as working platform should be stopped at once

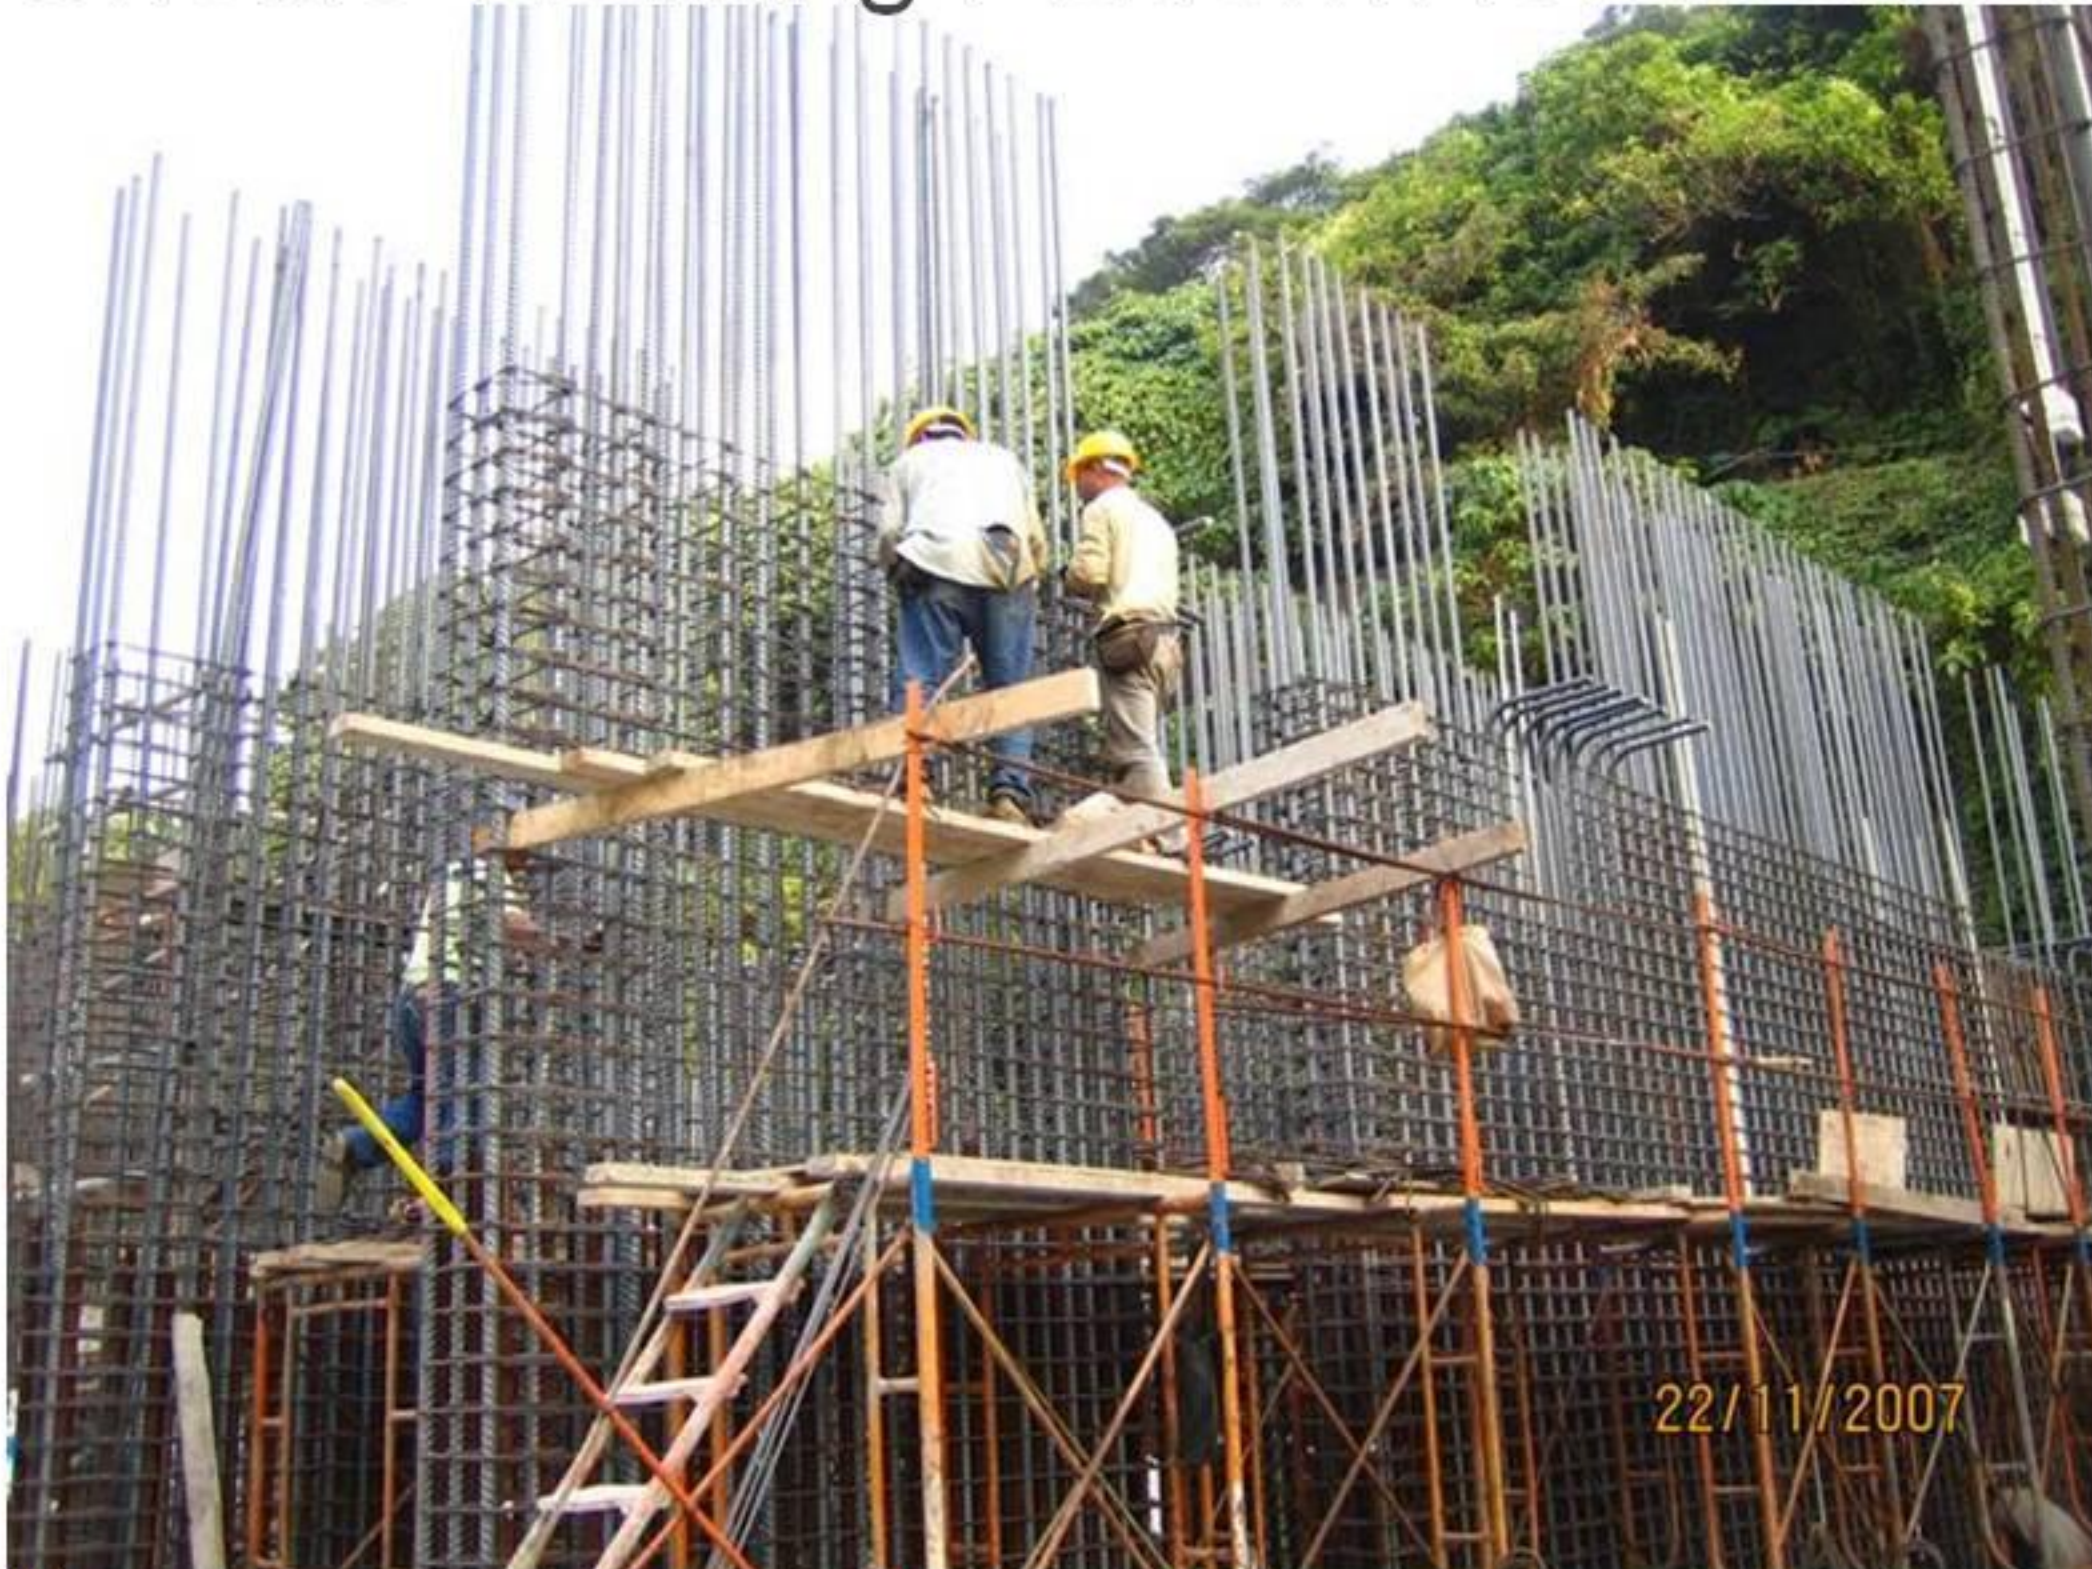
# Unsafe Working Platform for Worker

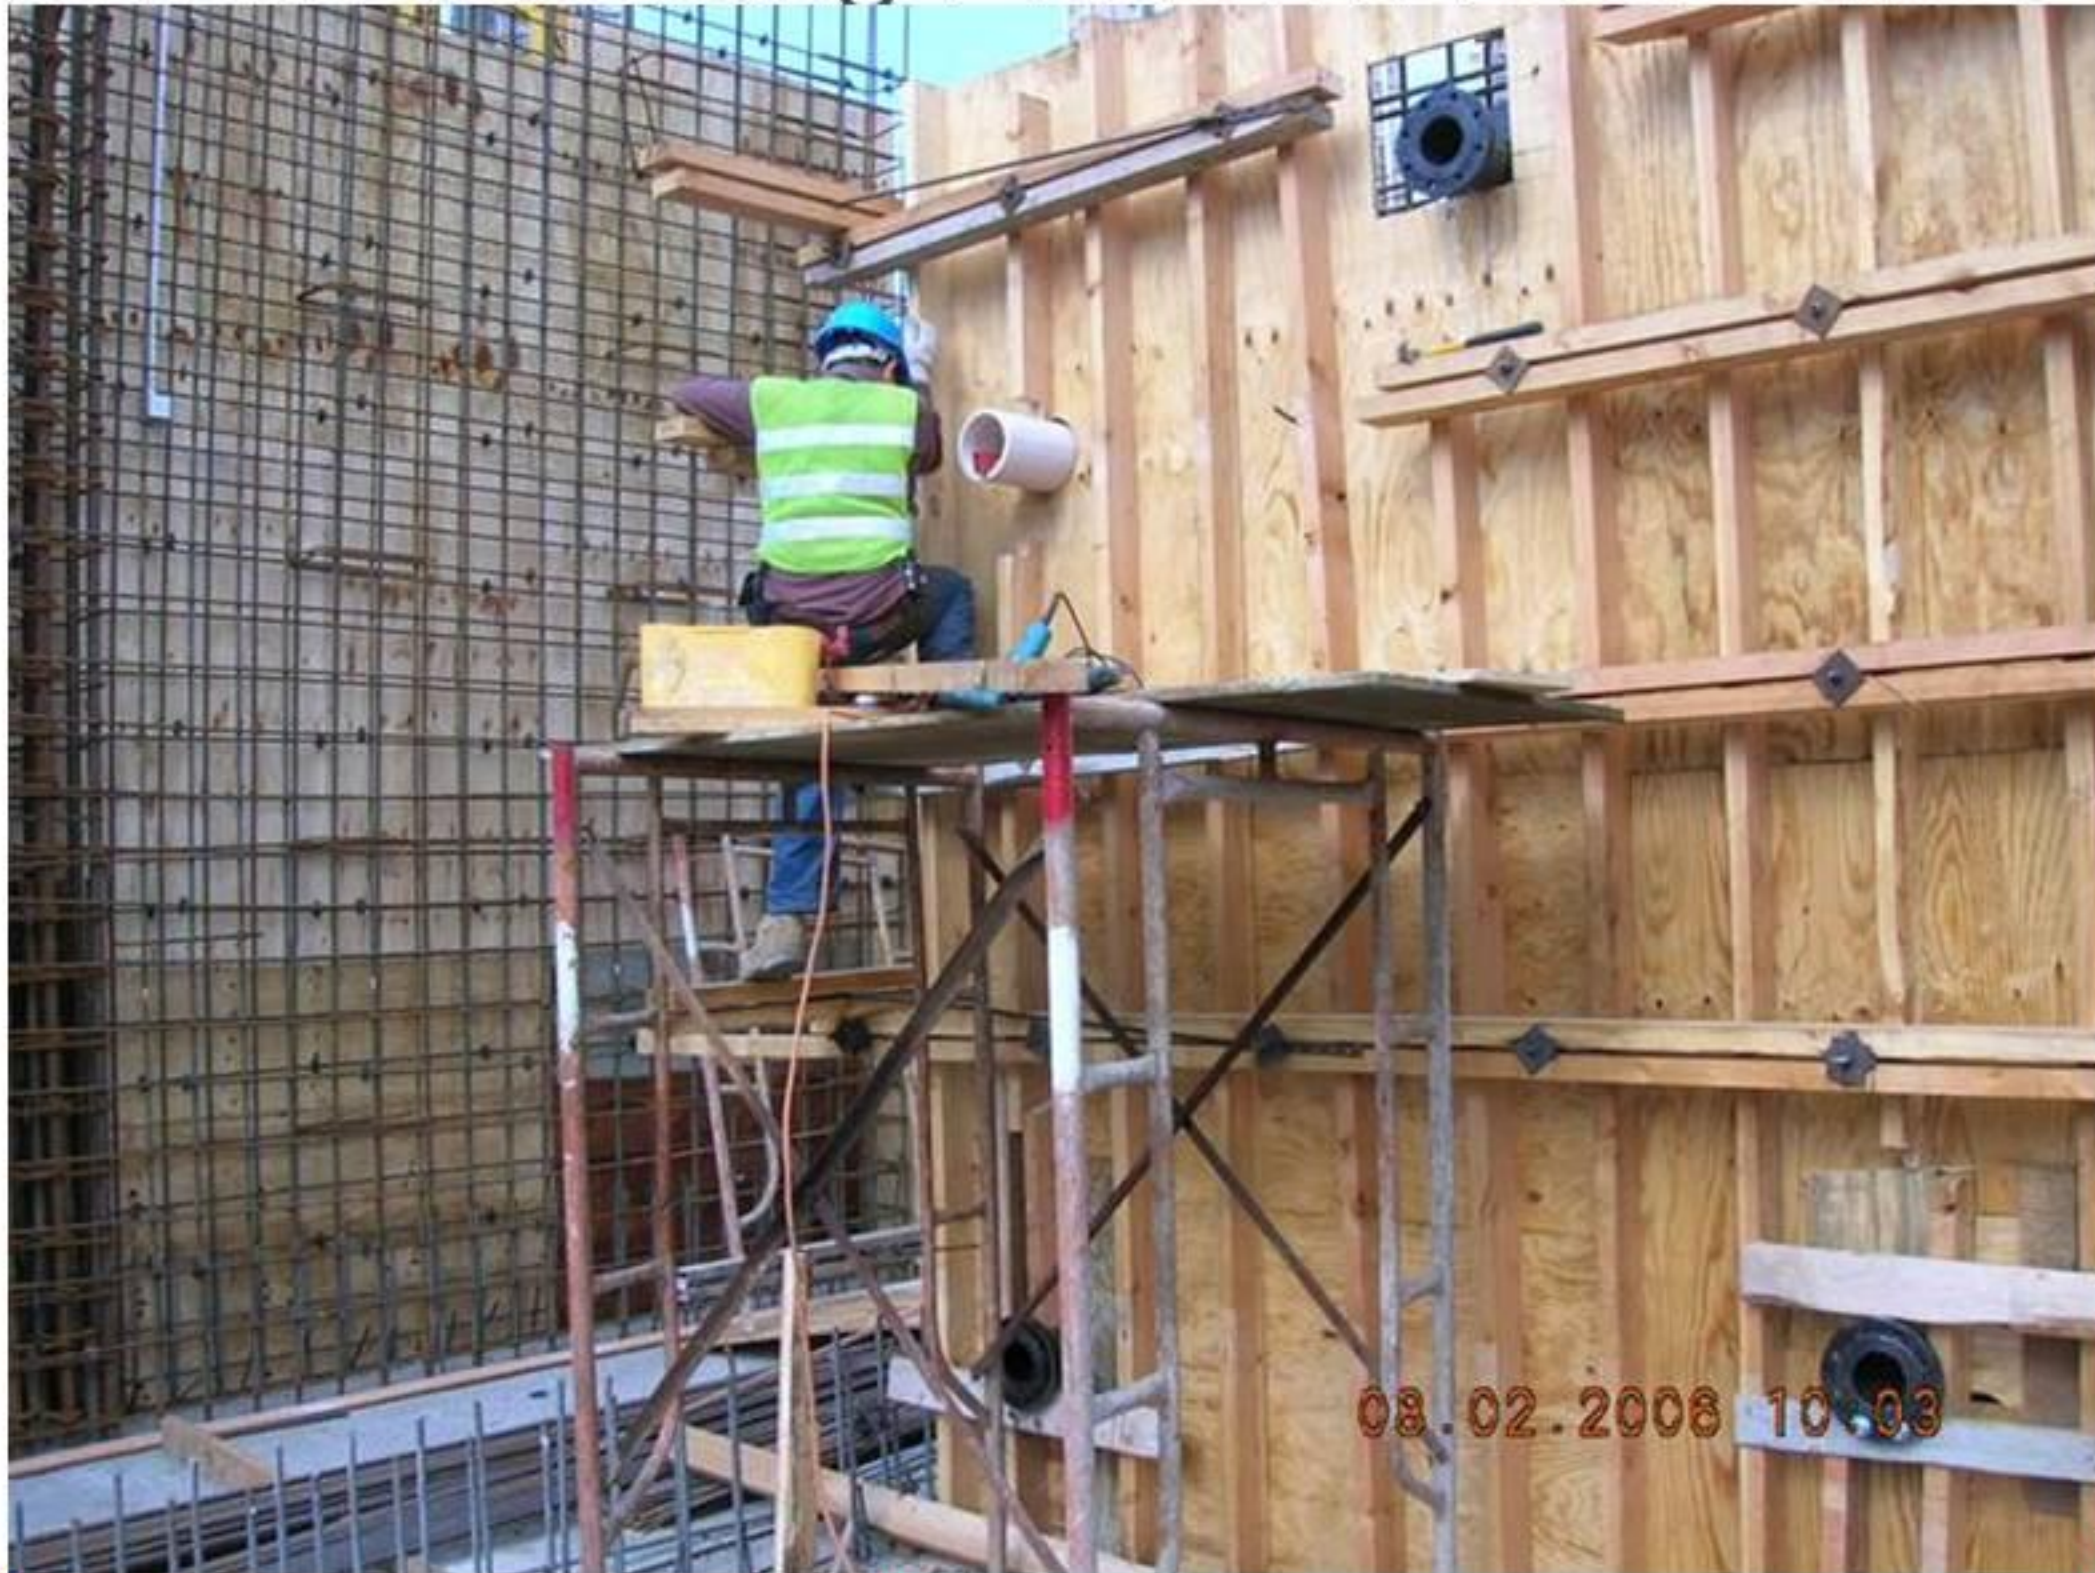
# Unsafe Working Platform for Worker
