# **SITE SAFETY Focus Seminar**

on New Works of  
Housing Department

**Site Safety** issues at -

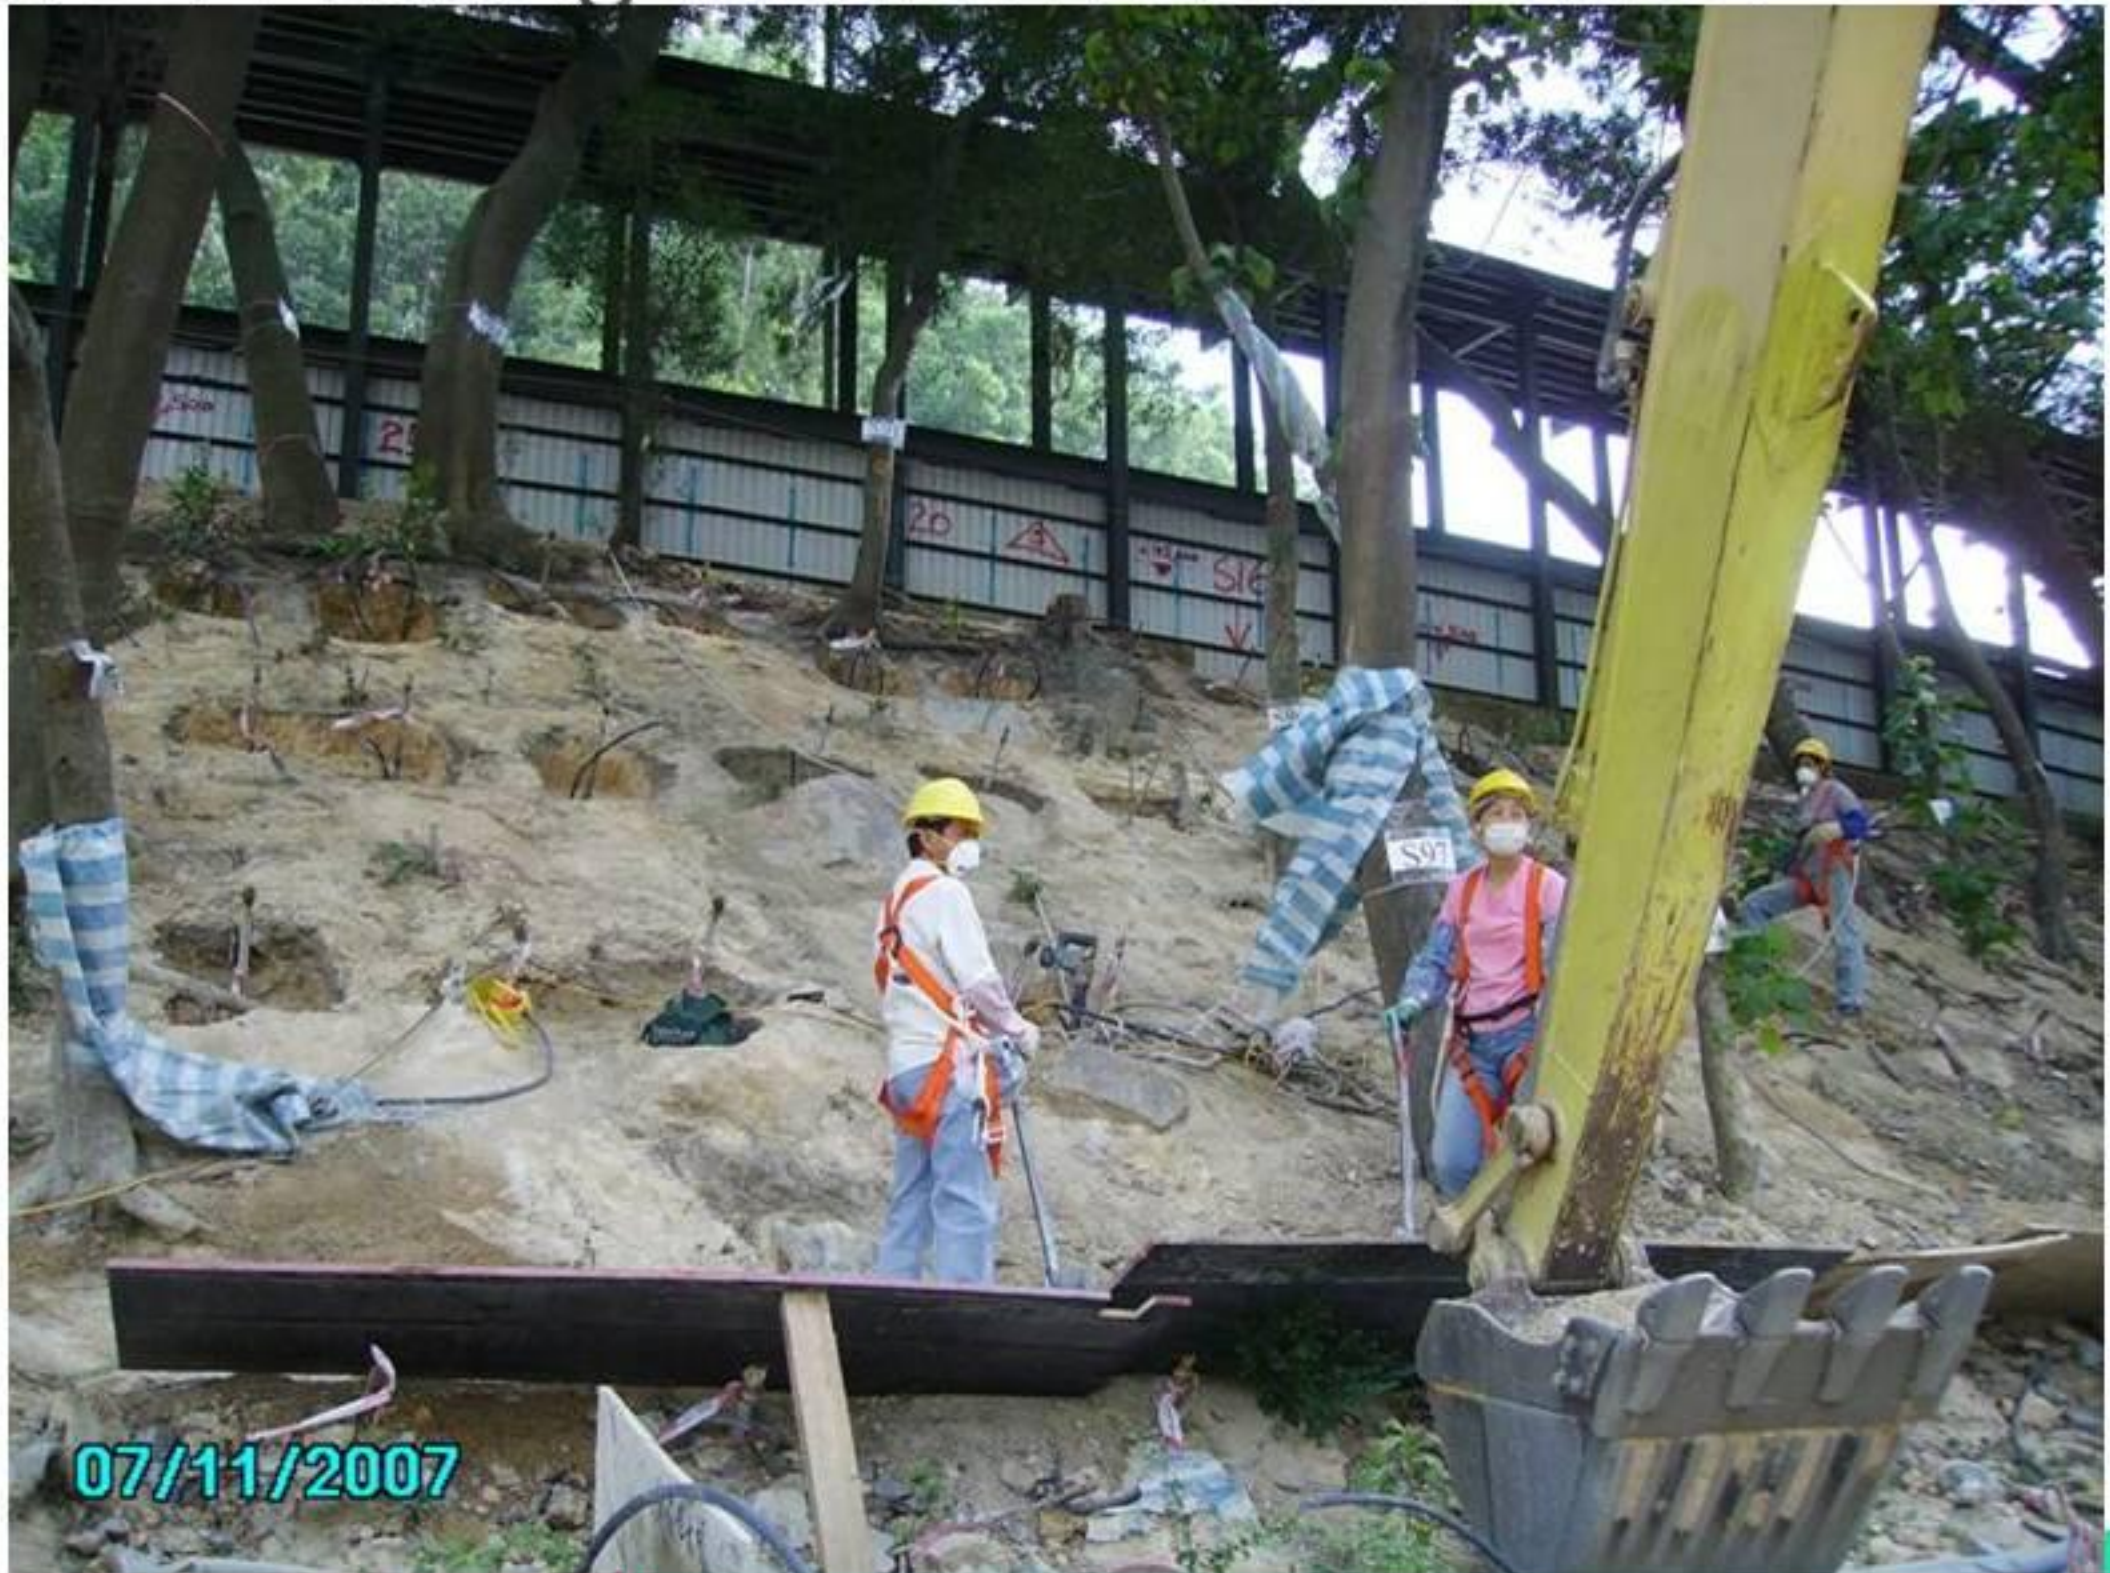
# Unsafe Working Platform for Worker

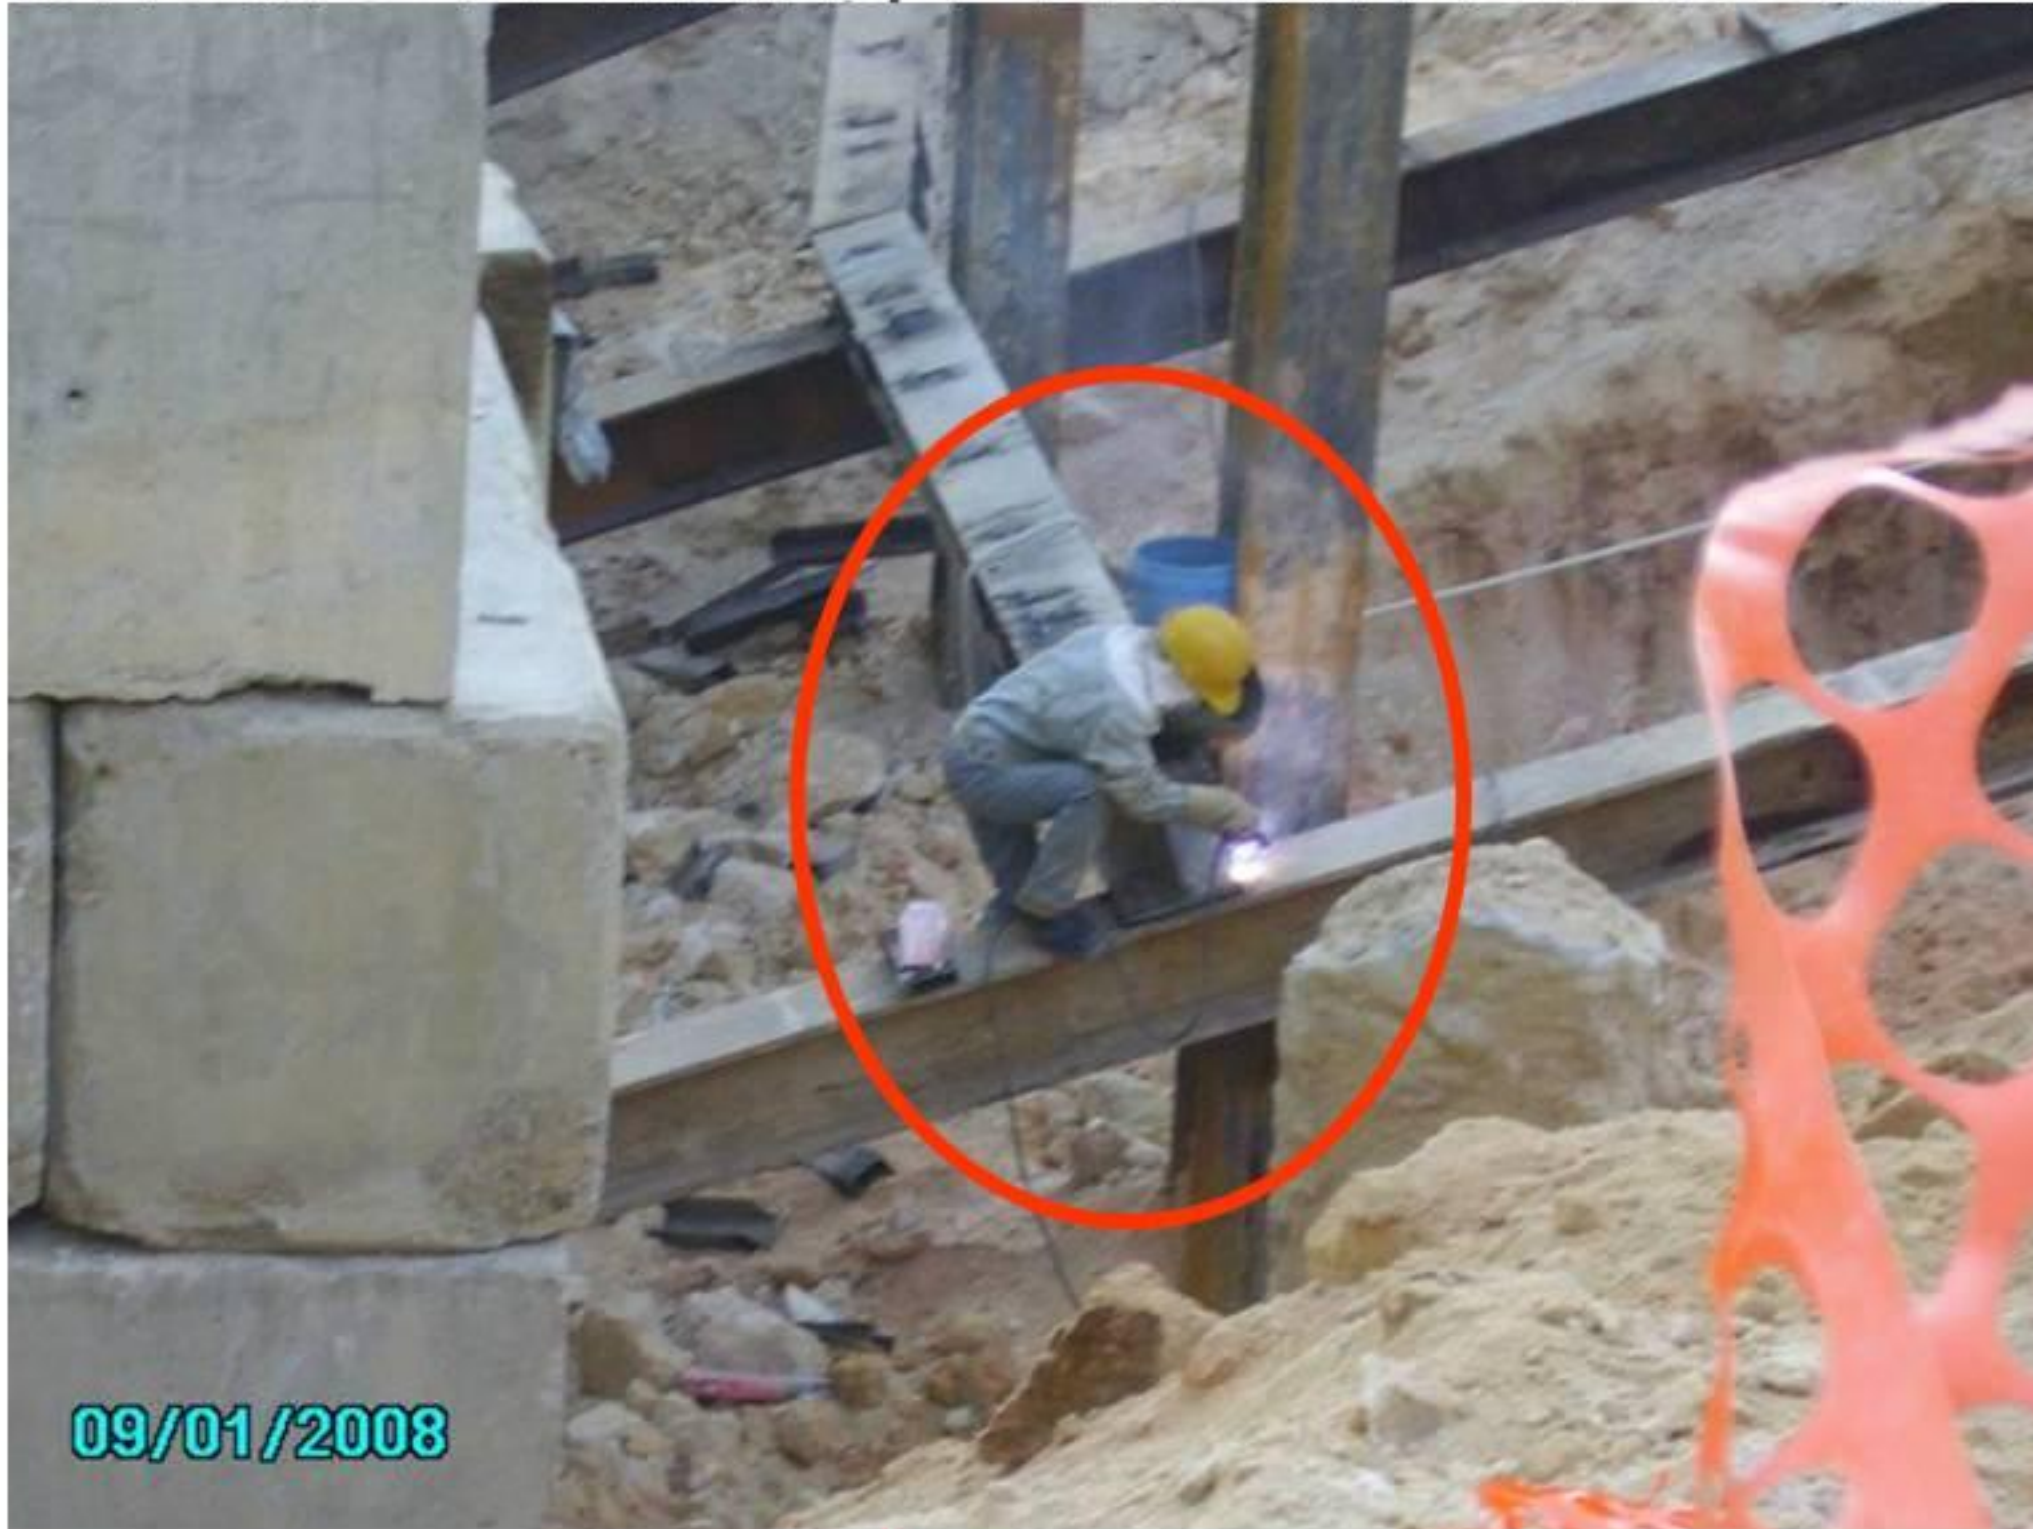
# Unsafe Working Platform for Worker

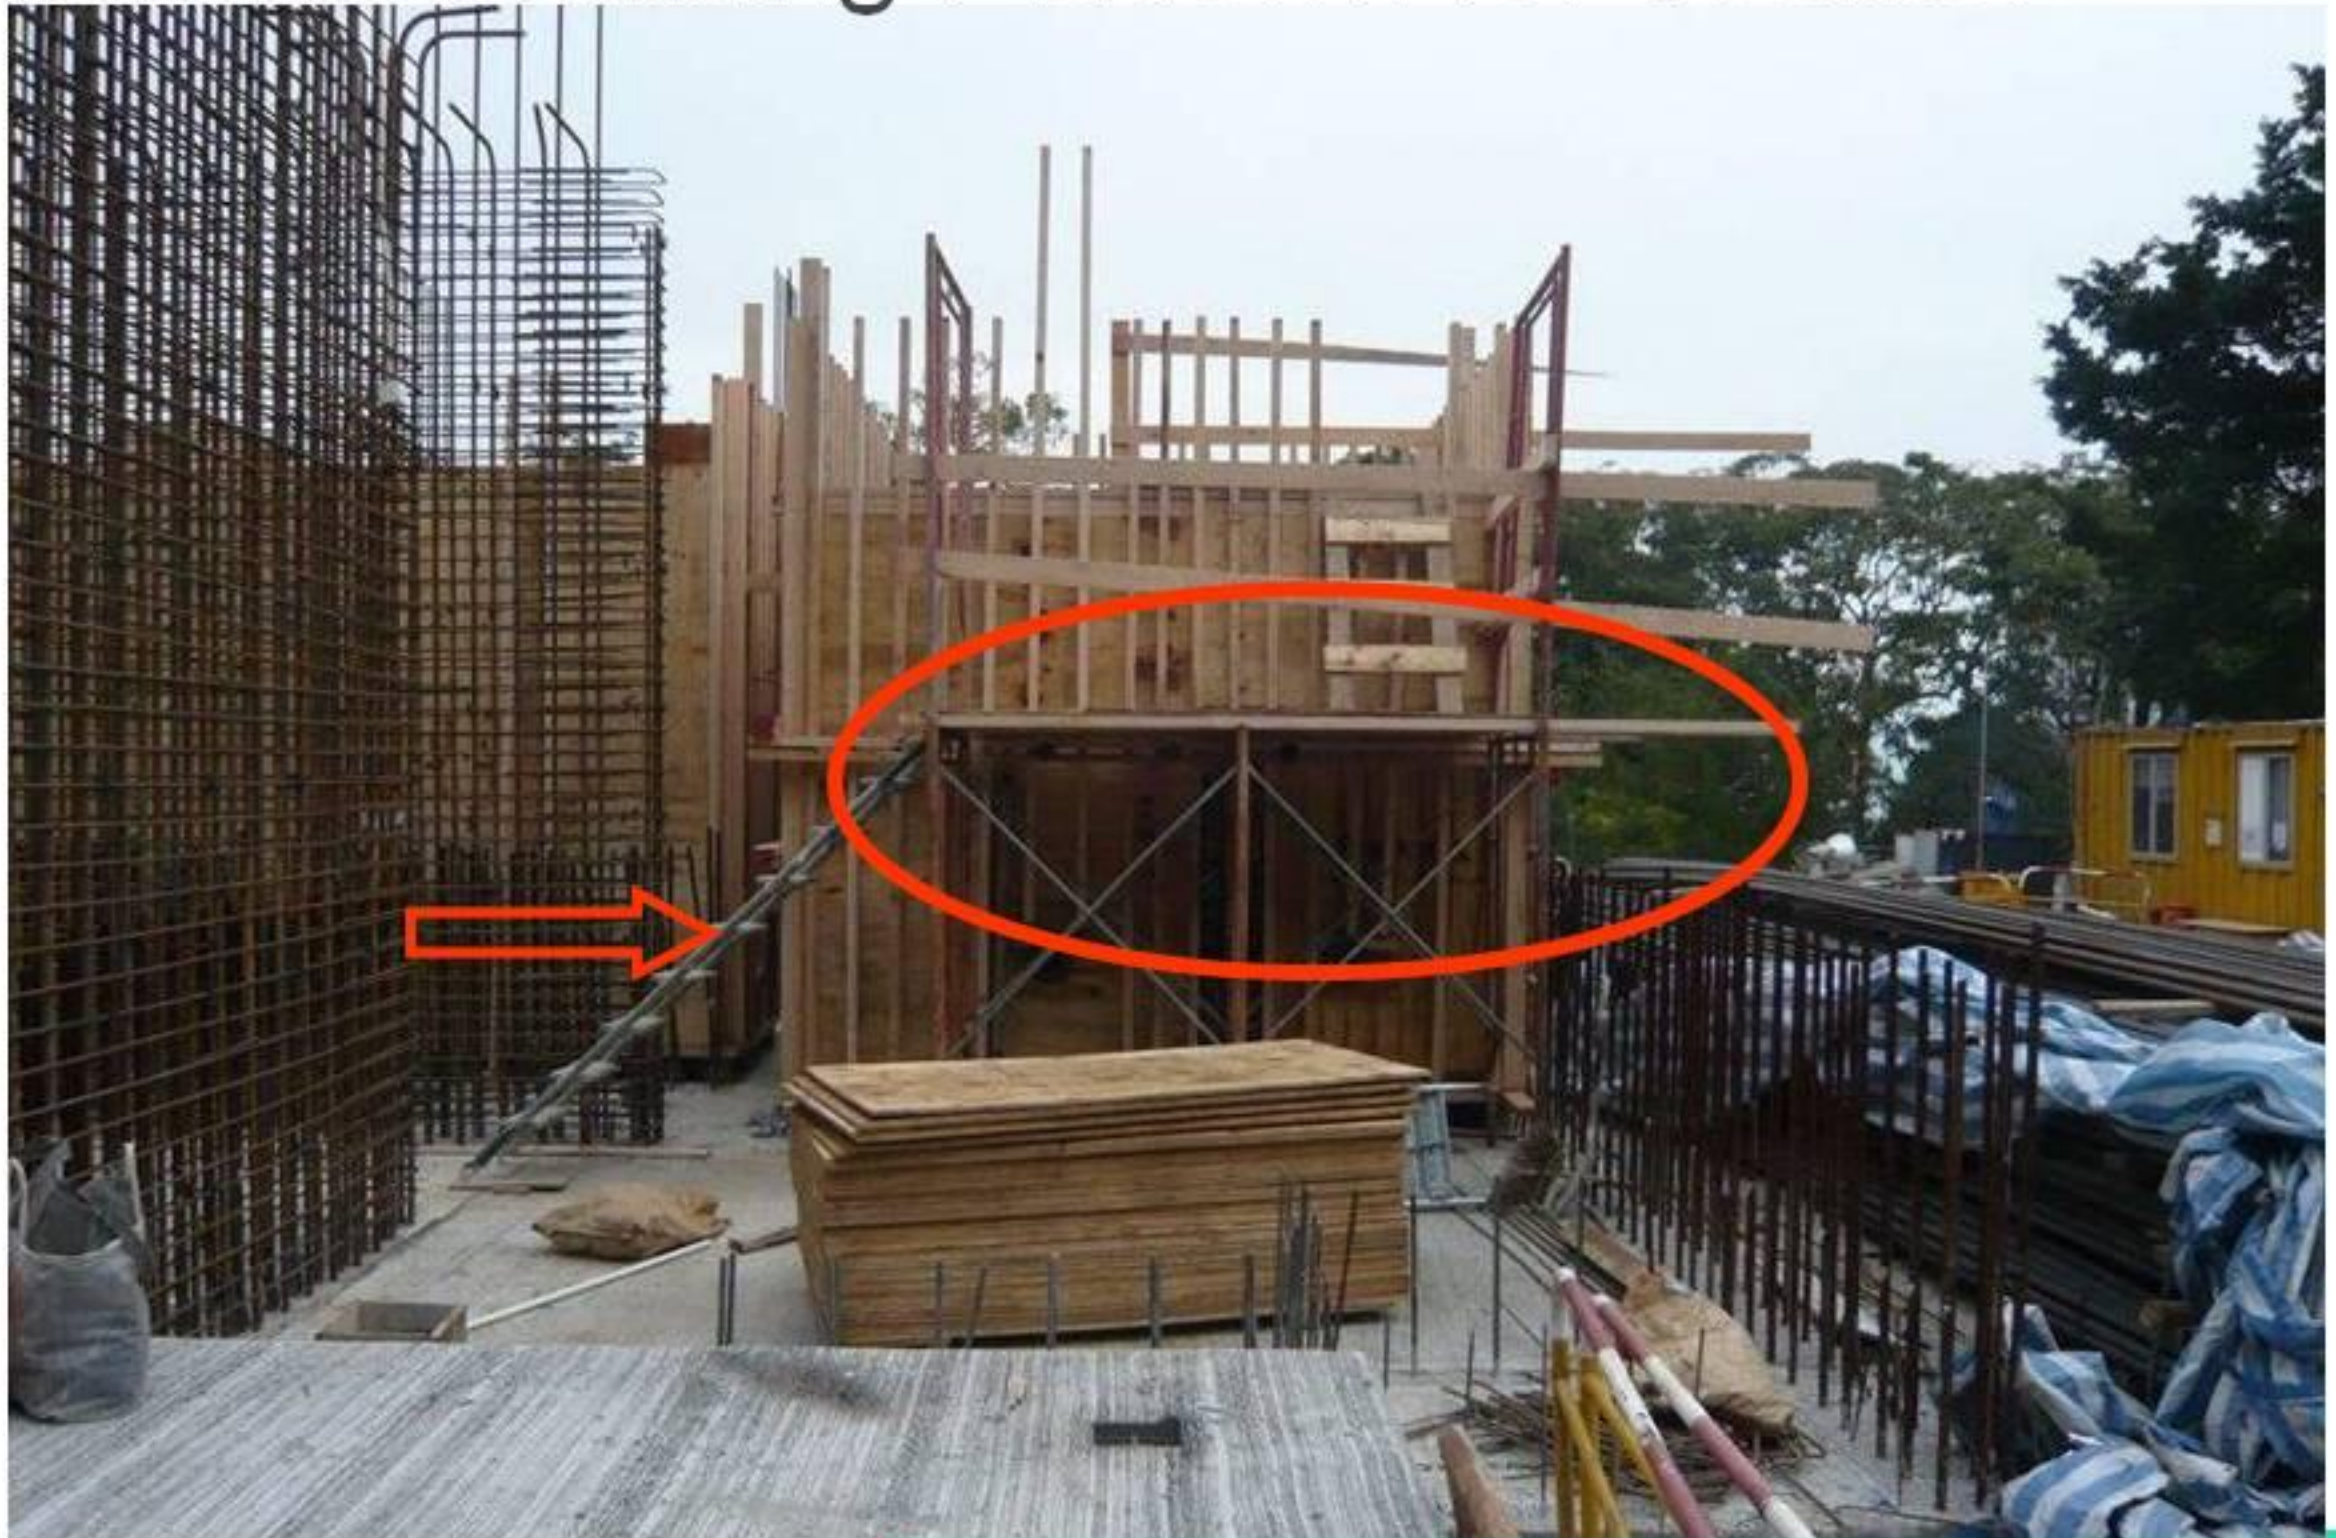
# Unsafe Working Platform for Worker

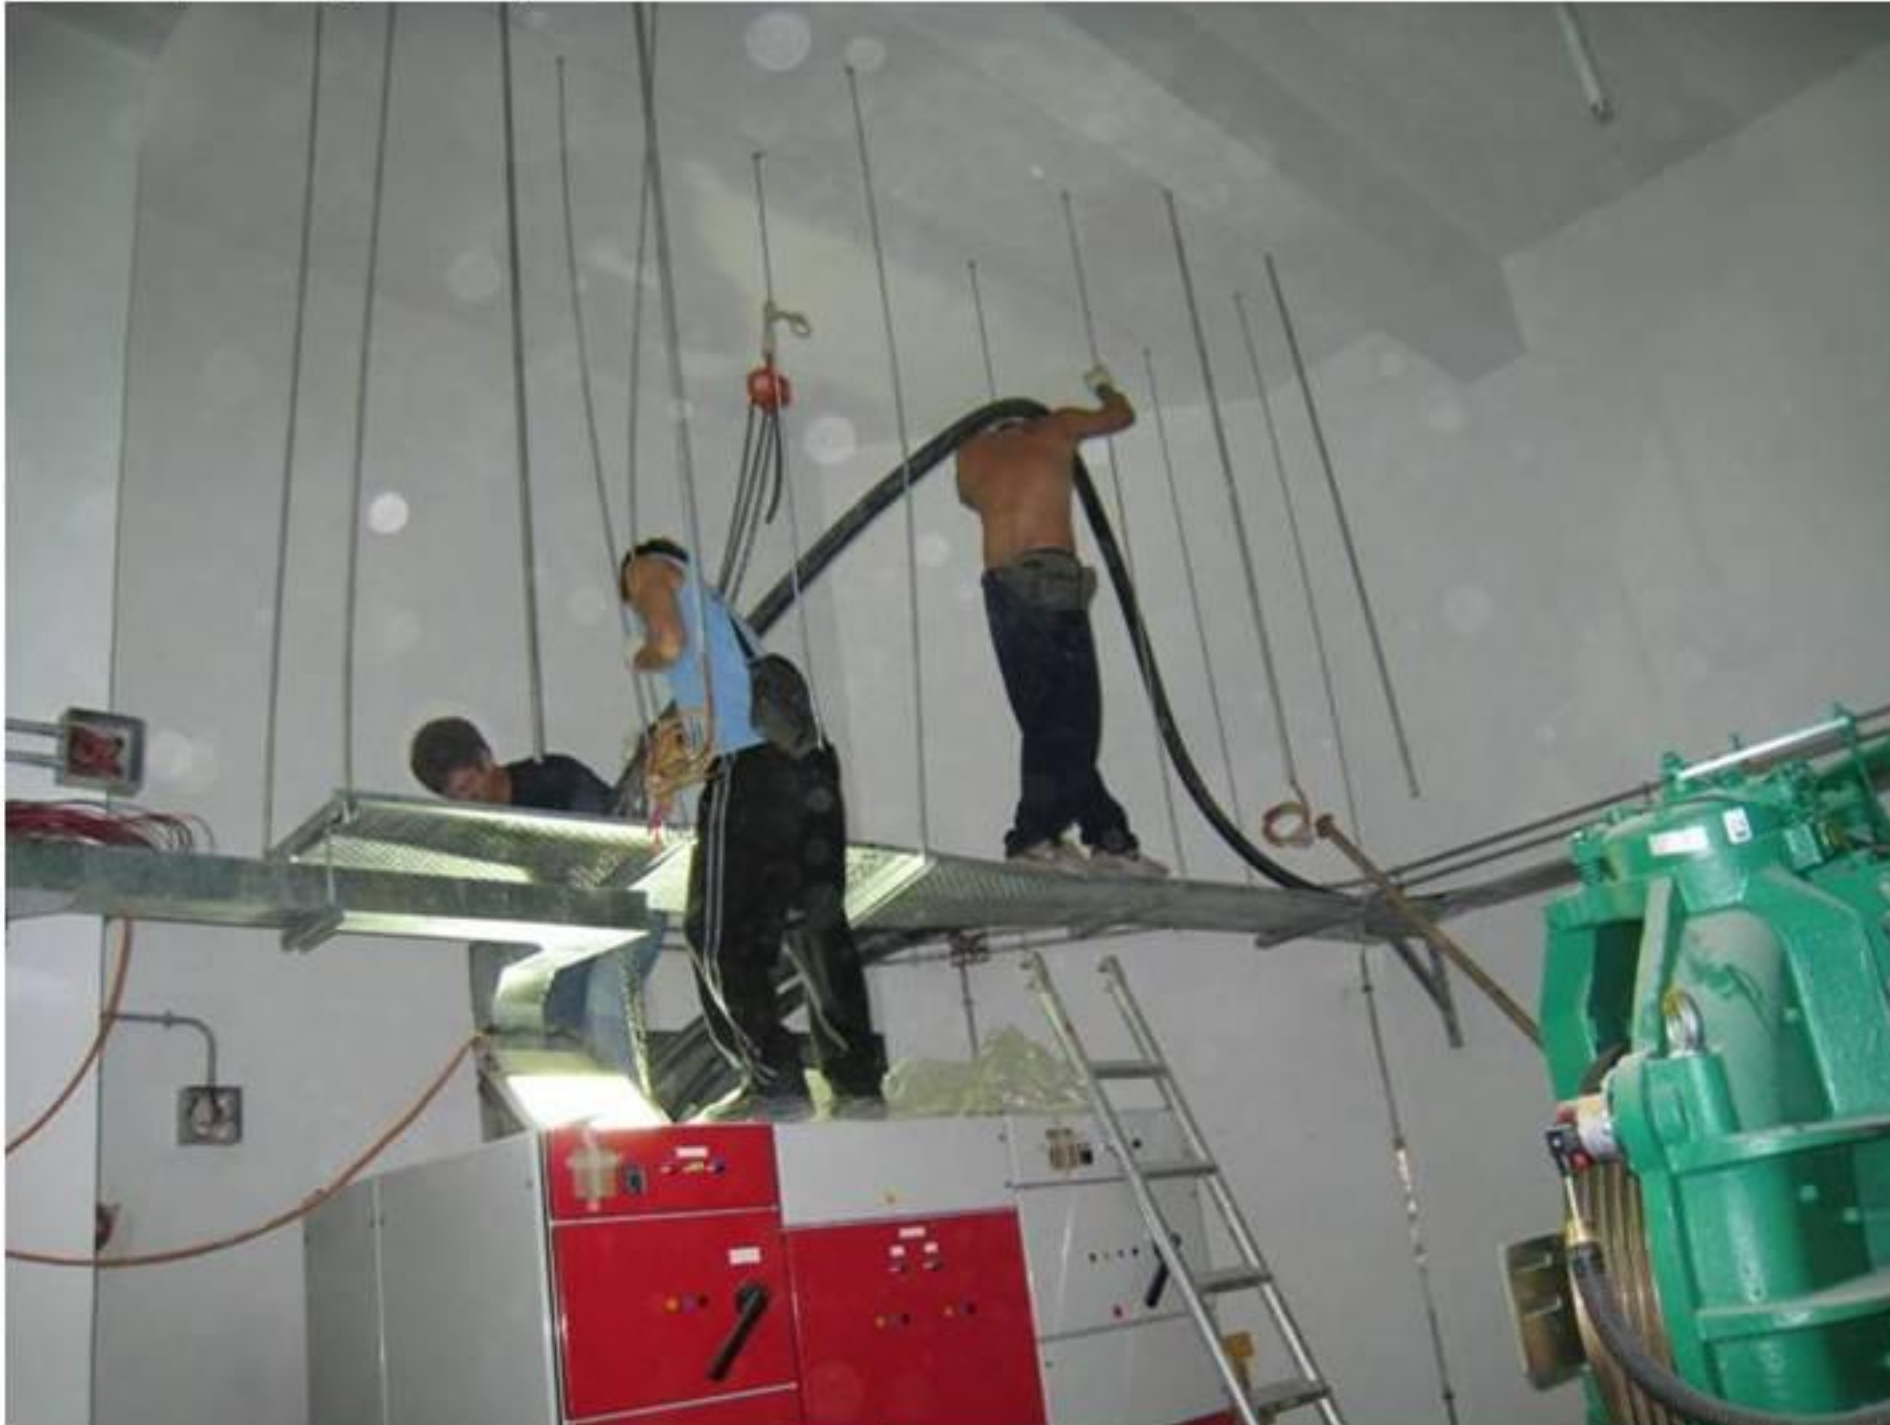
# Works at Height

**NO proper platform for works at above 2m high**

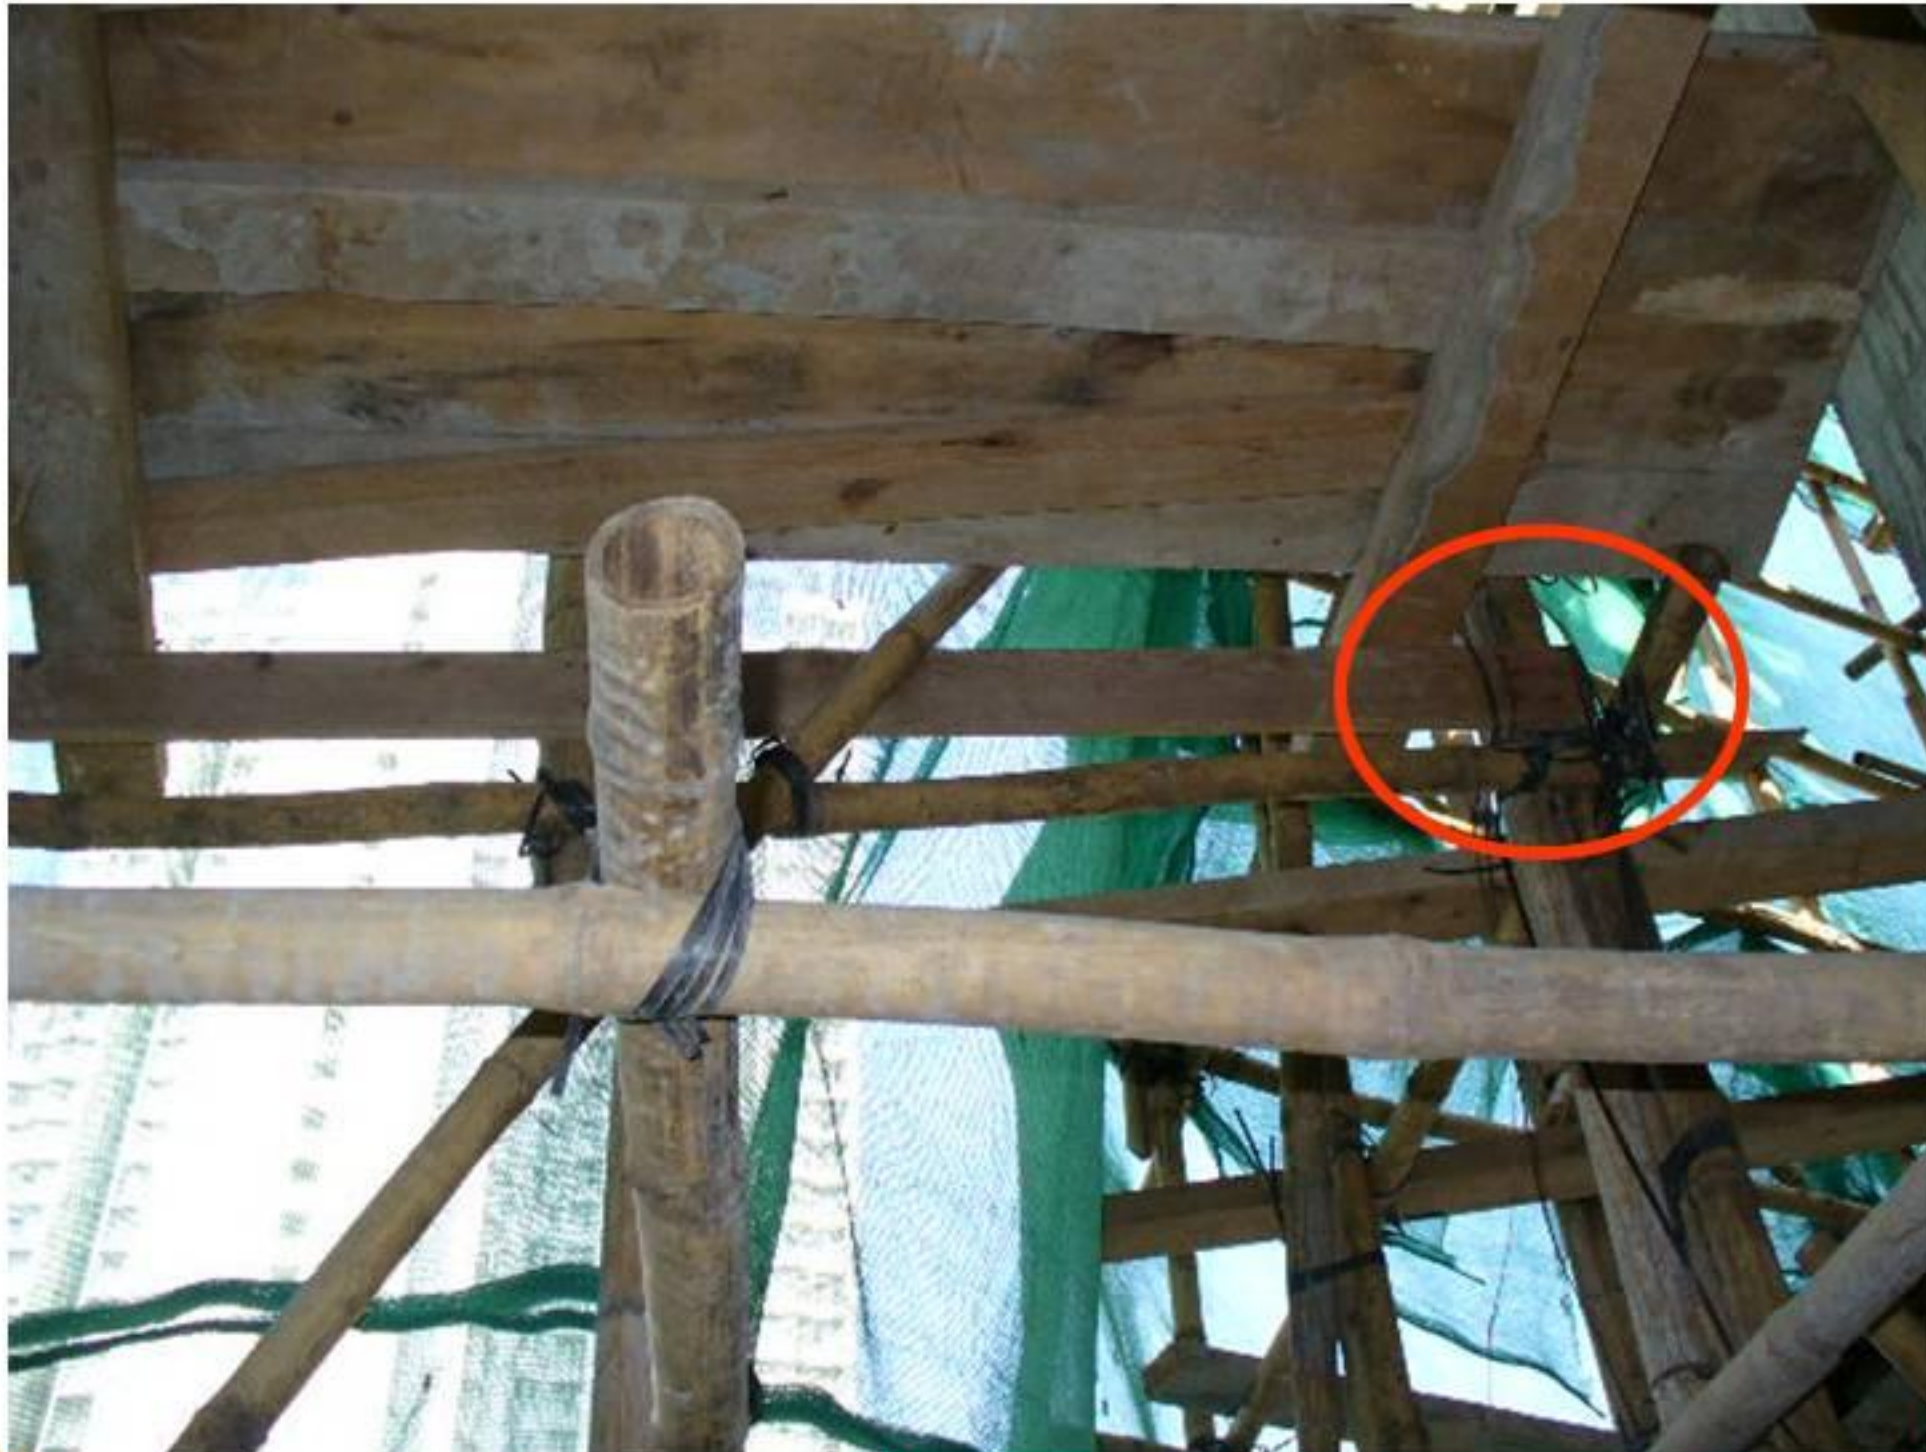
# Scaffolding Support timber boards nailed to bamboos

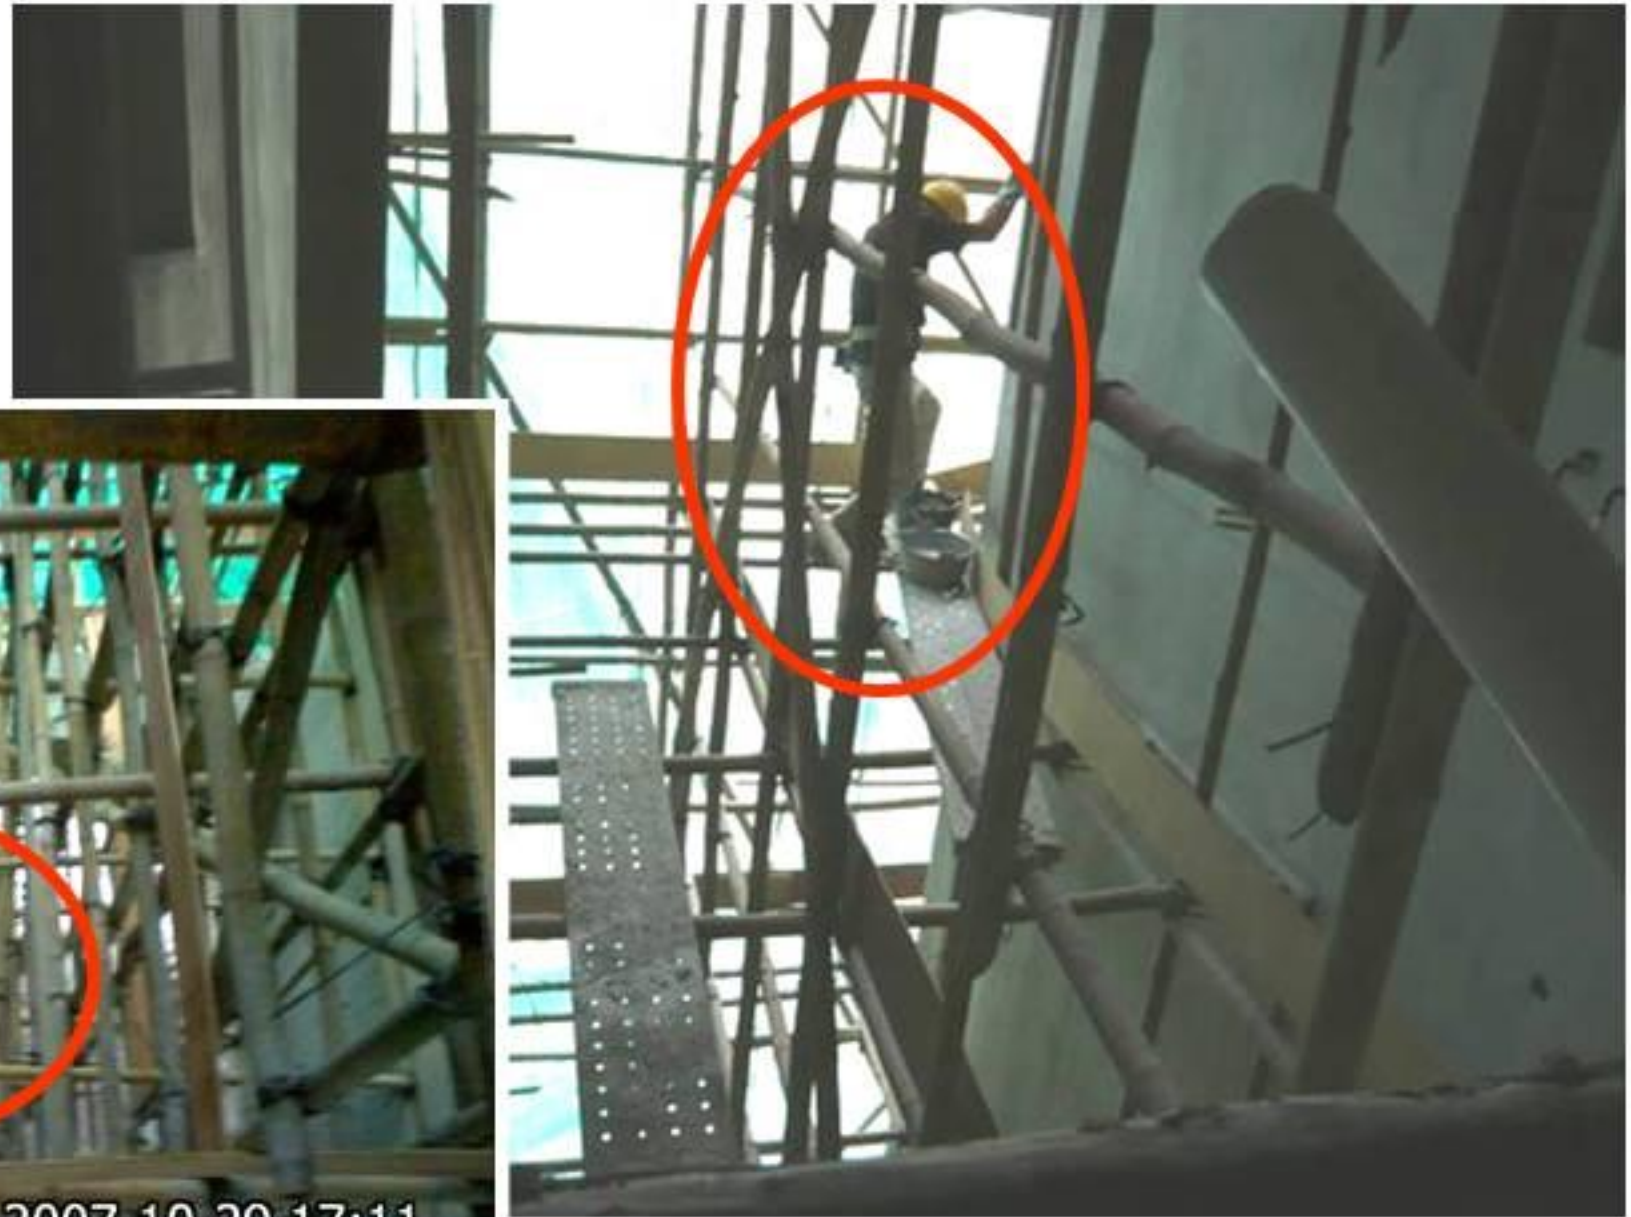
# Scaffolding Support

1. improper working platform
2. NO safety belt and lifeline provided

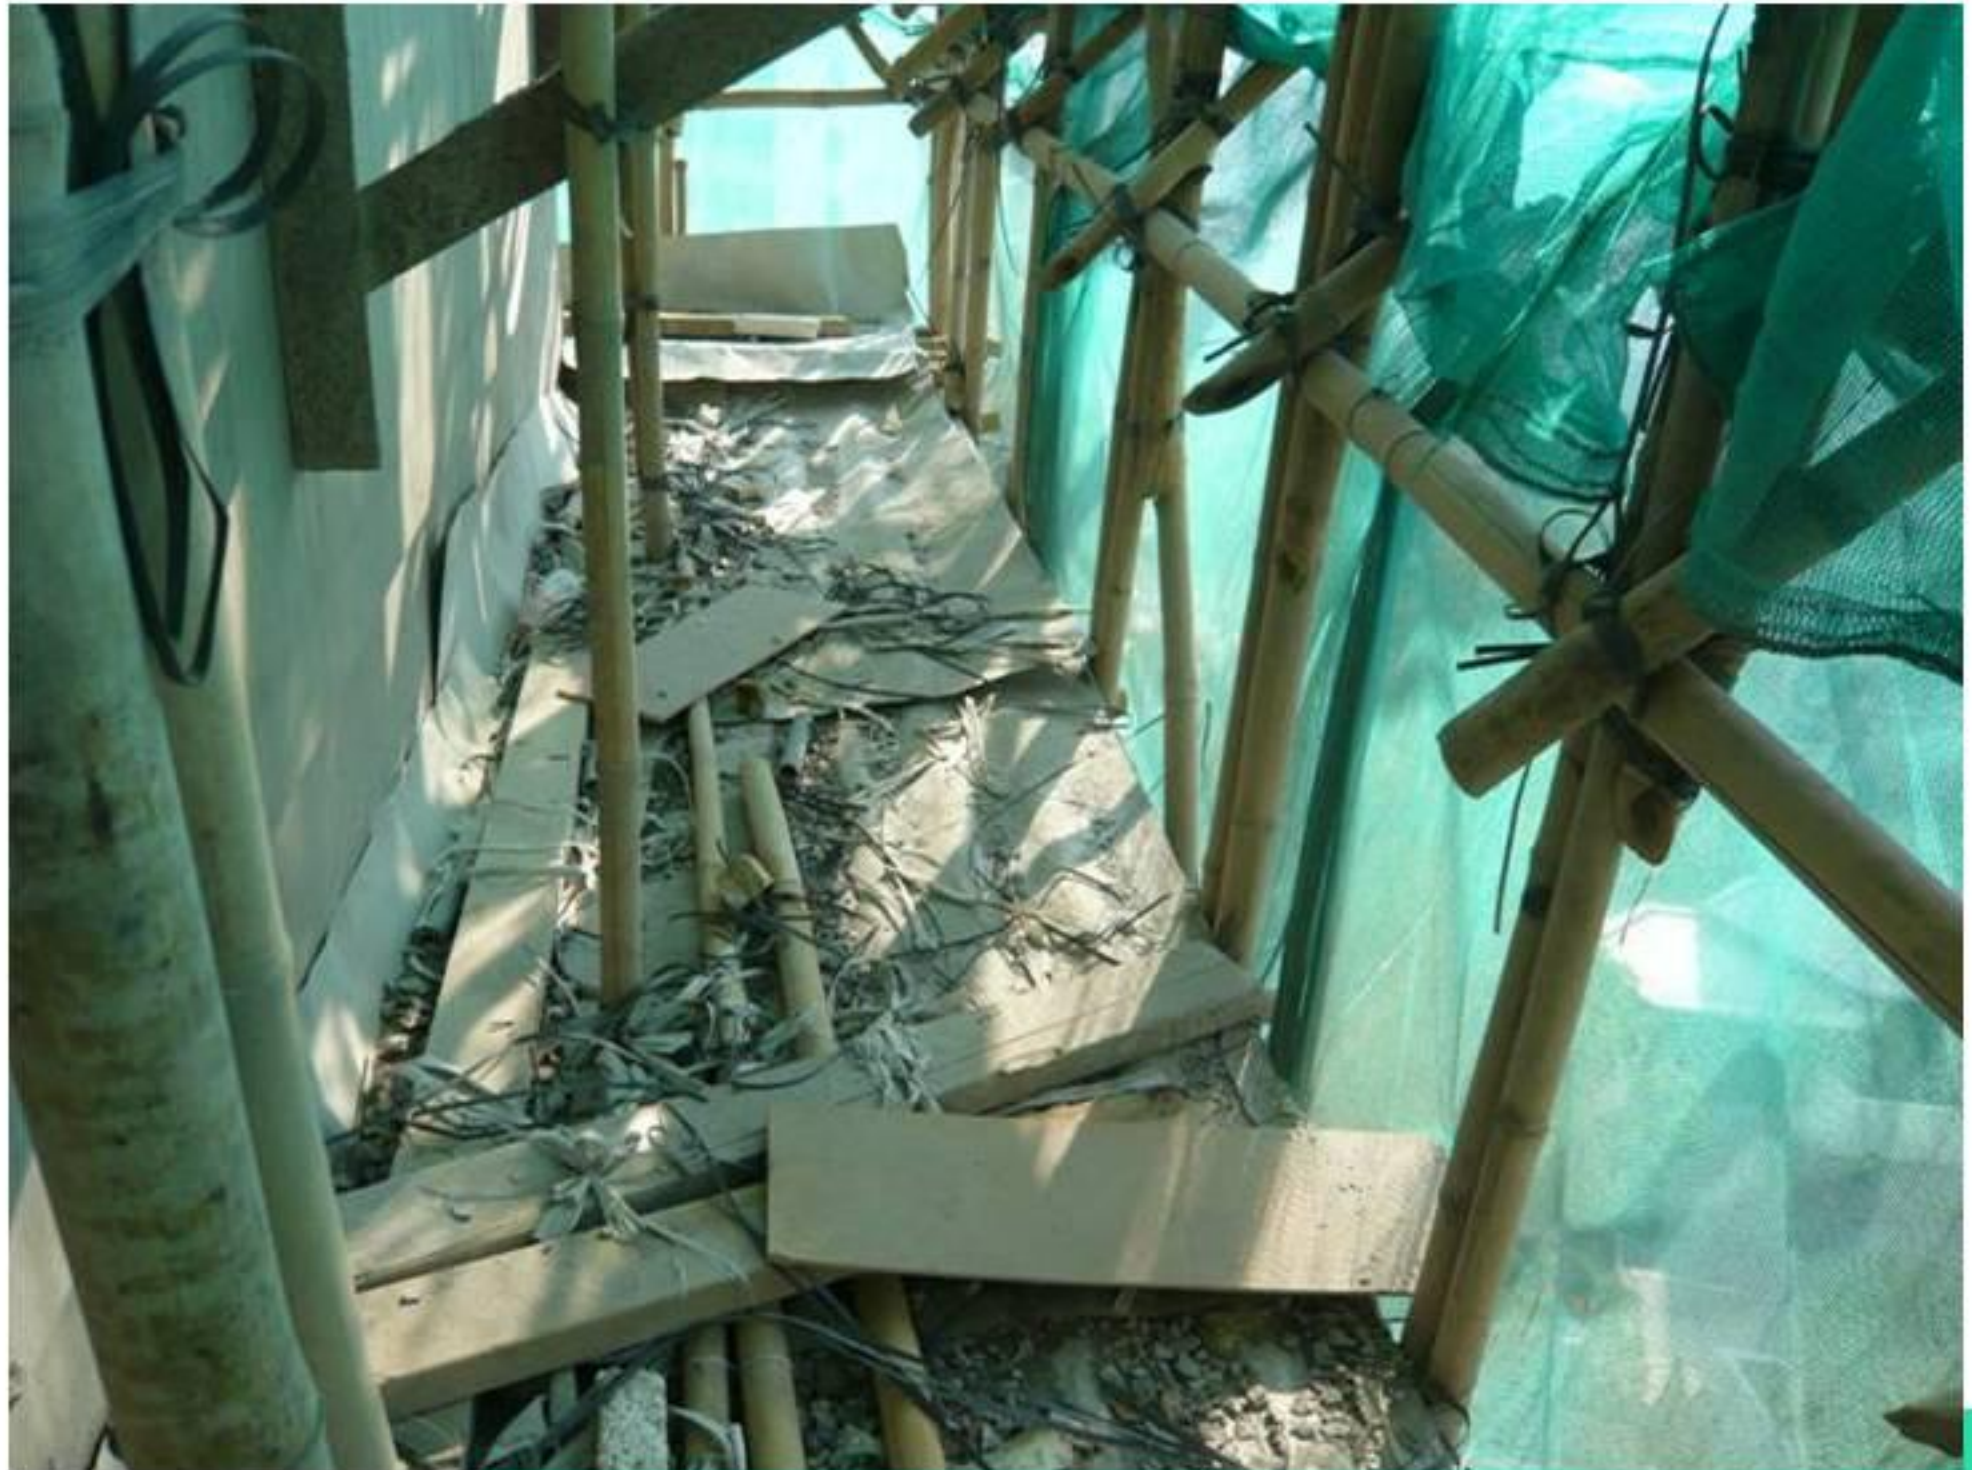
# Scaffolding Support debris on existing scaffolding

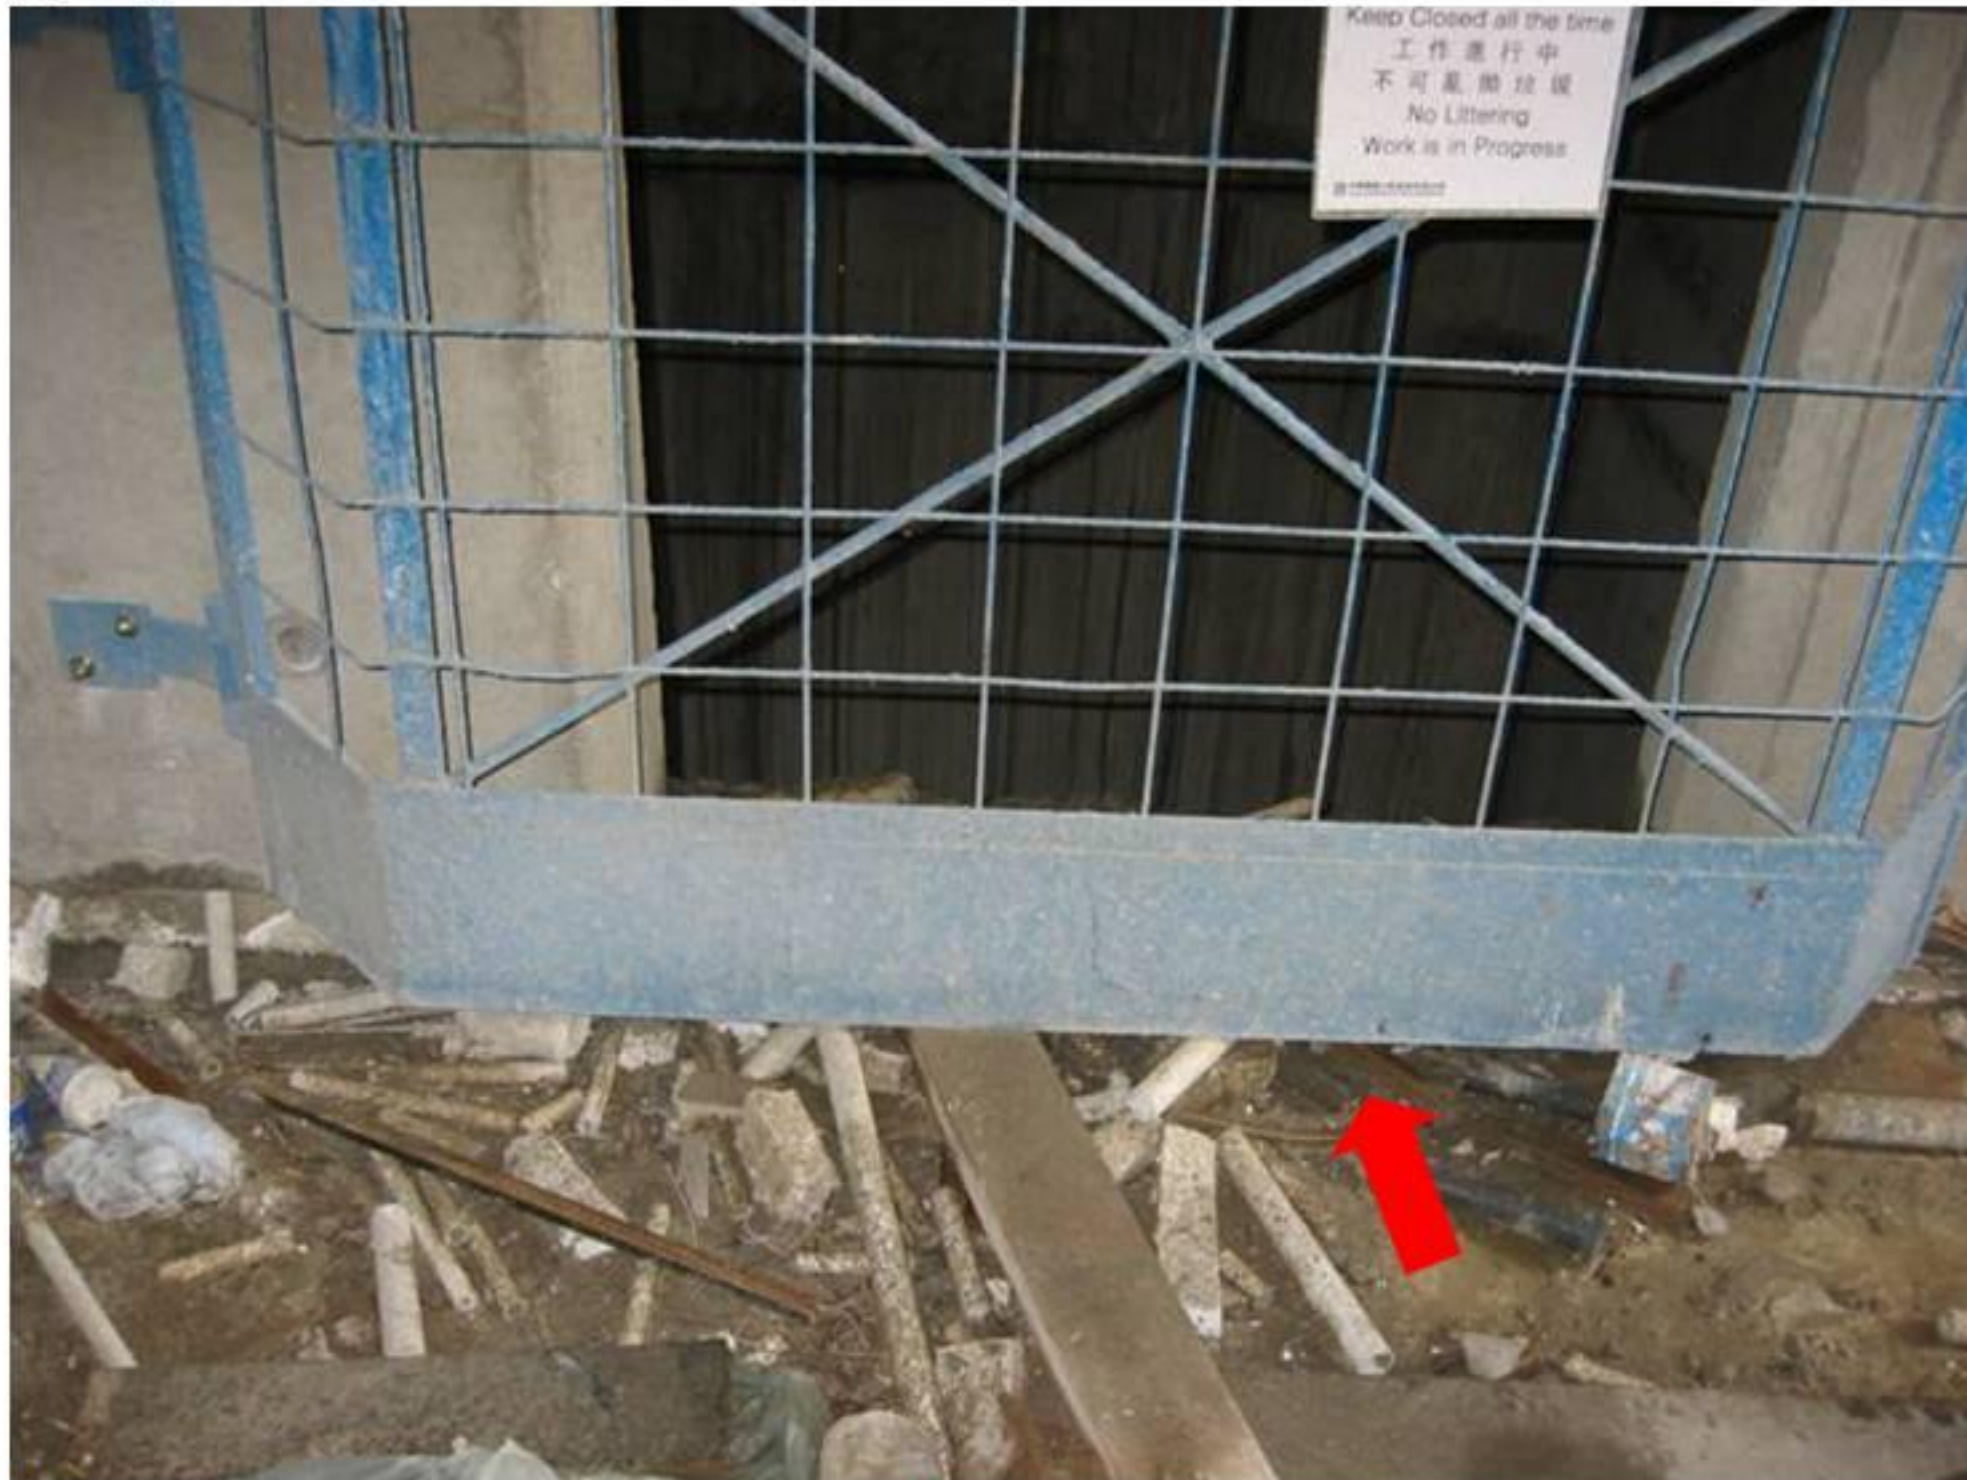
# Protection to Lift Shaft Opening gap left at toe of barrier
