# **SITE SAFETY Focus Seminar**

on New Works of  
Housing Department

**Site Safety** issues at -

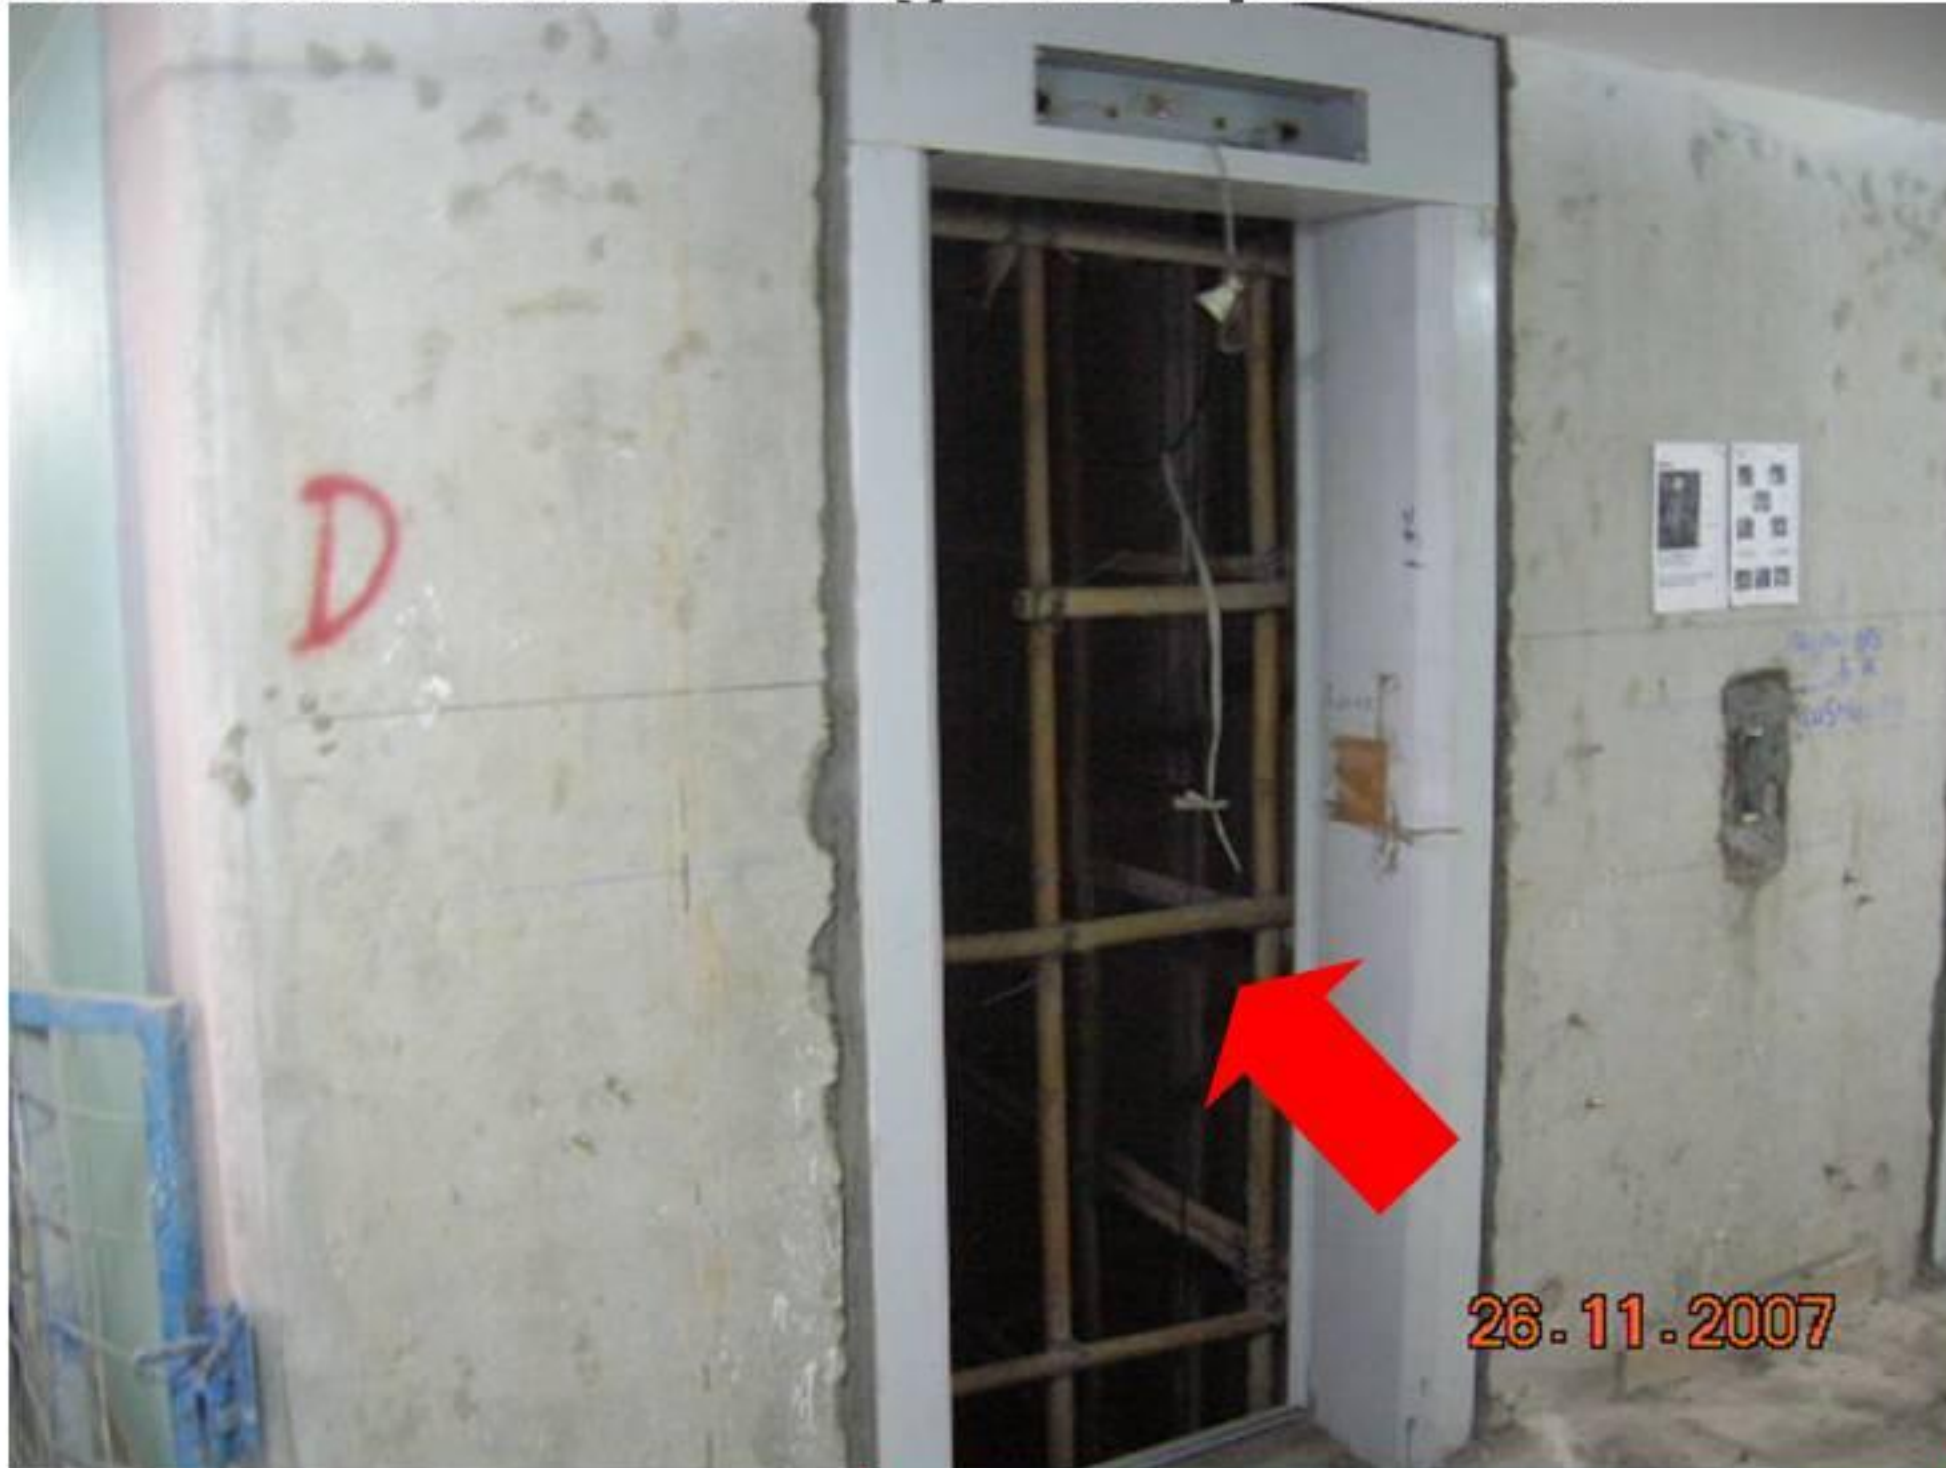
# During Lift Door Installation toe board and railings not provided

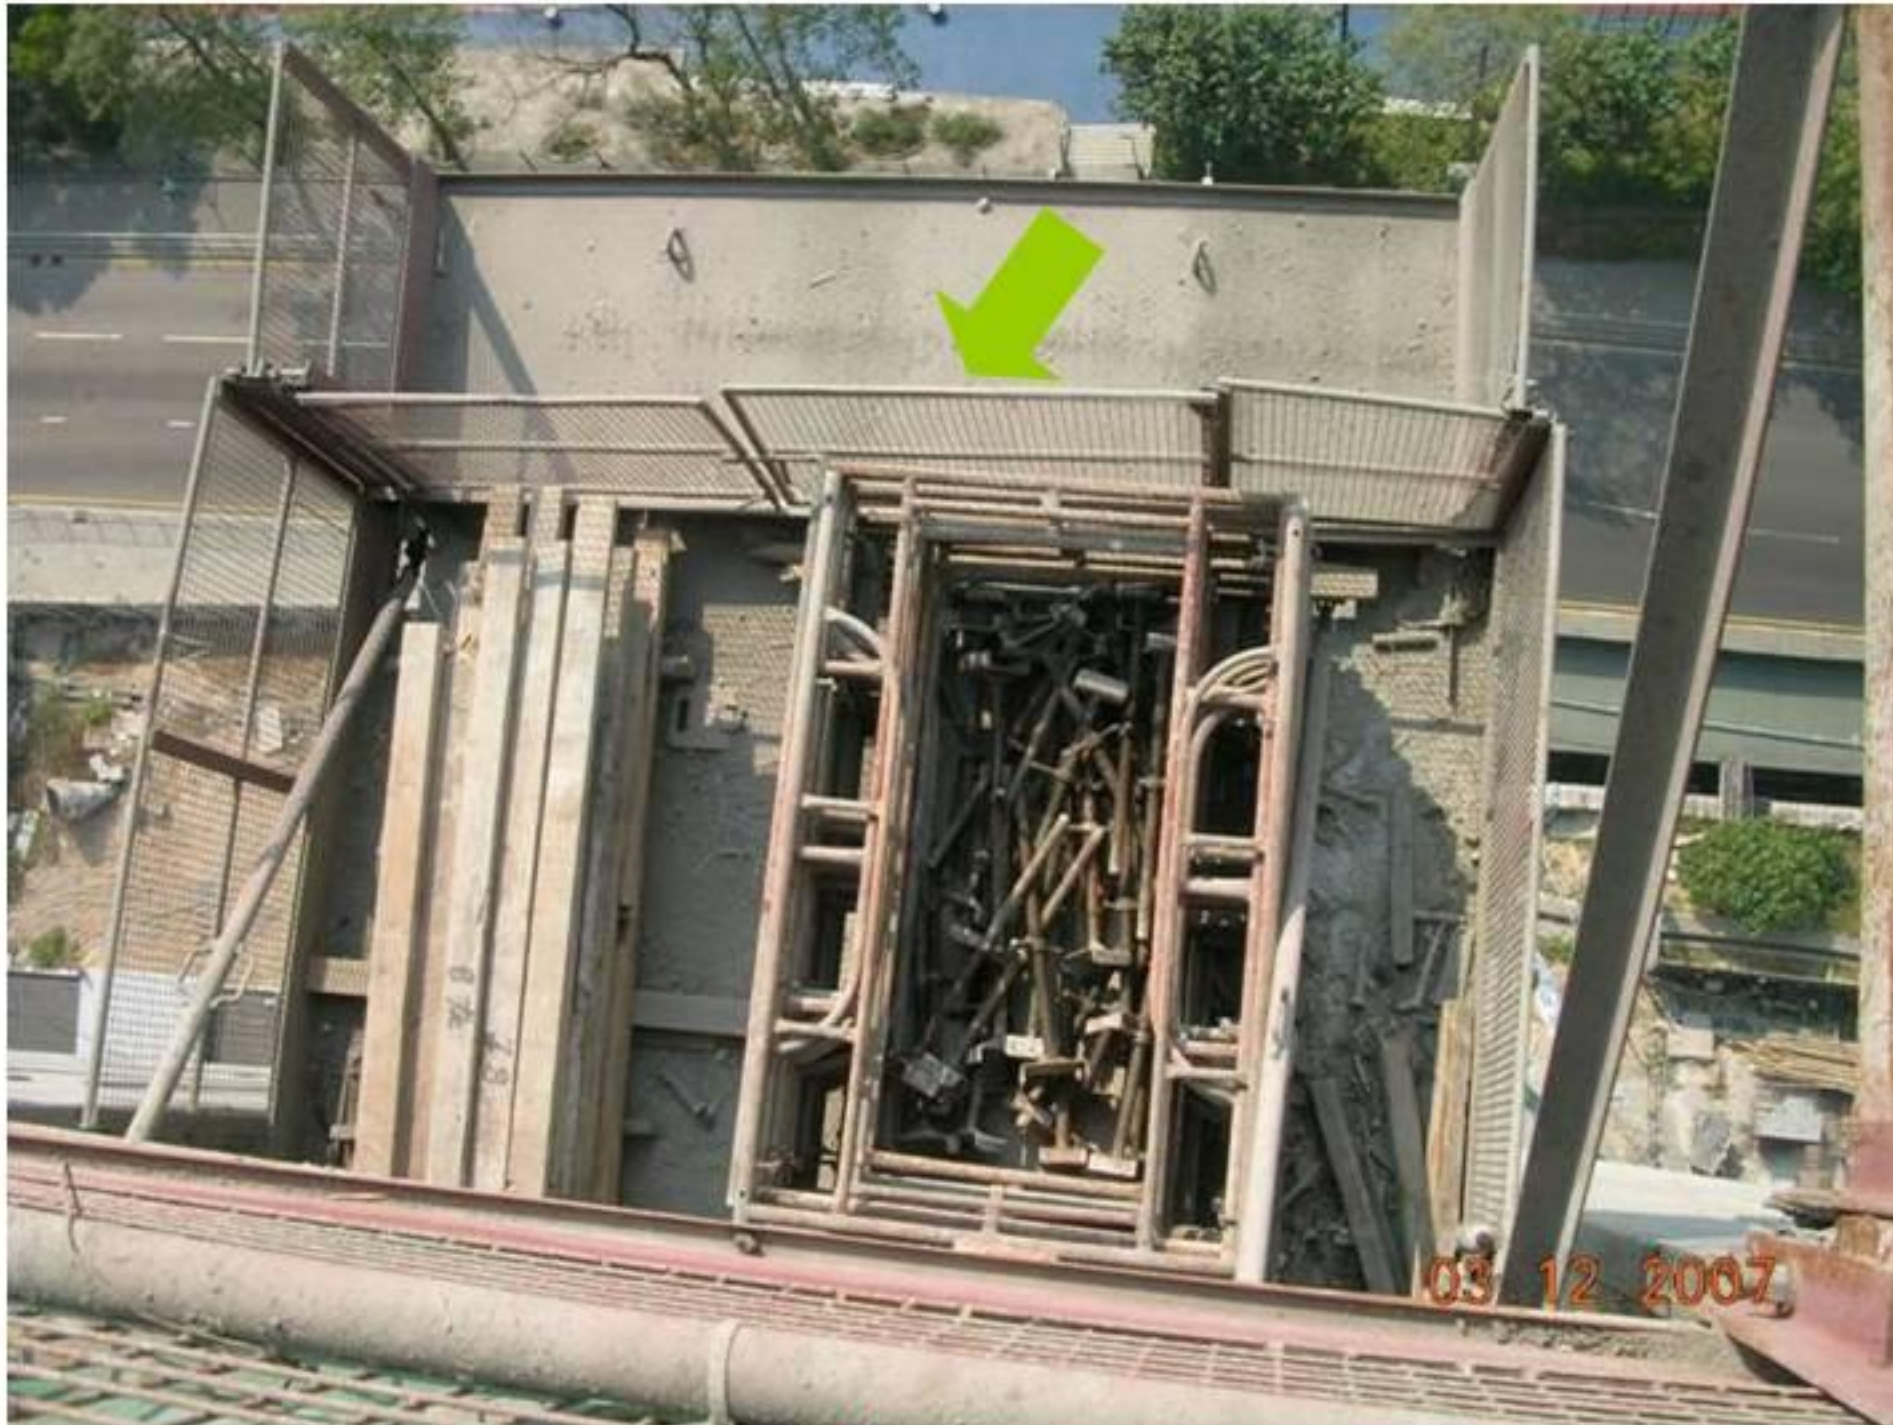
# Stacking Formwork on Temporary Platform platform with end gate installed

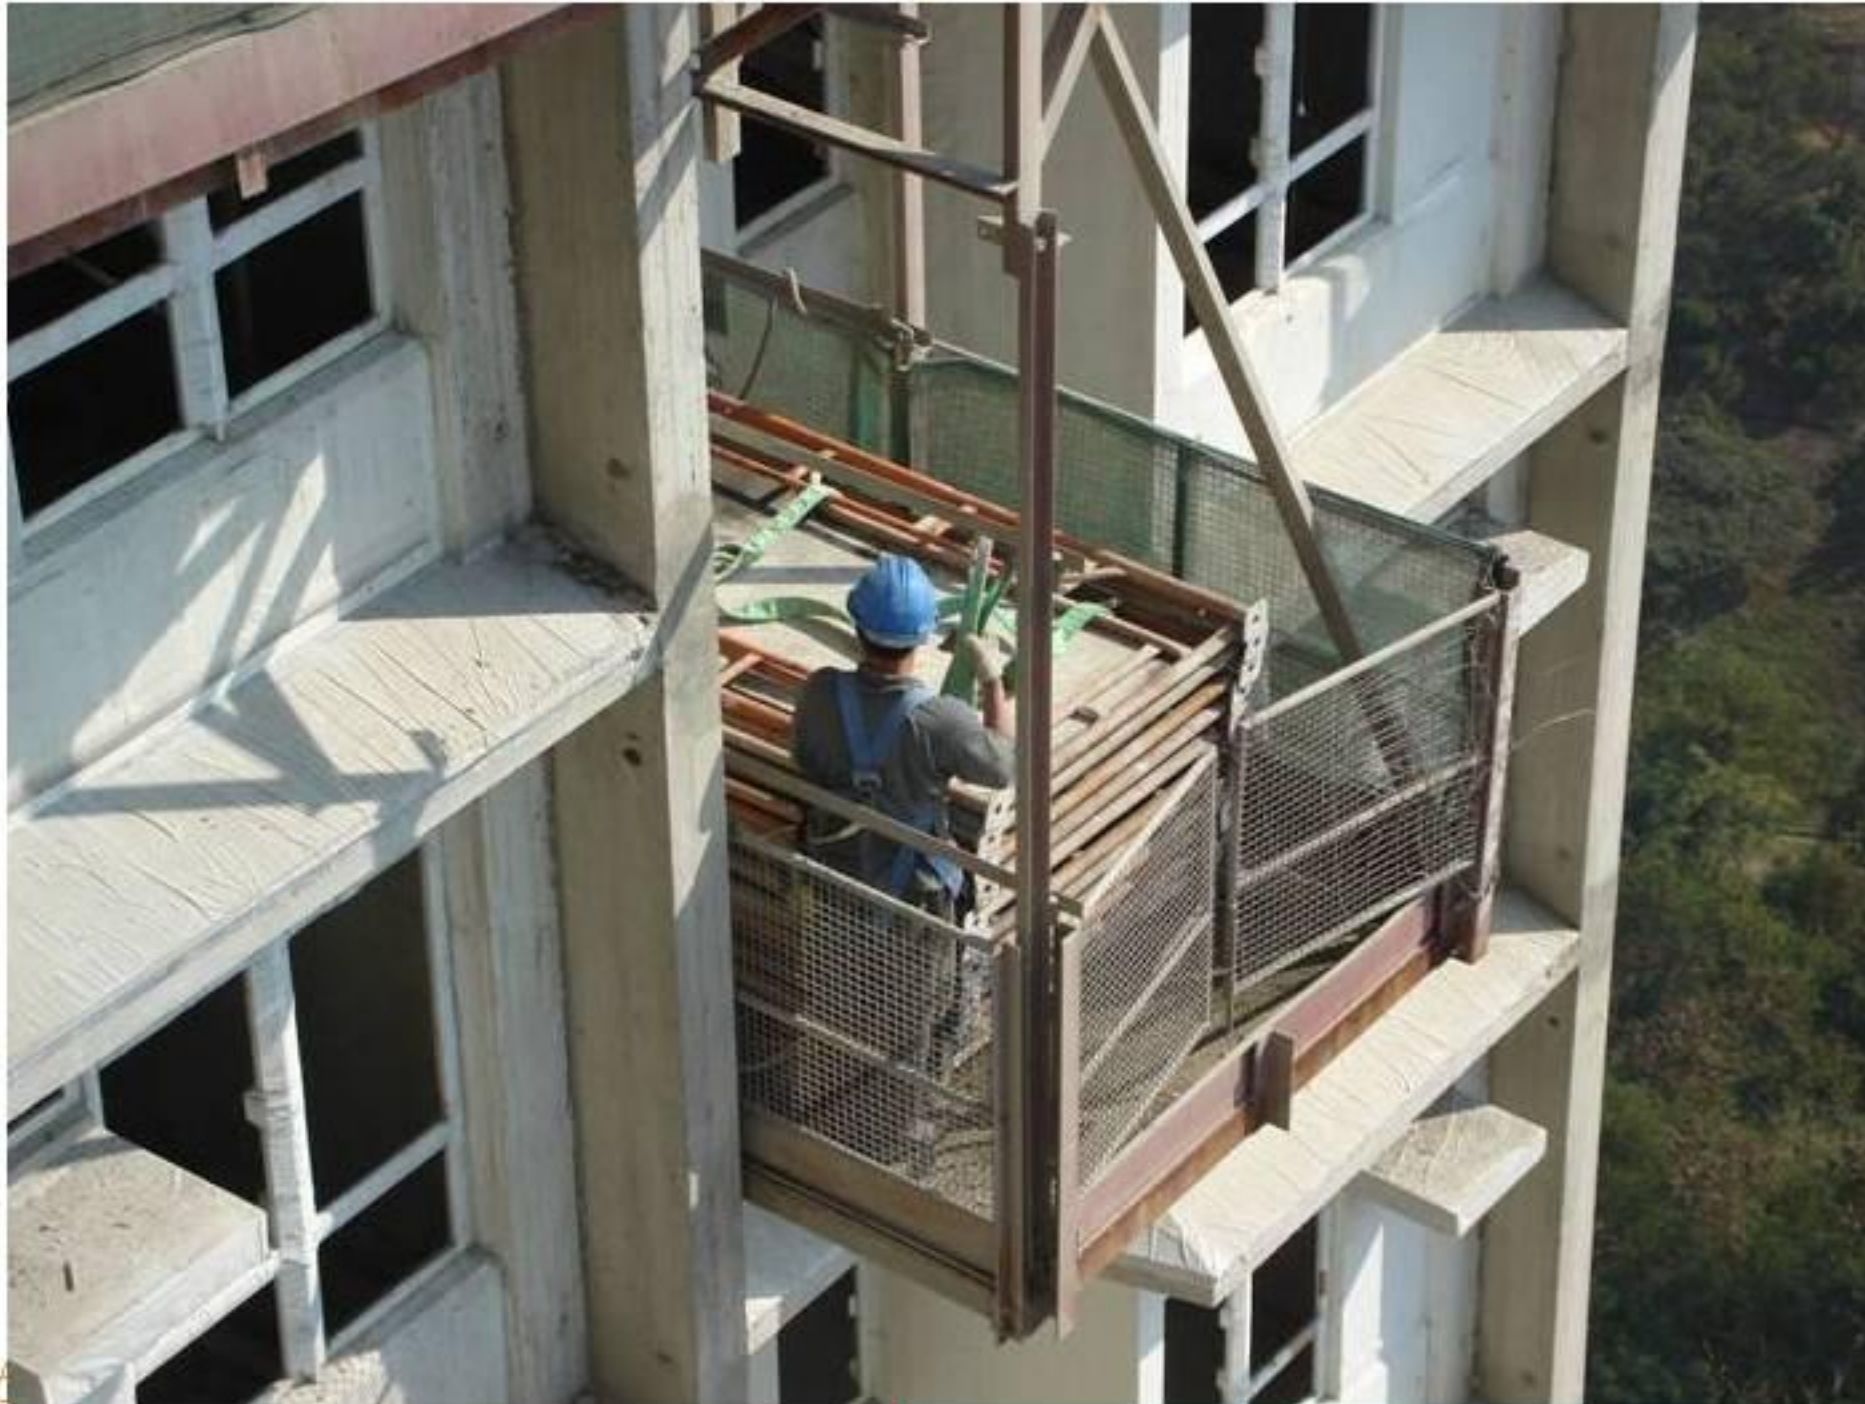
# Operation on Temporary Platform platform with end gate installed and worker in safety harness

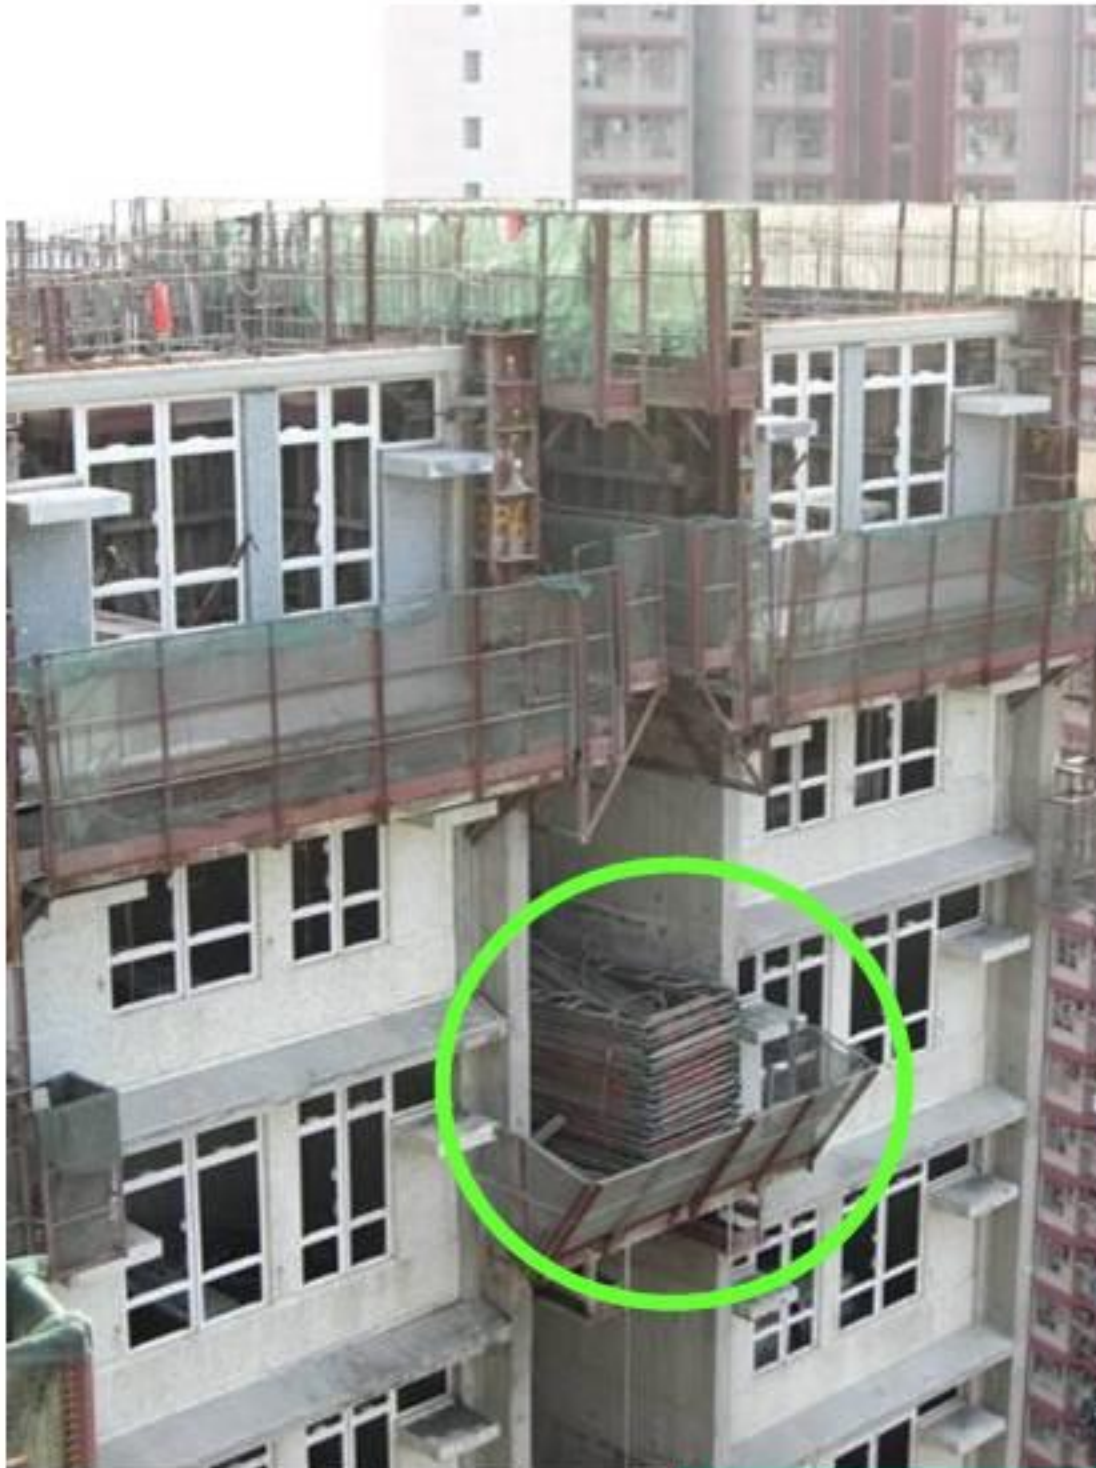
# Operation on Temporary Platform platform with fencing at the end installed

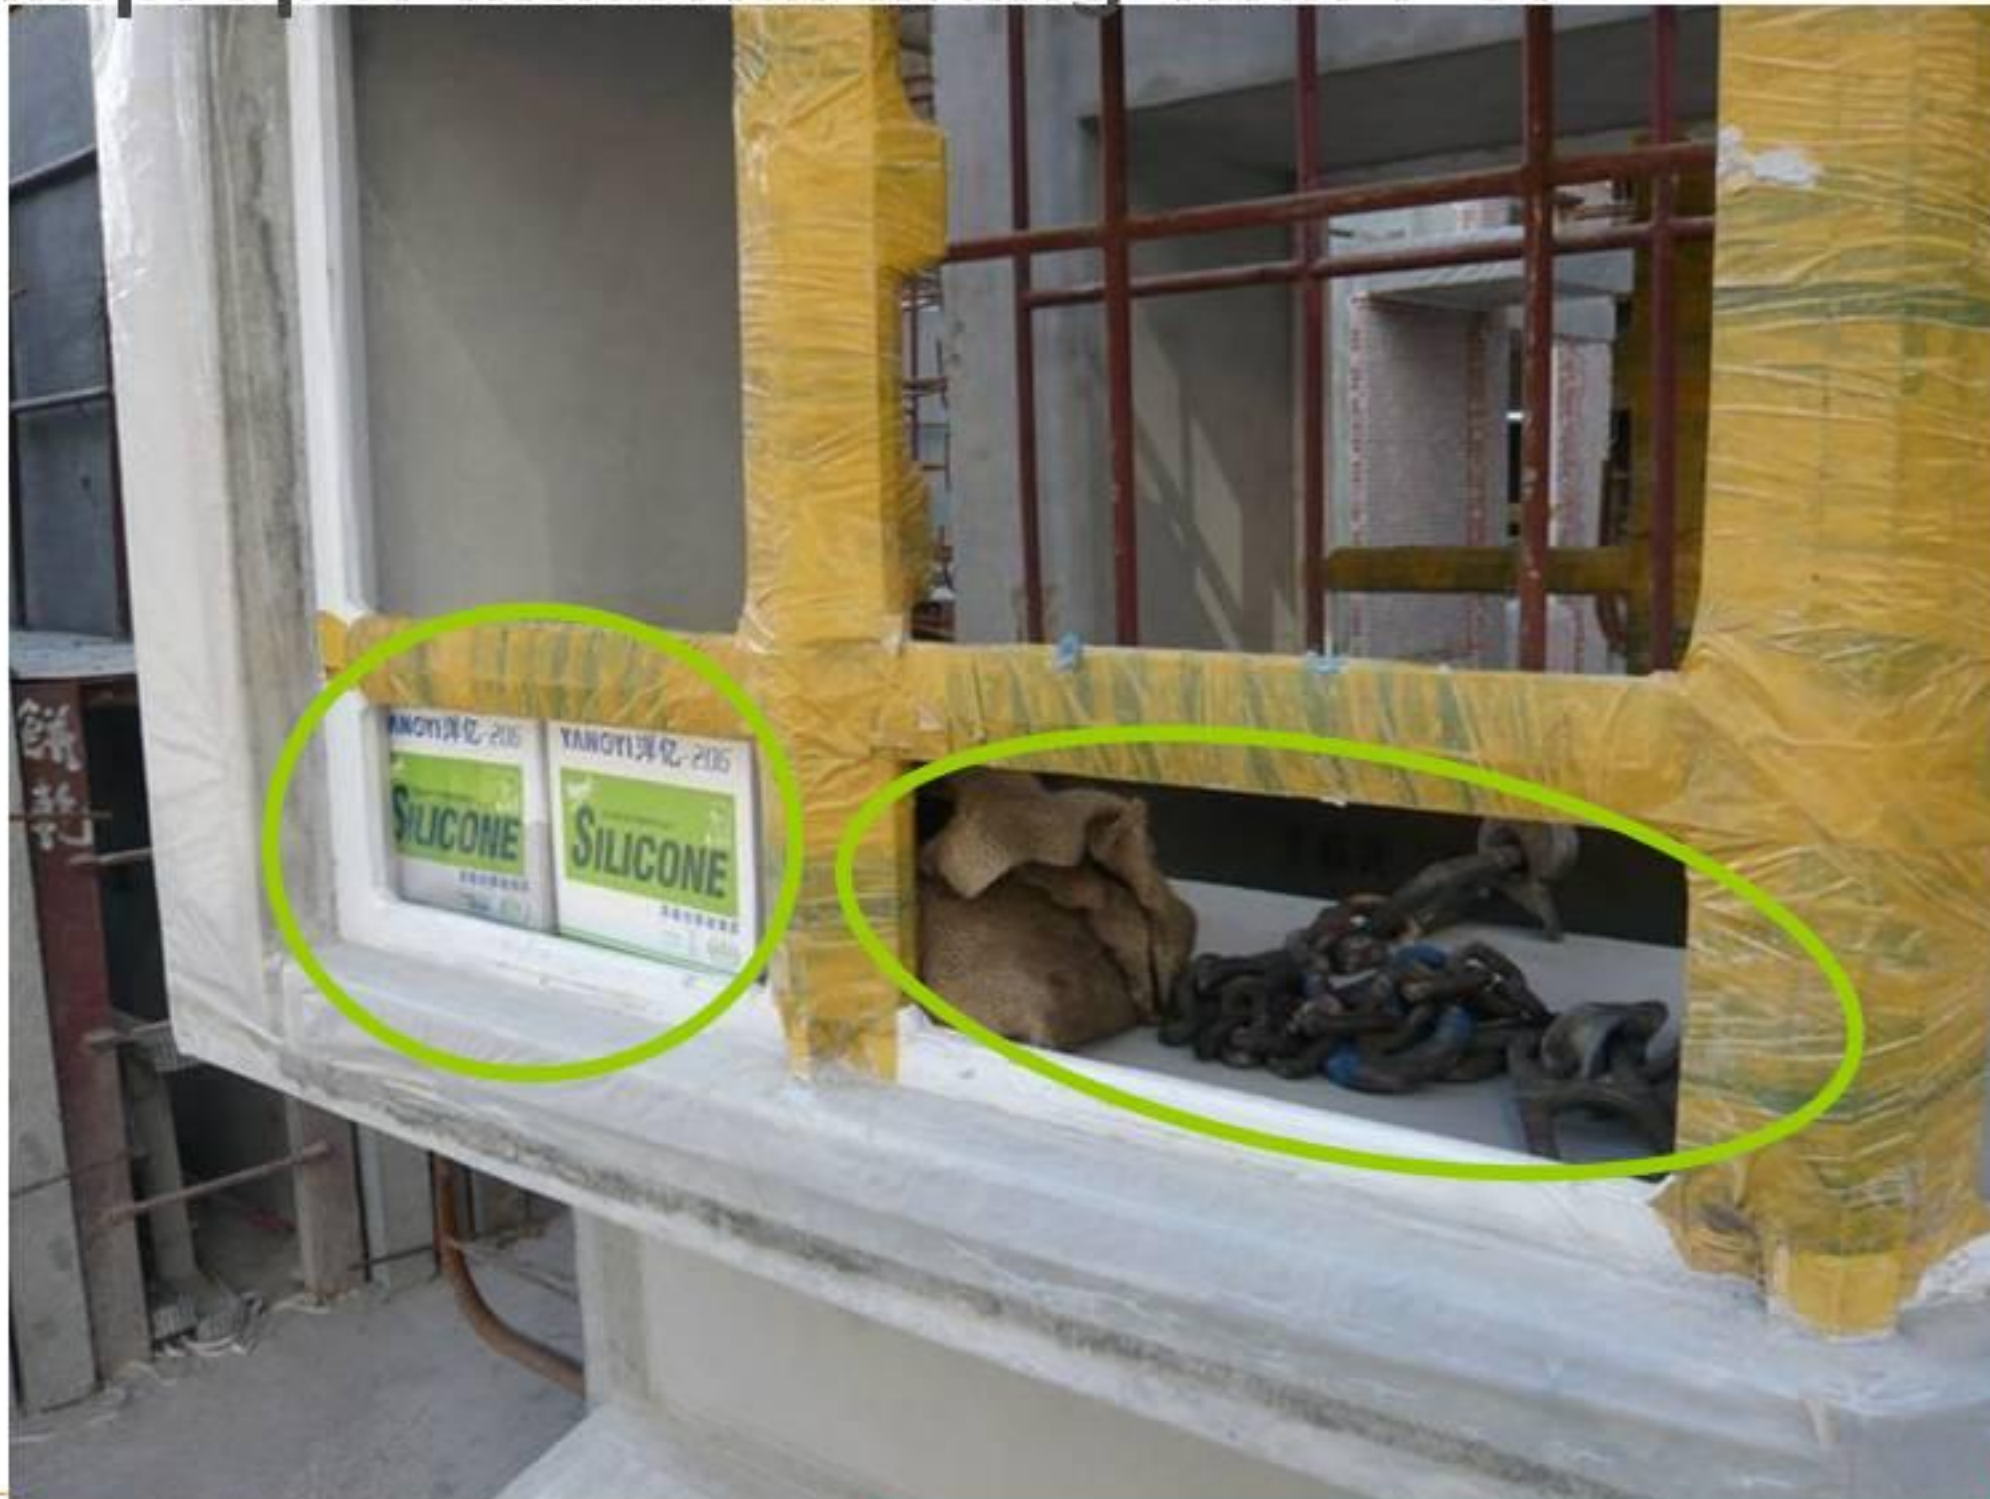
# Hoisting of Precast Facade Unit improper material lifting with PCF

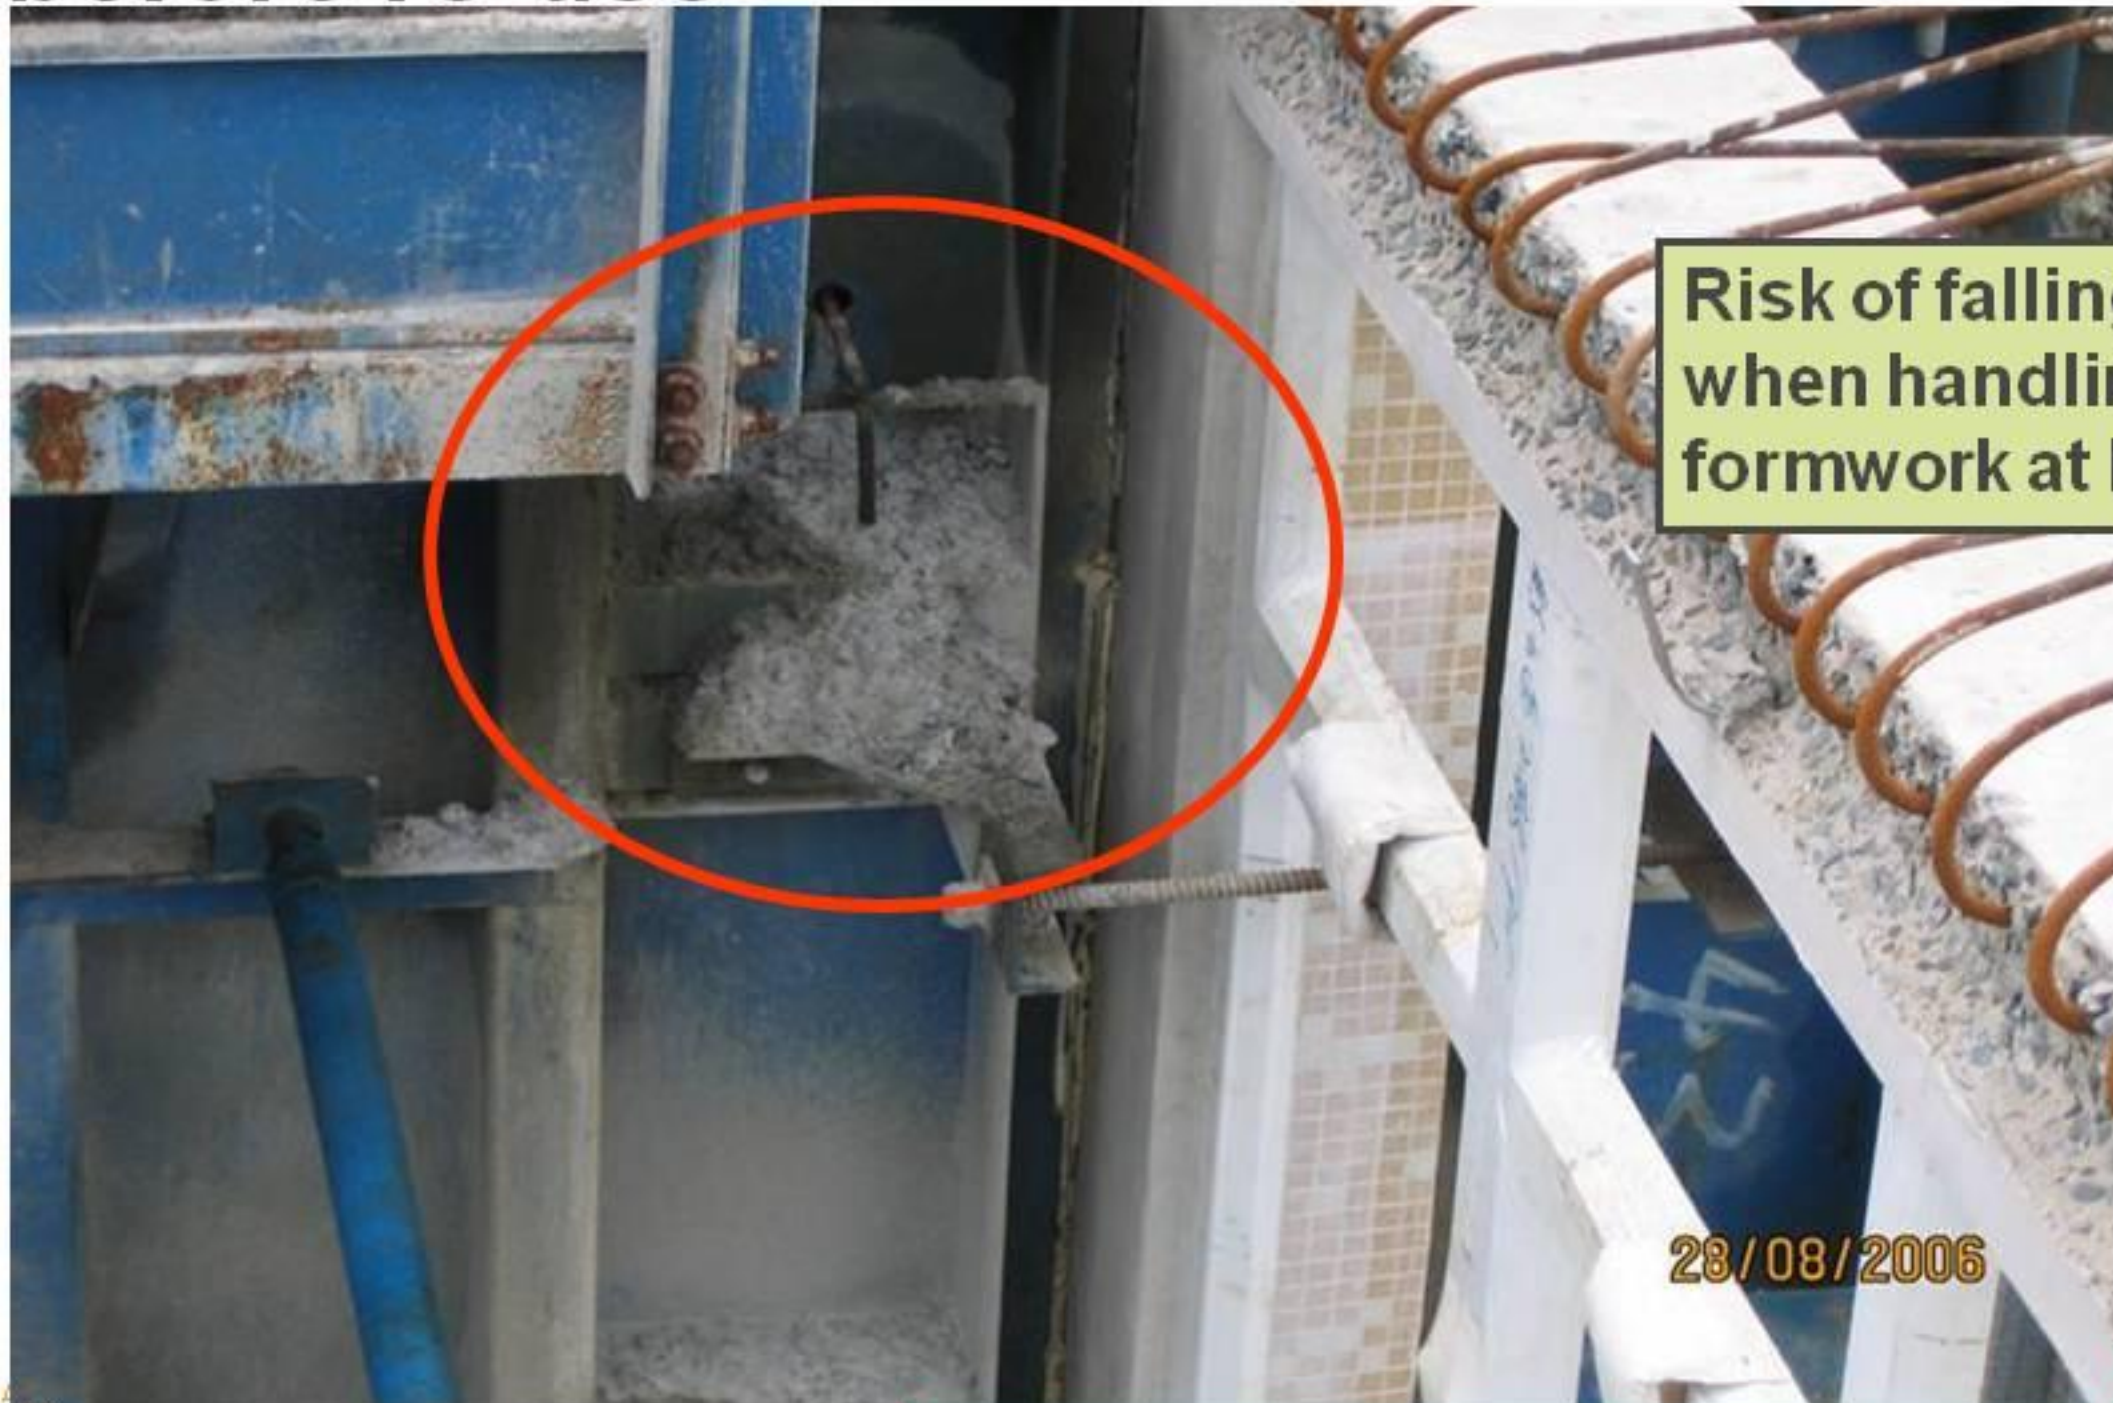
# Large Panel Formwork hardened concrete laitance NOT cleaned before re-use

**Risk of falling object  
when handling  
formwork at height**

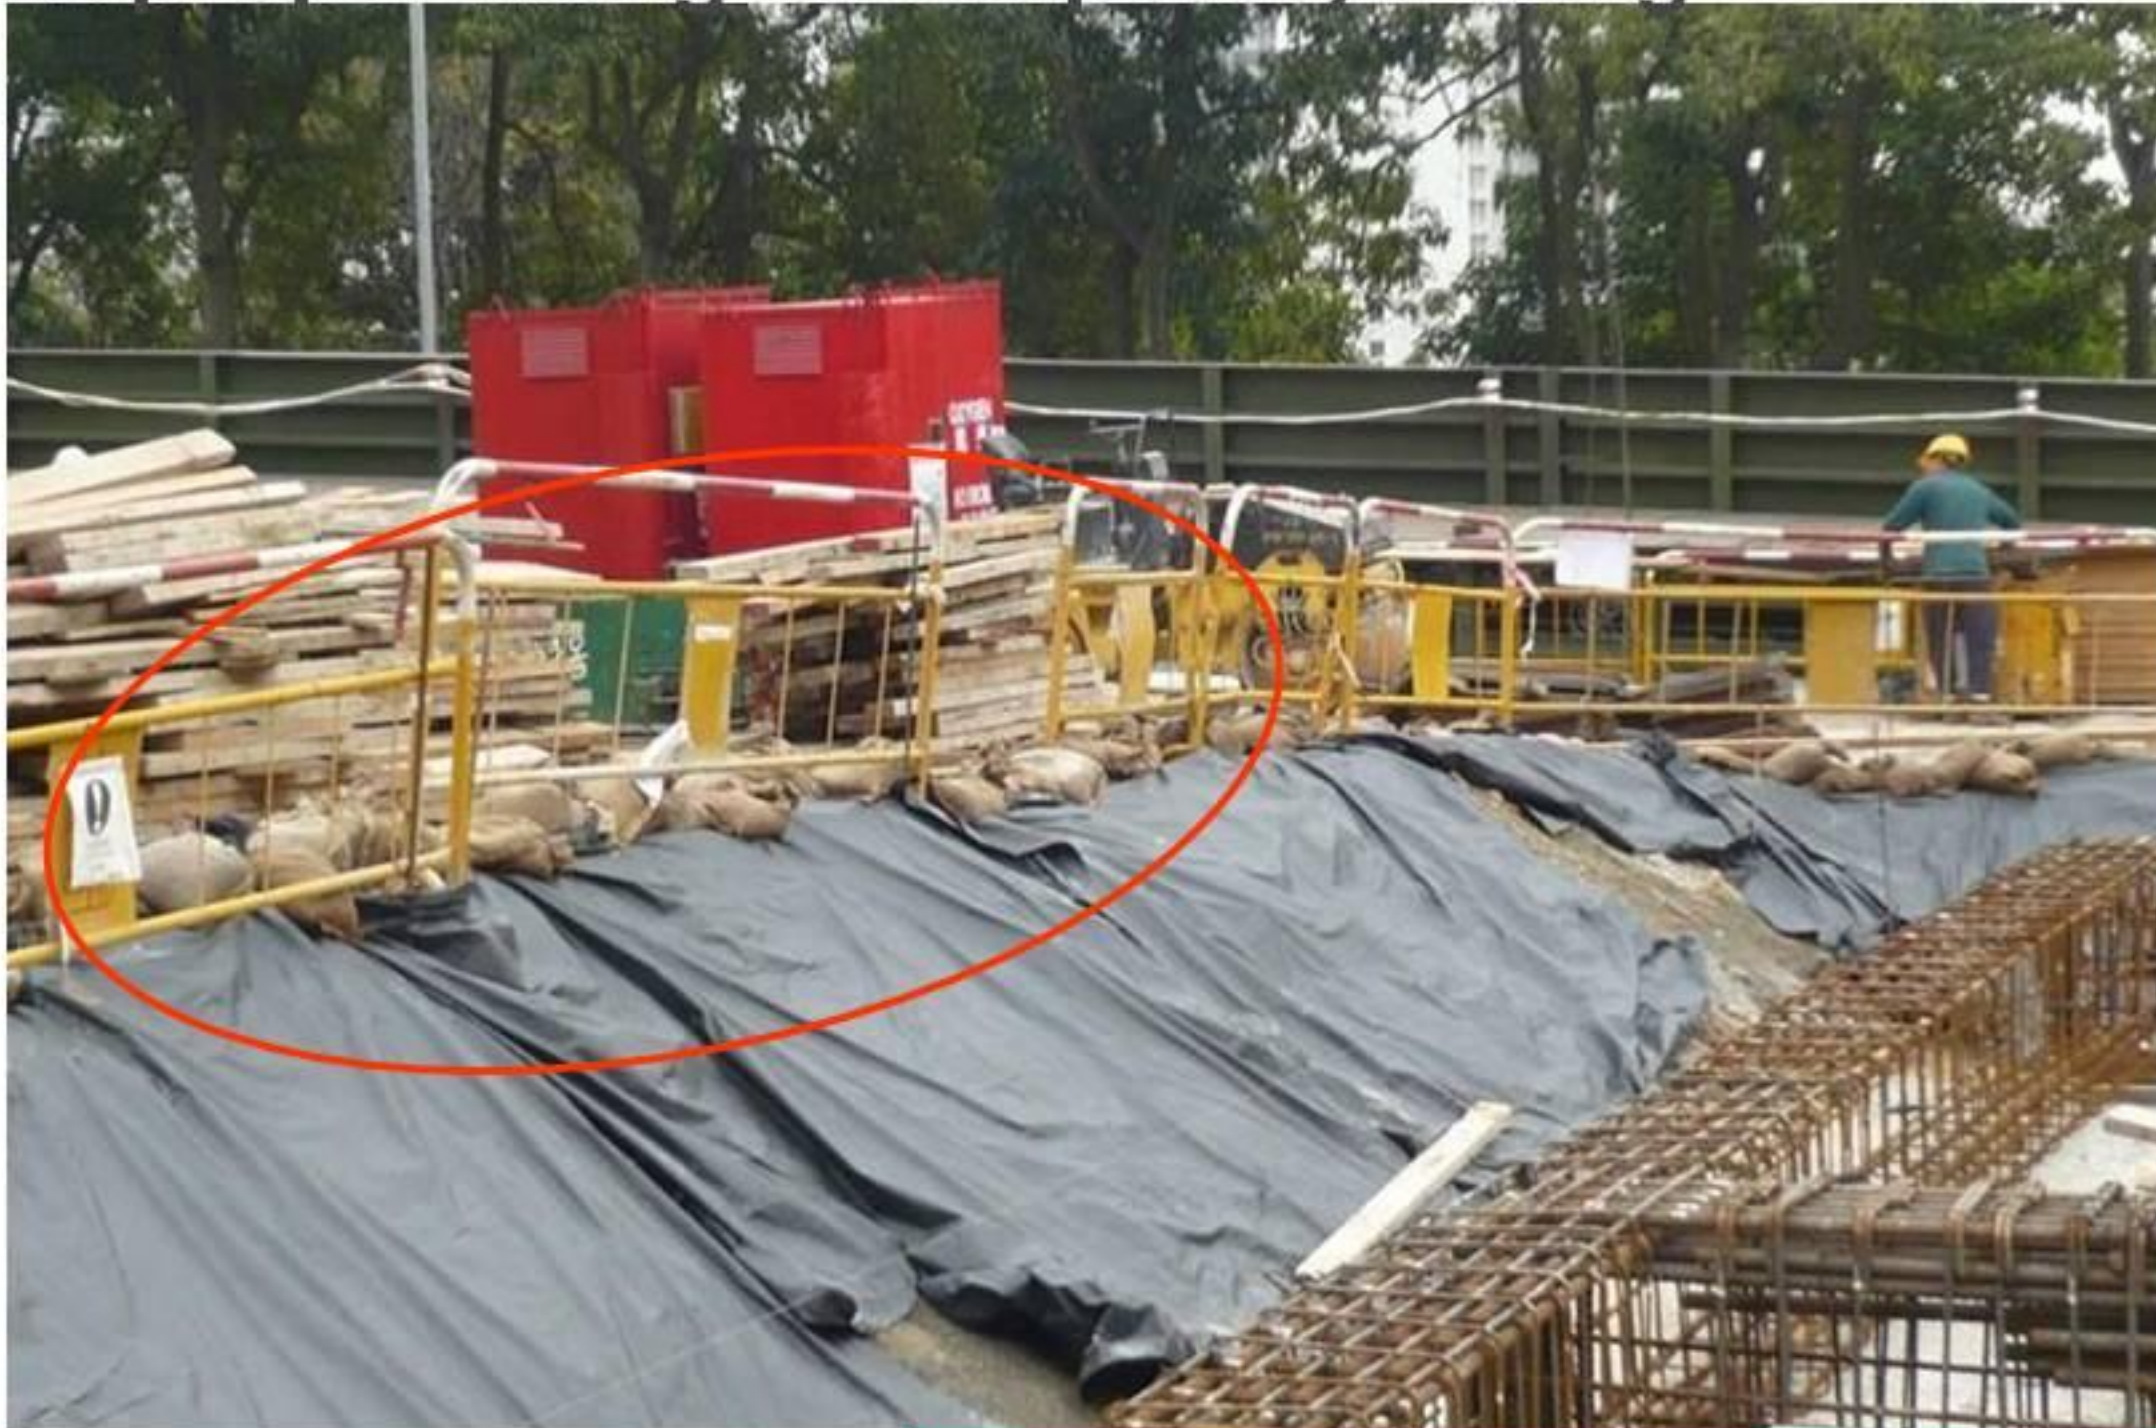
# Railing on Slope

## improper fixing of temporary railing

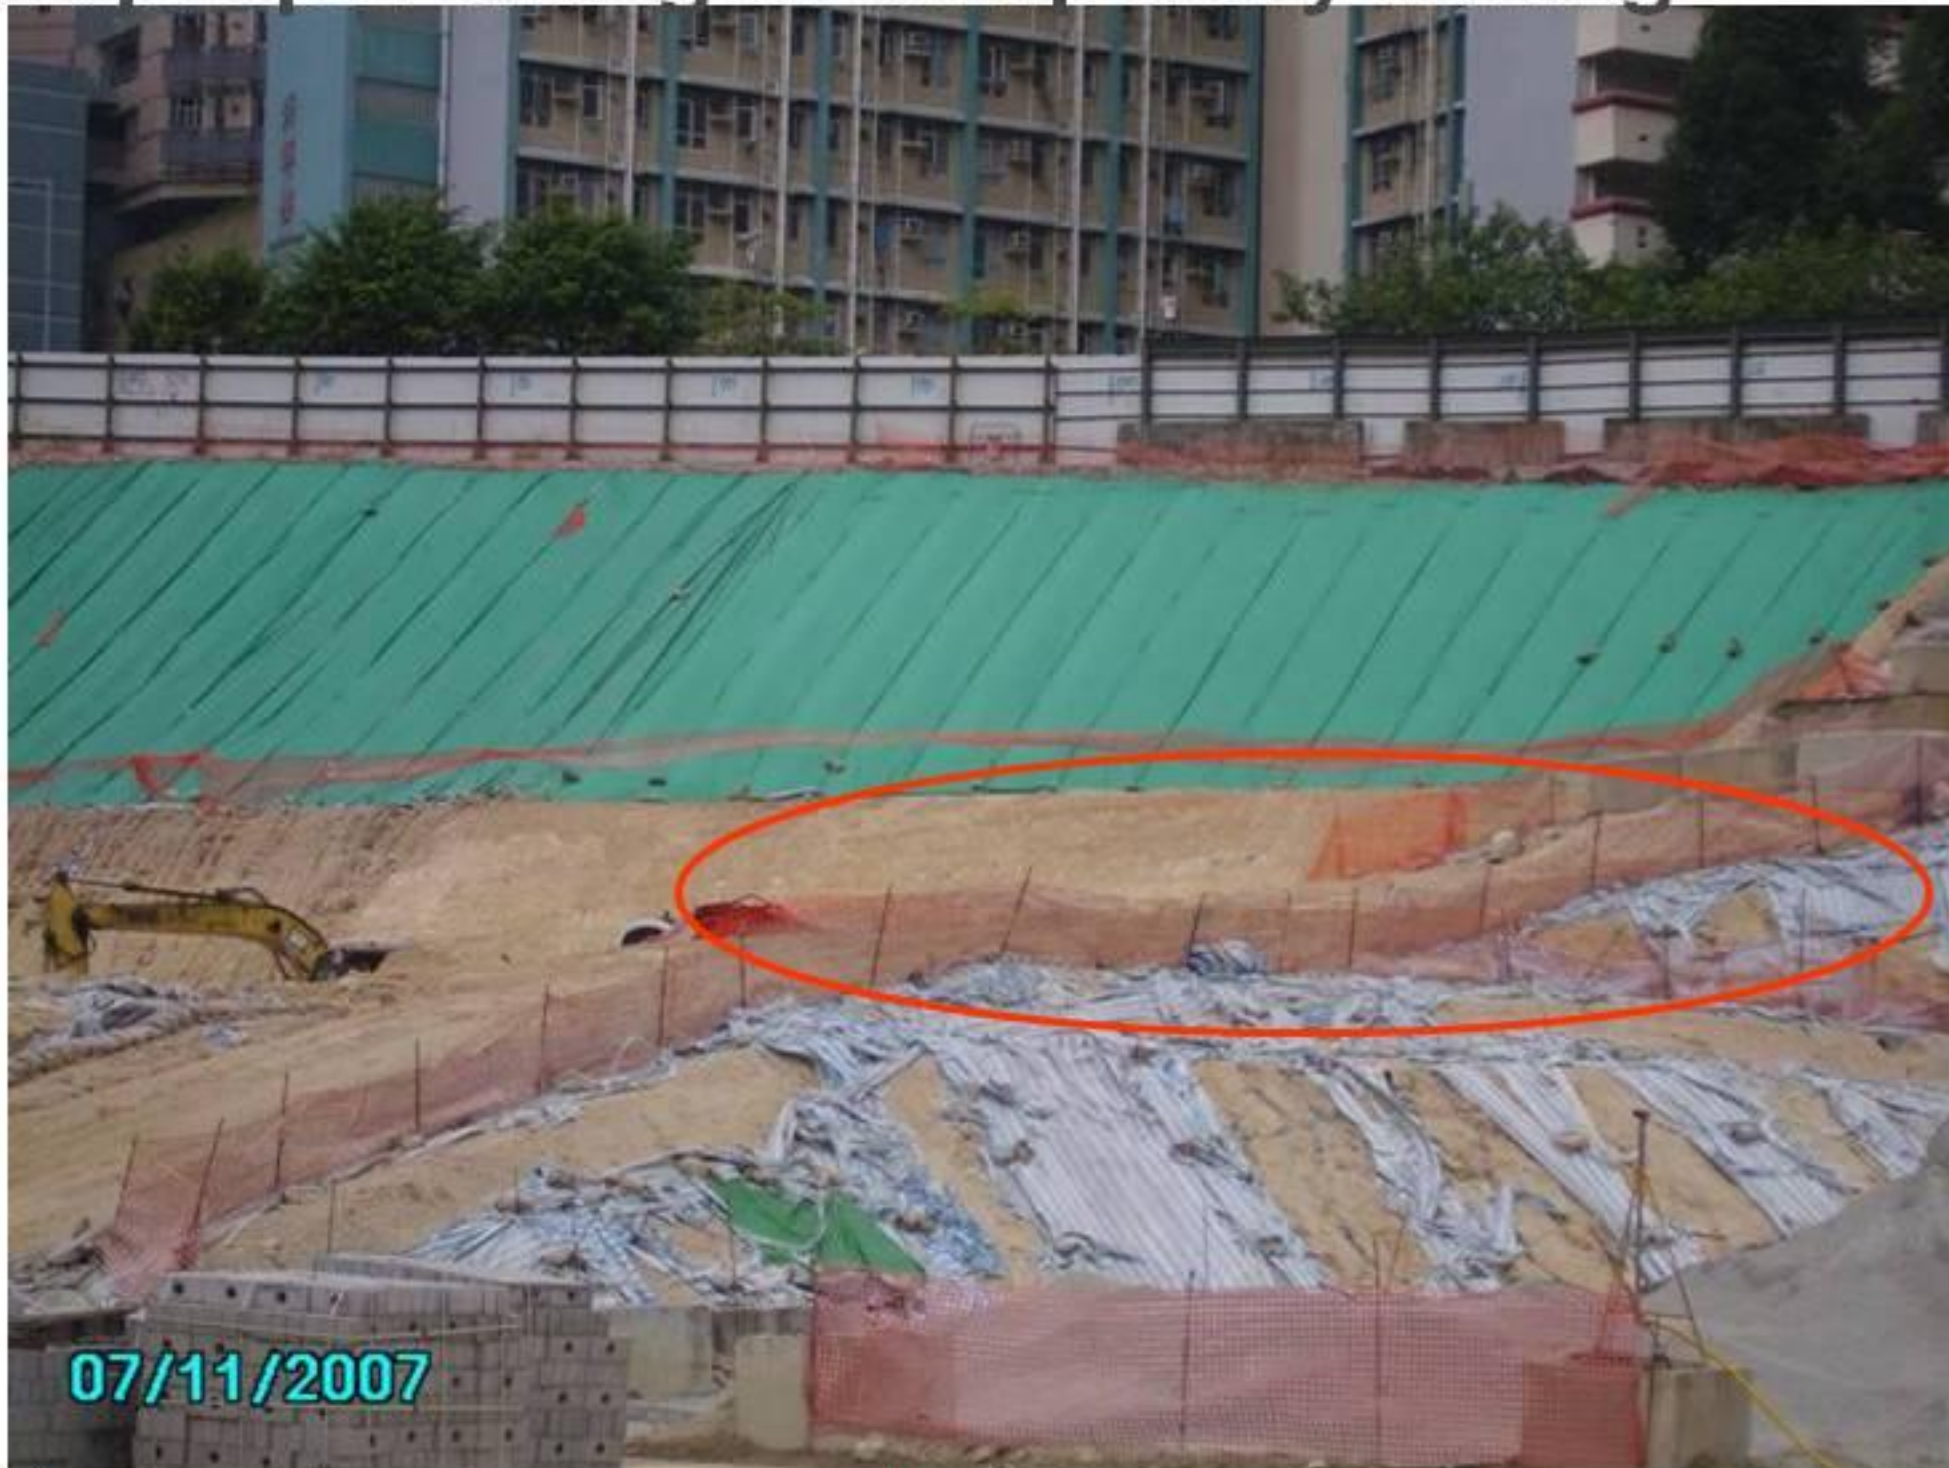
# Railing on Slope

## improper fixing of temporary railing
