# **SITE SAFETY Focus Seminar**

on New Works of  
Housing Department

**Site Safety** issues at -

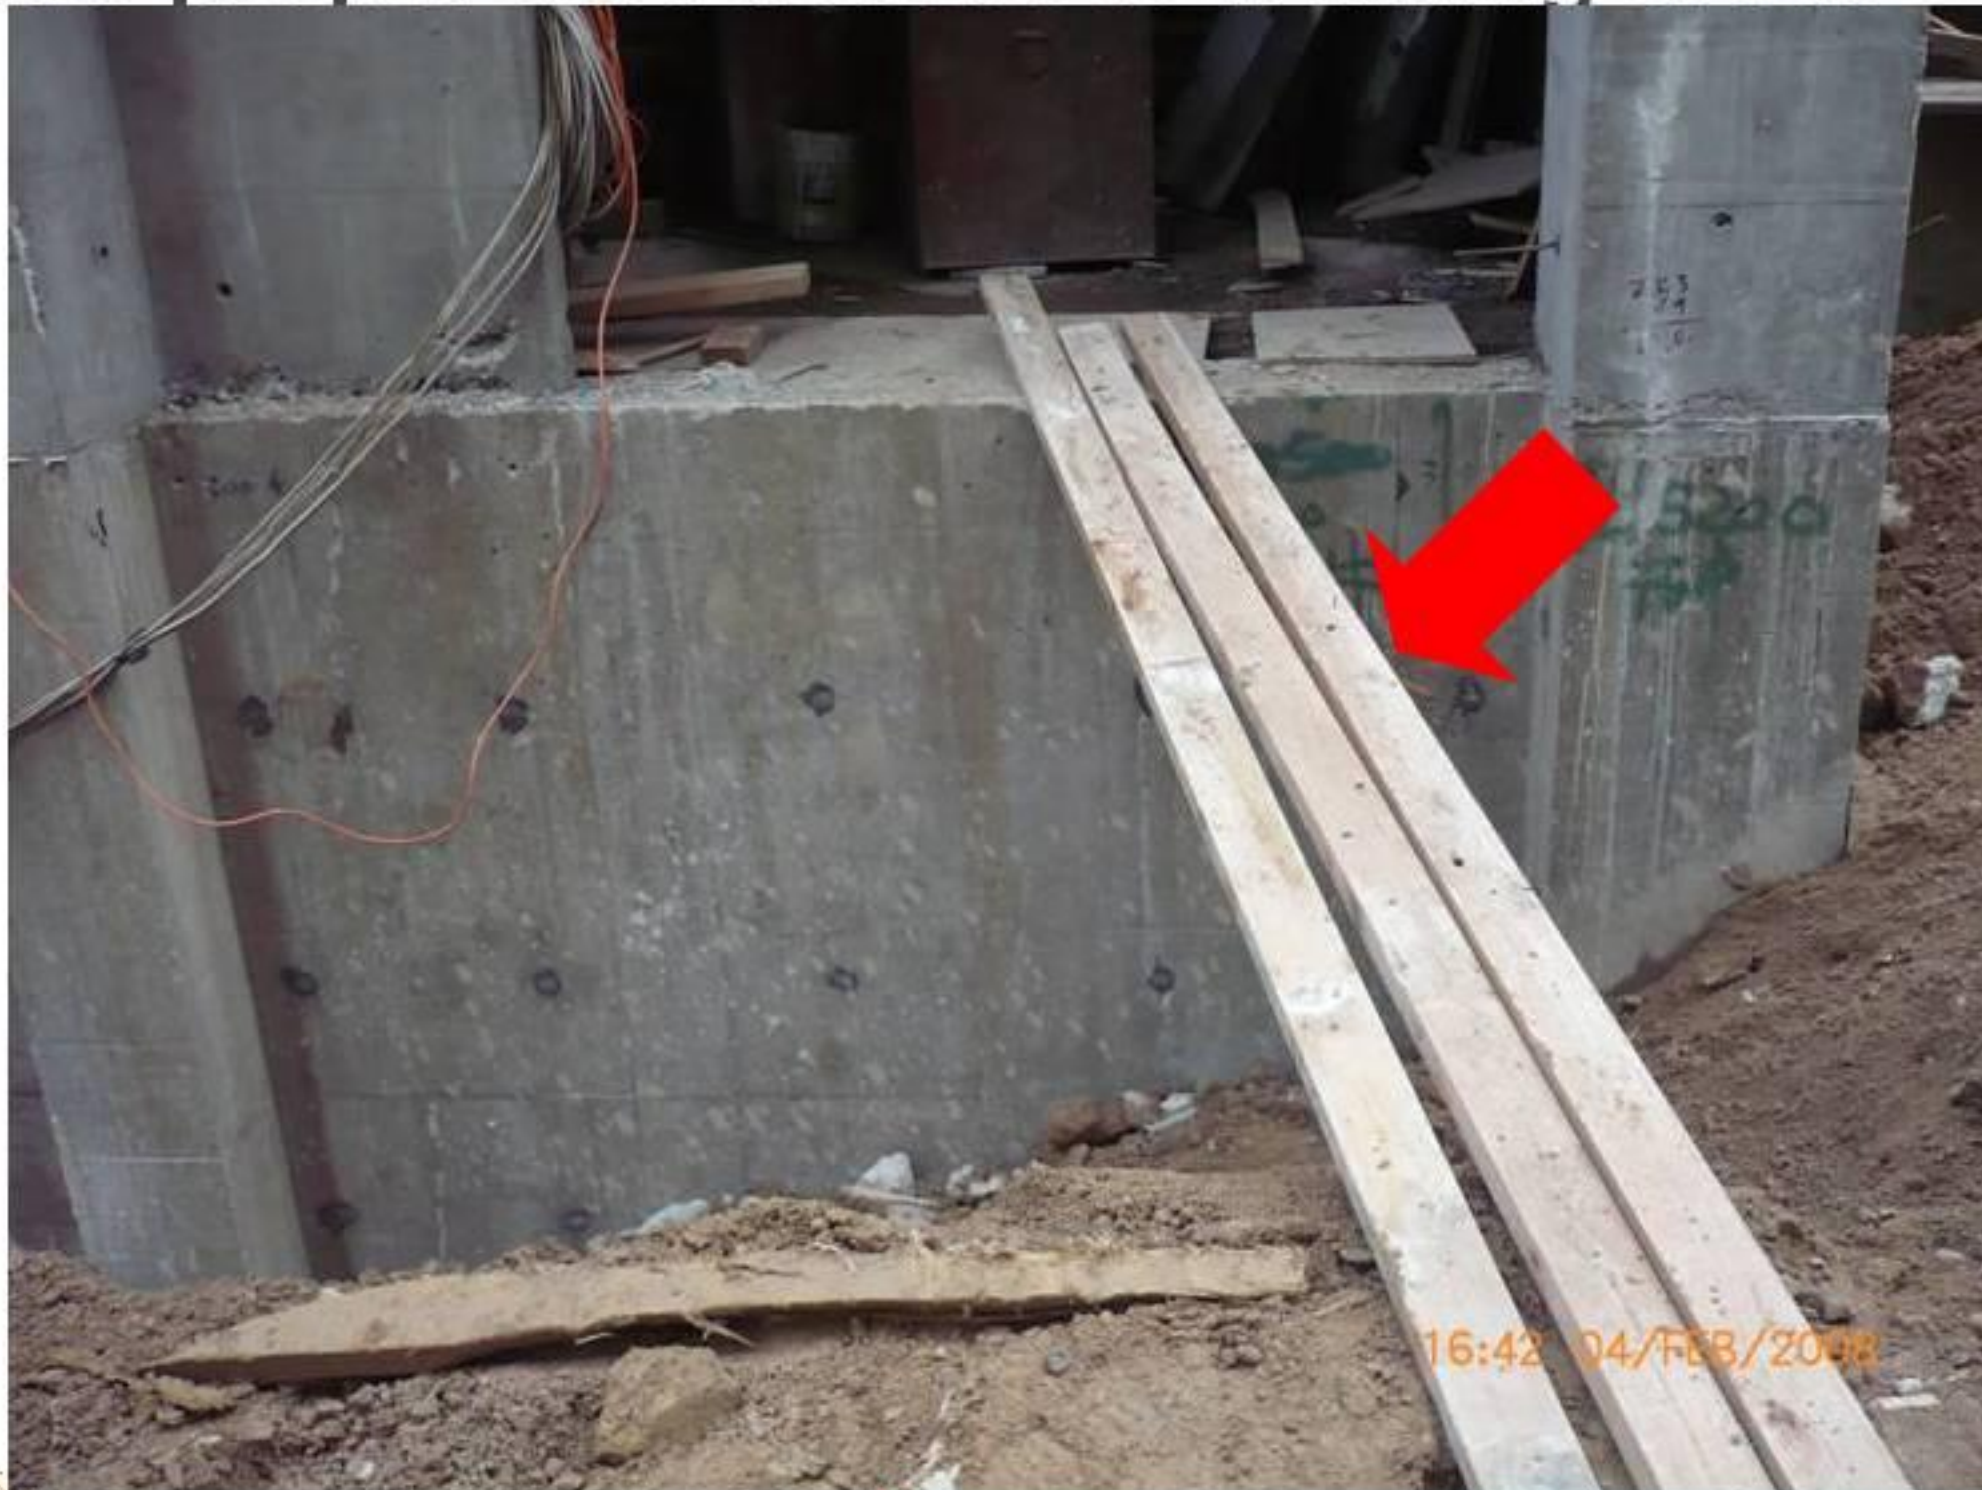
# Site Access

**NO proper safe access to working areas**

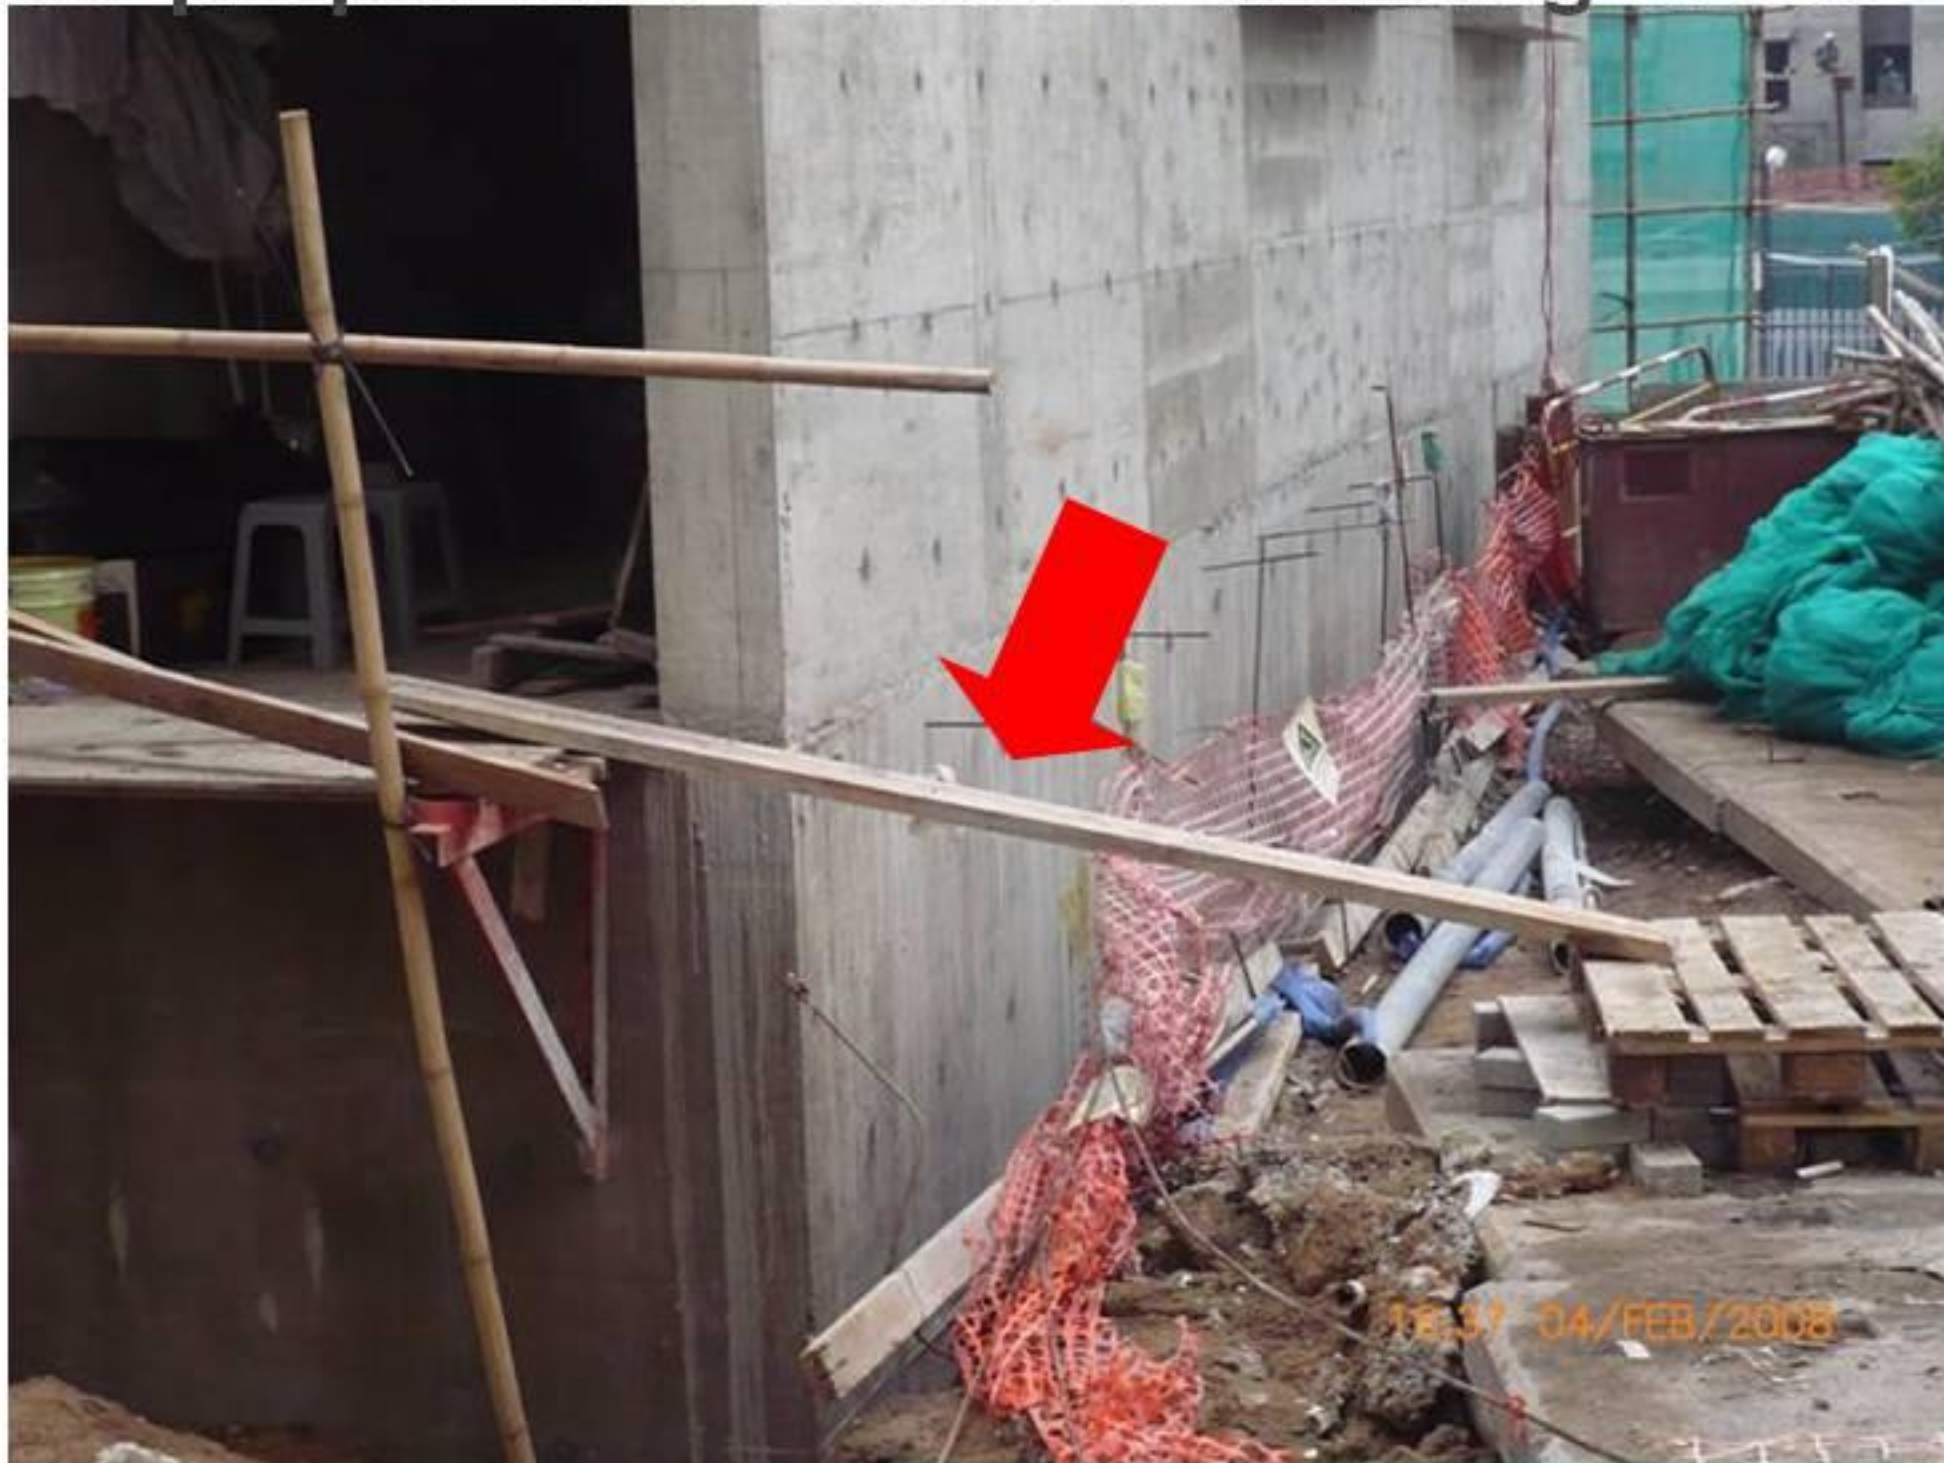
# Site Access

**NO proper safe access to working areas**

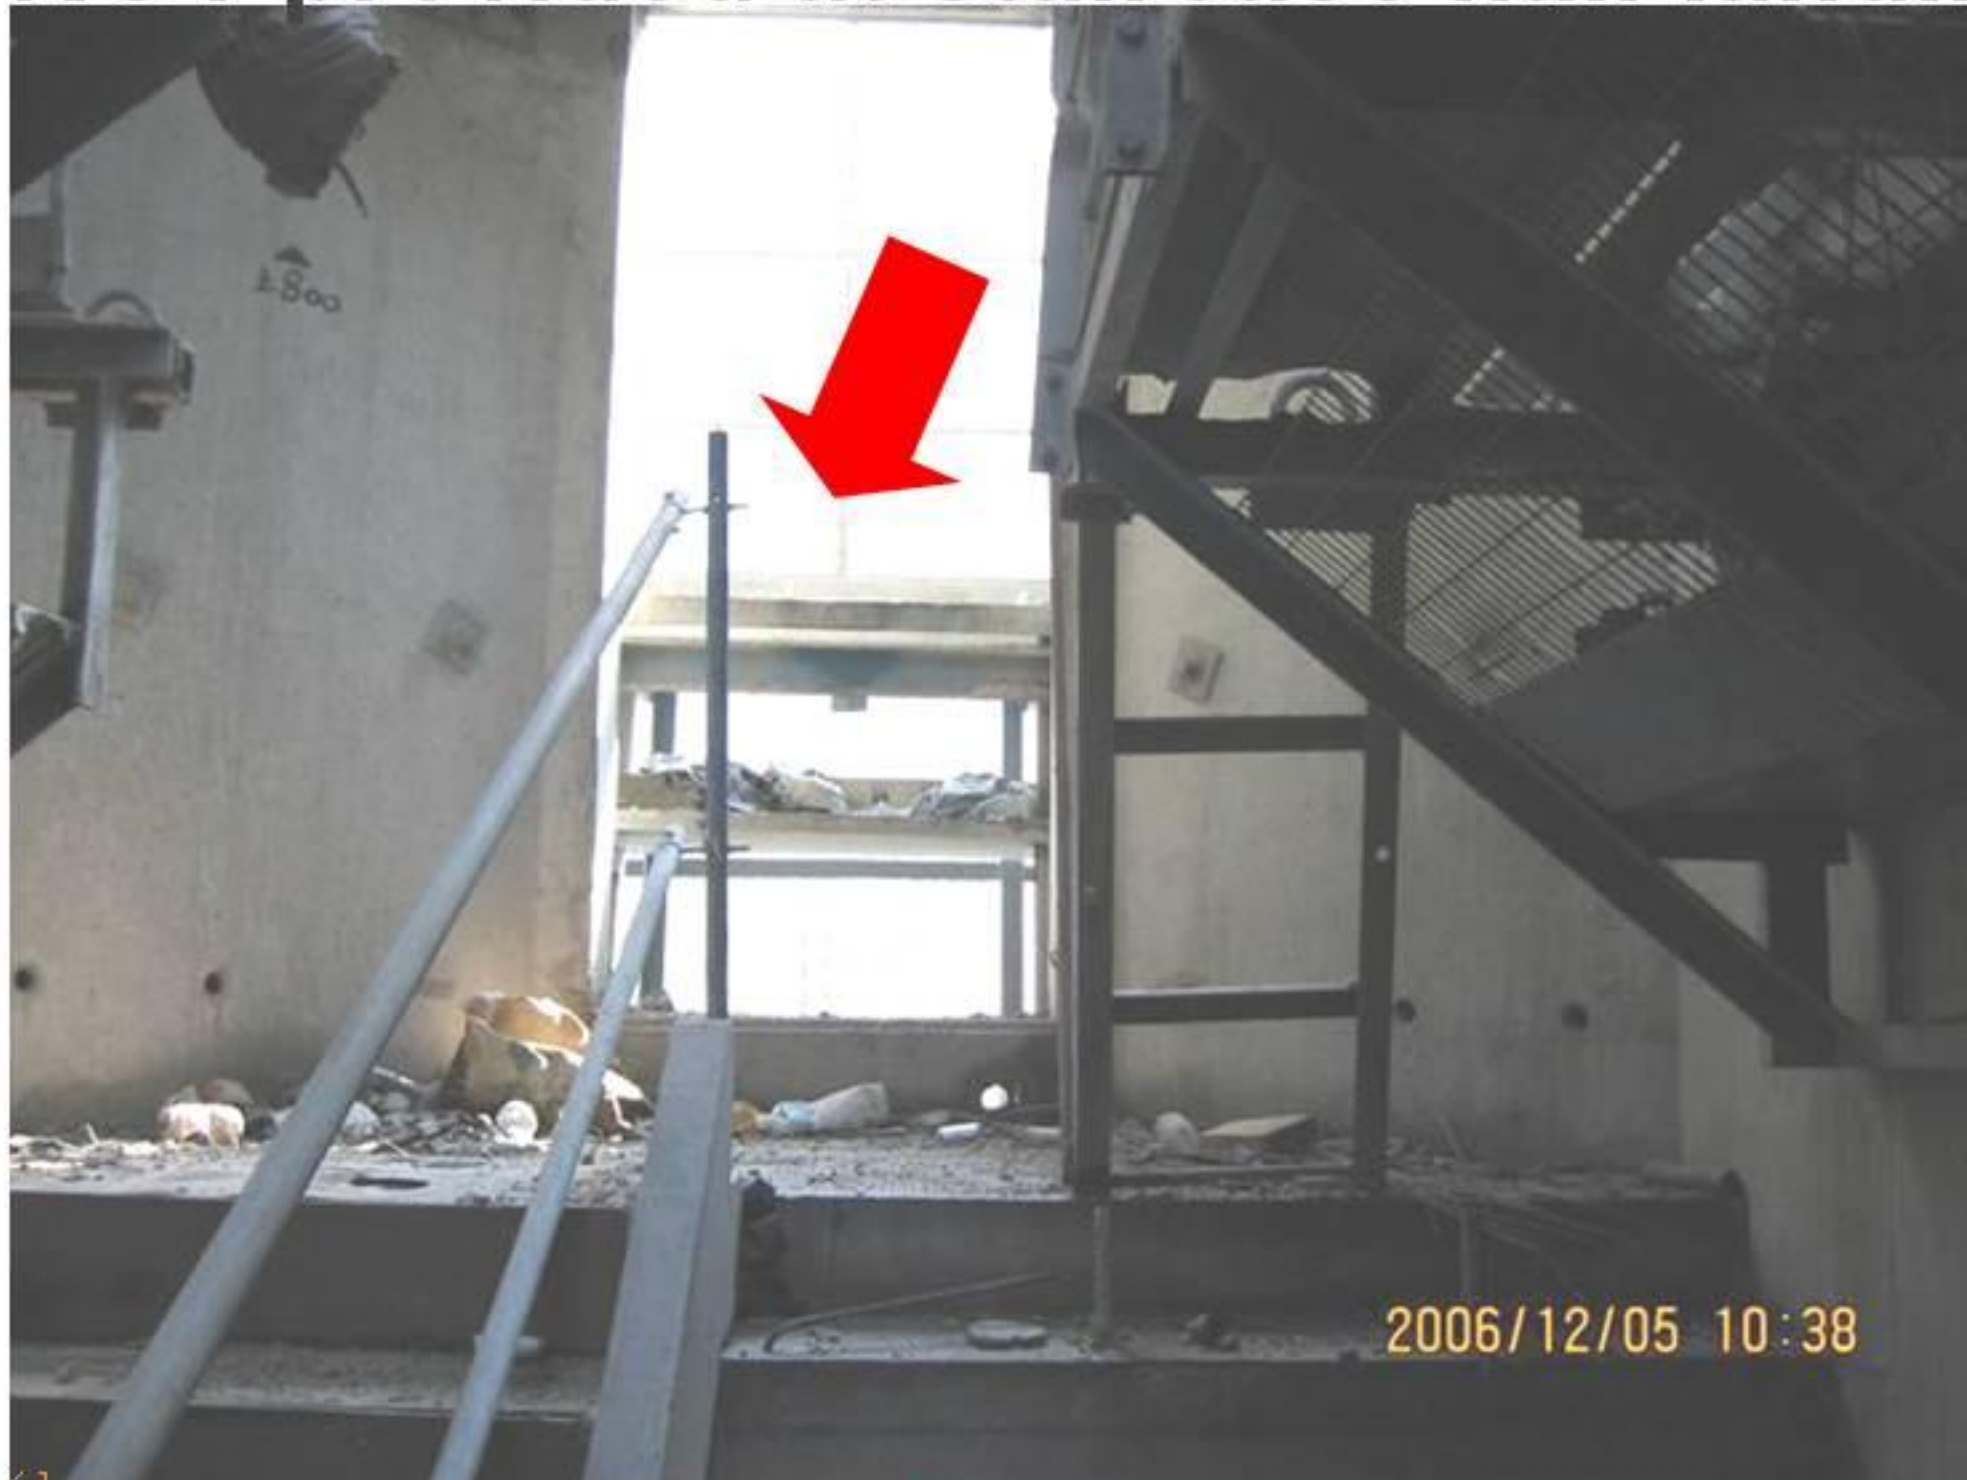
# Railing to Slab Edge **NOT** provided at staircase half landing

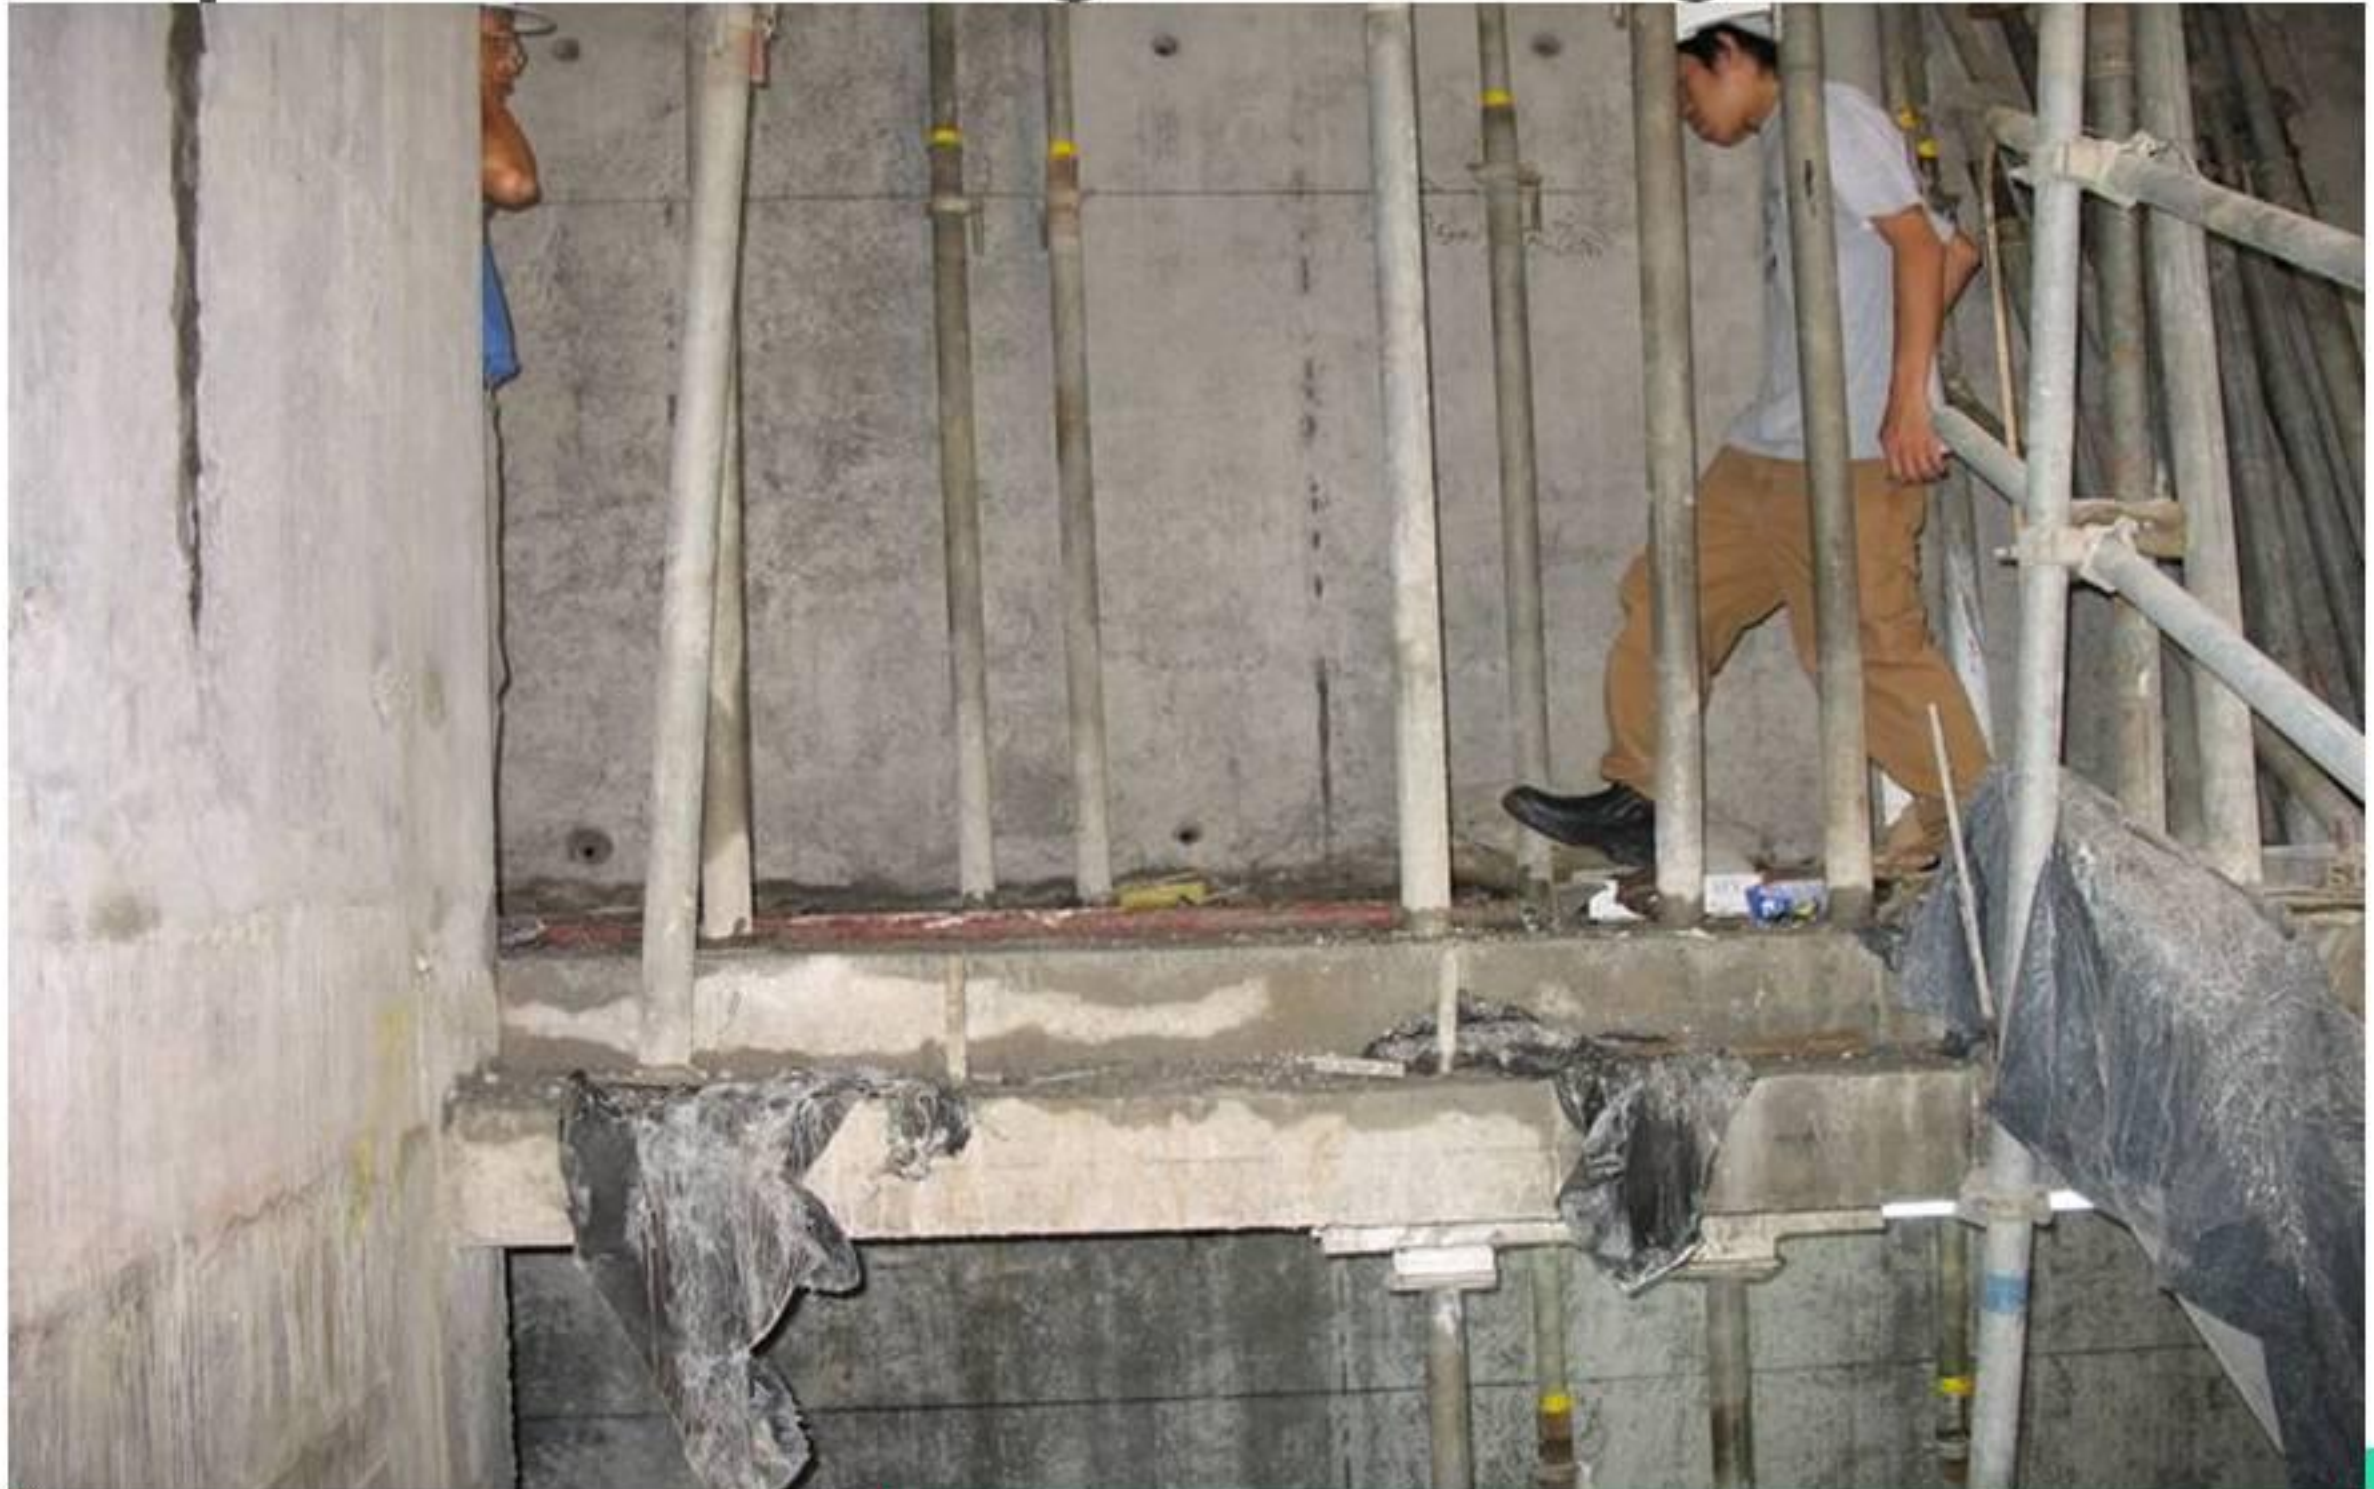
# Railing to Edge Slab

## NO protective railing at slab edge

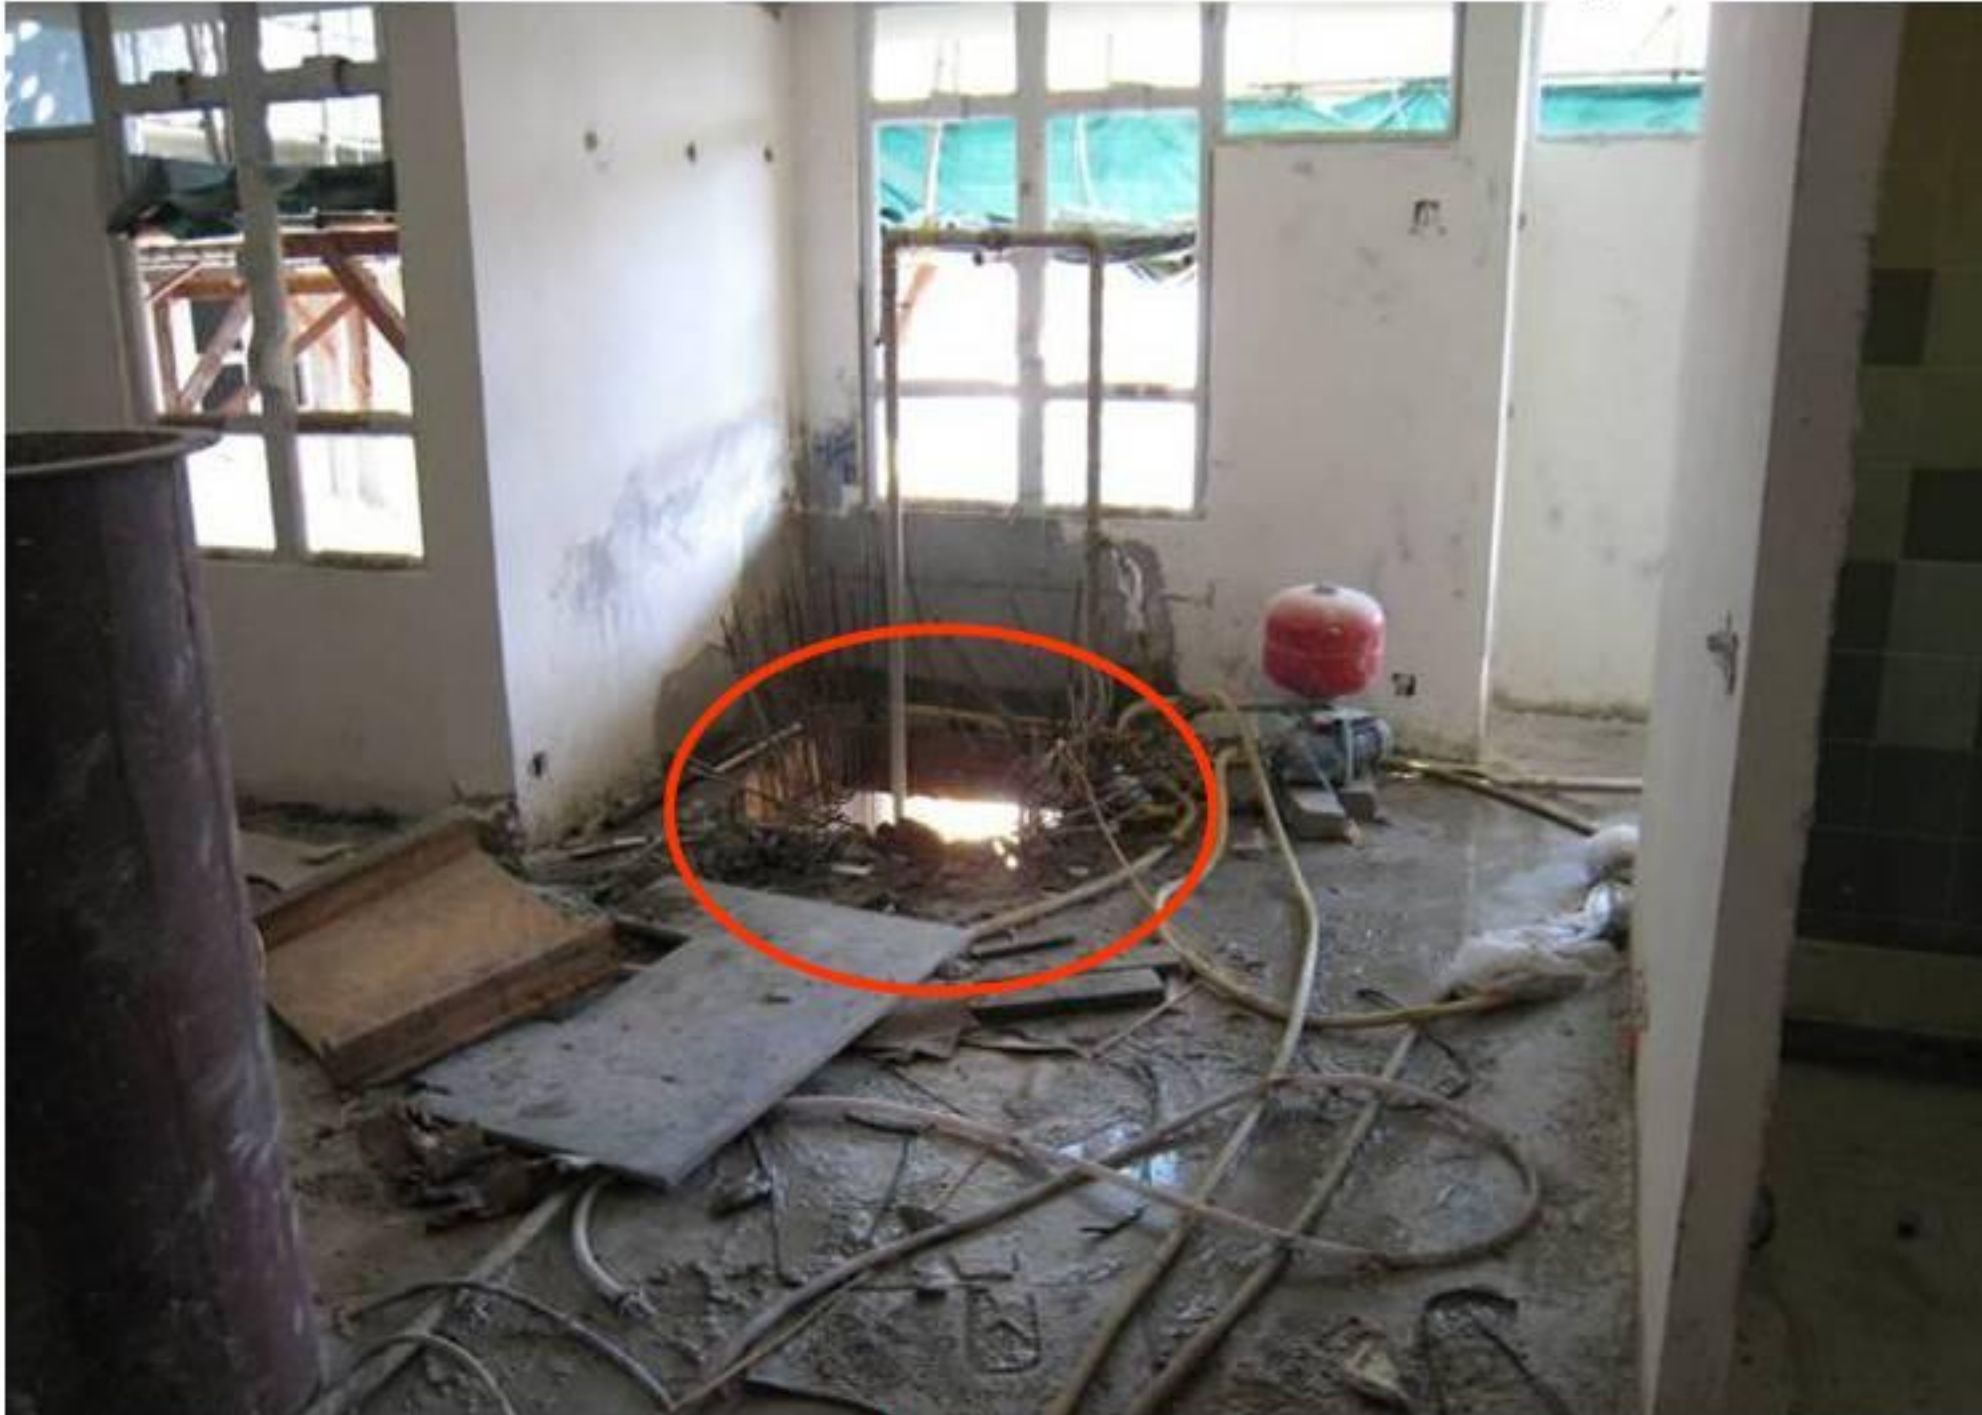
# Protection to Floor Opening

## NO railing / closed board to slab opening

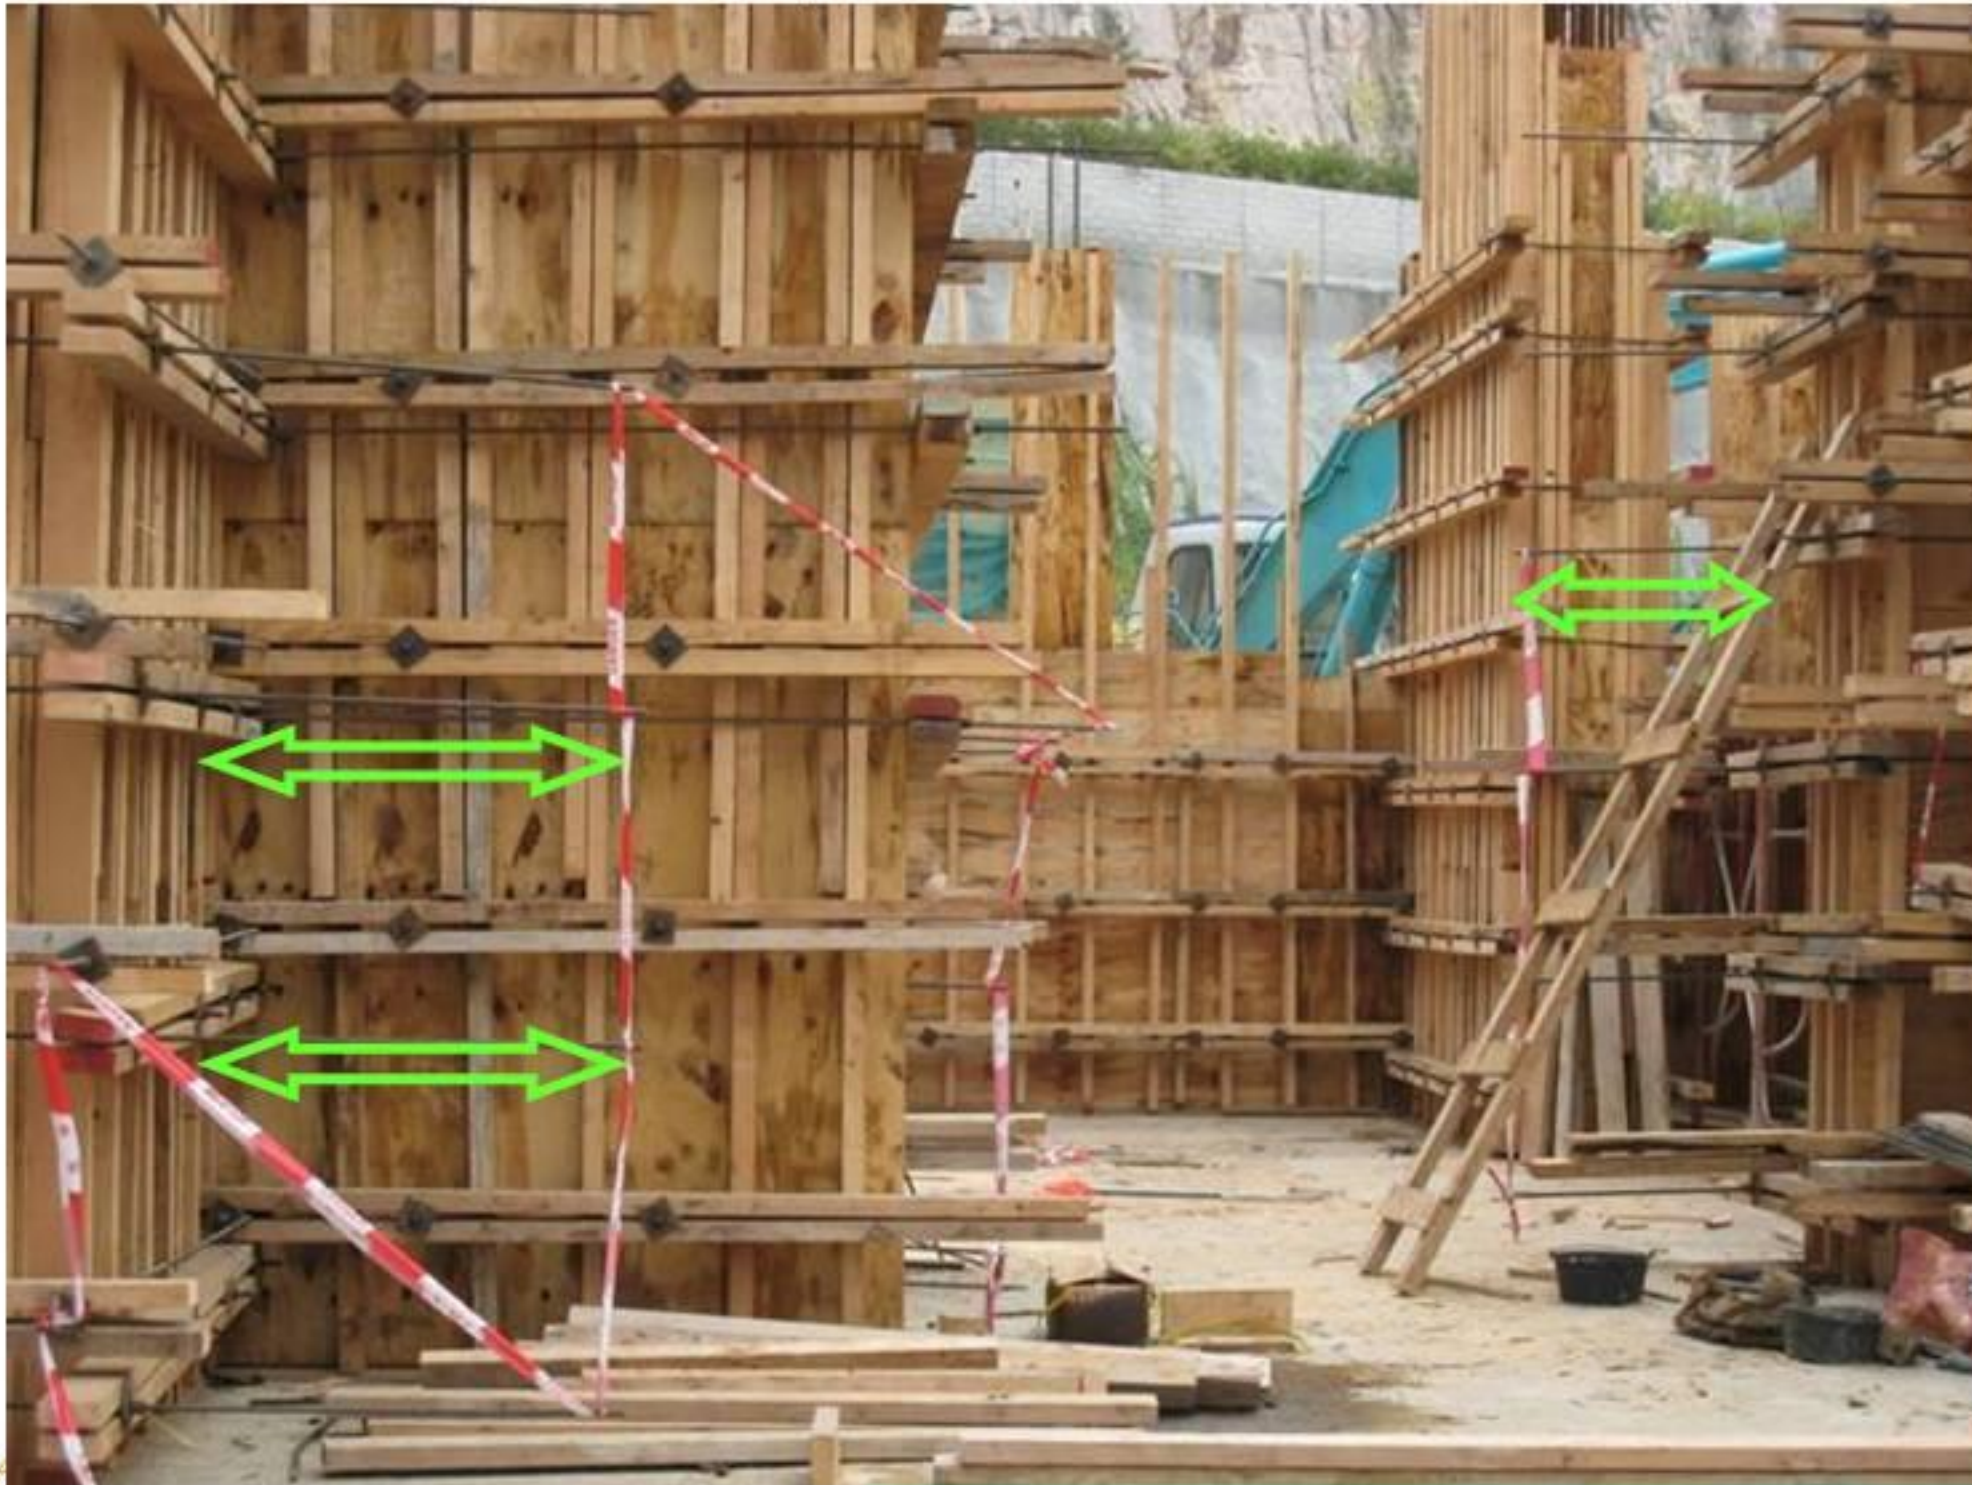
# Long Formwork Tie Rods excessively long projection / endanger workers

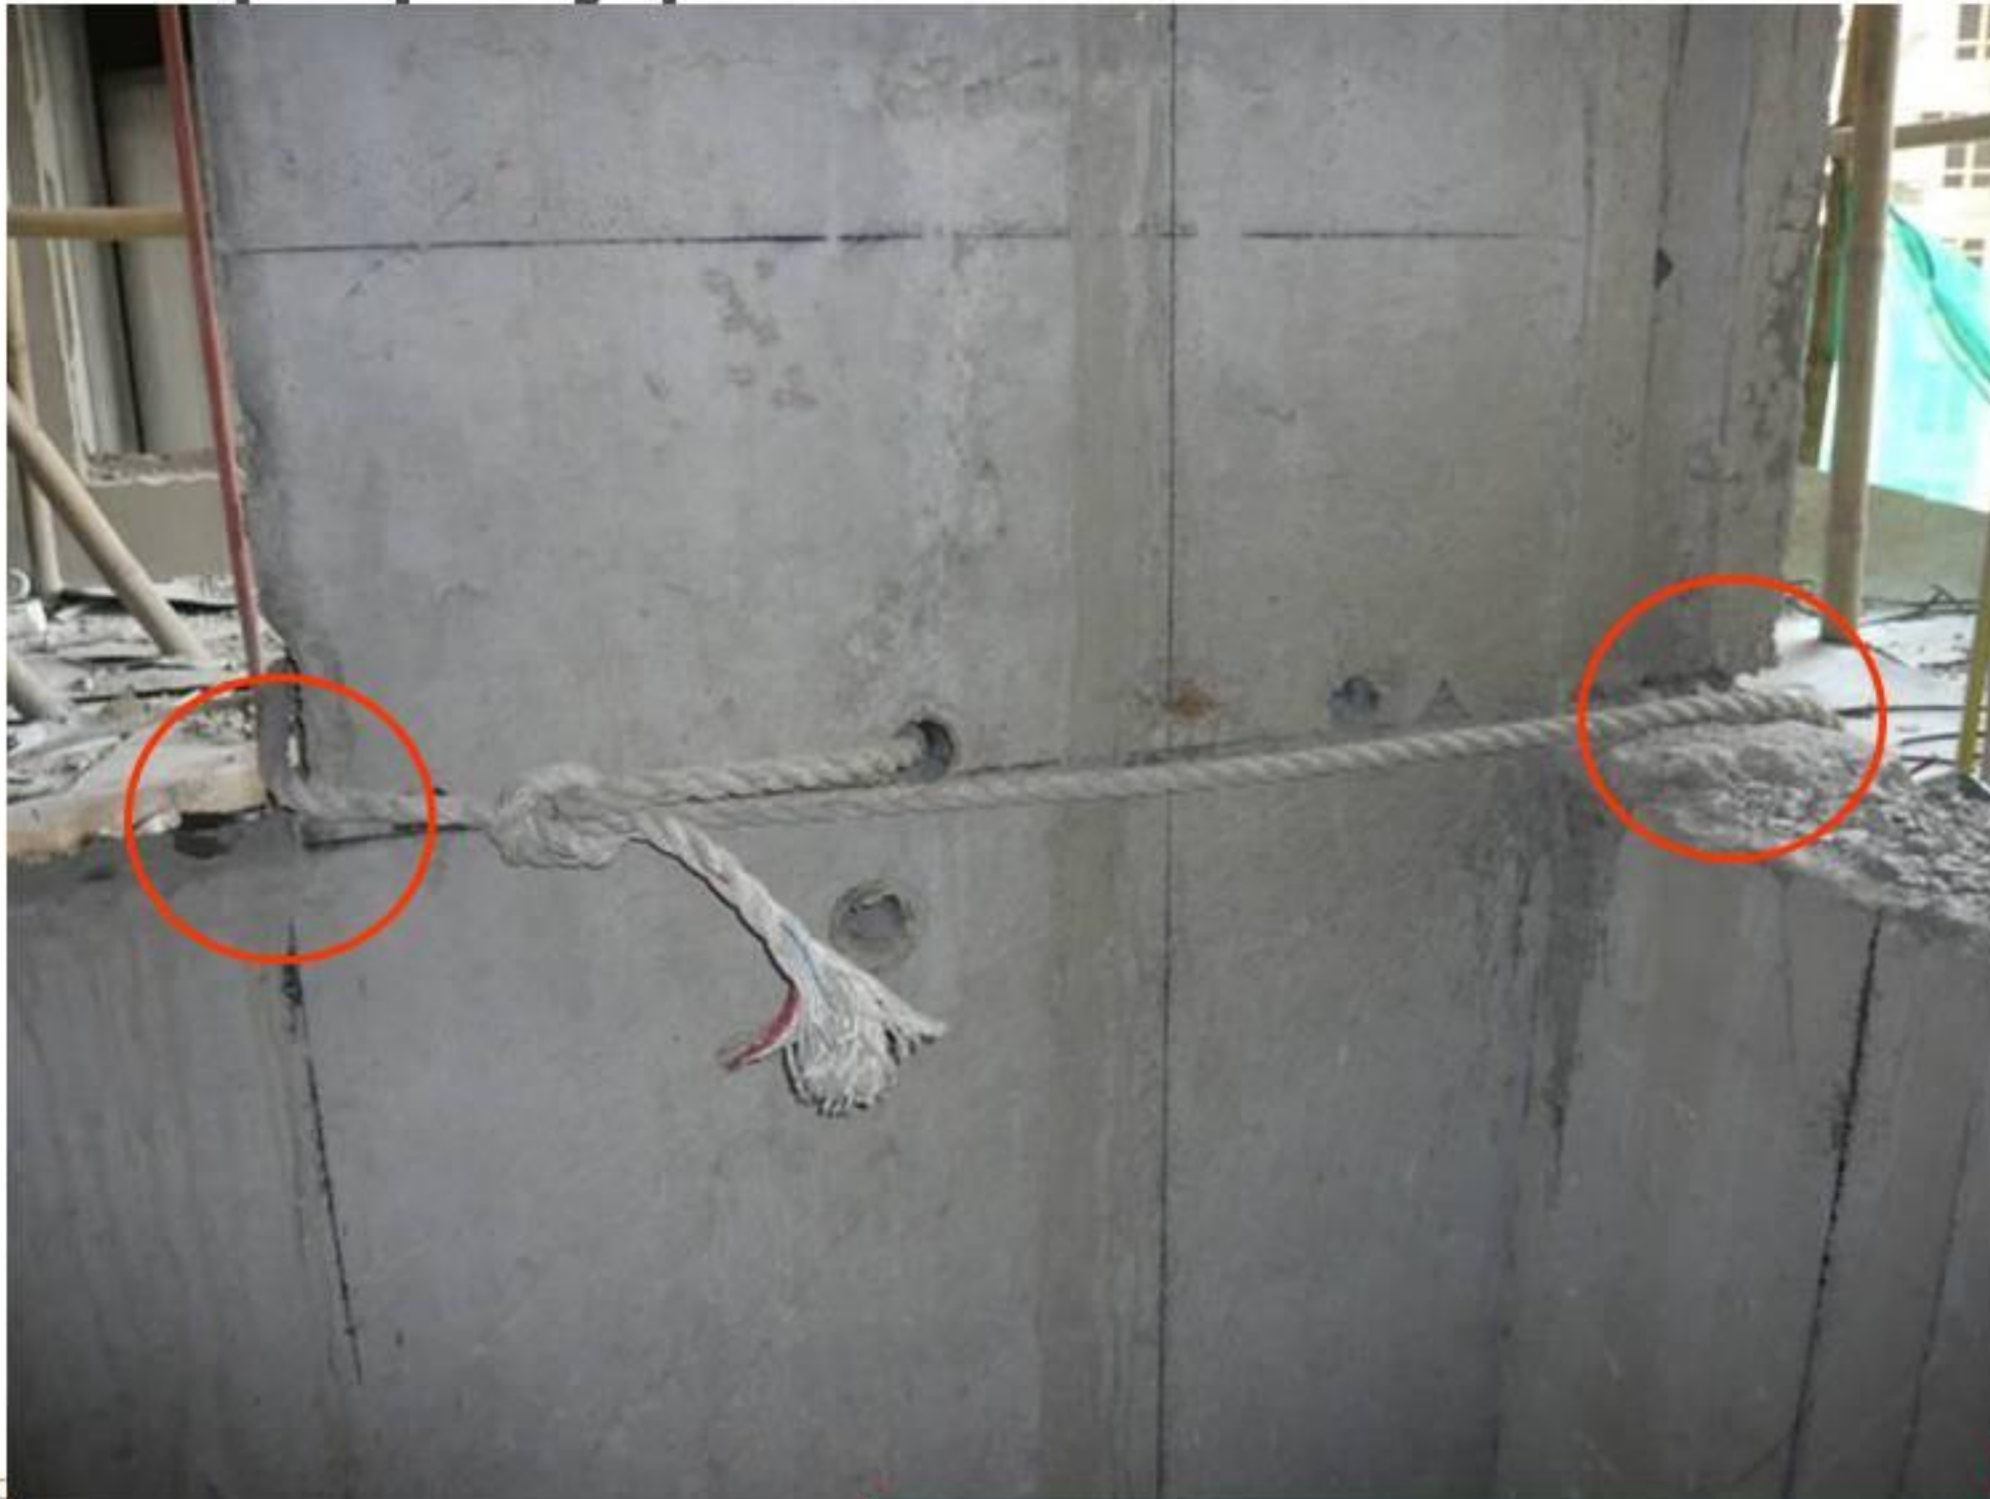
# Safety Lifeline NOT properly protected
