# **SITE SAFETY Focus Seminar**

on New Works of  
Housing Department

**Site Safety** issues at -

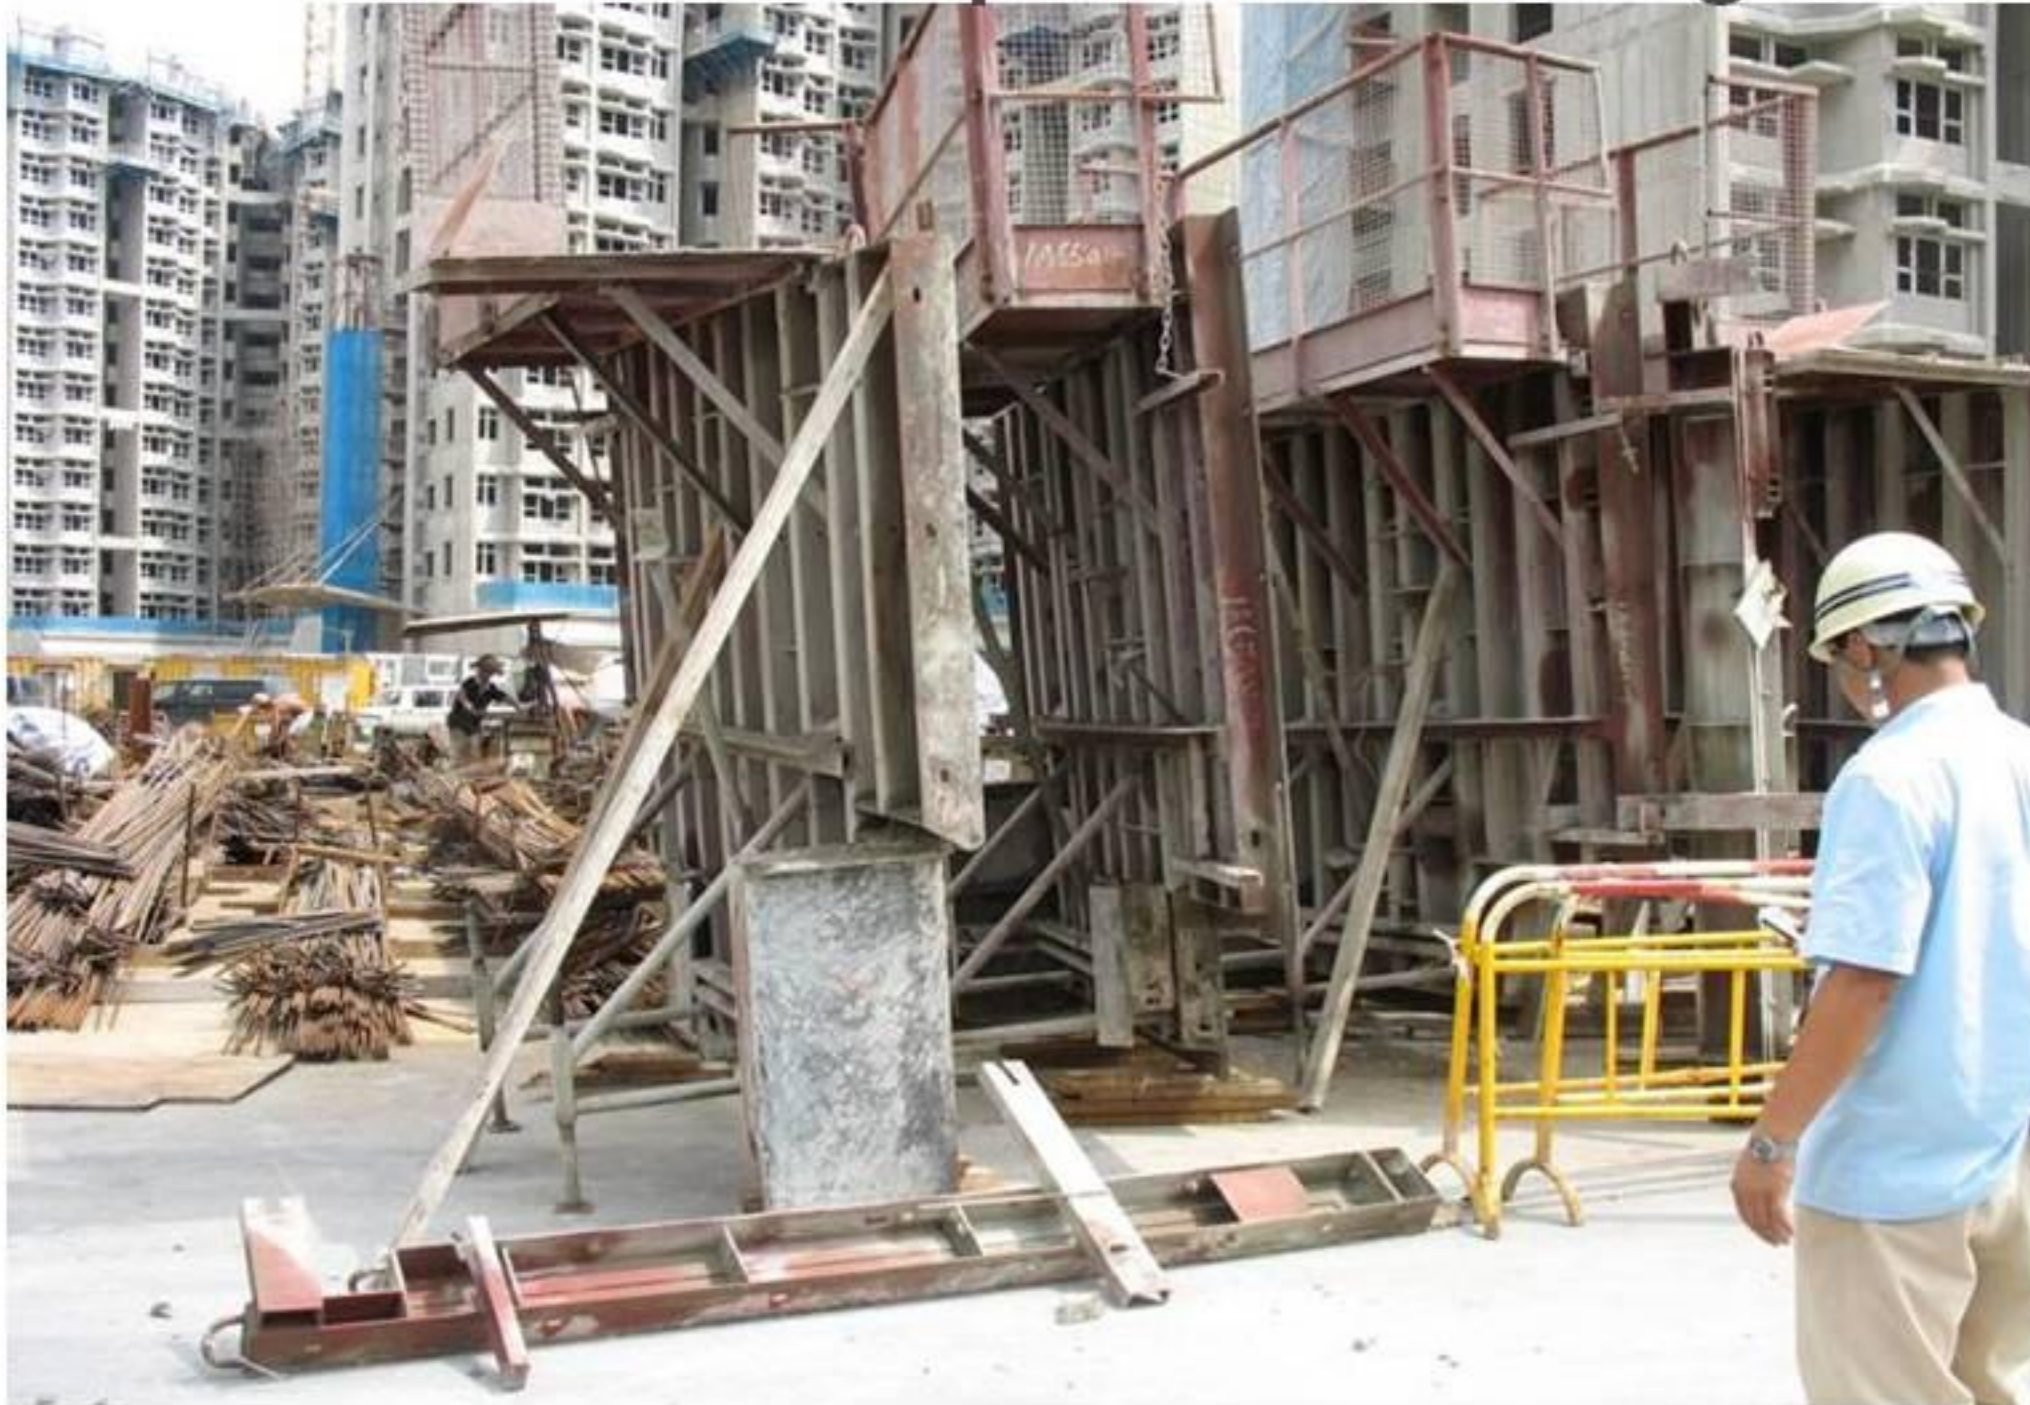
# Storage of Large Panel Formwork rested on timber strips and uneven ground

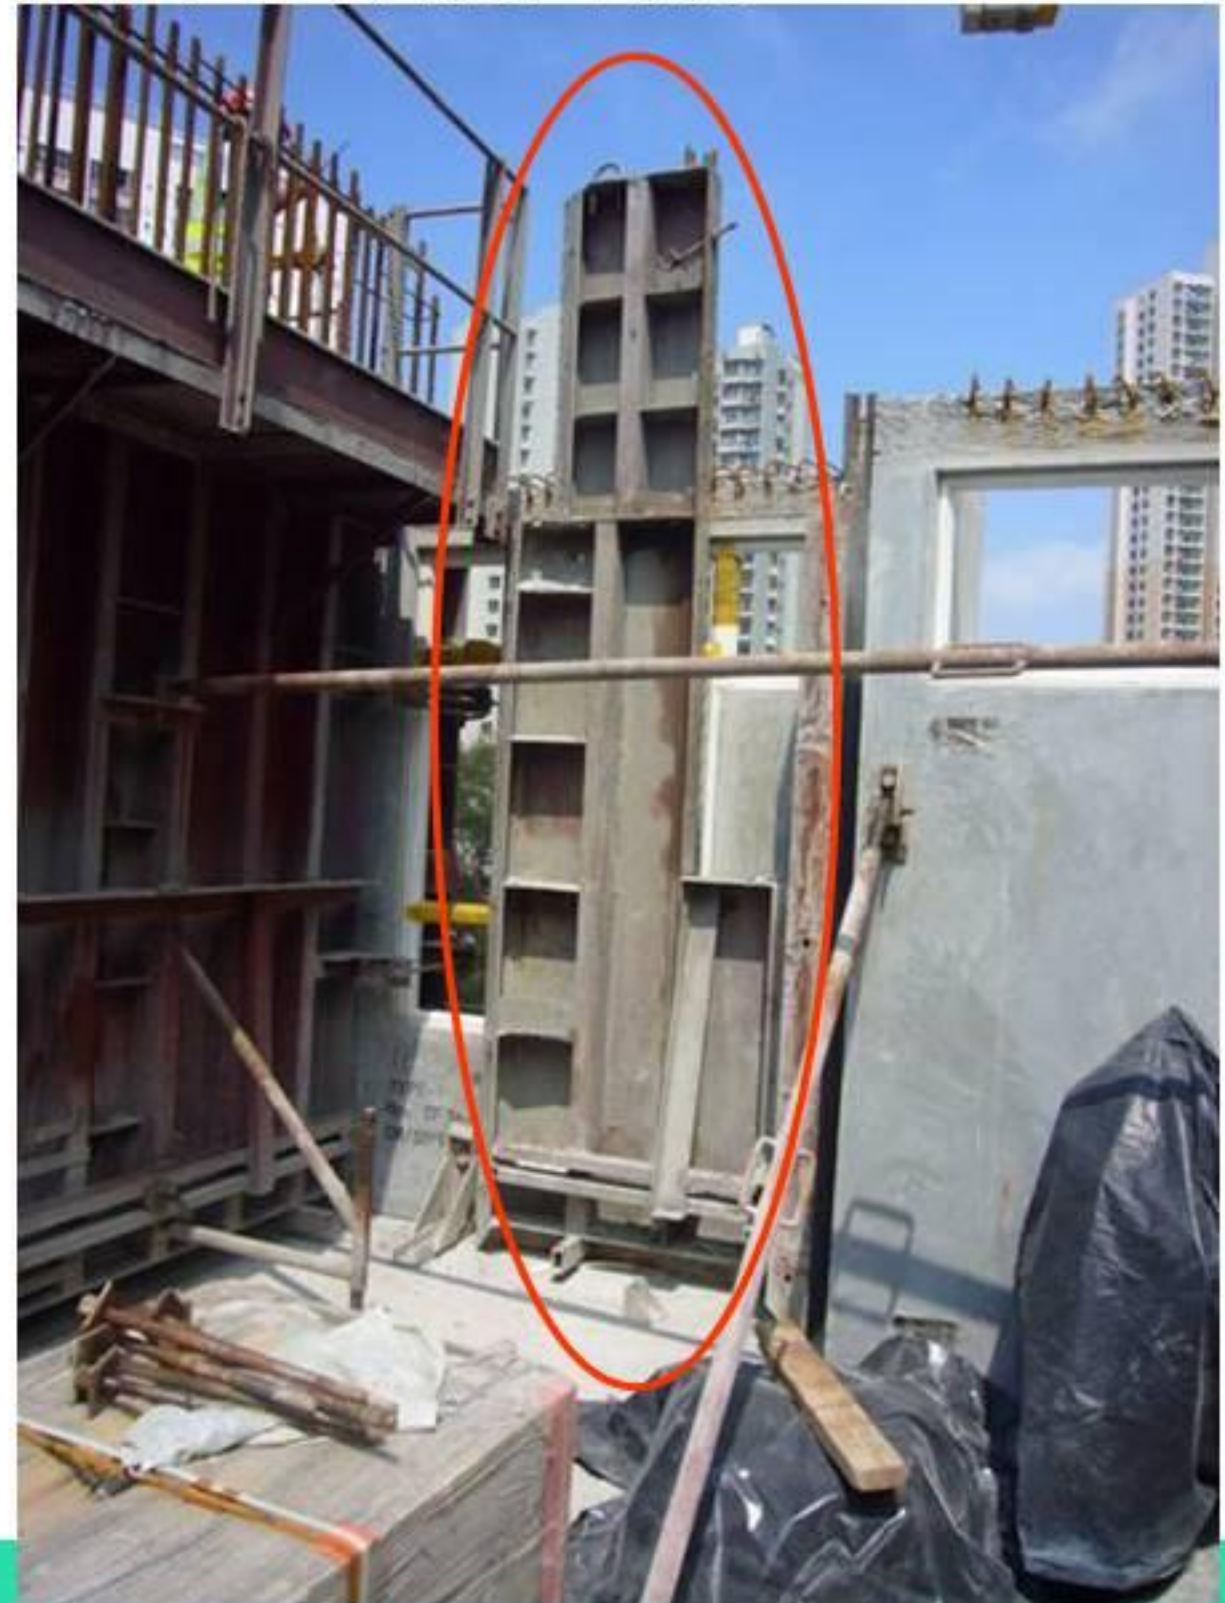
# Storage of Large Panel Formwork

**loosely lean on  
a precast facade  
causing danger to  
nearby workers**

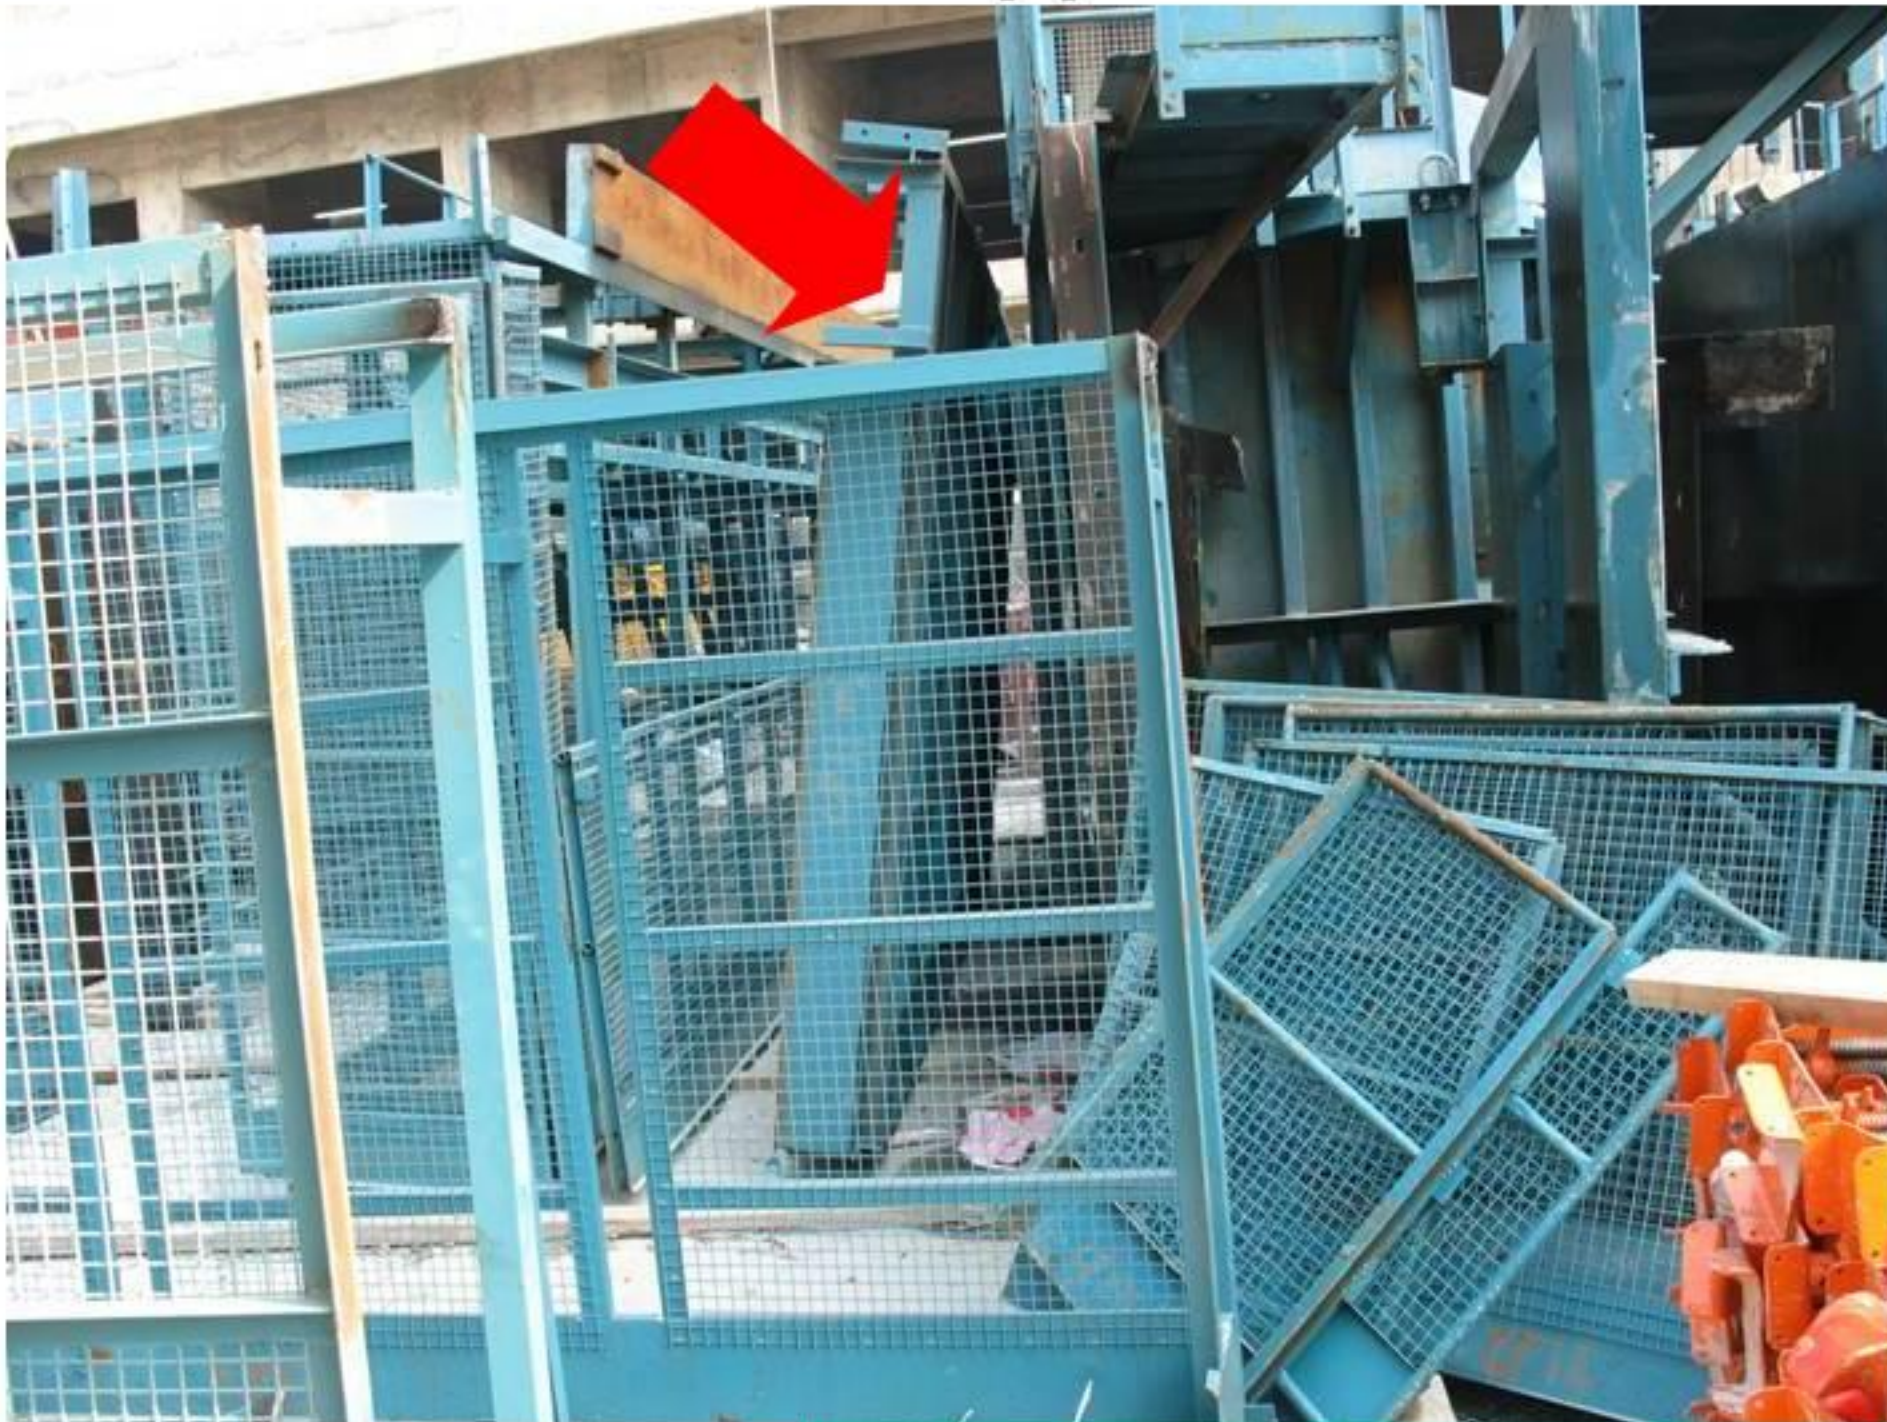
# Storage of Large Panel Formwork

## One not stored to the approved method statement

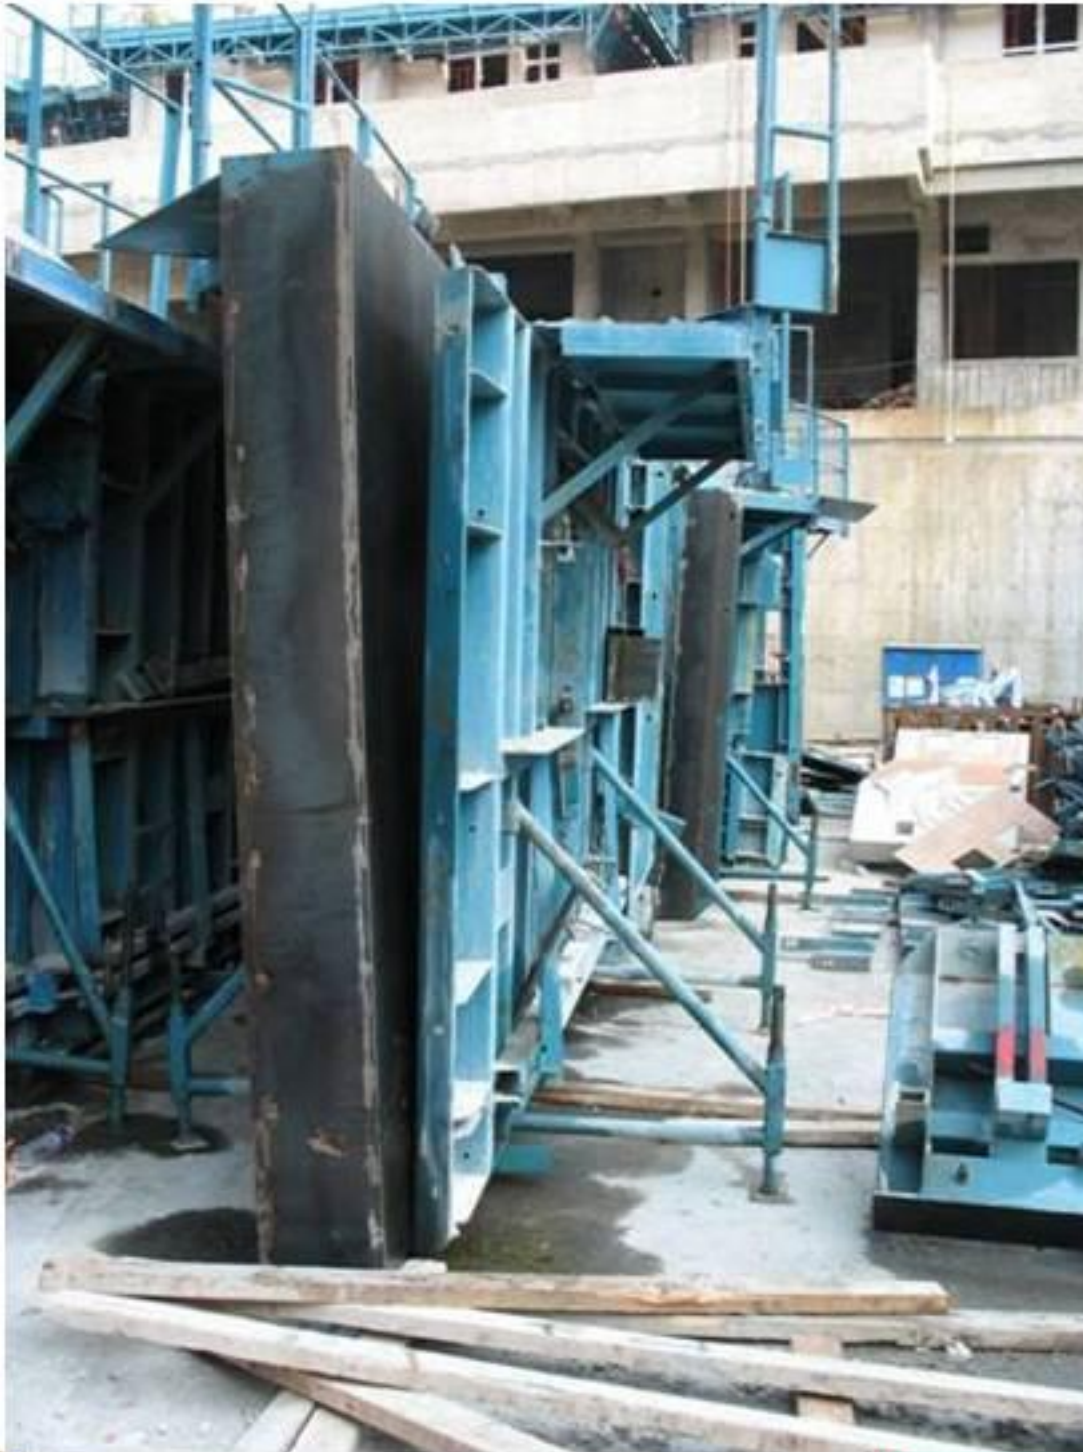
# Storage of Large Panel Formwork supported with steel struts

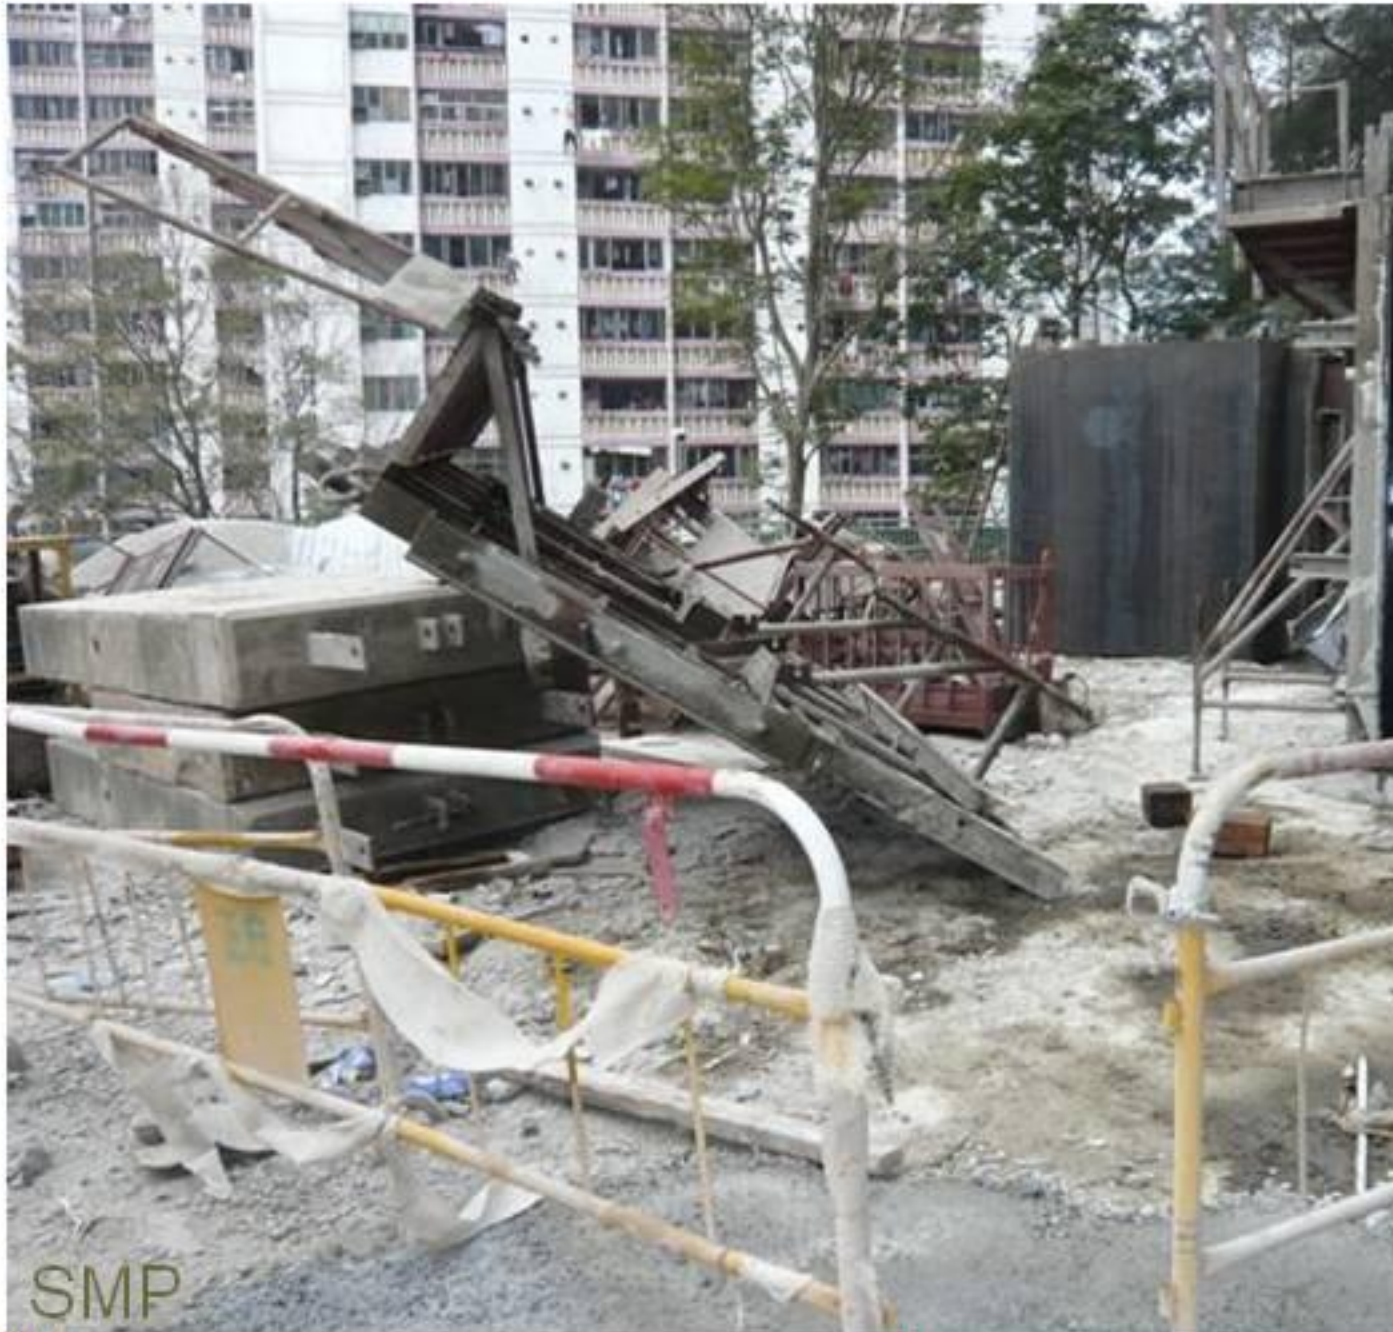
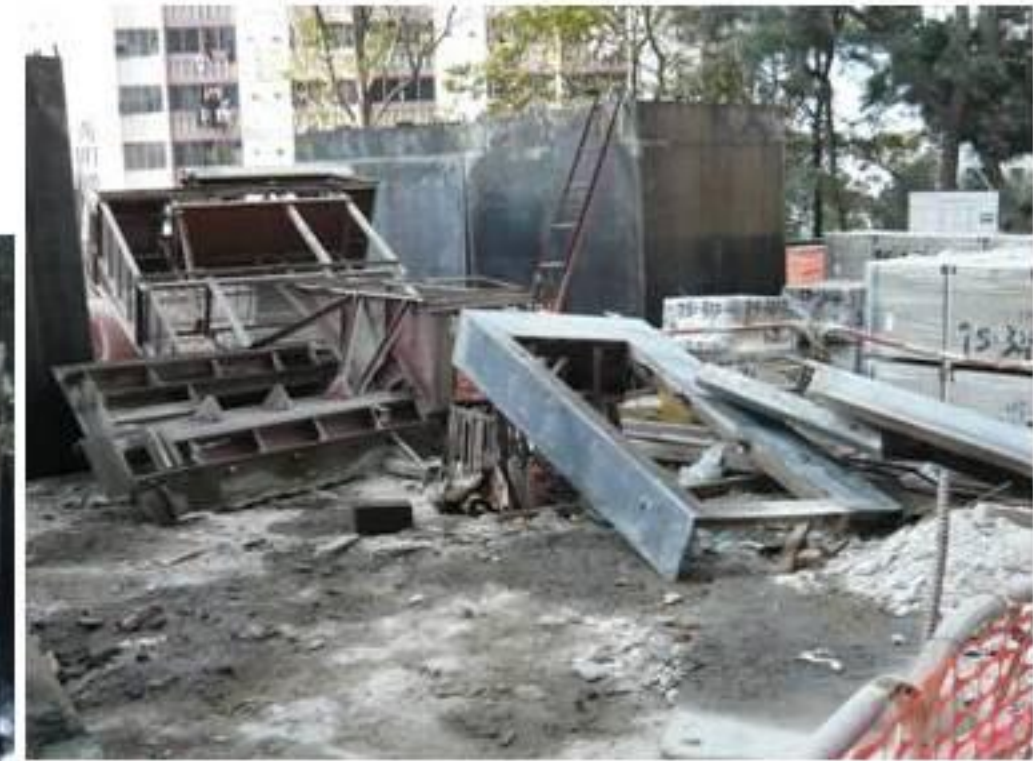
# Storage of Large Panel Formwork improper storage

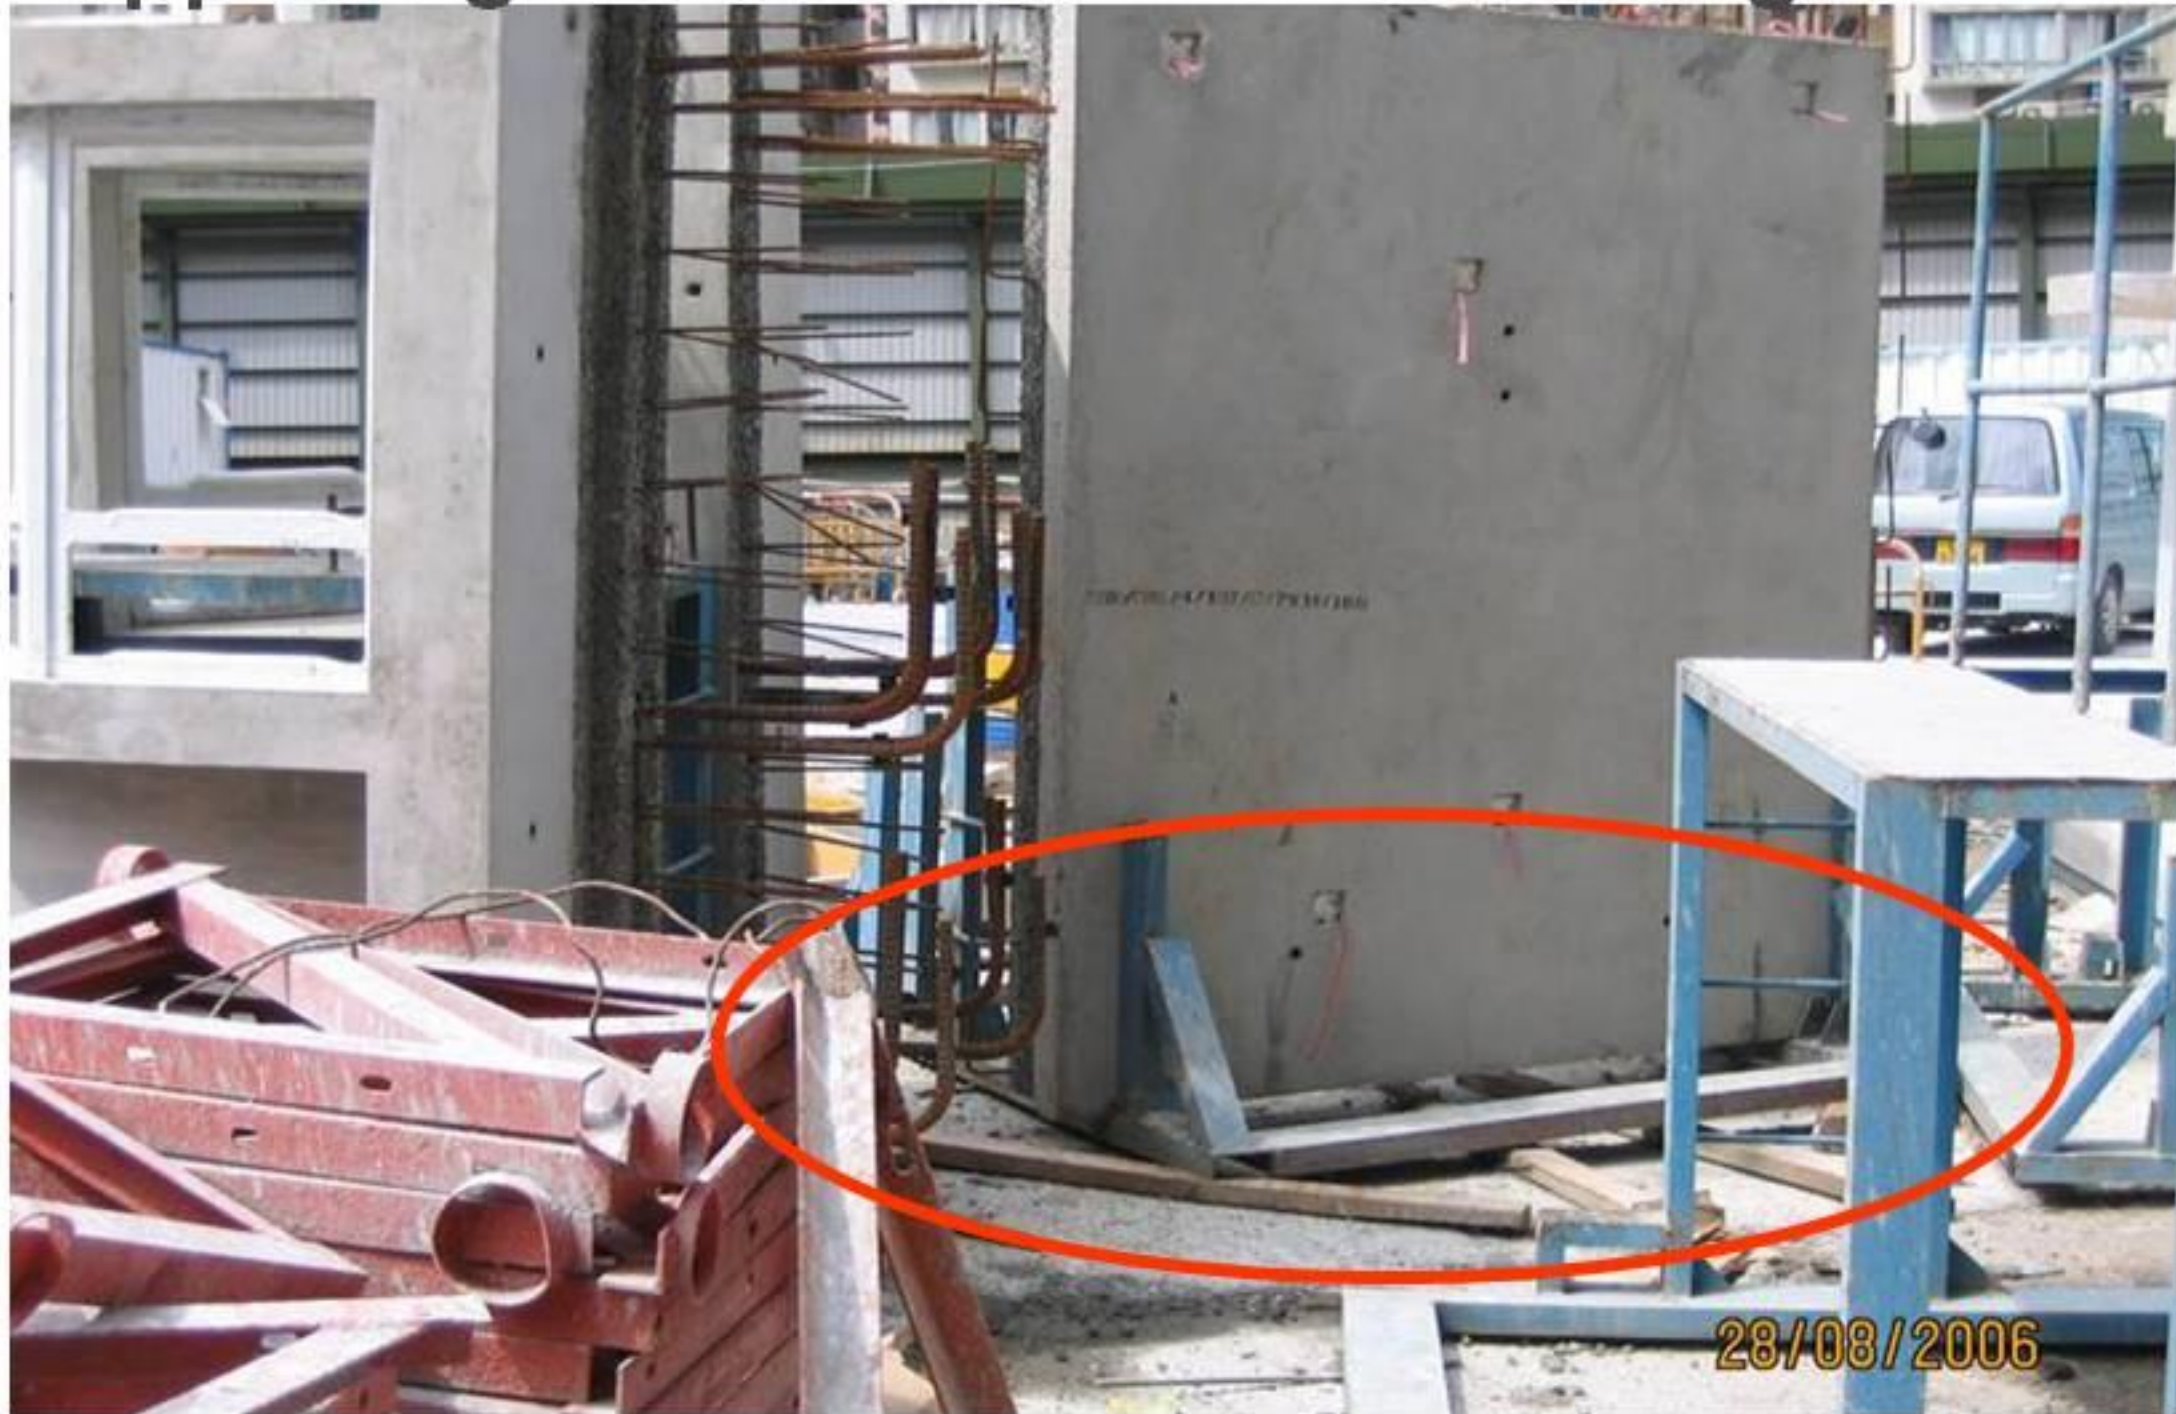
# Storage of Precast Facade Units supporting stands NOT rest on level ground

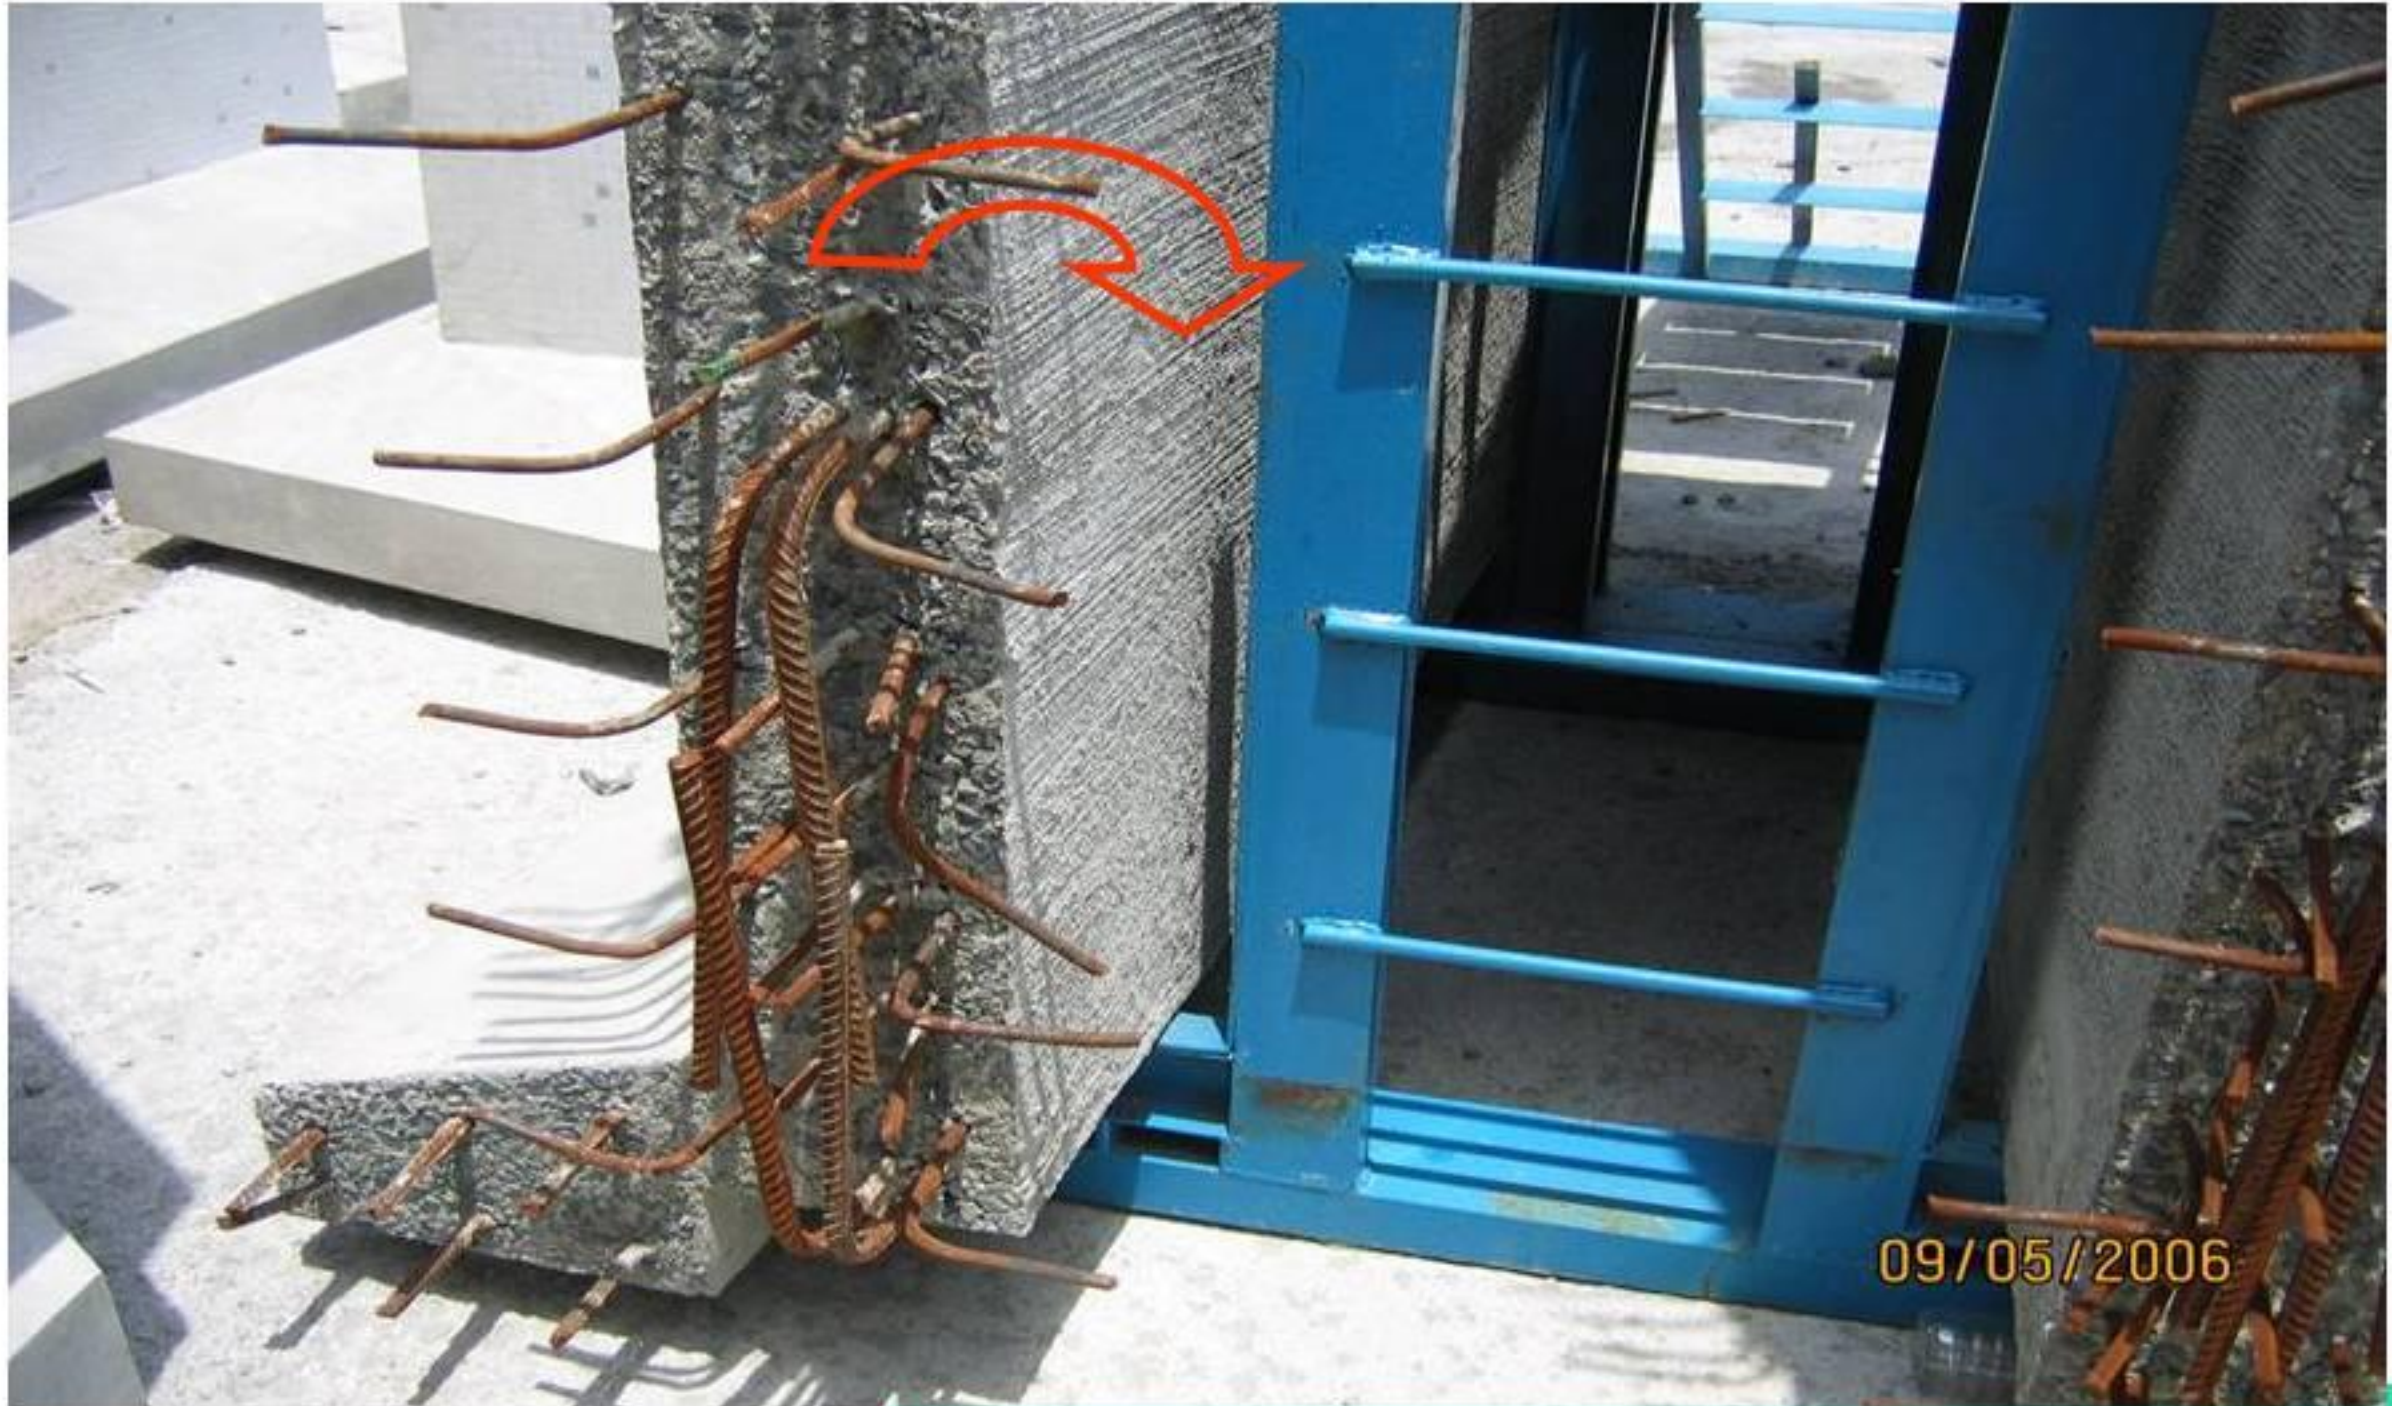
# Storage of Precast Facade Units stored NOT against the stand

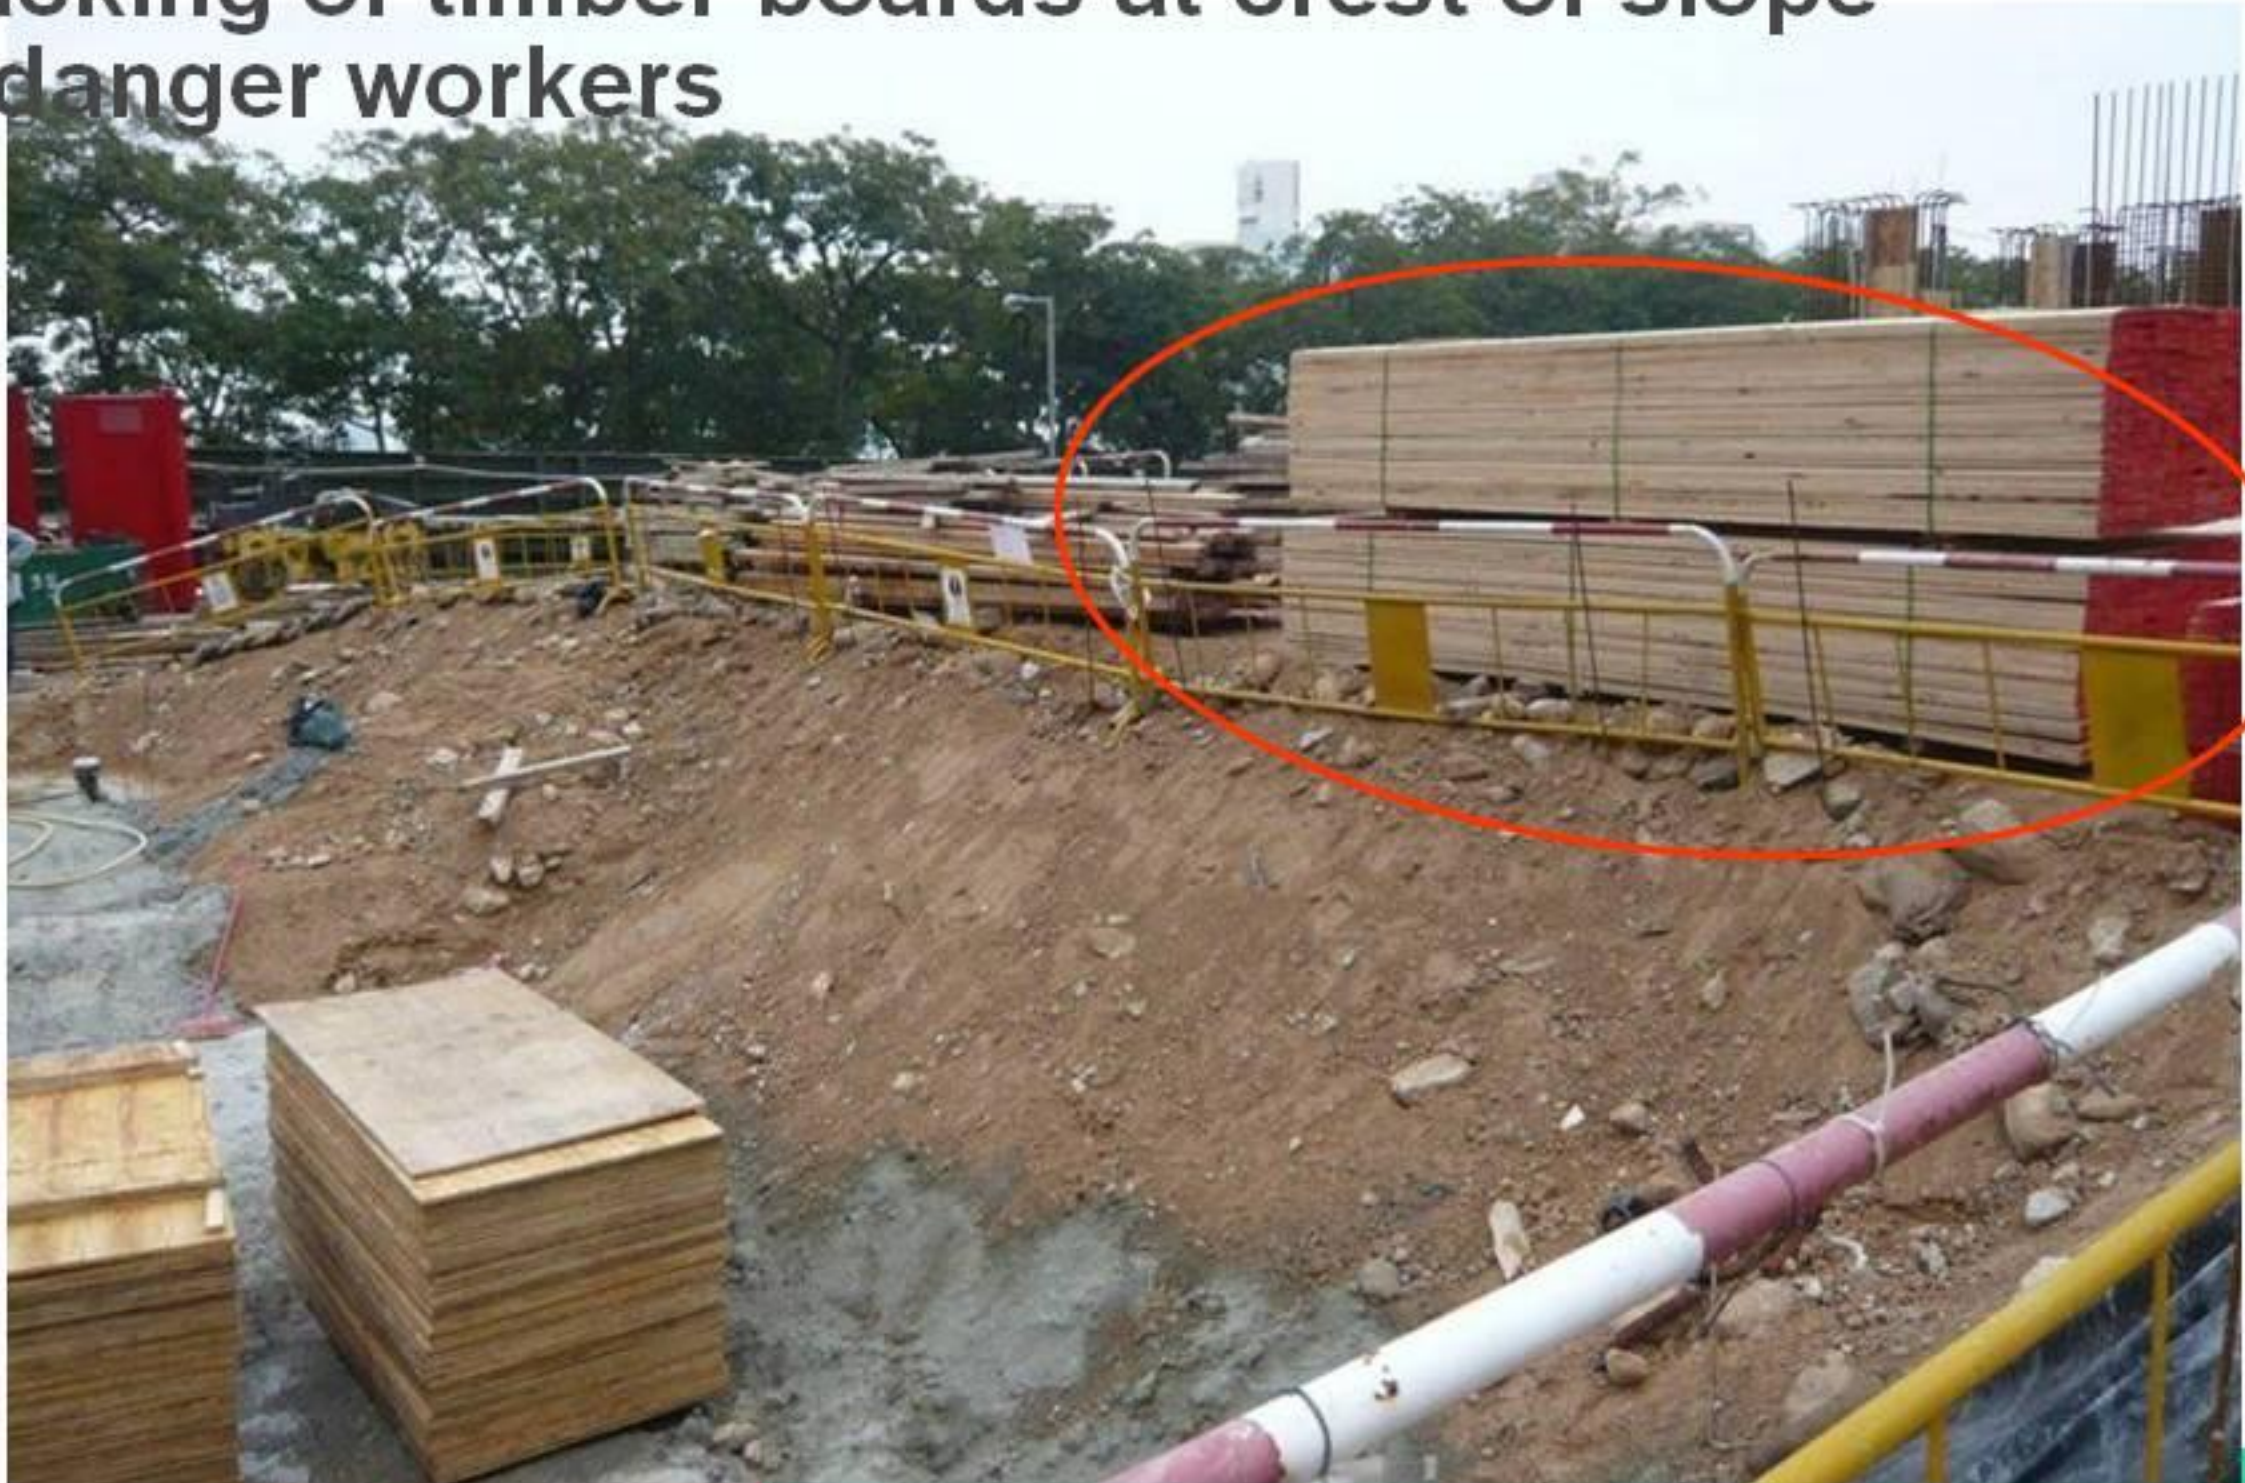
# Storage on Ground stacking of timber boards at crest of slope endanger workers
