# **SITE SAFETY Focus Seminar**

on New Works of  
Housing Department

**Site Safety** issues at -

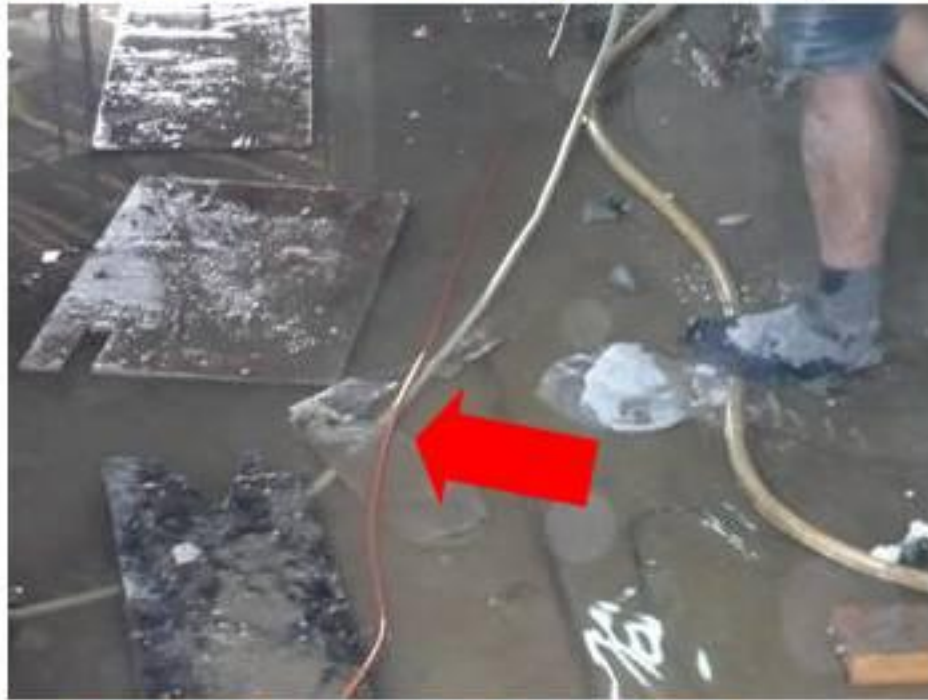
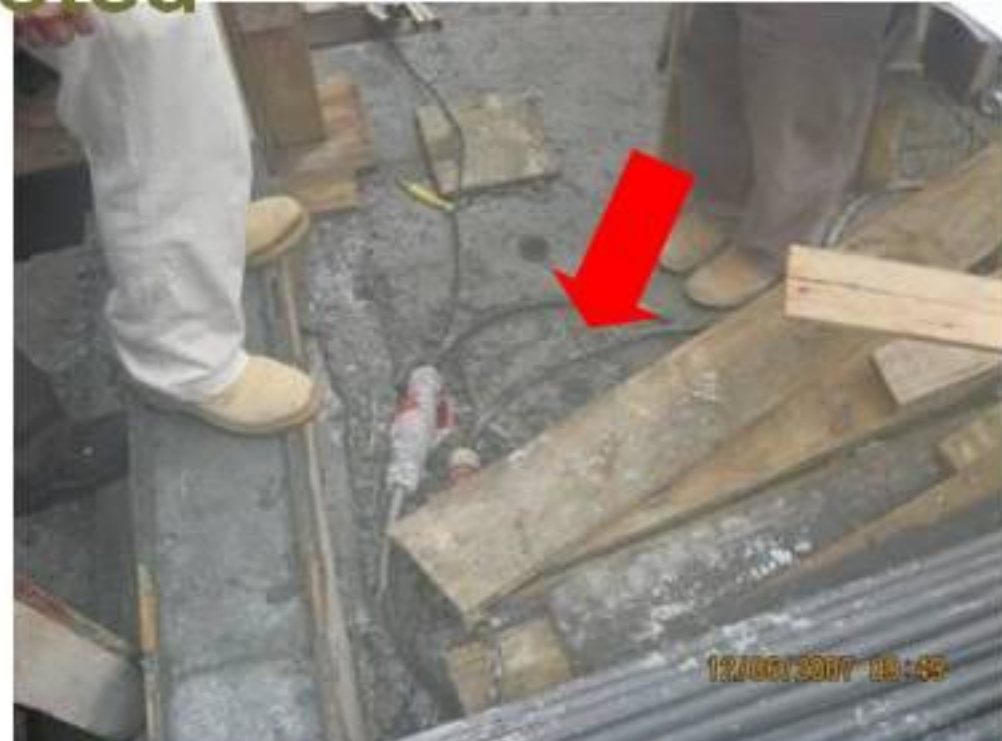
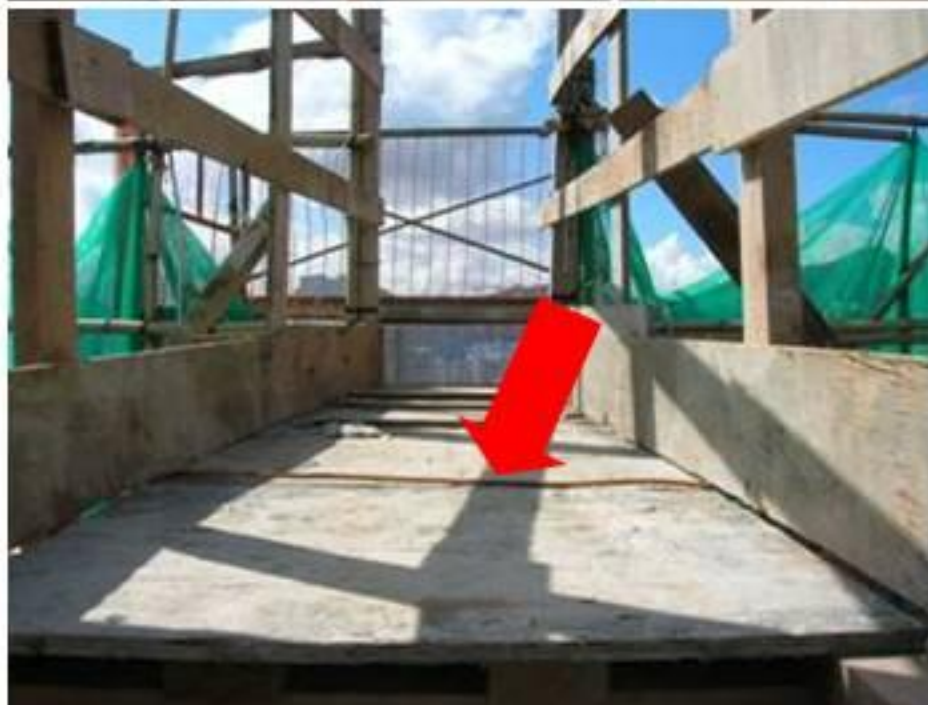
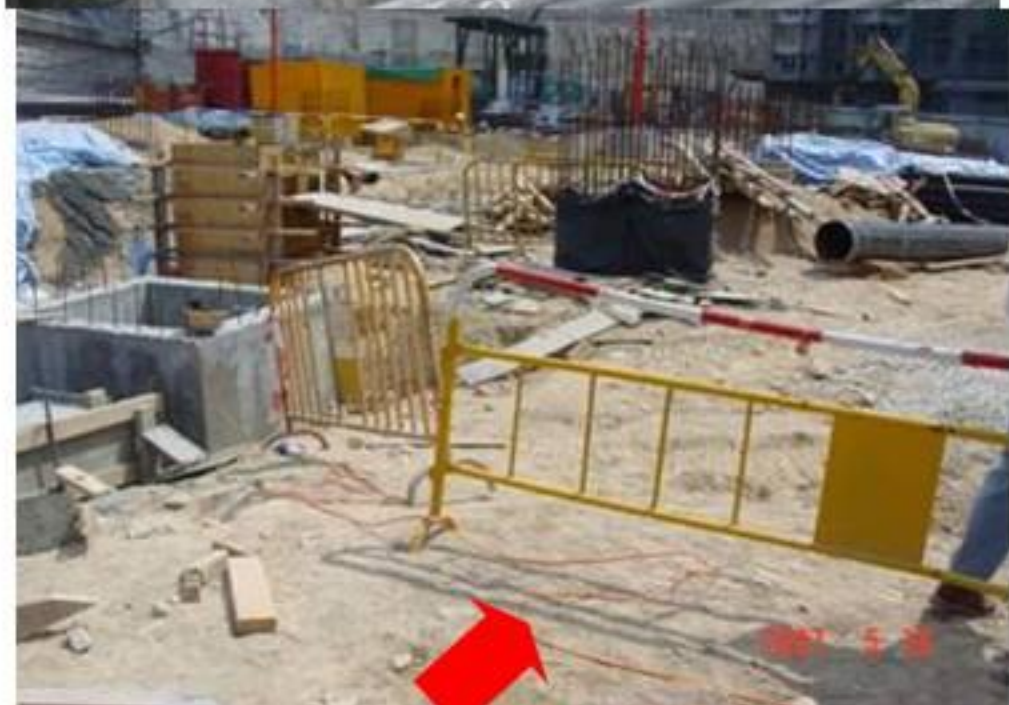
# Electric Cables Lying on Ground

**cases more frequently noted**

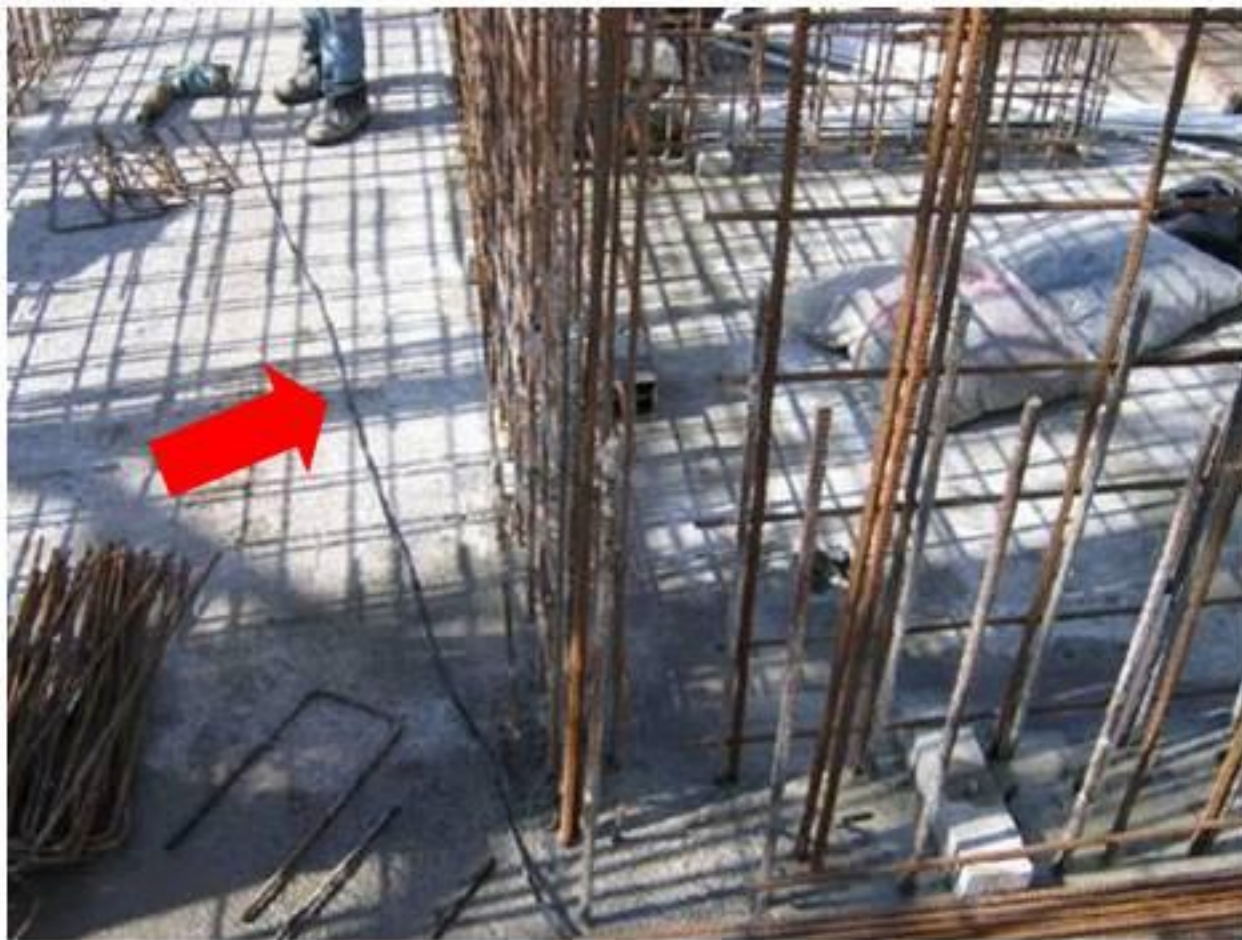
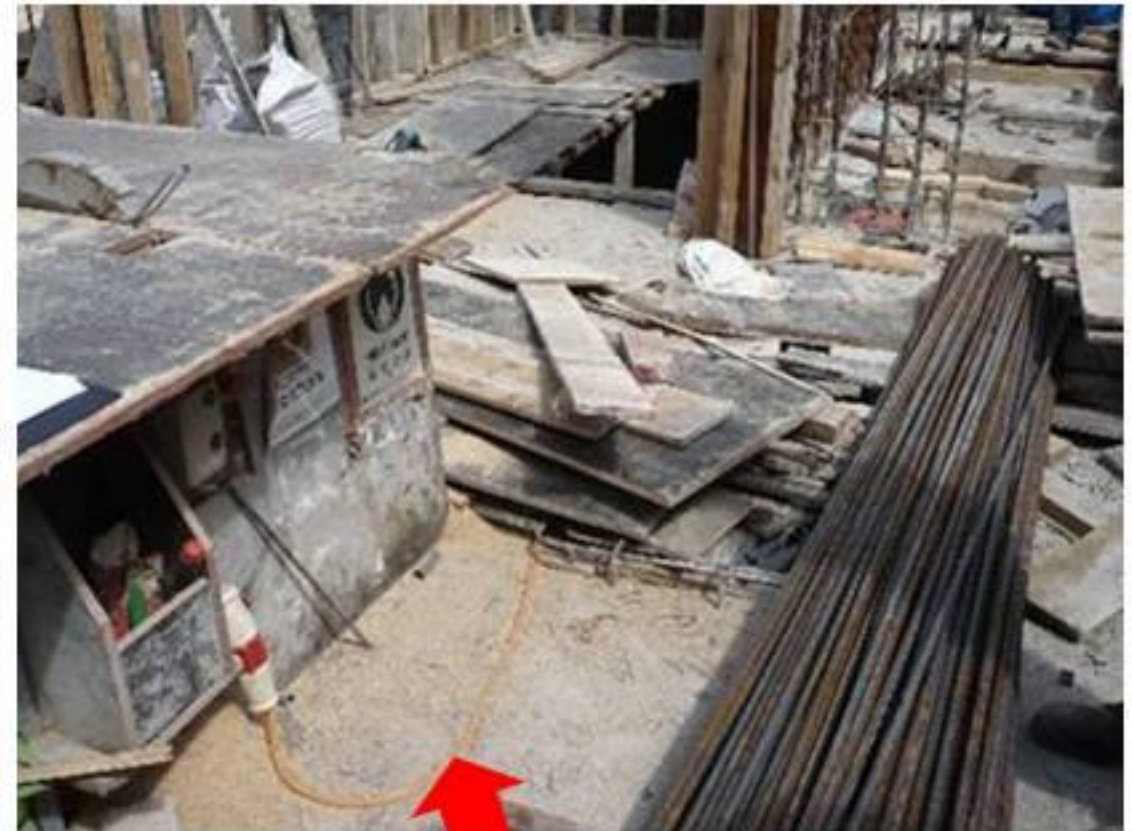
# Electric Cables Lying on Ground cases more frequently noted

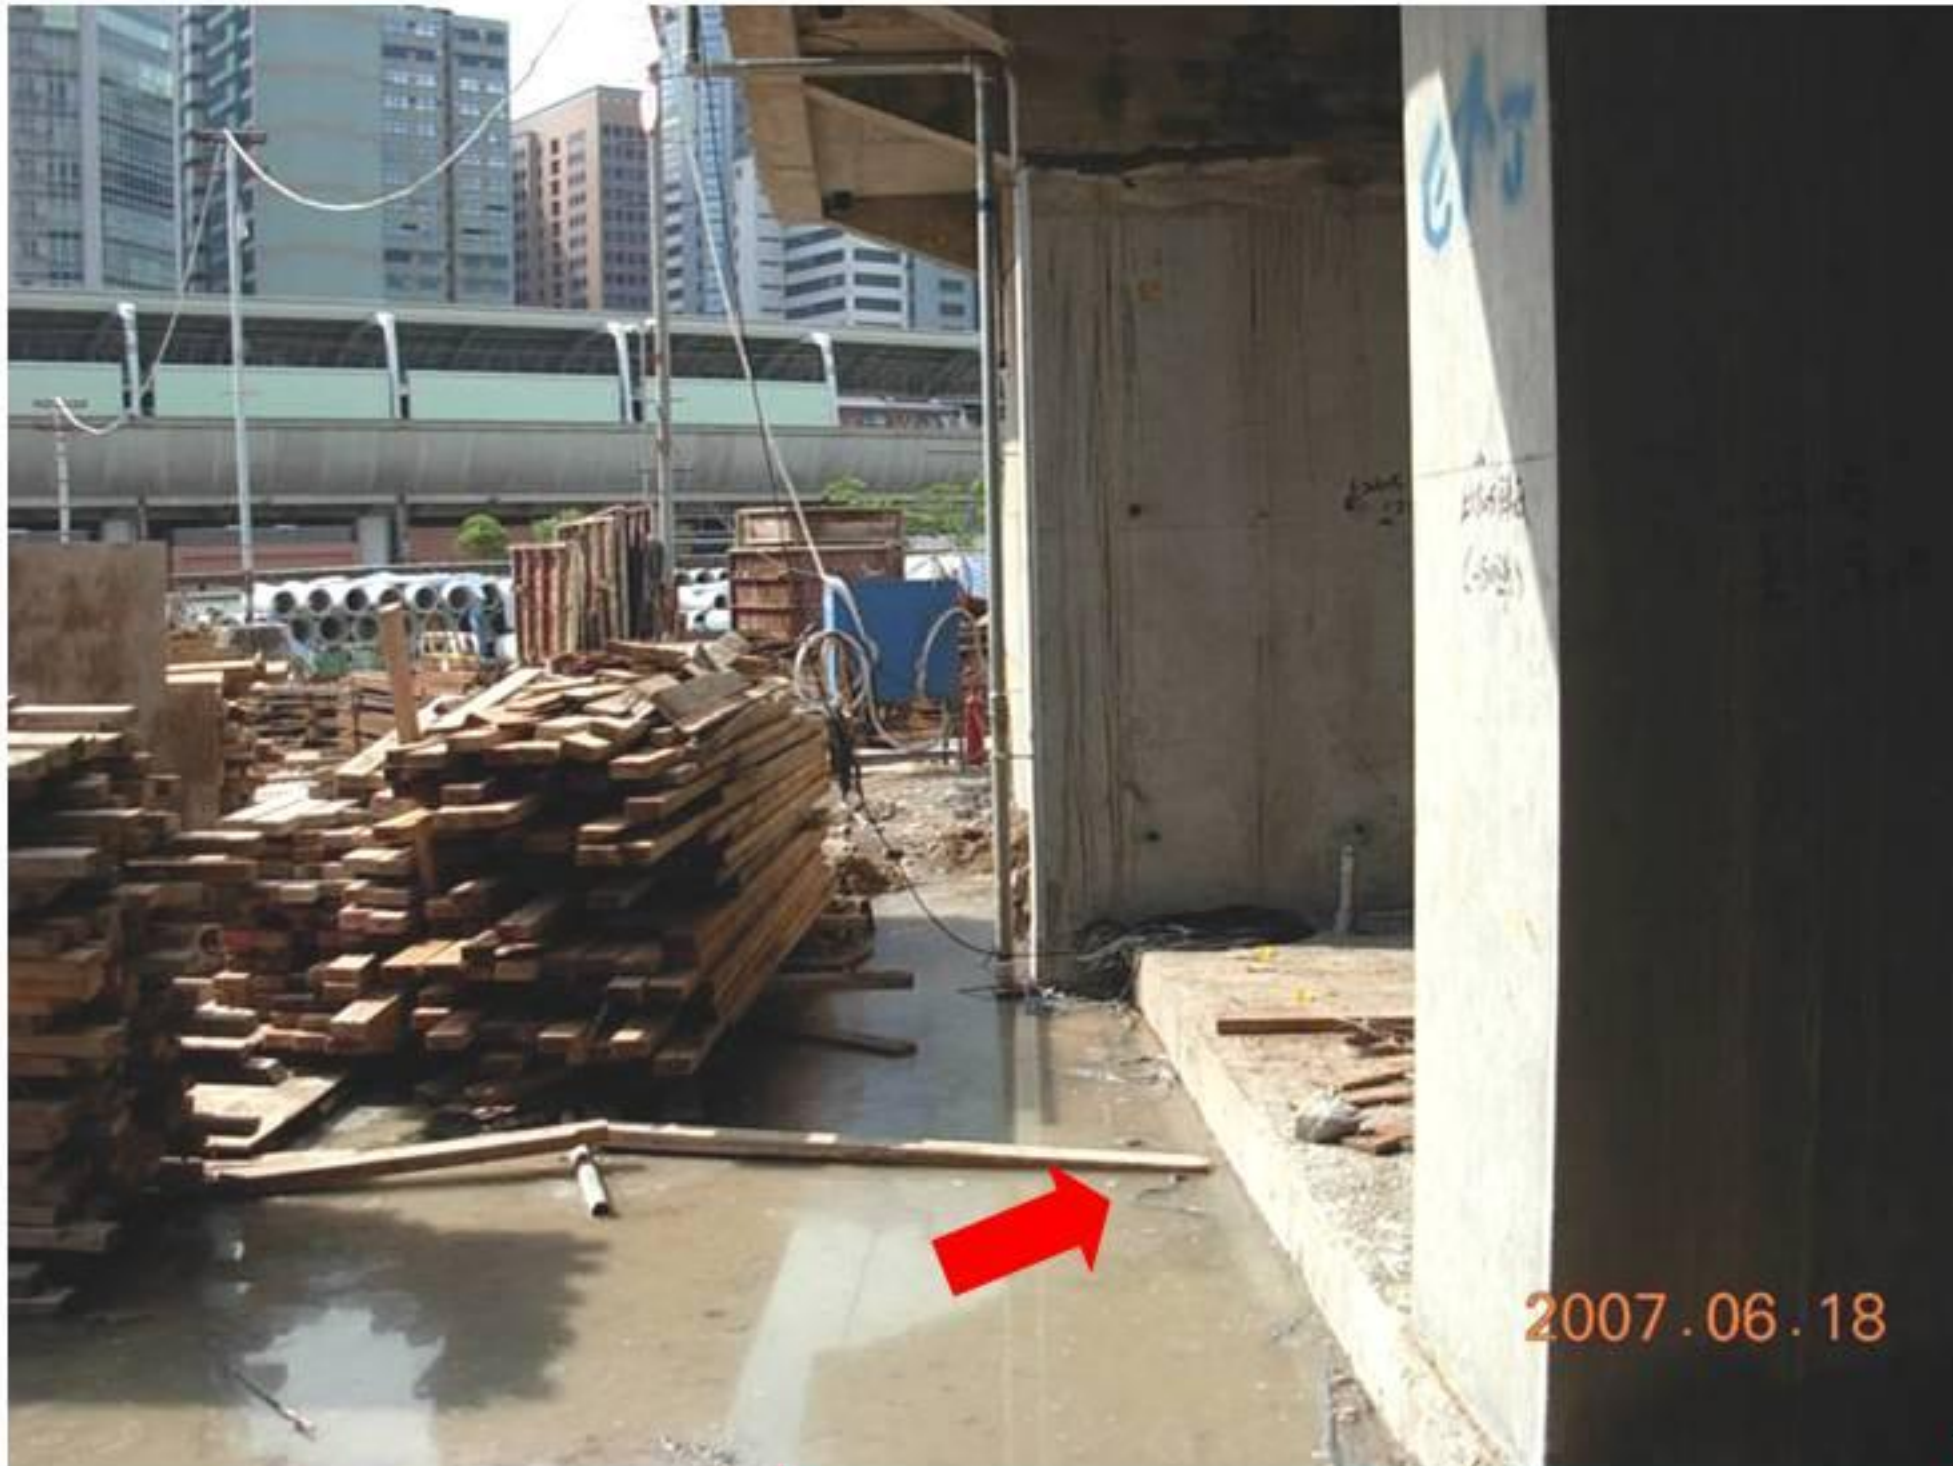
# Electric Cables Lying on Ground immersed in water

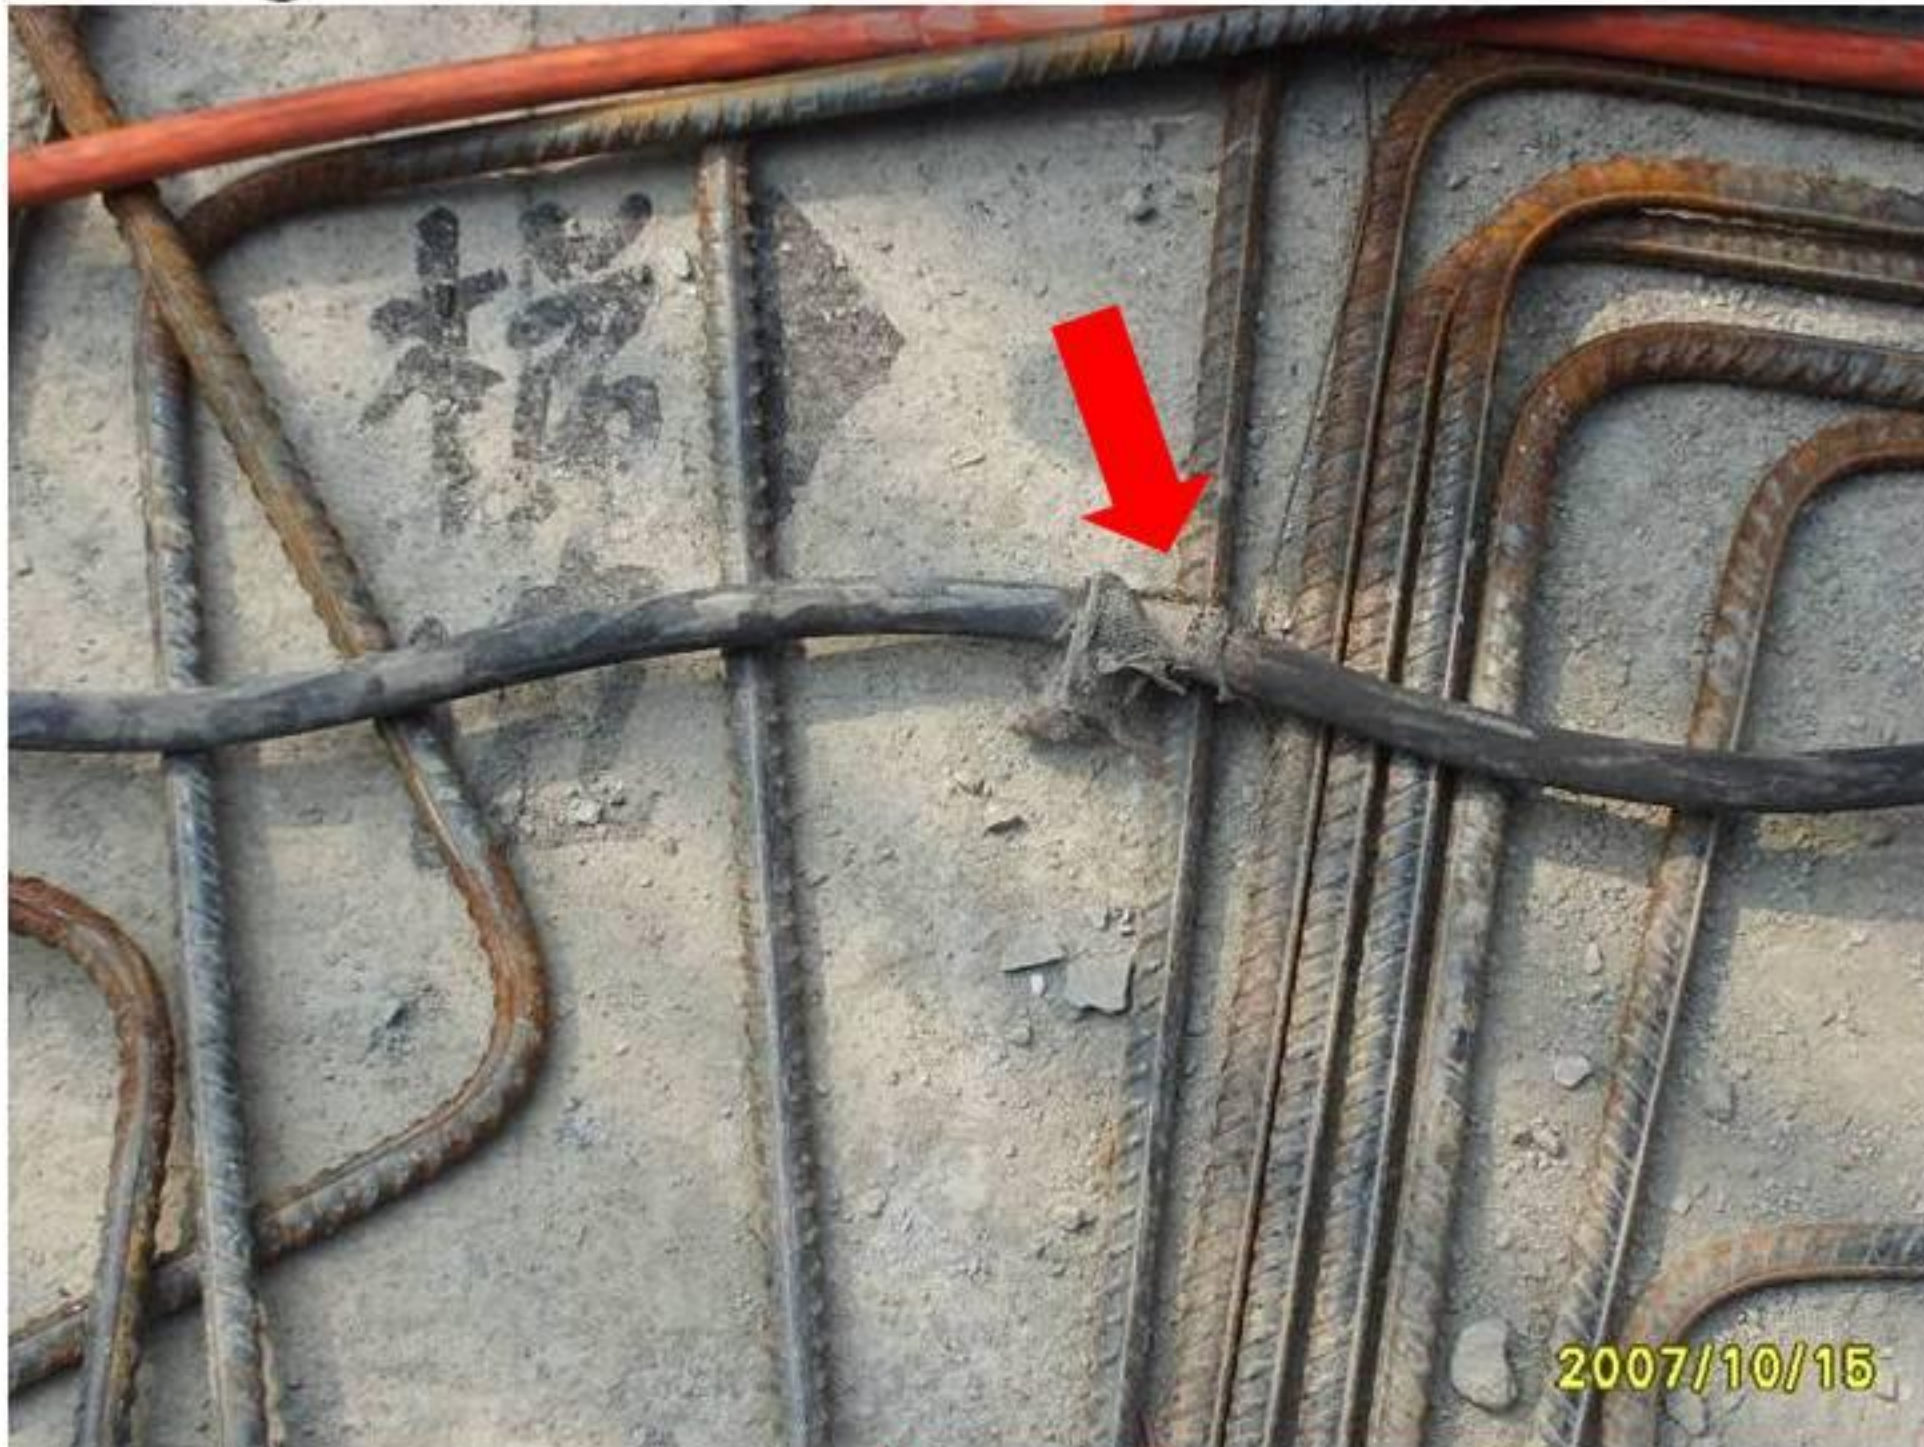
# Electric Cables Lying on Ground damaged

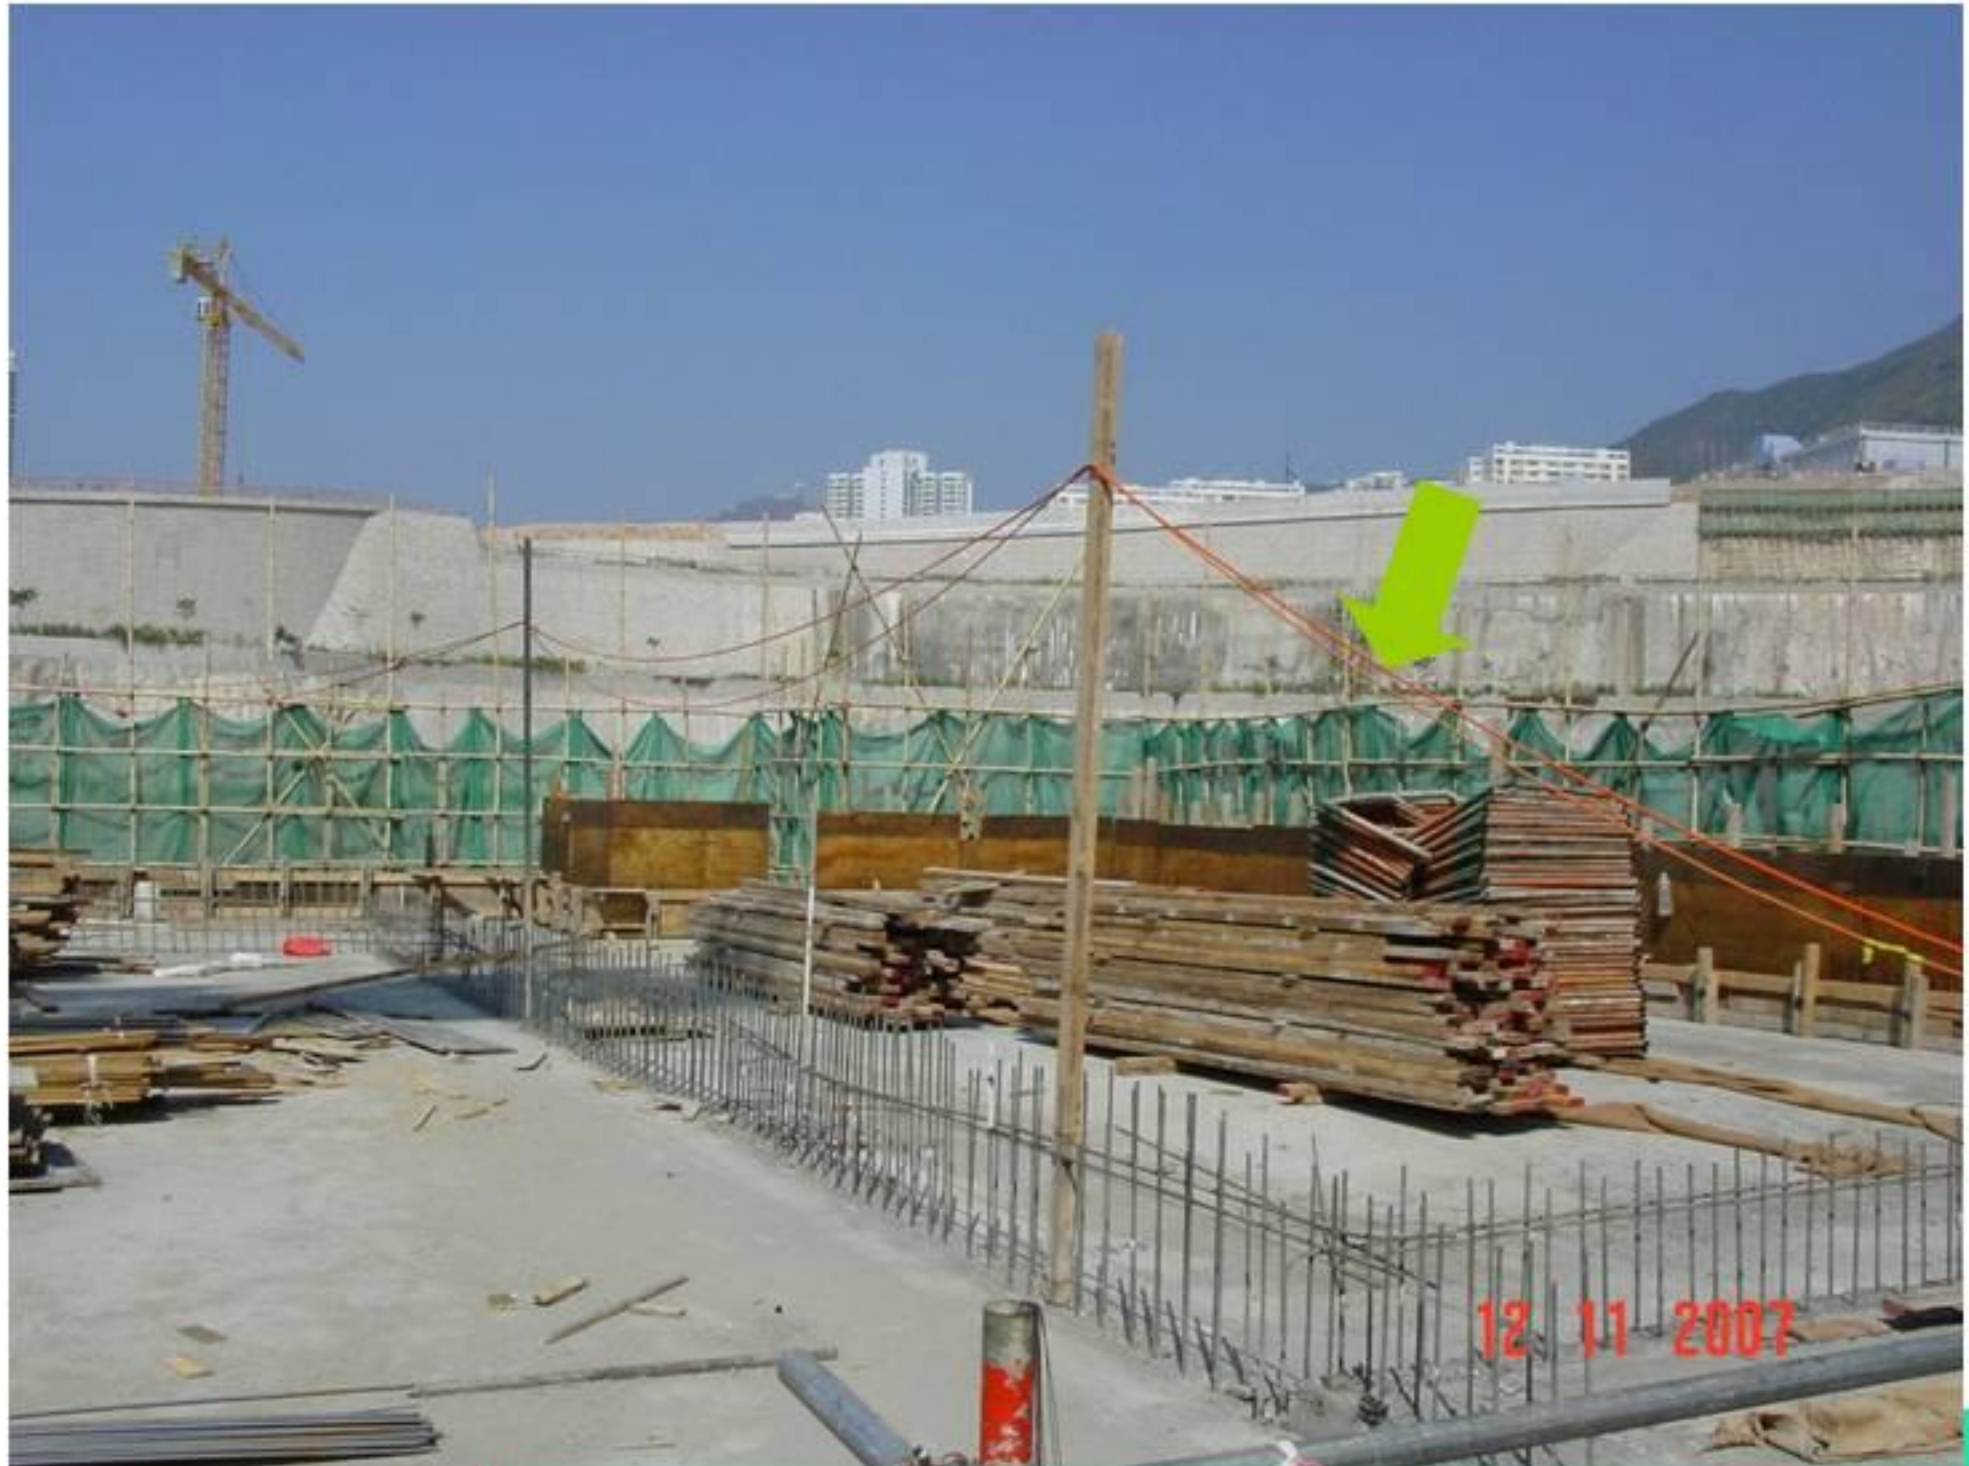
# Electric Cables Lying on Ground cases rectified

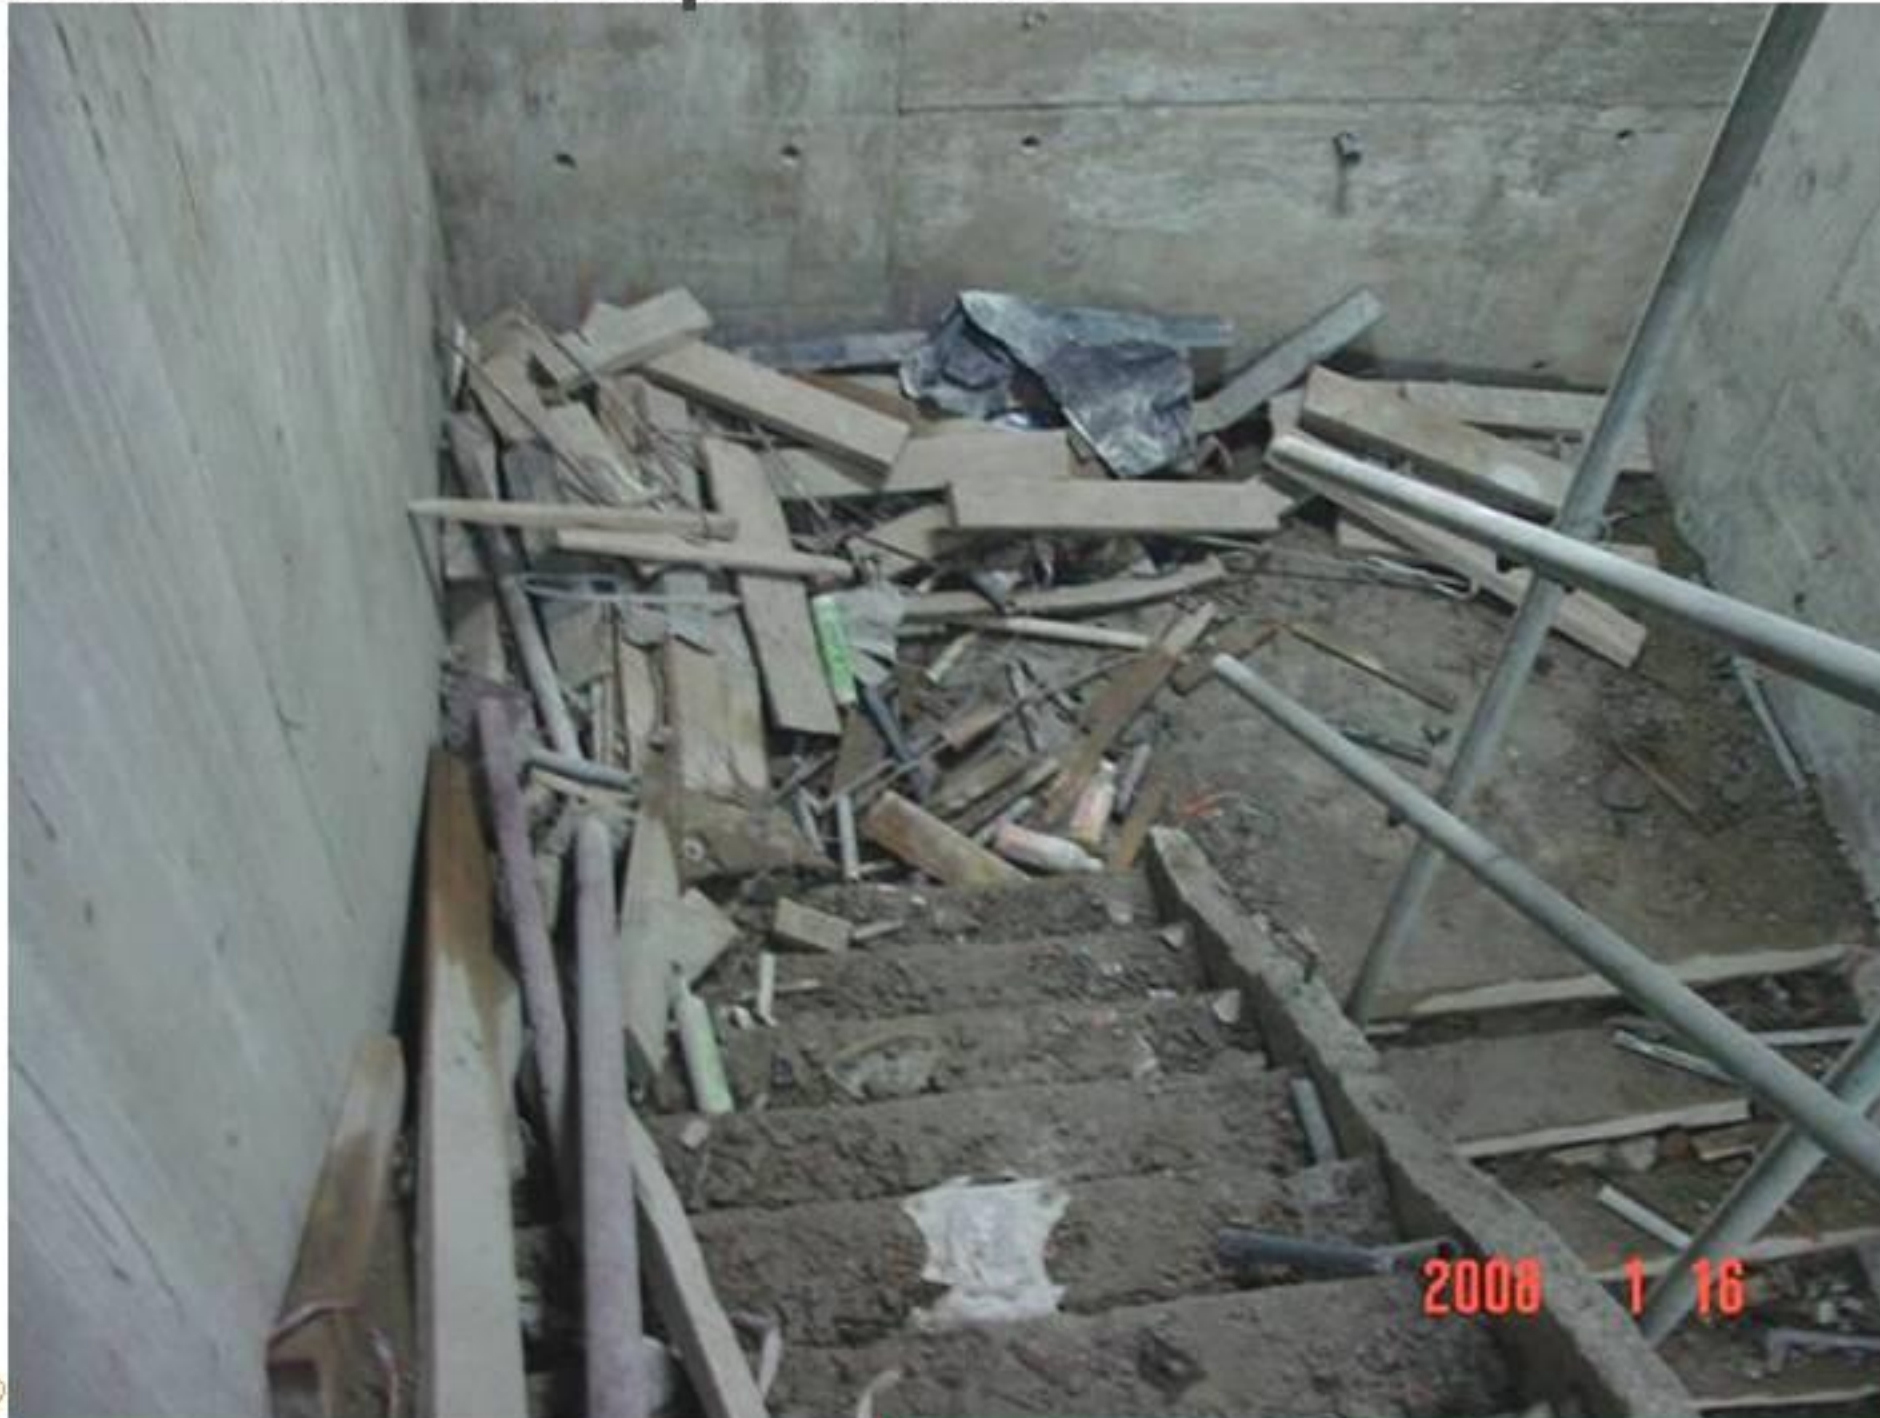
# Housekeeping on Site

## rubbish and timber planks stacked at staircase escape route

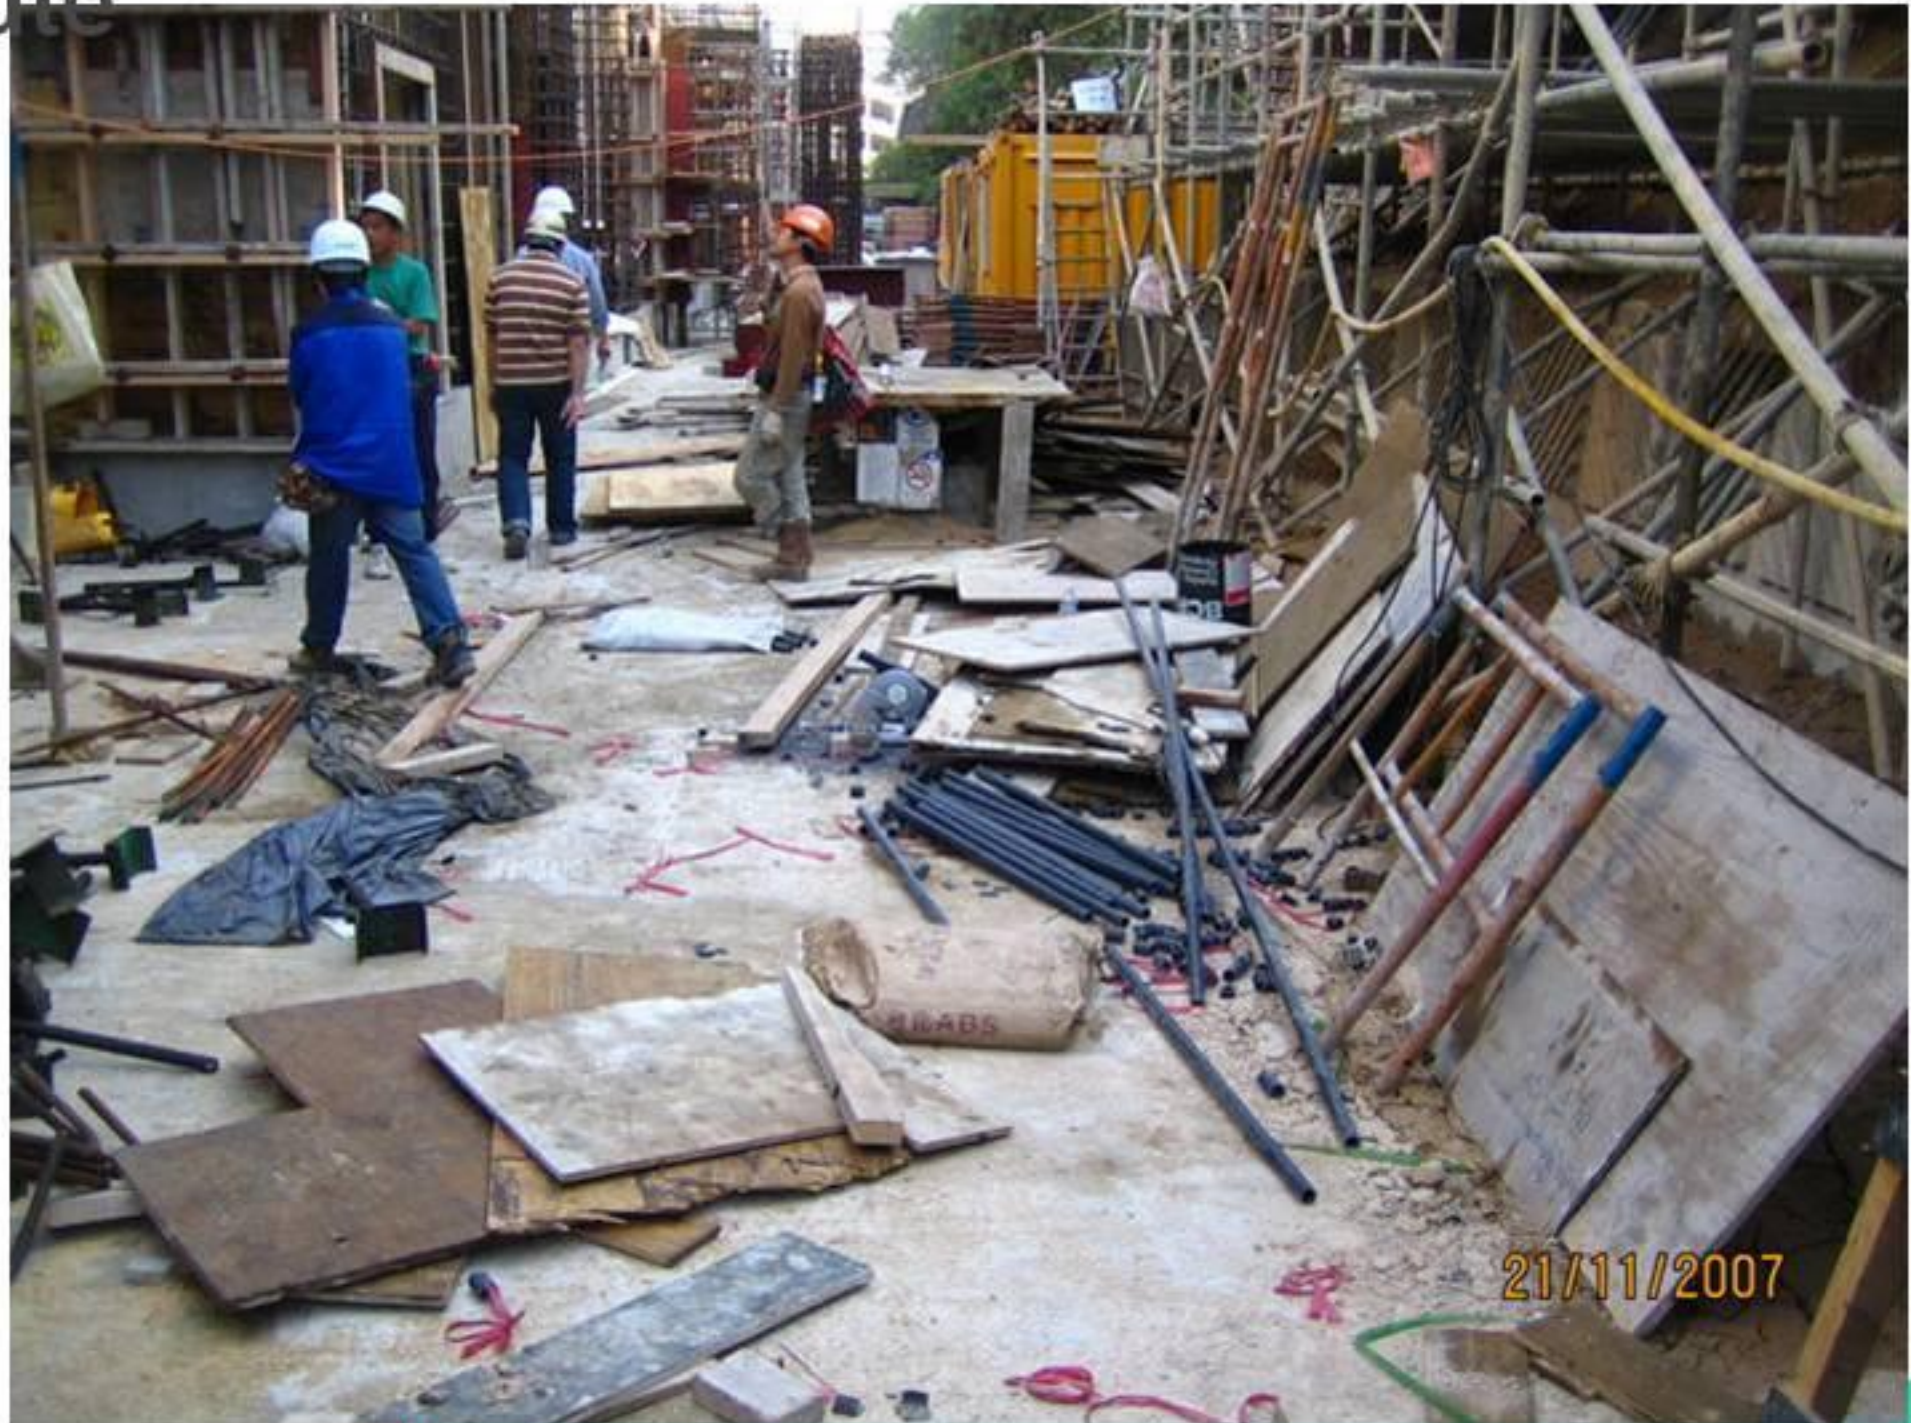
# Housekeeping on Site

## improper storage of construction material on access route

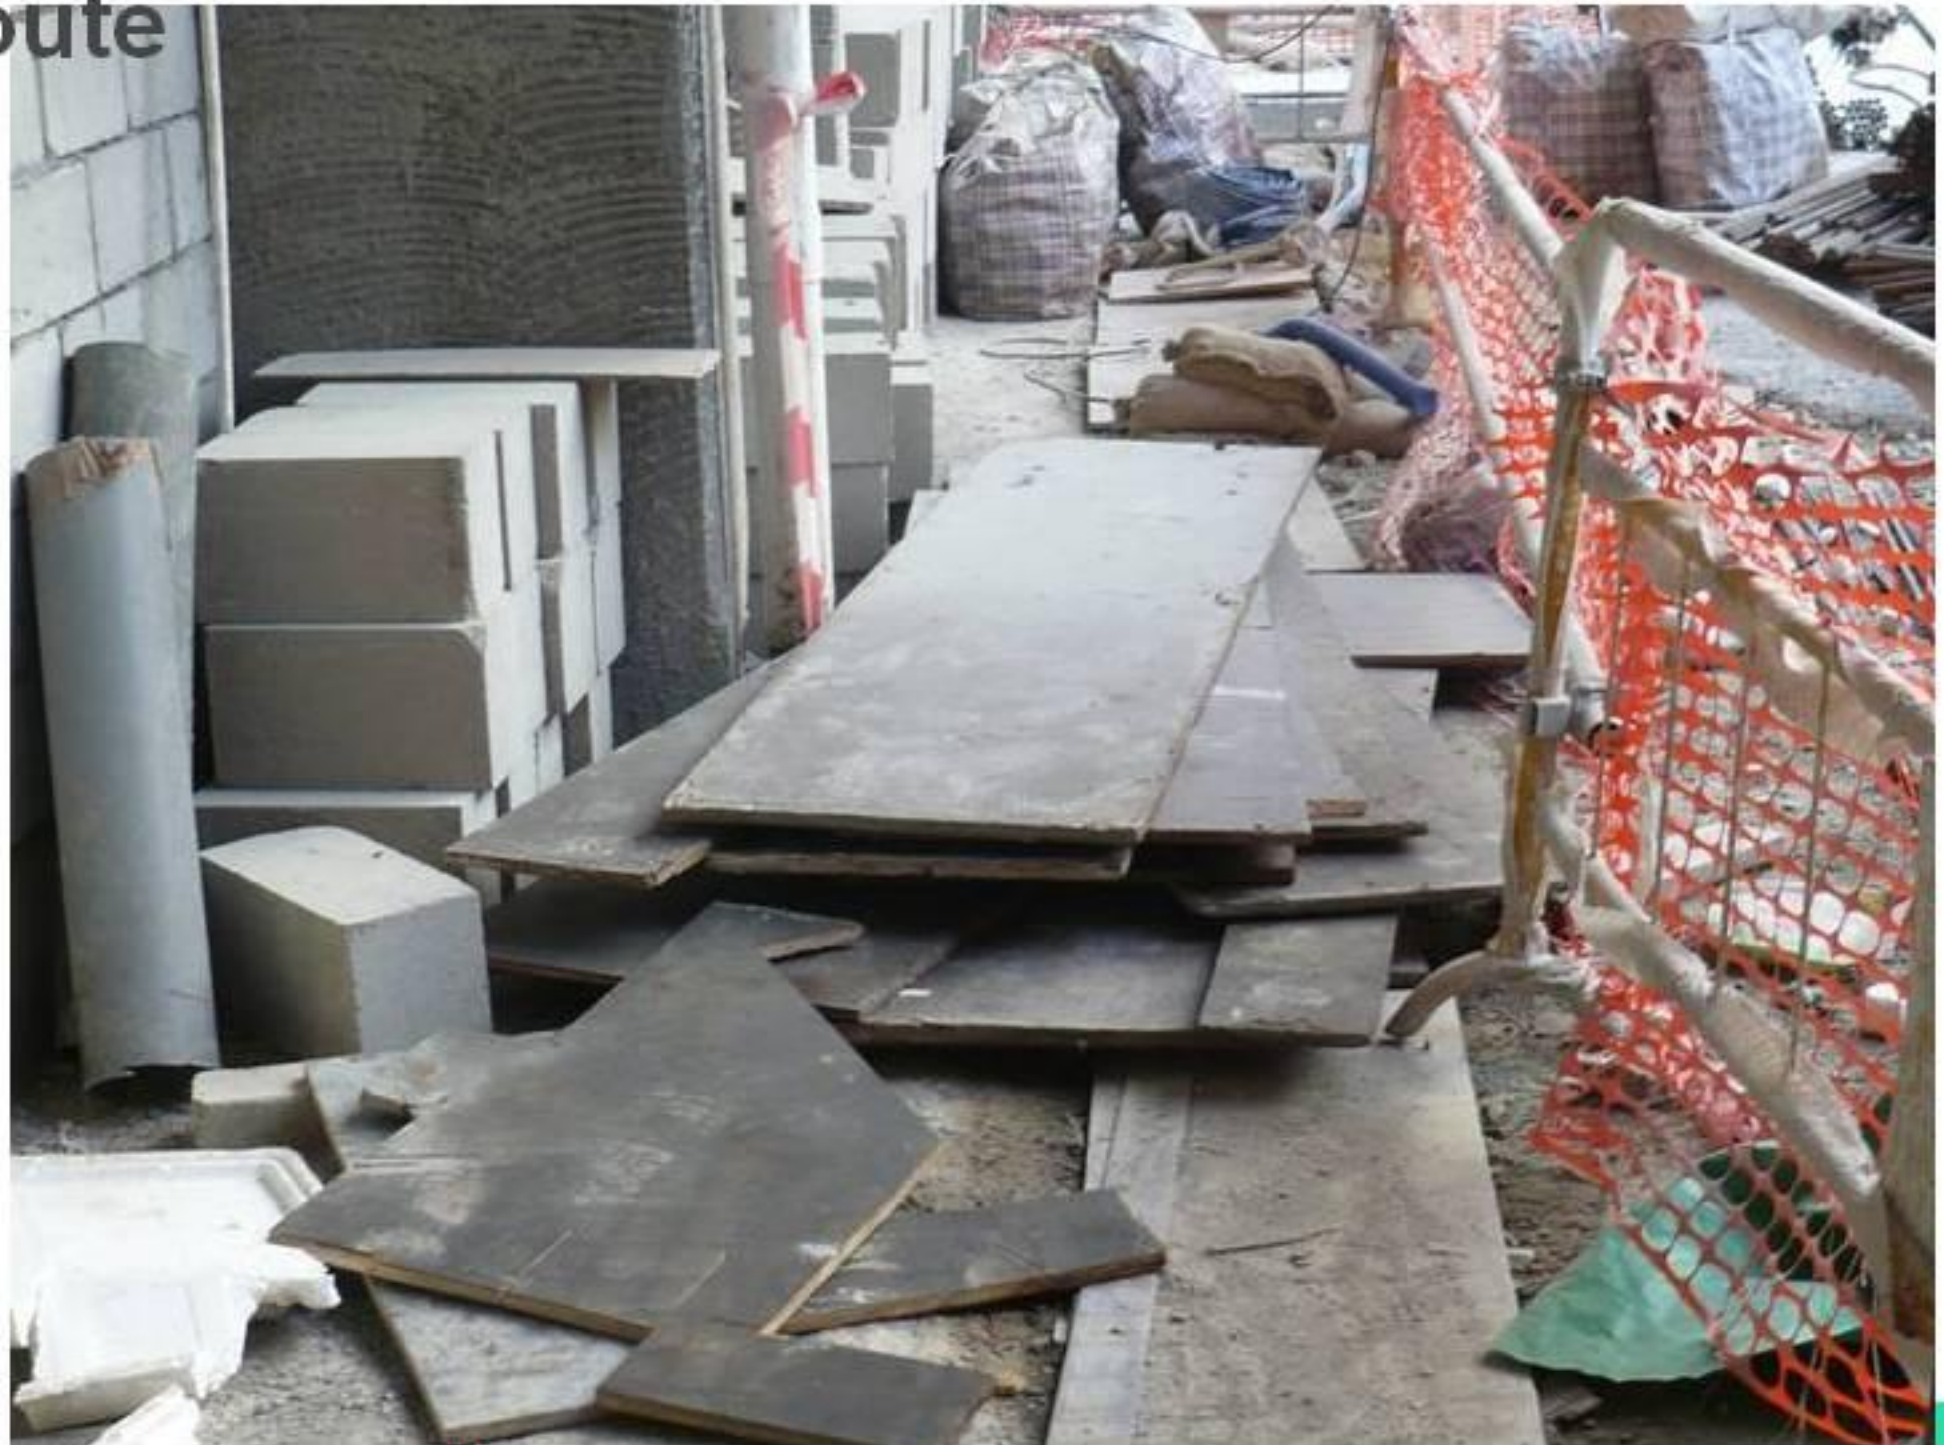
# Housekeeping on Site

## improper storage of construction material on access route
