# **SITE SAFETY Focus Seminar**

on New Works of  
Housing Department

**Site Safety** issues at -

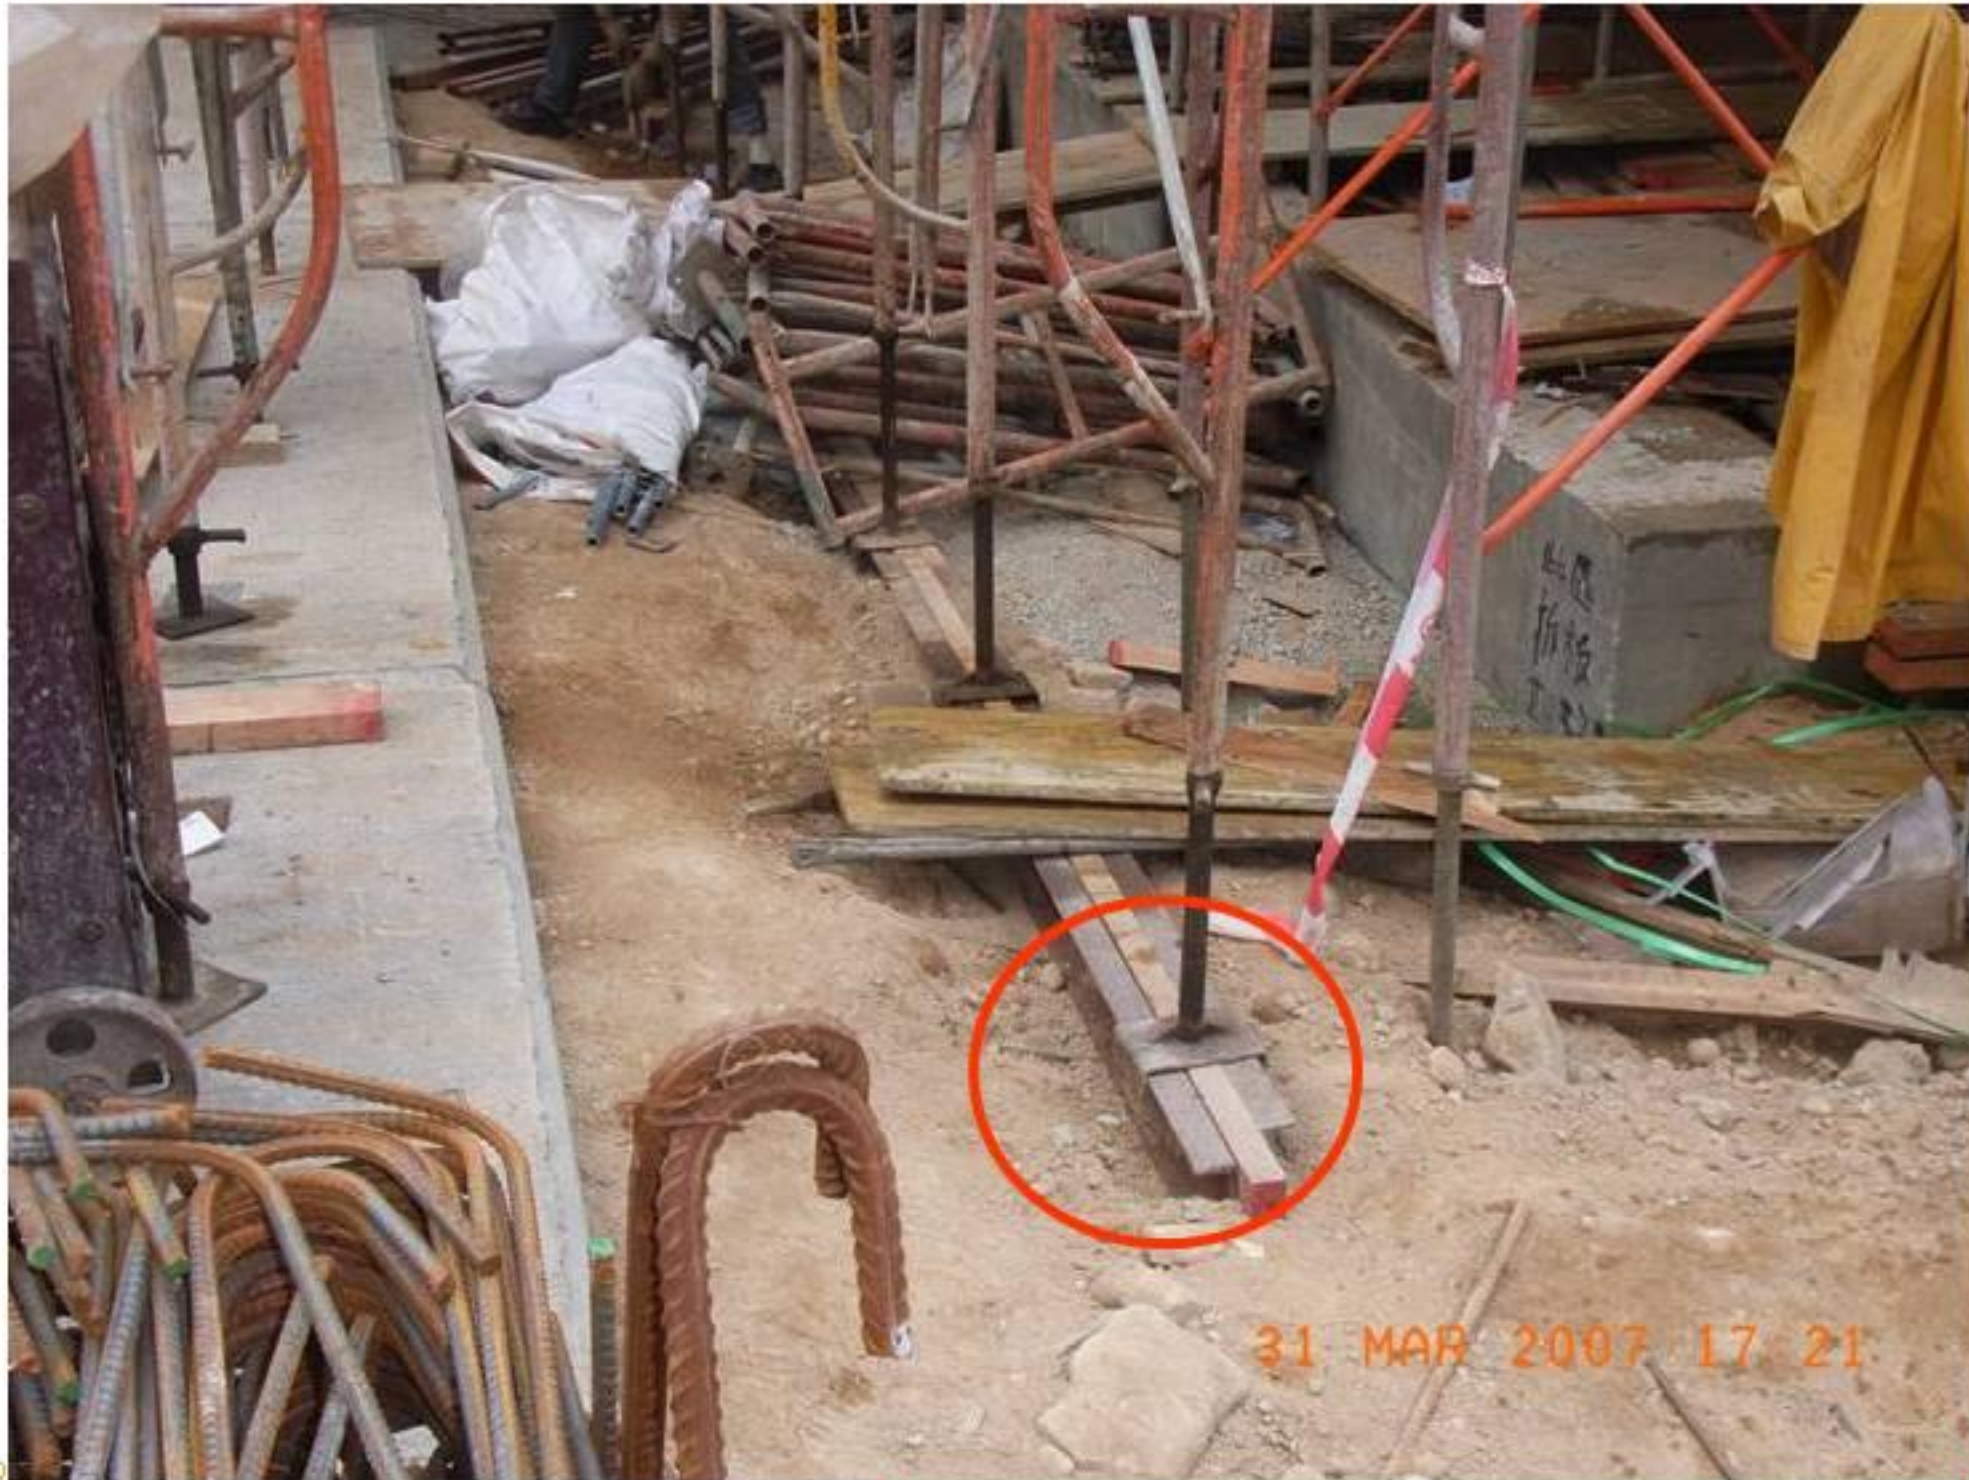
# Supports of Scaffolds for Formwork NOT sit on firm / solid ground

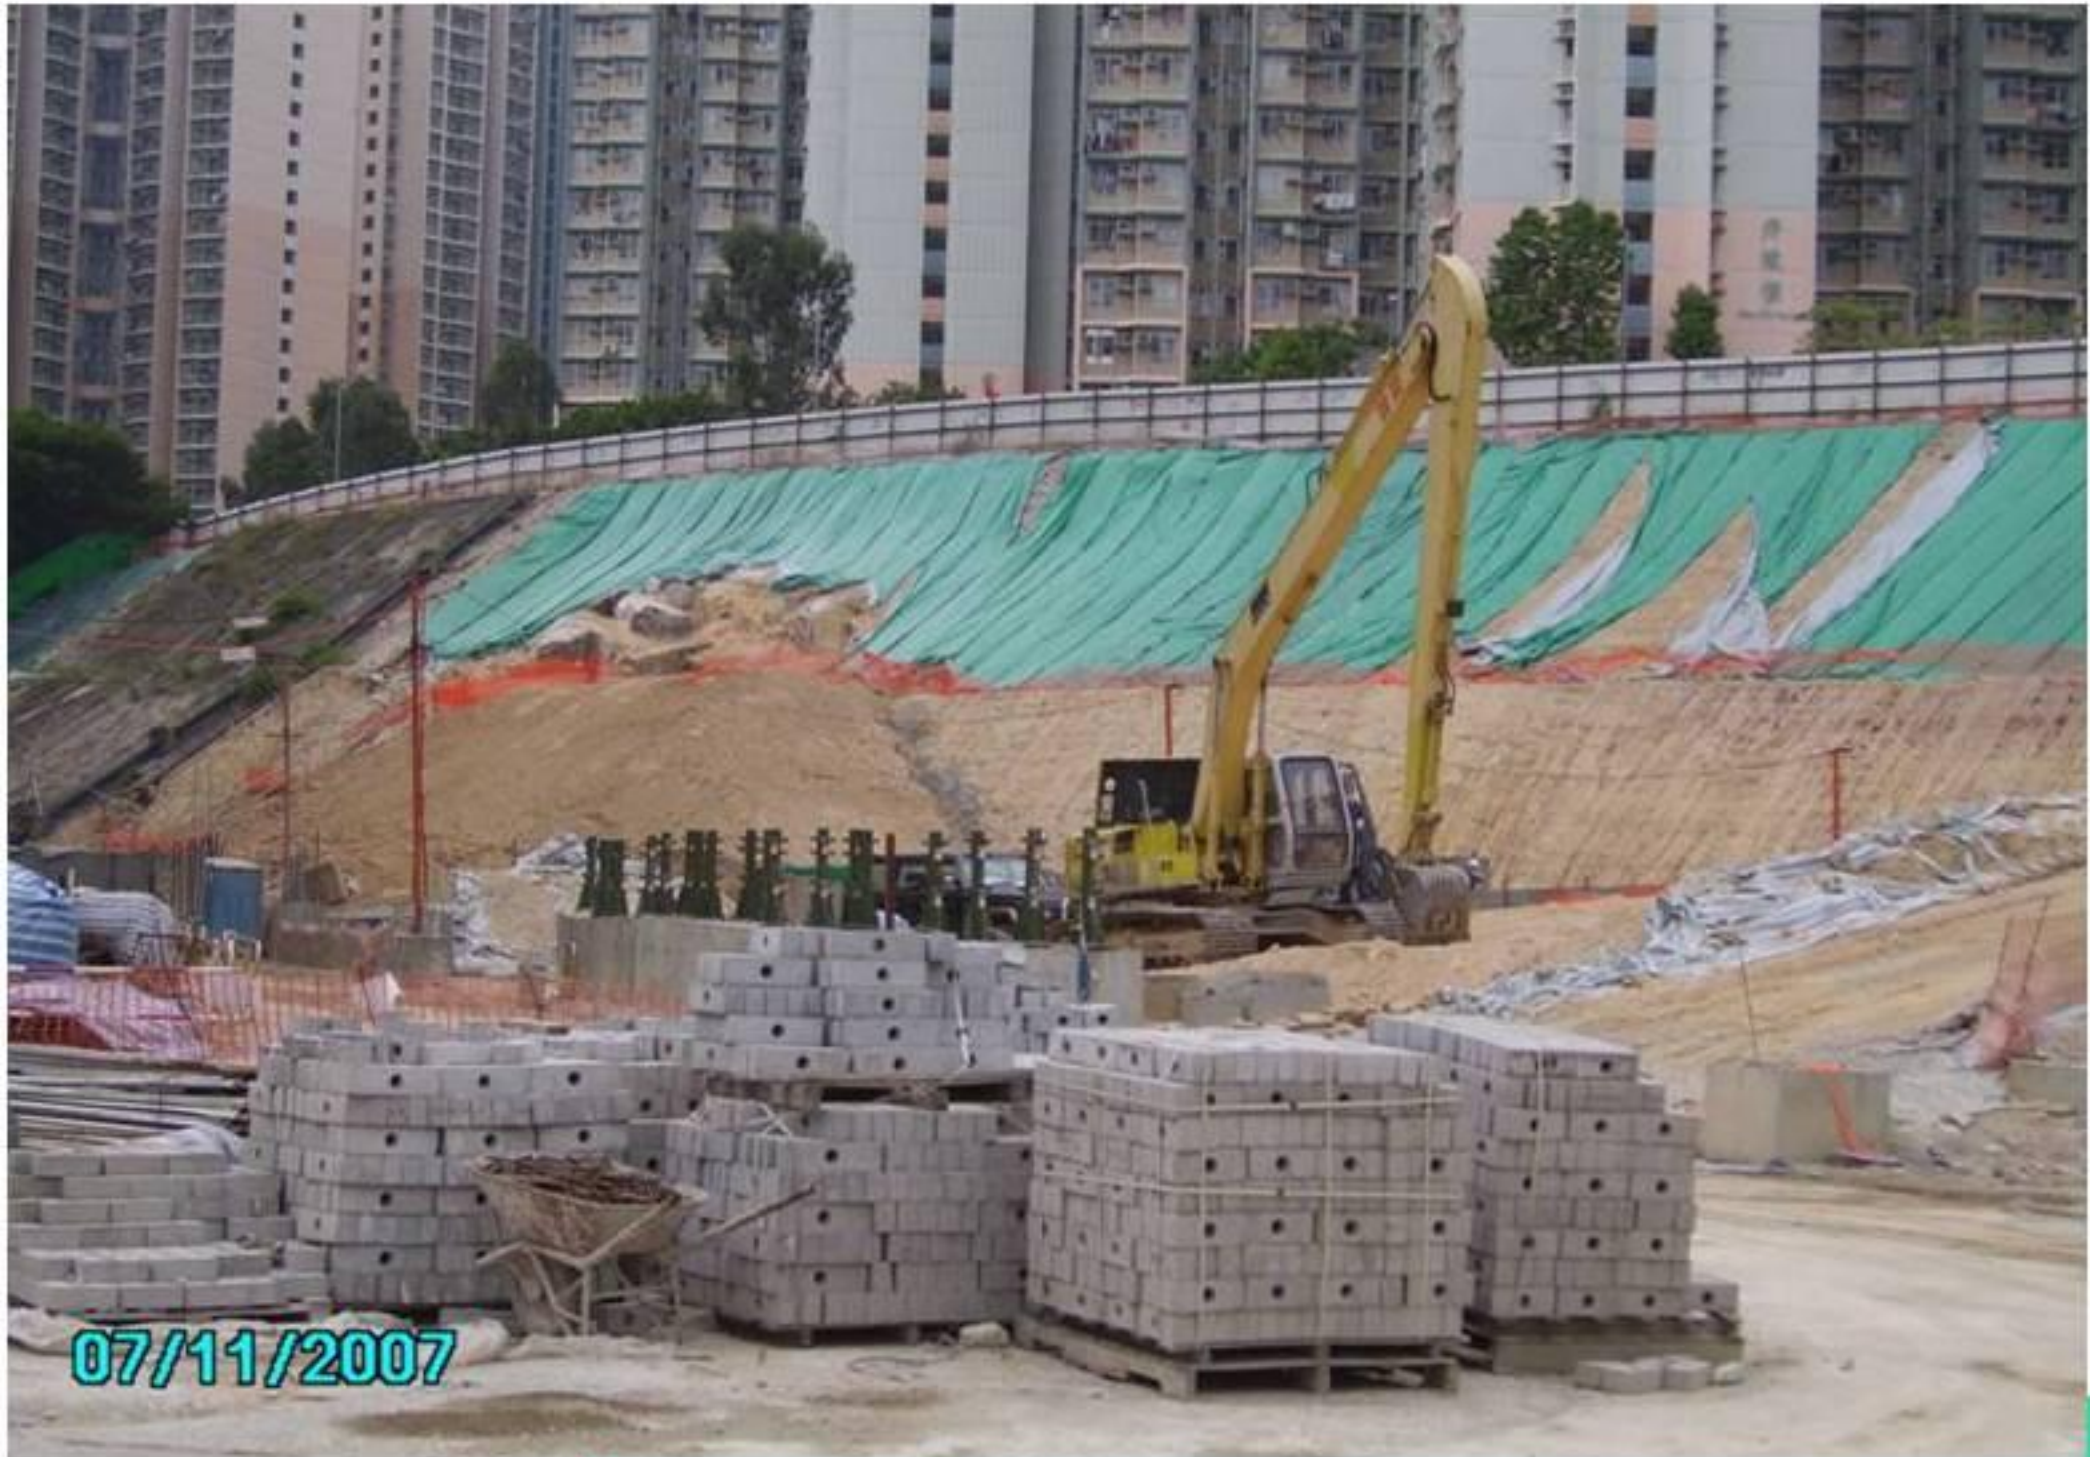
# Slope Surface improper protection

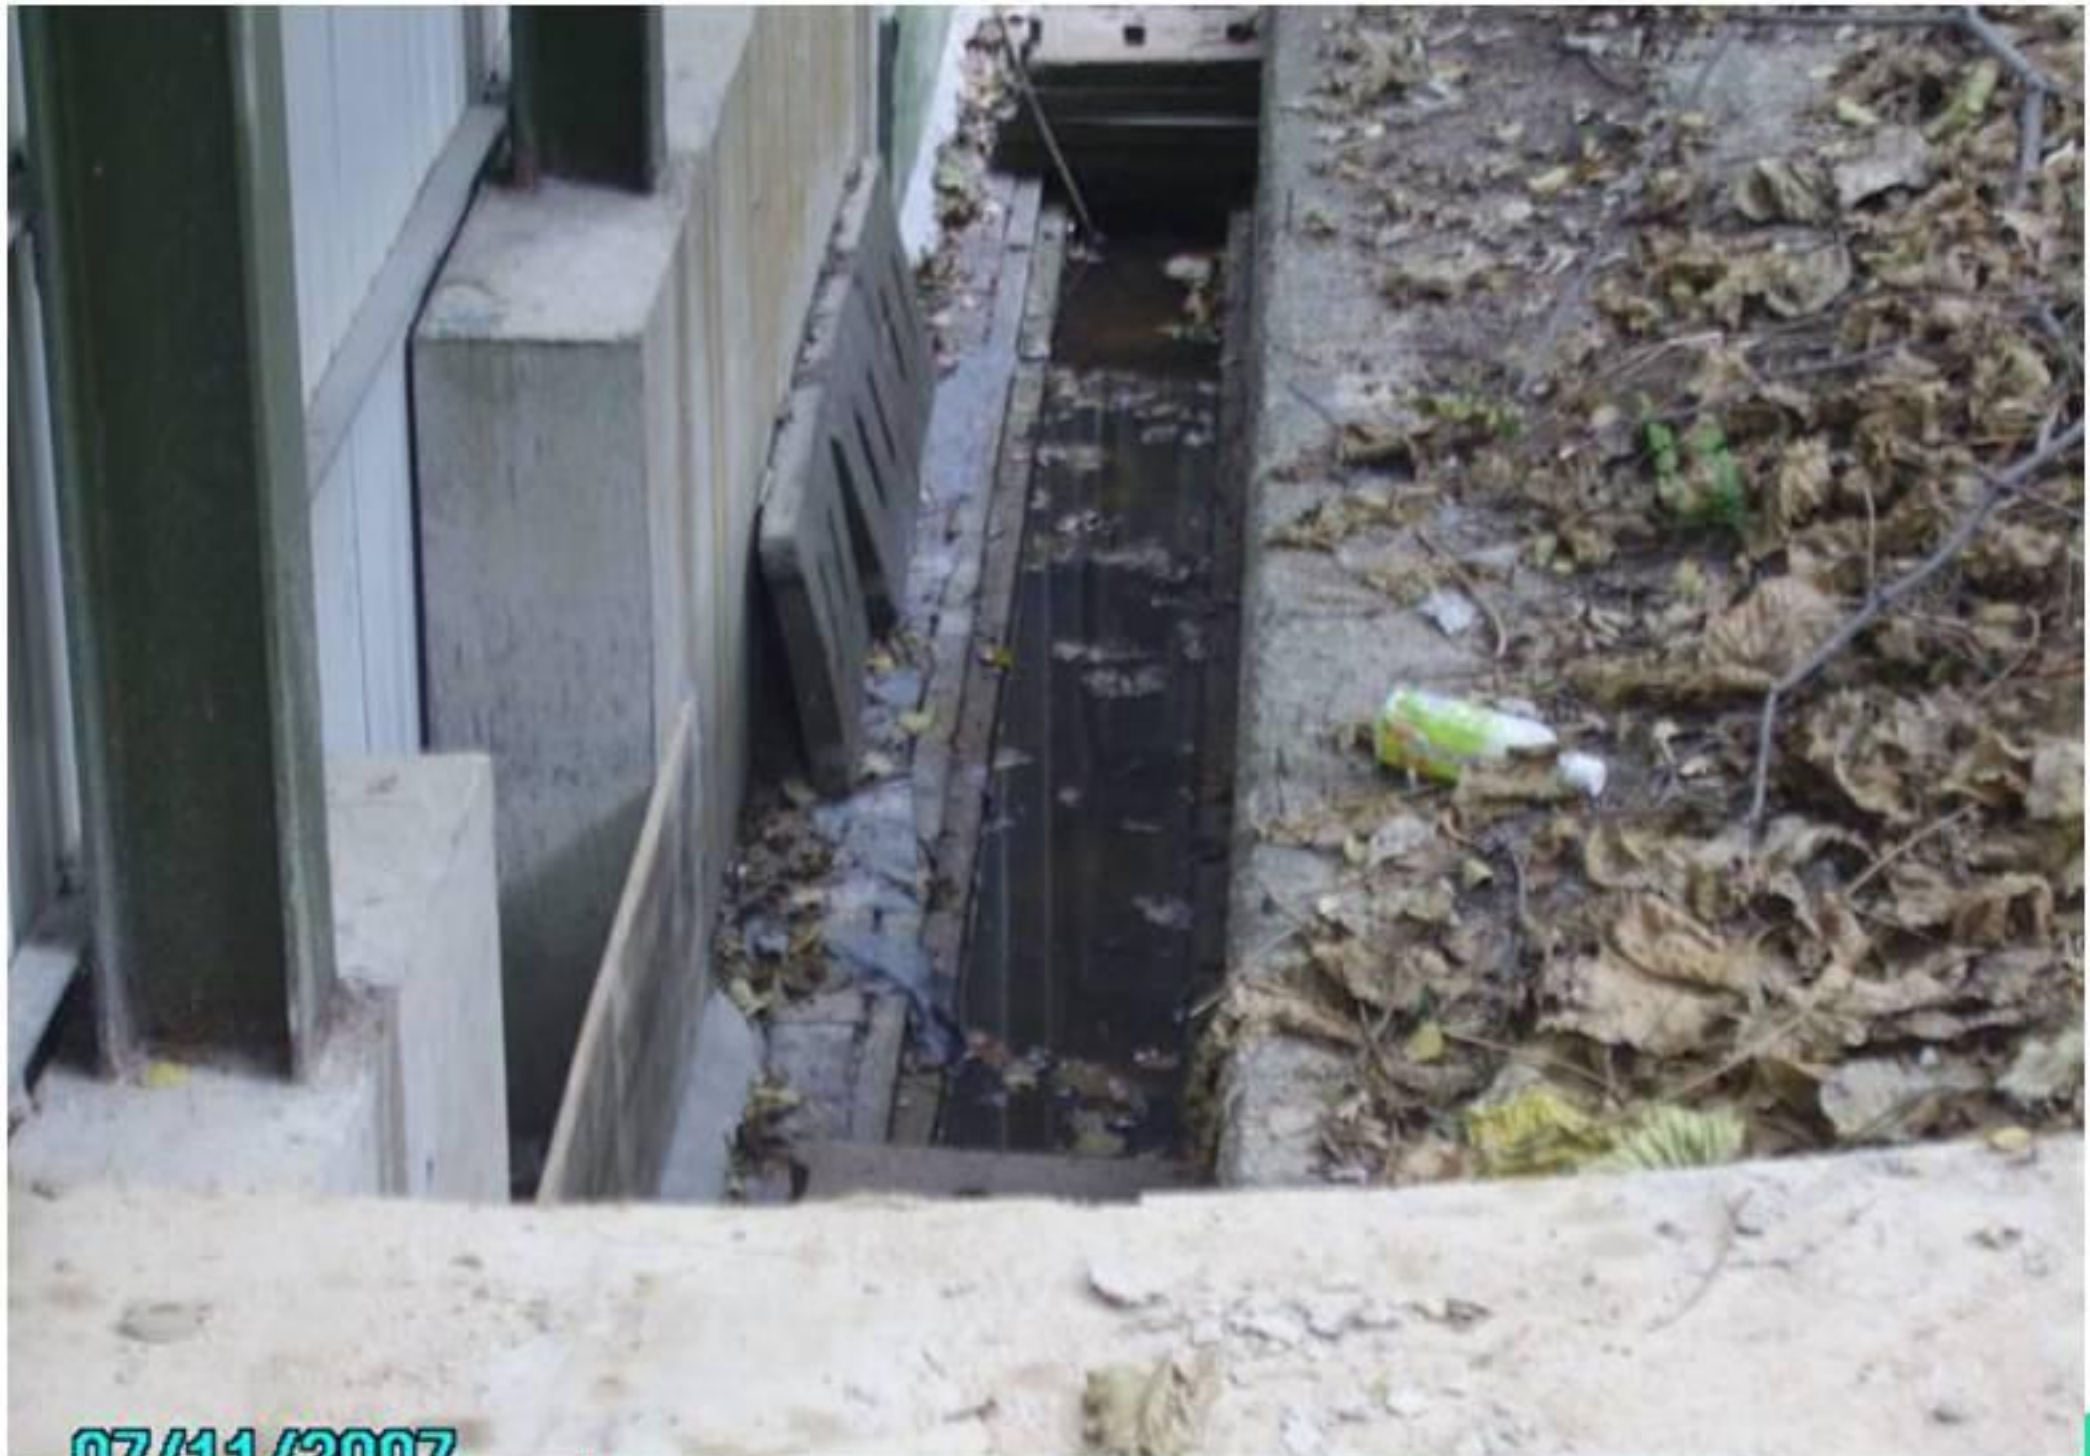
# Temporary Site Drainage System non-function on slope
