有利建築有限公司
Yau Lee Construction Co., Ltd.

從意外事故中學習

一條氣喉通在吊運途中下墮的險失事故

Investigation Report on Main Hoist Rope Failure of a Derrick Crane

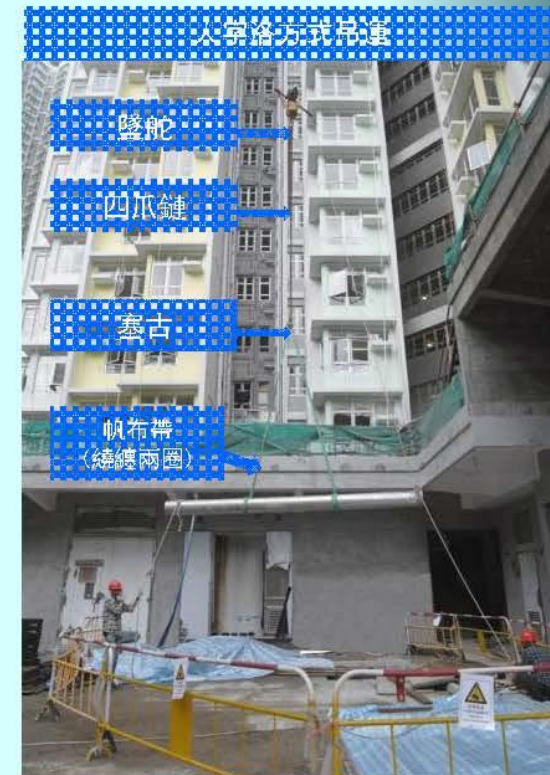
1. 事故當日上午，座管工安排使用躉船式吊杆裝置，將兩條金屬氣喉通吊往天面，當時天氣合適吊運工序的進行；
2. 管工及工作人員在圍封現場、例行檢查起重裝置及吊具後，進行吊運並順利將第一條氣喉通，吊上天面(35樓)；
3. 約在上午10:15分，工人繼續起吊第二條氣喉通上天面，惟氣喉通在吊近天面時，大科威也突然斷裂，喉通下墮至地面，事件中無人受傷；
4. 該喉通長約5.8 米，重約85公斤，而吊杆裝置的安全負重為4.5公噸；
5. 埋碼員在四爪鐵鍊底下加上兩條帆布帶繞纏喉通兩圈收緊，以防止鐵鍊碰及鐵料滑動(如右方模擬圖所示),並以人字洛方式起吊。

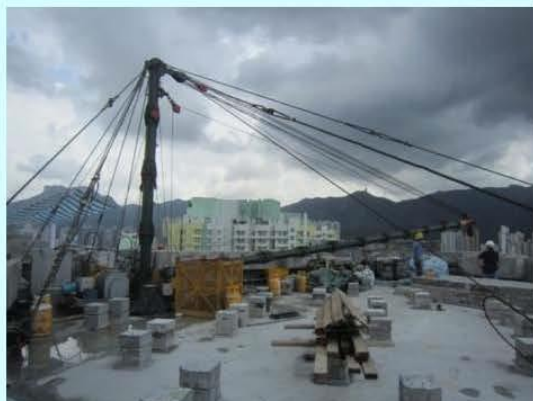
事故現場~第二座天面躉船式吊杆

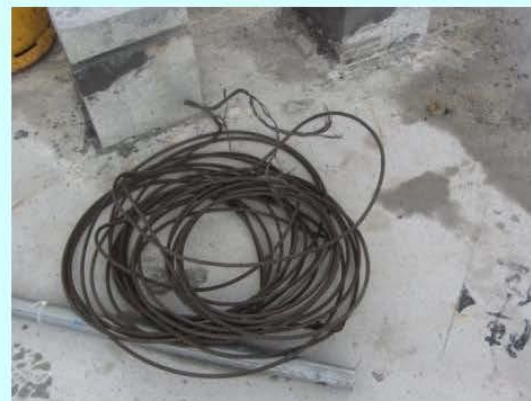
斷裂的躉船大科威也

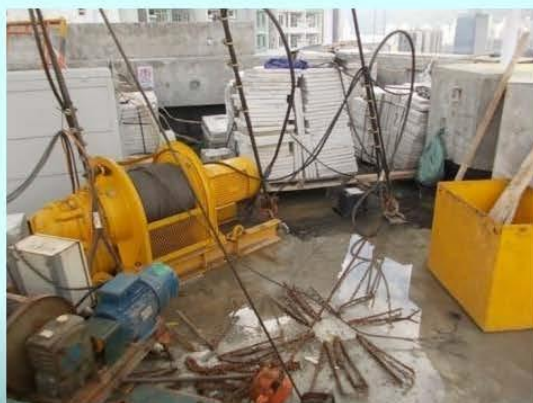
躉船大科威也捲筒

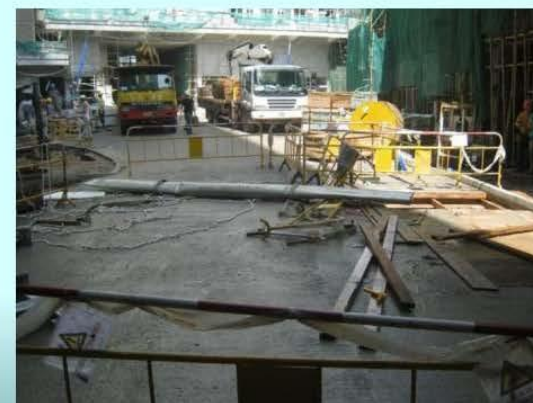
下墮的氣喉通

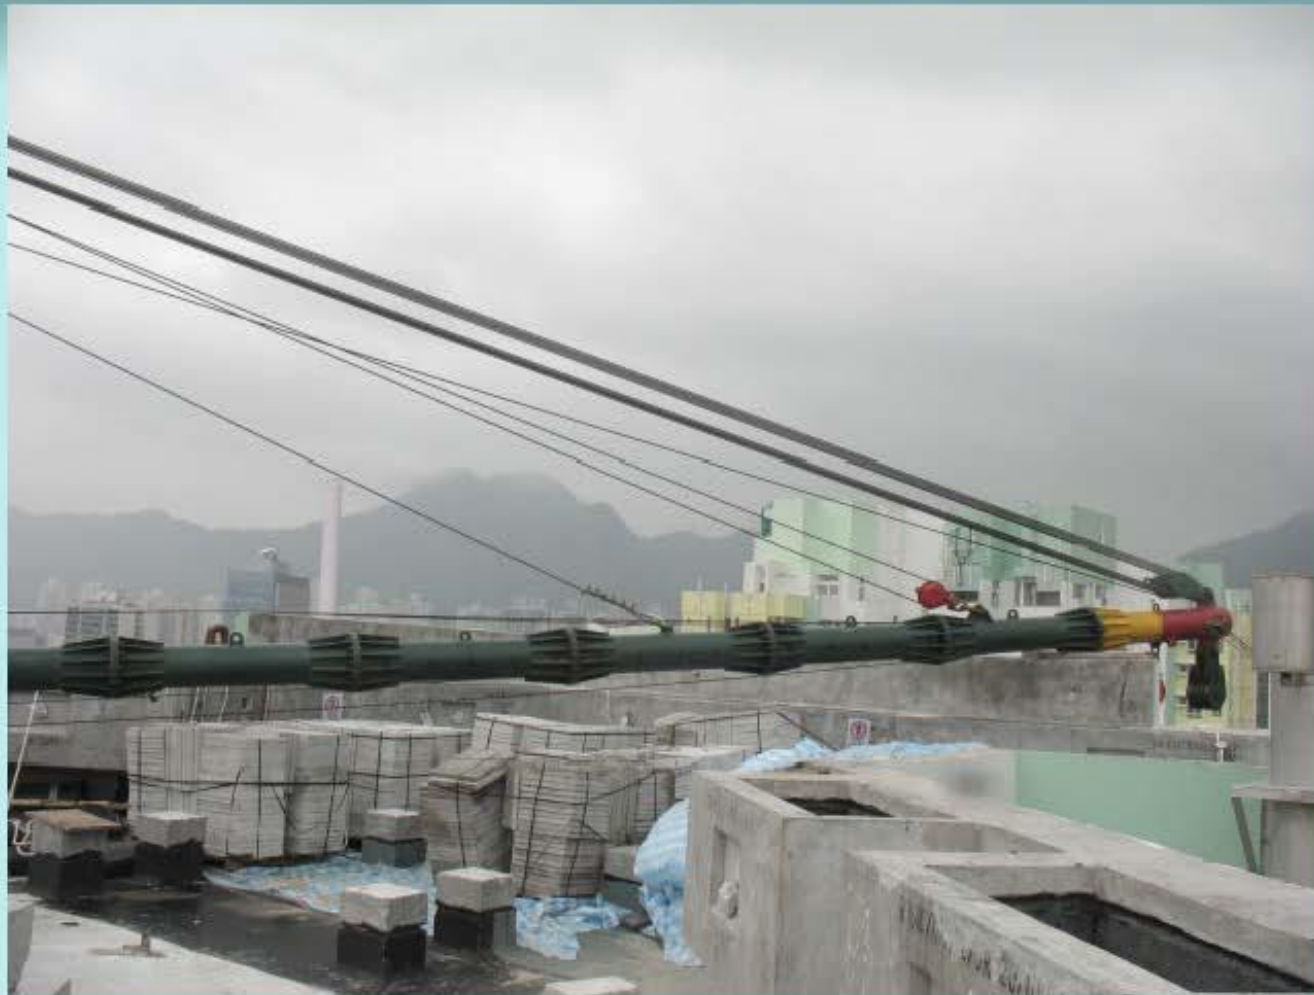
Boom rested on Parapet

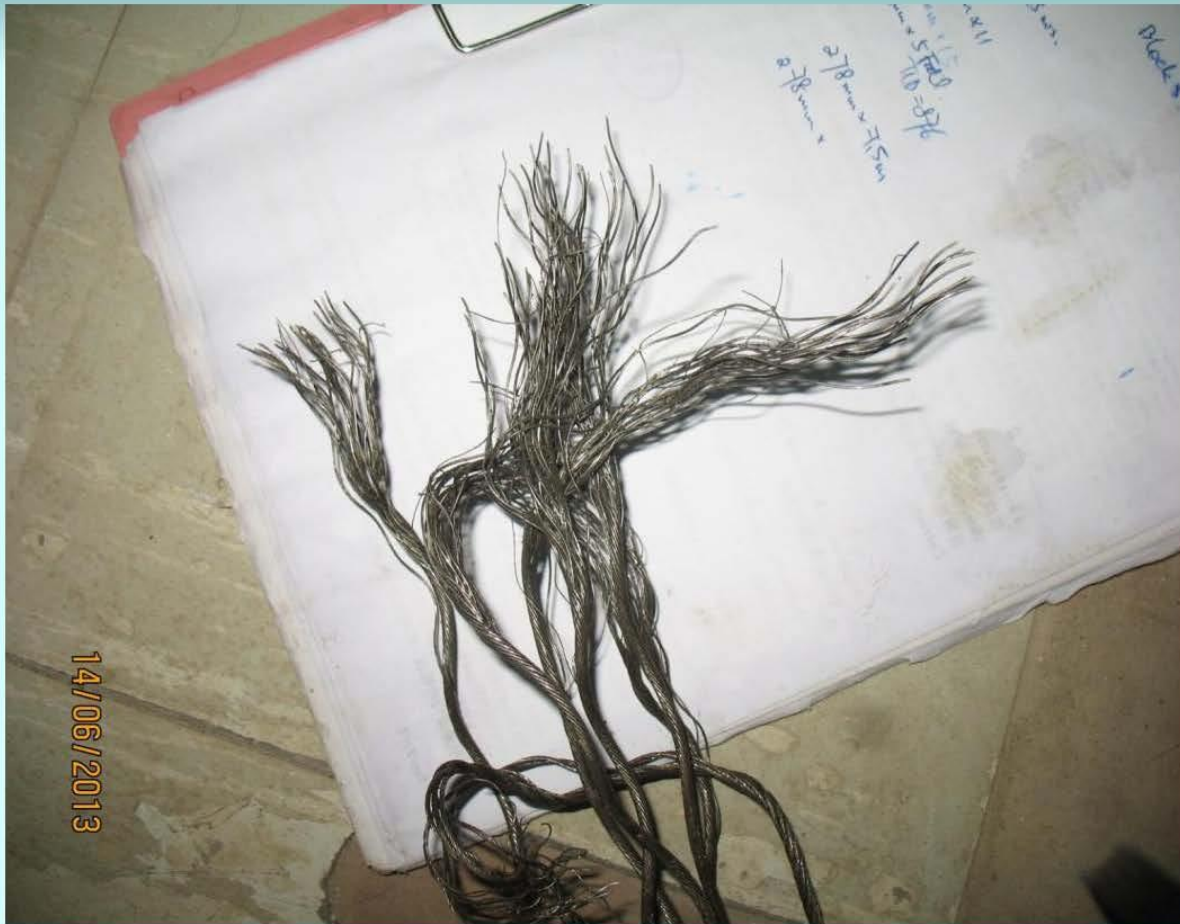
The broken surface resembled axe cut. The outer strands and the individual wire can separate easily. Wire rope broken surfaces clean with no foreign material.

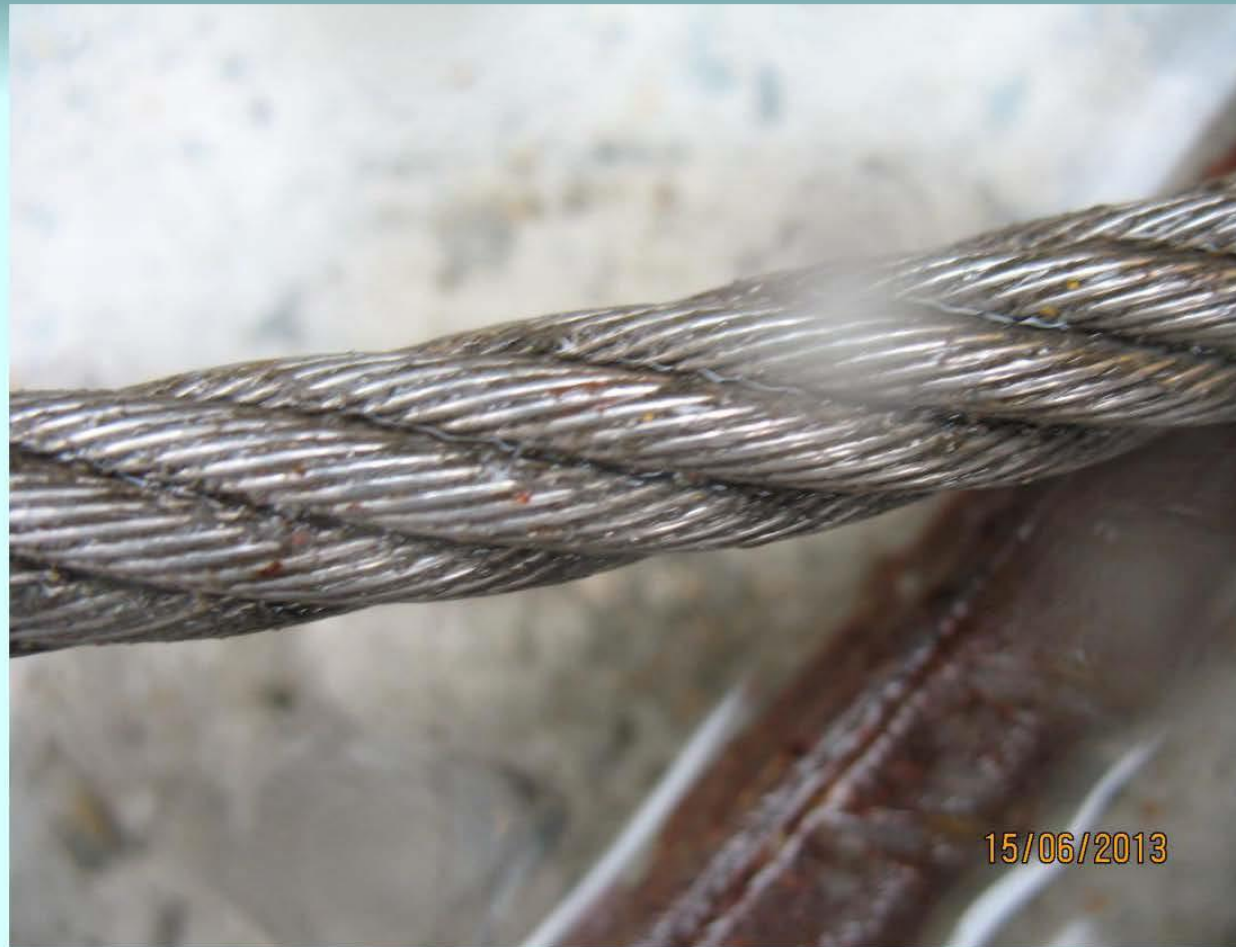
Wire rope showed no severe abrasive wear

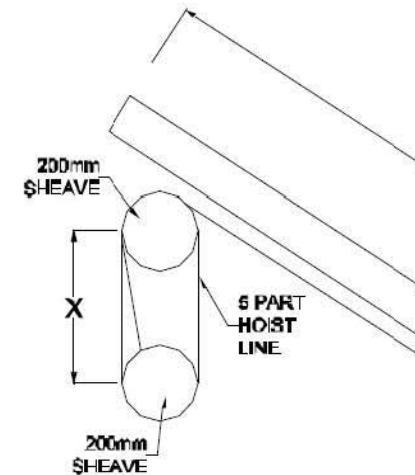
The broken wire rope connected to the “hook” measured 35m. With a 16.5m boom, the reported broken length of the wire was about 4m from the boom foot. The revving of the main hoist rope was 5 parts. The sheave was 200mm in diameter.

$$X = \frac{35\text{m} - 16.5\text{m} - 5\text{m} - \pi \times 0.2\text{m} \times 3.5}{5}; \text{ total 7 half circle of 200mm sheave} \\ = 2.26\text{m}$$

Over Hoist was not possible.

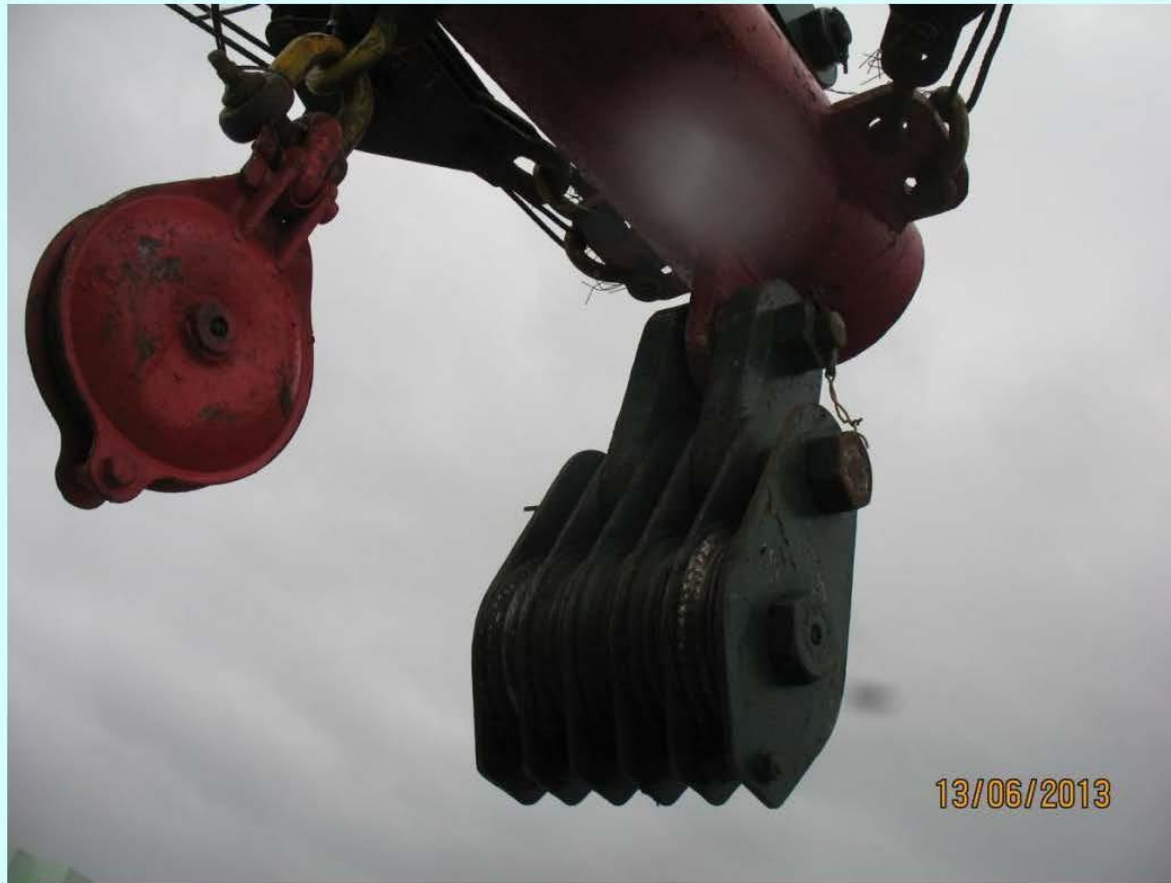
No noticeable hard hit mark on upper pulley block

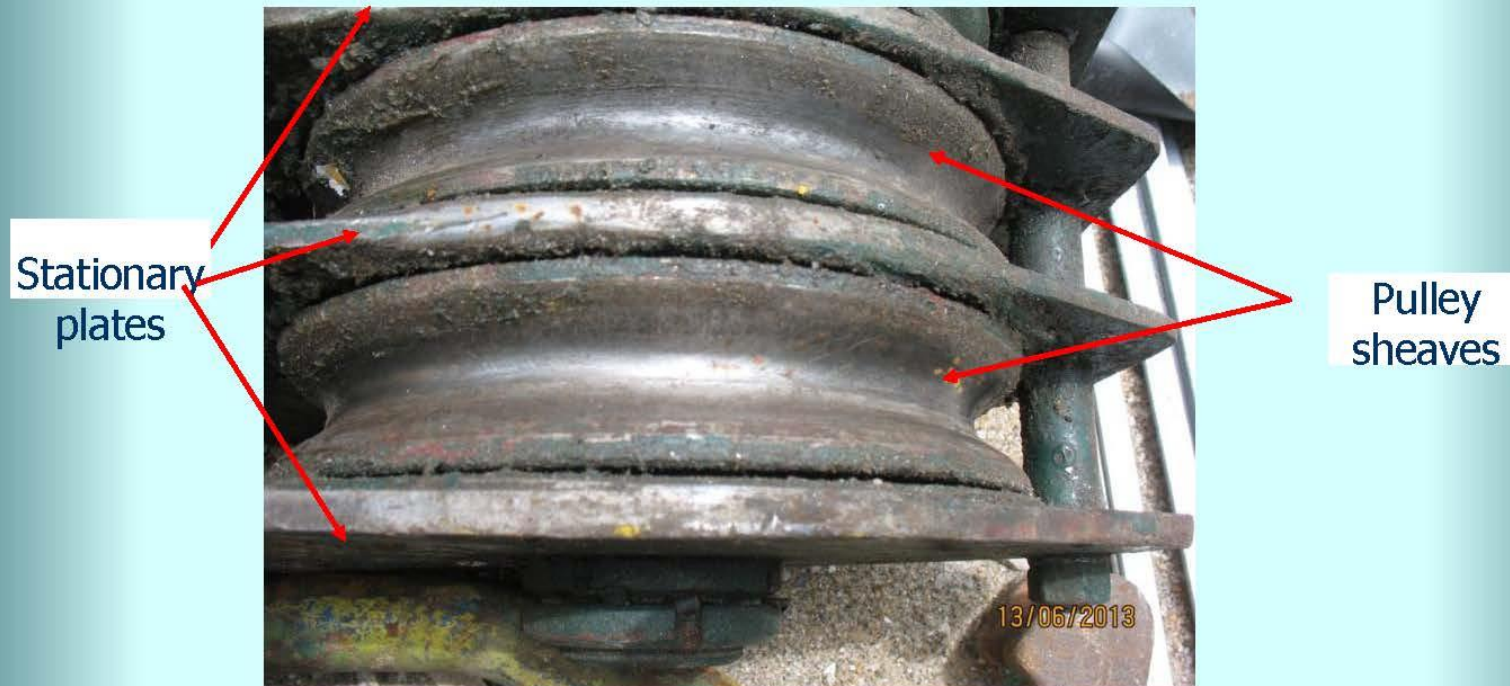
Pulley sheave with deep groove and pulley hidden by the stationary plates.

The chance of having wire rope cut by the pulley rim was slim.

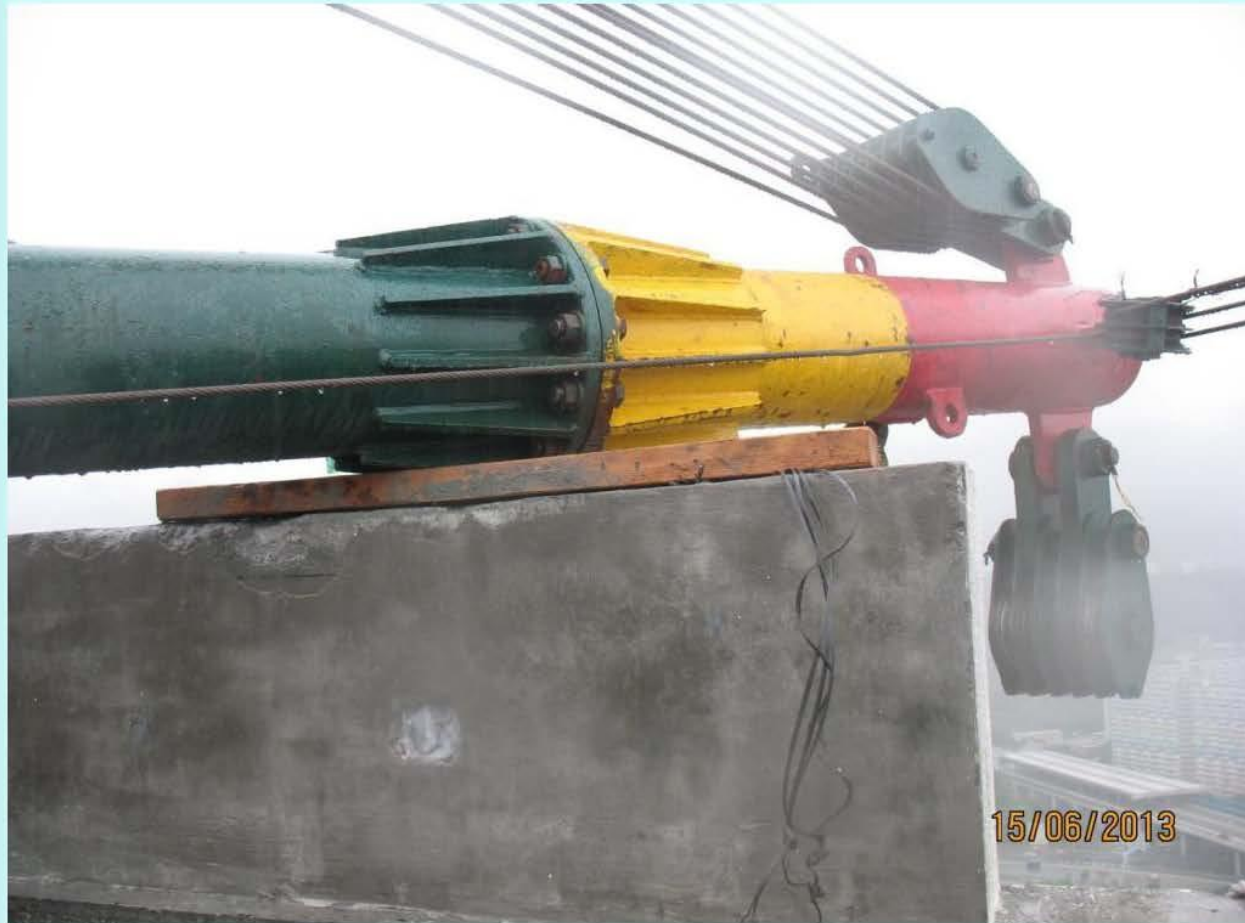
Sharp edges of the boom

The most possible wire rope failure was the rest boom movement under bad weather and strong wind. The sharp edges of the boom came in contact and created damage to the main hoist rope.

- ◆ The main hoist rope is to be put far away to be isolated from the rest boom on parapet.
- ◆ The main hoist rope must be carefully inspected whenever the boom rested on parapet or similar arrangement to ensure there was no induced damage.
- ◆ The rest boom is to be chained to the anchors on the floor if possible to minimise the chance of boom side movement.

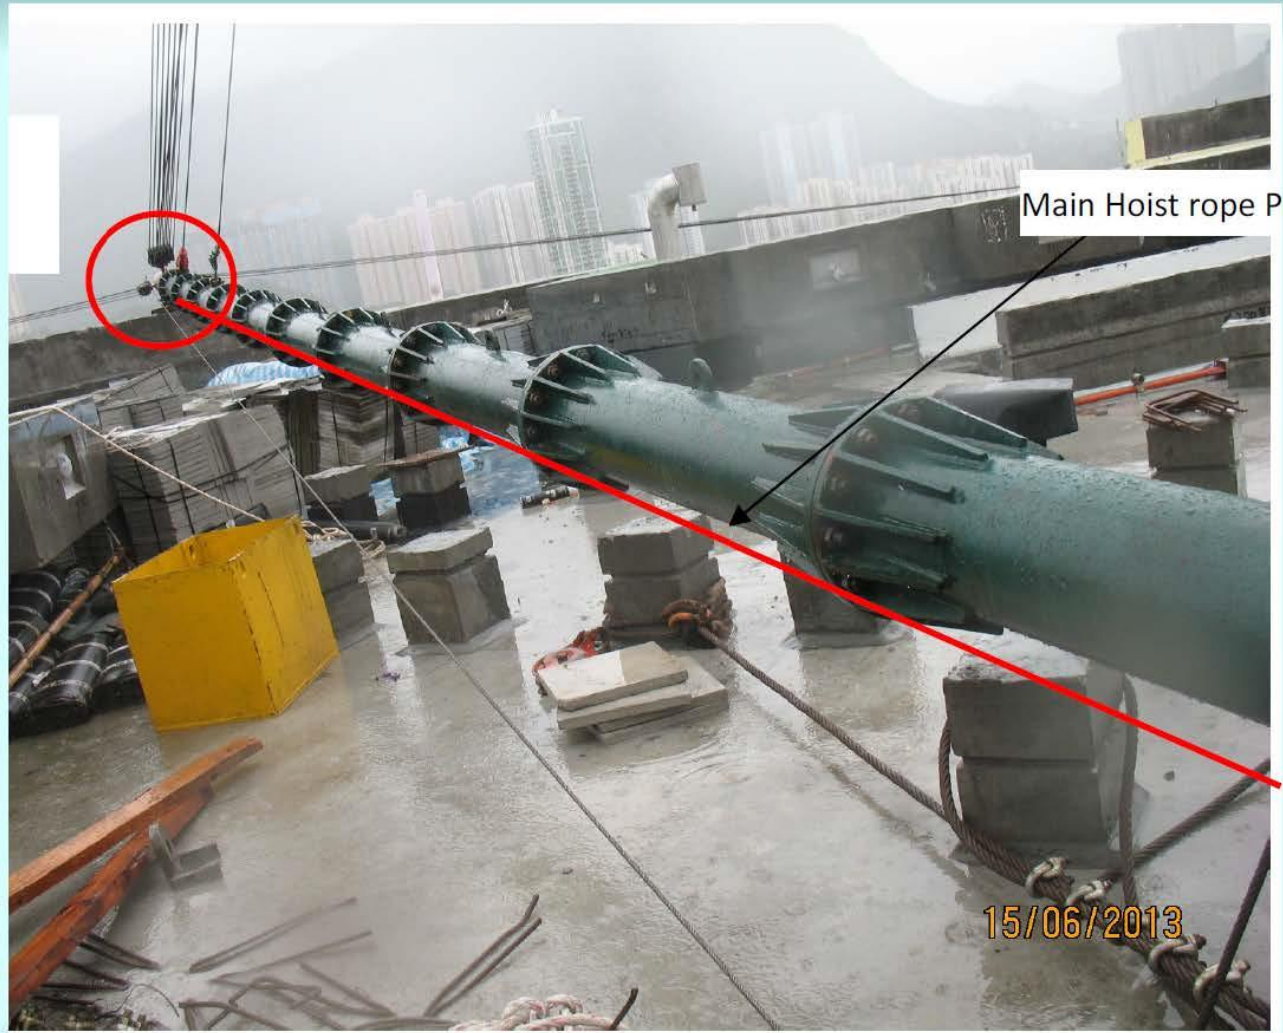
Boom rested on parapet and pull by 2 side wires

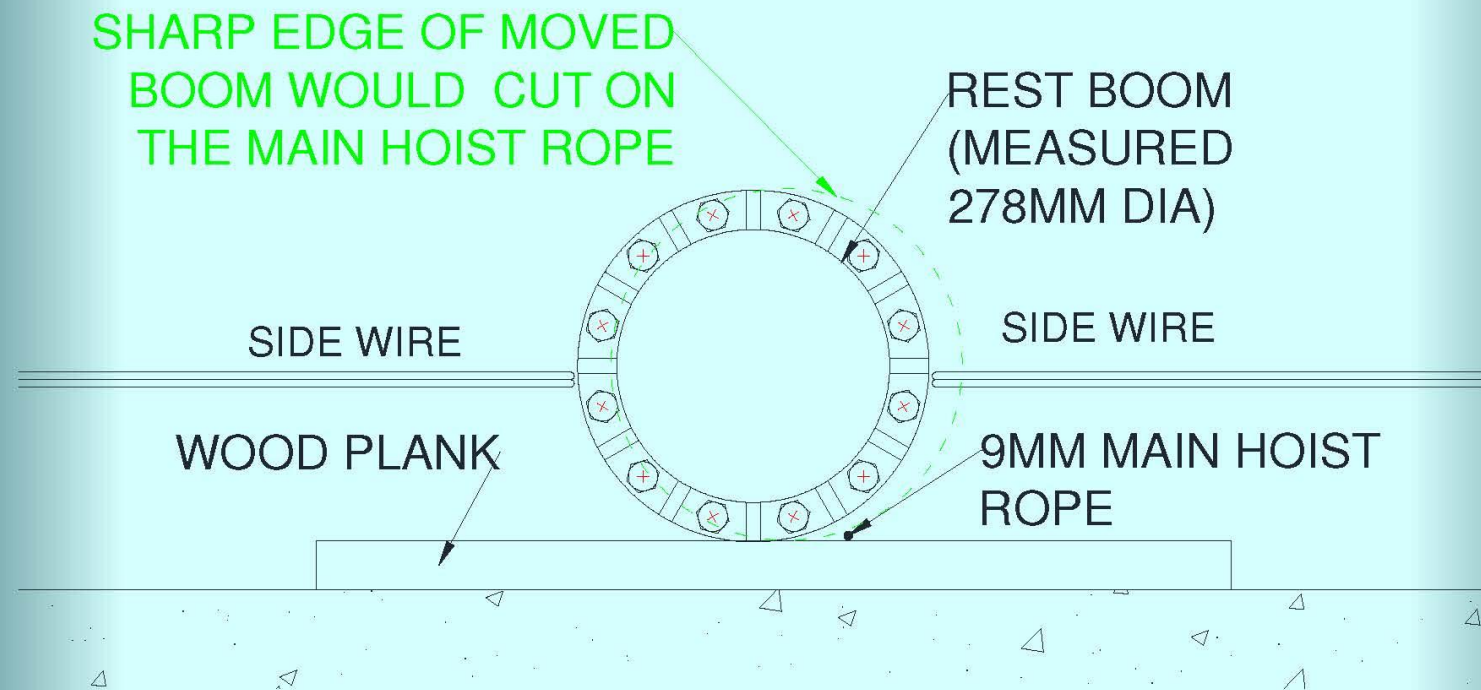
View from Front of the Rested Boom

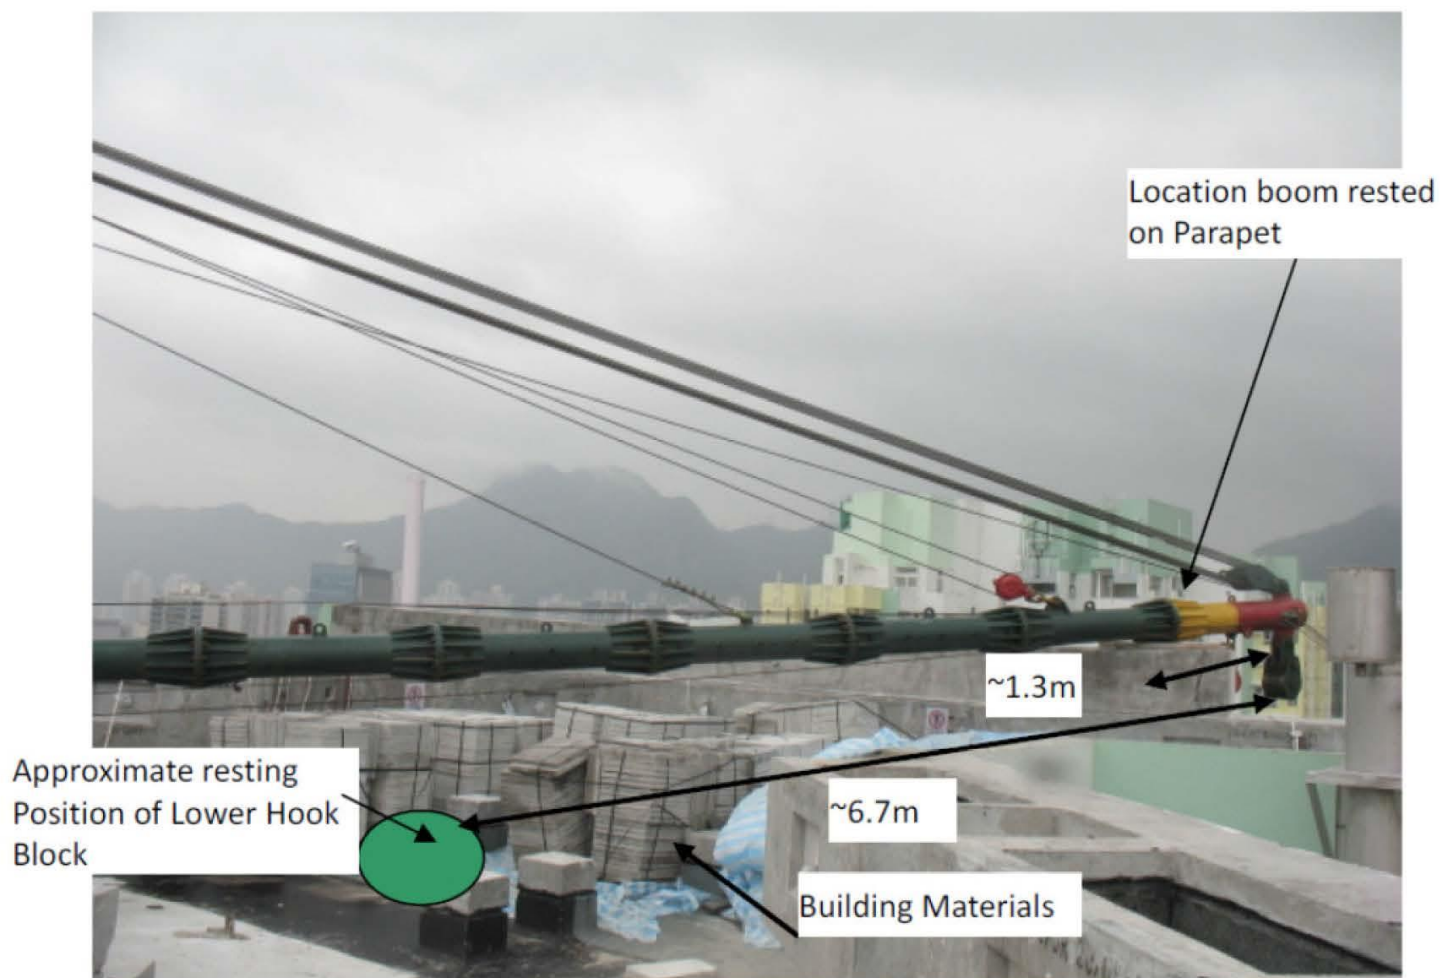
The total wire rope would be $5 \times (6.7\text{m}) + 1.3\text{m} \sim 35\text{m}$. This agreed with the measured wire rope (35m) failure position.

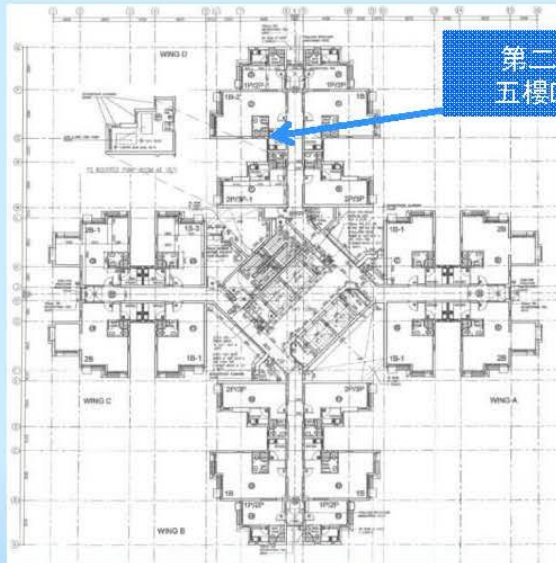
第二座
五樓D翼

1. 事發地點為第二座五樓D翼浴室；死者當時大字型臥倒在地，方向如右圖所示；
2. 死者表面沒有明顯傷痕，地面上只有少量血跡；

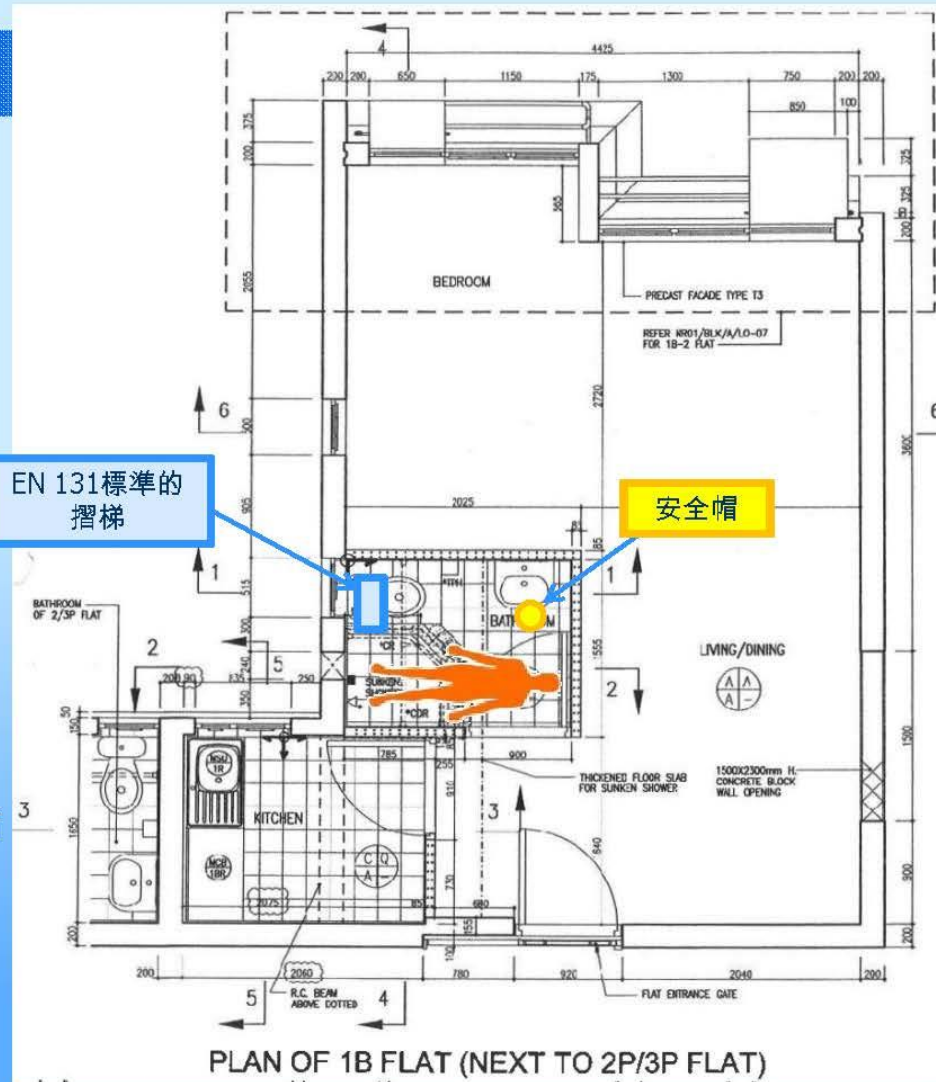
EN 131標準的
摺梯

安全帽

- 4. 附近發現連帽帶的安全帽；
- 5. 現場發現有一把EN131標準狀況良好帶扶手的摺梯；
- 6. 手工具(如勾仔、線鉗及鐵鉗等)。

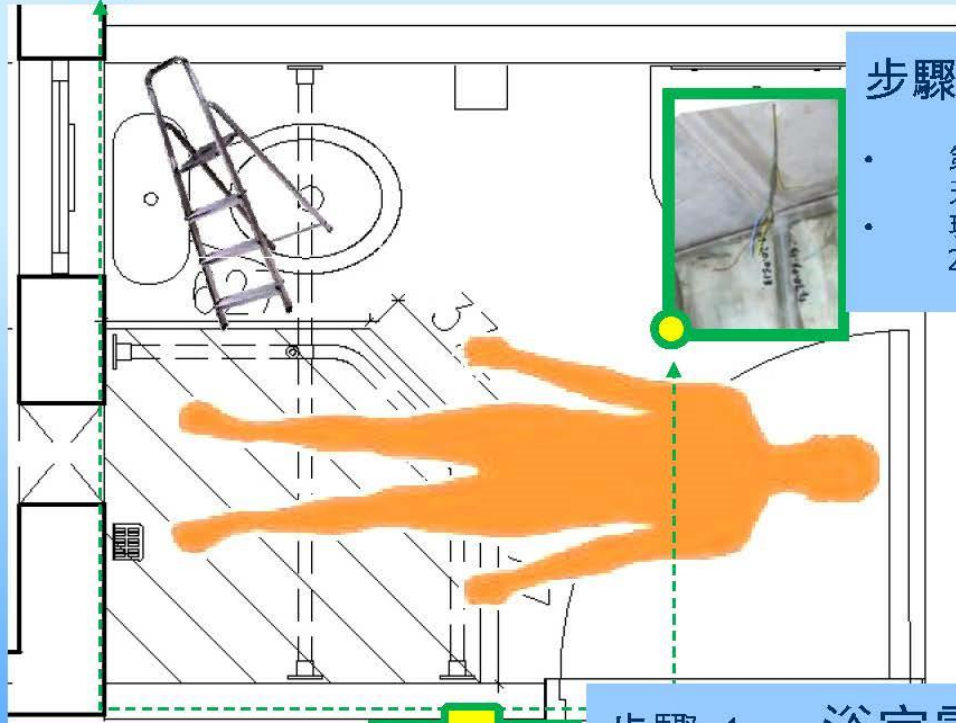
步驟2：浴室牆身抽氣扇出線位x2：

- 第一組線，已由浴身外牆身中間電掣位入，穿過本抽氣扇位出；
- 現場情況為已穿好，並已捲好入膠袋塞回原處；
- 此出線位處作業已完成；無須處理。

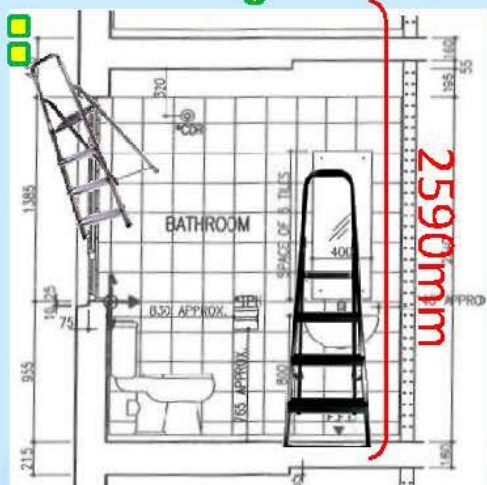
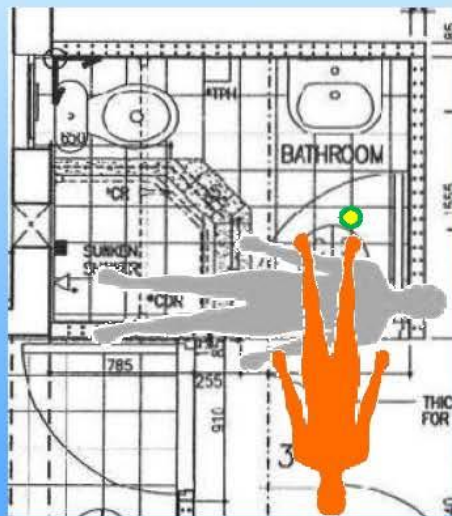
懷疑死者從高處墮下撞及頭部受傷

1. 抽氣扇出線位已完成包好,無須再上梯具工作；
2. 燈光位對落地面發現白色拉線用之尼龍線，更加証明死者並無在進行穿抽氣扇出線位相關之工作；
3. 再者，如果死者是從離地位置跌倒，照常會雙手自然反應四周亂抓意欲取回平衡，但死者發現大字型躺臥著，同時雙拳緊握；
4. 雖然死者有可能在天花板燈光位進行捲線及包膠袋程序，但從梯具傾側位置及方向，以及死者本身躺臥位置進行推斷，當時死者亦不大可能站在梯具上進行天花板燈光位之工序；
5. 假如死者當真使用梯具捲天花電線或包膠袋時跌倒，按道理死者應該向後跌，頭部甚至會跌出浴室門外(如橙圖所示)，而非橫躺浴室內(如灰圖所示)。

意外發生的可能性： 死者因為使用梯具而導致離地跌倒受傷之可能性不大。
