Site Safety Seminar for Capital Works New Works Contract

Lesson Learnt from Accident & Incident

Presented by: Eric Wong (Unit Safety Manager, Gammon Construction Limited)

Date: 12 May 2014

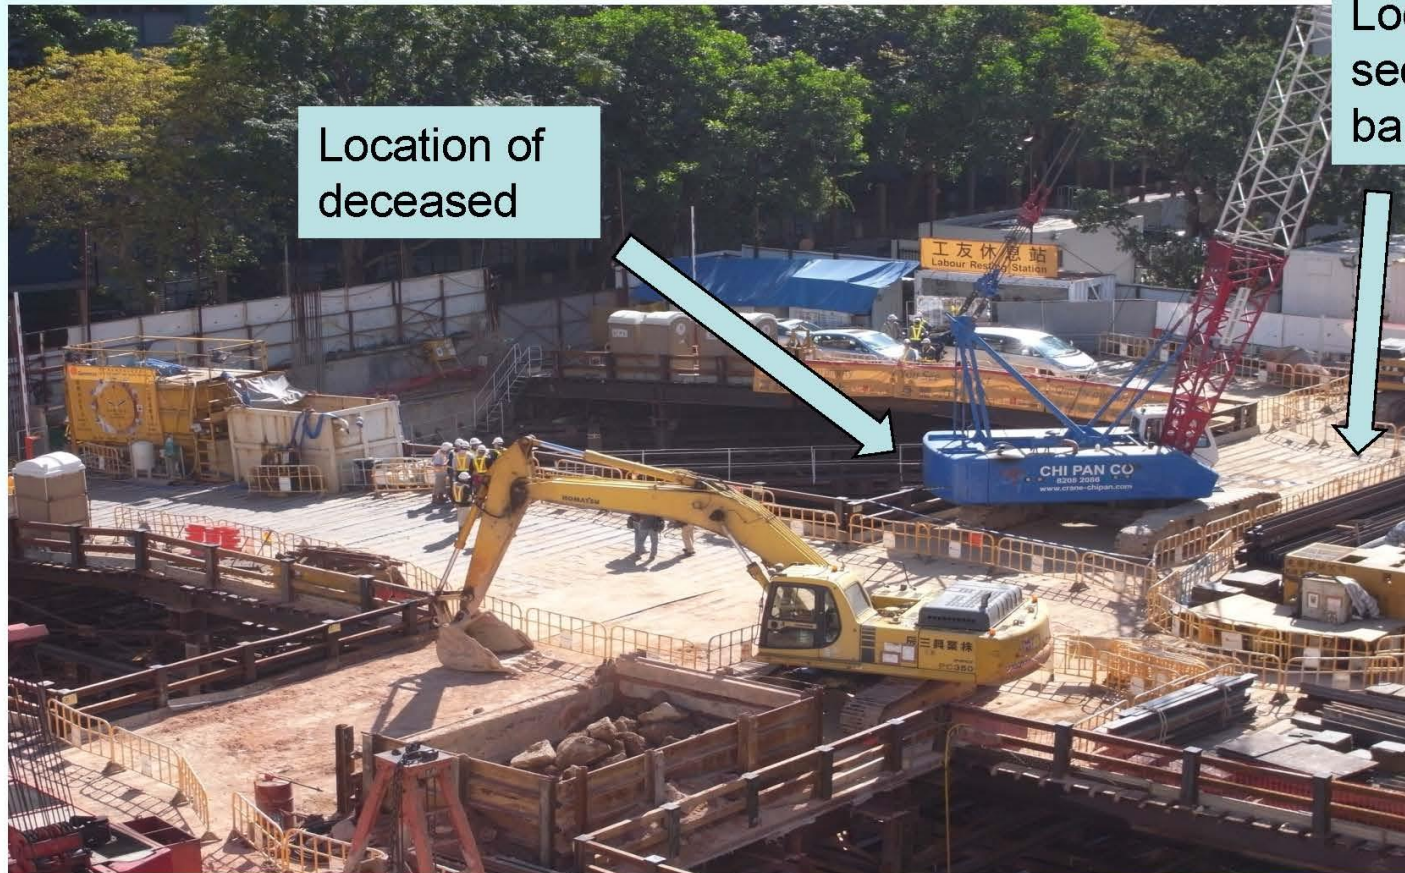
The incident was happened in the morning at a Foundations work site. A 54 yrs old rigger/banksman was crushed between the counterweight of a crawler crane and the steel railings.

Location of
second
banksman

Location of
deceased

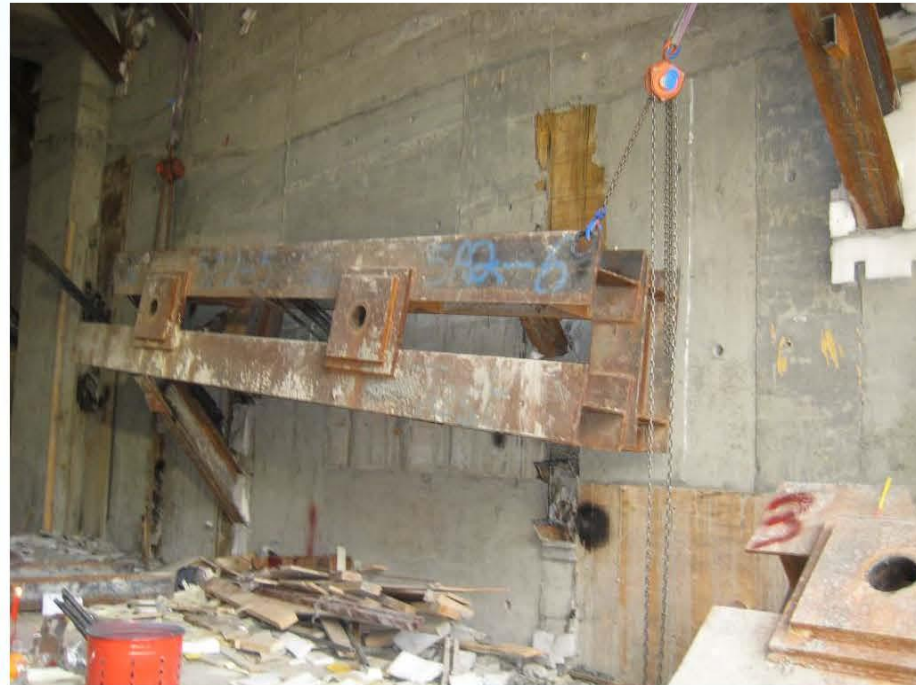
Reconstruction of the incident

The incident happened in the morning at a Building job site. A gang of workers were engaged in removing heavy steel waler boards and lowering them to the ground. The accident occurred when the steel waler, 4.5 metres in length and weighing approximately 1 tonne, shifted after the final support strut was cut. The waler shifted to the right, rotated and dropped approximately 500mm striking the operative, a 55 year old supervisor on the head with a fatal blow.

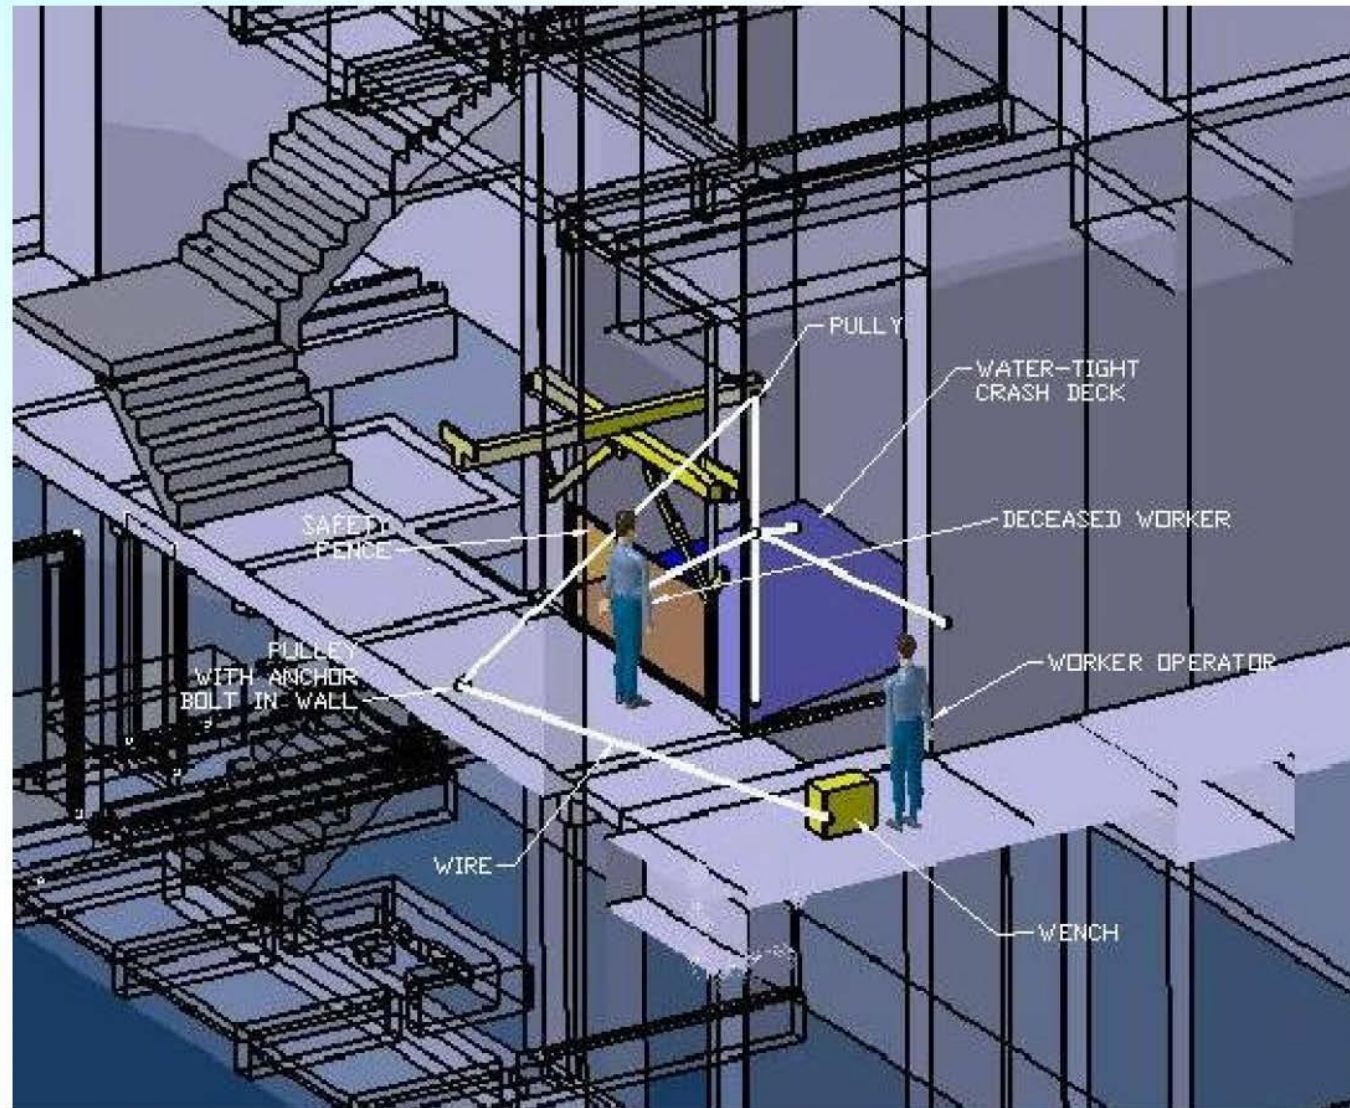
Accident Scene Schematic

At the time of the incident, the deceased was standing in front of the lift shaft opening and act as the banksman for the lifting operation. It was believed that the wall mounted pulley block was being pulled off due to the anchor bolt seriously deformed; and that caused the Crash Deck started to free fall under a unrestrained weight, at which point there was a sudden snapping action, which ripped the winch from its floor mountings and pulled it into the lift shaft together with the guy.

- deficiency in the design of the lifting system
- deficiency on the quality of installation of the lifting system

- Enhancement had been made to Temporary Works procedure
- Stringent control on Restricted Hours Work (required the approval by respective Divisional Director)
- Technical Directives and Best Practices Guidelines on anchorage system
- Management of subcontractors designs

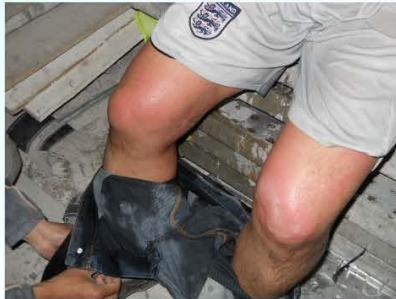
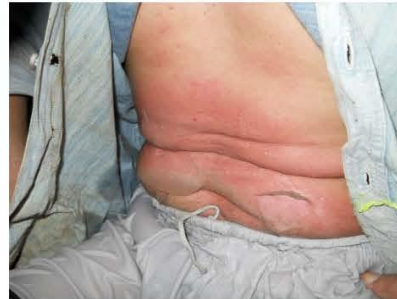
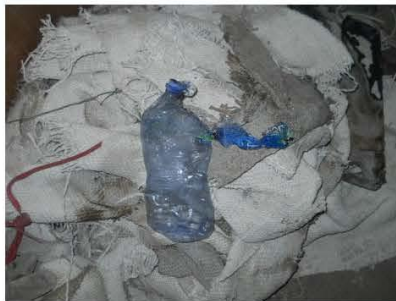
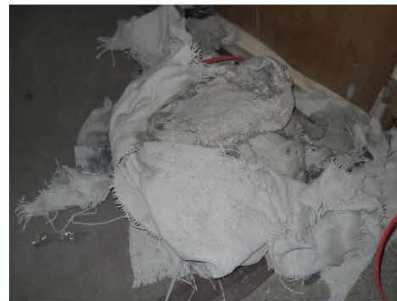
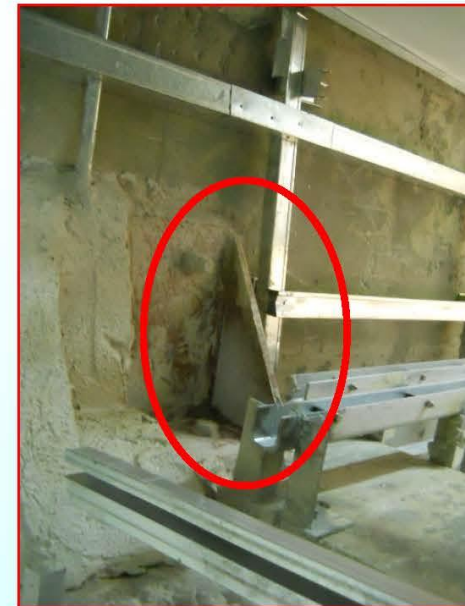
- Before the commencement of the flame cutting operation, the welder (the I/P) intended to wet the area with water in order to prevent the splashing of welding spark. However, the co-worker mistakenly passed him a bottle of “water” (thinner), and the I/P poured on top of the fire blanket. When he started the welding, the spark ignited the flammable substance and caused a flash over.
- The guy had put on a mask throughout the operation and that's why he might not smell the thinner
- That bottle of thinner with no label and was left by another subcontractor. The co-worker thought it was a bottle of drinking water and passed to the I/P

- The effectiveness on implementation of Hot Work Permit
- Control of chemical substances
