## **Executive Summary**

Here is the footage of Site Safety Seminar for Capital Works New Works Contracts of Housing Authority which was held on 12 April 2018 The speaker is Senior Consultant of Occupational Safety and Health Council Mr. Jack FONG His presentation topic is Housing Authority Lift and Escalator Nominated Sub-contracts Safety Auditing System (HALENSAS) Version 1.1.1 Findings of the 4th quarter of 2017 and the 1st quarter of 2018

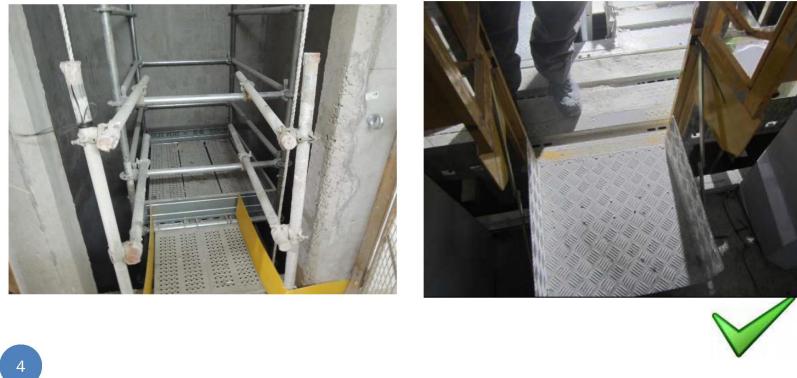
- Platform with guard-rails and toe-boards
- 安裝圍欄及踢腳板

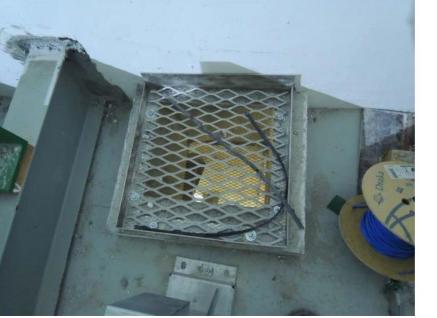
- Steel mesh is provided in lift machine room.

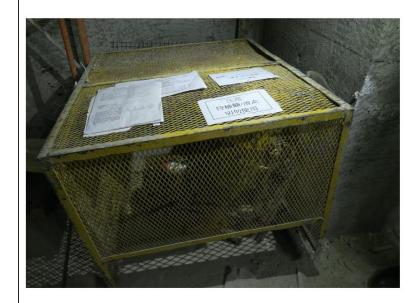
- Winch with effective guarding
- 絞車安裝有效護罩
