Housing Authority  
Surprise Safety Inspection Programme (SSIP)  
Good & Bad Practices  
香港房屋委員會  
突擊安全巡查計劃  
Q2 & Q3 2018 良好及不良作業

# Summary of Good Practices

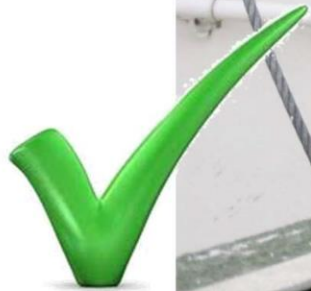
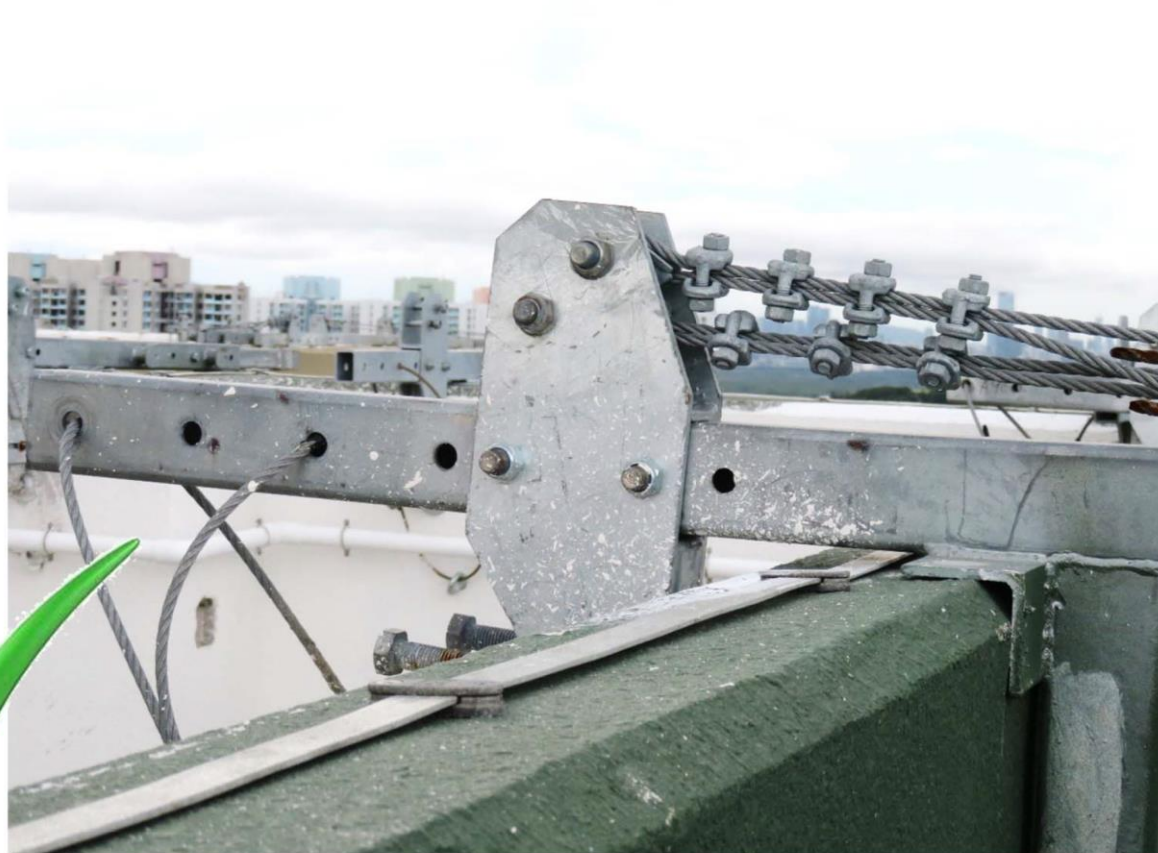
於吊船主纜末端使用合適威也夾。

Fist grip wire clips were used at main wire of gondola.

Main cables of gondola were fitted with suitable wire clips

According to Code of Practice (COP)

this type of wire clips did comply with regulations

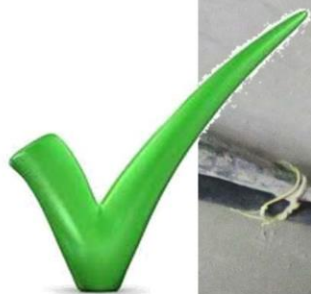
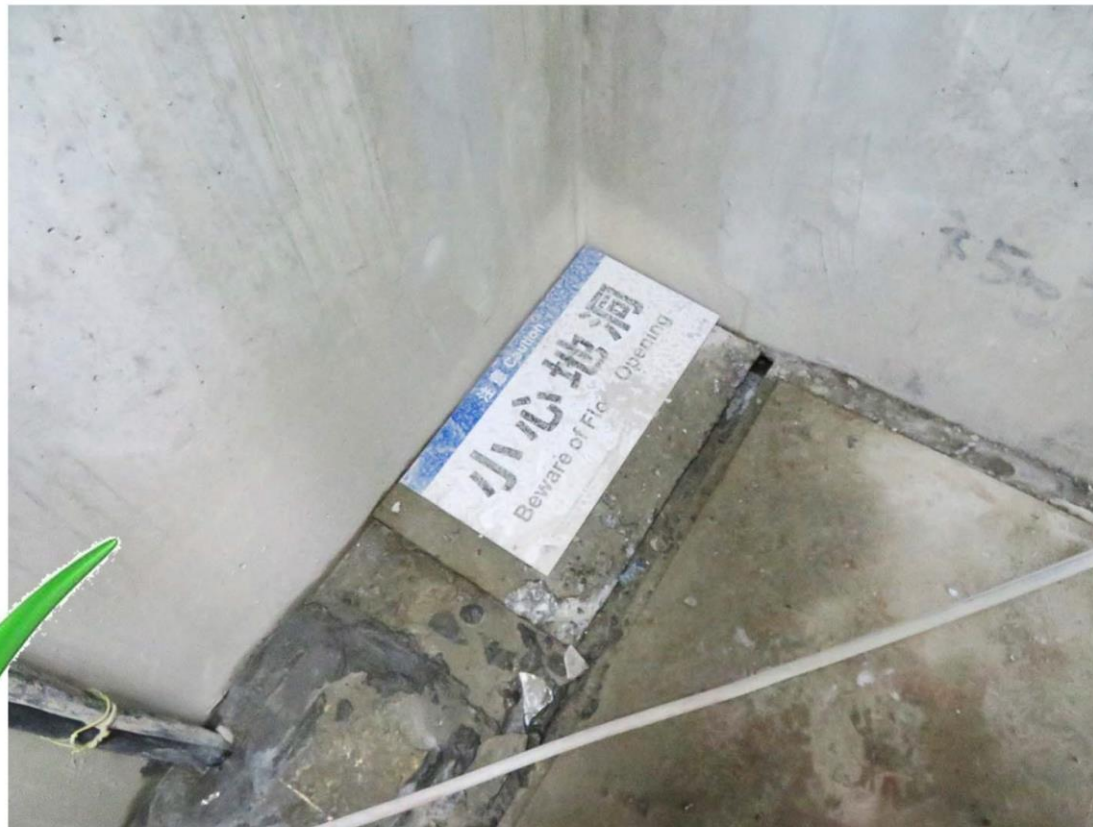
孔洞提供明确警示。

Clear warning notice for the floor opening.

Floor openings fixed with warning signs and

covered properly and safely

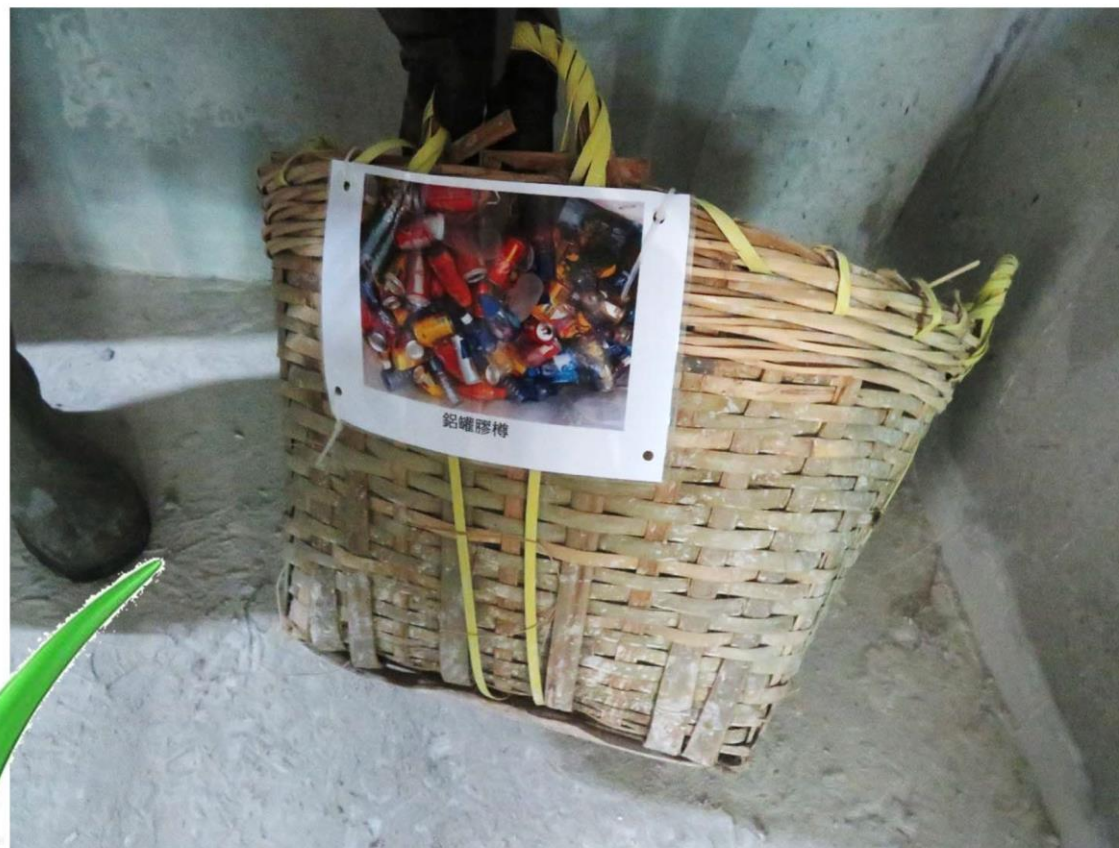
以圖片表示收集容器用途。

Photo was used to indicate the purpose of container.

Outside the container

pictures were attached to indicate the garbage types

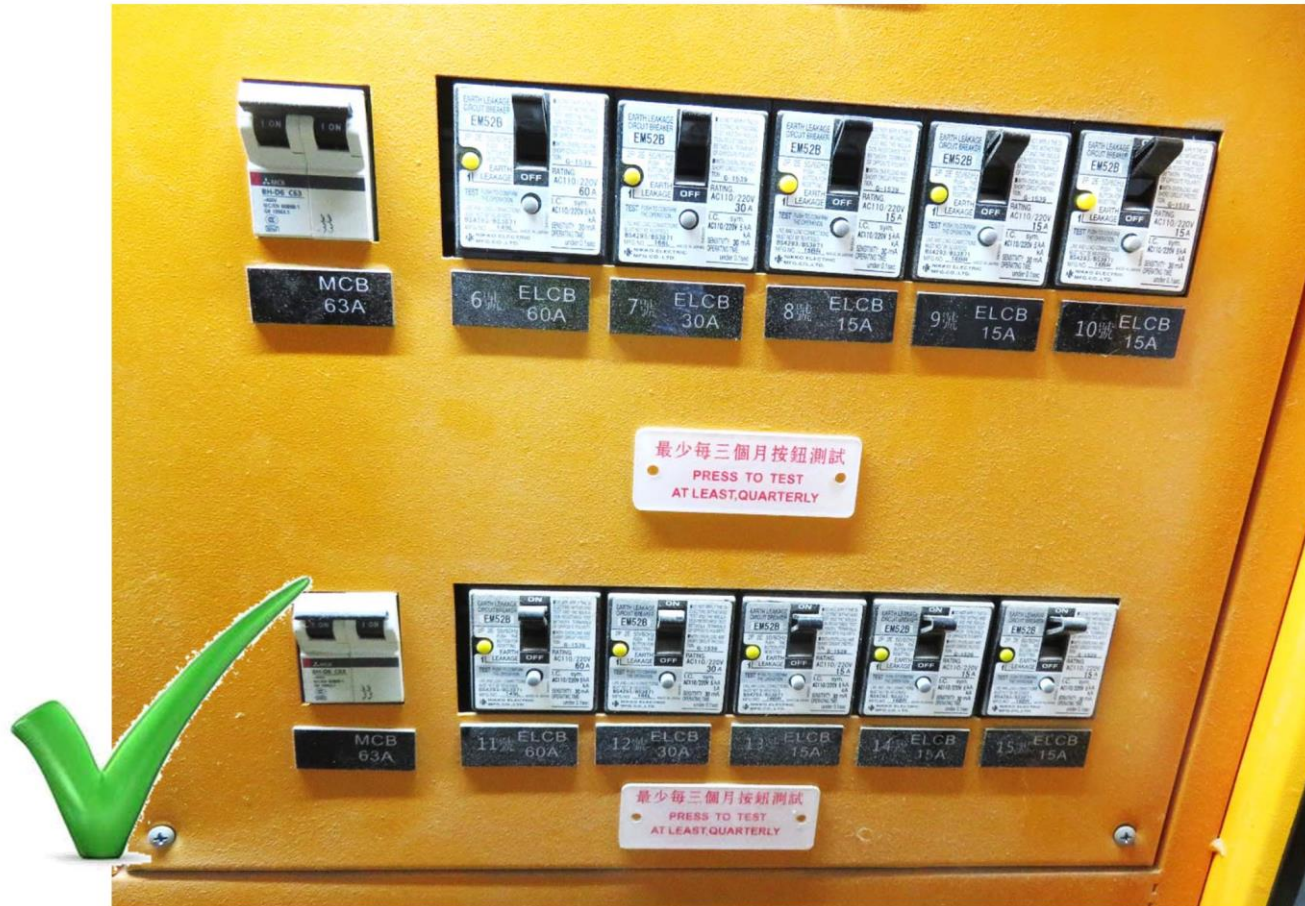
於電箱內掣位加設名牌。

Name tags were installed for identifying switches in distribution board.

Meticulous labels inside electric distribution board

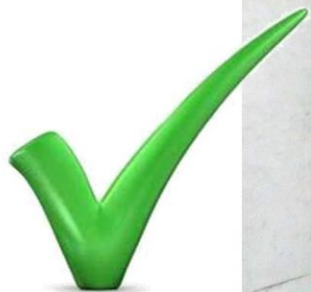
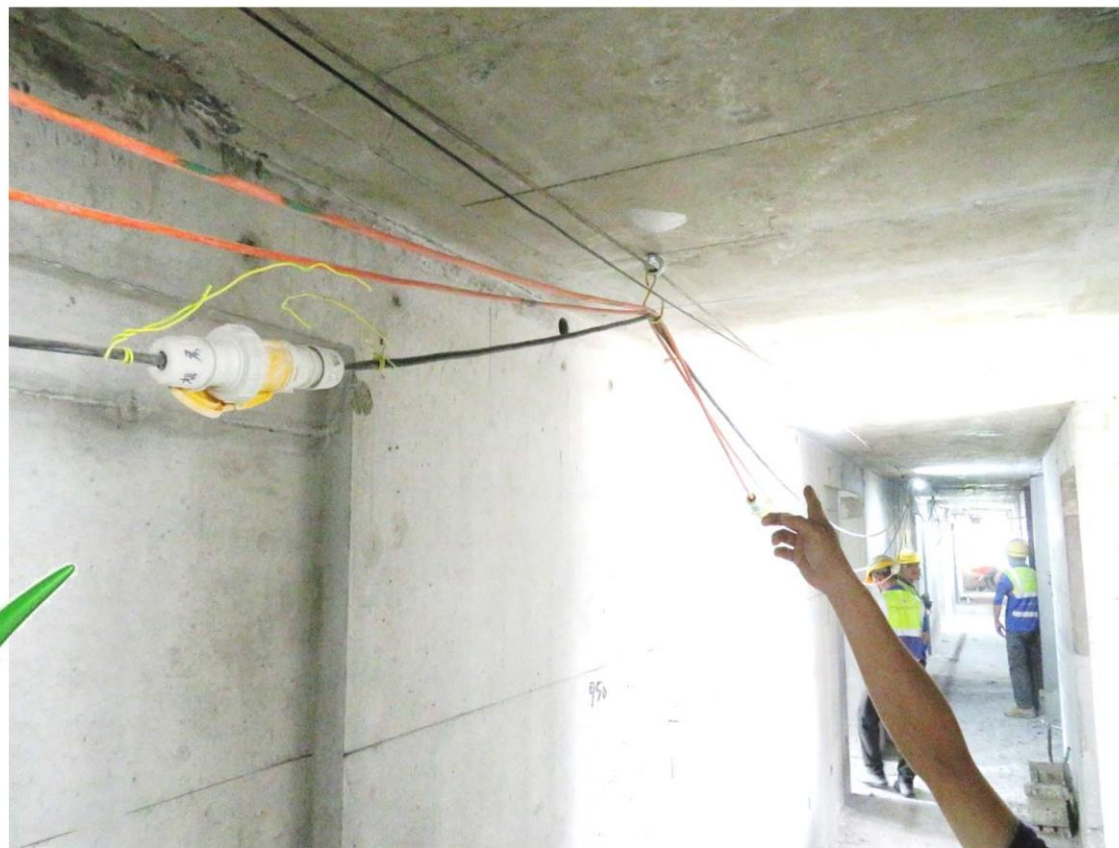
電線妥善掛高。

Electric cables were properly hung.

Cables were hung properly at high level
