Housing Authority
Surprise Safety Inspection Programme (SSIP)
Good & Bad Practices
香港房屋委員會
突擊安全巡查計劃
Q2 & Q3 2018 良好及不良作業

Summary of Good Practices

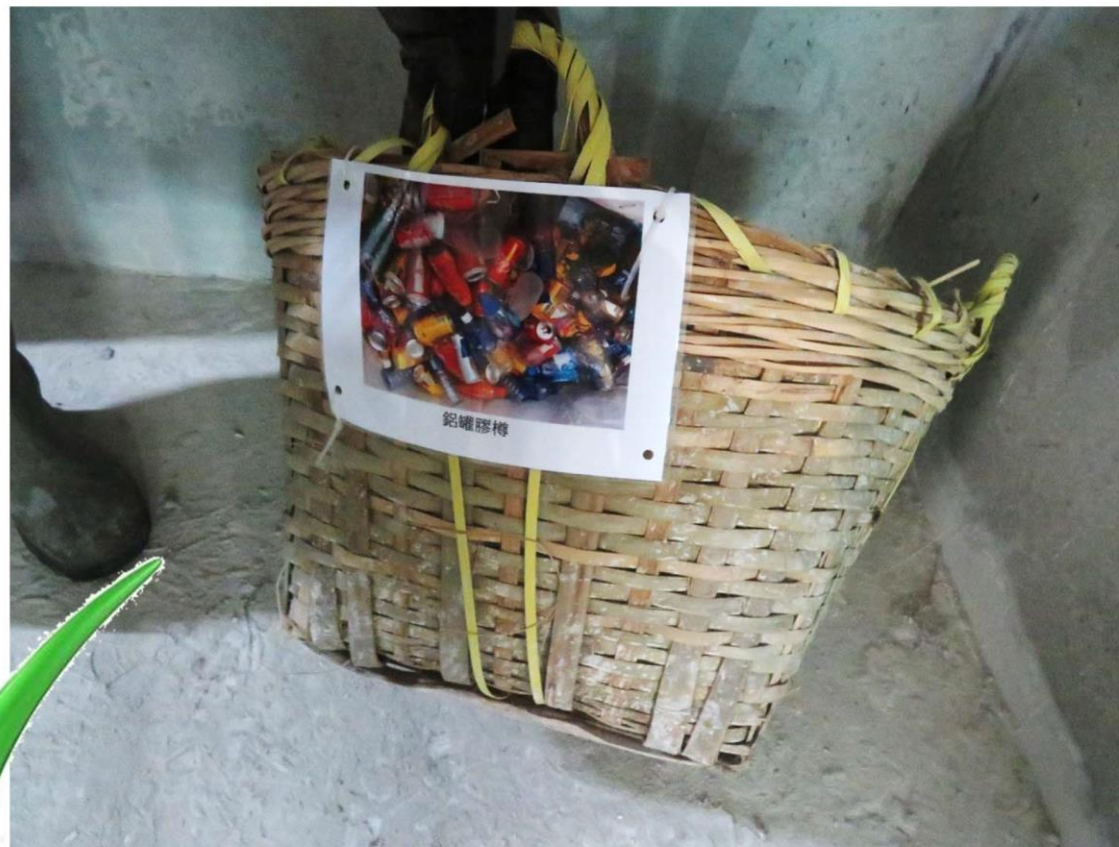
以圖片表示收集容器用途。

Photo was used to indicate the purpose of container.

以圖片表示裝了什麼垃圾
