# Housing Authority Surprise Safety Inspection Programme (SSIP)

## Good & Bad Practices

Q4 2018 & Q1 2019 良好及不良作業

Surprise Safety Inspection Programme (SSIP) – Findings in Q4 2018 & Q1 of 2019

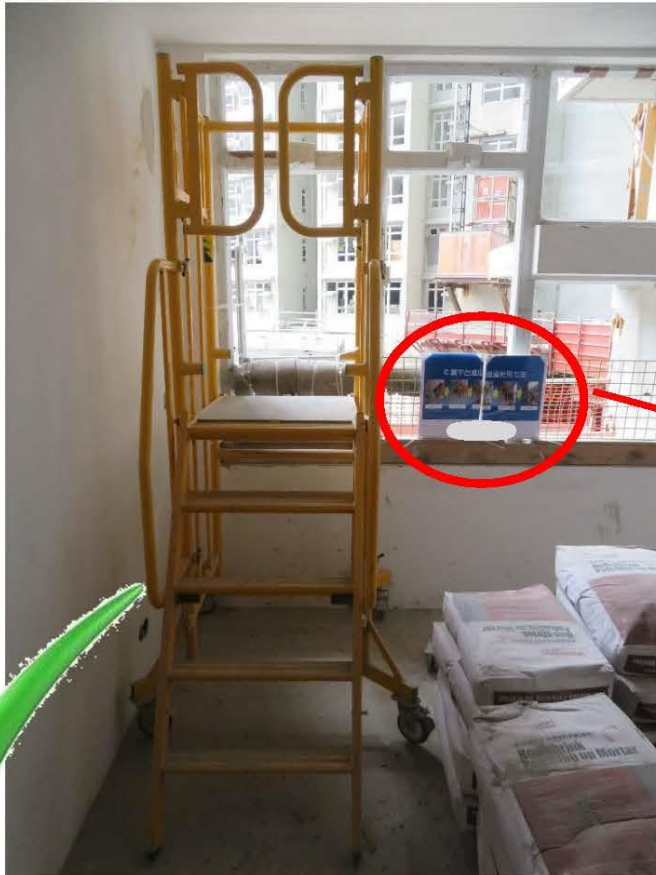
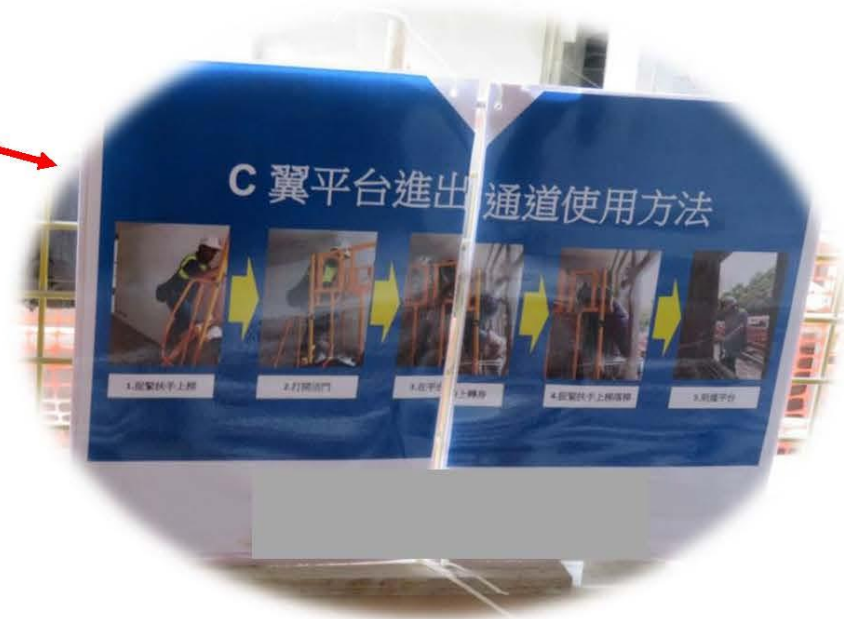
提供合適吊船進出口及相關安全指示

Safe means of access and egress for gondola with clear written safety instruction

This was an access and egress for a gondola

Here a yellow mobile working platform was used

It was meticulously constructed with signs on how to use it

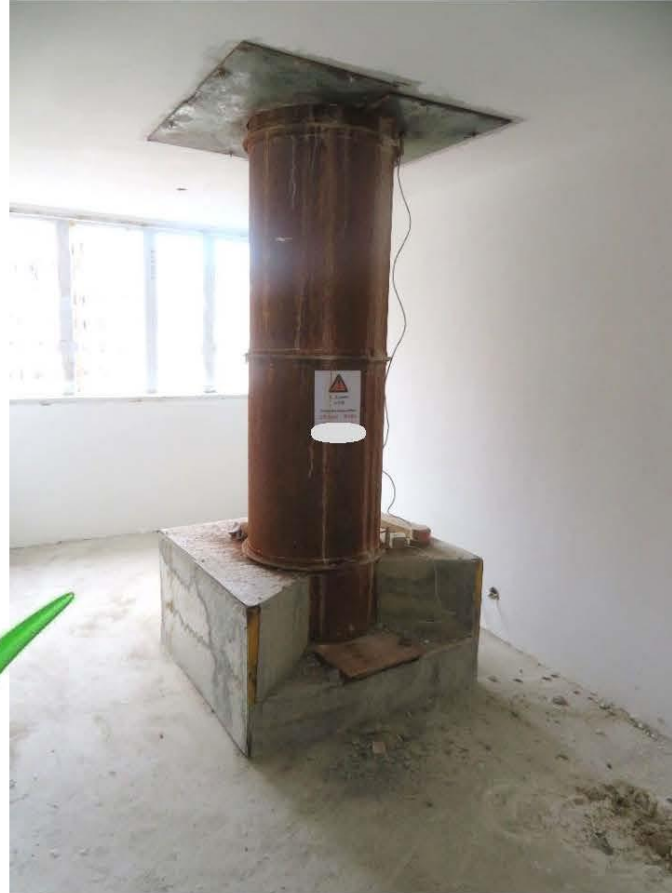
妥善覆蓋垃圾槽旁凸出鐵枝。

Projecting rebars were properly covered in refuse chute location.

This was the hopper of the refuse chute

There were no projecting rebars that jeopardise workers

This served the function of toe-boards

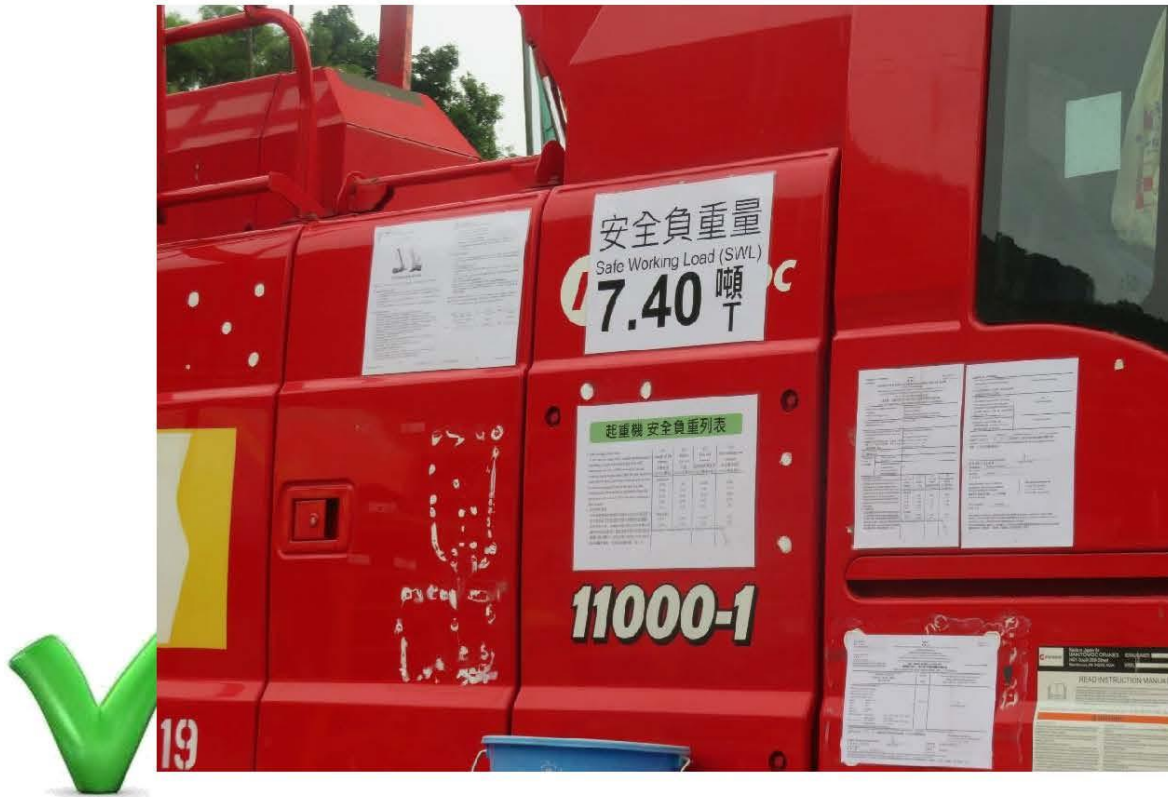
清楚列明起重機械的安全操作負荷。

Safe working load of lifting appliance was clearly displayed.

This was a warning sign about

the safe working load of mobile cranes (bilingual)

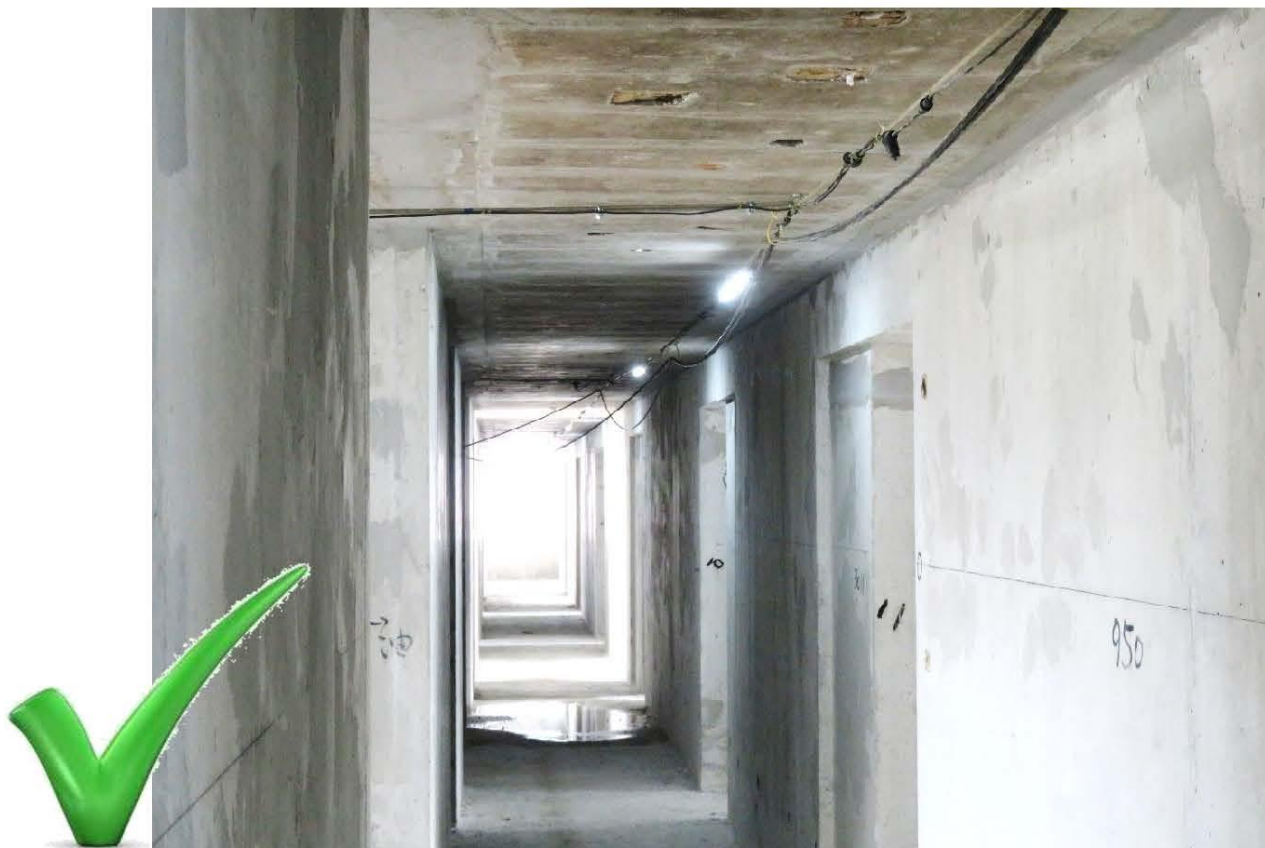
電線妥善掛高。

Cables were properly hanged.

Cables were hung at high levels, a good practice
