#### HALENSAS - 2019Q2-Q3

Summary on Good and Bad Practices 安全稽核結果

Occupational Safety and Health Council 職業安全健康局

Finding in Q2 & Q3 of 2019

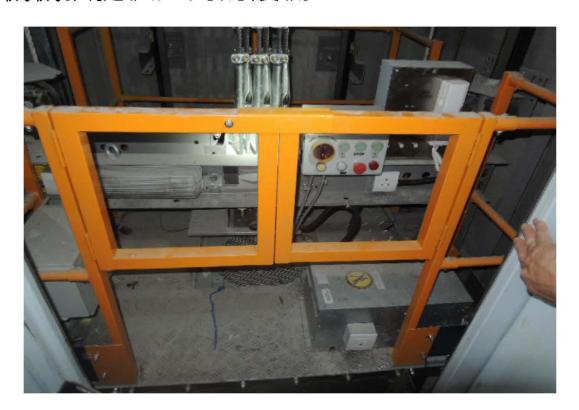
- Provision of sufficient guard-rails for car top
- 為升降機機頂提供足夠的護欄

For lifts, appropriate guardrails were basic

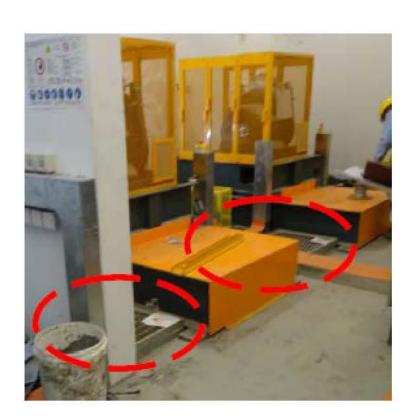
- Floor openings were properly covered
- 蓋好樓洞

These were floor openings with covers and warning signs
