HASAS(NW) - 2021Q2-2021Q3

Summary on Audit Findings 安全稽核結果

Occupational Safety and Health Council 職業安全健康局

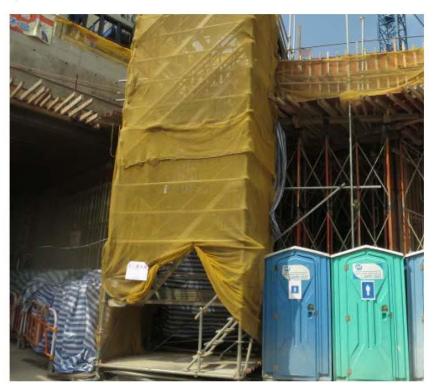
- Provision of safe means of access & egress
- 提供安全進出通道

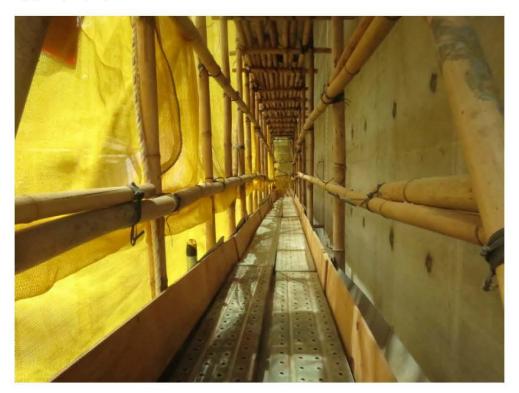
- Provision of proper working platform
- 提供合適工作平台

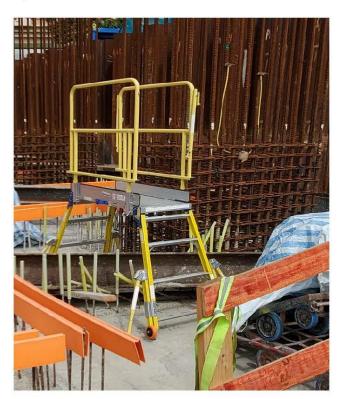
- Provision of safe means of access & egress
- 提供安全進出通道

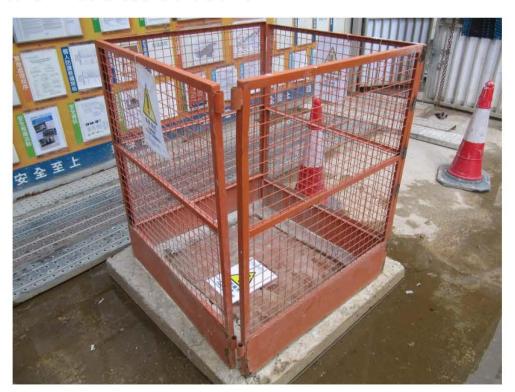
- Floor opening was fenced off properly with warning notices
- 地洞妥善圍封並張貼警告標示

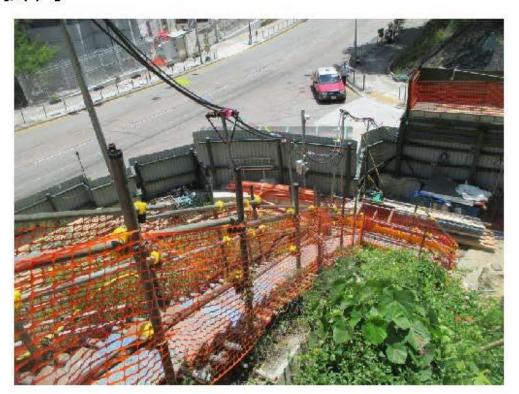
- Electric cables were properly suspended
- 電線妥善掛高

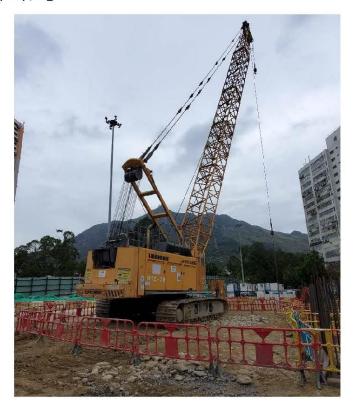
- Danger zone was fully fenced off
- 危險區域妥善圍封

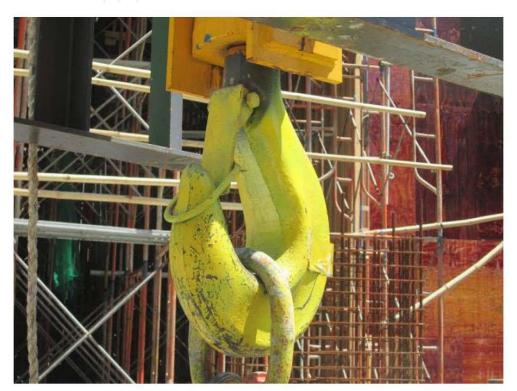
- Interlock devices for lifting hook
- 吊鈎設有互鎖式裝置

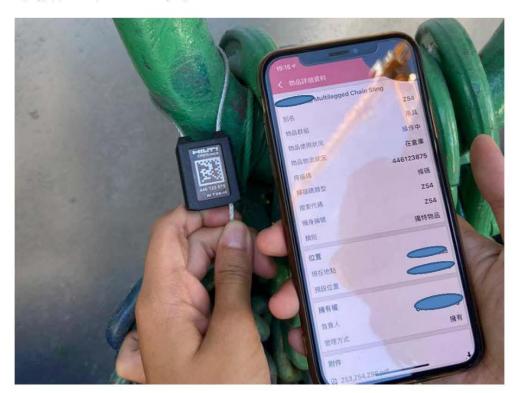
- QR code for checking lifting gears
- 使用二維碼檢查起重裝置

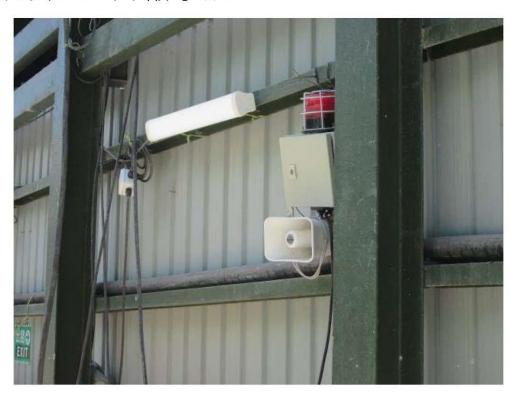
- Provision of tower crane lifting zone alarm system
- 提供天秤吊運區警報系統

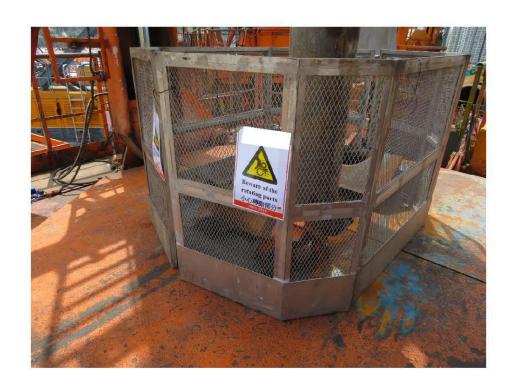
- Drill rod was fully fenced off by rigid barriers
- 使用穩固圍欄圍封鑽桿

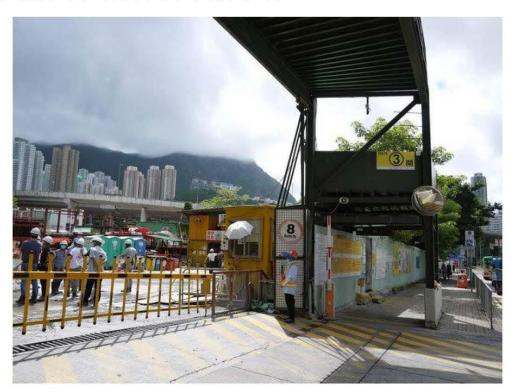
- Provision of height limit alerting system of site vehicle
- 提供地盤車輛高度限制警報系統

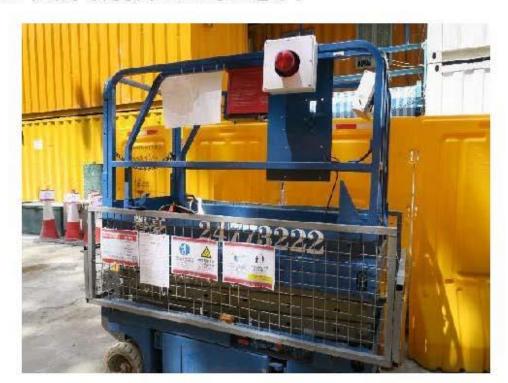
- RFID system to prevent from collision
- 無線射頻辨識系統預防碰撞意外

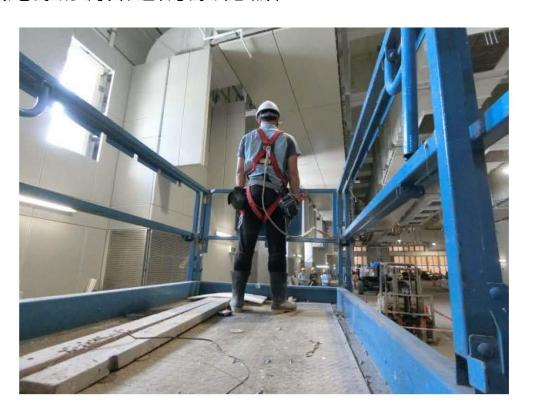
- Worker anchored lanyard at designated anchorage point
- 工友把尾繩繫於指定的繫穩點

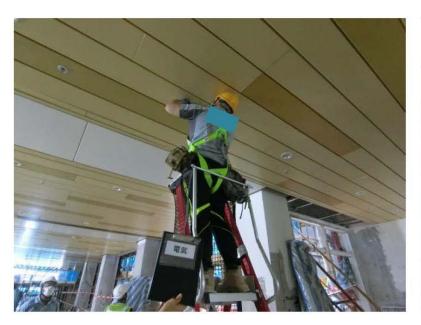
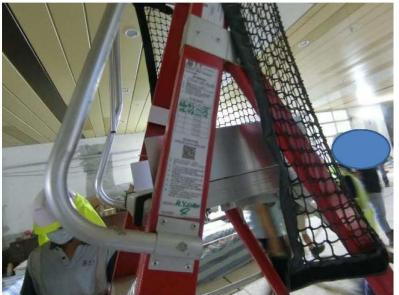
- Proper step platform was used
- 使用合規格的梯台

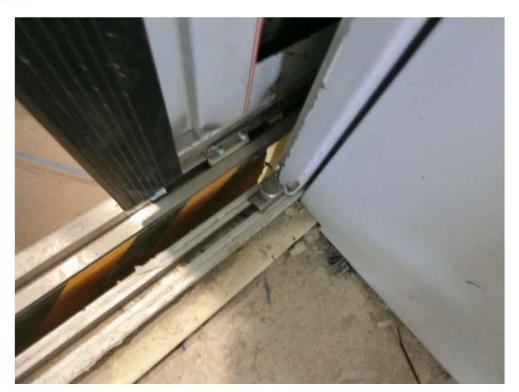
- Provision of door stopper
- 提供攝門器
