Housing Authority Surprise Safety Inspection Programme (SSIP) Good & Bad Practices for 2023 Q2 & Q3

2023 Q2 & Q3 良好及不良作業

職業安全健康局
OCCUPATIONAL SAFETY & HEALTH COUNCIL

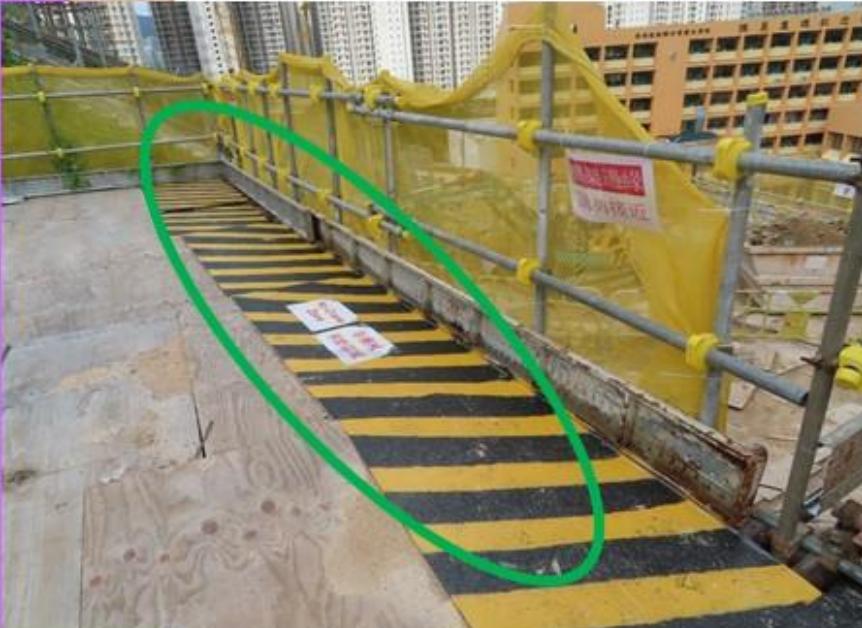
Pik Wan Road, Site A and Site B

Provision of clear identification of No Crane Zone on a timber scaffold on slope.

在杉棚架上面，很清晰看到良好的作業

臨近邊緣位置、承重力位置

不要擺放重型機械

要擺放在適當位置

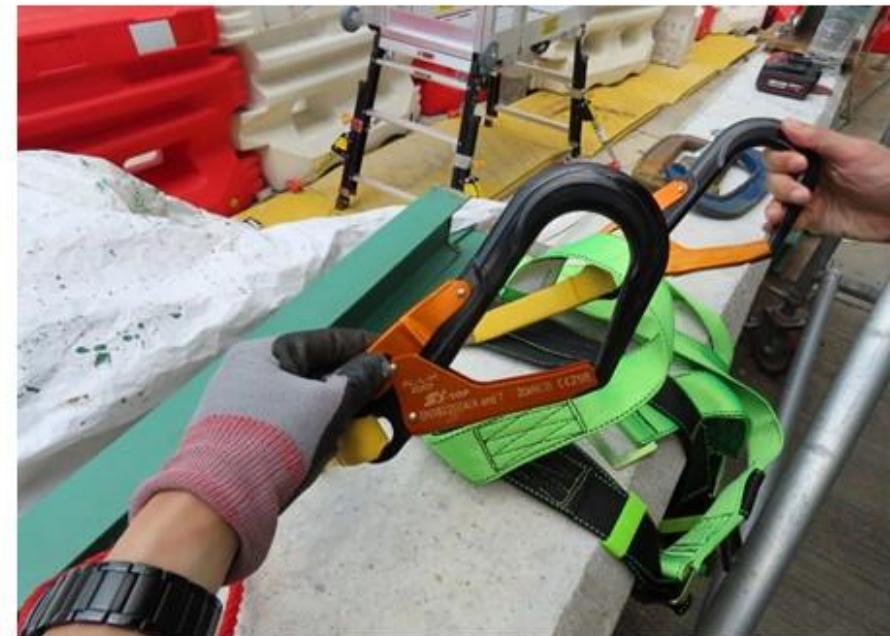
Hang Tai Road, Ma On Shan Area 86B Phase 2

Provision of light-duty PPE.

右面，我們鼓勵工人使用輕量的個人雙扣安全帶

傳統雙扣安全帶比較重

這個輕量版輕了大概是20至30%

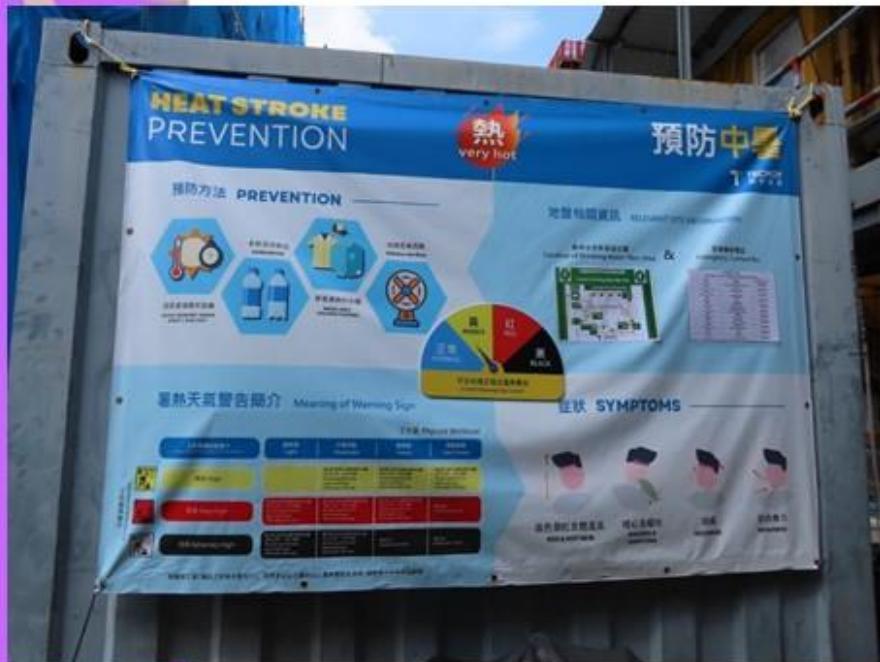
Sheung Shui Areas 4 and 30 Site 2 Phase 1

Provision of prevention of heat stroke information.

如果工人能夠在地盤

看到承建商提供的即時顯示屏板

知道當時的暑熱警告水平

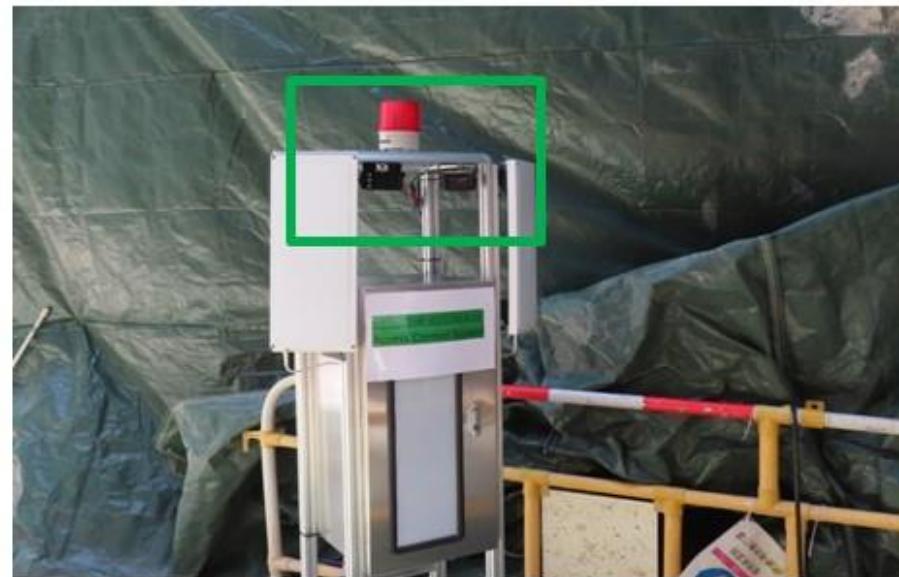
Fanling North Area 15 East Phase 2 and Yip On Factory Estate and Shek Lei Interim Housing

Use of real time camera monitoring alarm for safe access to and egress from the demolition site area to record unauthorized entry.

右面的拆卸工程

拆卸危險區

安裝實時監察系統

記錄有沒有未授權人士進入危險區

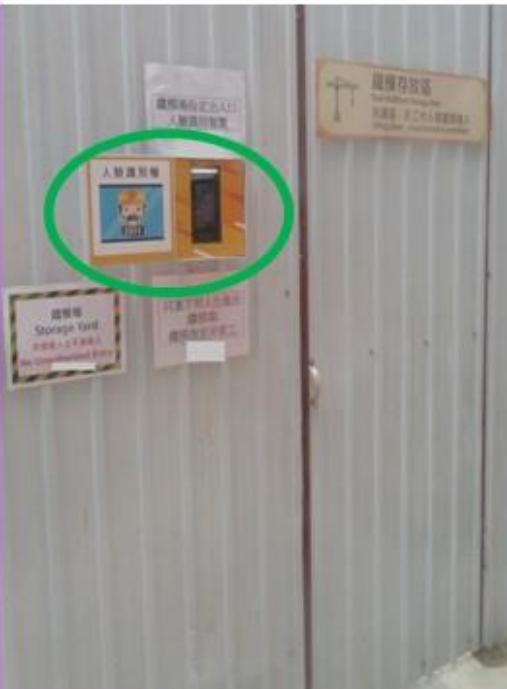
Sheung Shui Areas 4 and 30 Site 2 Phase 2 and Footbridge Works at Ching Hong Road North Phase 3

Use of facial recognition system for safe access to and egress from the storage yard of large metal formwork to prevent unauthorized entry.

另外大型物料的儲存處置

都是一些危險的位置，例如鐵模場等等

安裝人面識別系統

可以防止一些未授權人士進入危險區

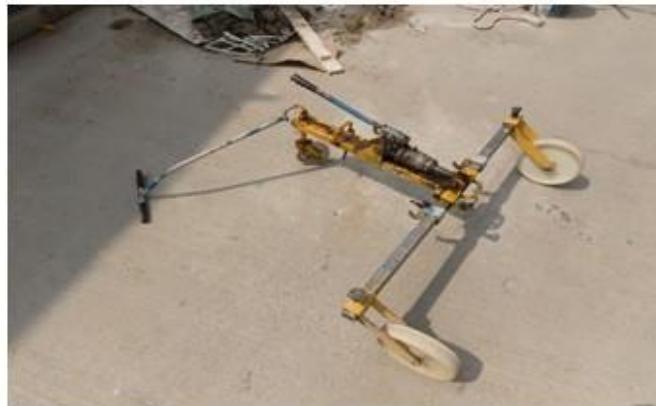
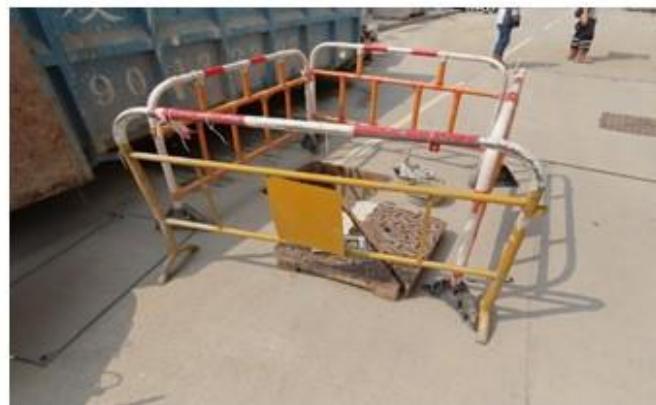
Ma On Shan Road and Hang Tai Road, Ma On Shan Area 86B Phase 1

Provision of mechanical aids for manual handling.

右面看到一些體力處理操作的輔助設備

讓工人打開渠蓋時使用
