HASAS(NW) – 2023Q2-2023Q3
Summary on Audit Findings
房委會安全稽核制度 - 2023年第2及第3季
安全稽核結果

Occupational Safety and Health Council
職業安全健康局

HASAS(NW) –2023Q2-2023Q3
Summary on Audit Findings (NSC)
房委會安全稽核制度 - 2023年第2及第3季
安全稽核結果(指名承判商)

HALENSAS –2023Q2-2023Q3
Summary on Good and Bad Practices
房屋委員會升降機及電梯指定分包合約安全稽核制度
2023年第2及第3季安全稽核結果

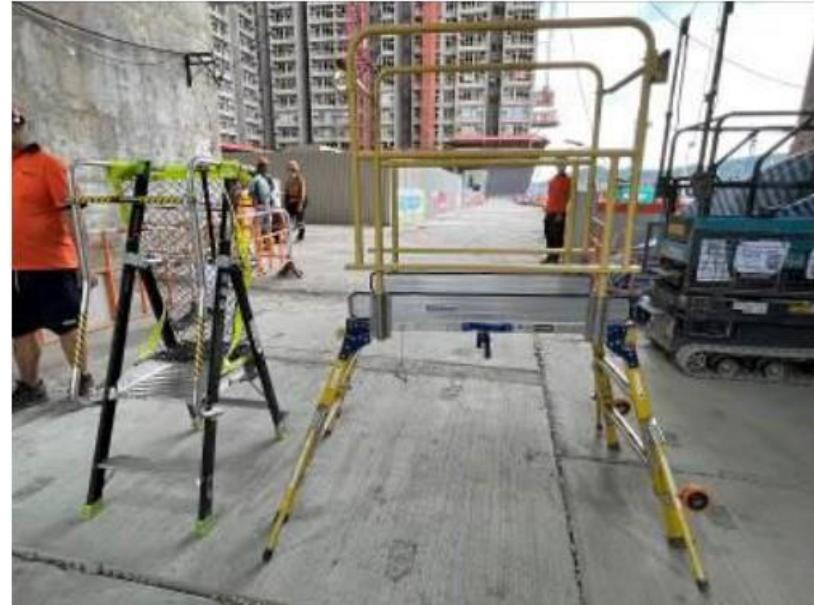
- Provision of suitable platform ladder and hop-up platform
- 提供合適梯台及功夫櫈

Sites generally used step platforms and hop-up platforms that met standards

The standard is EN131-7

which includes standards anti-tilt testing

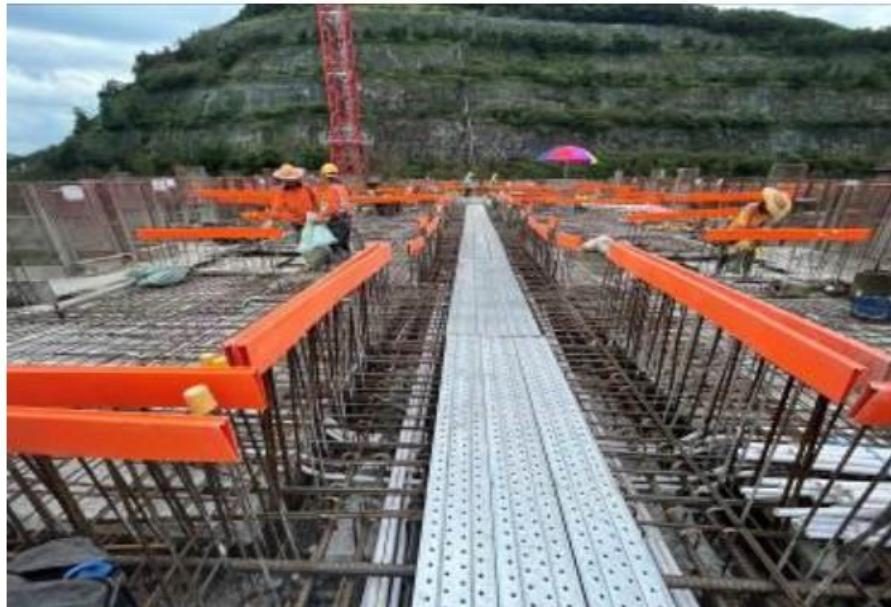
- Safe means of access & egress were properly maintained
- 為工作地點維持安全進出通道

Site housekeeping was good

for example, access was free from obstruction

protruding steel bars were protected

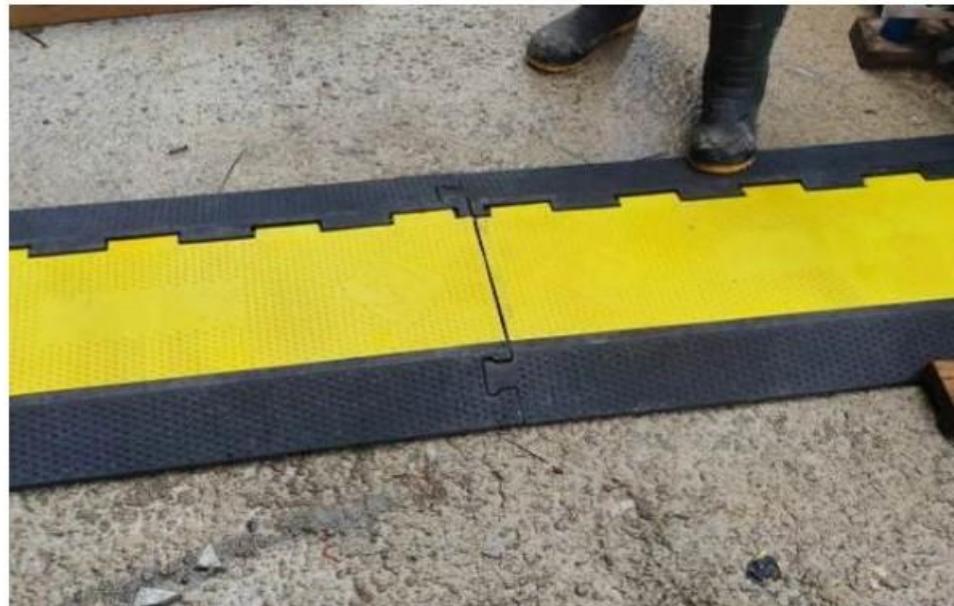
- Electric cable was properly protected
- 電線妥善保護

cables had sufficient protection

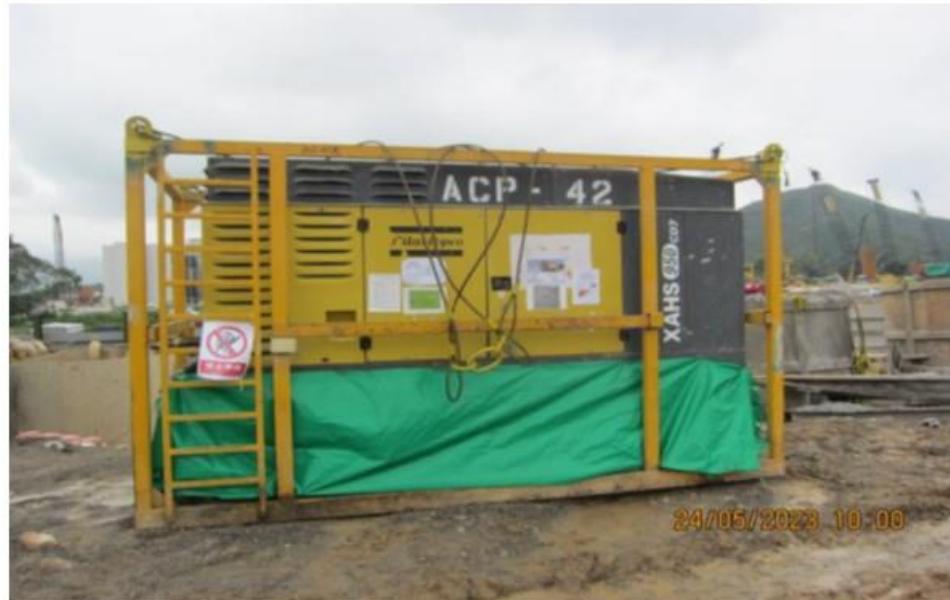
- Provision of wires for the steel frame housing air compressor to avoid rigging at height
- 於空氣壓縮機的吊架加裝接駁威以便埋碼員可以站於地上進行埋碼工作

Air compressors were placed in metal cages

with lifting chains on four corners

so that riggers can work safely from the ground

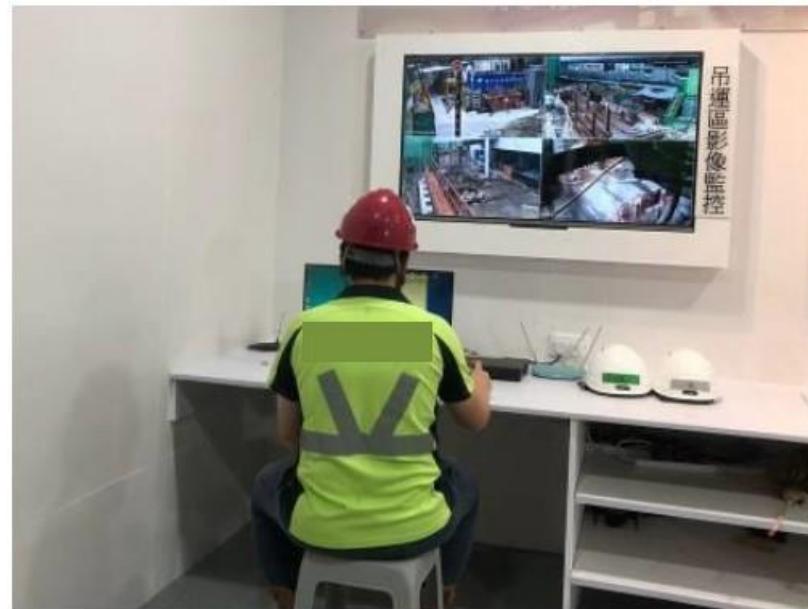
- CCTV system was installed for lifting zone
- 於吊運區安裝閉路電視監察系統

CCTV monitoring systems were installed in lifting zones

to safely monitor the lifting work

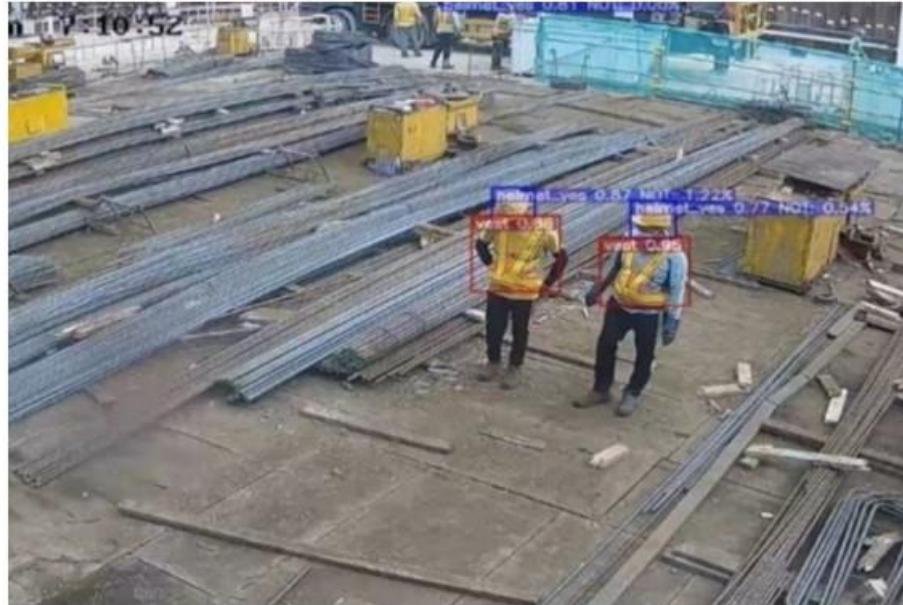
- Real time monitoring on proper wearing of safety helmet and reflective vest
- 實時監控安全帽、反光衣的正確佩戴情況

Some contractors used AI to monitor workers on site

checking proper use of safety helmets and reflective vests

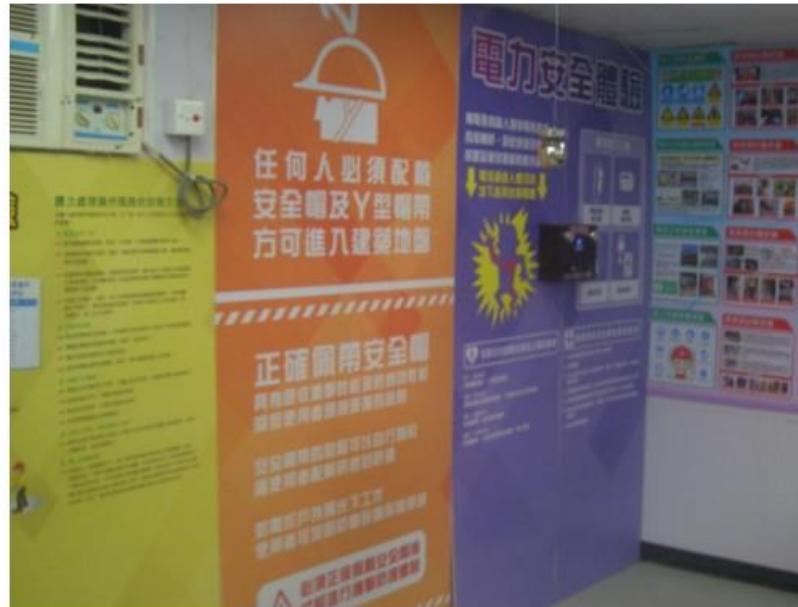
- Provision of somatosensory safety training facilities
- 提供體感安全訓練設施

Contractors also provided motion-sensing training equipment

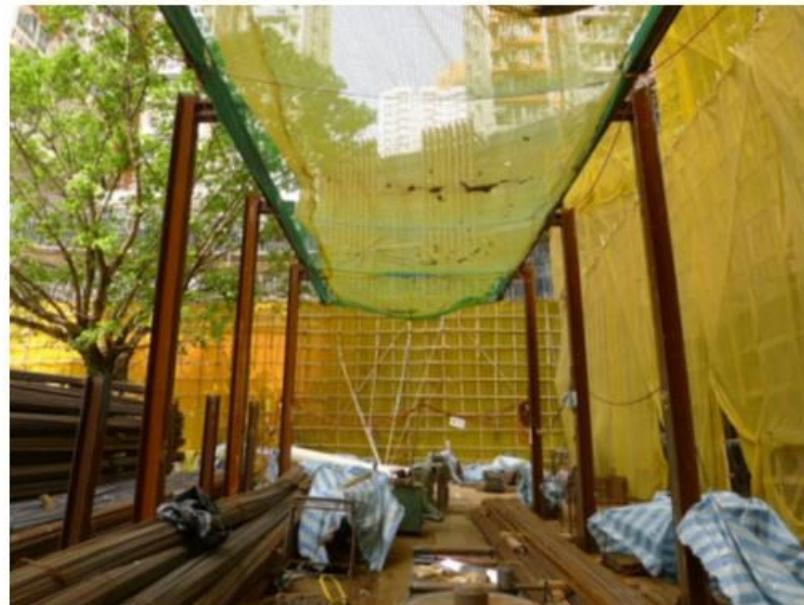
- Provision of electrically operated retractable net for steel bending yard
- 於扎鐵場上方提供電動開關保護網

and safety nets on site

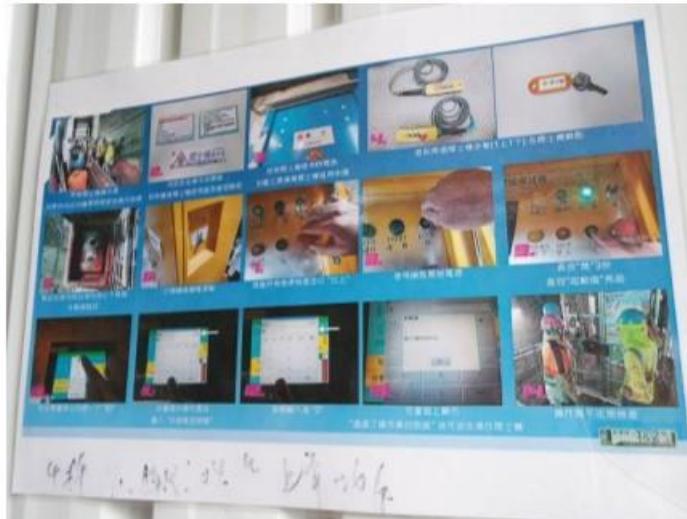
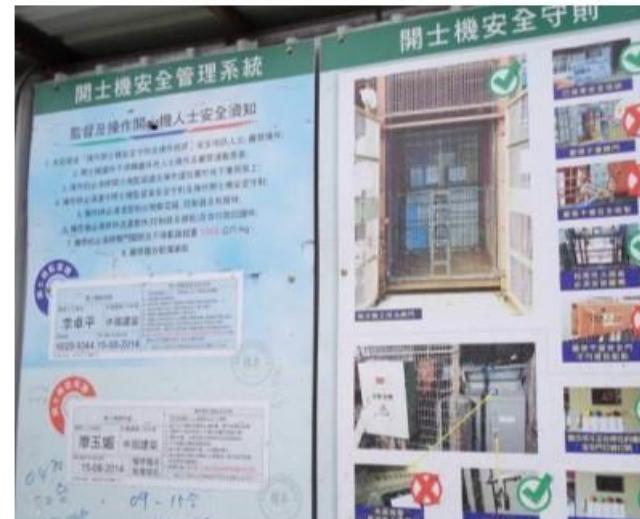
- Safe working procedure of operating material hoist was displayed
- 張貼物料吊重機的安全工作程序

Displaying safety operation procedures of using cranes

We strongly encourage contractors

to post method statements and work procedures on site

By using diagrams to explain the steps clearly

so workers can easily understand

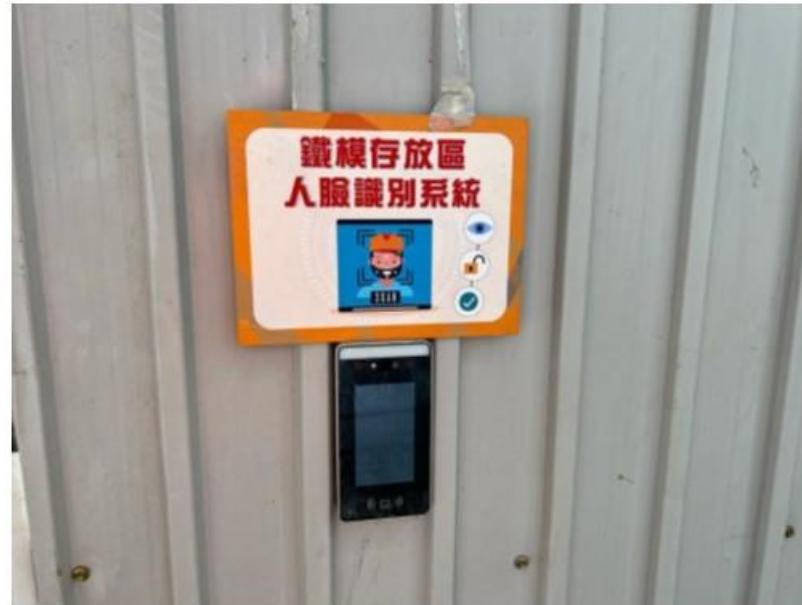
- Face recognition system at metal formwork storage area
- 於鐵模存放區安裝人臉識別系統

Facial recognition systems were installed in the formwork storage area

similar to a work permit system, allowing only authorised personnel to enter

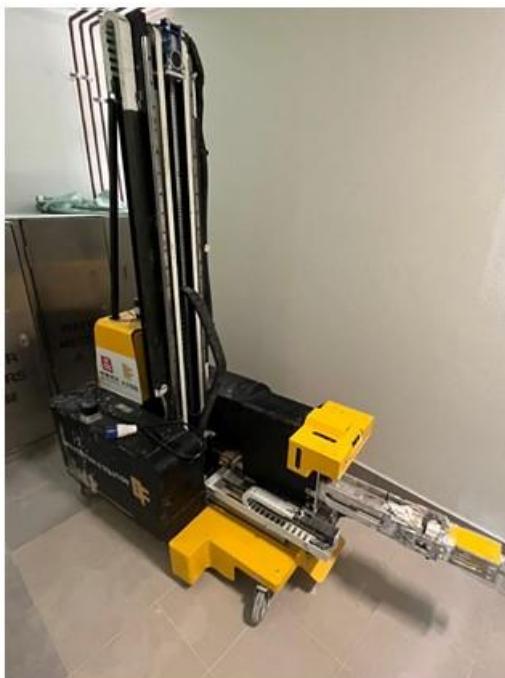
Skim coat robot

- The residential wall finishing robot is designed with multiple sensors and an AI recognition system. It has a maximum construction height of 3.3m, specifically for skim coat work. This advanced technology has the capability to reduce the workload of frontline workers and eliminate their exposure to various hazards.
- 這款智能牆面處理機器人可用於進行批灰工作，這配備多個感應器和人工智能識別系統，其最大施工高度可達3.3米。這項技術可以減輕工人的工作負擔，同時減少工人曝露於不同工序下所產生的危害。

a plastering robot was introduced on site

reducing workers' exposure to hazardous situations

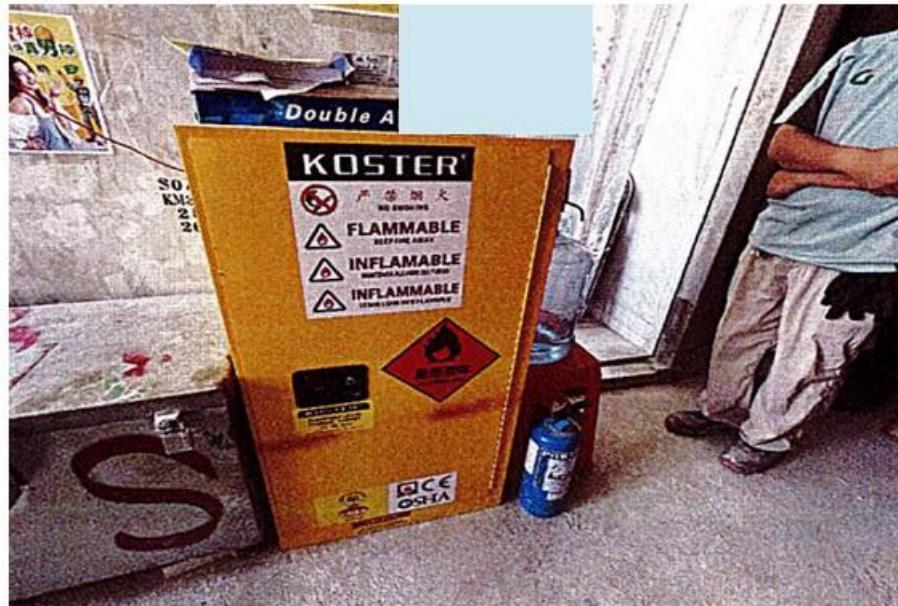
- Flammable storage cabinet was provided
- 提供易燃物品儲存櫃

to install flammable materials storage cabinets

which all comply with standards

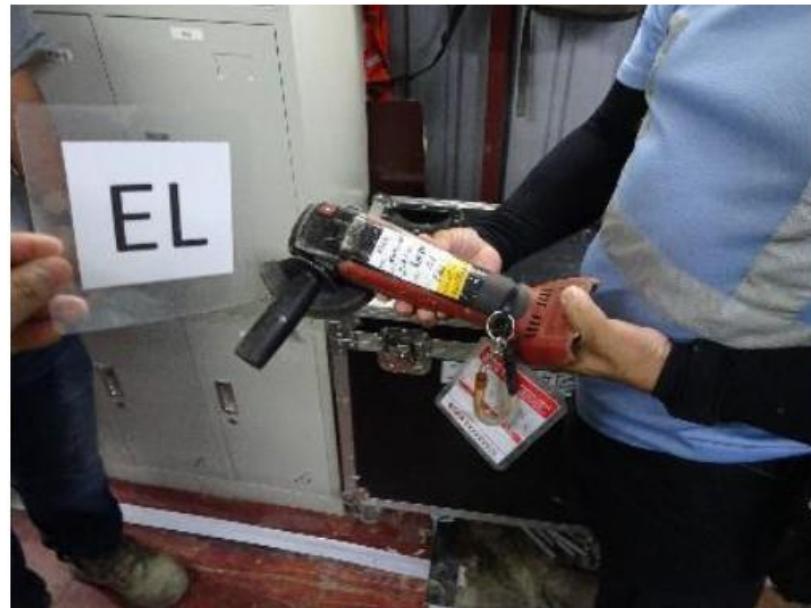
- Proper guarding and auxiliary handle were provided for angle grinder
- 角磨機安裝護罩及輔助手柄

Angle grinders were equipped with auxiliary handles

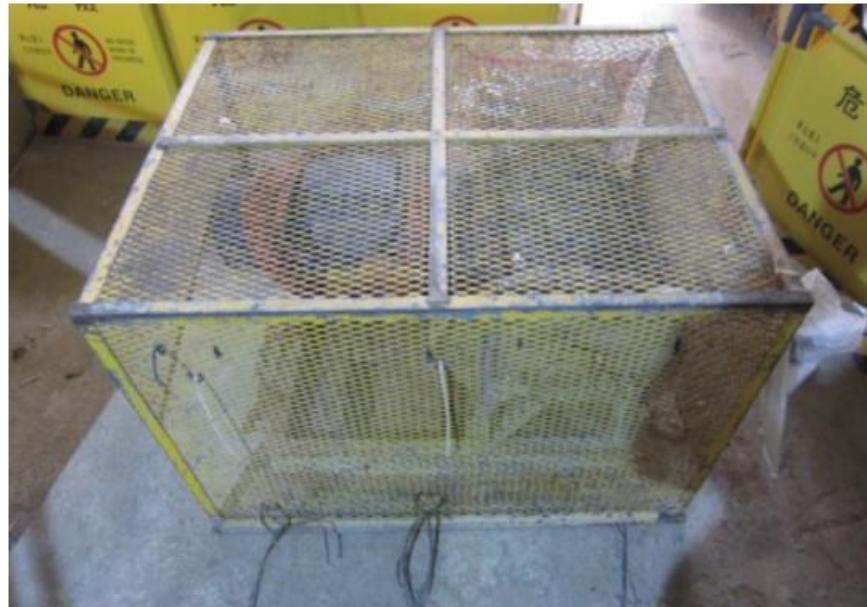
- Dangerous parts of winch was properly guarded
- 為絞車的轉動部份提供合適護罩

unused winches had guards on moving parts

to prevent workers from the hazardous components

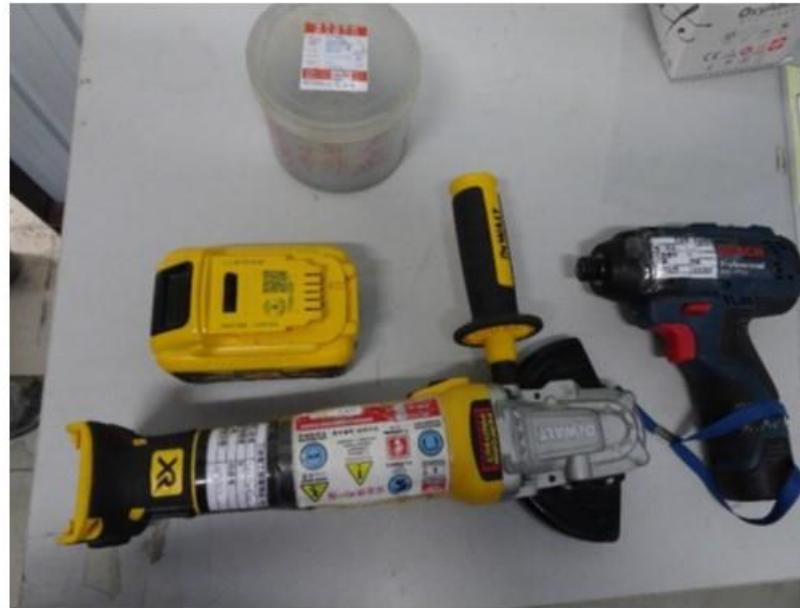
- Guarding and auxiliary handle were installed for angle grinder
- 為角磨機安裝護罩及輔助手柄

Angle grinders had guards and handles

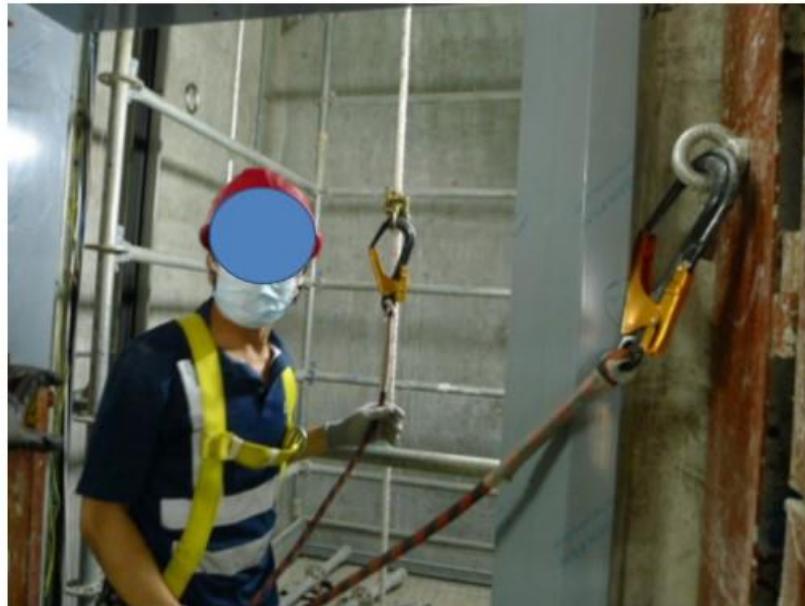
- Proper use of lanyard
- 正確使用尾繩

This photo shows the correct use of lanyards

When correctly using the twin lanyards

the main lanyard from the harness should be clipped to an independent fall arrest anchor

while the other lanyard on the right acts as backup

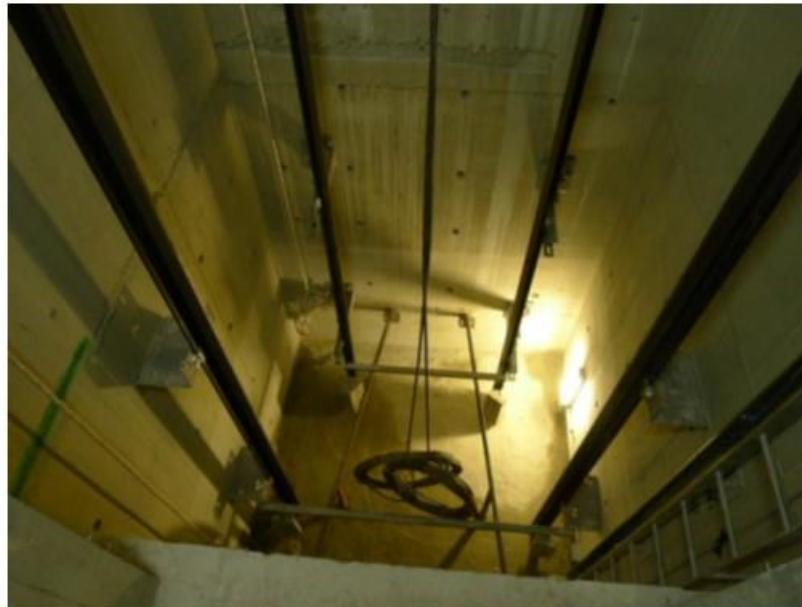
- Lift pit was maintained clean
- 井底保持整潔

This photo shows good housekeeping at the bottom of a shaft
