# Housing Authority Surprise Safety Inspection Programme (SSIP)

Good & Bad Practices for 2023 Q2 & Q3

香港房屋委員會  
突擊安全巡查計劃

2023 Q2 & Q3 良好及不良作業

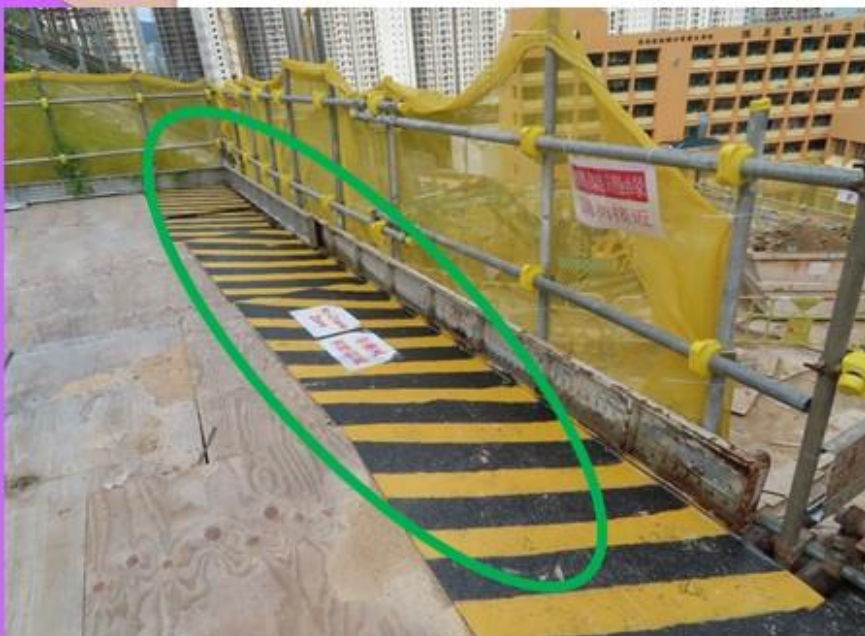
Pik Wan Road, Site A and Site B

Provision of clear identification of No Crane Zone on a timber scaffold on slope.

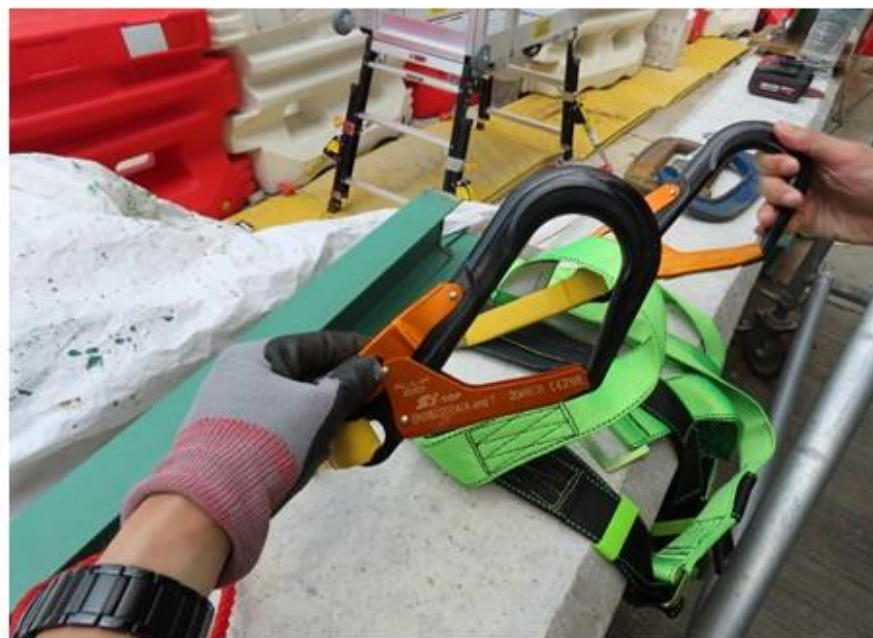
Hang Tai Road, Ma On Shan Area 86B Phase 2

Provision of light-duty PPE.

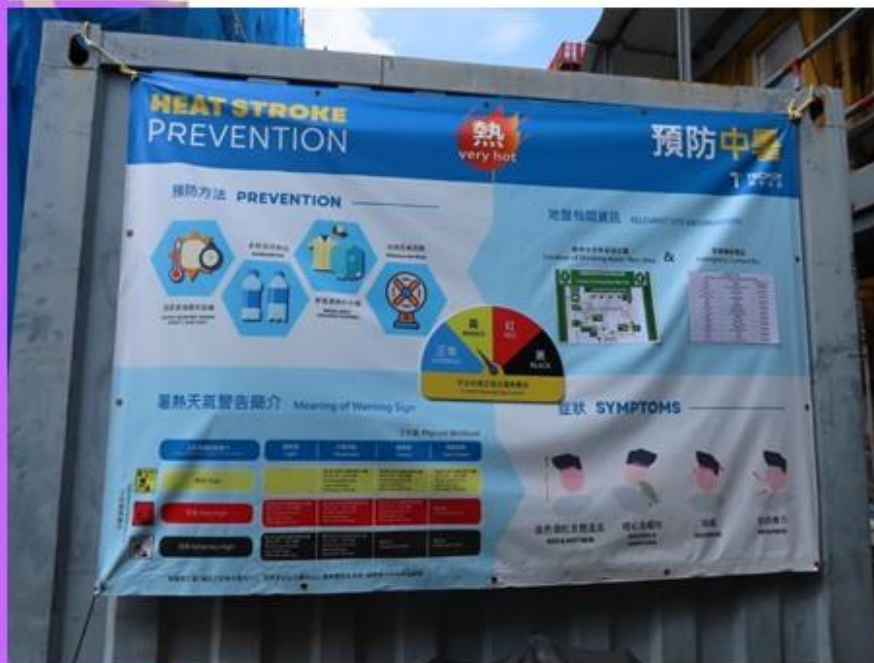
Sheung Shui Areas 4 and 30 Site 2 Phase 1

Provision of prevention of heat stroke information.

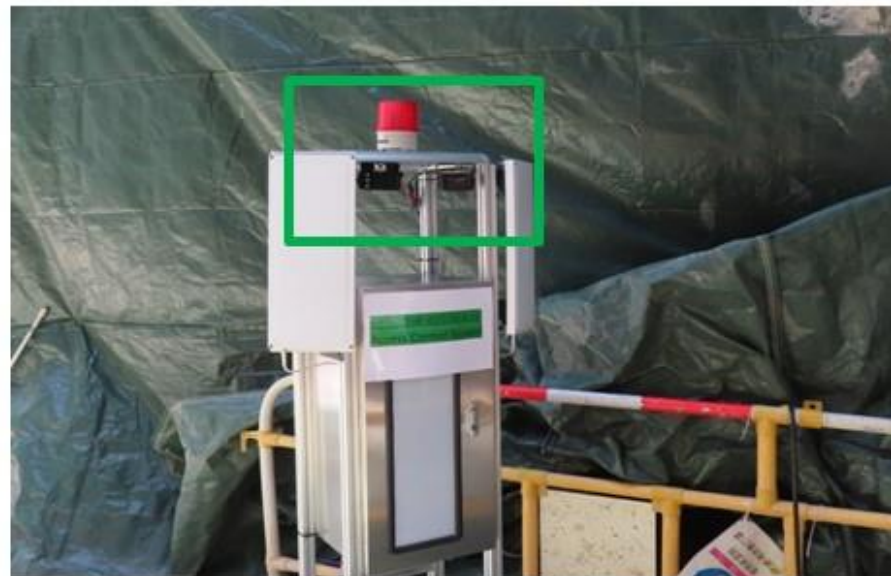
Fanling North Area 15 East Phase 2 and Yip On Factory Estate and Shek Lei Interim Housing

Use of real time camera monitoring alarm for safe access to and egress from the demolition site area to record unauthorized entry.

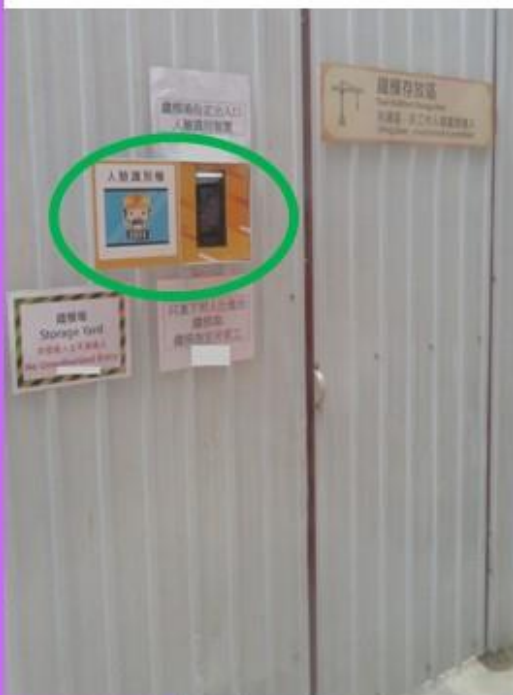
Sheung Shui Areas 4 and 30 Site 2 Phase 2 and Footbridge Works at Ching Hong Road North Phase 3

Use of facial recognition system for safe access to and egress from the storage yard of large metal formwork to prevent unauthorized entry.

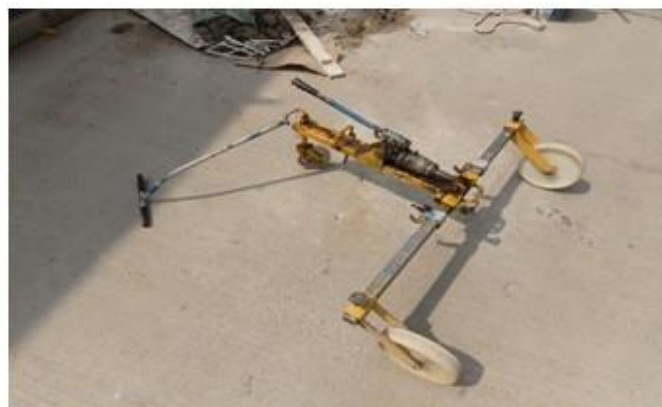
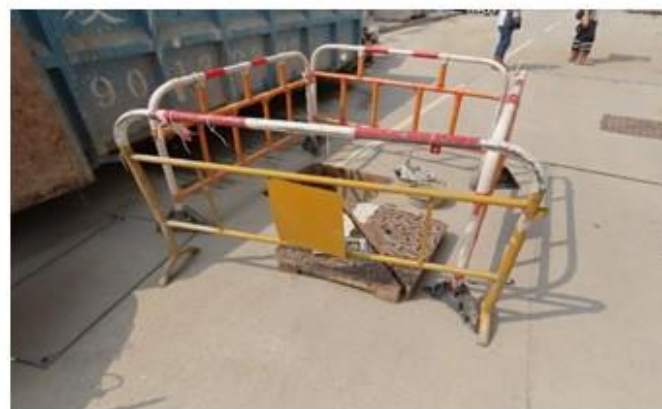
Ma On Shan Road and Hang Tai Road, Ma On Shan Area 86B Phase 1

Provision of mechanical aids for manual handling.
