HASAS(NW) – 2023Q4-2024Q1
Summary on Audit Findings
房委會安全稽核制度 - 2023年第4季及-2024年第1季
安全稽核結果

HASAS(NW) –2023Q4-2024Q1
Summary on Audit Findings (NSC)
房委會安全稽核制度 - 2023年第4季及2024年第1季
安全稽核結果(指名承判商)

HALENSAS –2023Q4-2024Q1
Summary on Good and Bad Practices
房屋委員會升降機及電梯指定分包合約安全稽核制度
2023年第4季及2024第1季年安全稽核結果

Housing Authority Safety Auditing System (HASAS) (For Building and Engineering Contracts)

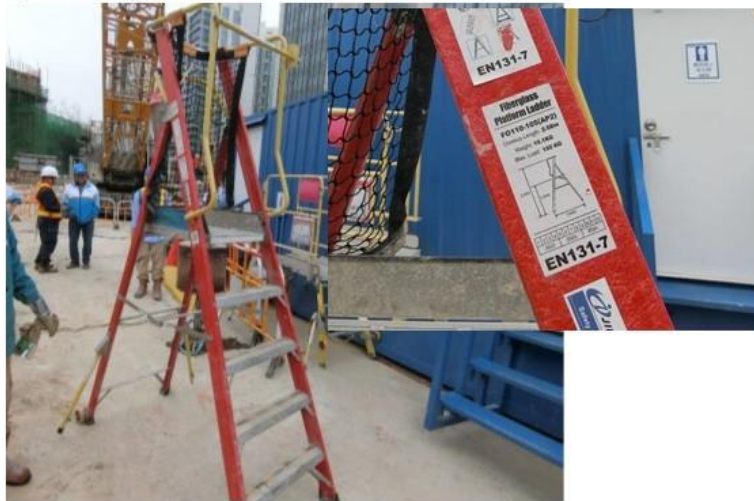
- Provision of suitable platform ladder and hop-up platform for work-above-ground
- 提供合適梯台及功夫橈進行離地工作
- Provision of protection for the independent lifeline
- 為獨立救生繩提供合適保護

On the left, there is a step platform

A closer look shows it meets the EN131-7 standard
which is our current compliance benchmark

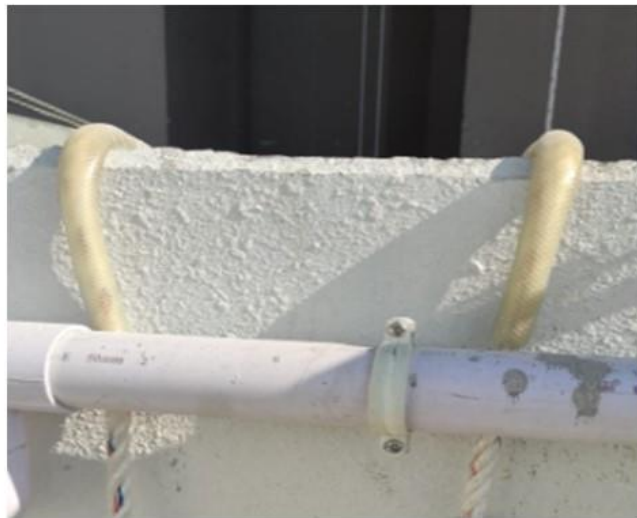
Next to it, there are independent lifelines
with sufficient protection

ensuring they won't easily wear out
even if rubbing against column edges

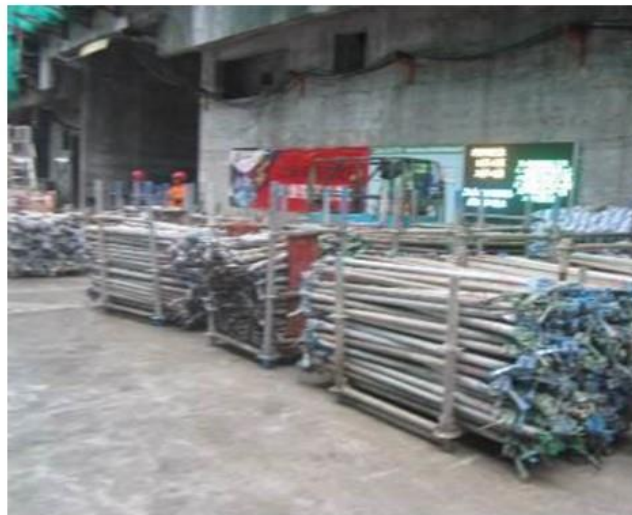
- Materials were properly stored
- 物料妥善存放

For material storage

there are also some good practices

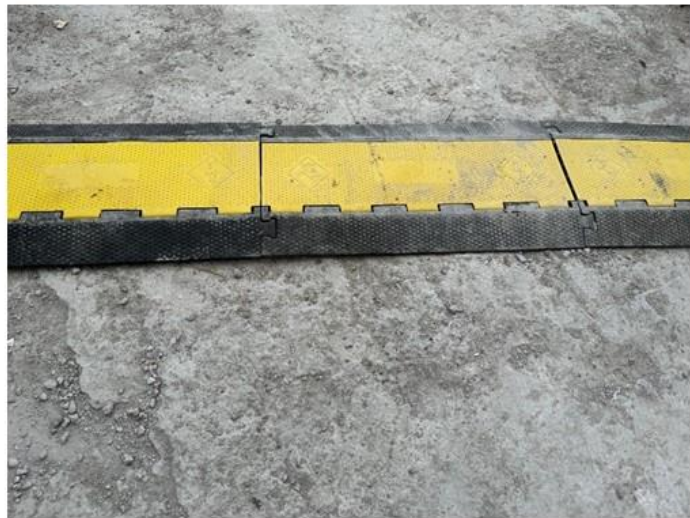
- Electric cable was properly protected
- 電線妥善保護

This shows cable protection

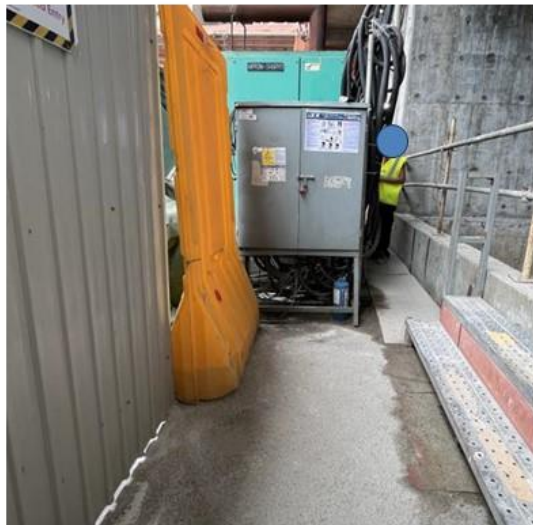
- Access to distribution board was provided
- 提供通道通往電箱位置

On the right is a passageway
leading to the electrical panel, which is an ideal
and a good practice example

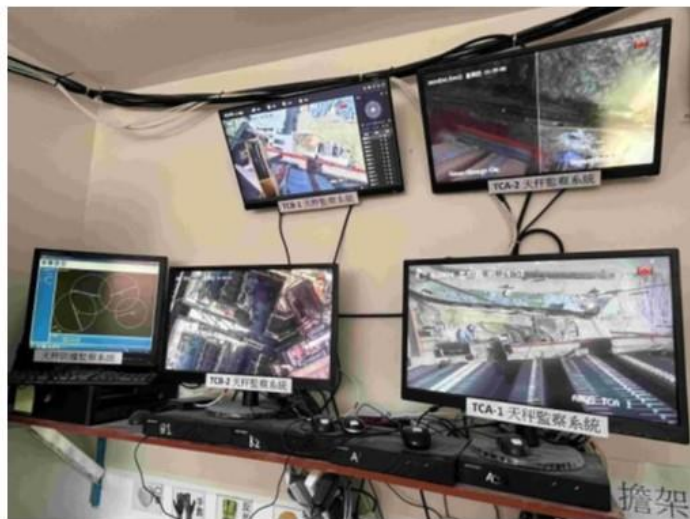
- CCTV system was installed for lifting zone
- 於吊運區安裝閉路電視監察系統

The lifting zone has a CCTV monitoring system

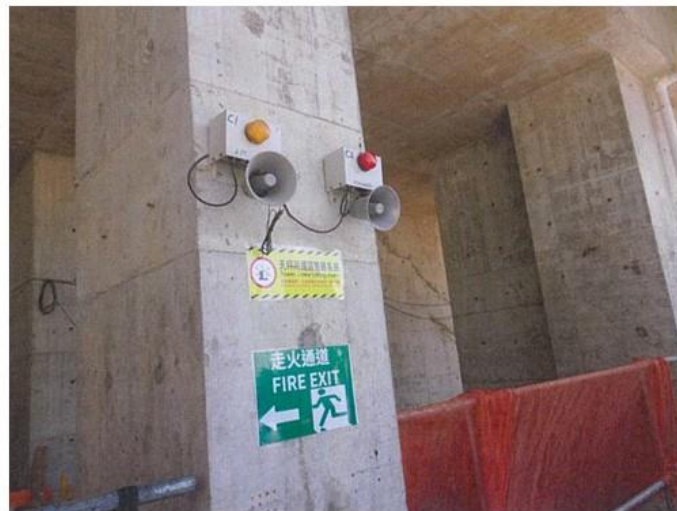
- A visual and audio alarm system was installed for lifting zone
- 於吊運區安裝視聽警報系統

On the right, there is also an alarm system
both of them are part of the Housing Department's contract specifications

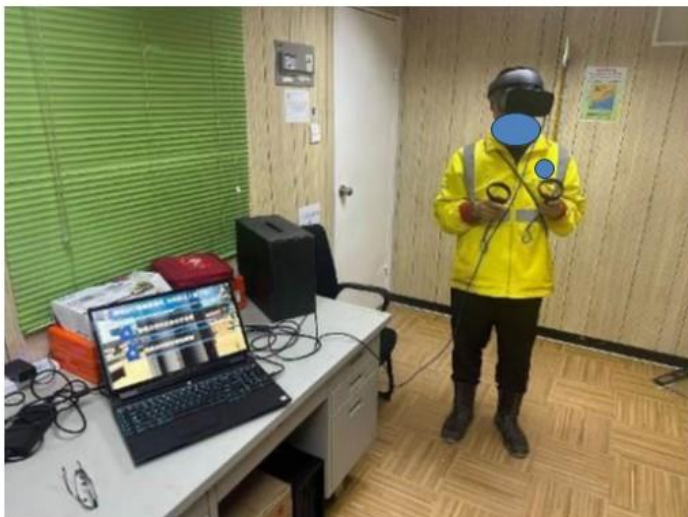
Most sites now provide VR safety training
which is also included in the Housing Department's new contract requirements

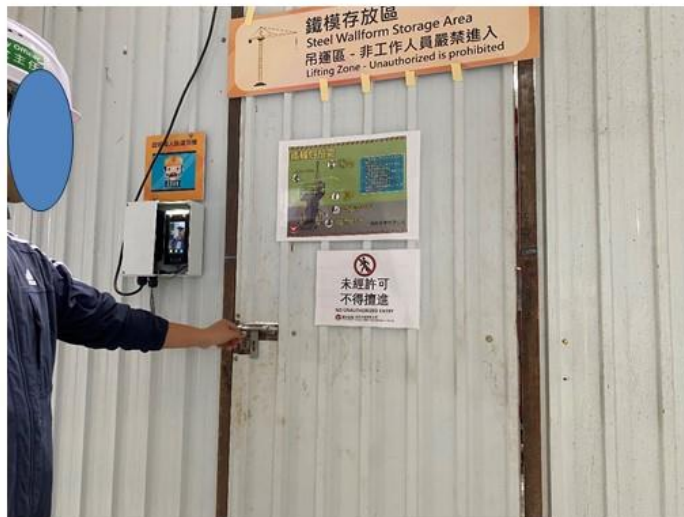
On the right, contractors have implemented facial recognition systems
to restrict access to areas like steel formwork storage

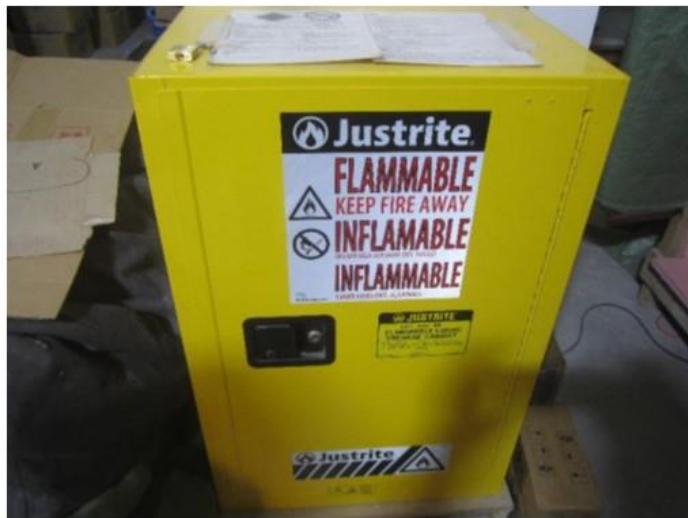
- Proper storage of chemical substances
- 化學物品妥善存放

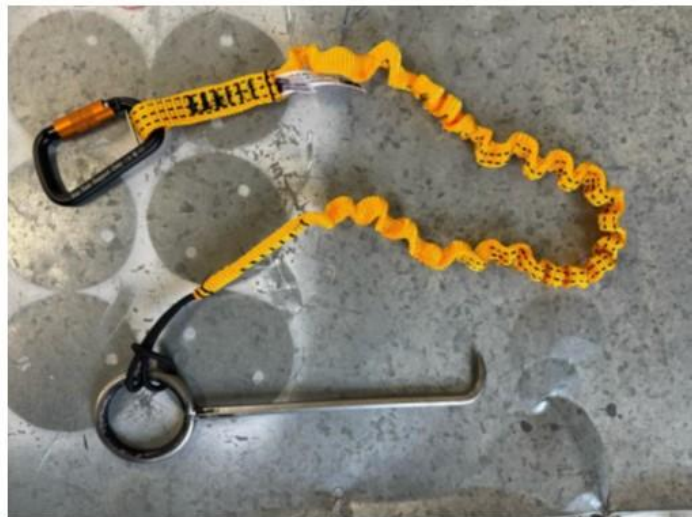
- Provision of hand strap for hand tools
- 為手工具提供手繩

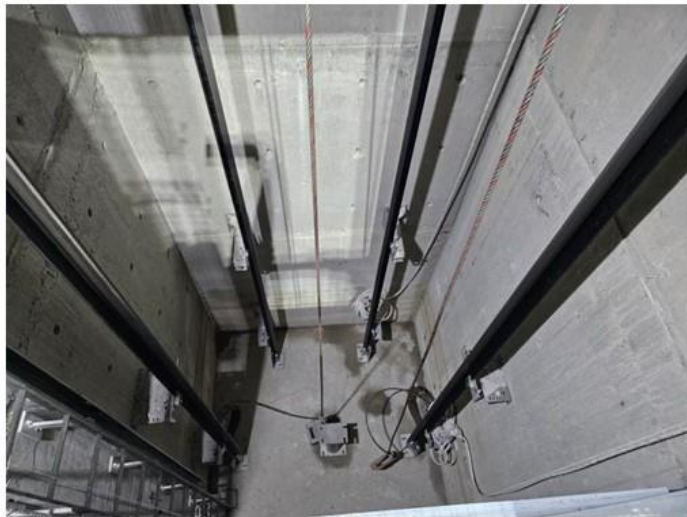
- Lift pit was maintained clean
- 井底保持整潔

As for the lifts, overall performance has been good
the bottom of the lift shaft looks tidy

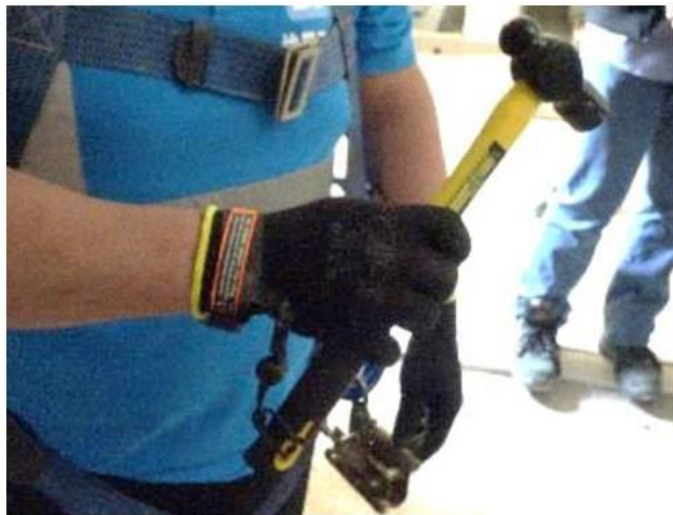
- Provision of hand strap for hand tools
- 為手工具提供手繩

some hand straps have also been used
