HASAS(NW) – 2025Q2-2025Q3  
Summary on Audit Findings  
房委會安全稽核制度 - 2025年第2季及-2025年第3季  
安全稽核結果

HASAS(NW) –2025Q2-2025Q3  
Summary on Audit Findings (NSC)  
房委會安全稽核制度 - 2025年第2季及2025年第3季  
安全稽核結果(指名承判商)

HALENSAS –2025Q2-2025Q3  
Summary on Good and Bad Practices  
房屋委員會升降機及電梯指定分包合約安全稽核制度  
2025年第2季及2025第3季年安全稽核結果

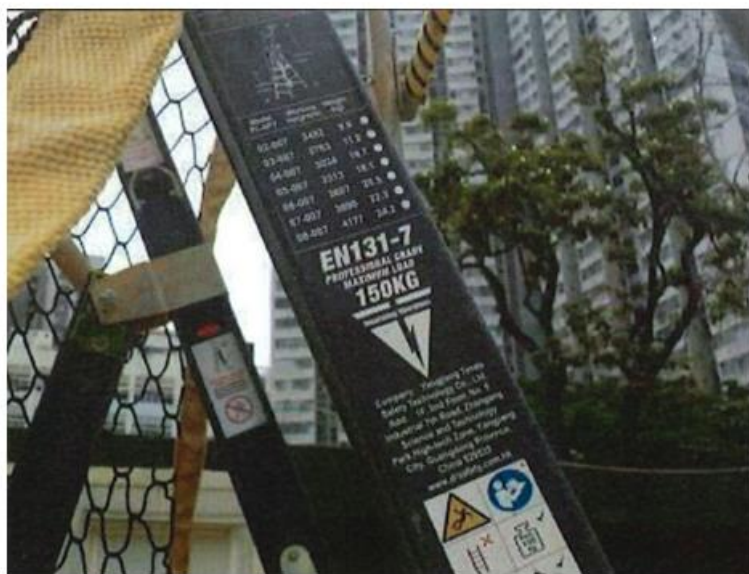
- Provision of suitable light-duty working platform
- 提供符合安全標準的輕便工作台
- Provision of Safe means of access
- 提供良好進出通道

In the photo on the left, we can see that many sites have already used

step platforms that comply with the EN131-7 standard

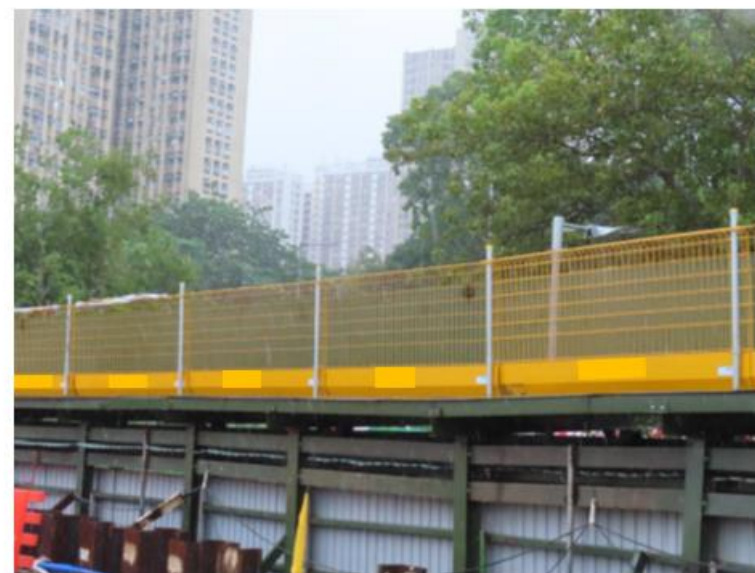
In the photo on the right, we can also see that the access route is

provided with adequate guardrails and toe boards

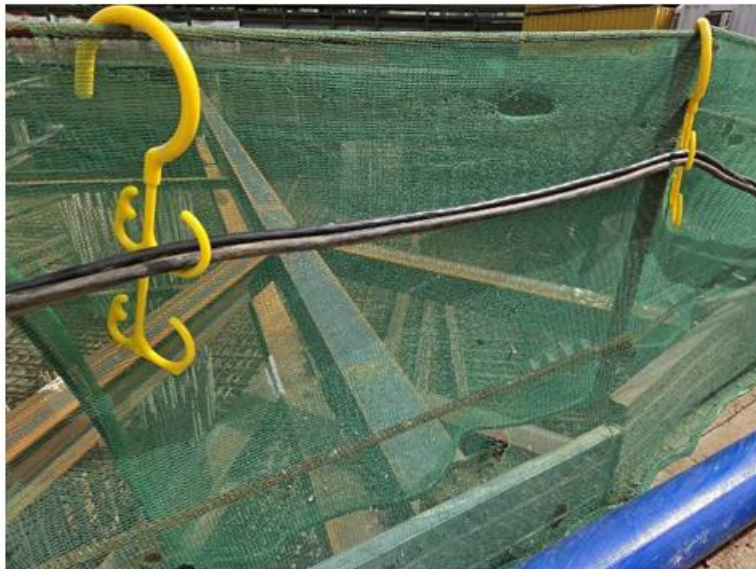
- Provision of cable hangers
- 提供電線掛架

cable hangers are provided to keep electrical cables elevated

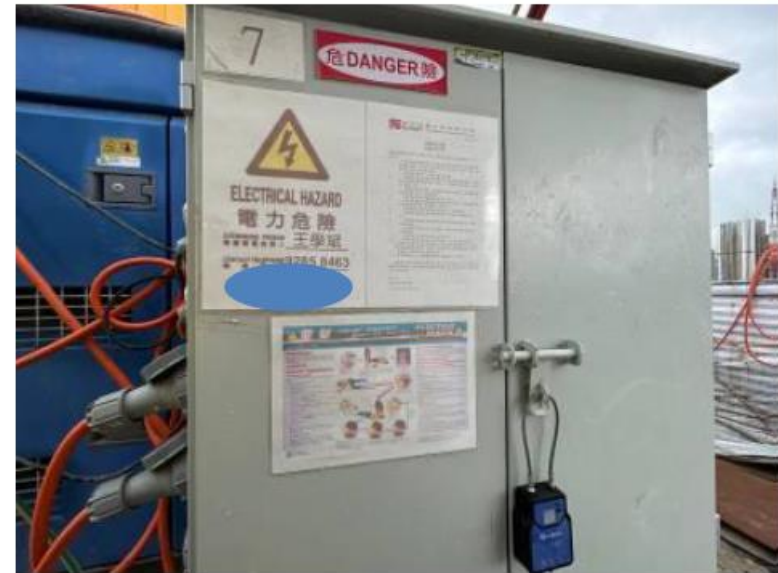
- Temporary distribution board was locked properly
- 臨時配電箱妥善鎖好

On the right, we can also see a distribution box

set up according to the Housing Department contract requirements

At present, many of them have been changed to electronic locks

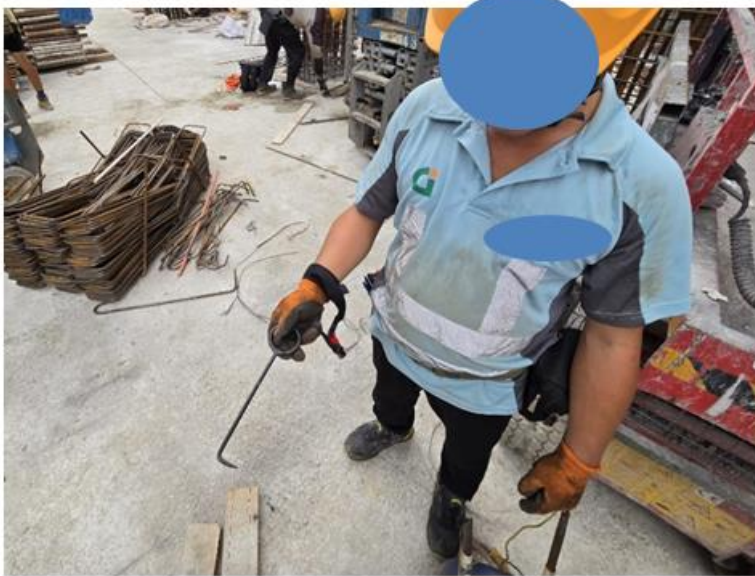
- Hand tool with tool strap
- 手工具配有工具尾繩

on the left, we can see the use of tool lanyards

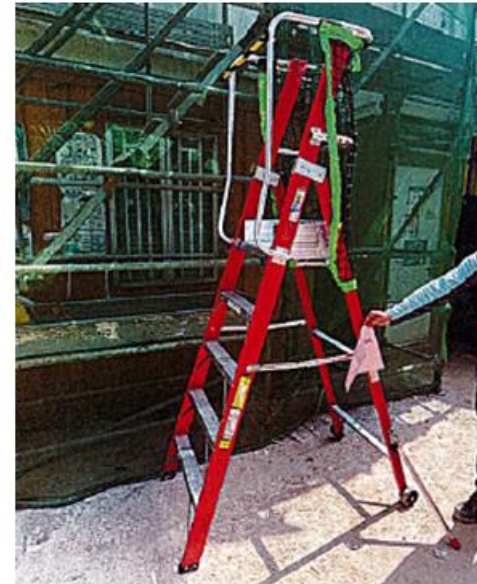
- Use of light duty working platform with compliance of EN131-7
- 使用符合EN131-7的輕便工作台

and EN131-7 step platforms are also used

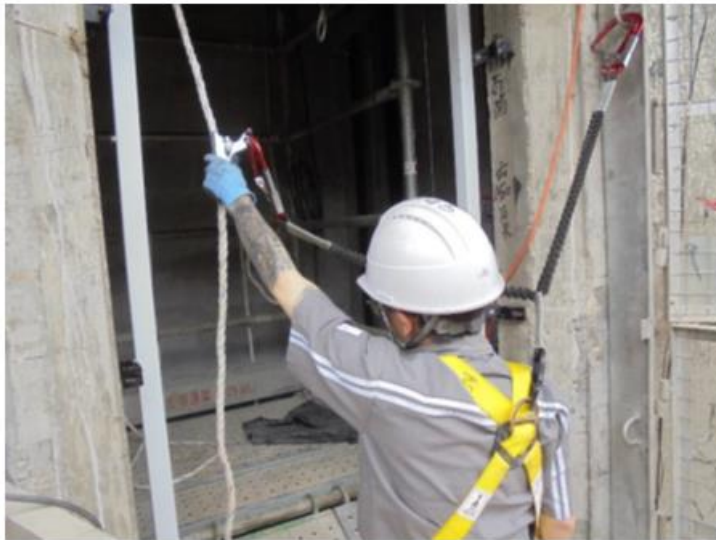
- Proper use of fall-arresting system
- 使用合適防墮裝置

For fall protection devices

the connector of the safety harness is directly attached to the fall arrester

This is the correct practice

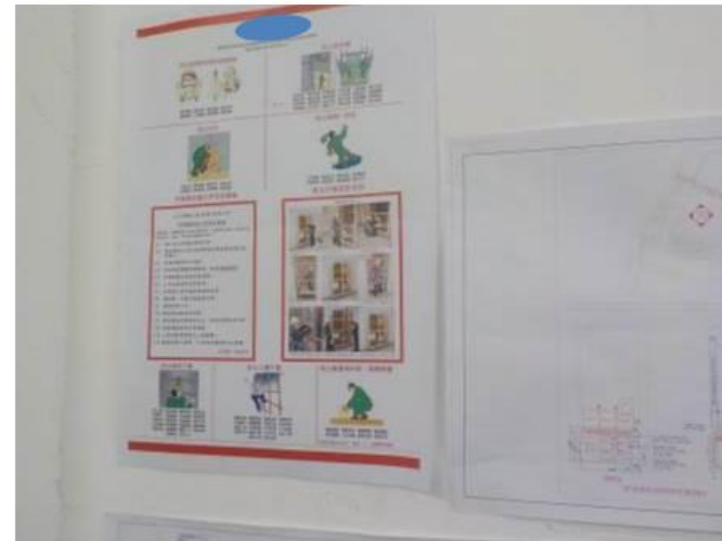
- Display of pictorial safe working procedures
- 顯示圖像化的安全工作程序

In addition, we can also see some visualised work procedures

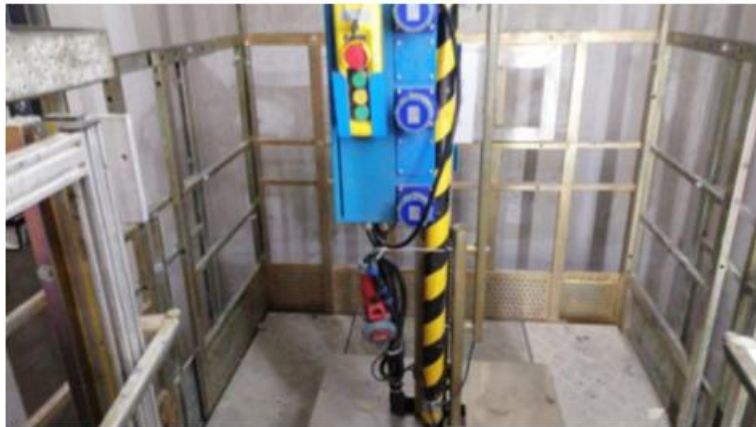
The guided suspended working platform

is provided with suitable guardrails and toe boards

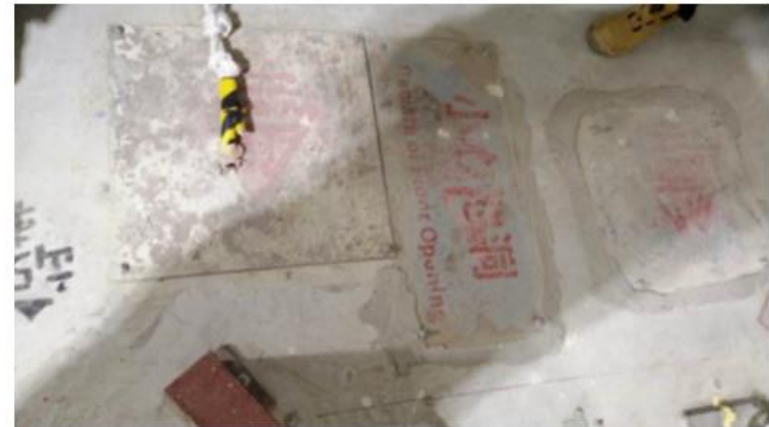
and openings are also securely covered
