**Memorandum for the Building Committee of
the Hong Kong Housing Authority**

**Asbestos Management in
Existing Old Public Rental Housing Estates**

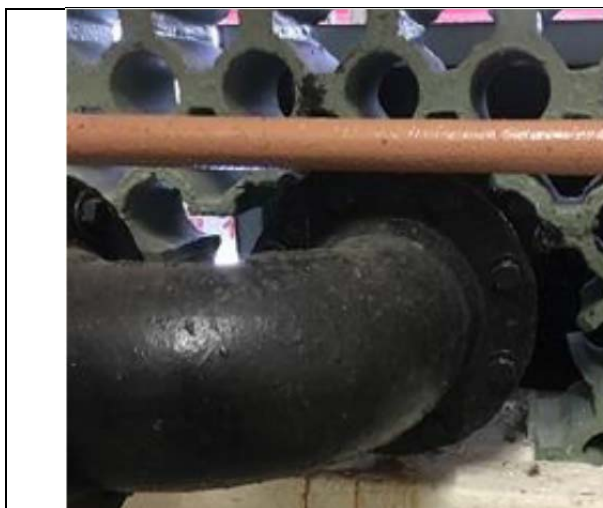
The grilles are found in good condition except about 4 to 6% are found to have minor defects or disturbed (see photos at **Annex C**). So far, all air samples taken at those grilles with minor defects or disturbed are in order, i.e. not exceeding 0.01 fibre/mL. The registered asbestos consultant considers that no repair action is required.

Disturbed grille panel

- (a) **Staircase and lift lobby grilles** – As mentioned in paragraph 8(a) above, about 4 to 6% grilles inspected are found to have minor defects or disturbed. Despite the registered asbestos consultant considers that no repair action is required, these grille panels will be prioritized for removal based on their condition under a planned programme.

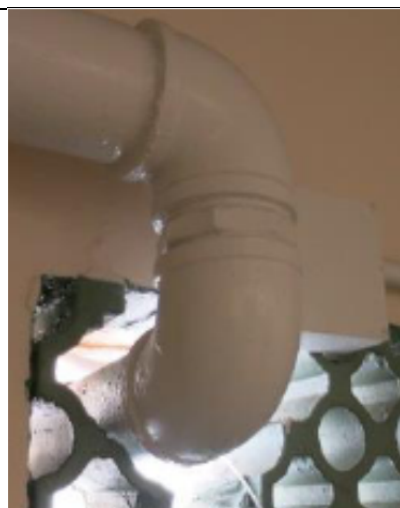
Disturbed grille panel

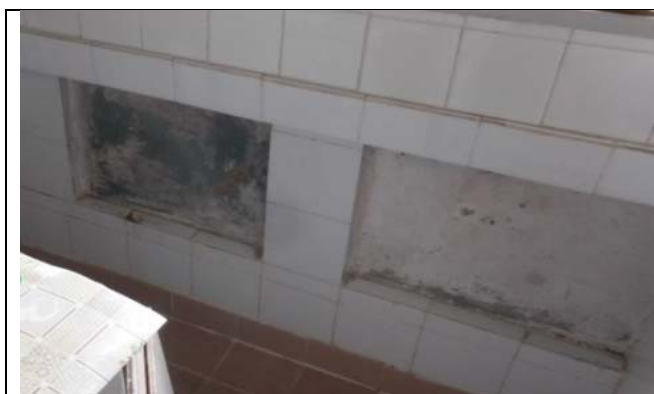
- (i) Seven flats in these two estates are found with defects requiring follow-up action. Additionally, in Hing Wah (II) Estate, two flats are found with internal encapsulation missing.
- (ii) In about 25% of the surveyed flats, tenants have fixed racks, hangers, screws and nails on the encapsulated ACM balcony grilles.
- (iii) Minor cracks, holes, damage and protruding pipes are found at external side of some encapsulated grilles.
- (iv) Unauthorized air conditioner supporting frames are found mounted on the external walls of 17 flats in Hing Wah (II) Estate.

Disturbed encapsulation

- (b) **Encapsulated Balcony grilles at domestic flats** – We have removed, re-encapsulated or segregated the grilles in the nine flats mentioned in paragraph 8(b)(i). Tenants will be reminded not to fix racks, hangers, nails or screws on the encapsulated grilles as depicted in paragraph 8(b)(ii). To take one step further, we will conduct repair works at the external walls mentioned in paragraph 8(b)(iii). Tenants will be advised to relocate the unauthorized air conditioners mentioned in paragraph 8(b)(iv) and the supporting frames will be removed by registered asbestos contractor. In the long term, ACM balcony grilles will be considered for removal during vacant flat refurbishment on condition-driven basis.

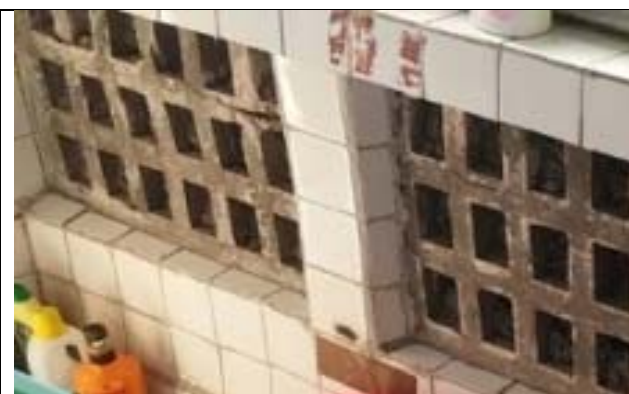
Missing encapsulation

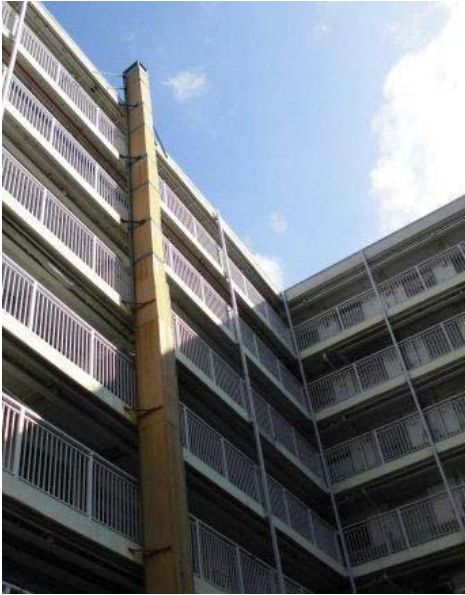
Chimney

Air samples collected so far at the chimney outlets, are in order, i.e. not exceeding 0.01 fibre/mL. Minor defects are found in the enclosures of some chimneys (see photos at **Annex C**). The registered asbestos consultant considers that no repair action is required in most cases except in Wah Fu (I) Estate where repair of the enclosure is being arranged.

- (c) **Chimneys** – We will continue to monitor the conditions of the ACM chimneys. Immediate repair will be made to the enclosure of the defective chimneys. Where opportunity arises, the ACM chimneys which are not in use, will be sealed up or removed altogether. For chimneys belonging to other owners, we will share with them our information on the ACM and their maintenance obligations^{Note 4}.
