Other practices 其他作業方式

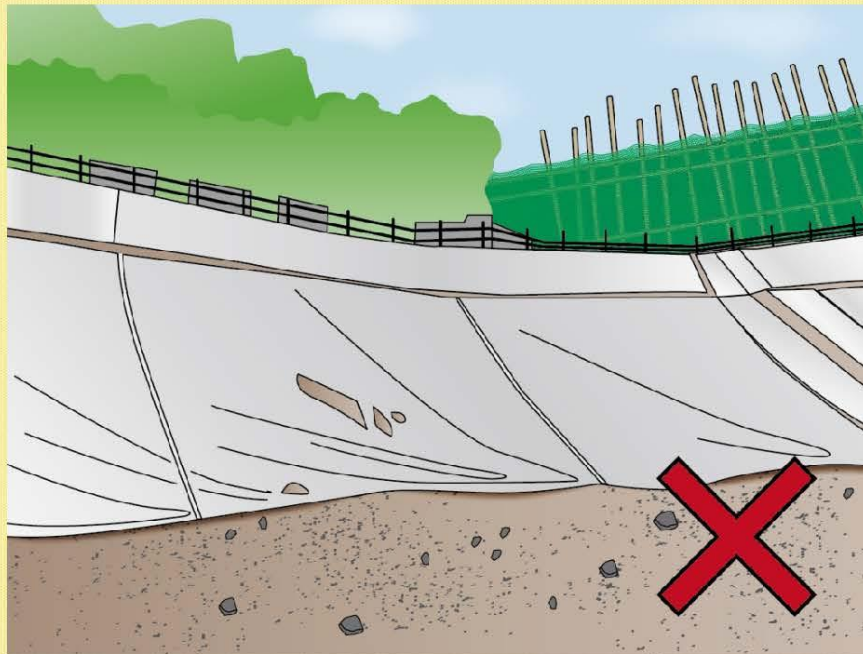
- No protection on slope edge
- 斜坡邊緣沒有保護

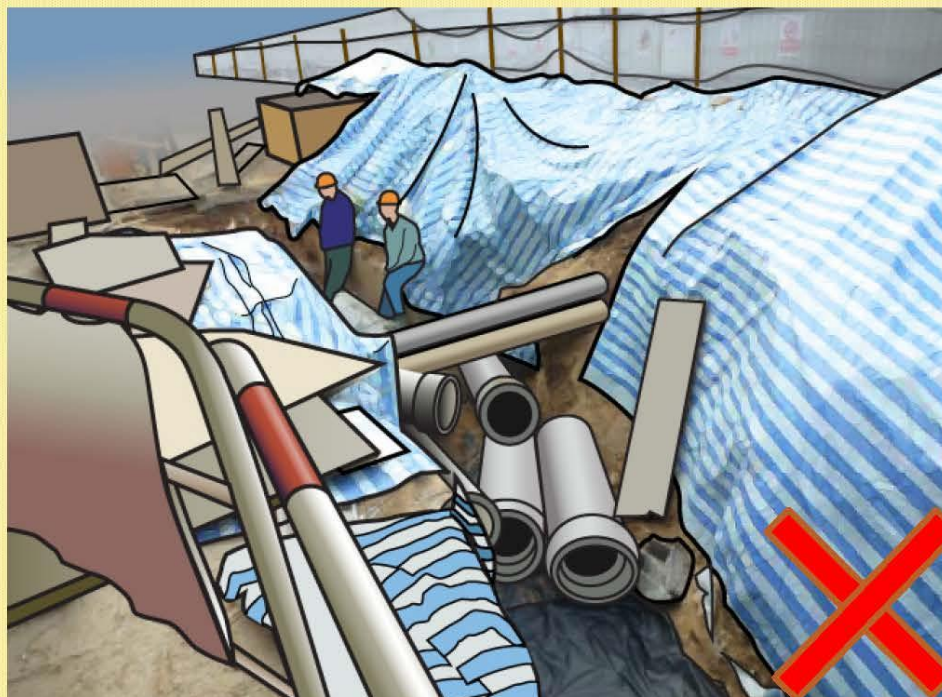
- Insufficient shoring in trenching works
- 壕坑挖掘工程沒有足夠的橫撐板

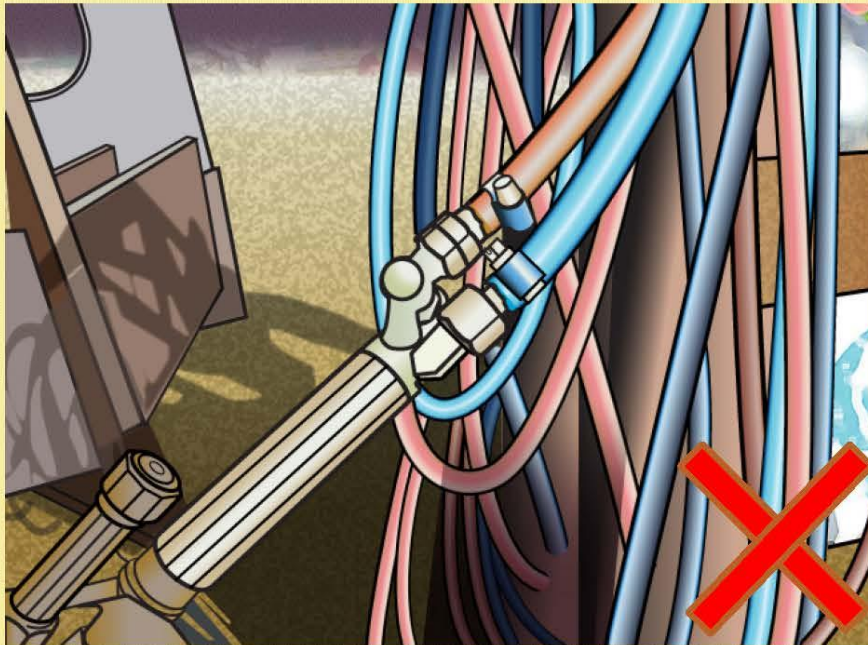
- Non-return valve was not installed between blowpipe and gas hose
- 吹管與氣喉之間沒有安裝止回閥

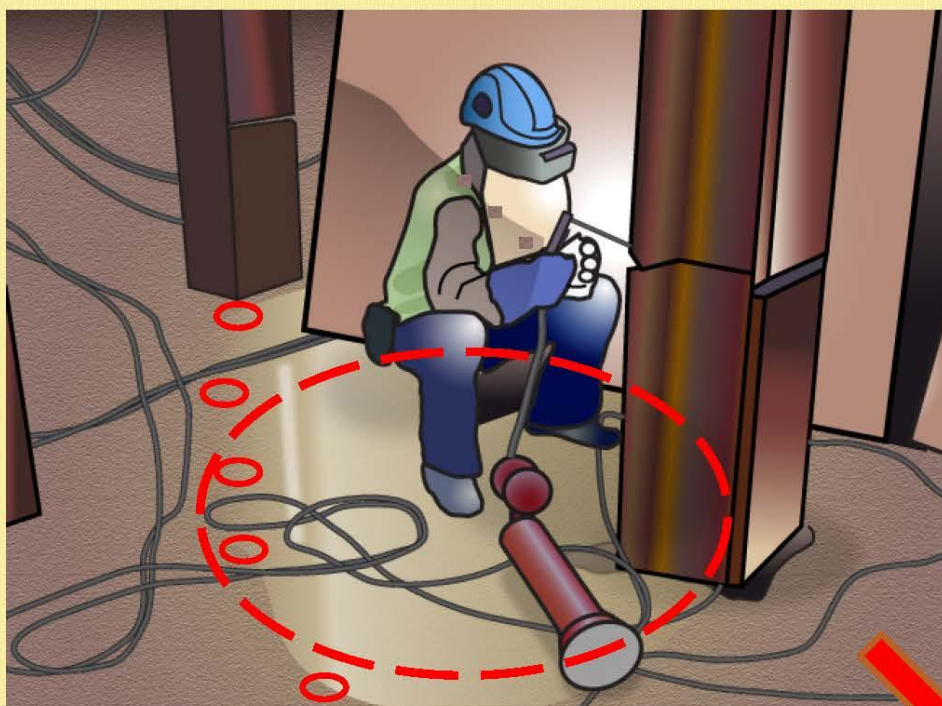
- Electric arc welding was taken place on wet floor
- 在濕滑的地面上進行電弧焊

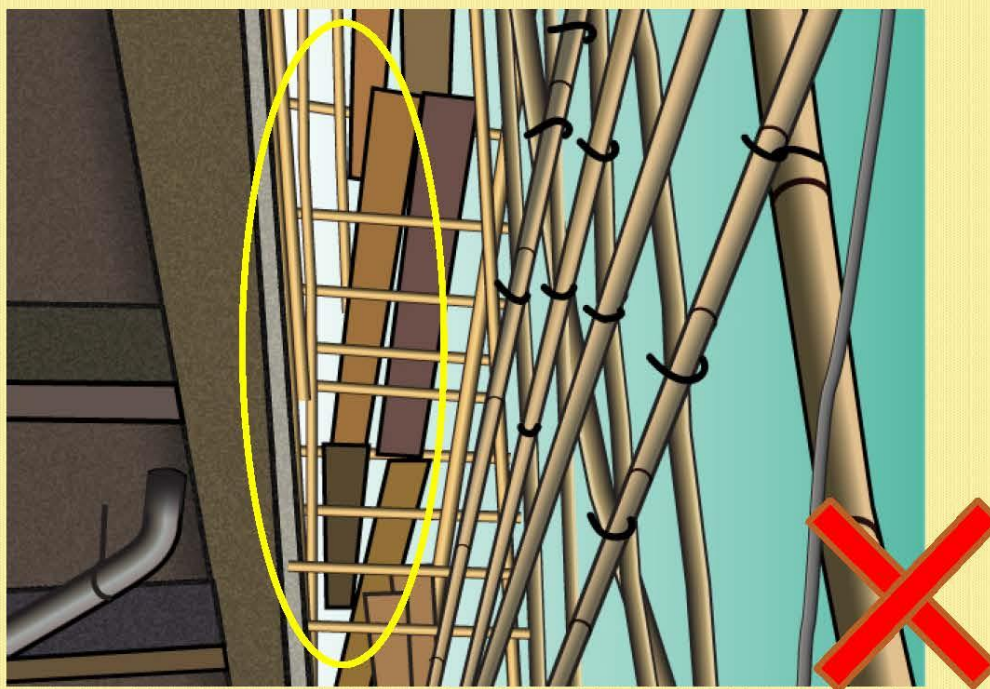
- The bamboo scaffold platform was not closely planked.
- 竹棚工作台的橋板沒有鋪好

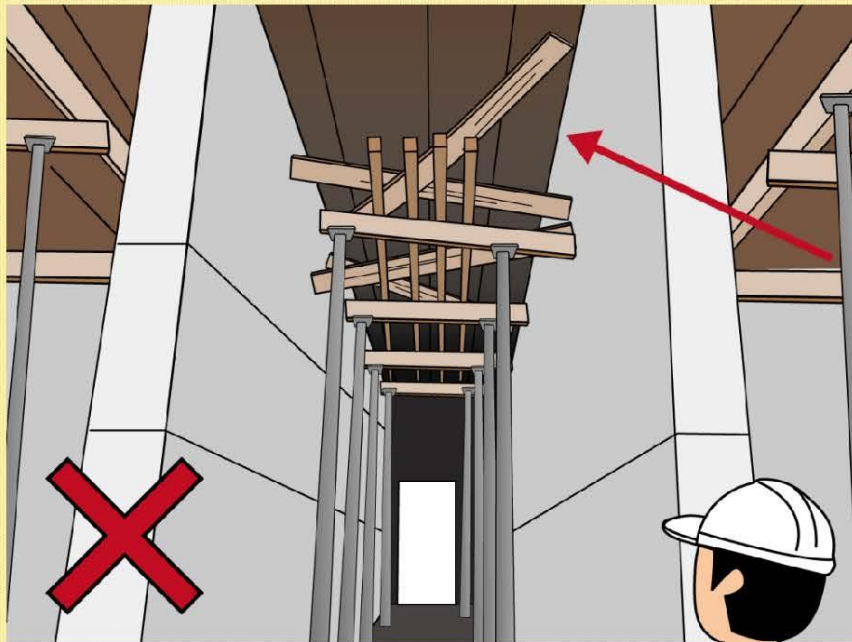
Loose Planks on High Level
木板置於高位

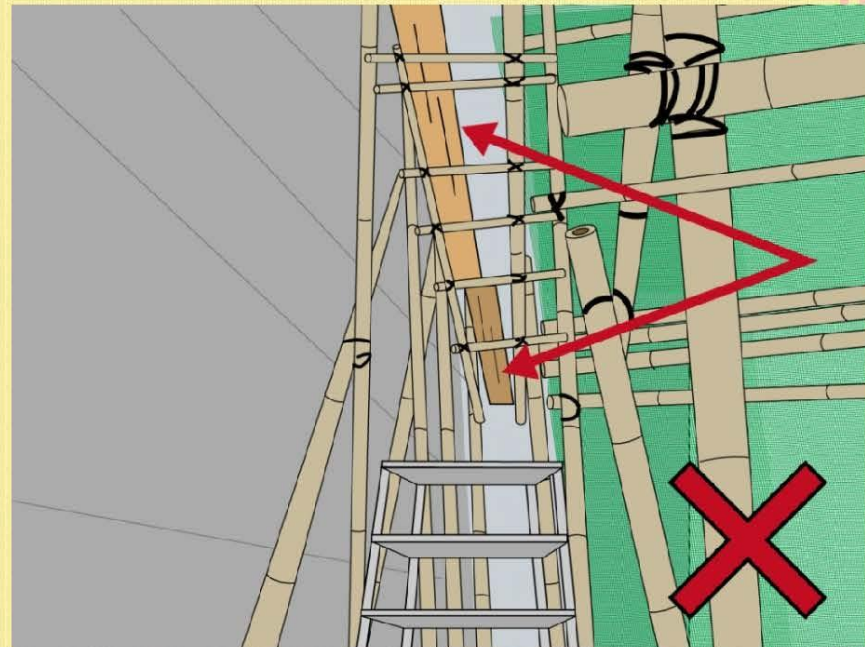
Loose Planks on Scaffold
鬆脫木板在棚架上

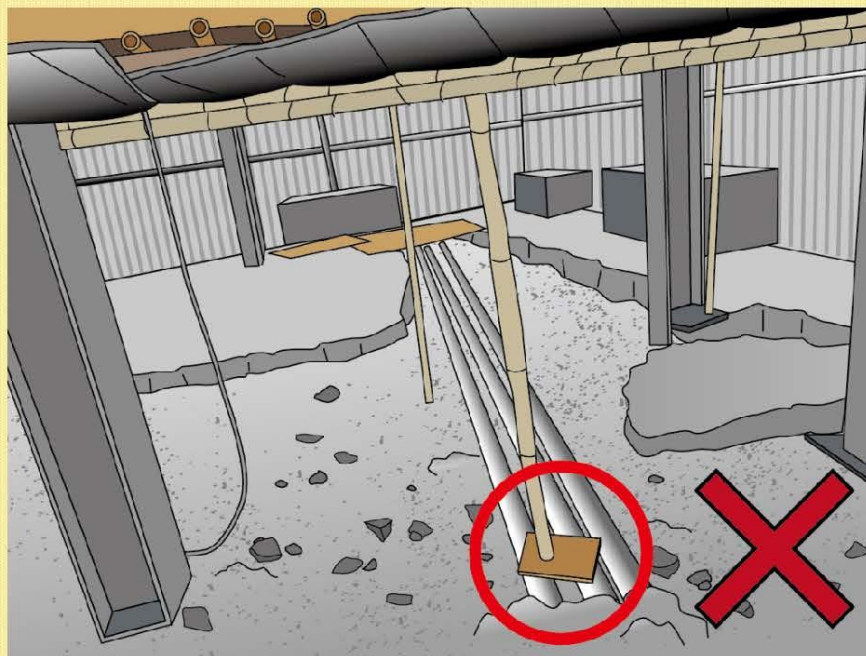
- Improper condition of bamboo scaffold
- 竹棚架的狀況欠佳

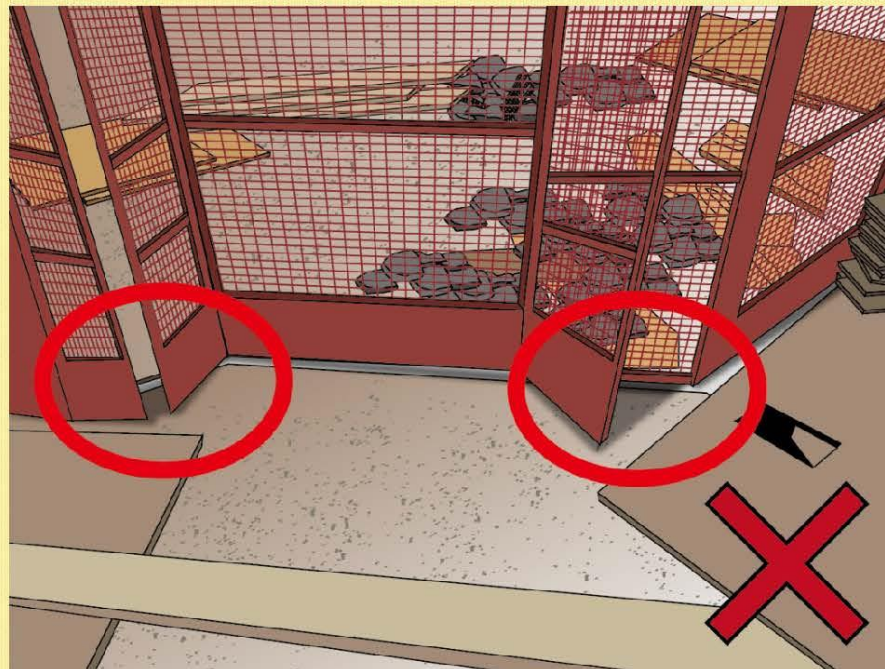
- Toe-boards with gaps
- 底護板有空隙

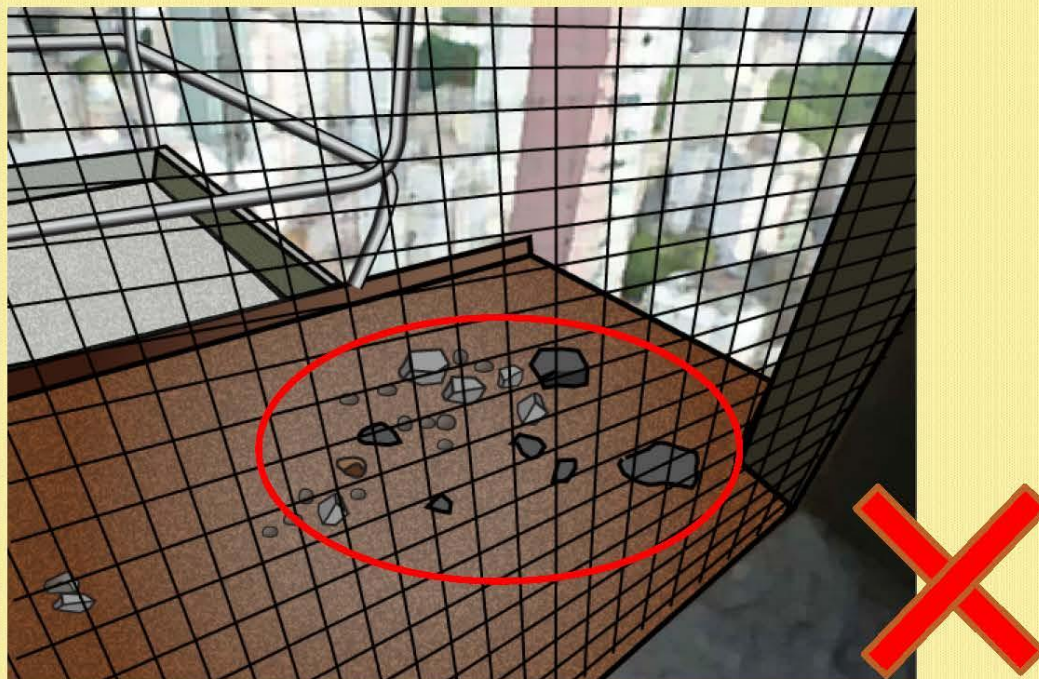
- Loose materials left on top of passenger hoist
- 鬆散物料在載人籠頂

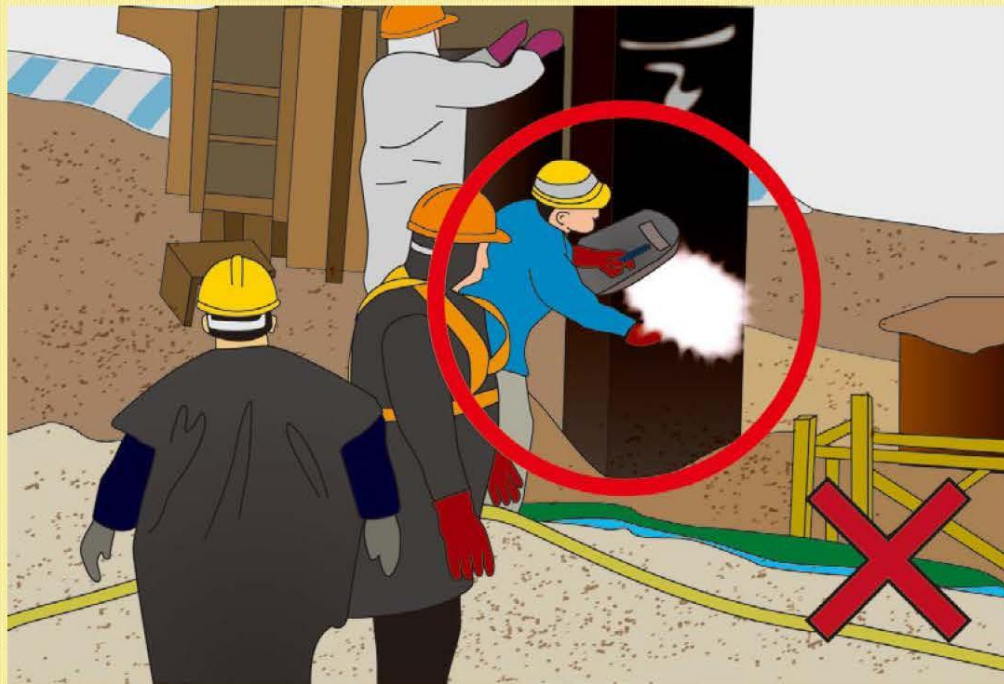
- Welding process without proper screen
- 焊接時沒有適當使用屏障

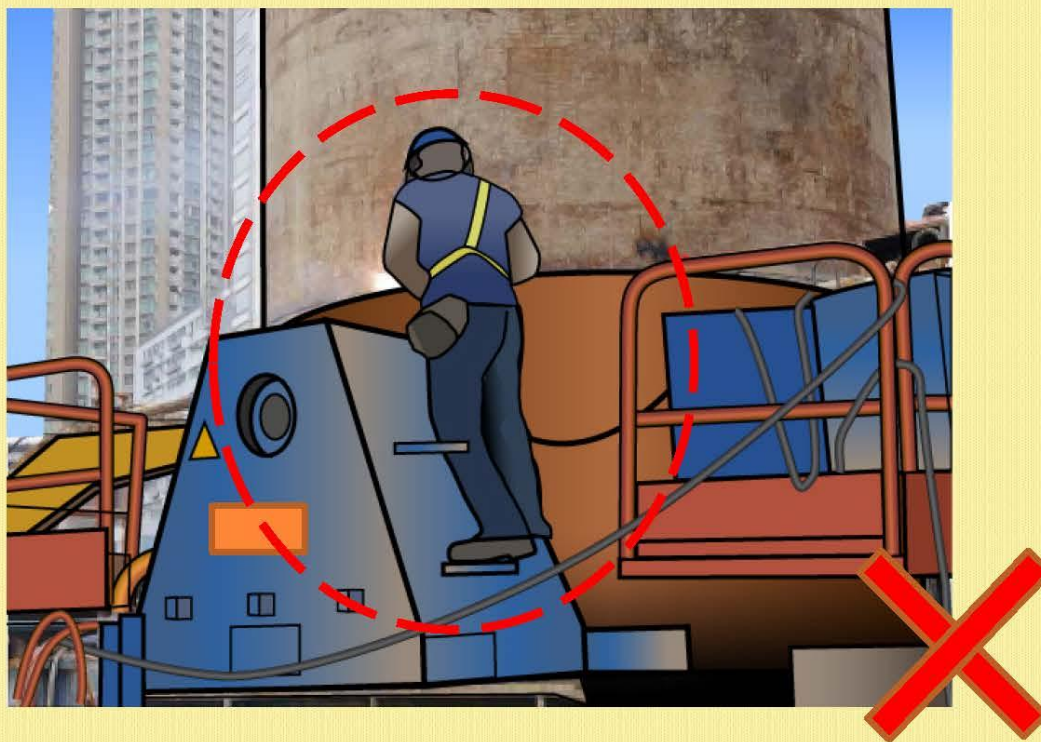
- A welder was working without proper protection
- 燒焊工人沒有適當保護

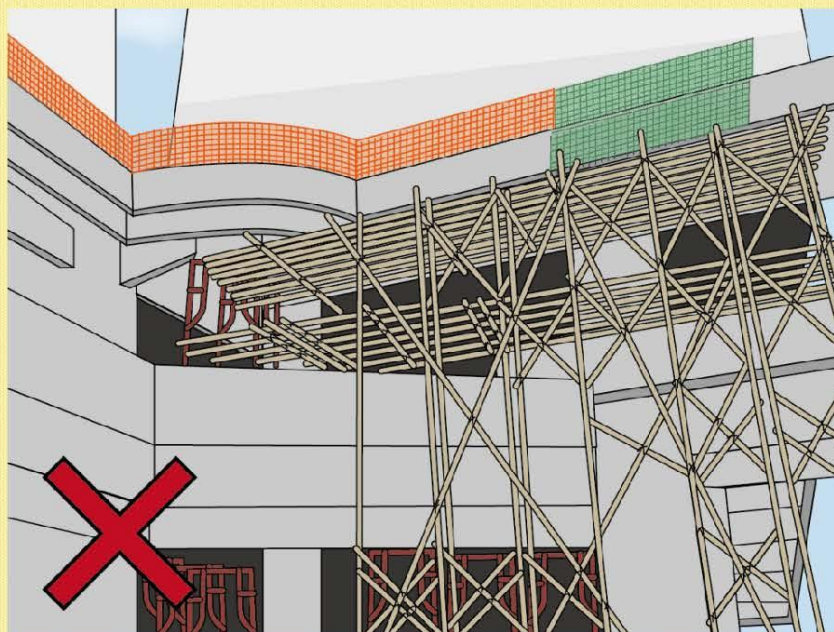
- No railing on falsework
- No access control to dangerous area
- 工作台沒有護欄
- 危險地帶沒有出入管制

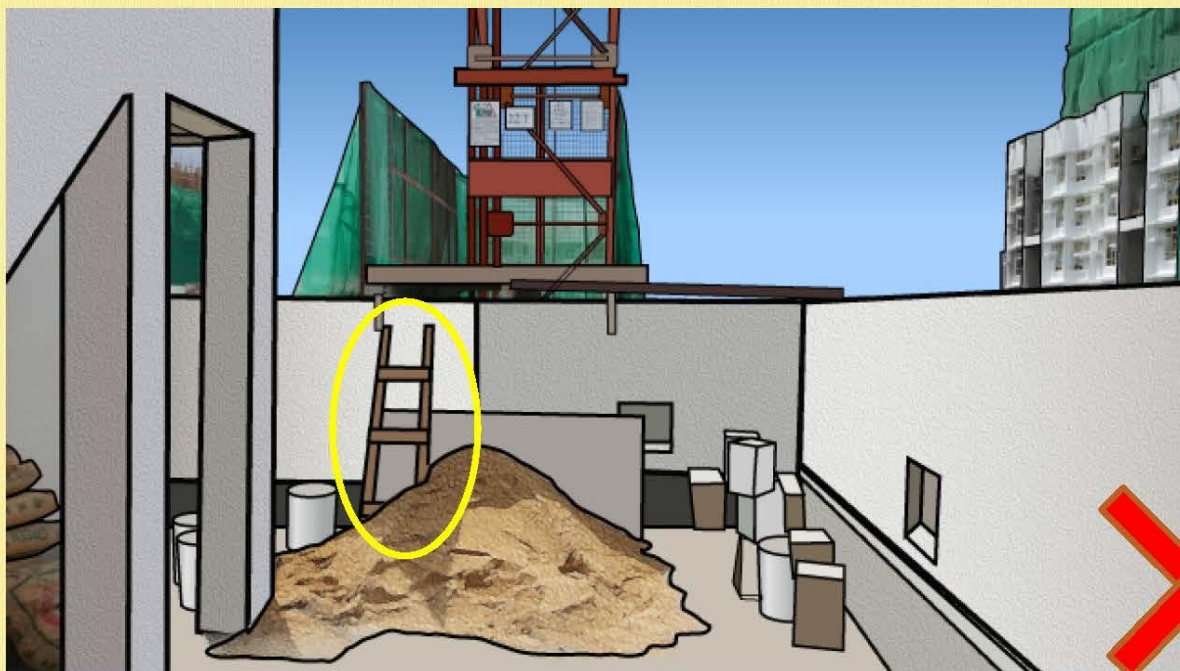
- Safe access and egress was not provided to the material hoist
- 未有提供前往物料吊重機的安全進出通道

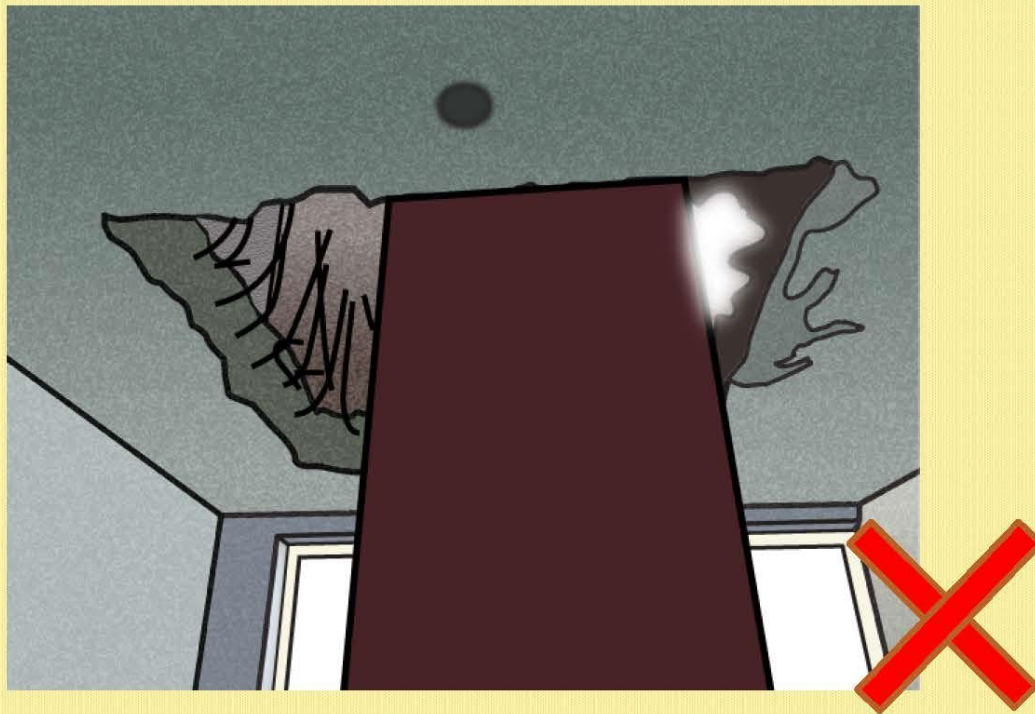
- The gap of Temporary Refuse Chute
- 垃圾槽開口

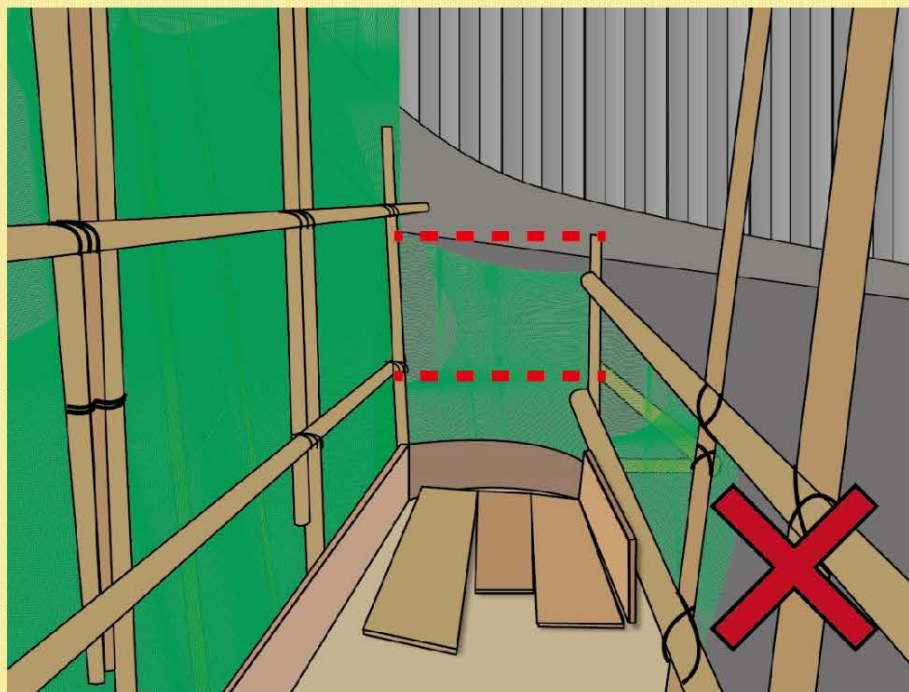
- No guardrails on edge of working platform
- 工作台沒有護欄

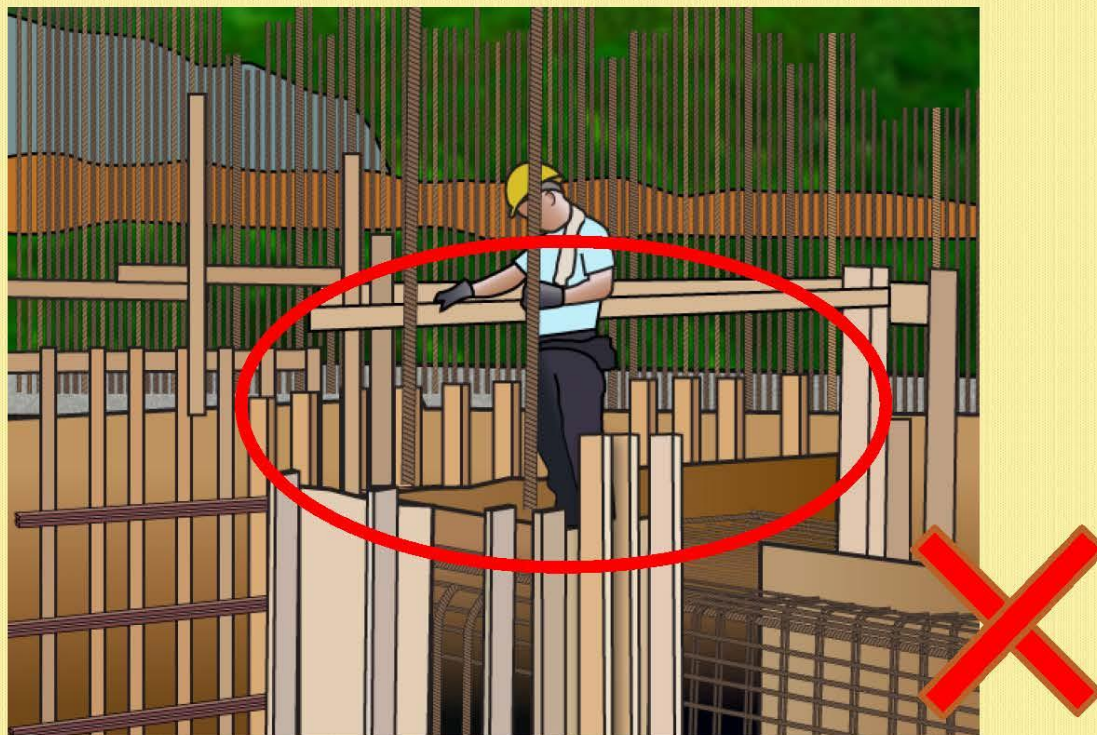
- Floor edges were not properly fenced
- 沒有在樓邊位置裝設圍欄

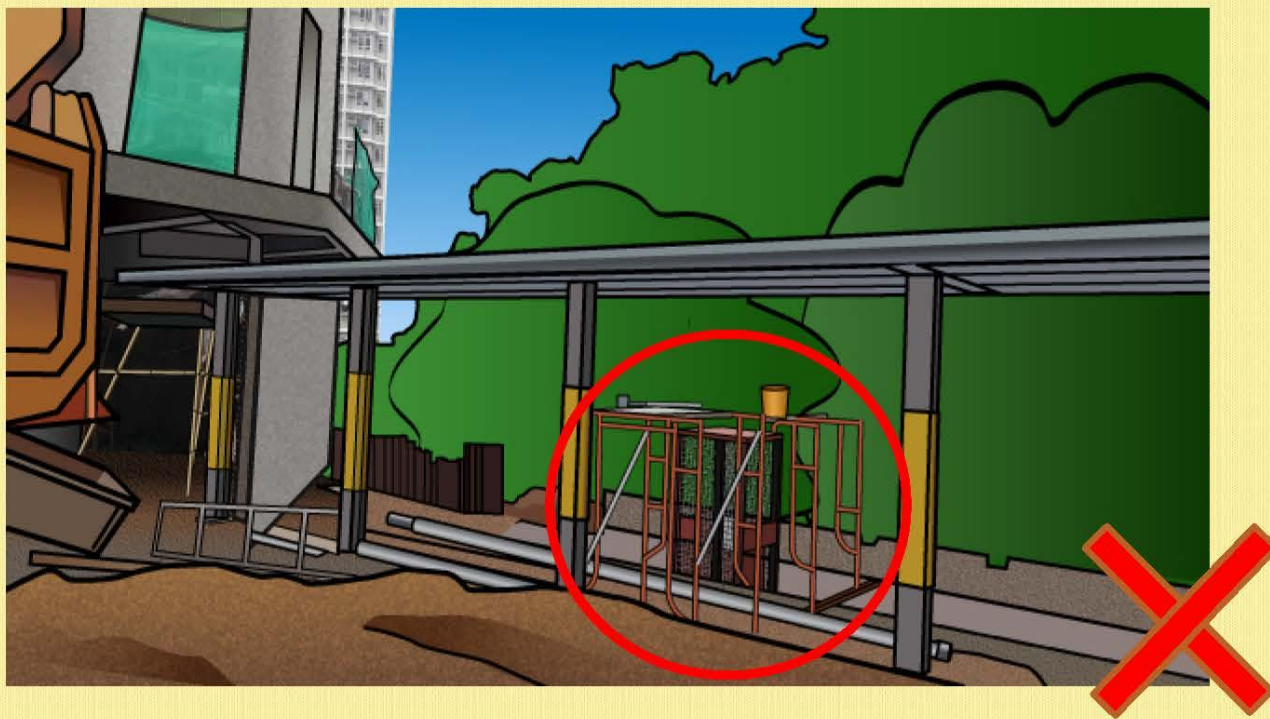
- Working platform without guardrails and toe-boards
- 工作台沒有安裝圍欄及踢腳板
