## **Memorandum for the Hong Kong Housing Authority**

### **Test Results of Water Samples taken from Public Rental Housing Estates completed in or after 2005**

## COMMISSION OF INQUIRY INTO EXCESSIVE LEAD FOUND IN DRINKING WATER

Task force announces preliminary findings of investigation into cause of excessive lead content in drinking water (with video)  
\*\*\*\*\*

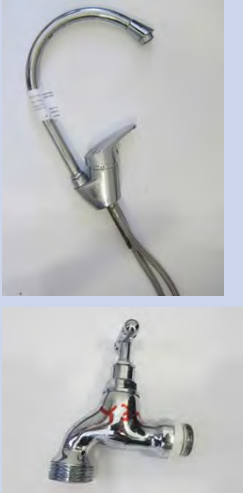
# Number of components from three water chains dismantled for examination/testing

Pipes, joints and fittings	Copper Pipes	Valves	Water Meter	Taps	Copper pipe Joints
Sample photos

Kai Ching Estate: Hong Ching Hse	15	8	1	4	17
Kai Ching Estate: Yuet Ching Hse	13	8	1	4	13
Kwai Luen Estate Phase II: Luen Yat Hse	16	12	1	4	17
Total	44	28	3	12	47
Hung Fuk Estate: Hung Hei Hse as 'control'	3	11	1	4	3

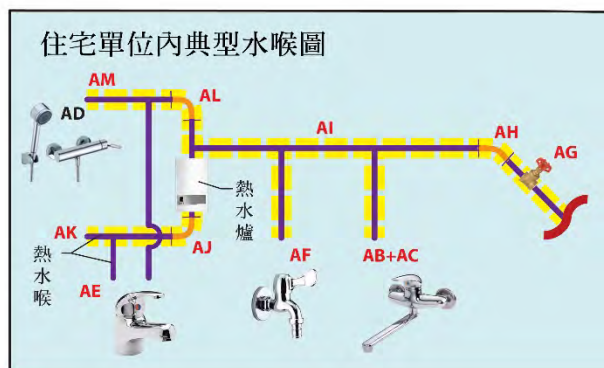
# Lead Leaching Result for Kai Ching Estate (Hong Ching House)

## Branch pipe within residential flat

Lead leaching from copper alloy valves, taps, and copper pipes / solder joints with dia  $\leq 76\text{mm}$  **detectable**.

Item No.	Pipe / fittings	Test Result
		Pb ( $\mu\text{g}$ )*
AB	Tap at kitchen	4.1
AC	Tap at kitchen_part 2	2.1
AD	Shower tap at toilet	0
AE	Basin tap at toilet	4.6
AF	Tap for washing machine	13.7
AG	20 mm dia. gate valve	14.9
AH	20 mm dia. elbow at kitchen	14.9
AI	20 mm dia. copper pipe at kitchen	16
AJ	20 mm dia. elbow (hot water pipe) at toilet	639.8
AK	20 mm dia. copper pipe (hot water pipe) at toilet	7.7
AL	20 mm dia. elbow (cold water pipe) at toilet	3.5
AM	20 mm dia. copper pipe (cold water pipe) at toilet	5.5

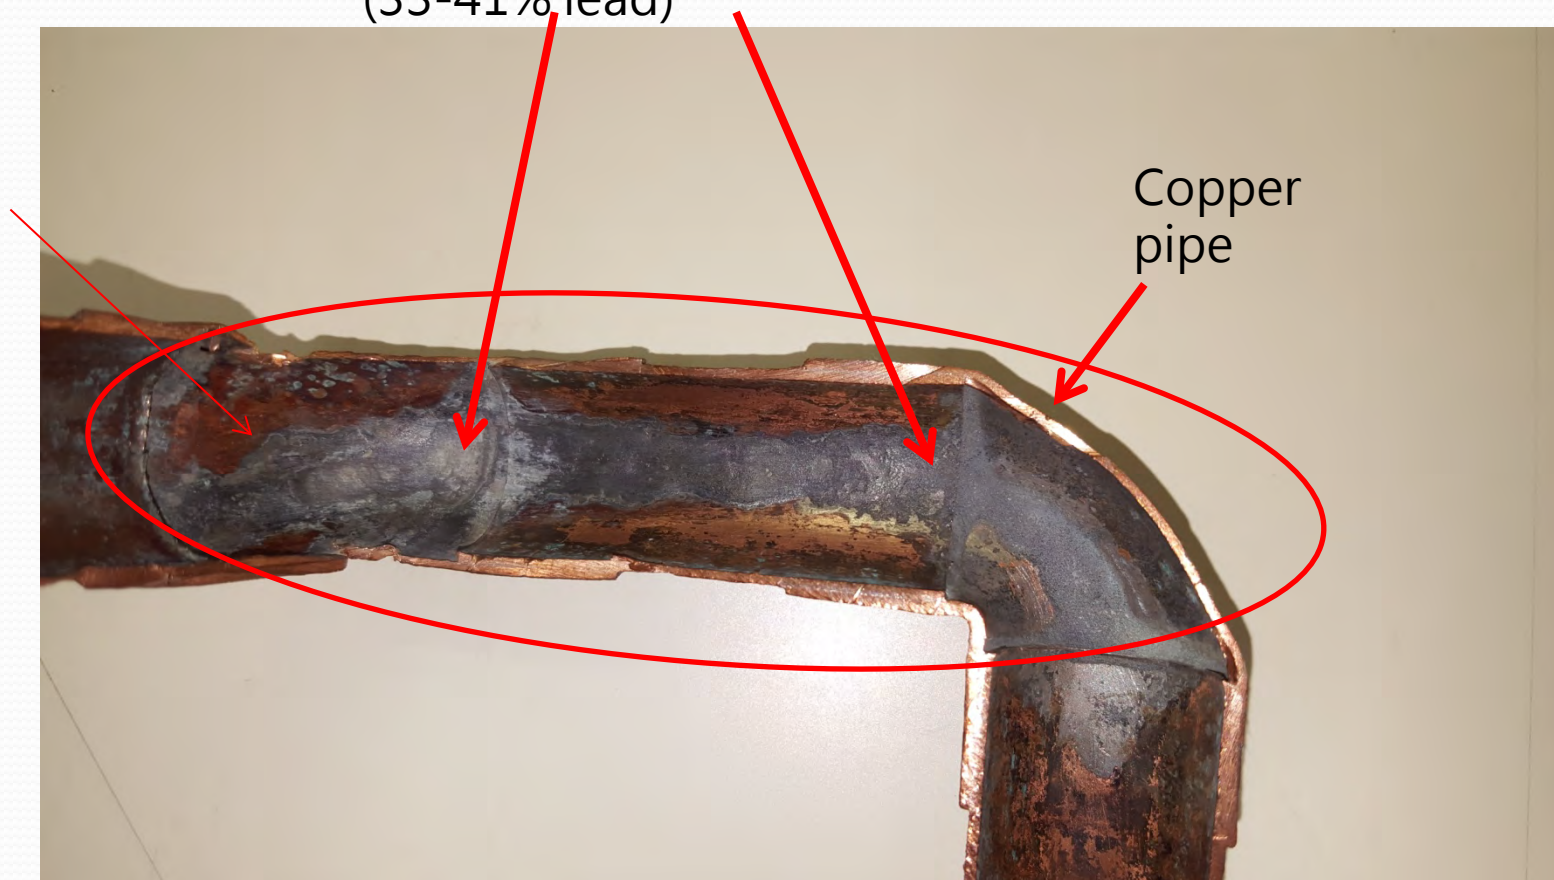
# Leaded solder joints

Leaded solder joints  
(33-41% lead)

**Lead solder seeped into the internal water surface due to unsatisfactory welding in some solder joints causing lead leaching.**

The preliminary findings revealed that leaded solder joints installed in the inside service were the cause of excessive lead in drinking water in Kai Ching Estate and Kwai Luen Estate Phase 2. Copper alloy fittings also leached lead but did not result in excessive lead in water.

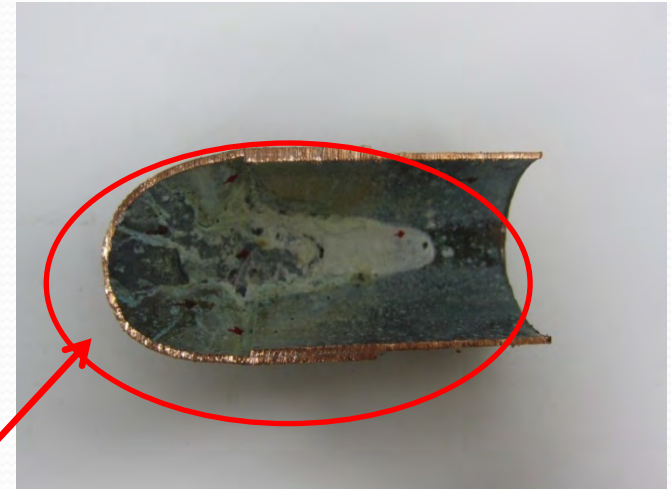
Copper pipe elbow

# Lead deposits in branch pipes and pipe fittings

deposits

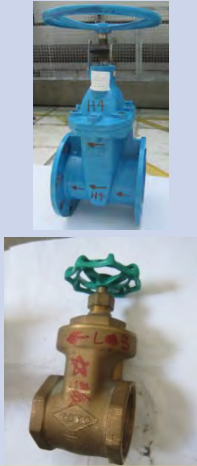
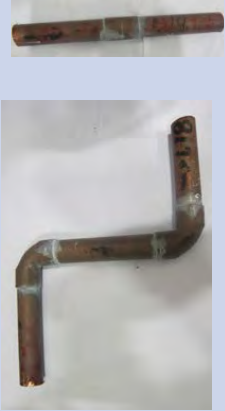
# Lead leaching result after cleansing of lead deposits<sup>19</sup>

Lead Leaching?					
Before Cleansing	Yes	Yes	Yes	Yes	YES
After Cleansing	<b>NO</b>	Yes	Yes	Yes	YES

*0.003 – 0.007 % impurities  
Comply with BS of less than  
0.1% impurities*

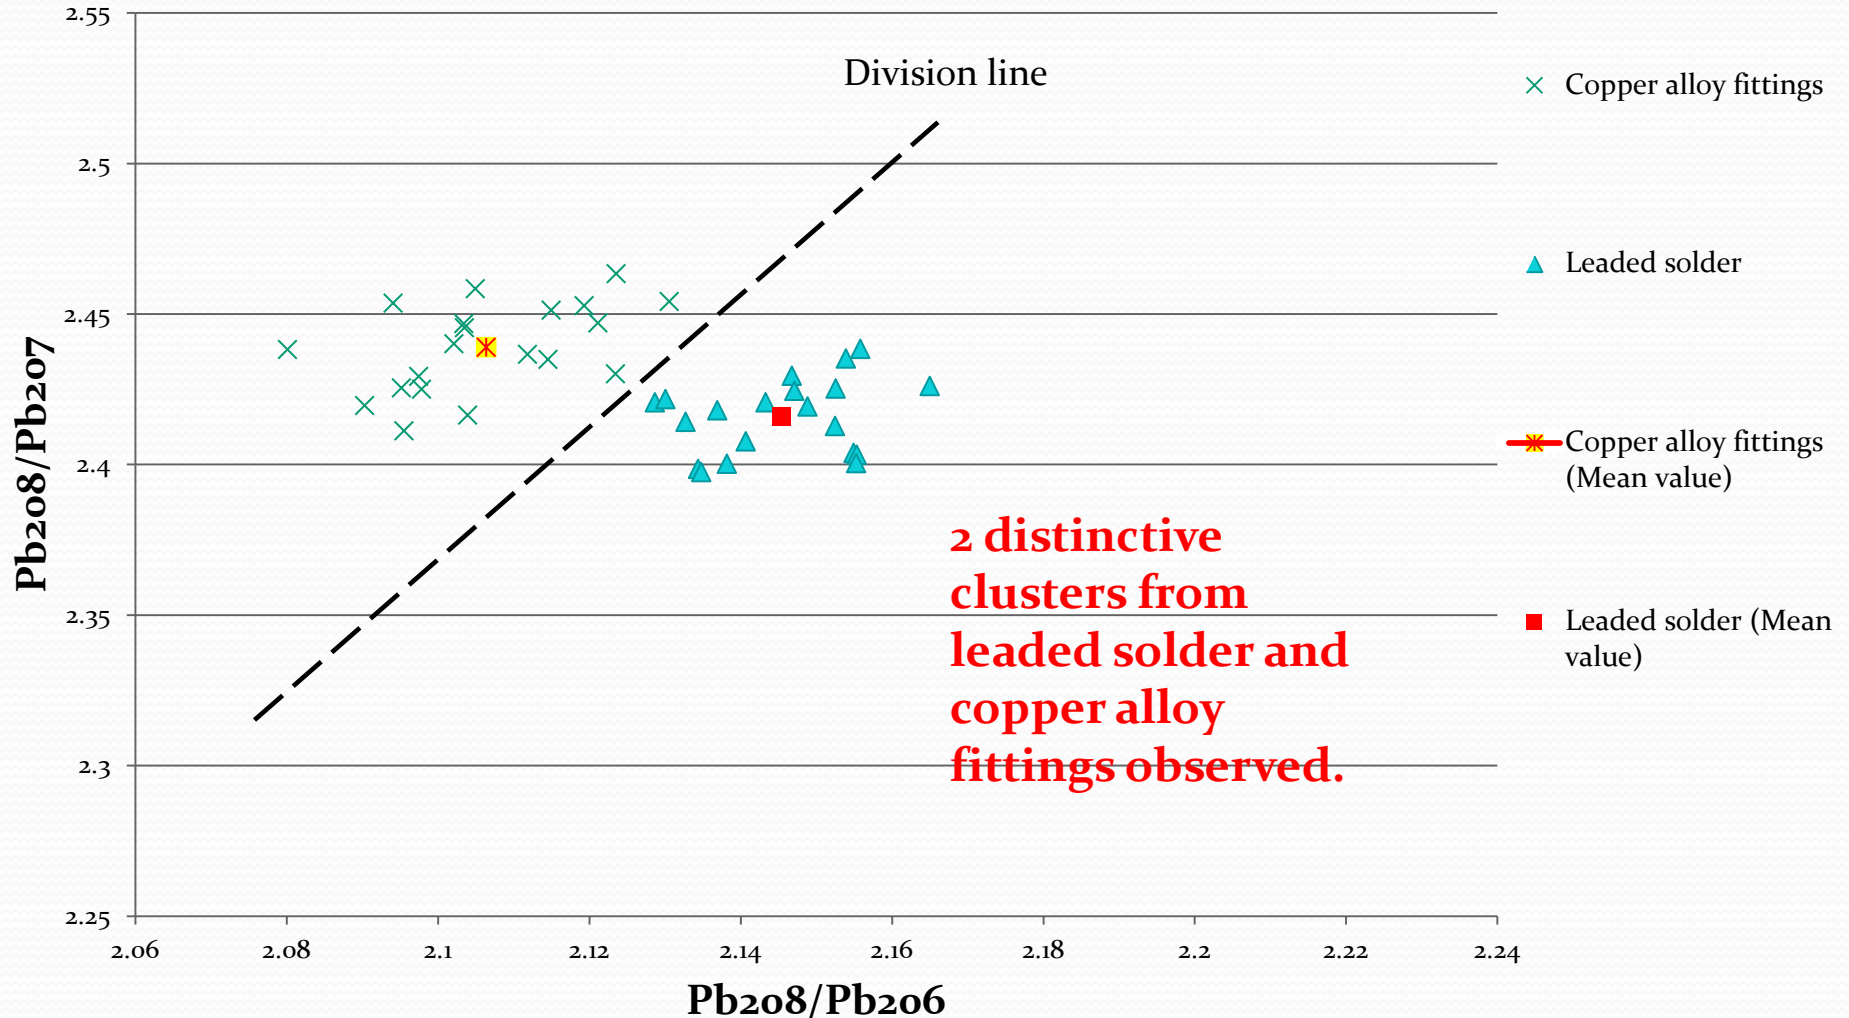
- Lead contains three main isotopes –  $^{206}\text{Pb}$ :  $^{207}\text{Pb}$ :  $^{208}\text{Pb}$ .
- Lead from different origins has different isotopic ratios (like fingerprint)
- Precision instrument can measure the distribution of different isotopic ratios, thus locating the source of lead in water
- By working out the ratios of lead isotopes in leaded solder, copper alloy fittings and water samples with excessive lead content (fingerprints), we can find out the main source of lead in water

# Isotopic analysis of leaded solder and copper alloy fittings

The task force also made use of lead isotopic analysis to identify the source of lead. While the lead isotopic ratios of leaded solder and copper alloy fittings were found in two distinctive clusters, the mean value of the water samples with excessive lead closely agreed with the mean value of leaded solder. In other words, lead in water came from leaded solder.

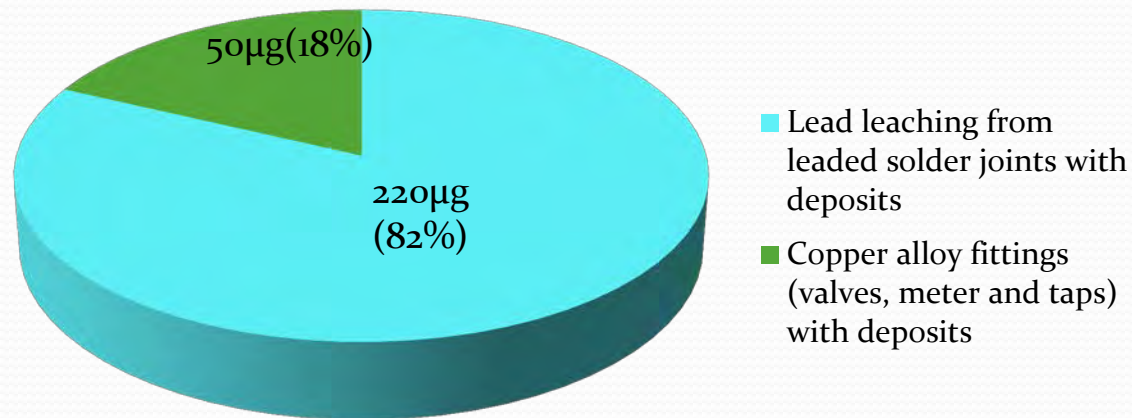
# Mathematic modeling

- Calculate the total lead amount leached and the contribution from all pipe components by using the 24-hour leaching test results (see diagram below).
- Assuming only copper alloy fittings leach lead, calculated lead leaching: **2.7  $\mu\text{g/L}$** , below WHO standard of 10  $\mu\text{g/L}$ . Lead leached from copper alloy fittings does not result in excessive lead in drinking water.
- Mathematic modeling confirms that excessive lead in drinking water in Kai Ching Estate and Kwai Luen Estate Phase II is caused by leaded solder joints.
