Protection Against Falling Objects - Good Practices

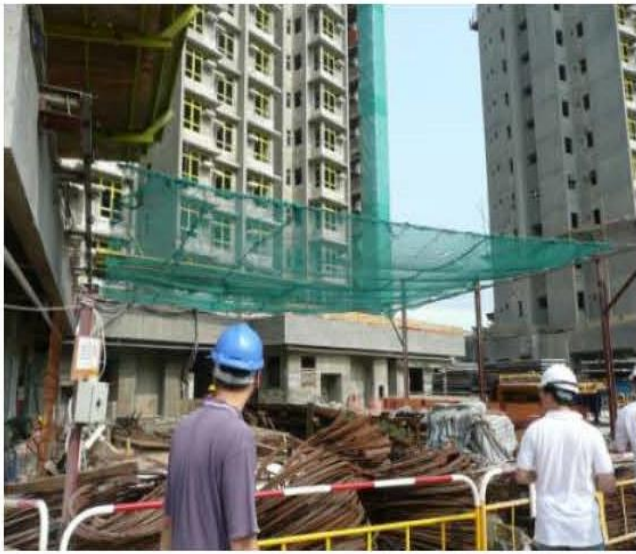
Photo 1

Extra fall protection for bar bending area

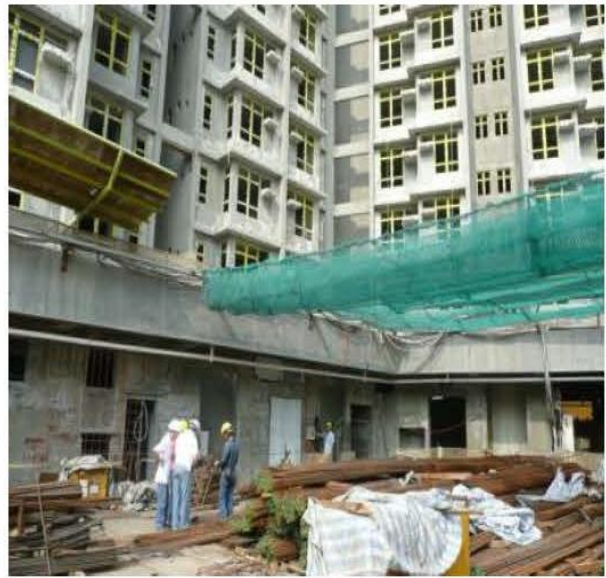
Photo 2

Extra fall protection for bar bending area

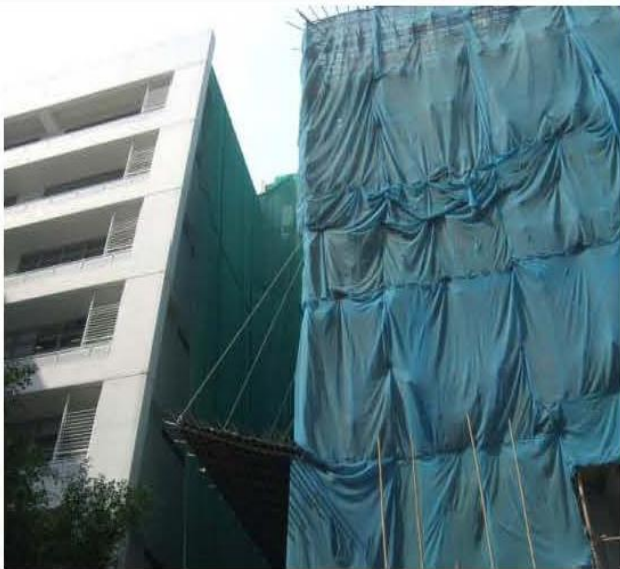
Photo 3

External Wall Bamboo Scaffold, Safety Nets and Catch Fan Maintained in Good Condition

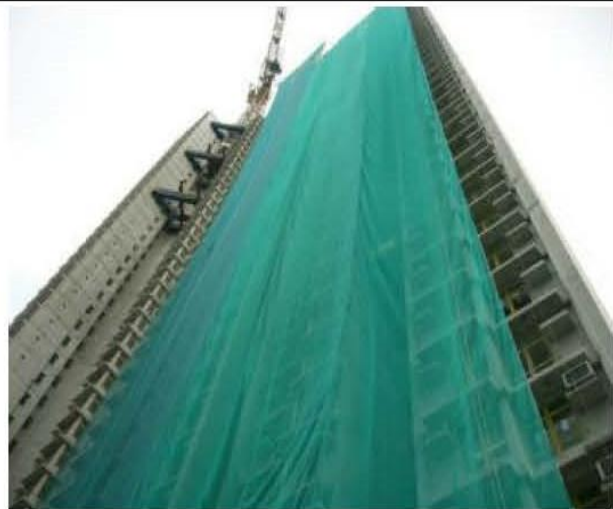
Photo 4

Large green net erected along the constructed building. It provided an extra protection to the external area workers and the public.
