Safe Lifting Works Management System

Speaker : Kelvin, W.C LEUNG
Hip Hing Engineering Co.,Ltd

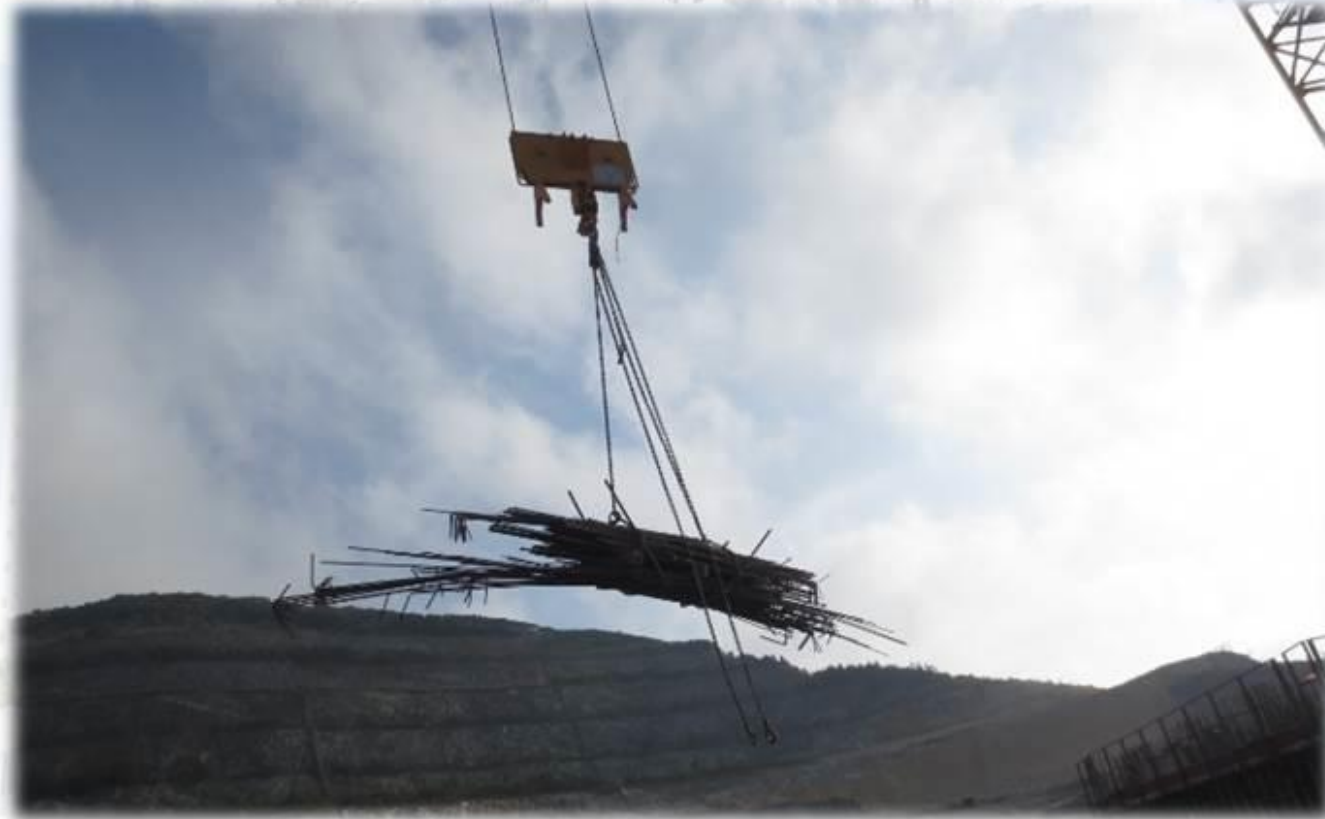
1. Improper Lifting Operation

After these accidents
we studied the major problem in the tower crane lifting
or any area for review
We summarized a few points
which might be the causes of the accidents
The first reason is improper rigging method
Take this picture as an example
you will note that there were long and short steel bars
rigged together by worker and hung on the hook
This increased the risk of collision with the building edge
causing the falling of steel bars
resulting in a serious accident

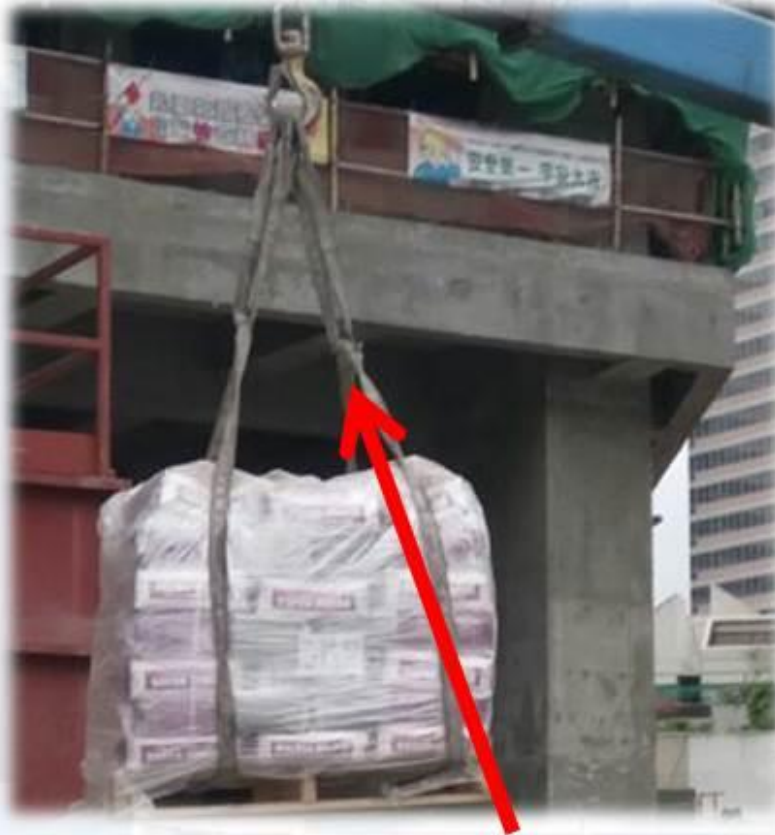
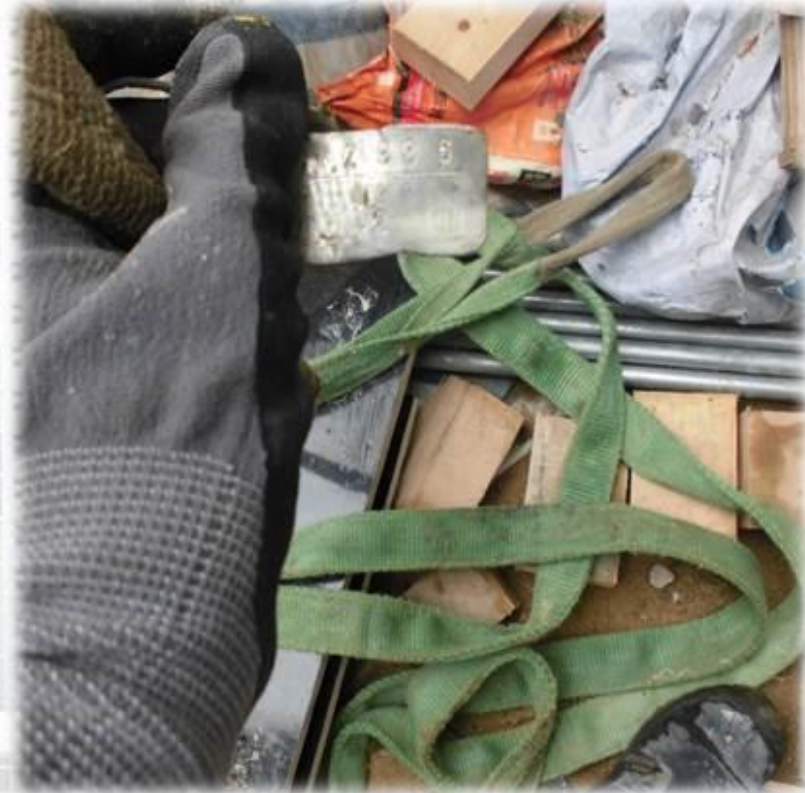
2. Poor Condition of Lifting Gears

Another possible cause of incident
was about the lifting gear
Two common irregularities of lifting gear
would be expiry of the service life and so poor condition
Even it was not expired, it might be mis-handled
causing accidents during rigging
The third cause would be more common, overloading
Theoretically, overloading could be avoided
As mentioned by Hanison's representative just now
the operator might have by-passed the system
Hence, not knowing when it was overloaded
This aspect should be noted
Fourth, it also happened on our site
The steel wires formed knots or even broken
in two to three months' time
(a short period of time)

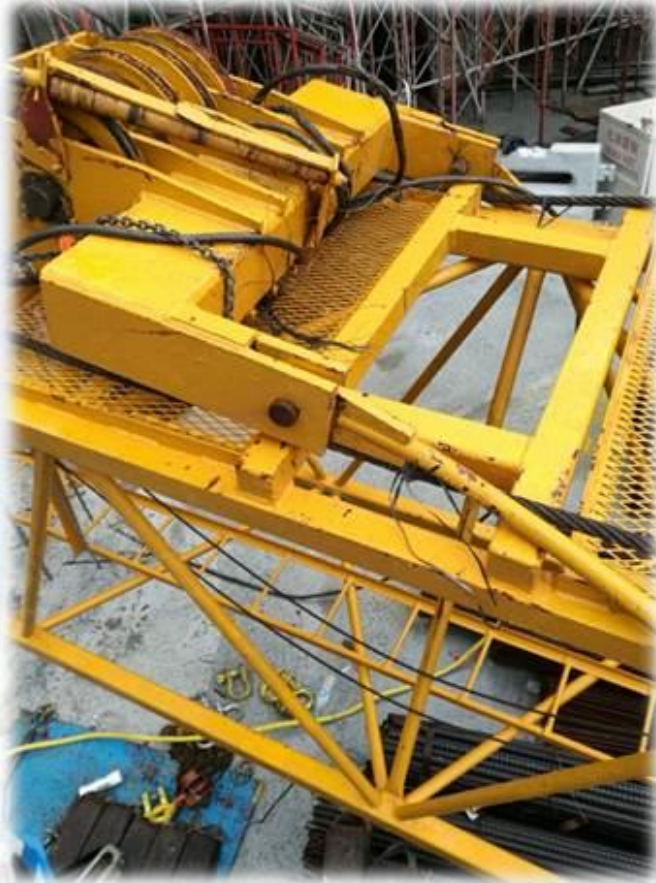
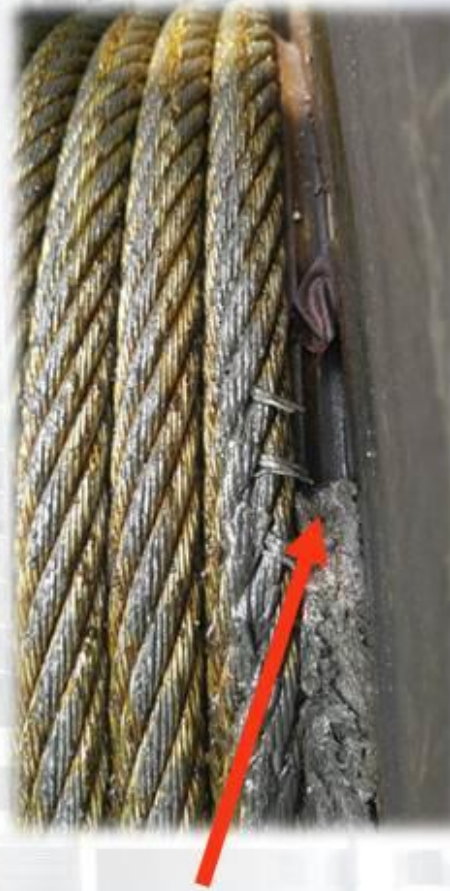
4. Broken Wire Ropes

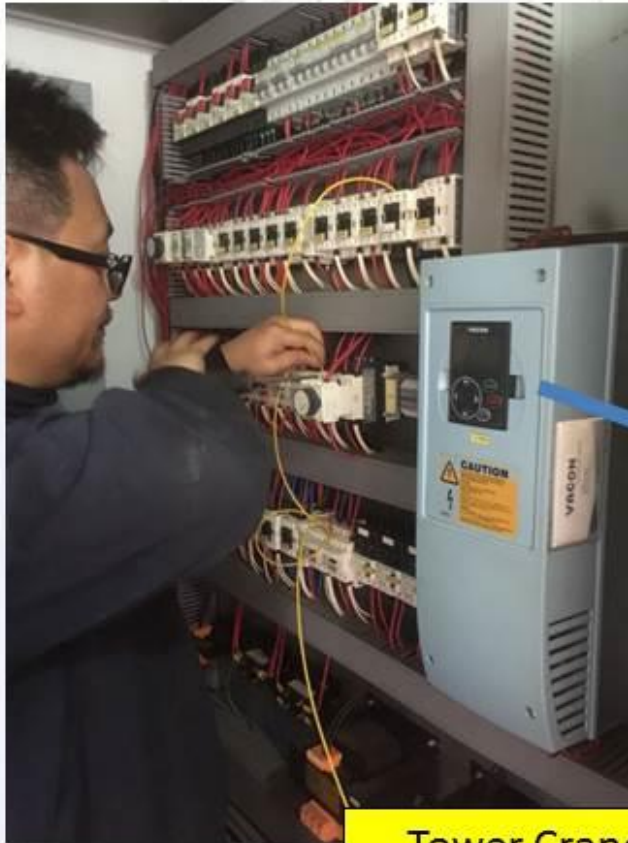
Tower Crane Inverter in Control Panel

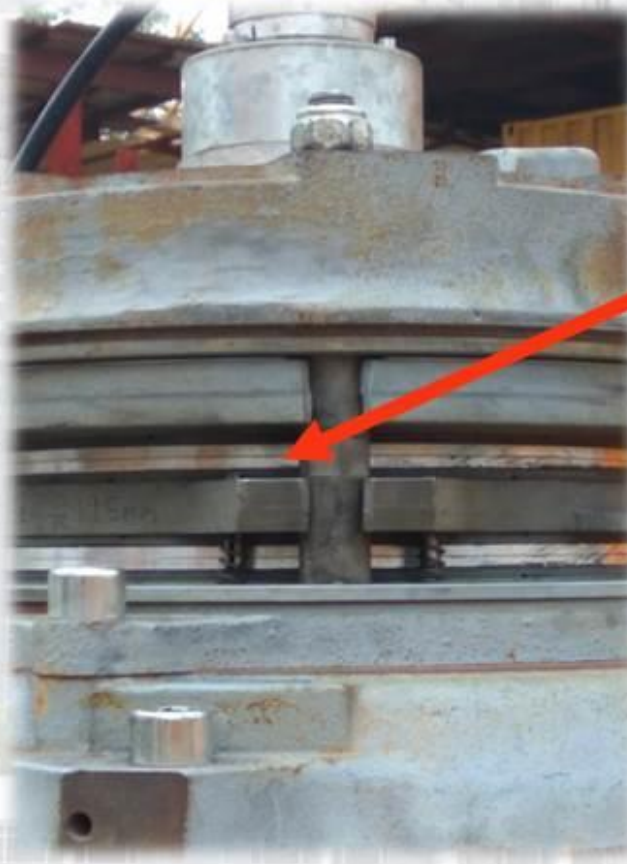
Brake was not released completely when the wire rope was moving upward or downward

Tower Crane Motor Brake

The other one was relatively rare
but if it occurred, it could cause a fatal accident
the brake system

This brake system controlled
the tower crane lifting operation

If the brake system was activated inappropriately

The brake disc in the brake system

would wear out continuously

until certain point that the brake fails

and the whole batch of loads would fall

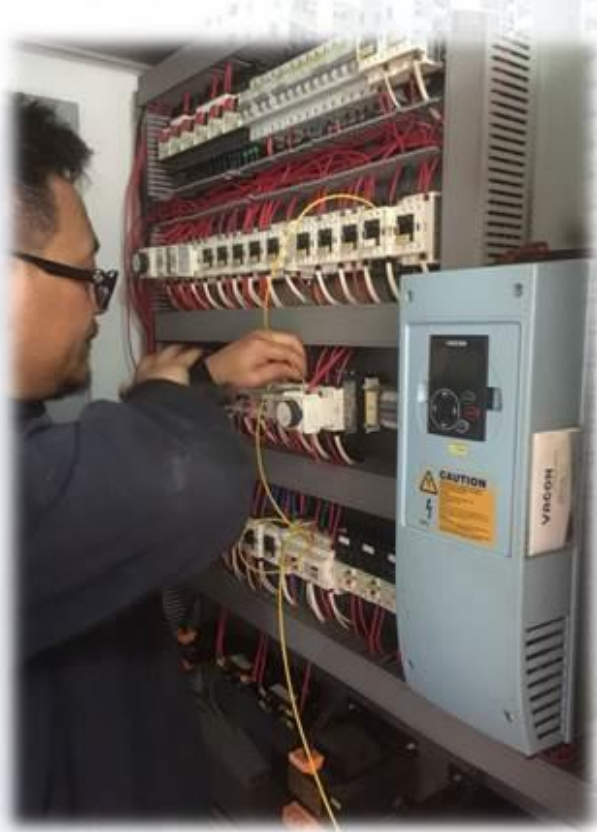
Checking the Inventor Function

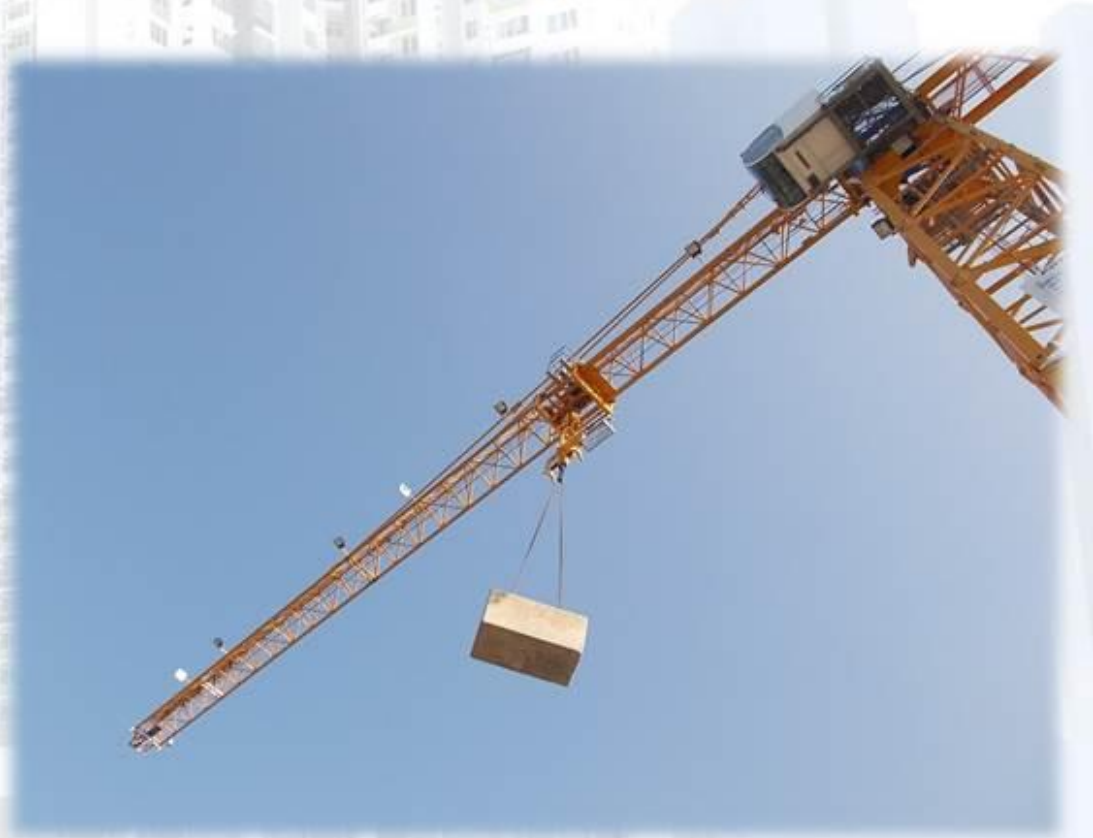
Trial Test the Inventor

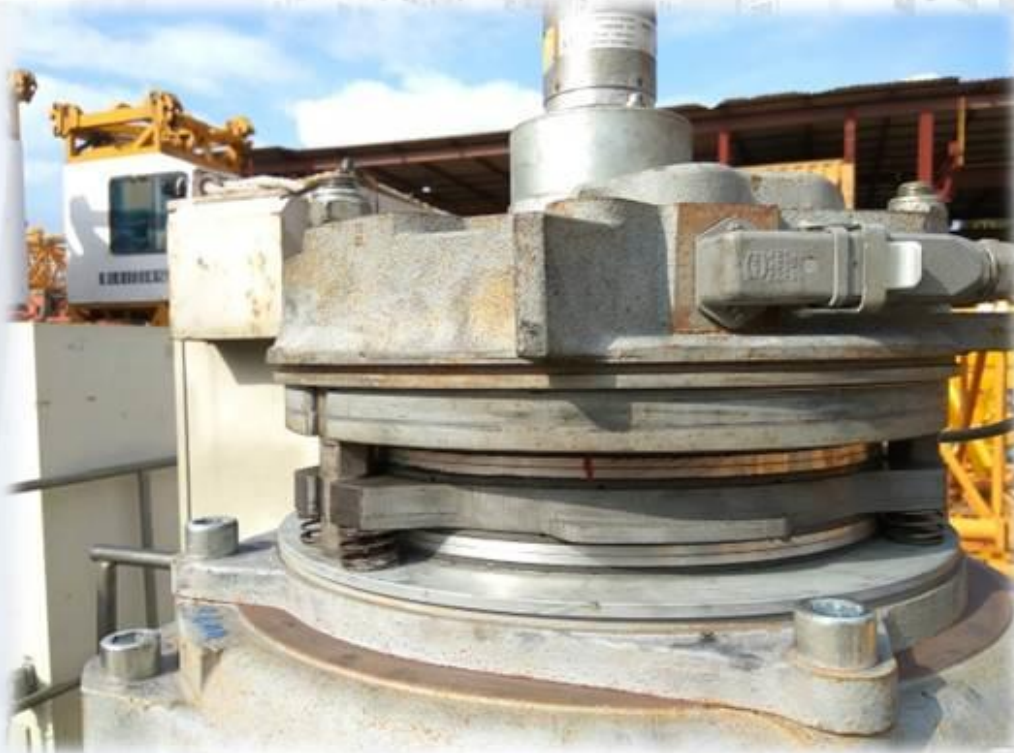
Checking the Tower Crane Motor and Brake

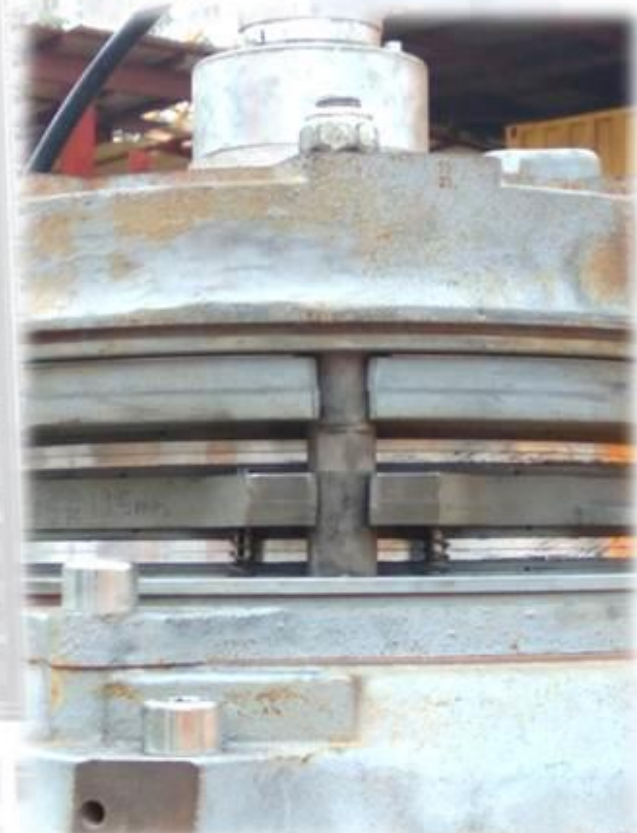
Trial Run the Brake

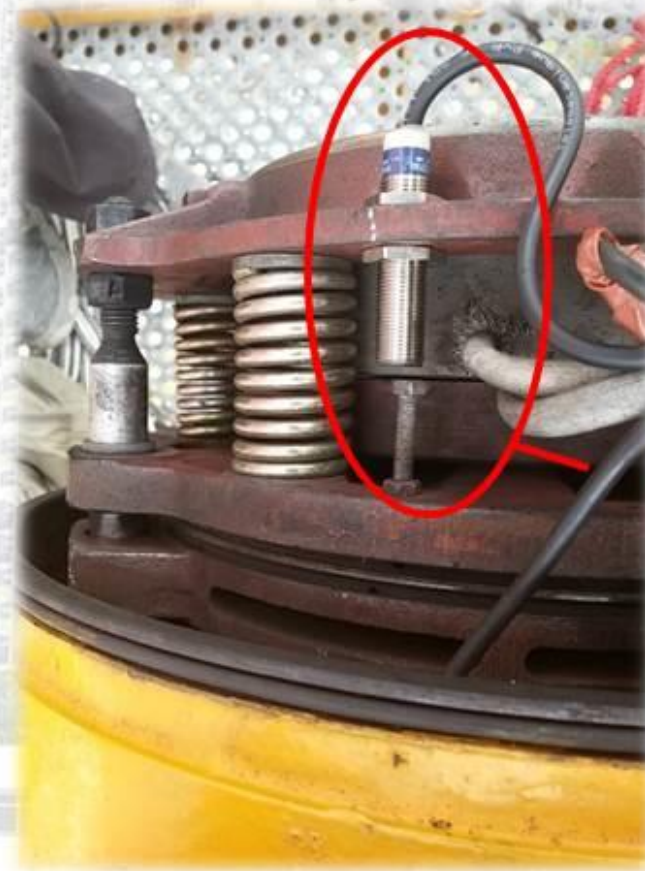
Brake Disc Thickness Sensor for Checking Brake Disc Thickness

To monitor the thickness of the brake disc
and give a warning when the thickness
is less than half of the original
The brake disc thickness deviated
for different models or manufacturers
For example, a 20 mm thick brake disc
the sensor will alert
when the brake disc thickness is less than 10 mm
The driver will be alerted
and notify the mechanical department
to repair and replace the brake disc

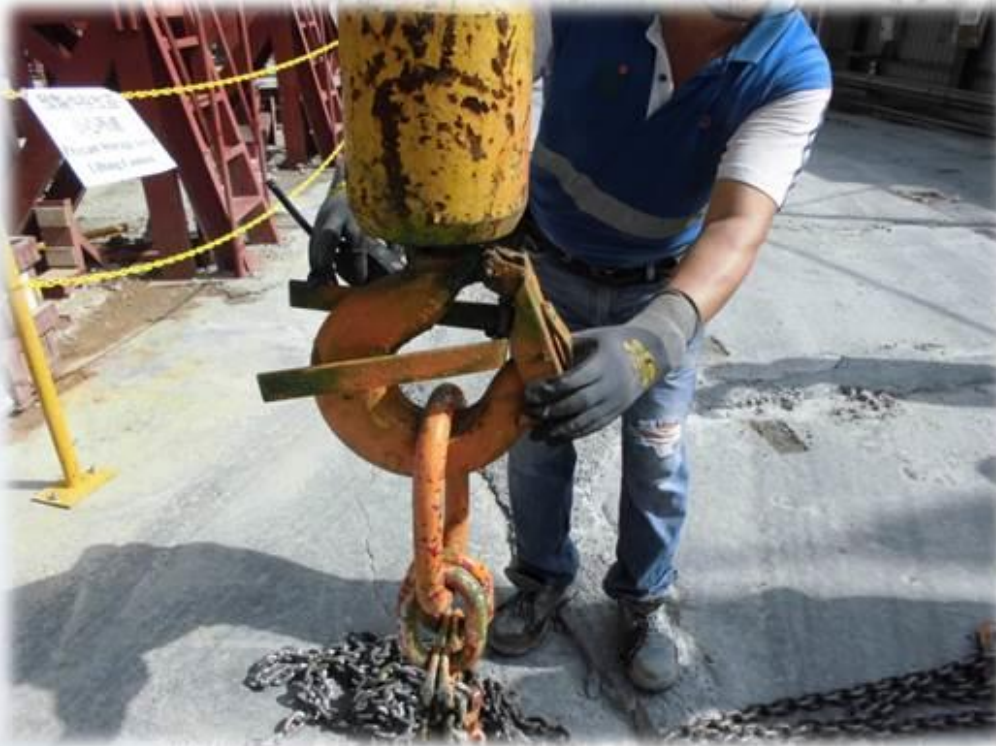
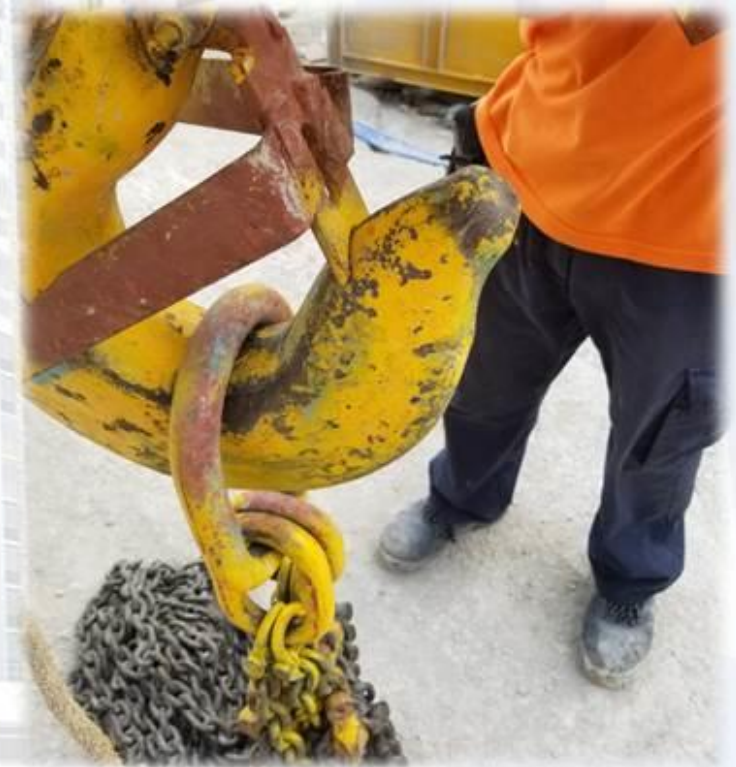
Interlocking Device for The Lifting Hook

We mentioned about falling objects
due to inadequate rigging
That is, "loosen hook"
Our company has specially developed an interlock device
to prevent falling objects from the hook
We also mentioned the wire ropes
What is wrong with the wire ropes?
According to our own experience
we found that the problem occurrence rate
of certain countries' wire ropes were higher
except Europe and Japan
Hence, from the middle of last year onwards
our company would only order
wire ropes manufactured from Europe or Japan
The advantage was their good quality
In fact, I would like to share a bit more
Taking the Kwai Chung site as an example
we noted that the wire ropes
from other countries in the past
would easily get tangling up or deformed
As the crane would be dismantled in one month
I struggled whether the wire ropes
need to be replaced or not?

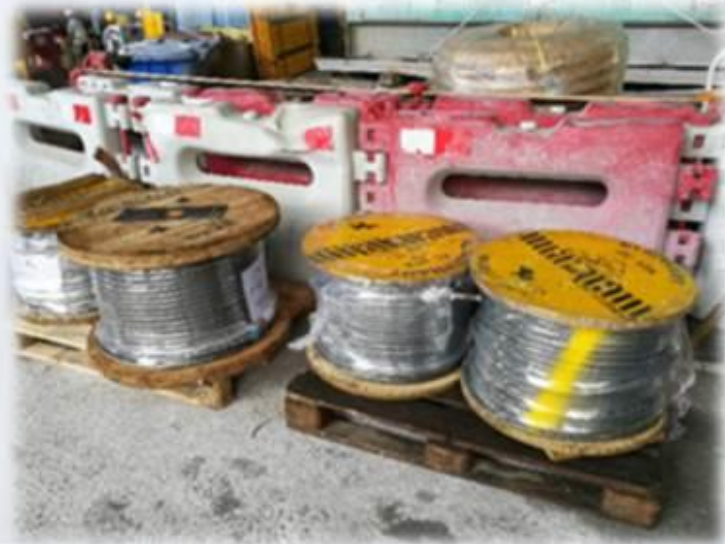
New Wire Ropes for Tie bars and Lifting Section

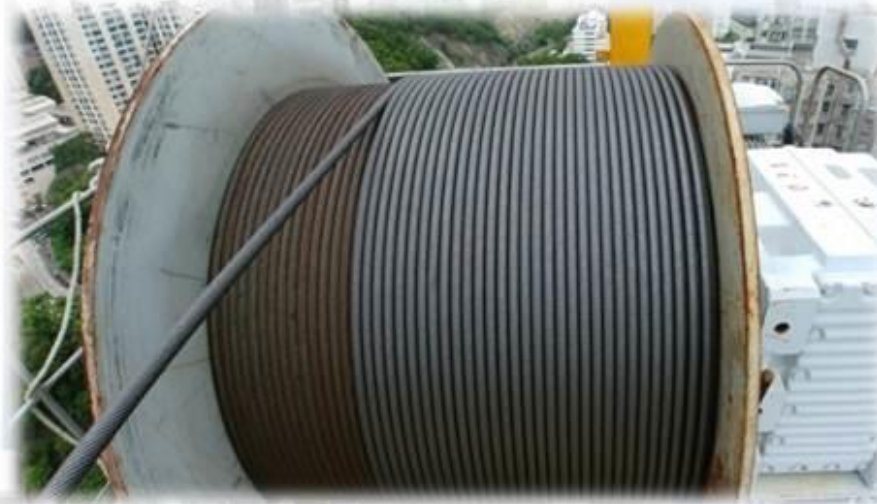
New Wire Ropes installation in the Tower Crane Hoisting

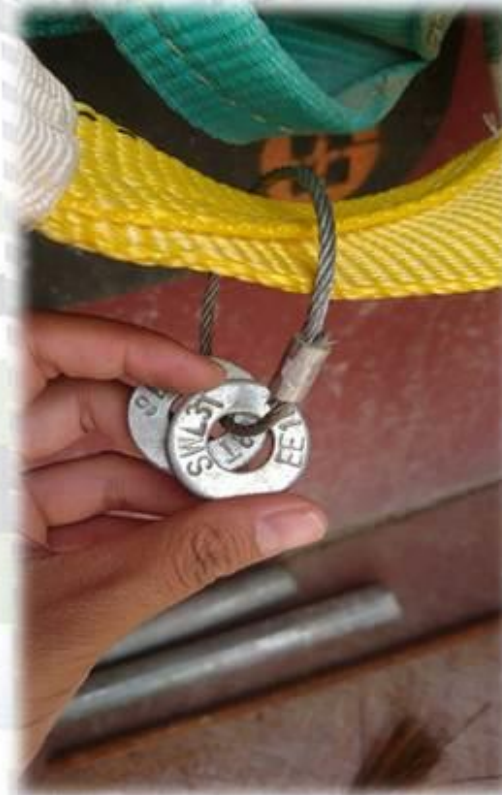
Provision of Double Marking of Lifting Gears & Nylon Webbing Slings
(Prohibition of re-examining the used nylon webbing slings) 20

We provided double markings on nylon webbing slings

The markings can be easily wear out in two or three months and can't be read

This method let the marking last longer
Moreover, we will not reuse nylon webbing slings
because it is easily affected by the weather
and it may require replacement after a few months
Avoid reuse, no re-examination is required
We will discard it right away
In terms of management
we have effective contract management
with our own sub-contractors
It is stated in the subcontracts
that the rigger and the signal man
have to perform separately and independently
They can't be performed by the same person
to avoid disputes
It allows clear execution by our frontline colleagues
Besides the alarm system in the lifting zone
we also install one more overload indicator visual alarm
You can see it on the right
that lamp with red, yellow and green
giving immediate alert to the signal man for the overload
To allow contingency, we have lowered the overload alarm
to 90% from full loading capacity of the tower crane
to allow pre-warning, alert early

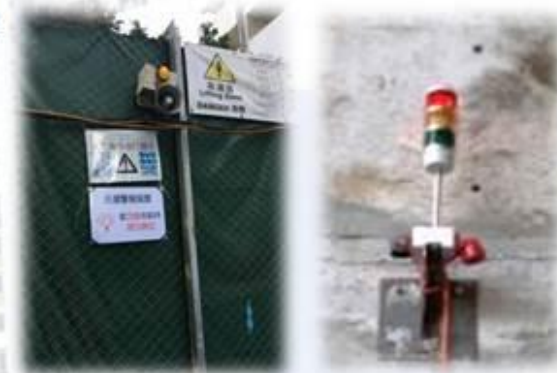
Loading Capacity of Tower Crane	Colour Signal
< 80 %	Green
80 % ≤ Loadings < 90%	Yellow
≥90 %	Red Alert

Audio Visual Lifting Alarm System & Automatic Safe Load Indicator

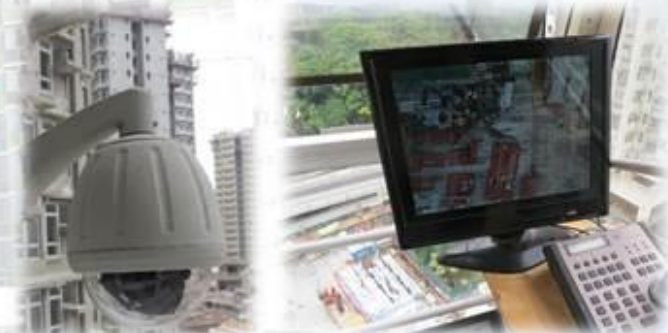
Multi-Angles Surveillance Cameras With Recording in Tower Crane & Lifting Zone

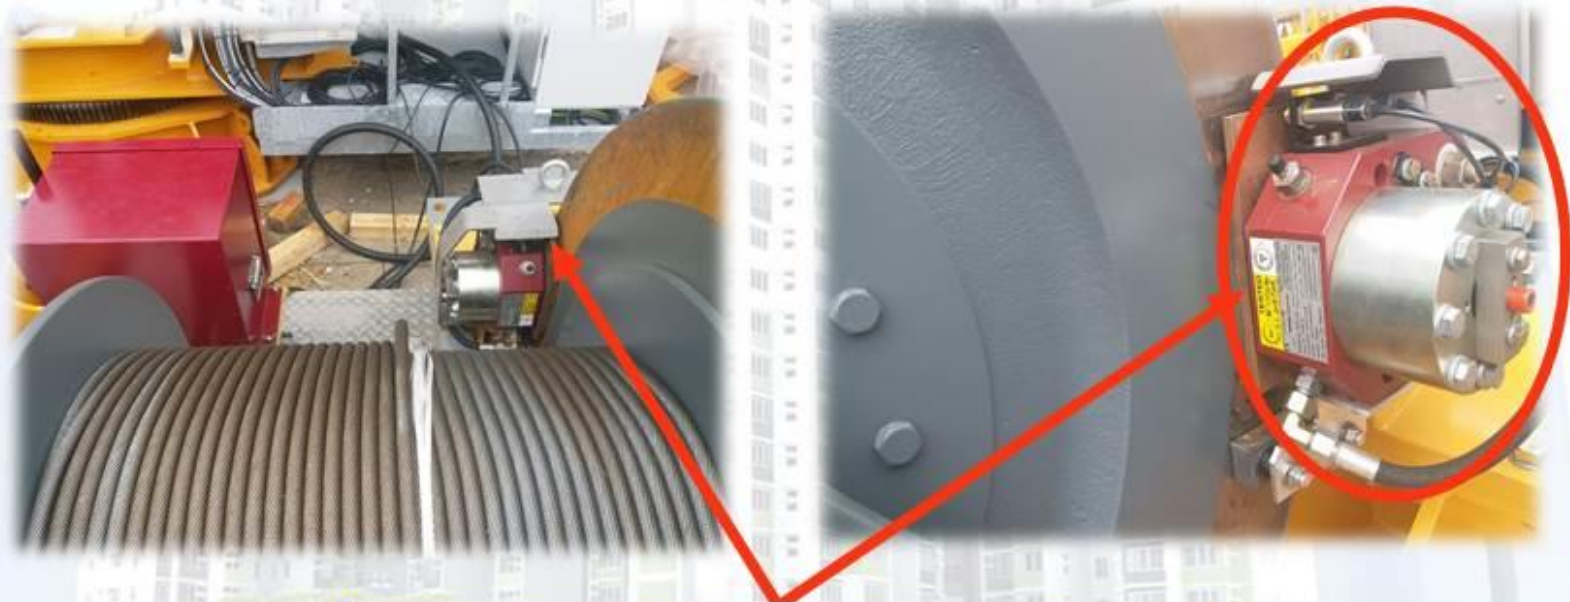
Secondary Brake System on Wire Drum

To comply with the requirements of the Housing Department
we install surveillance cameras with recording function
to monitor all tower crane lifting operations
After doing so many things
From 2018 till now, our company maintains
a zero accident record in lifting operation
Next, what is the way forward
We are planning with the supplier
to provide a secondary brake system on wire drum
This allow us to brake the objects being lifted

when main brake system fails
