應用建築信息模擬(BIM) 於水泉澳興建大跨度行人天橋的風險管理

何志偉博士
安全環保部副總經理
2020年11月2日

項目小檔案

工程項目名稱：水泉澳邨二期工程

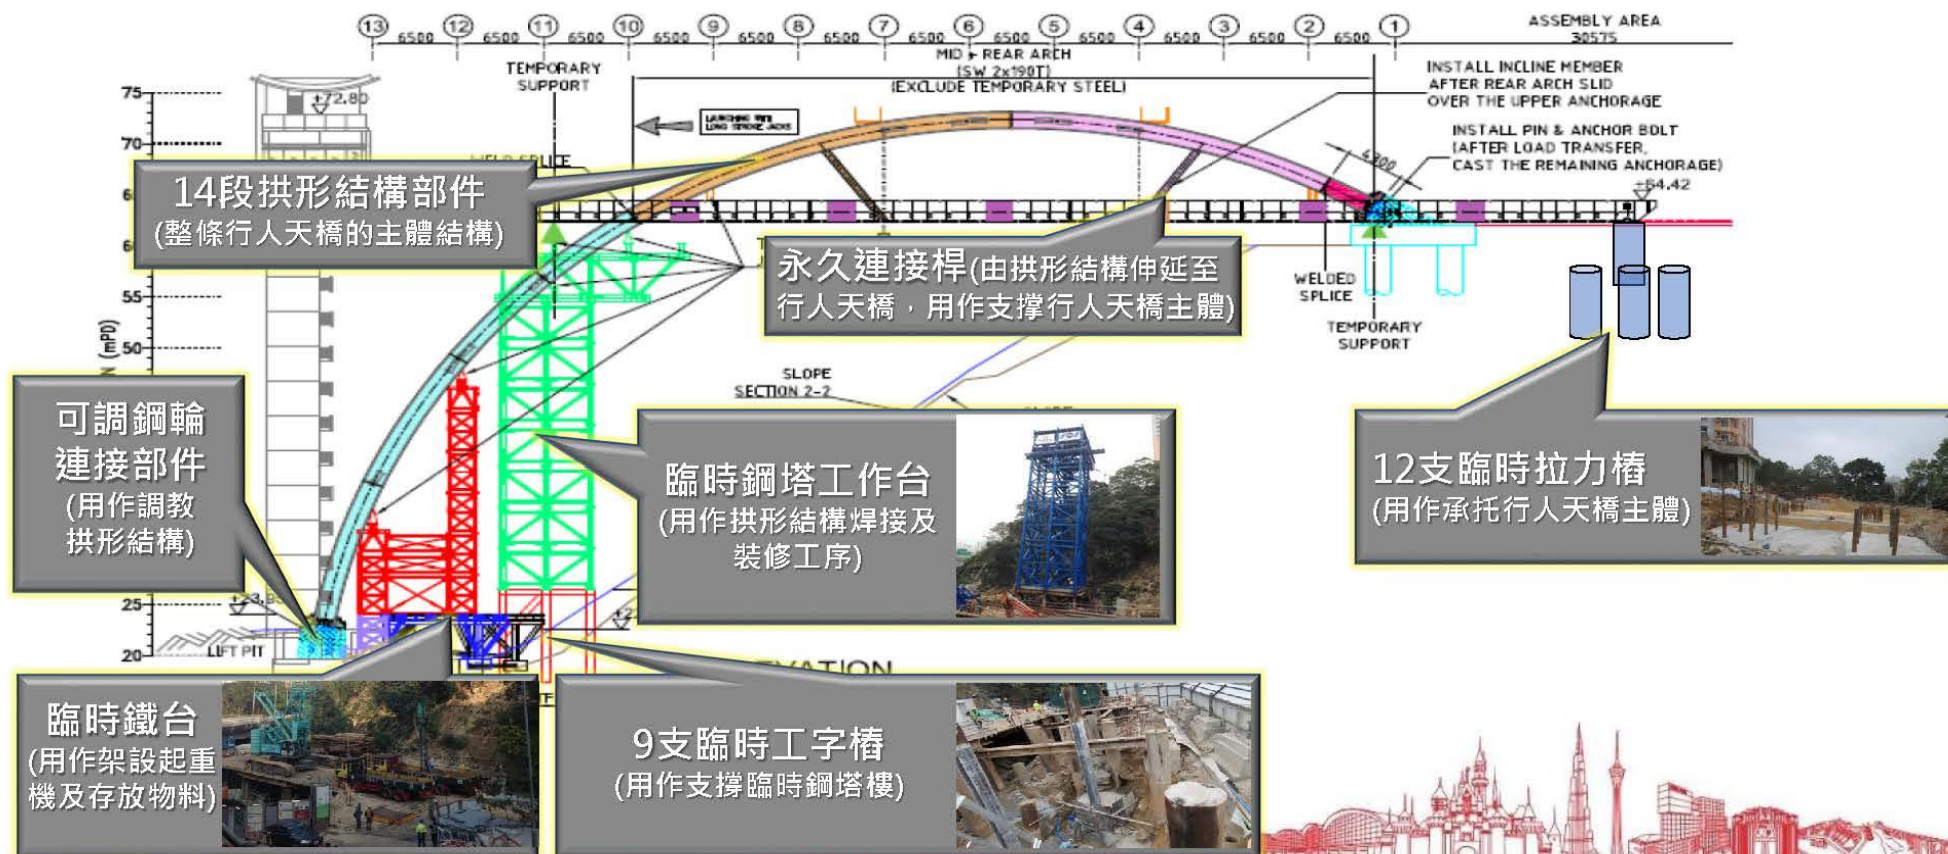
1.2 工程概況 – 結構簡述

1. 天橋的主體結構是由兩條對稱傾斜的拱形鋼管承托一條從山頂通往升降機塔樓的鋼結構組成
2. 升降機塔樓共15層高(約55米高)，由53支工字樁承托
3. 共需耗用2400公噸鋼材(永久及臨時結構各佔50%)
4. 工期約24個月，並於2017年第二季順利竣工

As you can see in the picture on the left where was the lift tower of the footbridge built? Actually, it was between a narrow road with two-lane two-way traffic and a natural stream that was under protection. The main part of this footbridge spanned over this natural stream and a steep slope. All these environmental factors added to the complexity of the construction works. This image shows the basic structure of the footbridge. There were 14 arch-shaped structural components. The footbridge itself was the main structure and these permanent connecting rods were extended from the arch structures. They provided support for the entire footbridge. There were also some pile foundation and other temporary works including 12 temporary tension piles on the side of the slope which helped to support the main structure of the footbridge. There were also 9 temporary H-piles at the bottom of the tower that helped support this temporary steel tower. Here you can see a temporary metal platform that was mainly used for setting up the cranes and for depositing materials. As you can see a temporary steel tower platform marked in green.

This platform was mainly for the welding of the arch structures and some other finishing work processes in the later stages of the project. Also, there was a steel gear that could be adjusted. The connecting part was used for making minor adjustments. On the whole, the construction of this footbridge involved certain safety hazards coincided with the theme of forum today. There were safety risks related to the lifting operations, the transport processes for temporary and permanent components and materials. There was work at height, some processes of installation and checks.

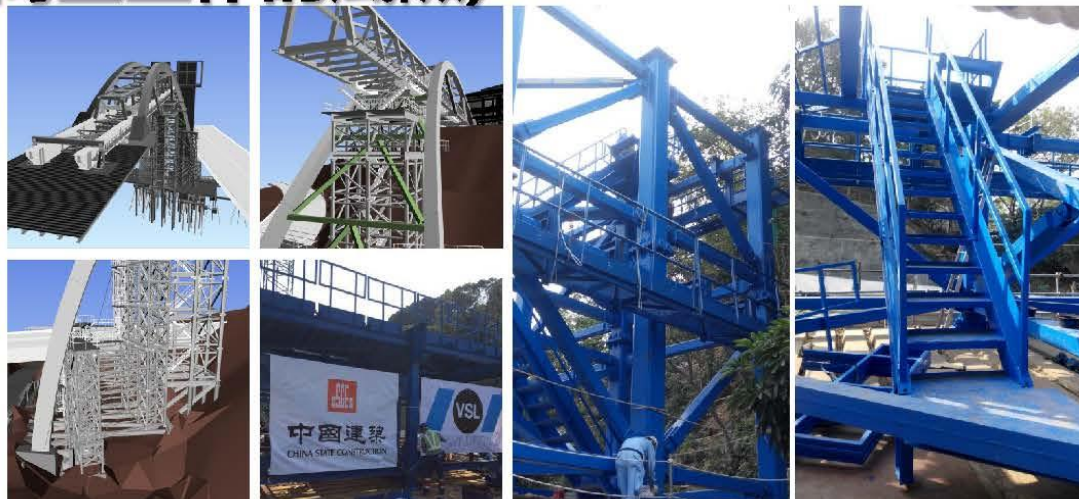
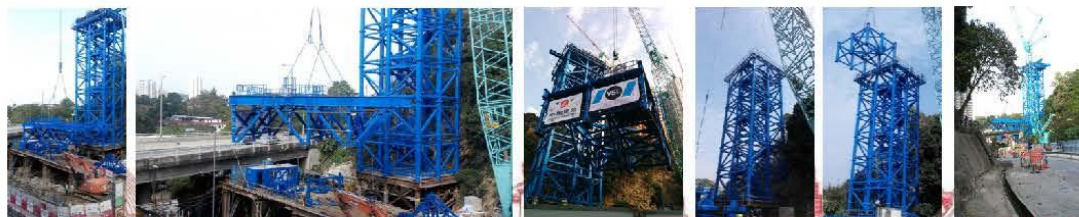
3.1 優化工作台設計(減低高空工作的風險)

工作台的設計

- BIM模擬斜拱橋接駁需要焊接的位置細節，有效設計合適工作台及安全進出通道

to decide whether lifting operations would be carried out that day
I have some examples here for you
We did BIM for some working platform designs
to model the details related to the welding positions for the arches
This helped our team design proper working platforms more effectively
as well as the safe access and egress routes
Another example shows
how we made special arrangements
for the installation of the arch-shaped footbridge
It enhanced the safety management of lifting operations and working at height
This animation shows that after the launching beam was designed
we modelled constructing a temporary working platform on top of it
Then, using this 250-tonne crane
we assembled this arch structure piece by piece in various phases
After the first part had been completed, we pushed it out part by part
Next, we repeated these steps to connect a temporary working platform
After assembling the second part, we pushed it out to merge with the first part

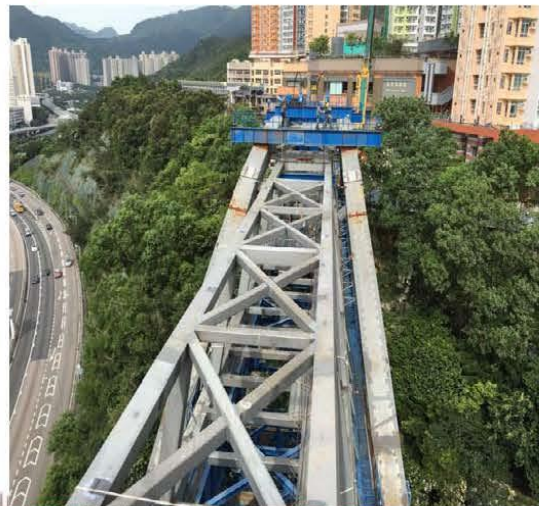
當導樑架設完成後

- ◆ 在導樑上搭建臨時工作台
- ◆ 利用250噸大型起重機逐步分段組裝拱橋結構部分
- ◆ 完成第一分段後，將整個分段推出
- ◆ 重覆架設臨時工作台
- ◆ 組裝第二分段拱橋後再次推出
- ◆ 完成接駁

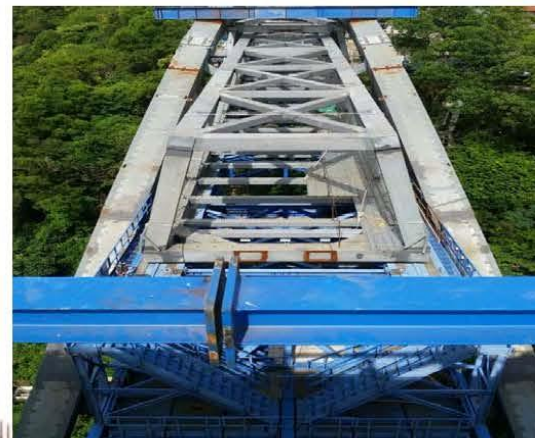
3.3 安裝天橋主體結構(提升吊運及高空工作安全管理)

- ◆ 利用250噸大型起重機吊運第一段橋身組件於導樑上進行組裝
- ◆ 推出第一段橋身組件，吊運第二段橋身組件於導樑上
- ◆ 組裝第一及第二段橋身組件
- ◆ 推出已連接的橋身組件，吊運第三段橋身組件於導樑上
- ◆ 重覆上述工序直至所有橋身組件安裝完成
- ◆ 所有駁口均為以半自動焊方法進行

This example shows how we installed the main structure of the footbridge
The site used a 250-tonne crane to lift some of the footbridge components
assembled them at the launching beam, then pushed out the first part of the bridge
Then, we lifted the components of the second part onto the launching beam
and then assembled the first and second parts of the footbridge together
We pushed it out and repeated the process with the third part and so on and so forth
As for the welding of the main structure of the bridge,
all the connections were welded together via semi-automatic welding
Here you can also see some of the renovation procedures for the bridge deck
A metal and bamboo scaffold was erected at the bottom of the deck
Considering weight limitation, we added a mesh at the bottom
and then covered it securely with a thick wooden plank
This main structure and all the working positions of
the double-row bamboo scaffolding were securely covered with nets

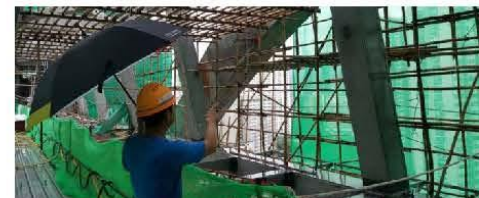
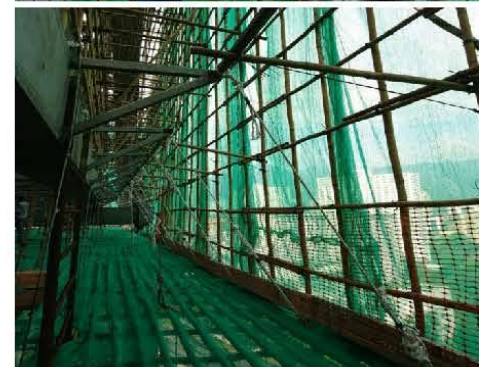
3.4 橋身裝修工序 (防止高空工作及墮物風險)

- ◆ 在橋身底部搭建混合吊棚，以密網墊底再以厚木板妥善覆蓋
- ◆ 主結構及所有工作位置以竹棚架和雙層棚網妥善覆蓋
- ◆ 全職棚架合資格人士，每週對棚架進行法定檢查

We arranged a competent person of bamboo scaffolding to be full time on site
to supervise the erection of the bamboo scaffolding
We also asked this competent person
to do weekly checks for the bamboo scaffolding and to sign a Form No. 5
In view of time constraints, I will conclude here
Over the course of around two years
this construction contract had zero incidents and zero prosecutions
In terms of quality, we achieved seamless welding
of the top and bottom arches, which was very hard to achieve
Our margin of error was less than the 20 mm allowed in our contract
Also, throughout the construction process
we strived to minimise any impact on the general public
This brings me to the end of my sharing today, thank you
