Construction Industry Council

塔式起重機組(天秤)安全管理計劃報告 (二零零七年十一月)

二零零八年四月一日

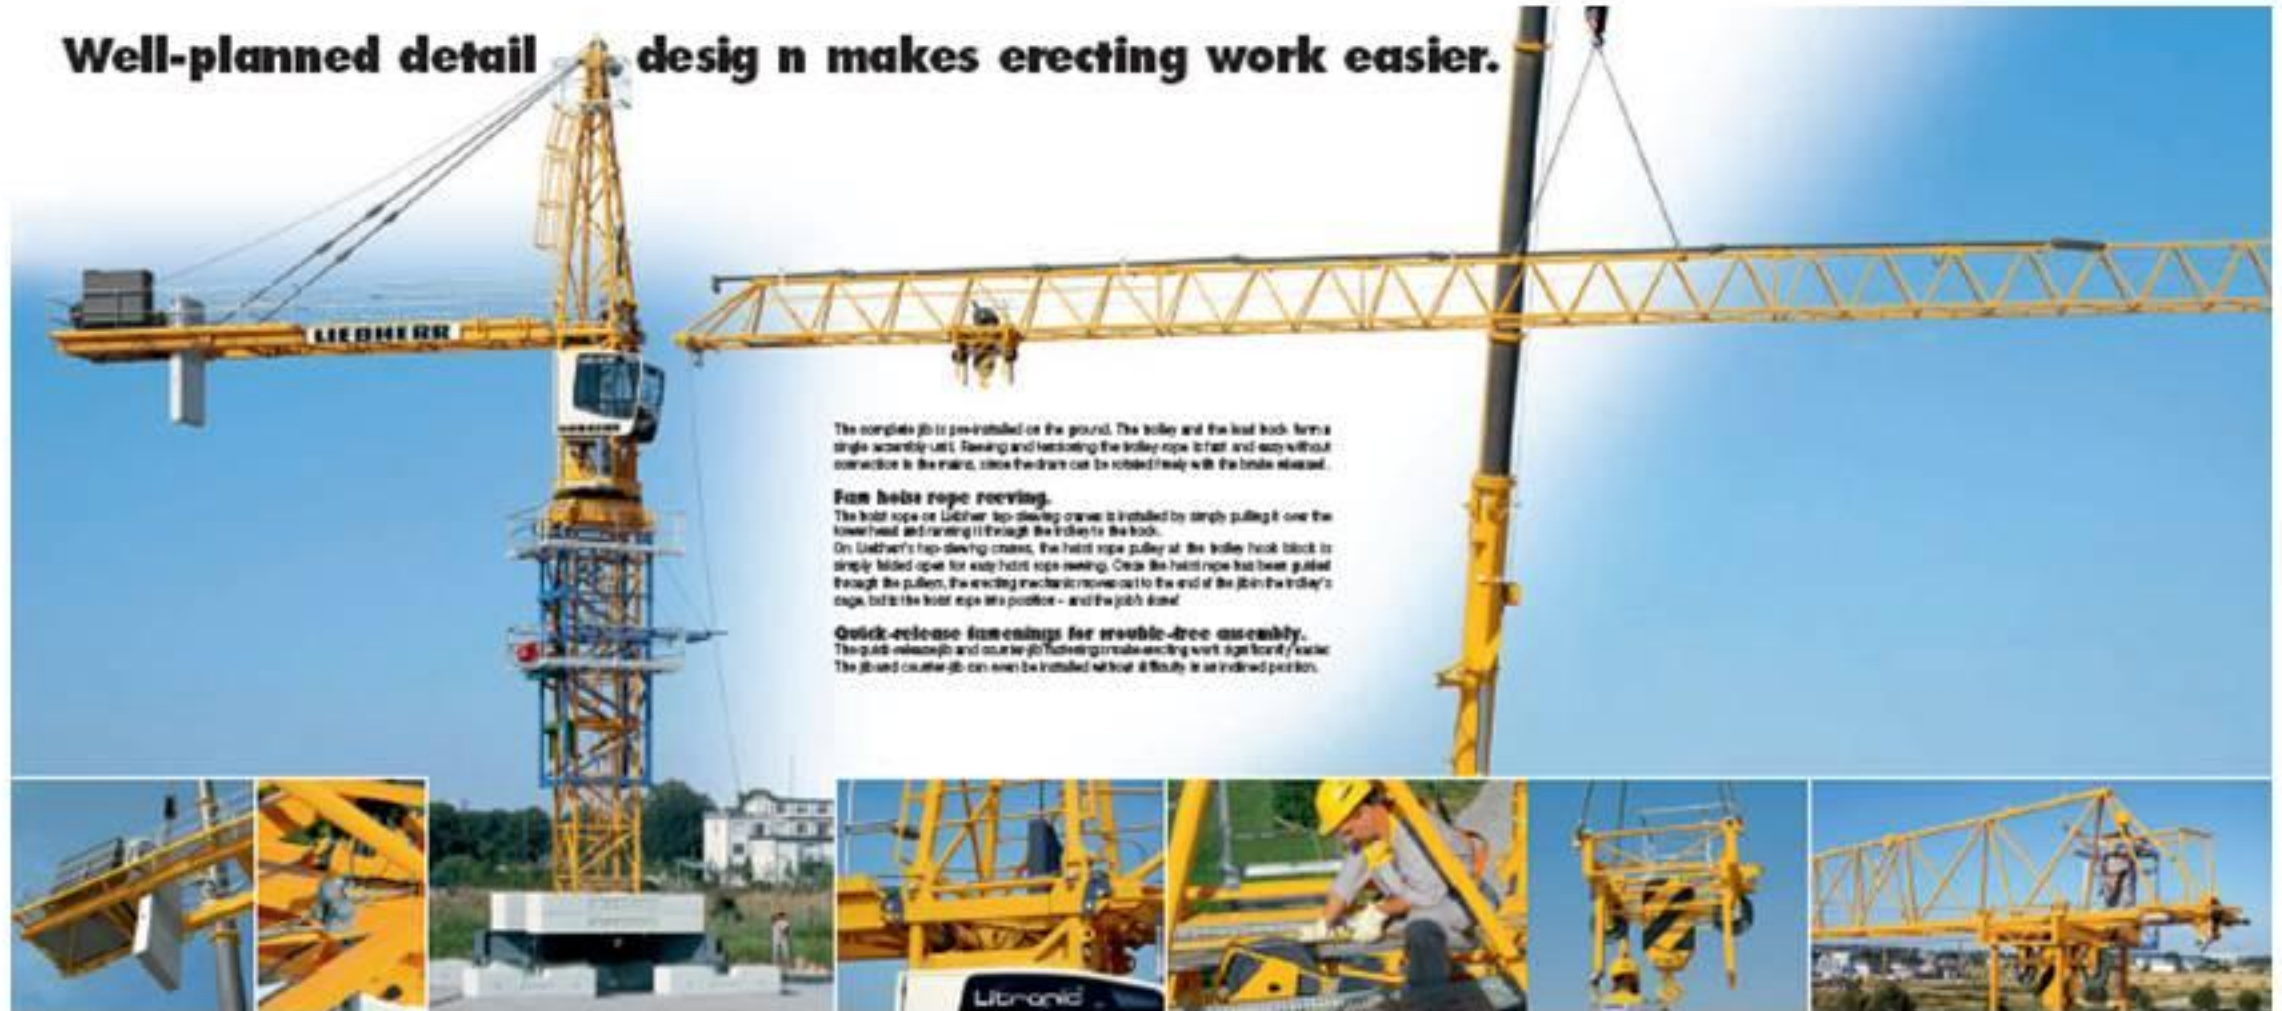
天秤的架設

Well-planned detail design makes erecting work easier.

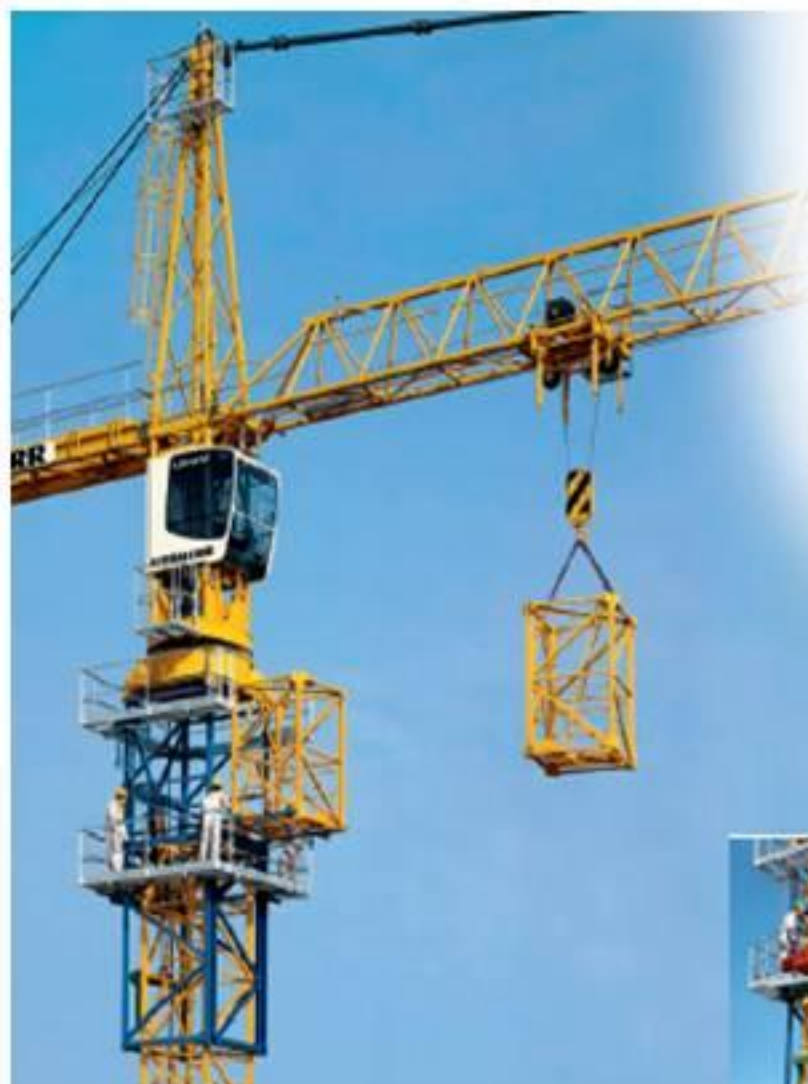
天秤的升降

5 Safety monitoring during climbing.

Liether's fast climbing system permits quick, easy and safe tower climbing. It consists of the guide section (blue), the hydraulic system (red) and the supporting cross-member (green). The guide section is bolted to the existing structure. For fast climbing, the entire upper part of the crane is lifted by the hydraulic ram. All tower sections are inserted from the front, using the crane's own hook. The tower crane then grows section by section.

Newly developed monitoring device.

The new monitoring device detects and prevents operating errors. The positions of the supporting equipment during climbing are monitored by limit switches.

Fast climbing.

Climbing is easy, fast and trouble-free. Position the climbing cross-member on the lower section, extend the ram, hold the upper part of the crane with the support shoe, extend the ram - this is all that's needed to complete the first climbing stage. For a 2.2-metre tower section, two climbing stages provide the space for the lower section to be pushed in and bolted to the tower.

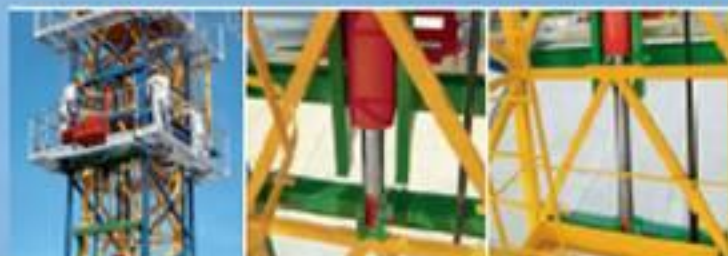
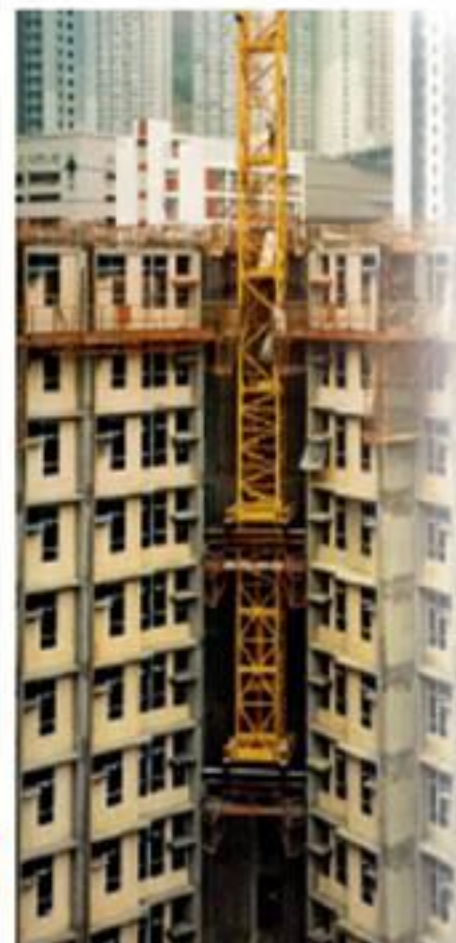
Climbing inside buildings.

Liether top-climbing cranes are ideal for use as climbing cranes in buildings. Liether tower cranes can be used in elevator shafts and even in the smallest ridges as the project 'grows' rapidly. The crane is fast-paced with the building.

The IC tower system.

The IC internal climbing tower has been designed specifically for narrow elevator shafts. Its dimensions are as small as 1.40 m x 1.40 m, which makes it perfect for even the smallest shafts. The entire climbing hydraulics are located in a space-saving manner inside the tower section.

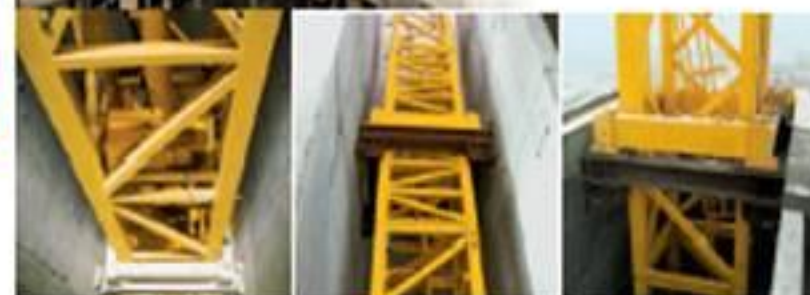
The hydraulic ram in the IC tower.

Geometry of IC tower in an elevator shaft.

The upper climbing frame of the IC tower.

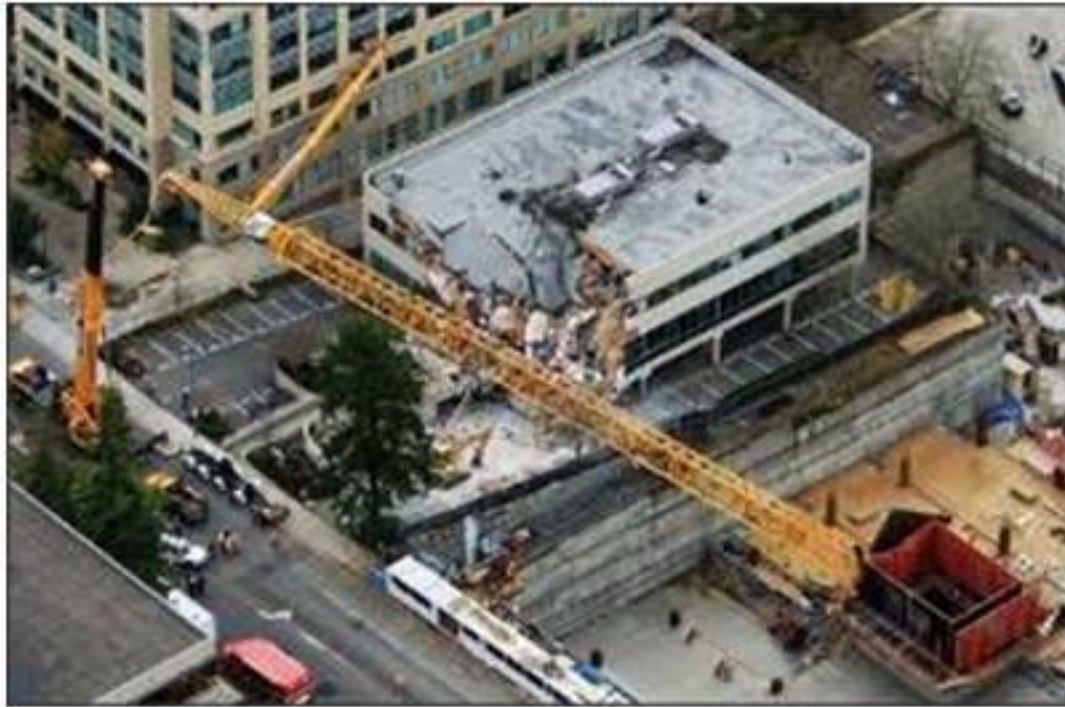
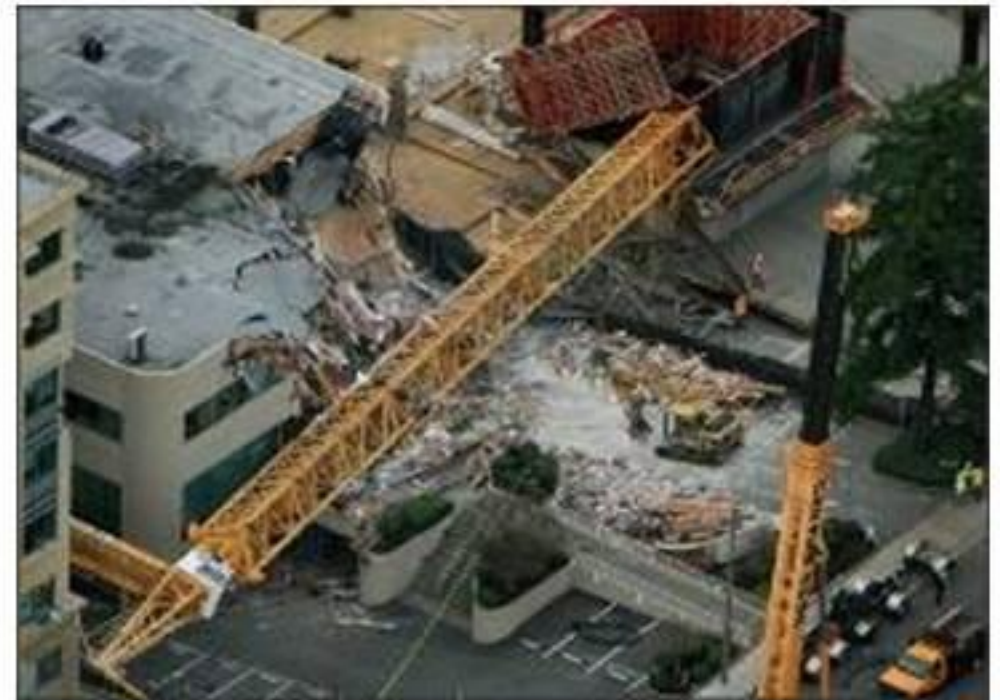
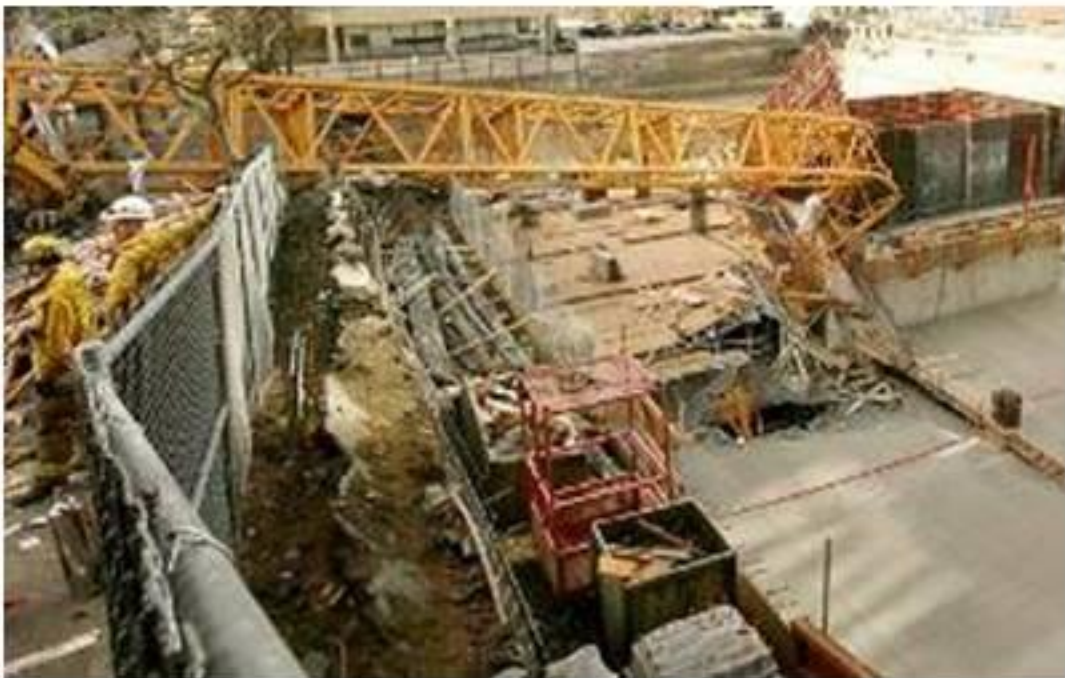
事例三

CRANE FOUNDATION FAILED

Tower cranes are normally set in thousands of pounds of concrete. Engineers specially designed a steel base at the Tower 333 construction site in Bellevue, but that design failed, leading to the crane's deadly collapse. A new crane was erected in January, this time in a standard base.
