# **Lesson Learnt from Accident and Incident –**

**Use of Builder's Lift and**

**Dismantling of Material Hoist**

**Hanison Construction Company Limited**

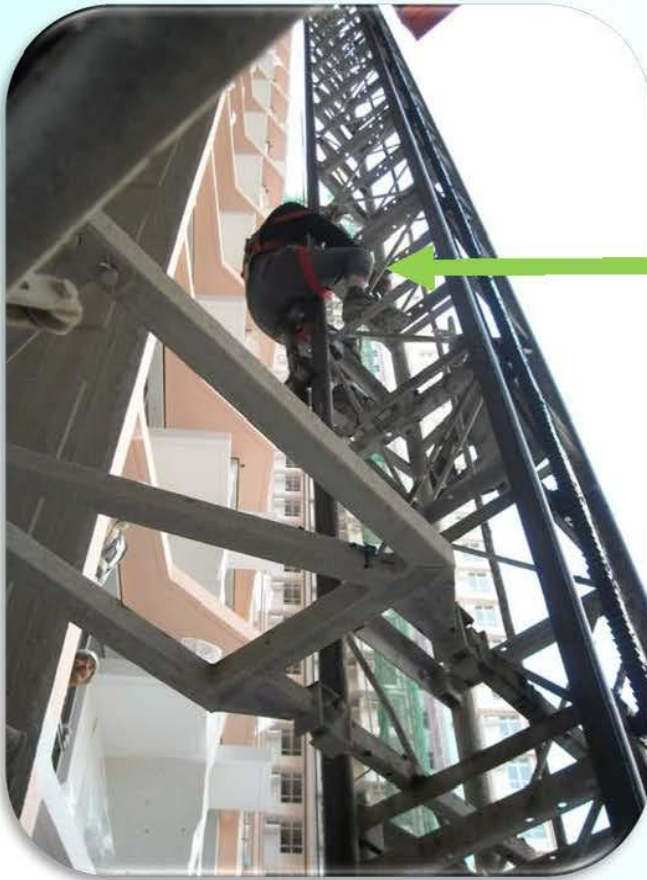
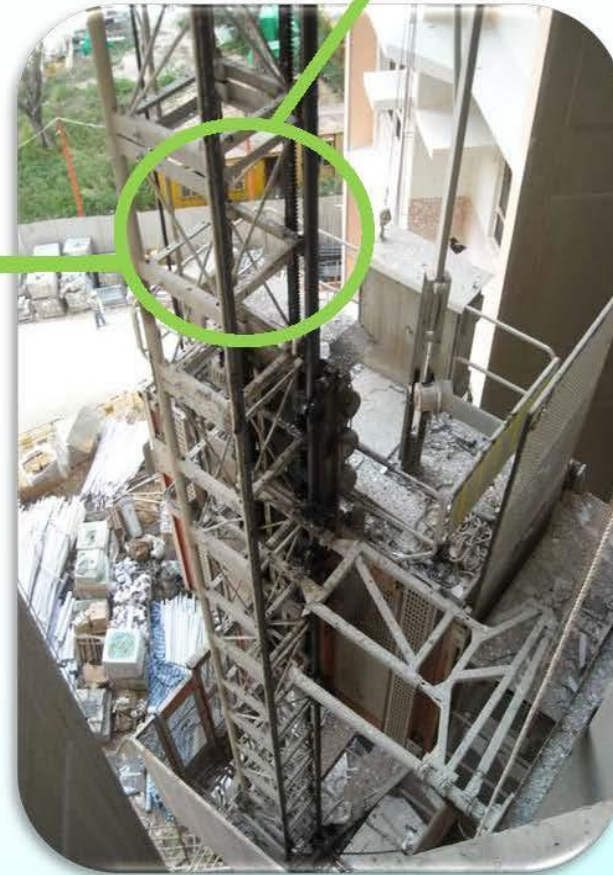
- The scene of the accident

Position of the I/P at about 6/F level

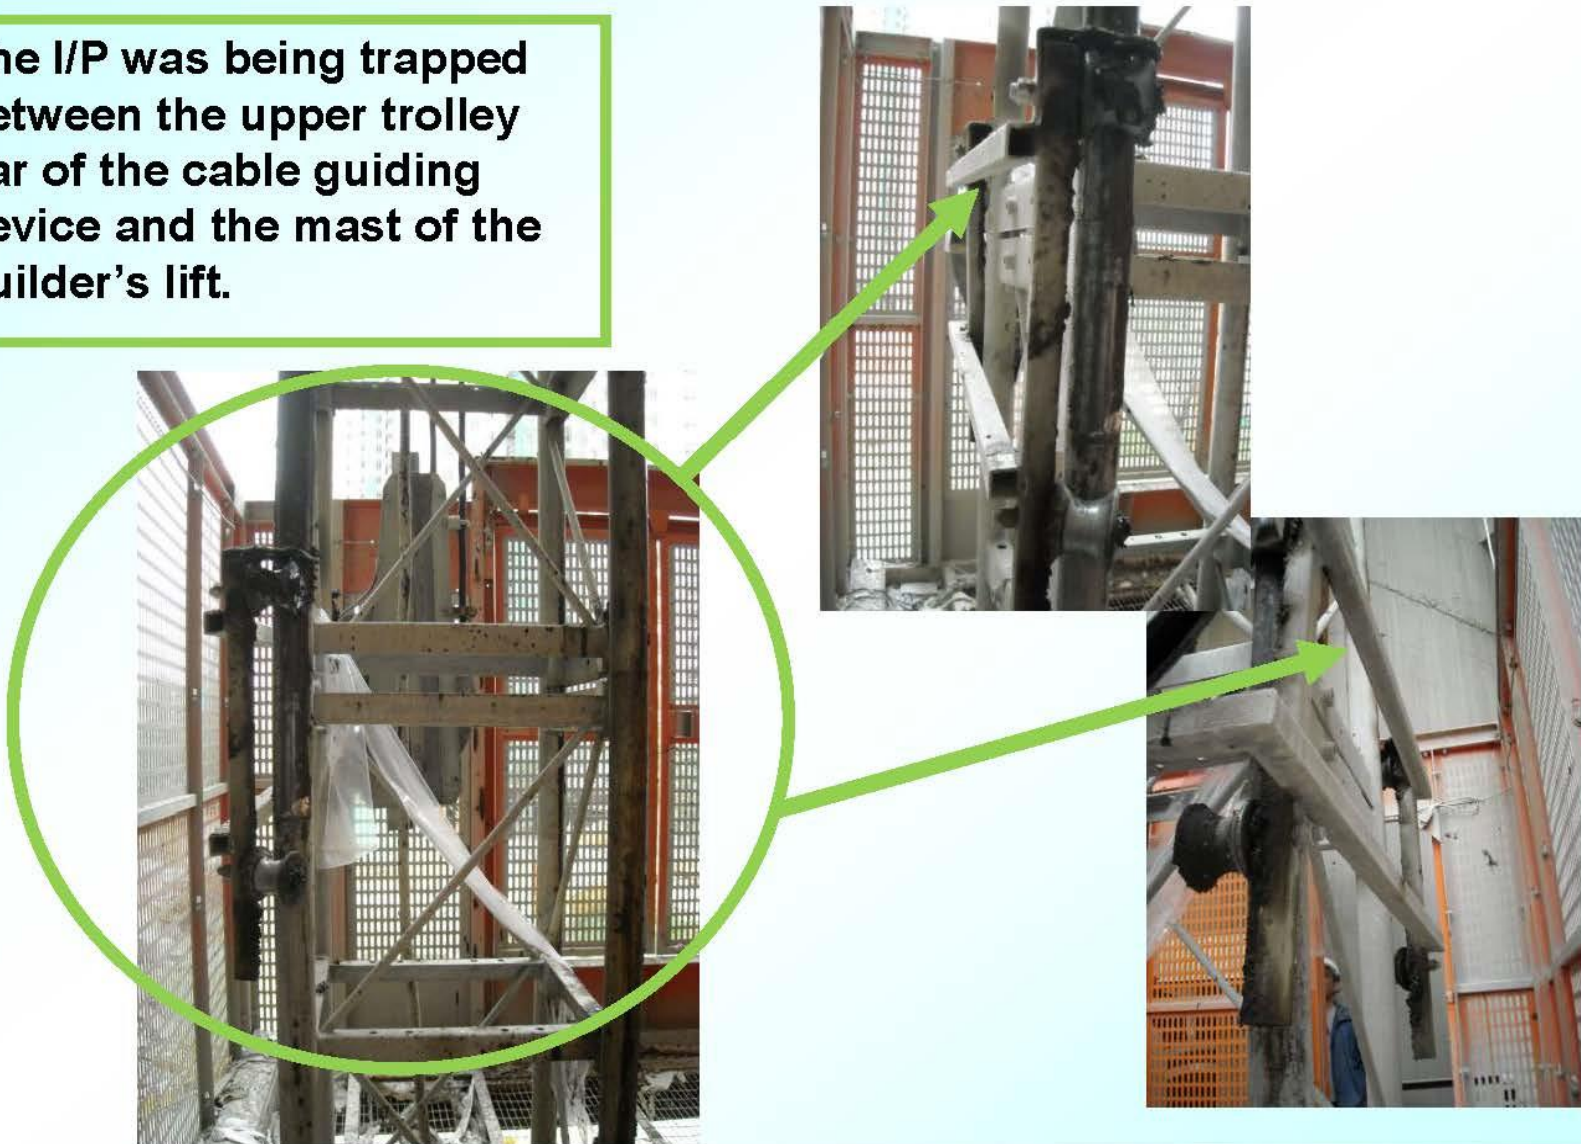
The I/P was being trapped between the upper trolley bar of the cable guiding device and the mast of the builder's lift.

- **Causes of the accident**
  - The I/P climbed over the safety railing and went outside the roof platform of the cage.
  - Miscommunication between the builder's lift operator and the I/P.

- **Lesson learnt**
  - Establish and maintain effective communication between the builder's lift operator and the worker engaged in dismantling the builder lift.
  - There should be an appointed person in charge of handover activities such as using and dismantling of builder's lift - handover the operating key for the lift.

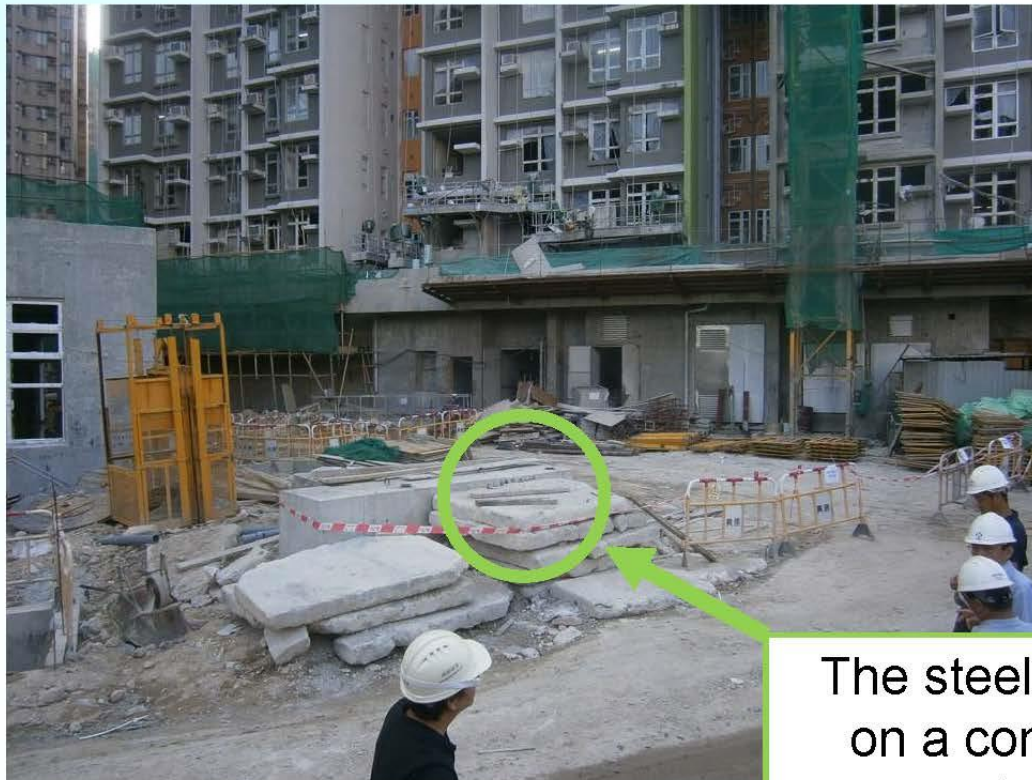
- Near miss incident happened on a project site at Tseung Kwan O.
- A 3-metre steel U-channel which was tied between the mast of material hoist and floor slab of 26/F fell down to ground level.

The steel U-channel fell and hit on a concrete slab within the barricaded area

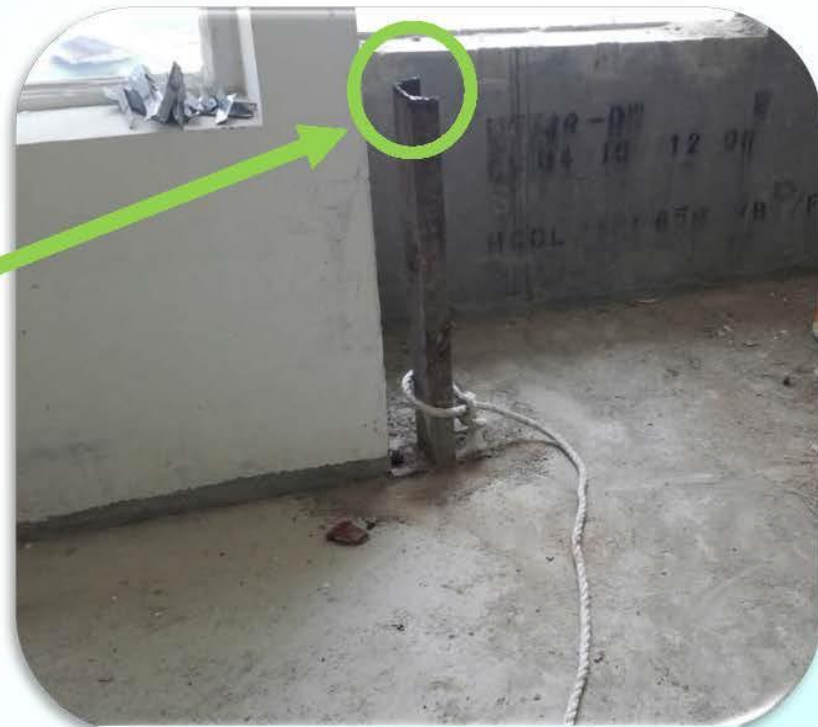
- **Cause of the incident**
  - The fall of the steel U-channel was due to the crack of weld at the joint of the horizontal and vertical channels.
