HASAS(NW) – 2018Q2 - 2018Q3

HALENSAS – 2018Q2 - 2018Q3

Summary on Audit Findings

Occupational Safety and Health Council

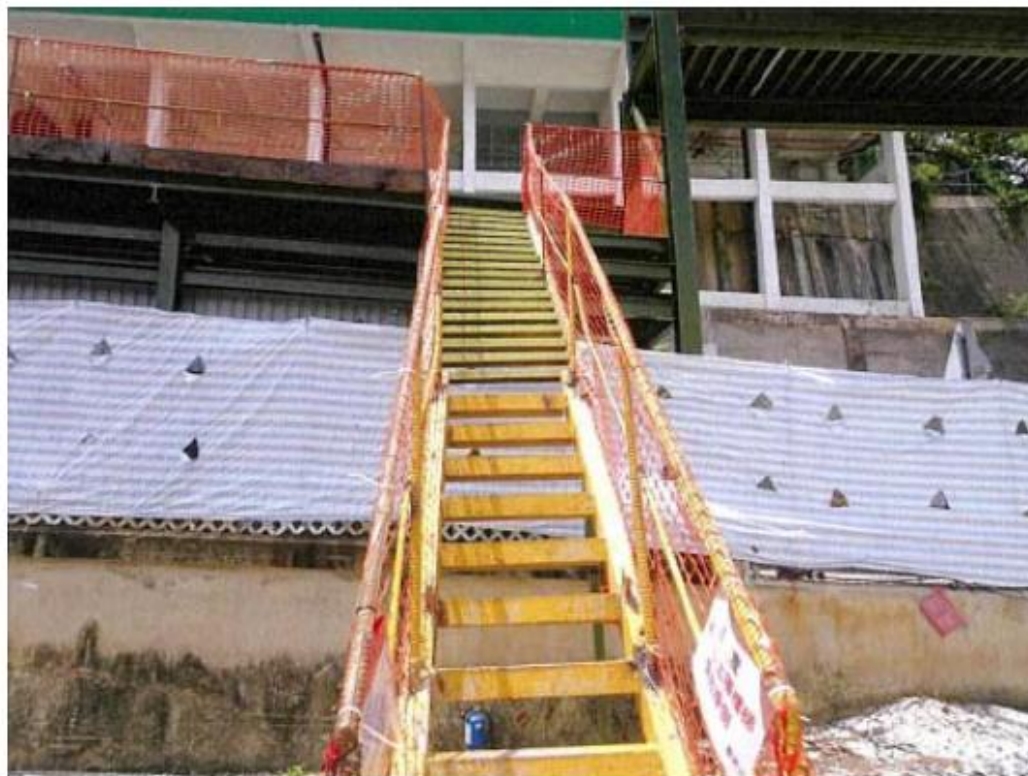
- Safe means of access and egress was provided
- 提供妥善進出口

The up and down passageways were ideal

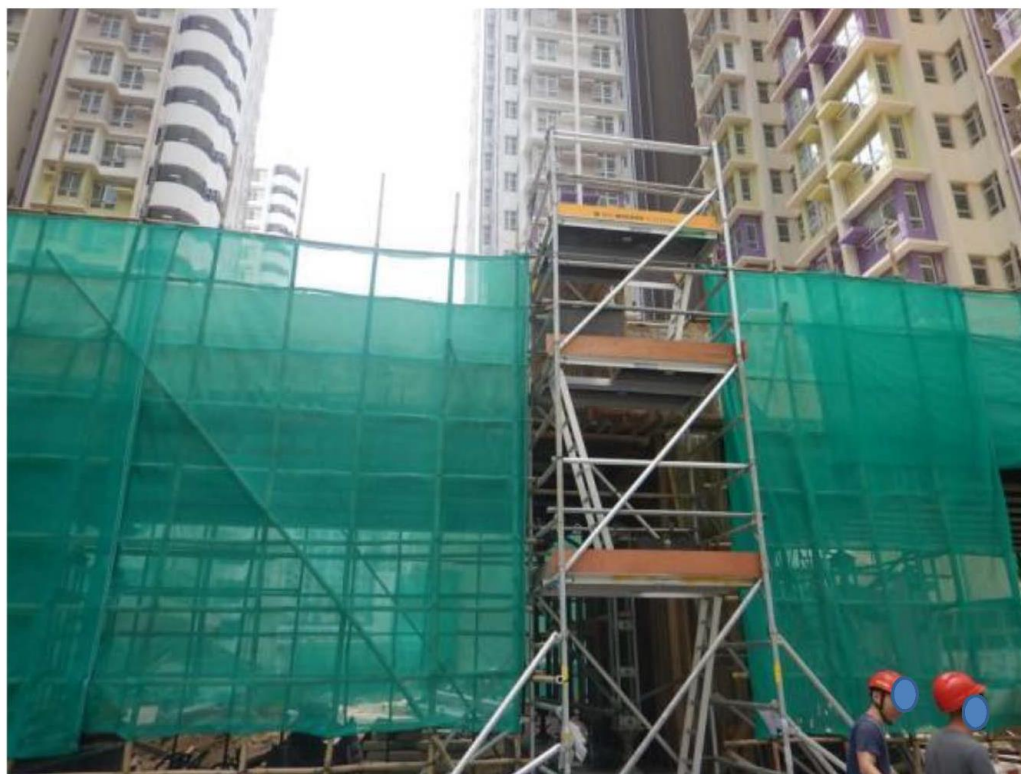
- Safe means of access and egress was provided
- 提供妥善進出口

These platform entrances and exits

were at ideal locations

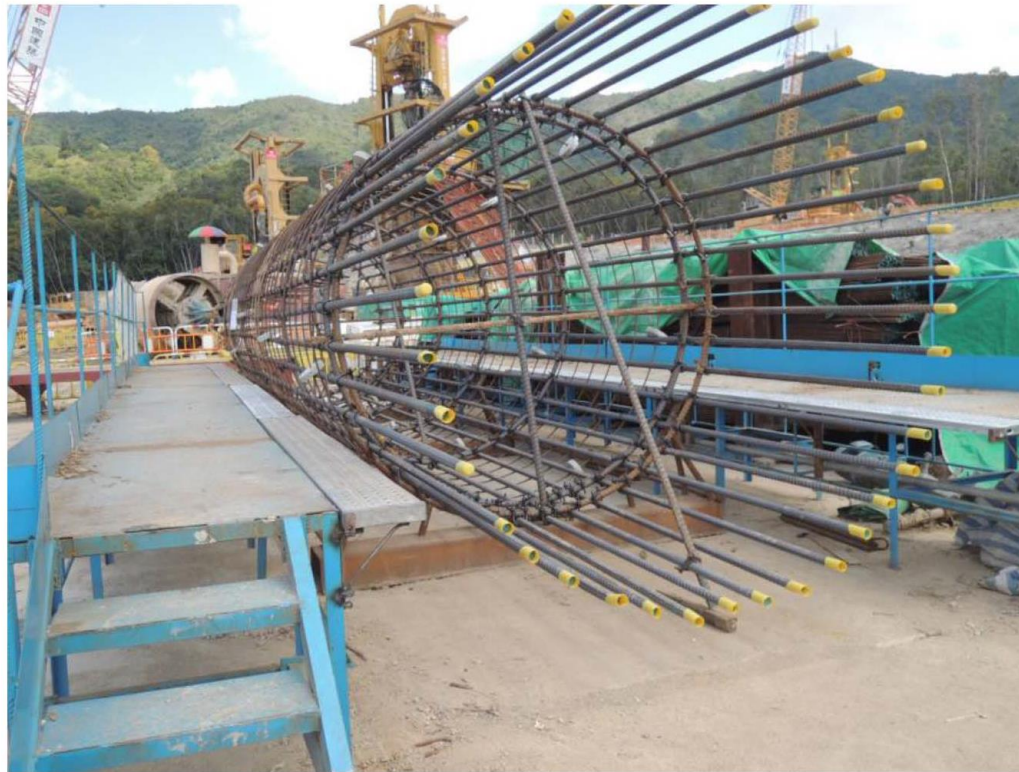
- Adjustable working platform was provided for reinforcement cages of bored piles works
- 為扎結鑽樁鐵籠工作提供可調節工作平台

This was where a reinforcement cage was

There was a work platform

The original design of the work platform

had a gap here

The previous audit recommendation was undertaken

and improvement was made

to build an adjustable work platform

This part could be extended to reduce the gap

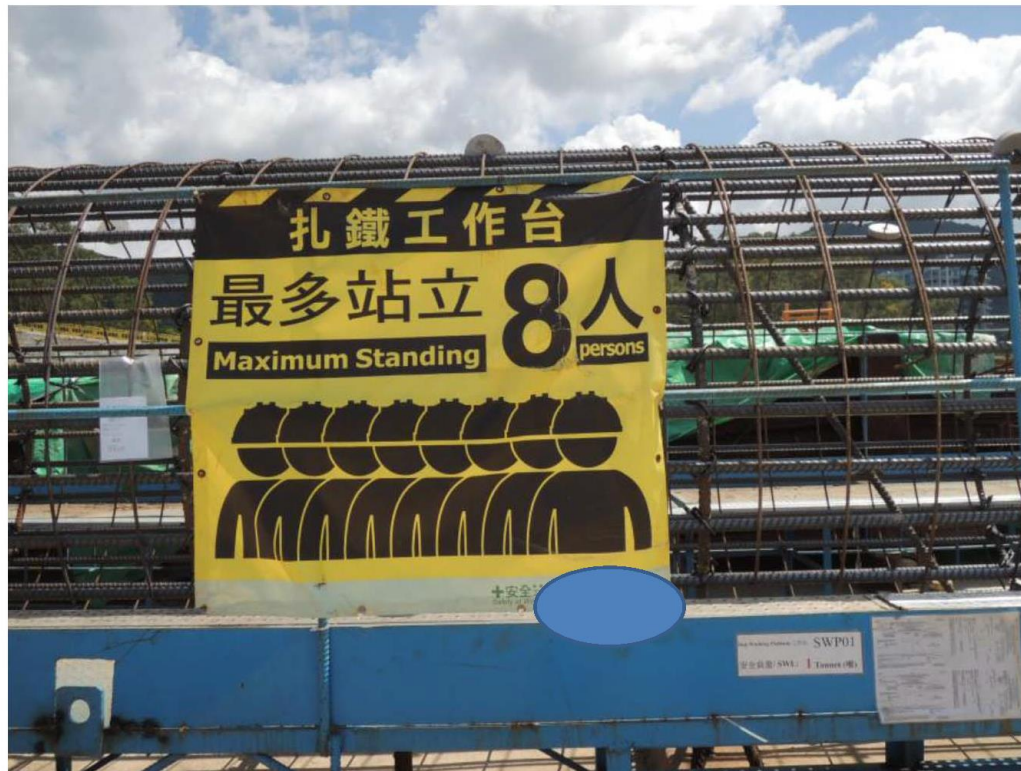
- Safe working load for working platform was clearly displayed
- 清晰標明安全工作負荷

This was a bar bending working platform

Safe loading was very important

The number of persons allowed had been clearly stated

This display was very clear

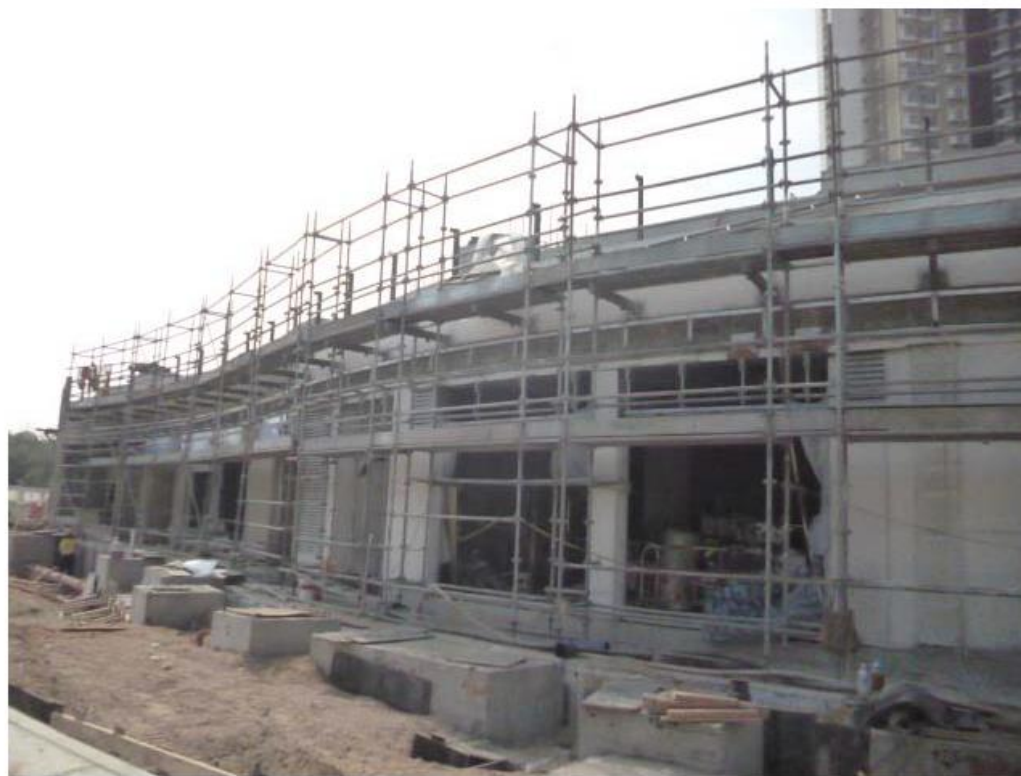
- Proper guard-rails and toe-boards installed for working platform
- 為工作台安裝合適護欄及底護板

These were guardrails and toe-boards

Basically the arrangements were fine

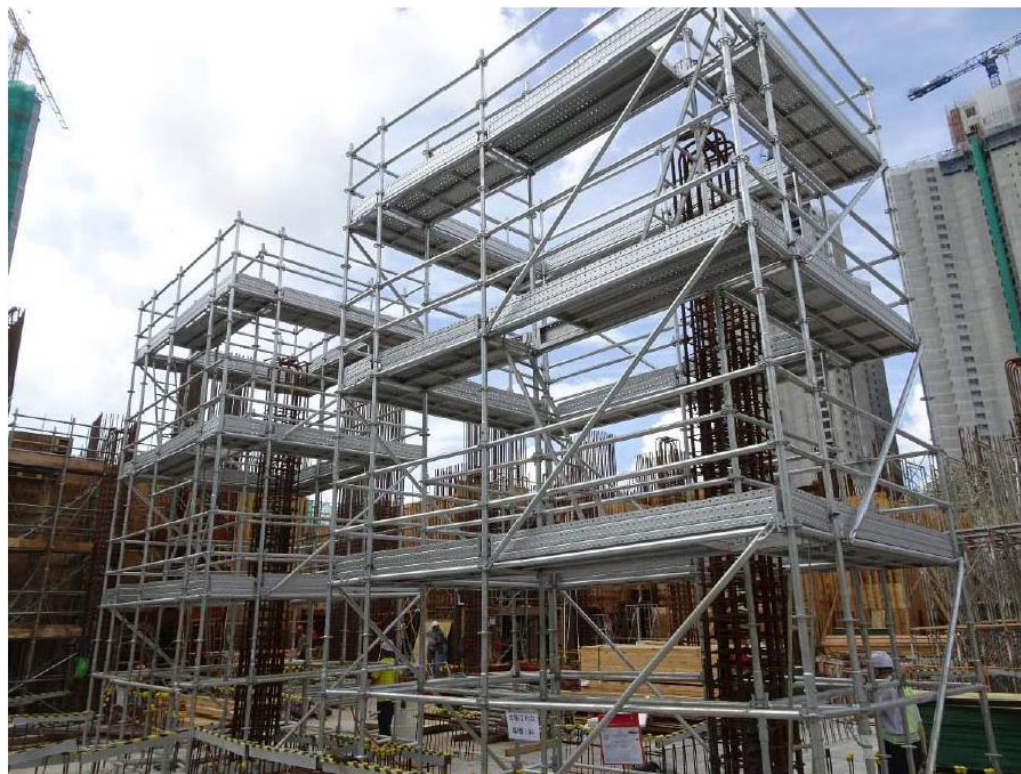
- Proper guard-rails and toe-boards installed for working platform
- 為工作台安裝合適護欄及底護板

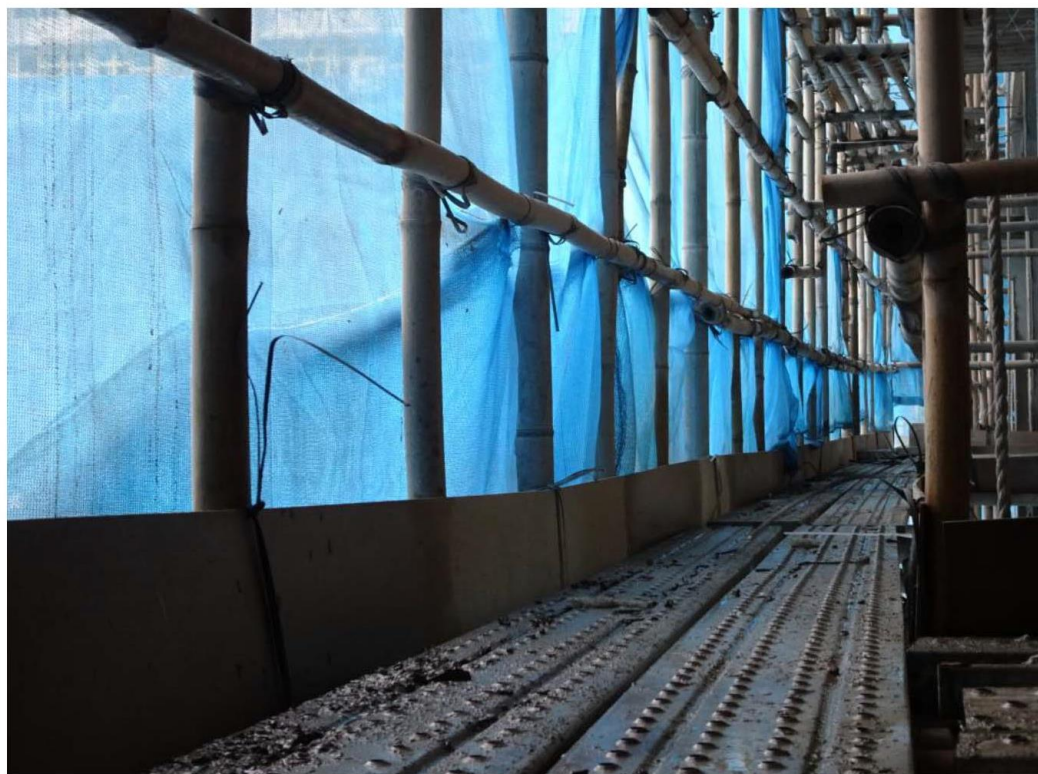
- Working platform closely boarded
- 工作台密鋪

If the bamboo scaffolding does not provide closely spaced bamboo

The planking must be closely paved

This is closely spaced bamboo scaffolding

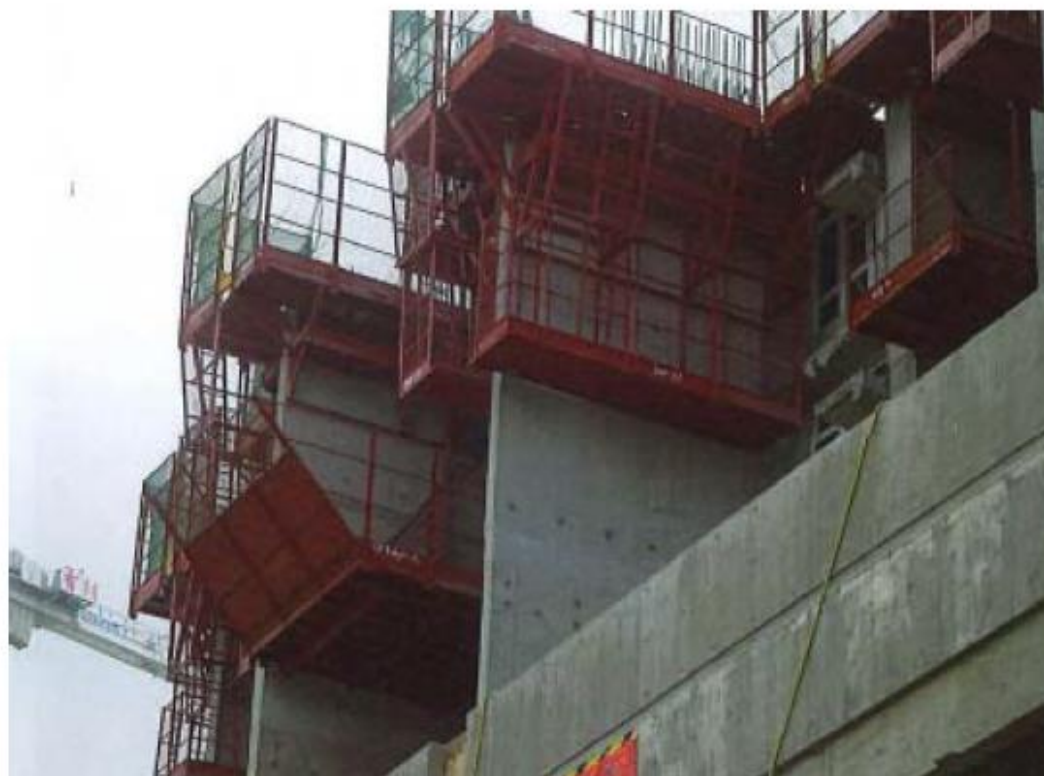
- Proper guard-rails and toe-boards installed for working platform
- 為工作台安裝合適護欄及底護板

Guardrails and toe-boards extended to become working platform

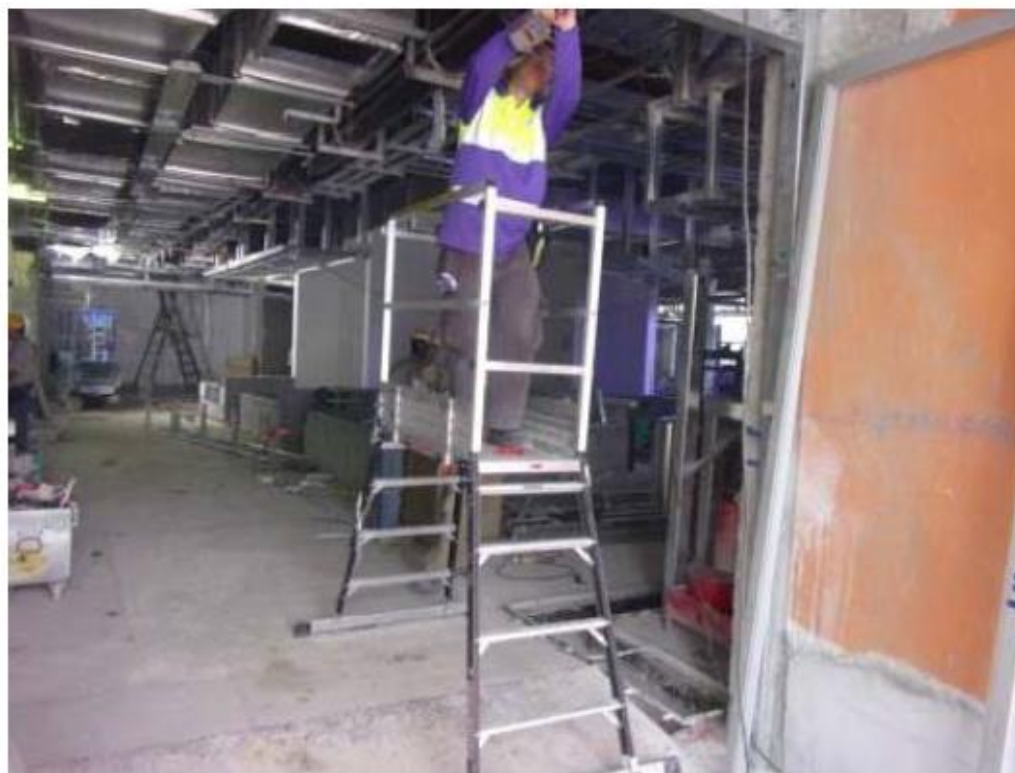
- Hop-up platform with guardrails and toe-boards provided
- 提供設有護欄及底護板的功夫檯

Hop-up platforms were usually used indoors

We saw Nominated subcontractors (NSC) using them too

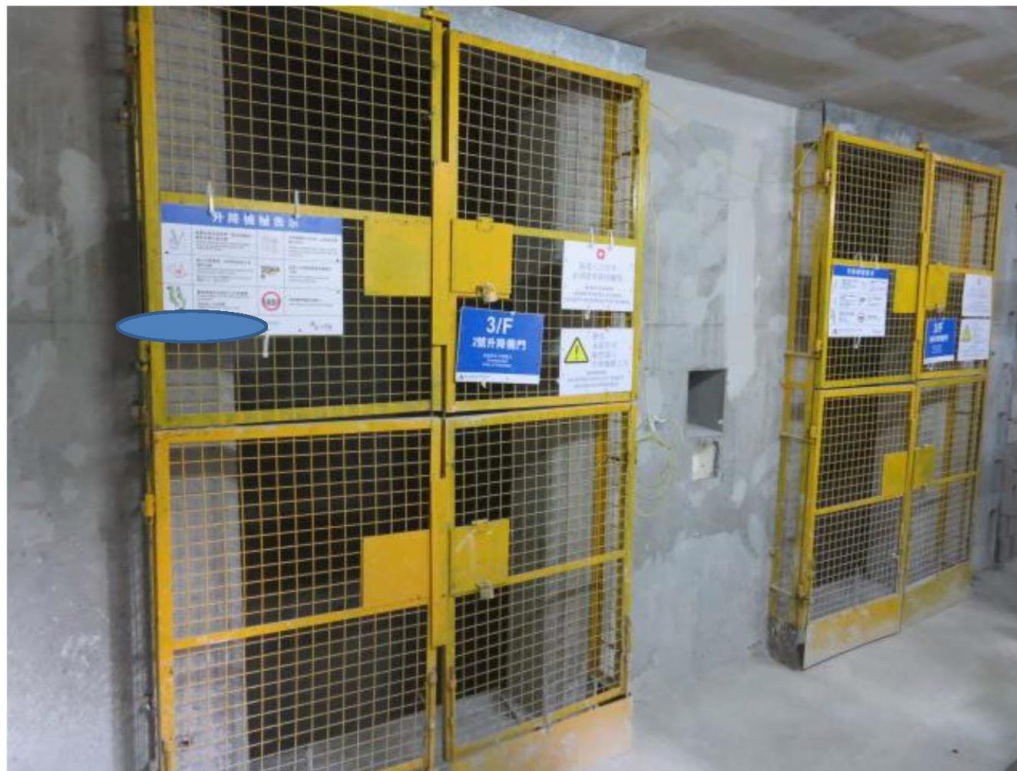
- Lift shaft openings enclosed and locked
- 圍封及鎖上升降機槽的開口

At the opening of lift shaft

the installation of a 4-panel gate was ideal

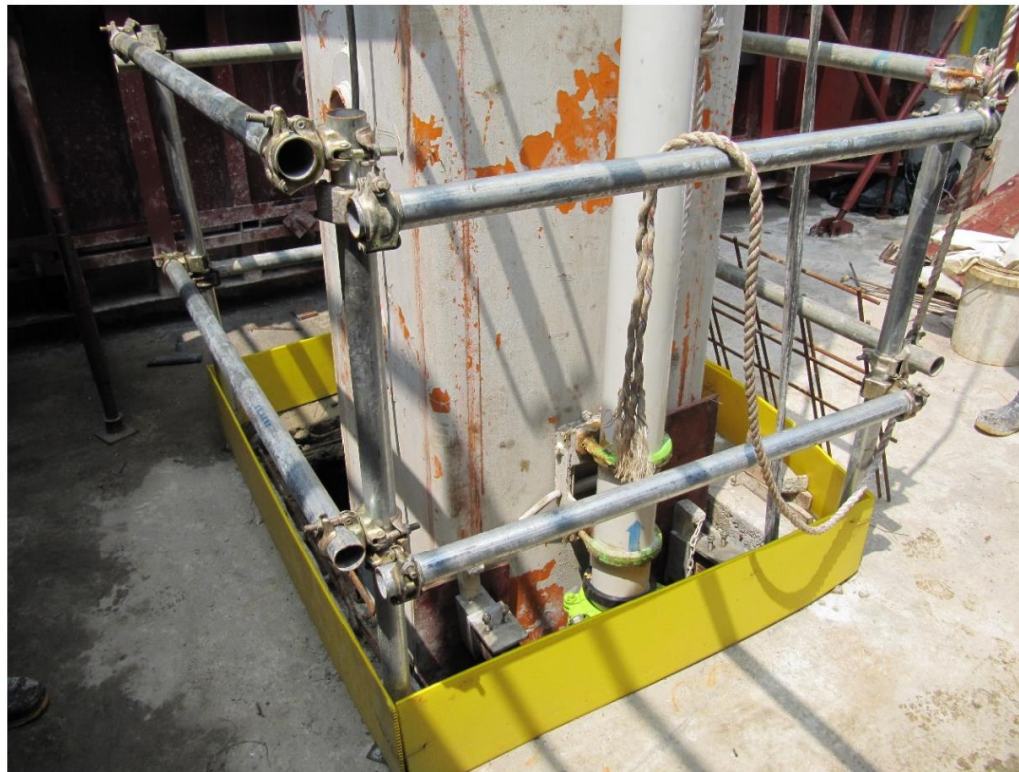
- Floor opening with proper guardrails and toe-boards
- 地洞設有合適護欄及底護板

Other recent concerns were floor openings at internal working areas

These were also properly handled

There were guardrails and toe-boards for the floor openings

providing instant protection

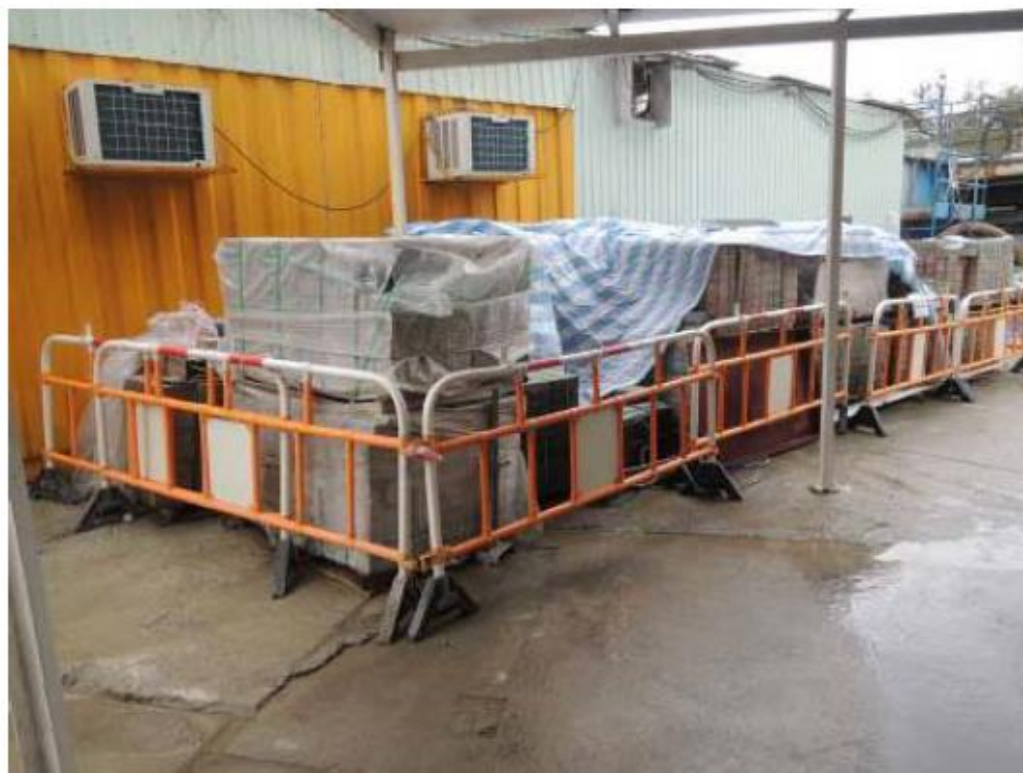
- Designated storage area with fencing
- 圍封指定存儲區域

these were designated storage areas

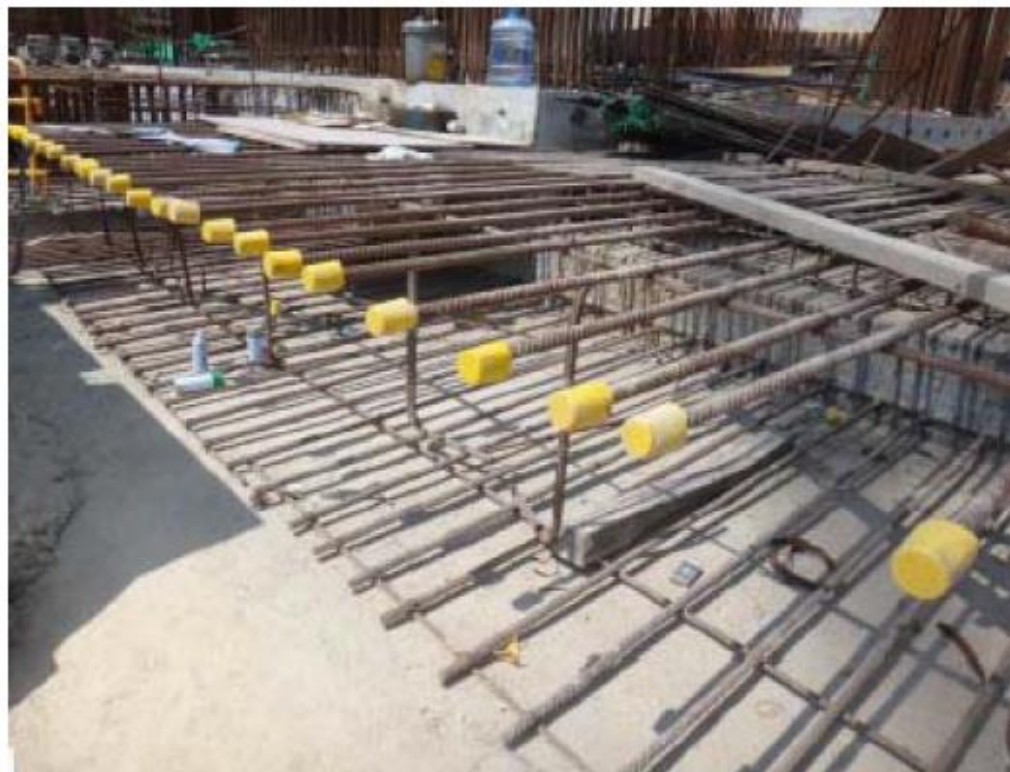
- Sharp objects were protected
- 為尖銳的物體作出保護

These were sharp starter-bars, they were covered by caps

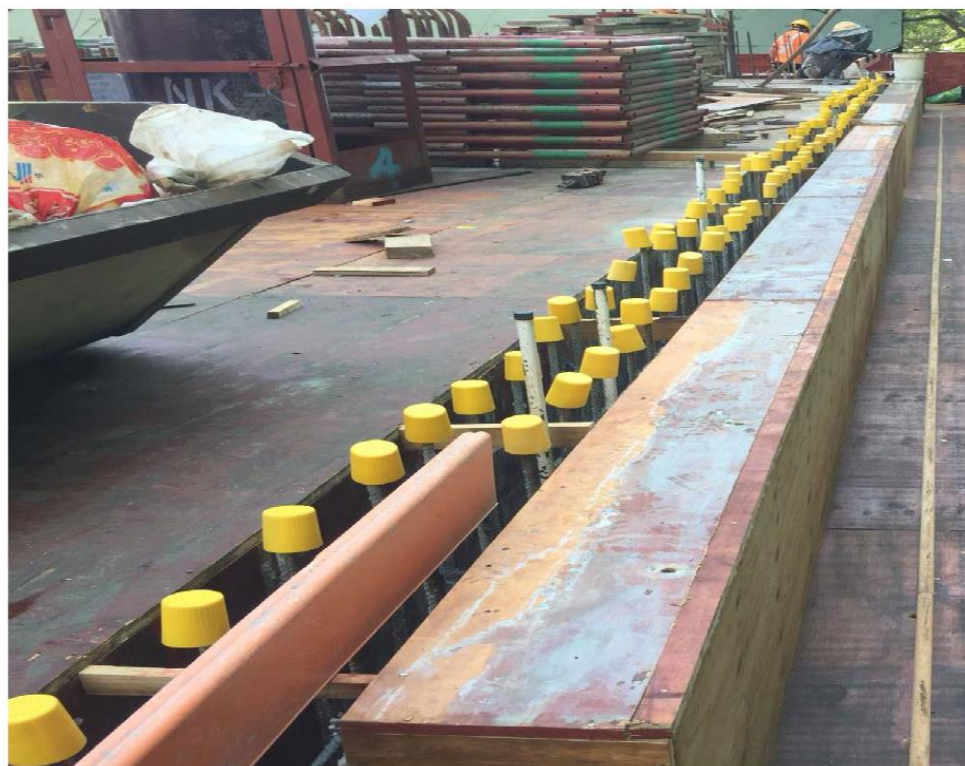
- Sharp objects were protected
- 為尖銳的物體作出保護

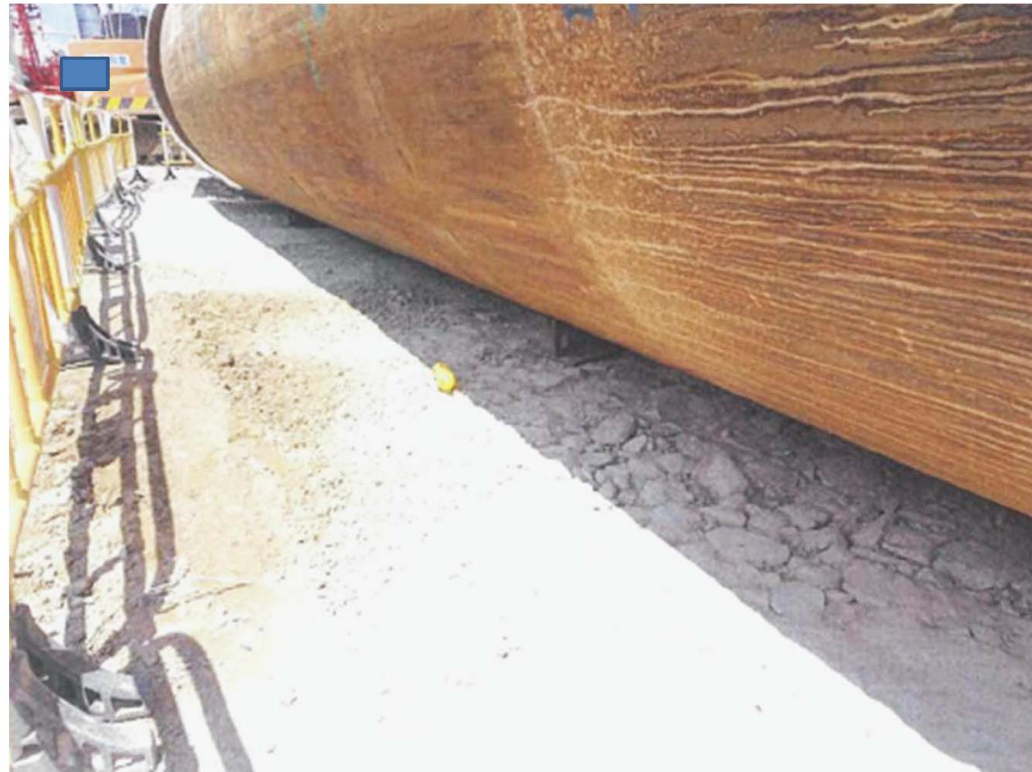
- Proper wedge was provided
- 提供適當楔子存放圓筒物料

Cylindrical materials were provided with wedges to prevent rolling

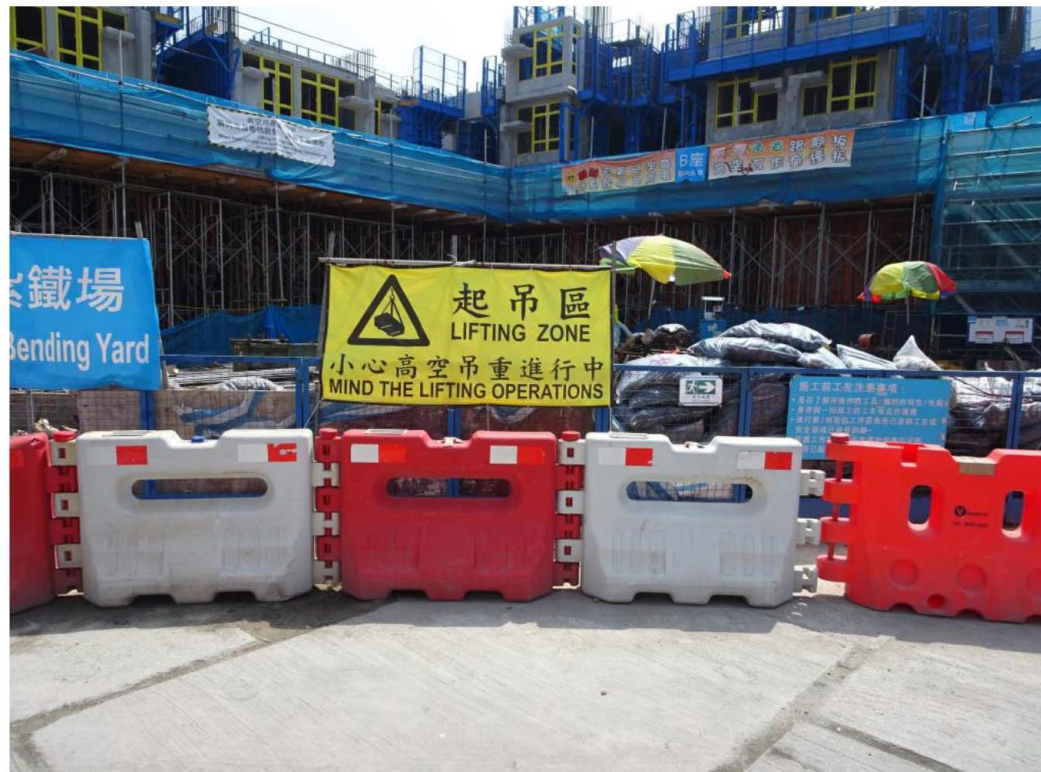
- Lifting zone was fenced off
- 圍封吊運區

Now, lifting areas were required to follow Code of Practice (COP)

giving workers sufficient protection

This was a proper example

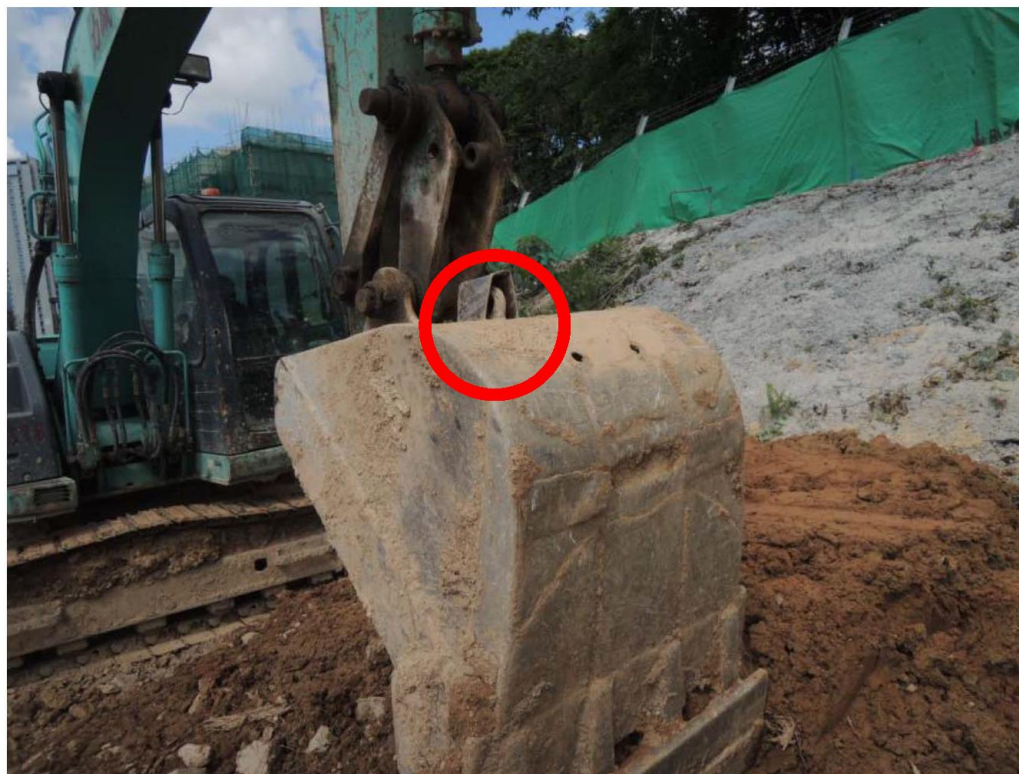
- Covered the lifting hook of excavator
- 封好挖掘機不使用的吊鉤

When not in use, the lifting hook of an excavator

must be sealed in advance

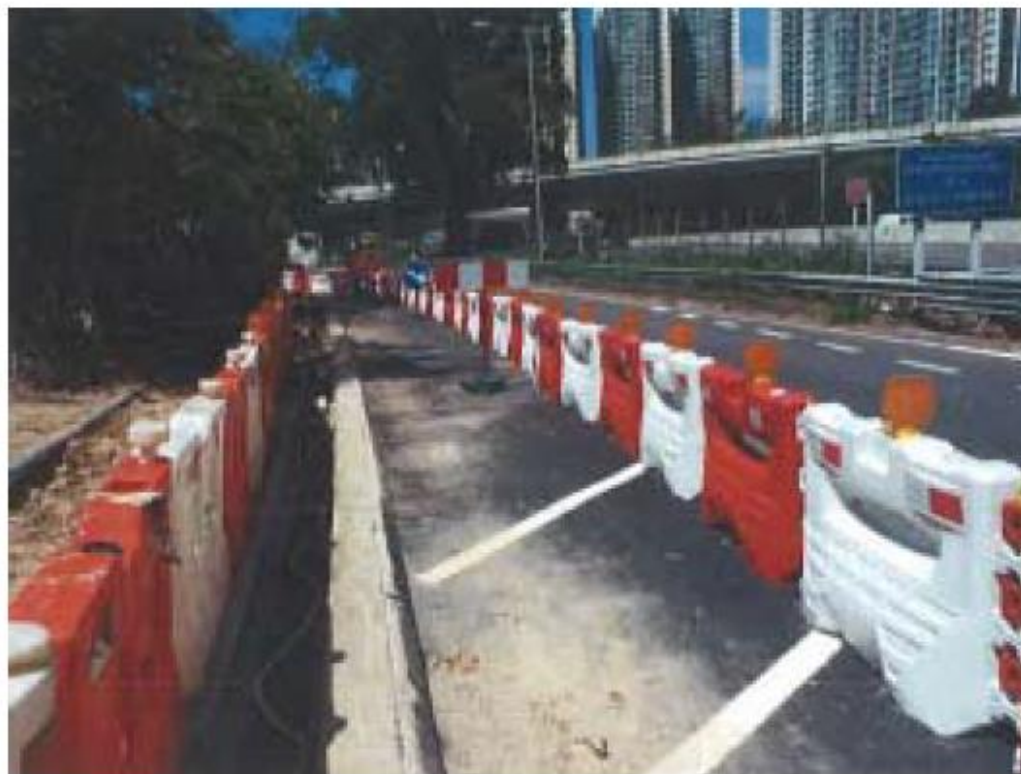
- Demarcate working area properly
- 妥善分隔工作地方

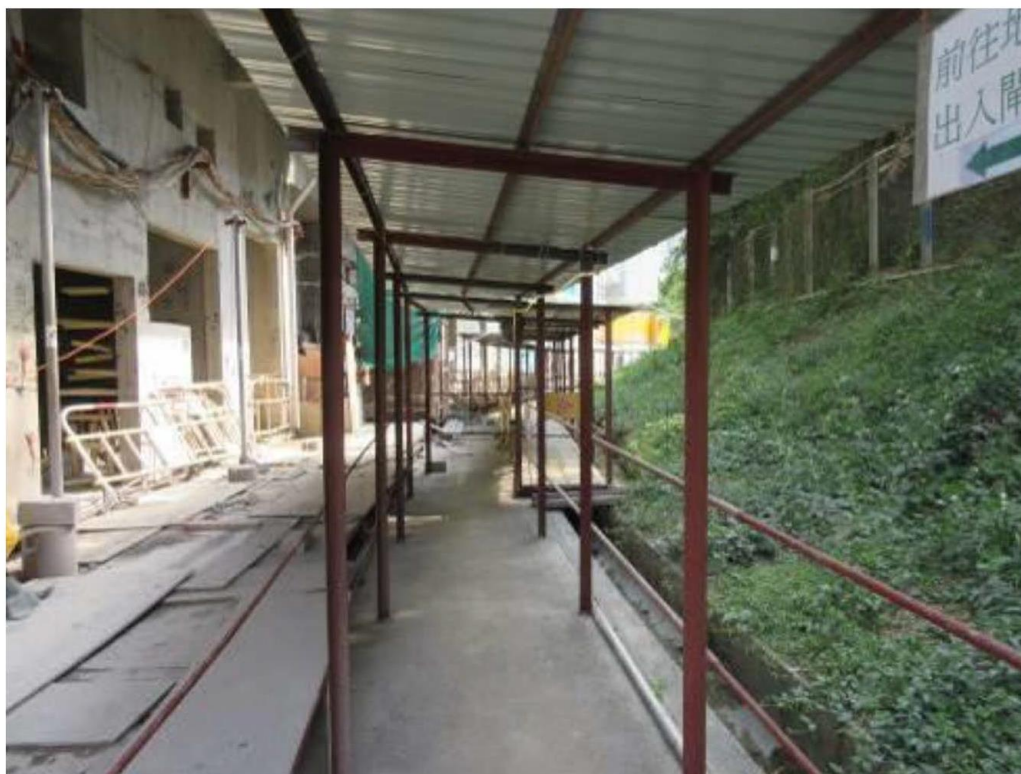
- Covered walkway provided
- 提供有蓋行人通道

Besides, in work areas

there should be a separate pedestrian passageway

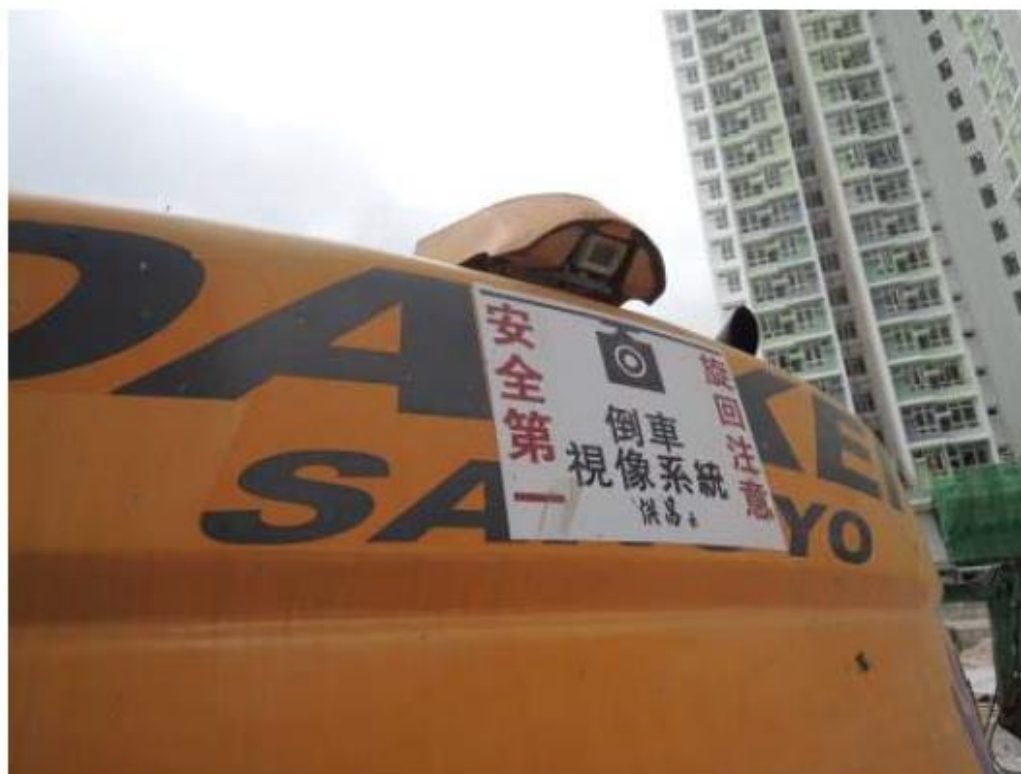
- CCTV provided for excavator
- 為挖掘機提供倒車視像系統

Excavators must be provided with a reversing video device

This installation is quite common

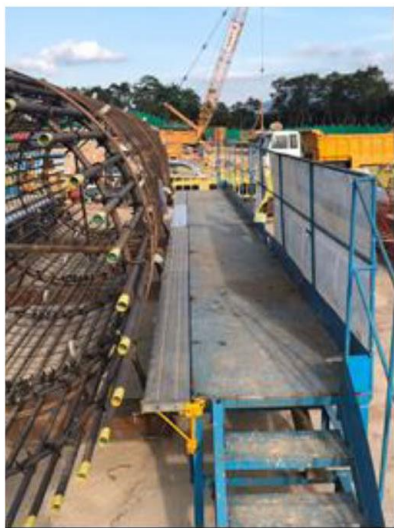
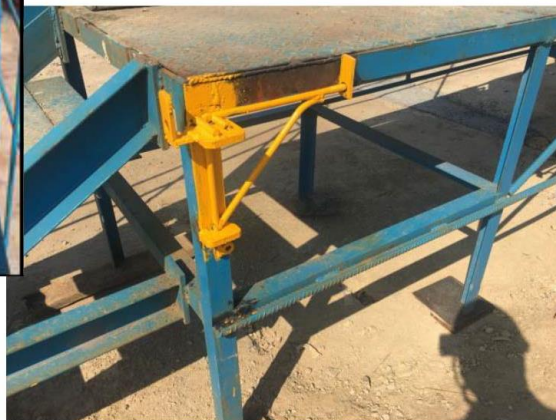
- Fabrication of Reinforcement Cages Working Platform Extension
- 扎結鐵籠可伸延工作台

- This working platform is adjustable which can reduce the gap between reinforcement cage. It can reduce related accident.
- 使用這個可調較的工作台，可減少工作台與鐵籠之間的距離，減少相關的意外發生。

extendable working platforms were used at locations for bar bending

and gaps could be reduced

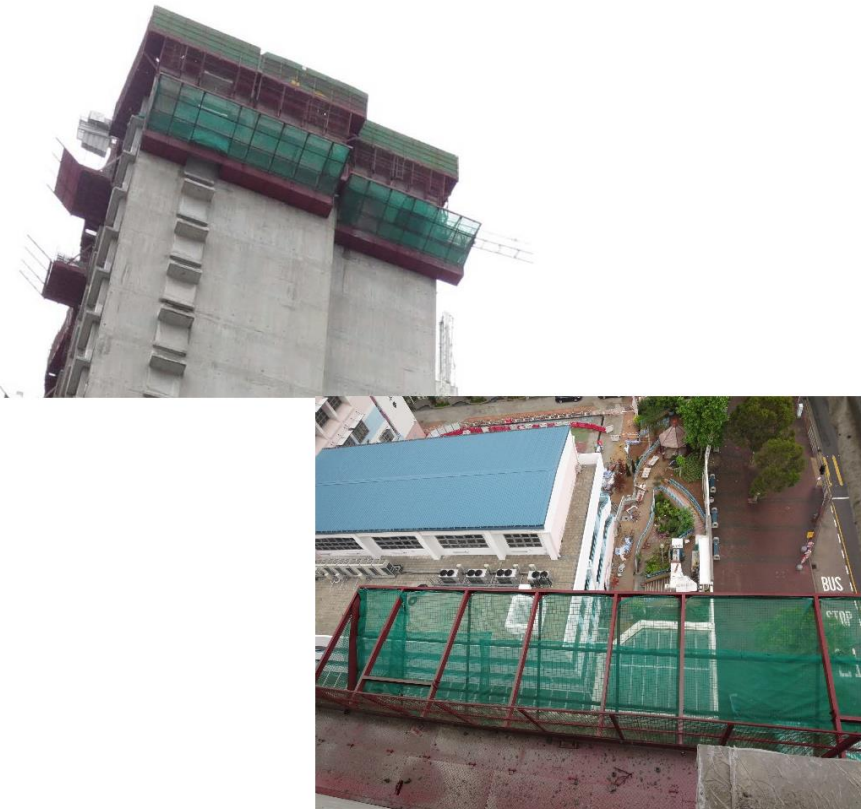
- External Wall Mounted Working Platform with Wall Mounted Catch Fan
- 外牆式工作平台連掛牆斜棚
- The external wall mounted working platform was installed with catch fan which could help to collect falling materials of the building. This safety design could effectively improve the risk of falling objects.
- 外牆式工作平台及裝有掛牆斜棚，有助收集建築物的下墜物。這安全設計可以有效地改善物料下墜的風險。

This was an external wall mounted working platform with wall mounted catch fan

Very often, when the catch fan was raised

when the concrete work of a floor was finished

This catch fan was lifted every 5 floors

The purpose was to keep as closely as possible to the working floor

that was to reduce the chance of falling objects

and stop materials from falling during work

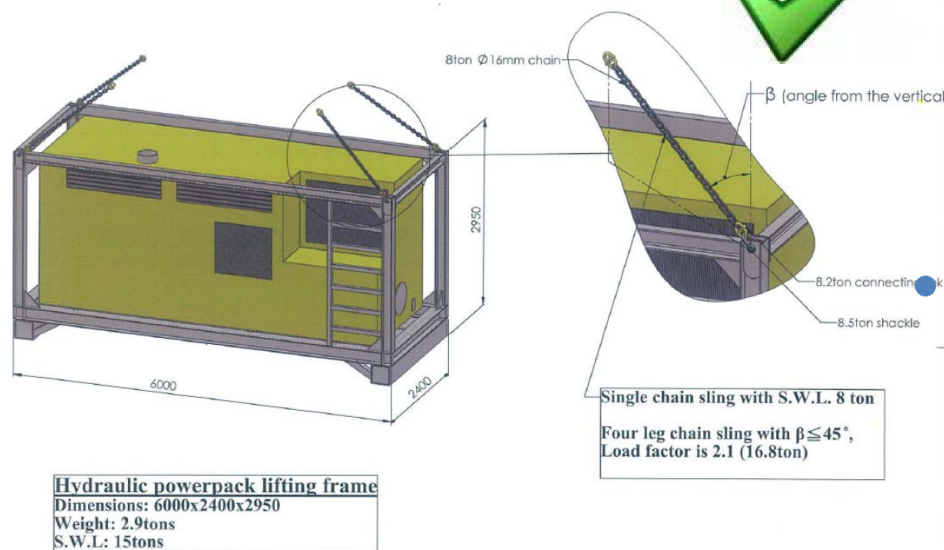
- Bridging Chains on Corners of Steel Frame
- 吊架加裝接駁短鏈

- Adding bridging chains on the 4 corners of steel frame to eliminate workers to work at height while rigging. This device would allow workers rigging on ground and reduce the chance to work-above ground. It can effectively eliminate the risk of working at height while rigging.

於吊架頂部每隻角位置，加裝接駁鏈一條(即共4條)，以便埋碼員可以站於地上進行埋碼工作，以完全剔除高空工作之風險。

Bridging chains were added on corners of steel frame

an easier way to explain, it was a short chain is put in each corner

During lifting, workers on the ground floor could carry out rigging

They need not climb up or use a ladder

They only have to work on ground level

This reduced the risks of working at height

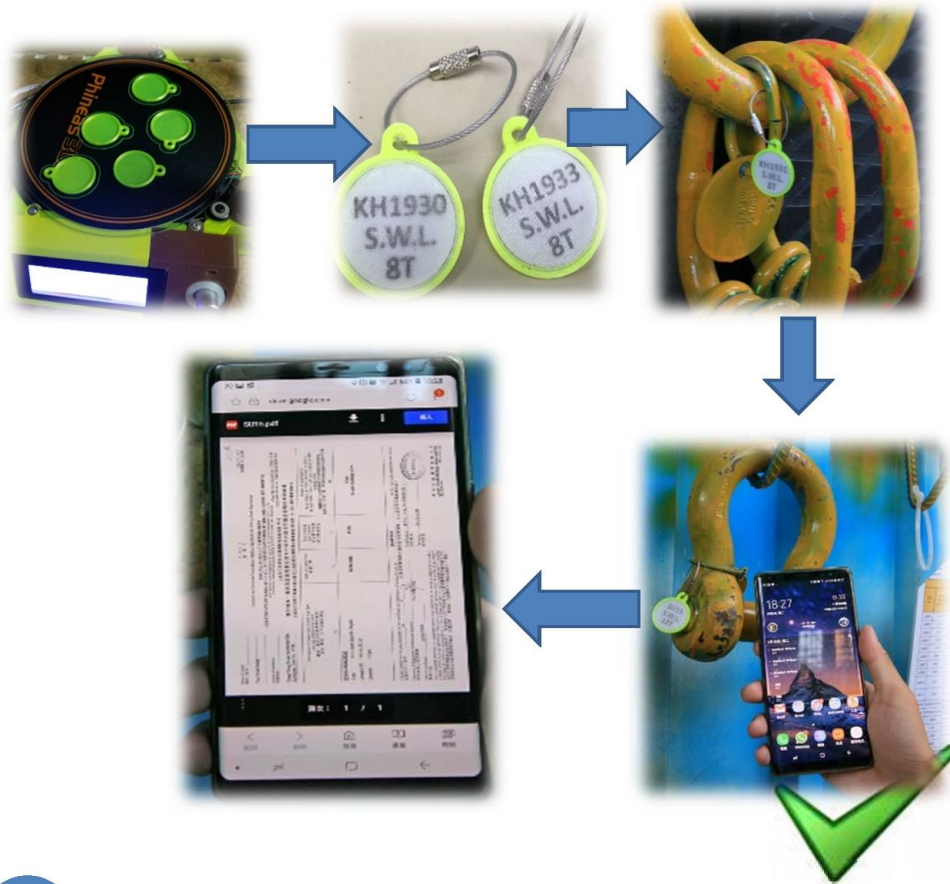
- Smart Tag
- 智能吊牌

- Print the tailor made Smart Tag on the 3D printer with RFID label. Worker/Site Supervisory Staff can read the lifting certificates information by touching the Smart Tag with their mobile phone.
- 根據不同吊具尺寸以3D打印機度身訂造內置RFID標籤吊具牌，工友/地盤管理人員以手機觸碰標籤以閱讀吊運証書資料。

This was smart tag of lifting tools, a RFID technique

Custom made with 3D printing

According to the tools and their designs

different tags could be printed with RFID cards fitted internally

Foremen and workers could use these tags with ease

using a smart phone to read lifting certificates and other information

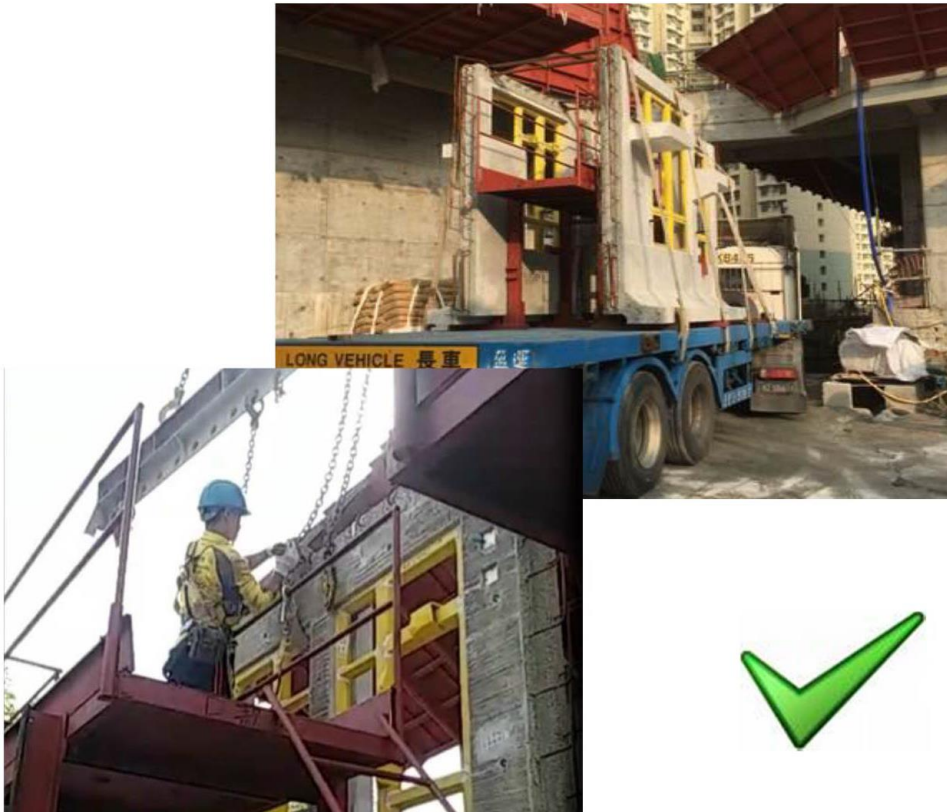
- Permanent working platform at the trailer for handling precast facade
- 拖車預製件永久工作平台
- The permanent working platform was installed at the trailer to reduce the worker using temporary working platform or ladder. Risk of fall from height would be reduced significantly. This provision would further enhance the working at height safety and improve the efficiency of the worker.

安裝在拖車上之預製件永久工作平台，可以減少埋碼員在臨時工作台或梯子上進行埋碼工作。從而減少從高處下墮的風險。這項設計將進一步改善高空工作的安全，並提高工作效率。

Permanent working platforms could be fixed on trailers

for handling precast components

Working platforms were prepared for hanging and removing the hooks

Platforms and ladders were not needed to attach the hooks

This could be fixed on the trailer in advance
