Housing Authority Surprise Safety Inspection Programme (SSIP) Good & Bad Practices for 2023 Q2 & Q3

香港房屋委員會 突擊安全巡查計劃

2023 Q2 & Q3 良好及不良作業

"Surprise Safety Inspection Programme (SSIP) – Findings in Quarter 2 of 2023 to Quarter 3 of 2023"

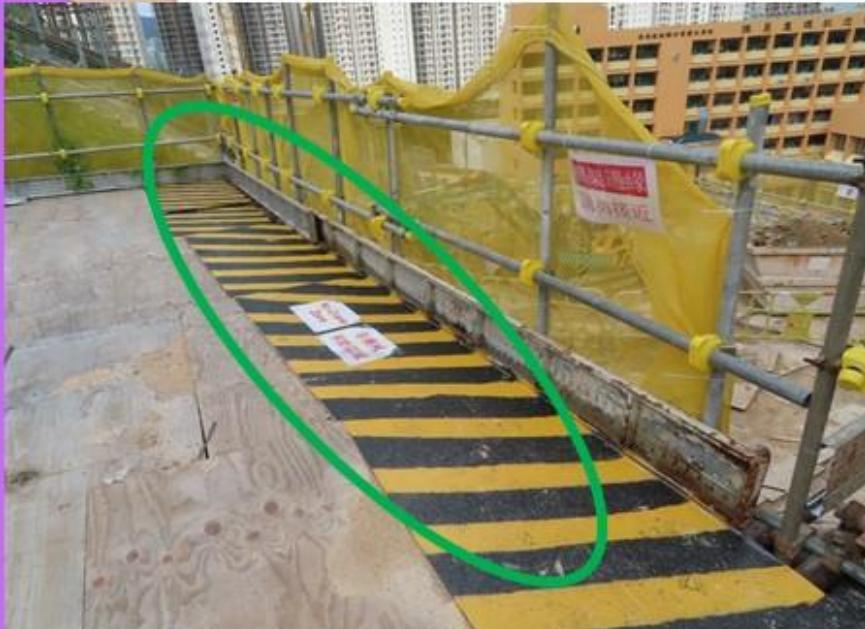
Pik Wan Road, Site A and Site B

在斜坡杉棚上提供有清晰識別的非機械移動區域。

Provision of clear identification of No Crane Zone on a timber scaffold on slope.

In the left photo
we can clearly see good practice on the bamboo scaffolding
Heavy machinery should not be placed
near the edges or load-bearing areas
It must be placed in suitable positions

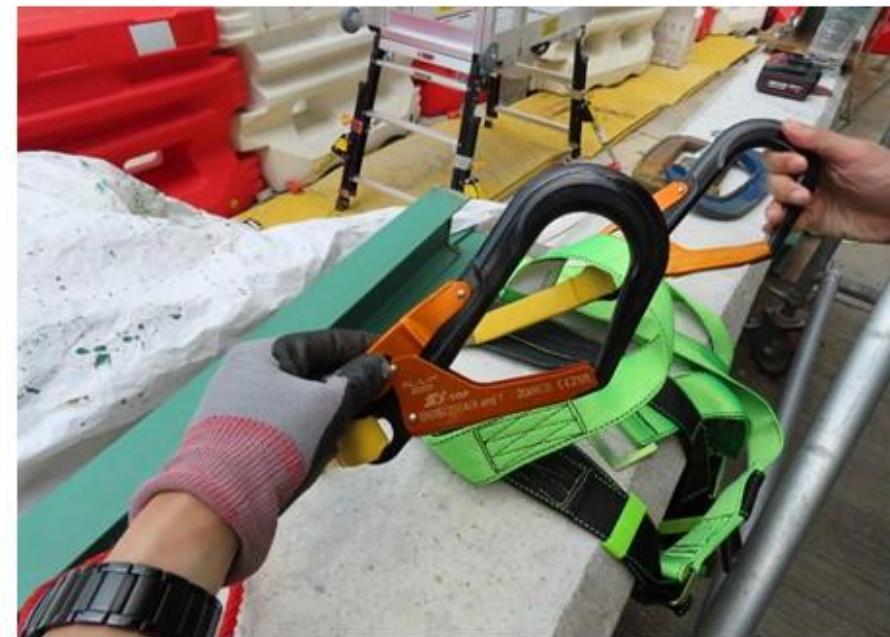
Hang Tai Road, Ma On Shan Area 86B Phase 2

提供輕量型個人防護裝備。

Provision of light-duty PPE.

On the right, we encouraged workers to use lightweight double-lanyard safety harness
Traditional double-lanyard harnesses are heavier
this lightweight version is about 20 to 30 percent lighter
We have also procured and promoted
fall arresters that comply with standards
