HASAS(NW) – 2024Q2-2024Q3
Summary on Audit Findings
房委會安全稽核制度 - 2024年第2季及-2024年第3季
安全稽核結果

1. Overview on HASAS (NW) & HALENSAS Performance
2. Summary on Audit Findings 2024 Q2 – 2024 Q3

Housing Authority Safety Auditing System (HASAS) (For Building and Engineering Contracts)

Findings in Quarter 2 of 2024 and Quarter 3 of 2024

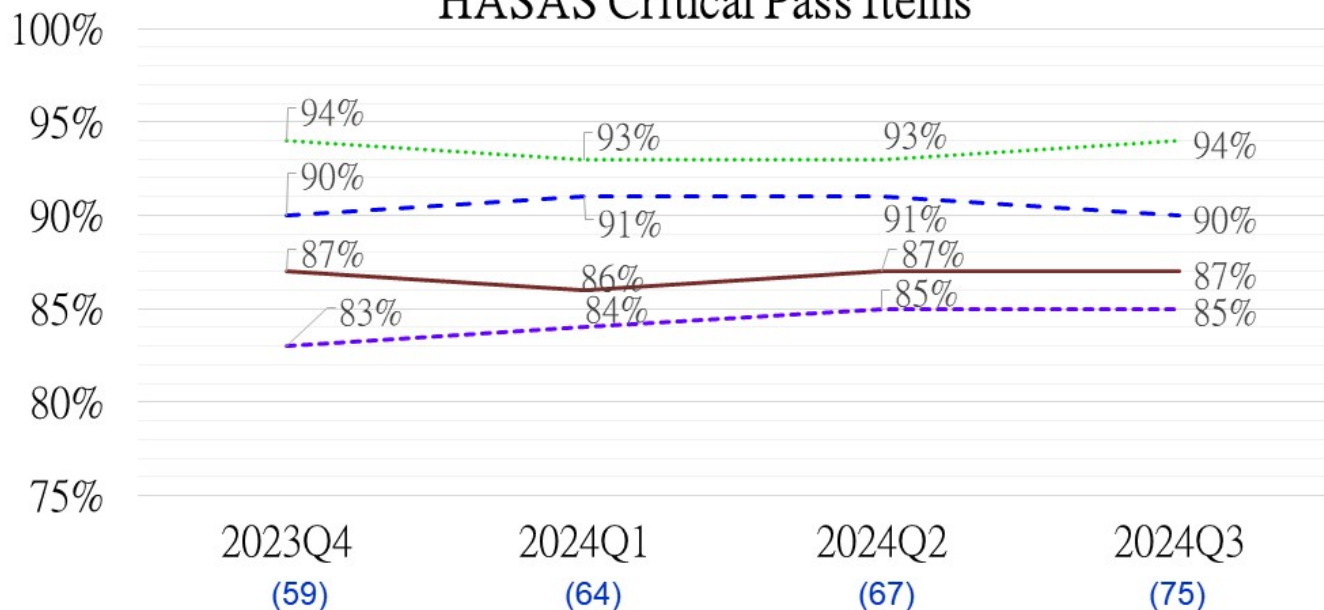
HASAS Critical Pass Items

--- Section 14.2.3 - Lifting Operations

--- Section 14.4.1 - Tower Crane

..... Section 14.3.2 - Electrical Supply System

— Section 14.4.2 - Mobile Crane

The green line at the top represents electrical systems improved by 1%

The blue dotted line representing tower cranes dropped by 1%

The brown line and the bottom-most line represent safe use of mobile cranes and tower cranes

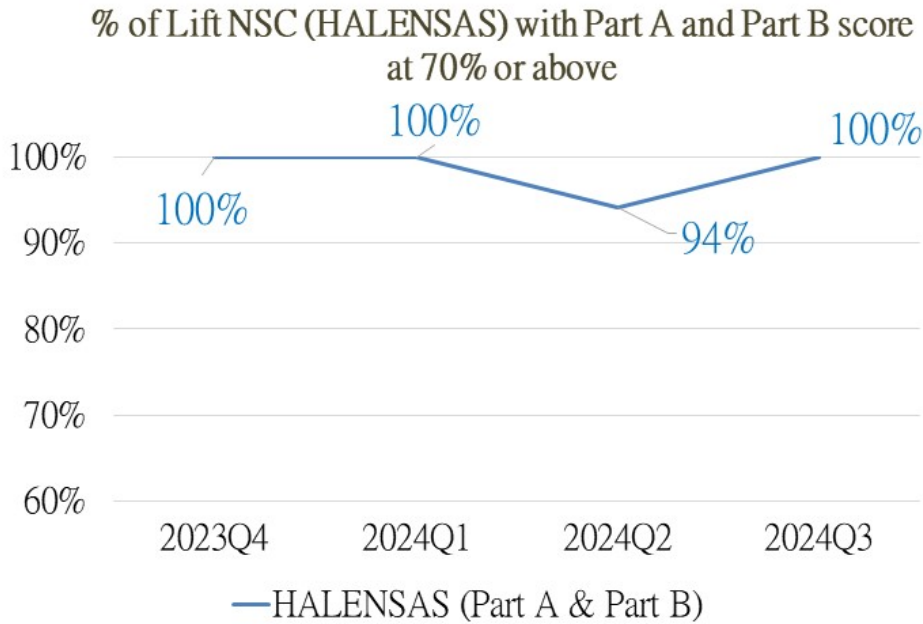
Chart 1E

2023 Q4	2024 Q1	2024 Q2	2024 Q3
HALENSAS	17(17)	16(16)	16(17)	19(19)

For lift and escalator works, 19 contracts were audited

All passed with scores of 70 or above in Q3

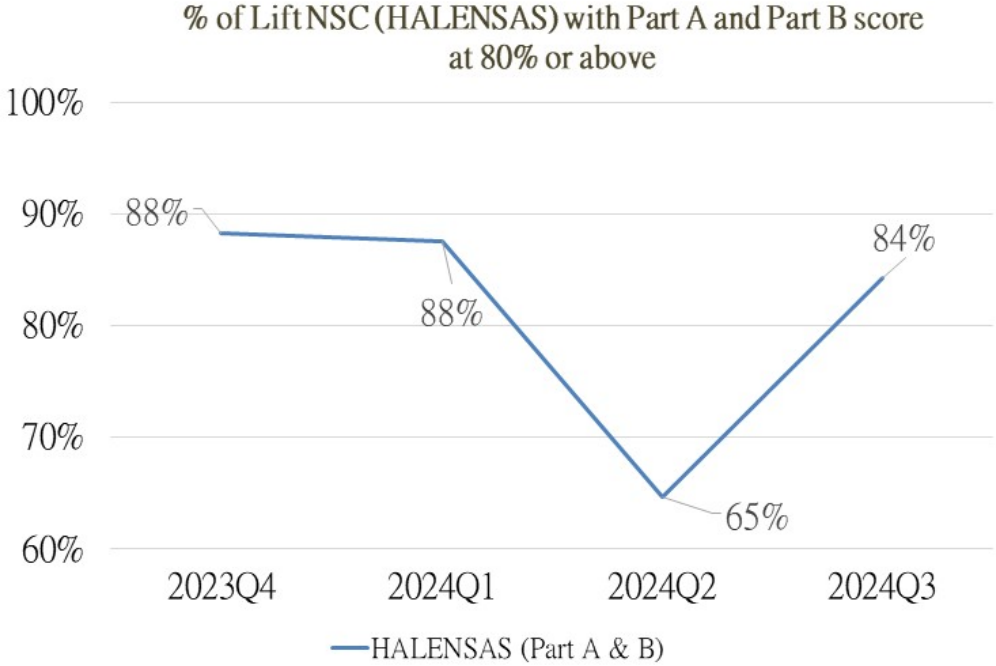
Chart 1F

2023 Q4	2024 Q1	2024 Q2	2024 Q3
HALENSAS	15(17)	14(16)	11(17)	16(19)

Most also met the 80-point requirement

84% of them reached that level

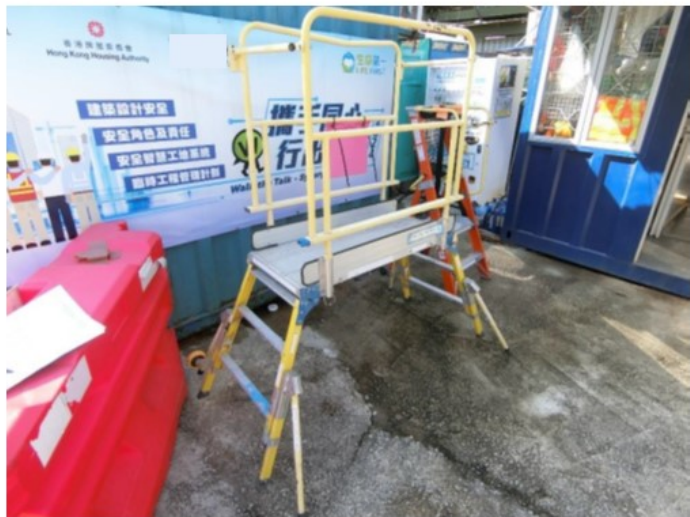
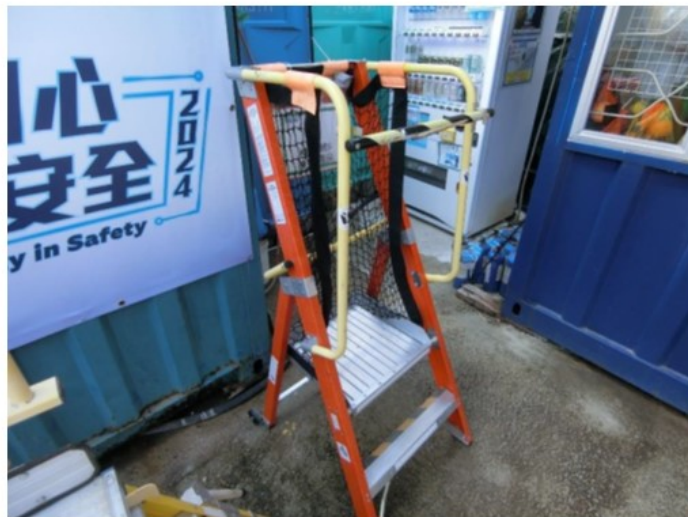
- Provision of suitable platform ladder and hop-up platform
- 提供合適梯台及功夫橈

Many have adopted compliant step platforms or hop-up platforms

The current standard is EN131-7

EN131-7 ensures anti-tip testing has been passed

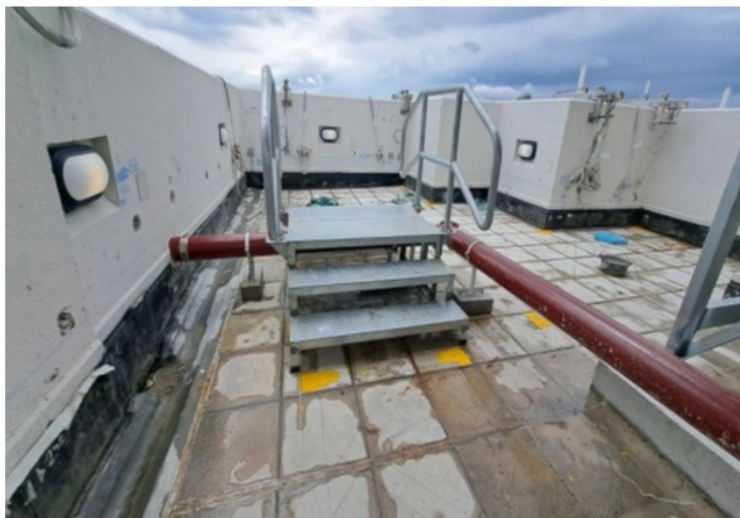
- Safe access & egress were provided
- 提供安全進出通道

you can see access platforms built to cross over pipework

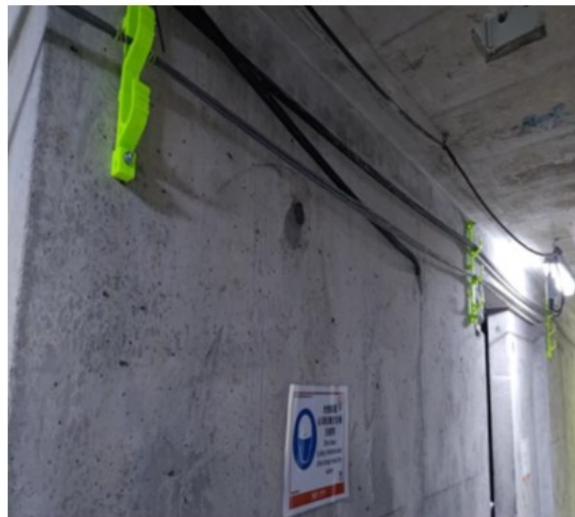
- Electric cable was properly suspended
- 電線妥善掛高

Indoor spaces also have cable supports installed

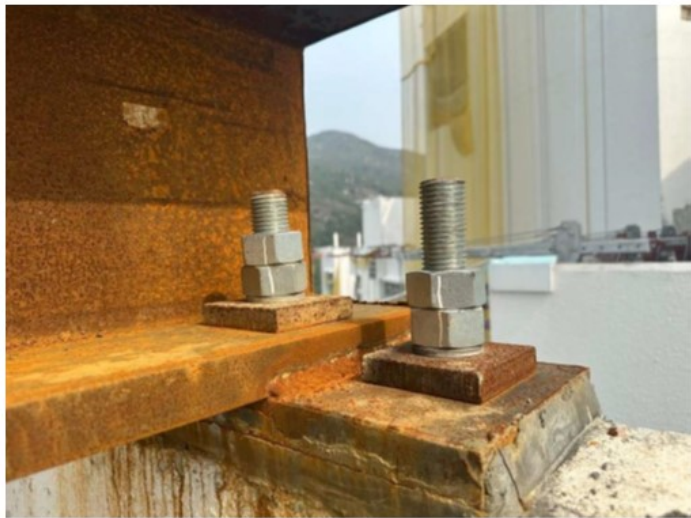
- Applying markings to the bolts to monitor the tightening status
- 於螺栓上加上標記以監察其緊固狀態
- Provision of bridging chains for the steel frame housing generator to avoid rigging at height
- 於發電機加裝吊架接駁吊鏈以便埋碼員可以站於地上進行埋碼工作

is drawing a straight line across bolts and nuts

This helps to monitor whether any bolts have shifted

or been loosened, which is a good practice

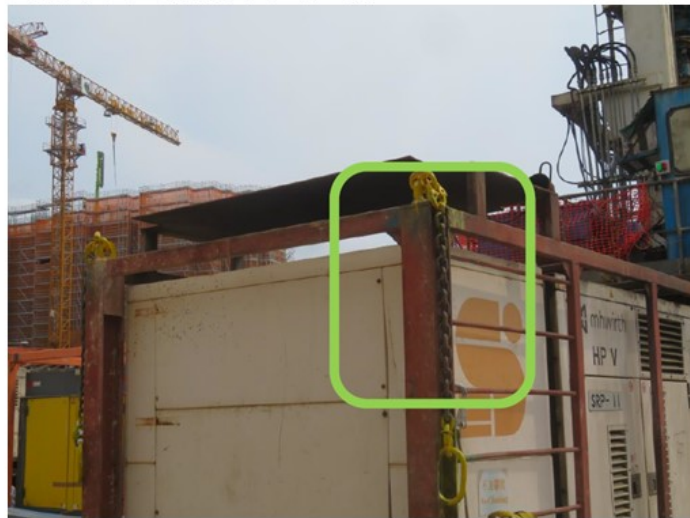
On the right, a generator has been secured with four chains at the corners

This helps rigging personnel anchor it properly from ground level

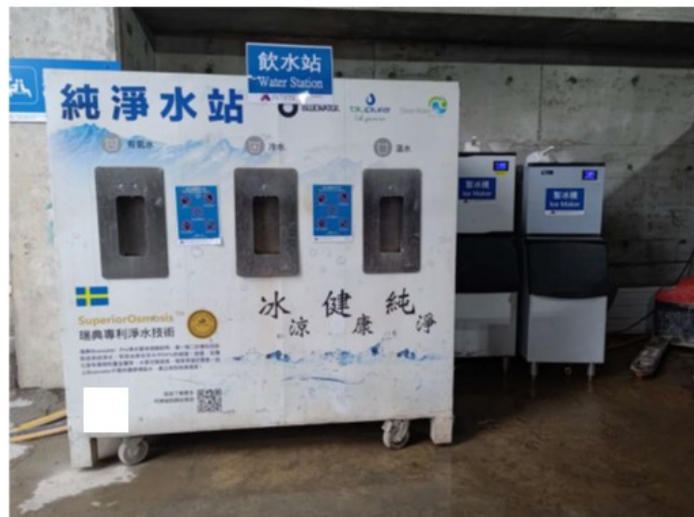
- Provision of sufficient welfare facilities
- 提供足夠的福利設施

which is good welfare facilities provided by a site

They imported a water dispenser from overseas

It provides hot and cold water, as well as sparkling water

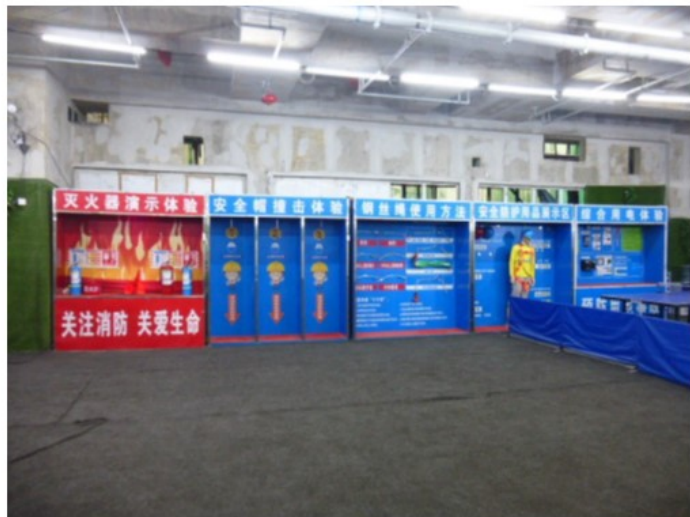
- Provision of somatosensory safety training facilities
- 提供體感安全訓練設施
- Alerting system was installed at the entrance of confined space
- 於密閉空間進出口安裝警示監察系統

In one of the contracts, they set up a facility

to let workers experience safety scenarios

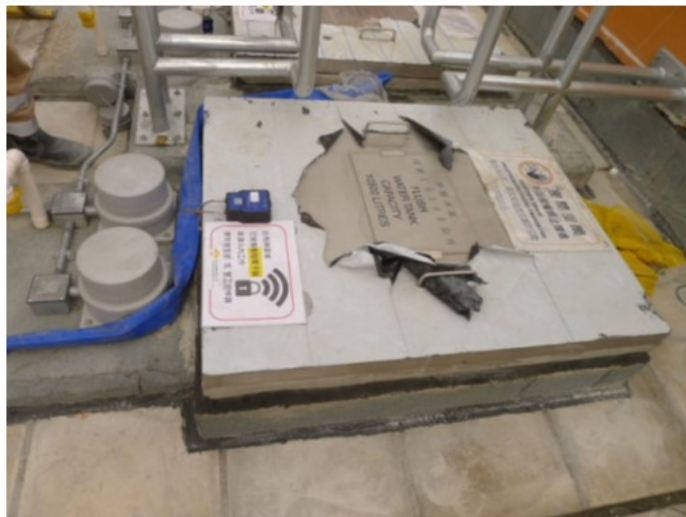
is an alert system installed at confined space entrances and exits

When the cover is opened when someone is trying to enter

it sounds an alert so that site management can pay attention

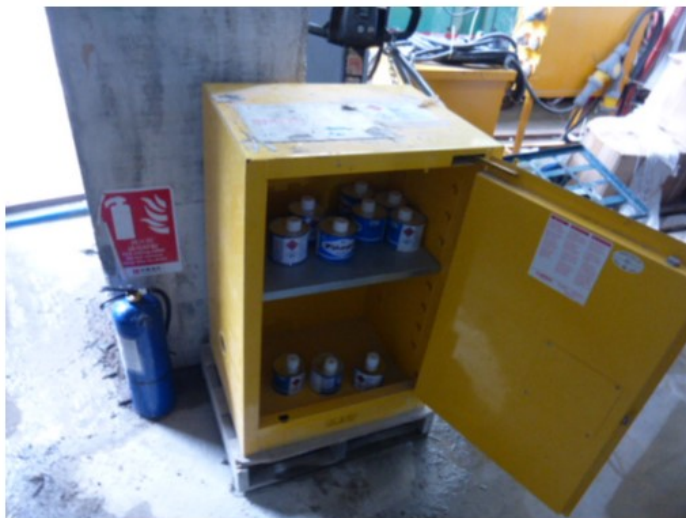
- Flammable storage cabinet was provided
- 提供易燃物品儲存櫃

Many nominated sub-contractors have procured flammable goods storage cabinets

to store such items safely

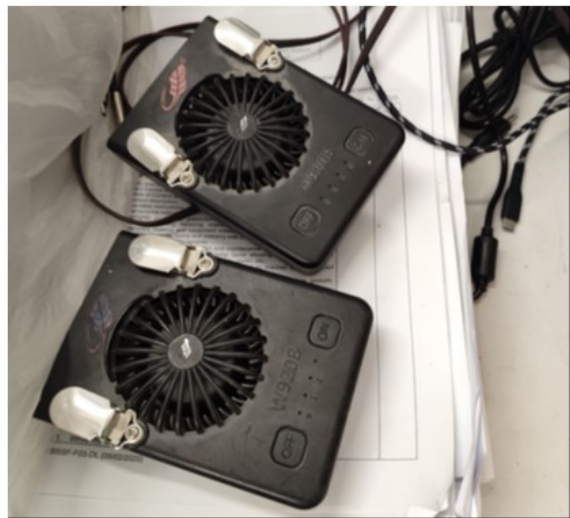
- Provision of portable fan
- 提供便攜風扇

On the right is a portable fan

used to help workers cool down during summer

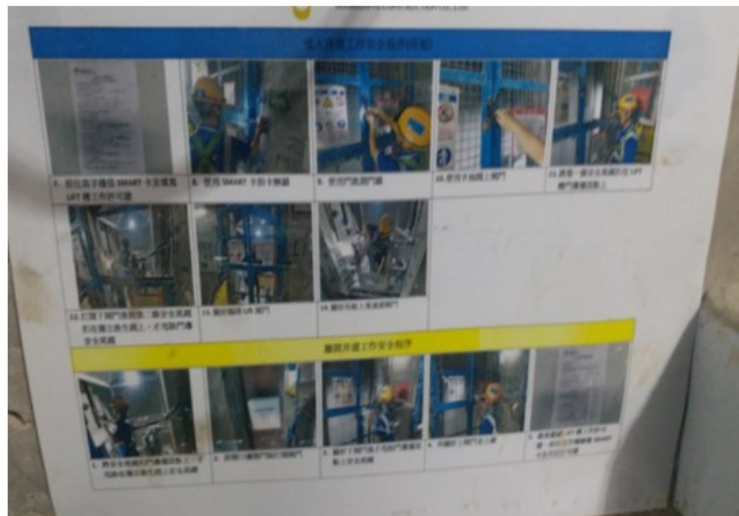
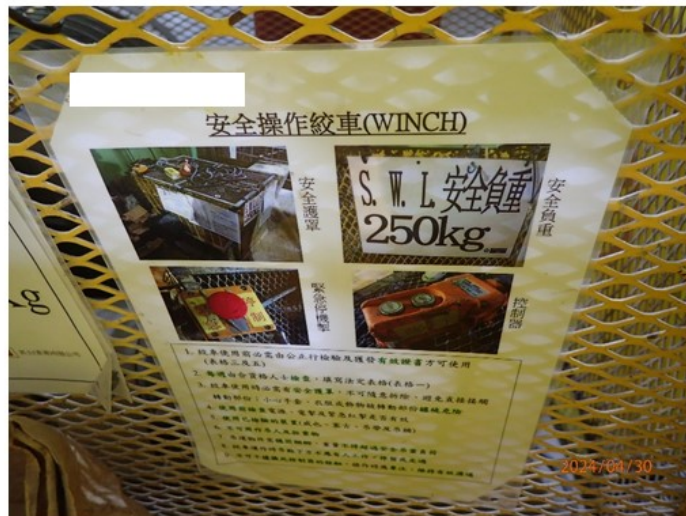
- Safe working procedures were displayed
- 張貼安全工作程序

we saw many visualised graphical work procedures posted on site

visual guides help them better understand the requirements

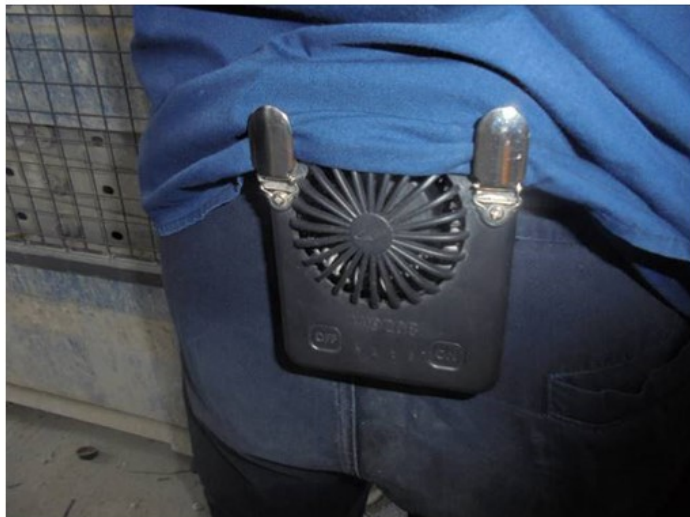
- Provision of portable fan
- 提供便攜風扇

Again, we see good use of portable fans and tidy material storage

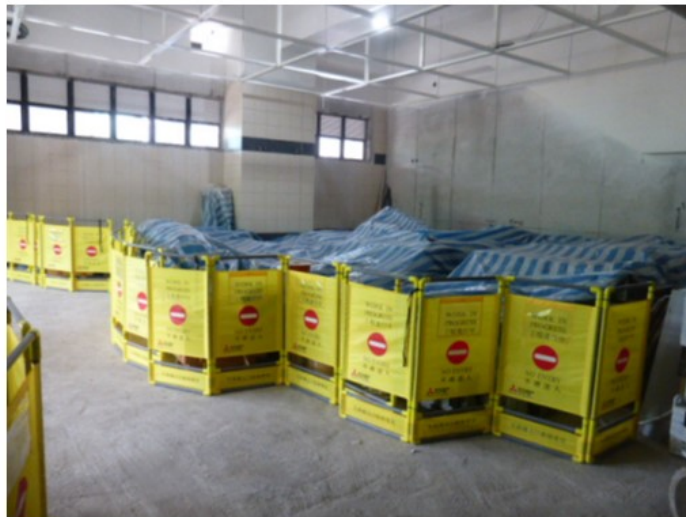
- Materials were properly stored
- 物料妥善存放
